INDOOR AIR QUALITY REASSESSMENT

**Waterford Street School
62 Waterford Street
Gardner, Massachusetts**

Prepared by:
Massachusetts Department of Public Health
Bureau of Environmental Health
Indoor Air Quality Program
June 2010

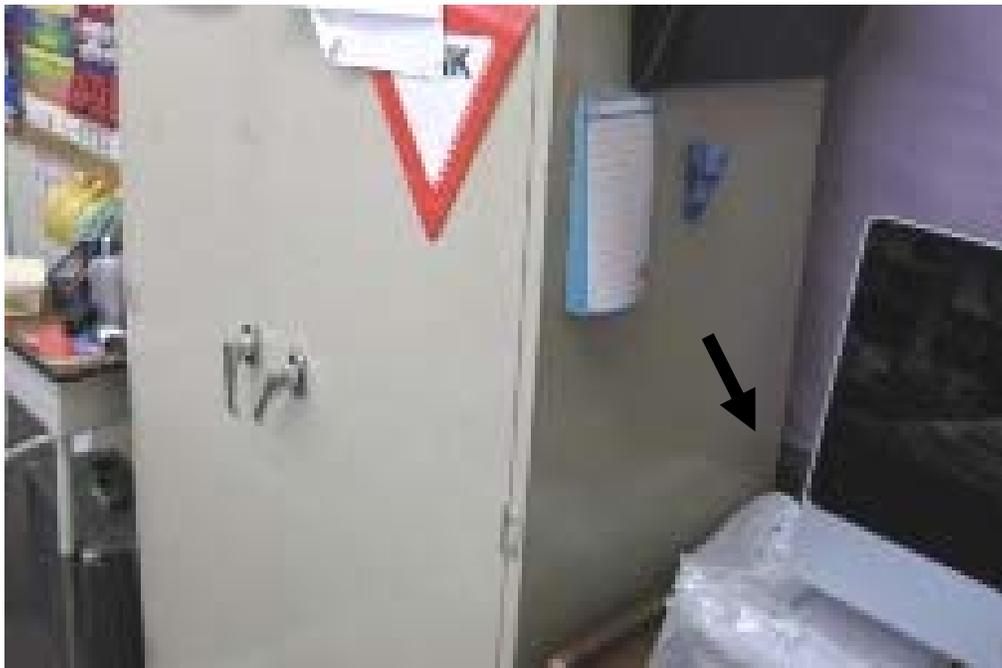
Picture 2

The mechanical exhaust system in classrooms consists of grated wall vents ducted to rooftop motors. A number of the exhaust vents were blocked by furniture and classroom supplies (Picture 2). As with the univents, in order to function properly, exhaust vents must remain free of obstructions.

Exhaust Blocked by Metal Cabinet

6. Remove obstructions from in front of ventilation equipment.
7. For buildings in New England, periods of low relative humidity during the winter are often unavoidable. Therefore, scrupulous cleaning practices should be adopted to minimize common indoor air contaminants whose irritant effects can be enhanced when the relative humidity is low. To control dusts, a high efficiency particulate arrestance (HEPA) filter equipped vacuum cleaner in conjunction with wet wiping of all surfaces is recommended. Avoid the use of feather dusters. Drinking water during the day can help ease some symptoms associated with a dry environment (throat and sinus irritations).

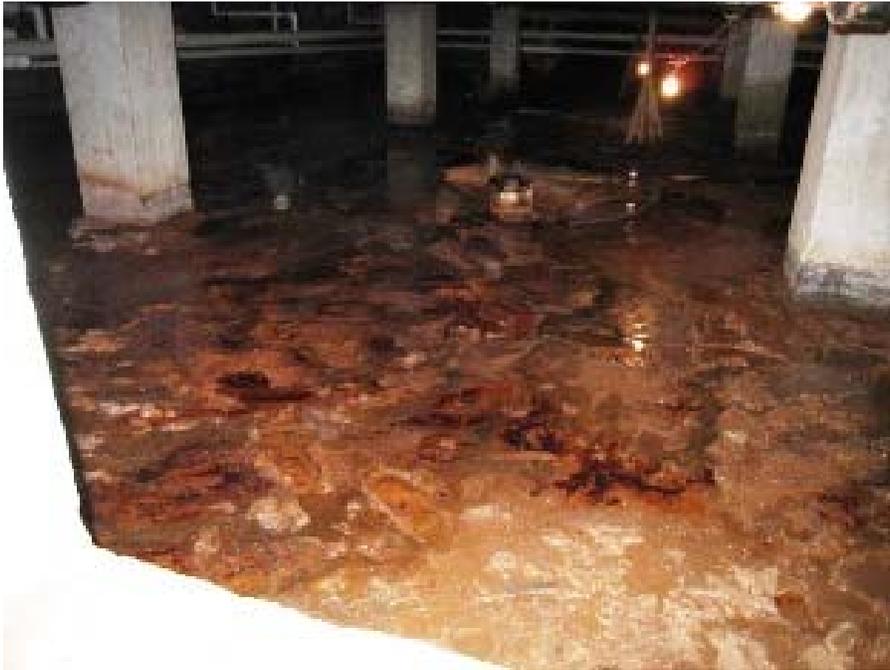
Picture 3

The crawlspace contained a substantial amount of standing water (Picture 3). It was reported by WSS staff that the school was built on a swamp; four sump pumps operate year round to pump water from the crawlspace. The high water mark observed on pillars within the crawlspace indicates the water rises substantially during high groundwater conditions. Mr. O'Brien reported that the crawlspace is passively vented by a series of pits located along the exterior wall/foundation of the building (MDPH, 2007). Most of these vents were obstructed by heavy snow cover during the assessment; however, preventing air flow (Picture 4). Another vent was covered by pea stone (Picture 5). If vents are not kept clear of snow, melting snow will likely enter the crawlspace in warmer weather. In addition to the passive ventilation, Mr. O'Brien reported that a mechanical ventilation system exists to exhaust air from the crawlspace through a rooftop vent.

Standing Water in Crawlspace

10. Routinely monitor and maintain sump pumps in good working order.
11. Repair deteriorated mortar on exterior masonry.
12. Repair areas of broken, missing concrete.

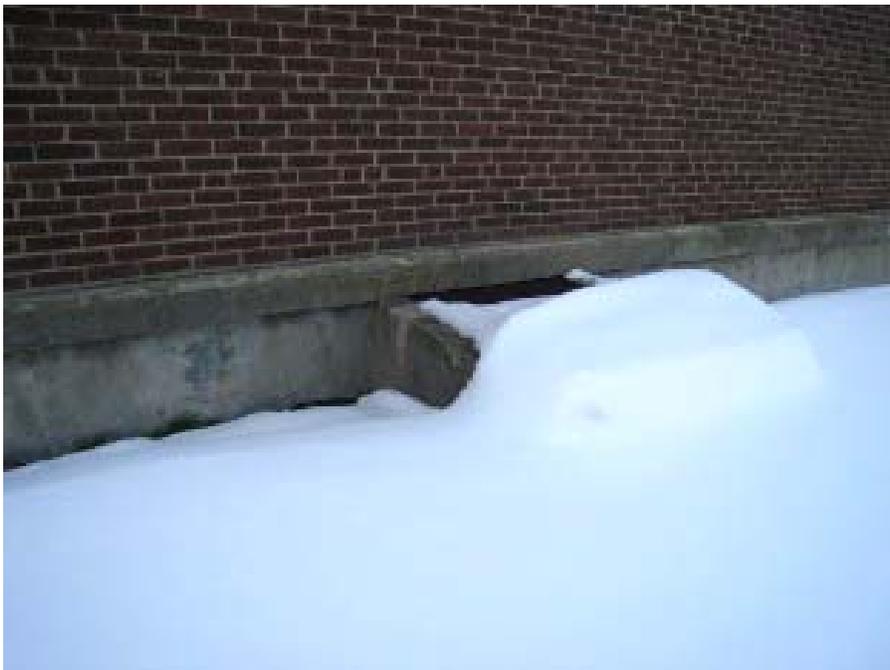
Picture 4

Passive Vent Covered With Snow

8. Clear all obstructions from the grates on top of exterior passive vents.
9. Ensure mechanical ventilation for crawlspace is functioning at all times.

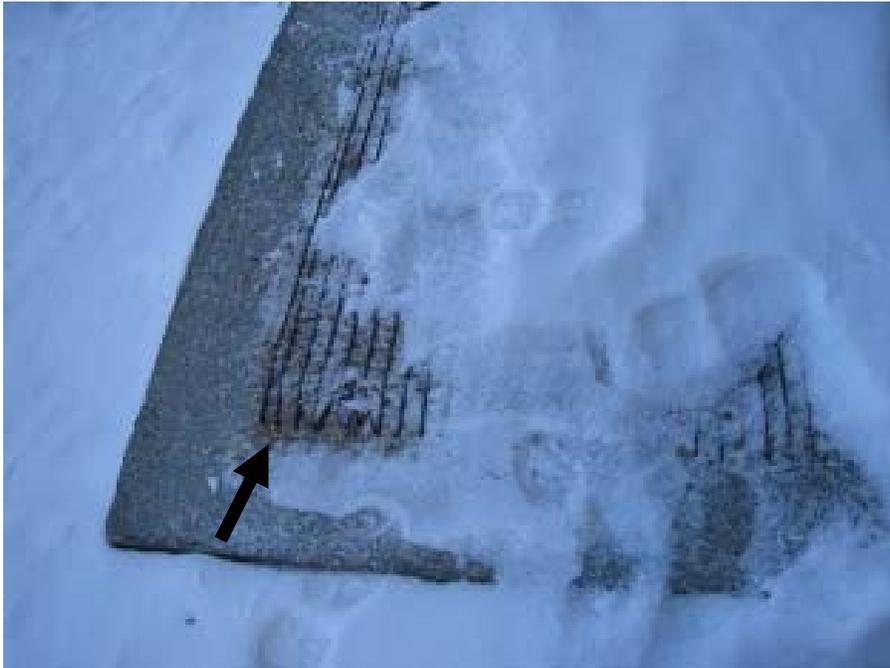
Picture 5

Passive Vent Obstructed by Pea Stone and Snow

- **Remove gravel from the passive foundation vent shown in Picture 6.**
 - **Action:** At least one vent was filled with gravel on the day of the reassessment.

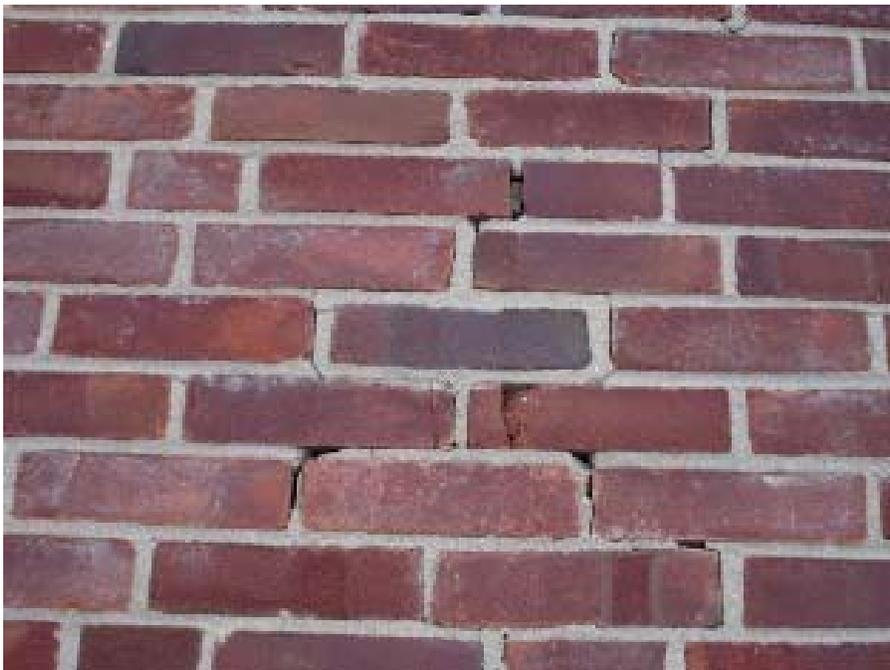
Picture 6

Cracked, Deteriorated Mortar

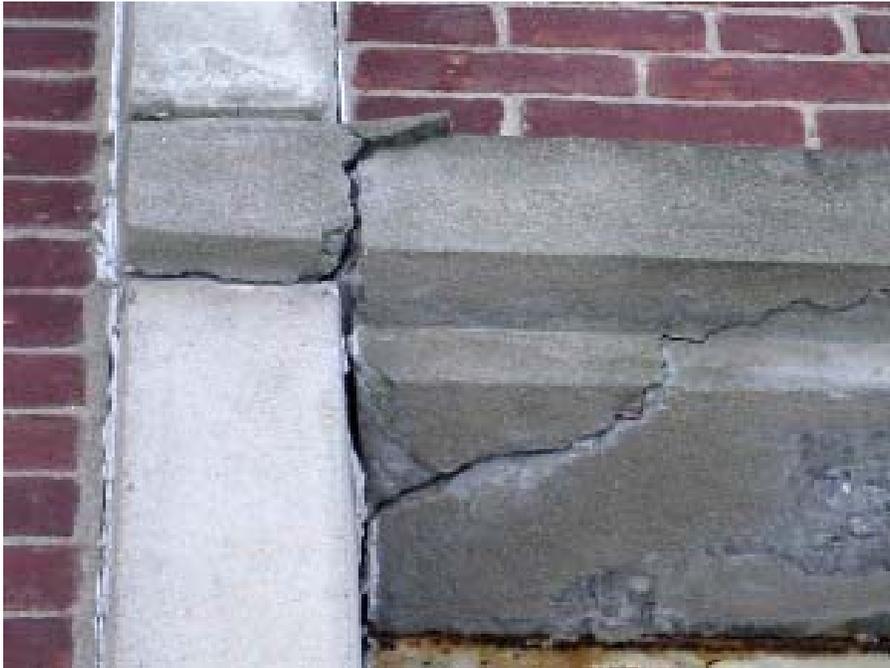
Picture 7

Crevices and Deteriorated Concrete

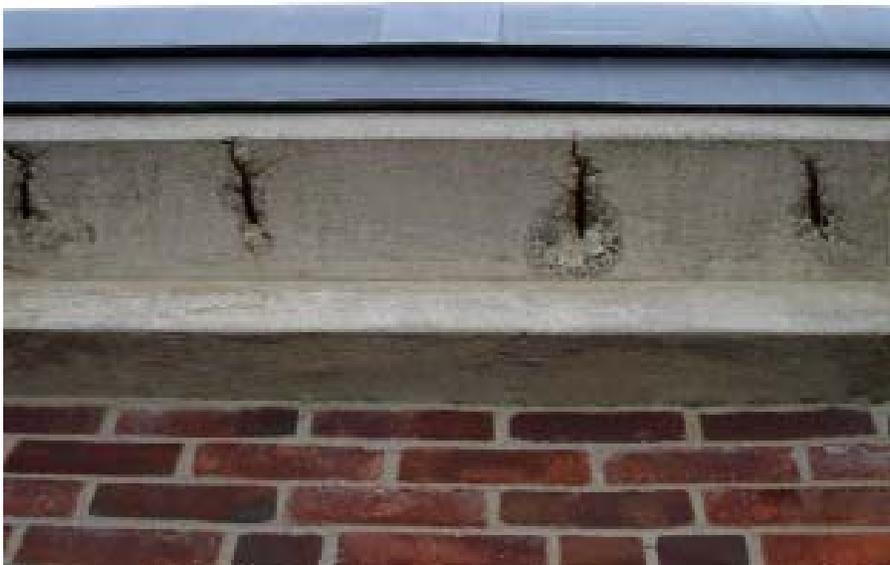
Picture 8

Failing Concrete and Exposed Rebar

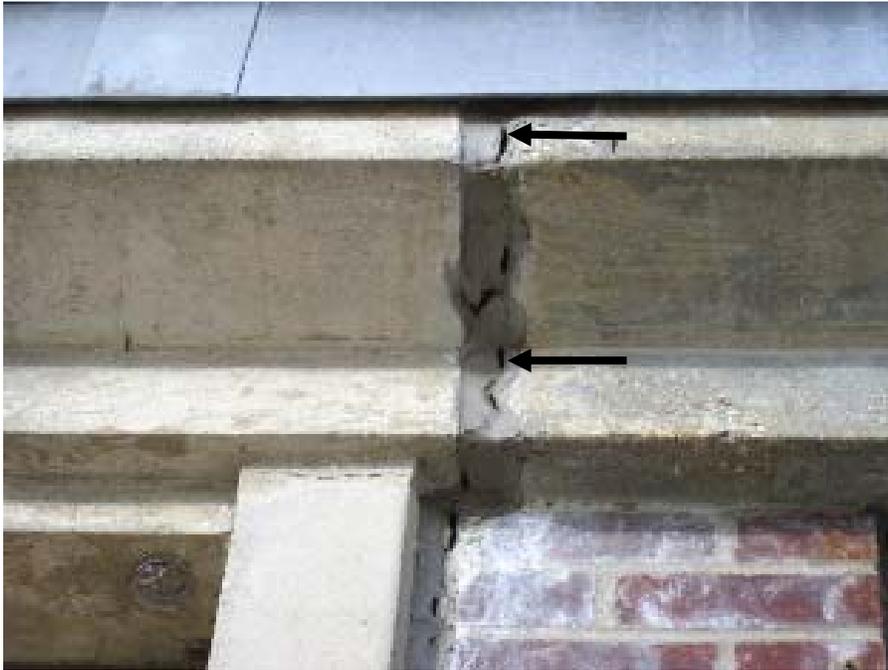
Picture 9

Expansion Joint Sealant in Disrepair

13. Address deteriorated window and expansion joint sealants in accordance with EPA regulations and the MDPH guidance document related to PCBs in building materials.

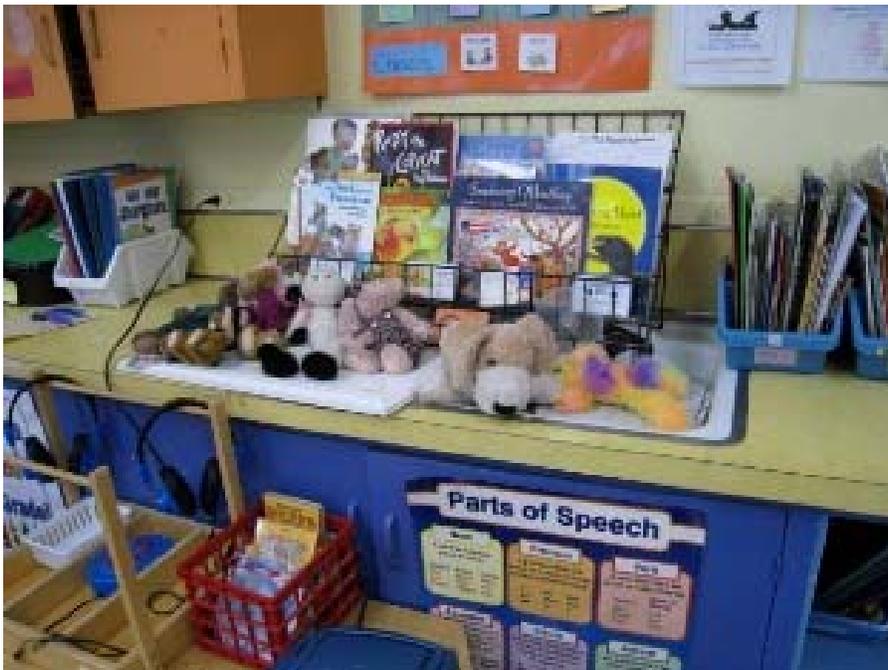
Picture 10

Double Bay Sink Utilized for Storage

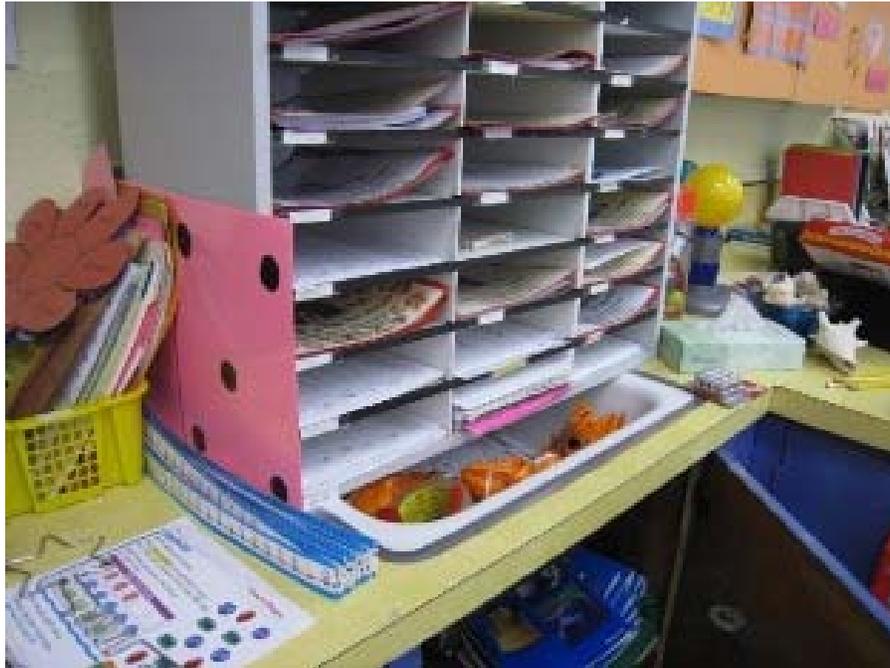
Picture 11

Other conditions that can affect indoor air quality were observed during the assessment. In at least two classrooms, sinks had dry drains. The purpose of a drain trap is to prevent sewer gases and odors from entering the occupied space. When water is poured into a trap, an air tight seal is created by the water in the U-bend section of the pipe. These drains must have water poured into the traps at least twice a week to maintain the integrity of the seal. Without water, the drain opens the room to the drainage system. In one classroom, sinks were used as storage compartments with unsealed drains (Pictures 10 and 11). If a mechanical device (e.g., exhaust fan) depressurizes the room, air, gas and odors can be drawn from the drainage system into the room. The effect of this phenomenon can be increased if heavy rains cause an air backup in the drainage system.

Sink With Dry Drain

17. Pour water into drains twice a week (or as needed) to maintain an airtight seal.
18. Disconnect service to unused sinks, then seal drains.
19. Eliminate use of air fresheners.

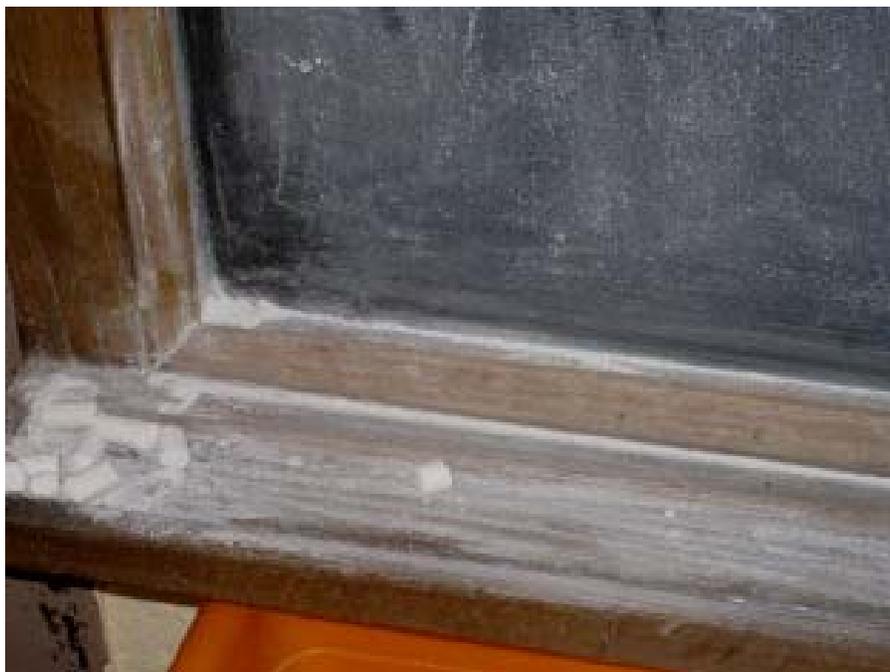
Picture 12

Chalk Dust Accumulation

22. Routinely clean dust accumulation from personal fans.
23. Periodically clean chalkboards and trays of accumulated dust.
24. Seal spaces around utility holes and breaches in walls/floors and ceilings with an appropriate fire-rated sealant, paying particular attention to breaches between the first floor and the crawlspace.

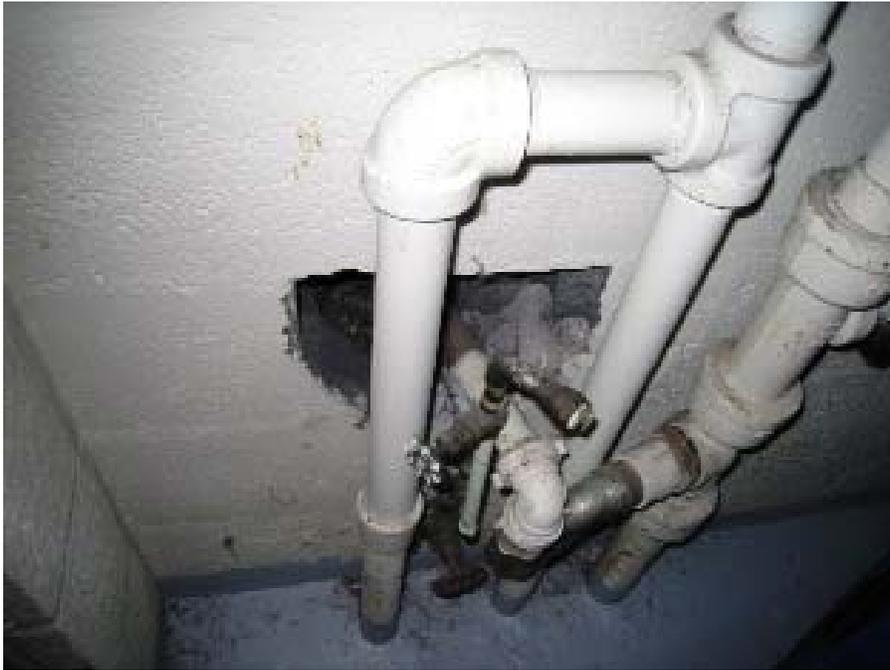
Picture 13

Open utility holes can provide a means of egress for odors, fumes, dusts and vapors between rooms and floors.

Open Utility Hole

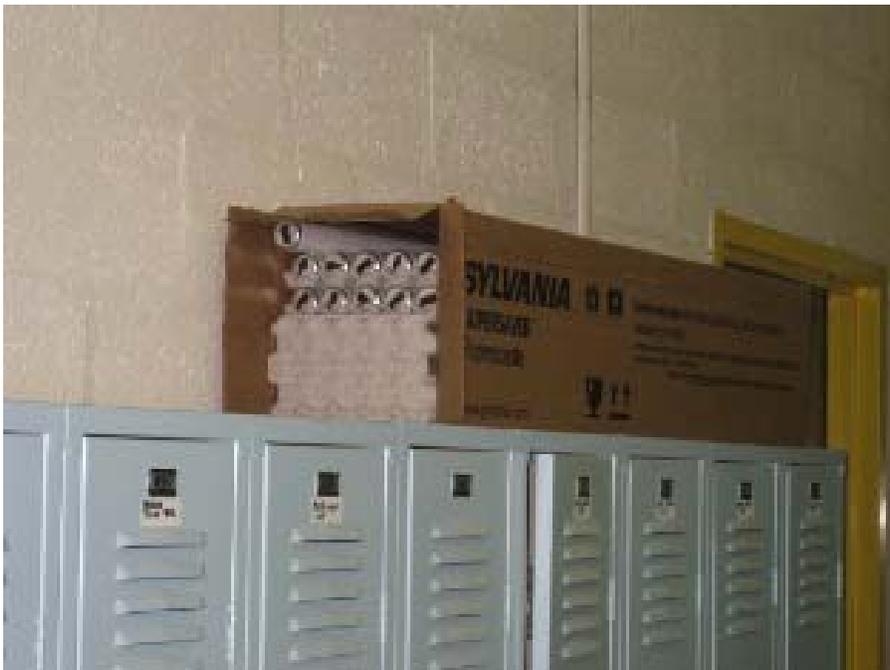
Picture 14

Boxes of fluorescent light bulbs were stored above lockers in the hallway (Picture 14). Since fluorescent light fixtures contain mercury, it would be prudent to store them in an area where they would not be subject to damage. For further information concerning proper storage and handling of fluorescent light fixtures, consult the Massachusetts Department of Environmental Protection's (DEP) website; <http://www.mass.gov/dep/toxics/stypes/hglamps.htm>.

Fluorescent Light Bulb Storage

25. Store food in airtight, rodent-proof containers.
26. Store fluorescent light bulbs in a secure area and in accordance with Massachusetts Department of Environmental Protection's guidelines.

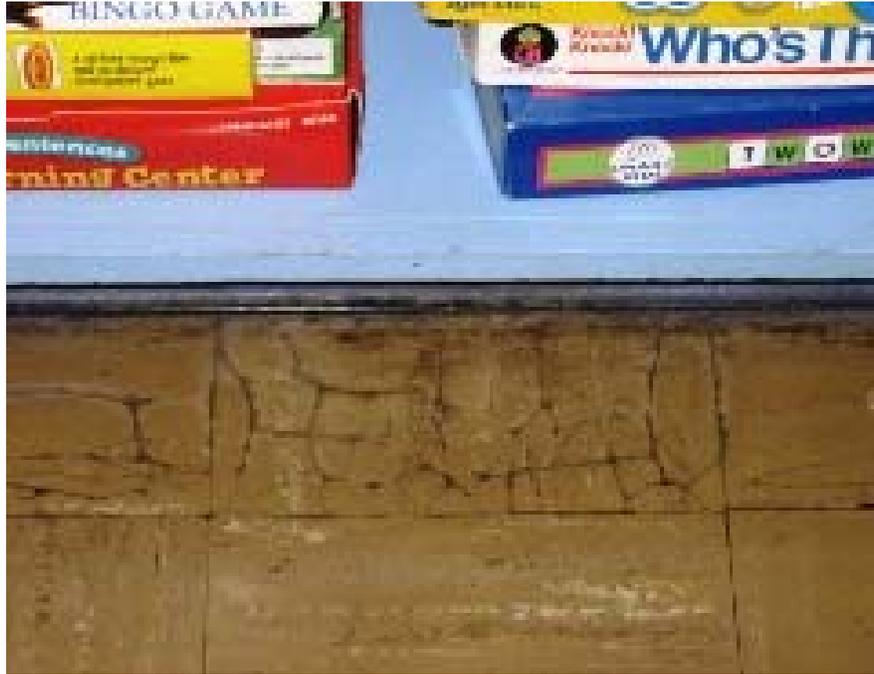
Picture 15

Damaged floor tiles were observed in some areas (Picture 15). Floor tiles of this type and age often contain asbestos. Intact asbestos-containing materials (ACM) do not pose a health hazard. If damaged, ACM can be rendered friable and become aerosolized. Friable asbestos is a chronic (long-term) health hazard that can lead to serious lung disease (i.e. mesothelioma). These types of health impacts are very different than those more typically associated with indoor air quality comfort problems (e.g. headaches, fatigue). Where ACM are found damaged, these materials should be removed or remediated in a manner consistent with Massachusetts asbestos remediation laws (MDLI, 1993). Some unit ventilators are covered with a deteriorated material of unknown composition (Picture 16). The composition of the material should be determined prior to taking any corrective action in the event it also contains ACM.

Damaged Floor Tiles

27. Determine composition of damaged floor tiles and damaged material on top of univents. If found to contain ACM, remediate in accordance with applicable State and Federal regulations.

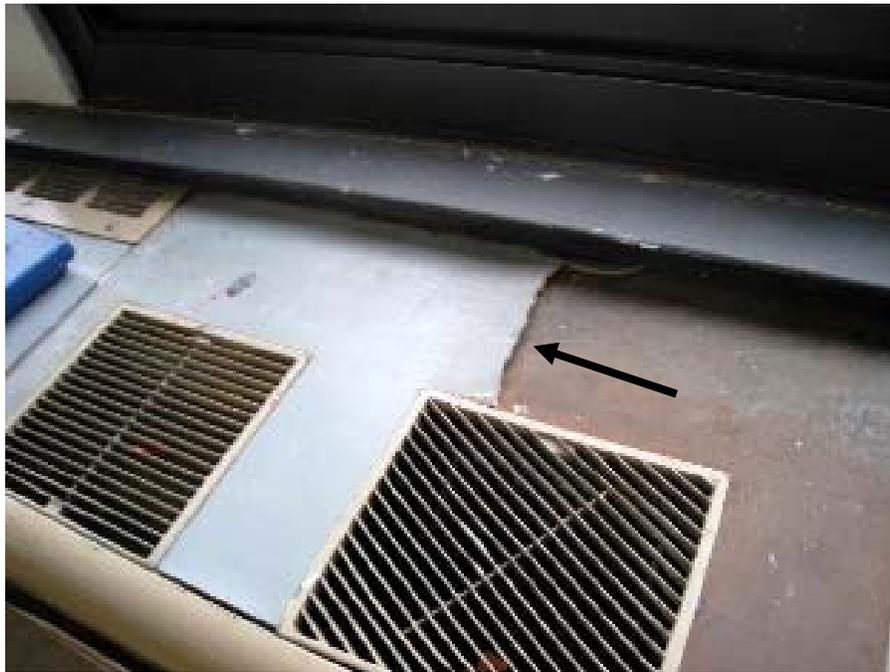
Picture 16

Damaged Material Covering Univent
