INDOOR AIR QUALITY ASSESSMENT

**West Street School
14 West Street
Granby, Massachusetts**

Prepared by:
Massachusetts Department of Public Health
Bureau of Environmental Health
Indoor Air Quality Program
October 2010

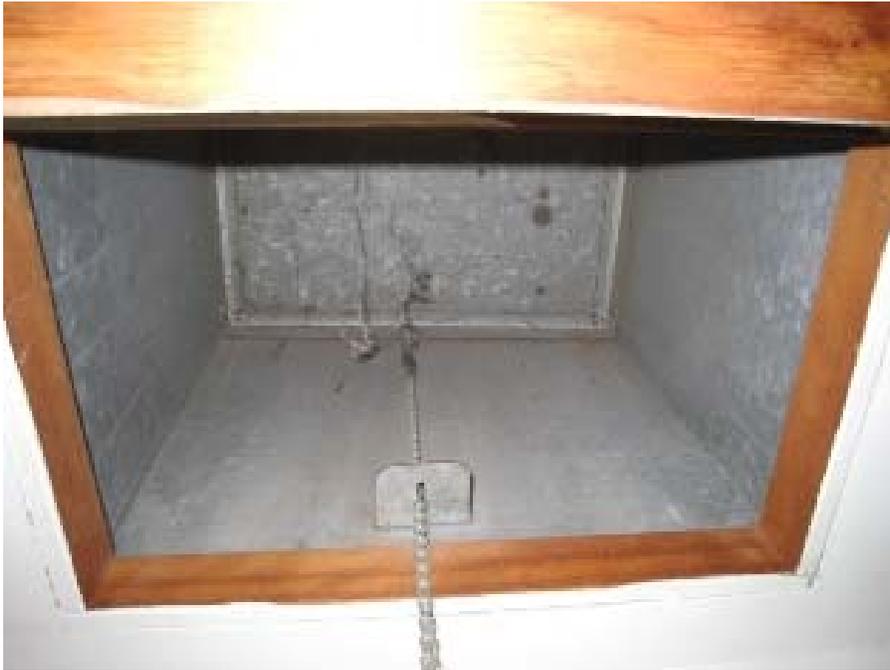
Picture 7

Damper to Exhaust Vent in Closed Position

4. Open dampers to exhaust vents and remove obstructions from in front of ventilation components.
5. Consider adopting a balancing schedule of every 5 years for all mechanical ventilation systems, as recommended by ventilation industrial standards (SMACNA, 1994).

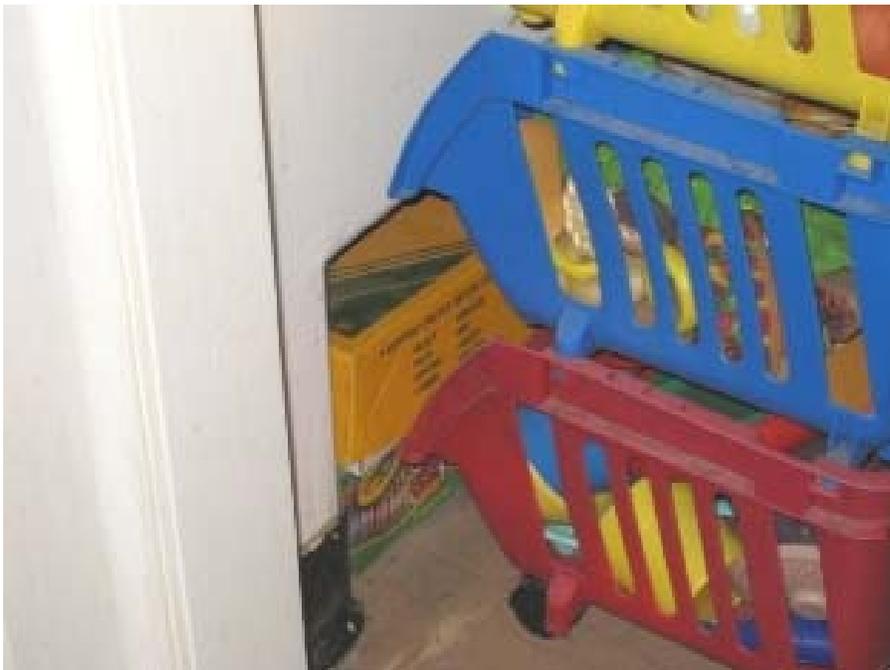
Picture 8

Obstructed Exhaust Vent, Note Items Stored *Inside* Vent

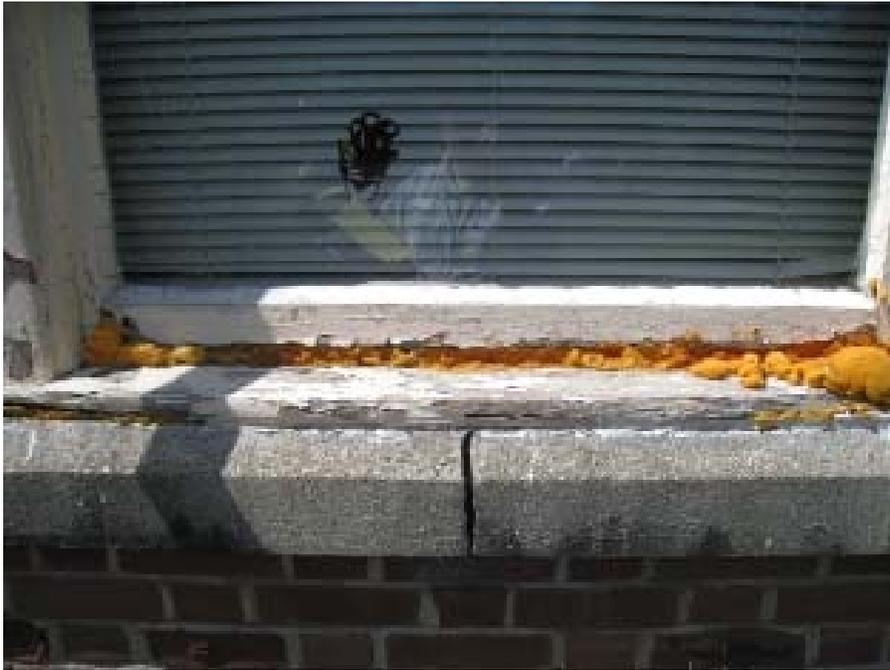
Picture 9

- Numerous wooden window sashes had severely deteriorated rails and sills which were repaired using expandable foam (Picture 9). The application of expandable foam likely resulted in many windows no longer being openable;

**Window in Severe Disrepair
Note Attempt to Seal with Expandable Foam**

1. Consider the installation of replacement windows throughout the school, beginning with the wooden windows in severe disrepair. Consult MDPH Guidance on PCBs in Schools in Appendix B. Ensure the school is in compliance with EPA regulations regarding PCBs in schools prior to conducting testing and/or replacement.
2. Consider repainting all surfaces with peeling paint. Please be advised the building must be in compliance with EPA's new Lead Renovation, Repair and Painting Rule (40 CFR 745.80 through 745.92) that went into effect on April 22, 2010.

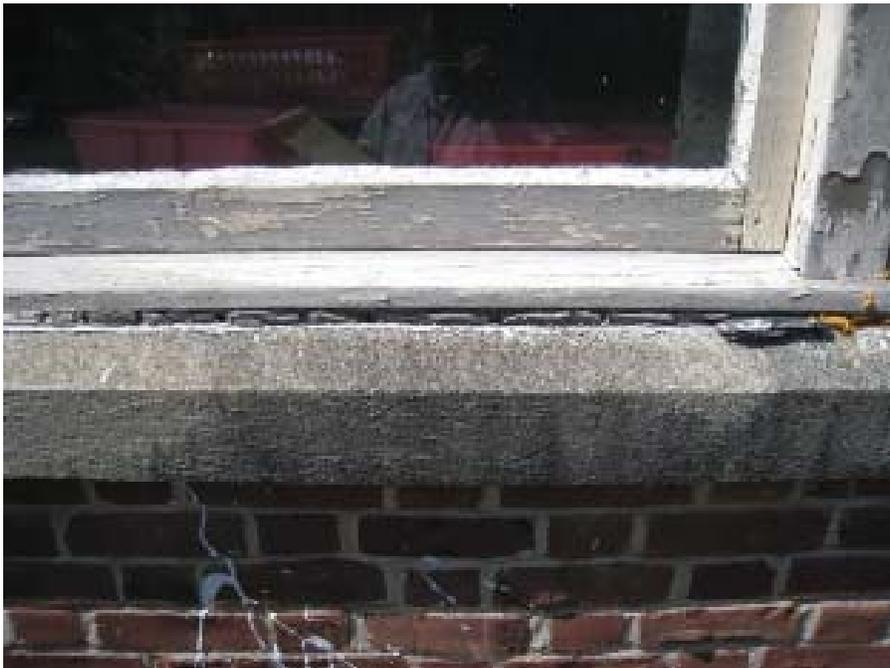
Picture 10

Deteriorated Caulking Beneath Window

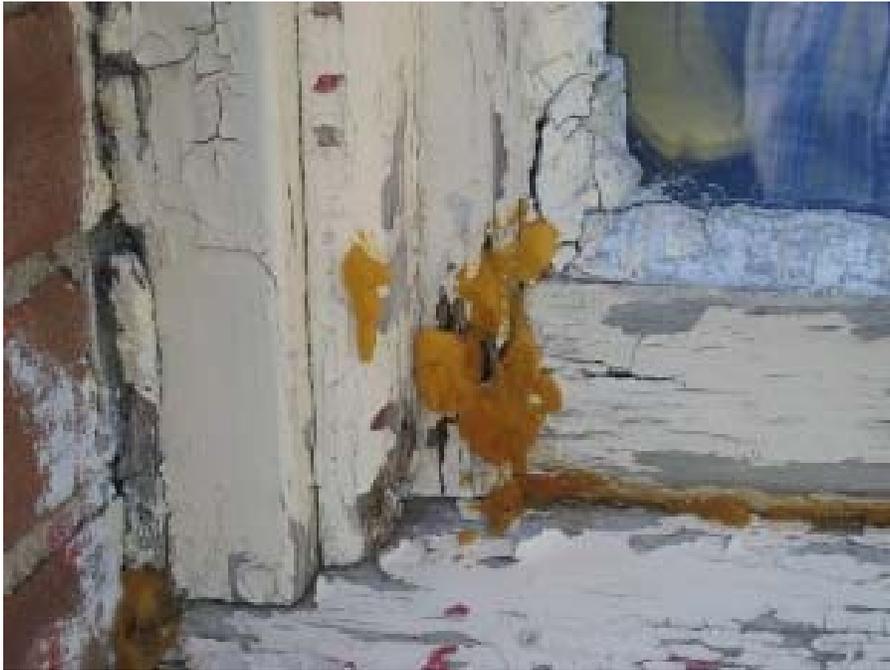
Picture 11

- Window glazing was cracked and/or missing (Picture 11);
- Deteriorated wood was observed on exterior window sills;
- Extensive peeling paint was observed on many exterior surfaces allowing wood fibers to become exposed to moisture, which will accelerate deterioration;

**Deteriorated Caulking and Window Glazing
Note Peeling Paint and Foam Used to Stabilize Rotted Rail/Stile Joint**

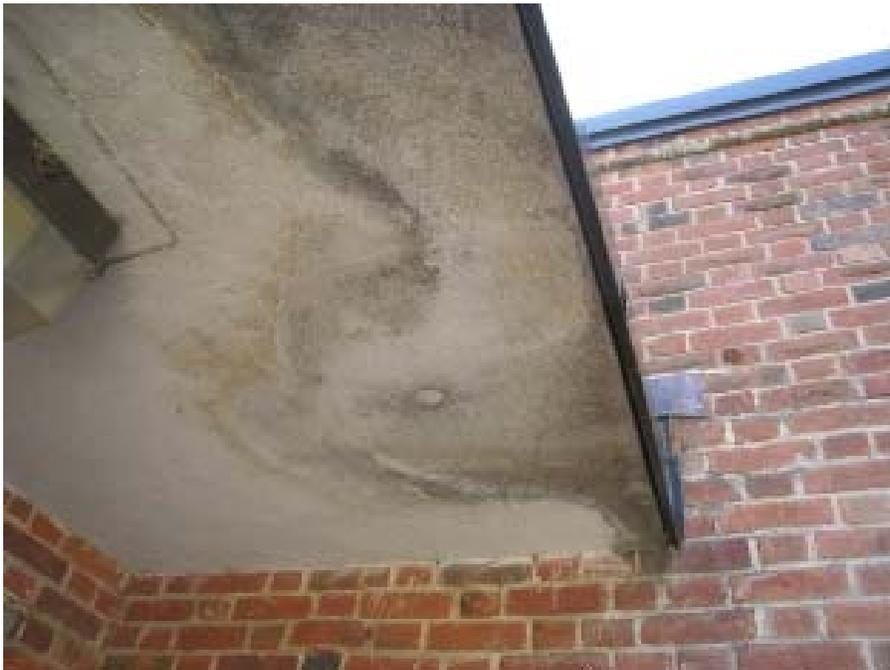
Picture 12

- A large gap was observed between the windows and soffits;
- Evidence of chronic moisture damage was observed on the underside of an exterior overhang (Picture 12);

Evidence of Chronic Water Damage on Overhang

7. Repair gaps between windows and soffit.
8. Repair leak on exterior overhang that has resulted in the water-damaged underside.
9. Repair cracks and holes in foundation.

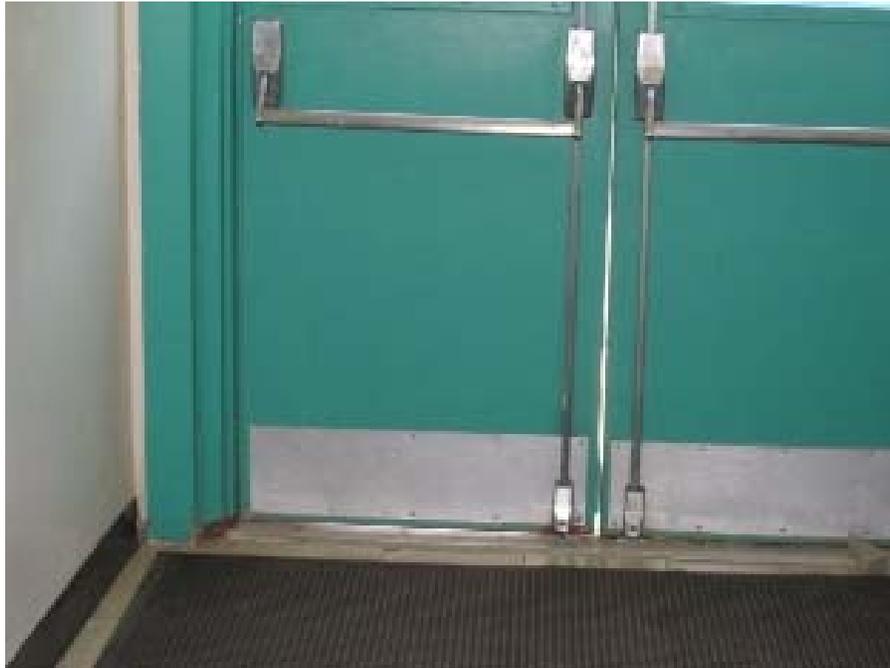
Picture 13

- Cracks/holes were observed in the foundation;
- Numerous exterior doors exhibit gaps, are water-damaged and are delaminating (Pictures 13 and 14);
- Mortar was cracked, crumbling and in disrepair (Picture 15);

**Large Gap Between Doors
Note Daylight Visible Below Door**

10. Repair or replace damaged or ill-fitting exterior doors.
11. Repair or replace cracked or missing mortar.
12. Consider eliminating mulch from garden adjacent to the building.

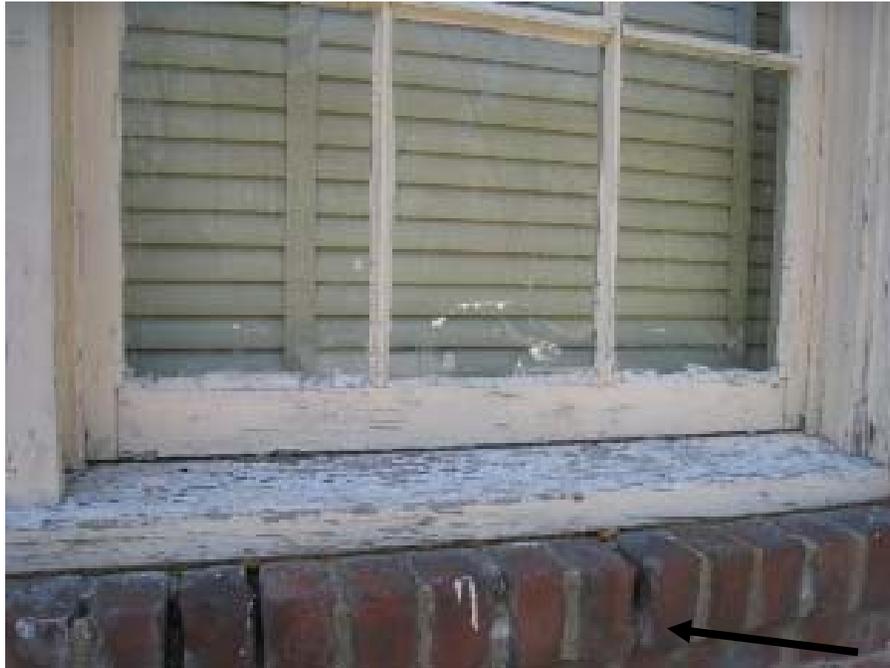
Picture 15

**Missing Mortar (Arrow);
Also Note Peeling Paint and Broken, Missing Glazing**

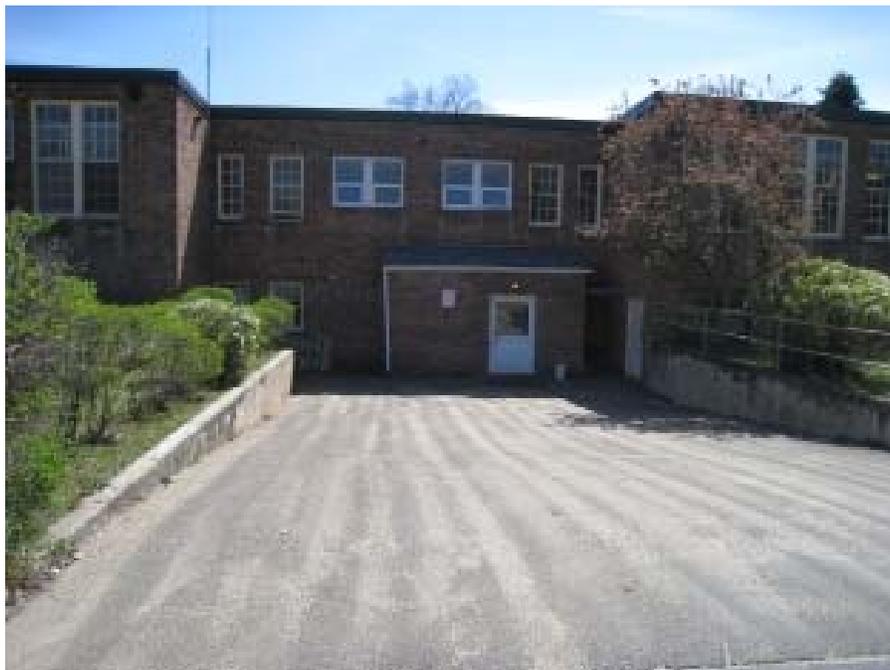
Picture 16

- The driveway slopes toward the building in one area, resulting in surface water being directed at the building during rainstorms (Picture 16);
- Moss was observed at the base of the building and is indicative of chronic water exposure, and

Driveway Slopes Toward Building

13. Repair deteriorated areas of tarmac.
14. Investigate drainage options to reduce/eliminate surface water from collecting in sloped driveway and impacting the building.

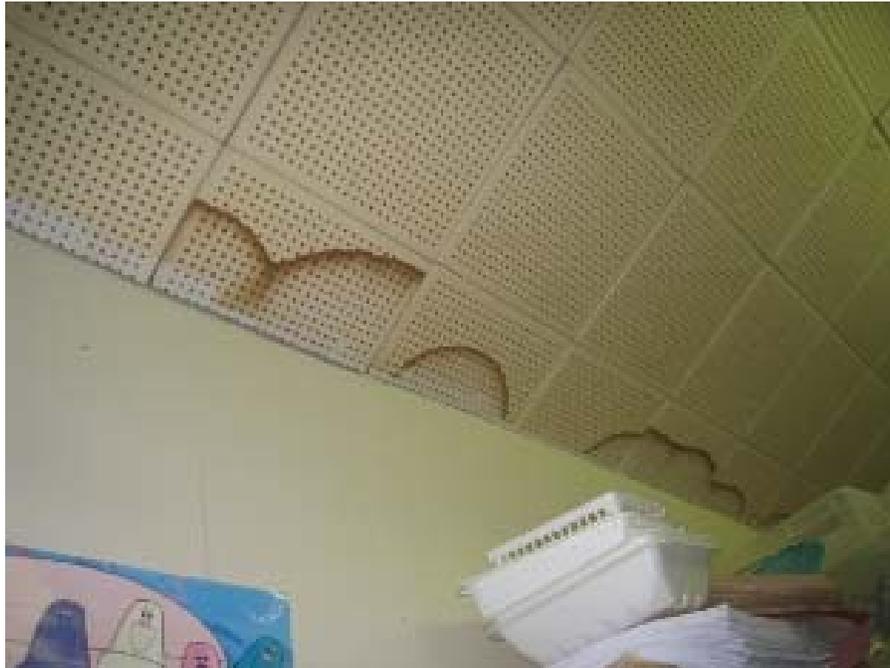
Picture 17

It was reported that the rubber membrane roof was replaced in 2008. Several classrooms had water-damaged ceiling tiles which can indicate sources of water penetration from either the building envelope or plumbing system (Picture 17; Table 1). Water-damaged ceiling tiles can provide a source of mold and should be replaced after a water leak is discovered and repaired. Evidence of water infiltration was also observed on the floor of the boiler room. Efflorescence was observed on brick walls in the lower level (Picture 18). Efflorescence is a characteristic sign of water intrusion. As penetrating moisture works its way through mortar around brick, it leaves behind characteristic white, powdery mineral deposits. It is important to note that efflorescence is not mold growth.

Water-Damaged Ceiling Tiles

19. Repair any existing water leaks and replace any remaining water-damaged ceiling tiles. Examine the area above these tiles for mold growth. Disinfect areas of water leaks with an appropriate antimicrobial, as needed.

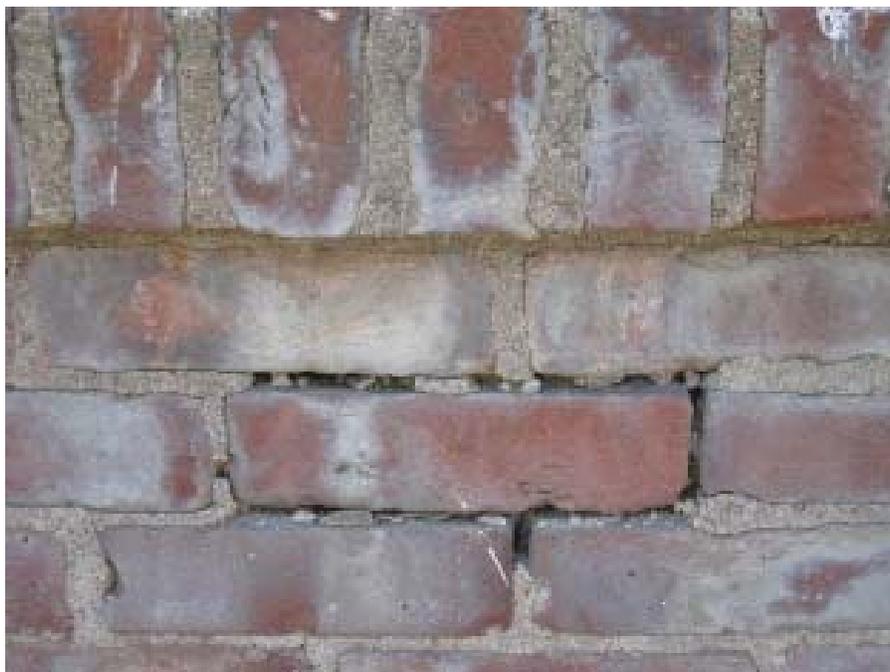
Picture 18

**Efflorescence on Masonry
Note Missing, Broken Mortar**

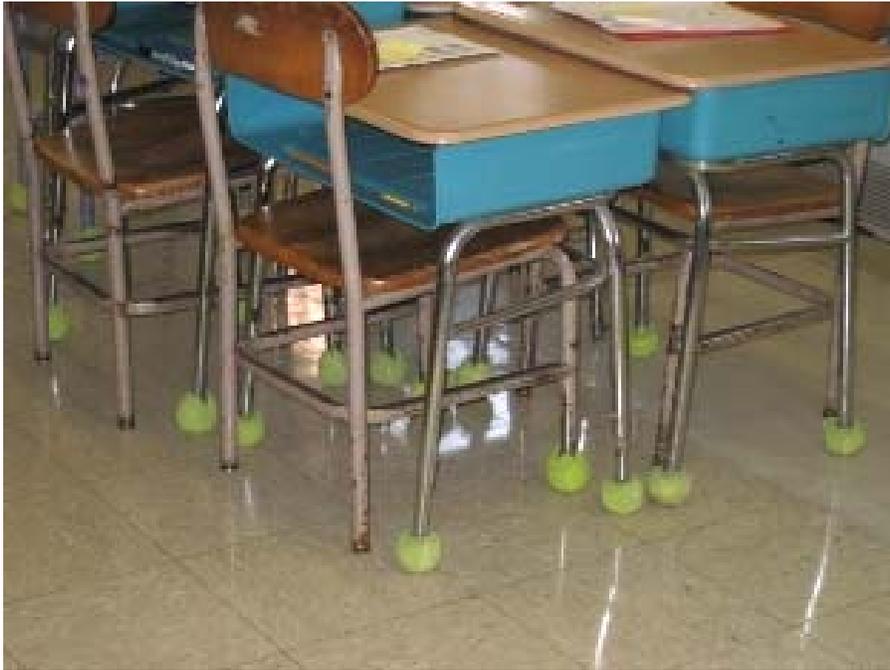
Picture 19

In an effort to reduce noise from sliding desks, tennis balls were observed sliced open and placed on the base of the legs (Picture 19). Tennis balls are made of a number of materials that are a source of respiratory irritants. Constant wearing of tennis balls can produce fibers and cause VOCs to off-gas. Tennis balls are made with a natural rubber latex bladder, which becomes abraded when used as a chair leg pad. Use of tennis balls in this manner may introduce latex dust into the school environment. Some individuals are highly allergic to latex (e.g., spina bifida patients) (SBAA, 2001). It is recommended that the use of materials containing latex be limited in buildings to reduce the likelihood of symptoms in sensitive individuals (NIOSH, 1997).

Tennis Balls Utilized as Glides on Legs of Desks

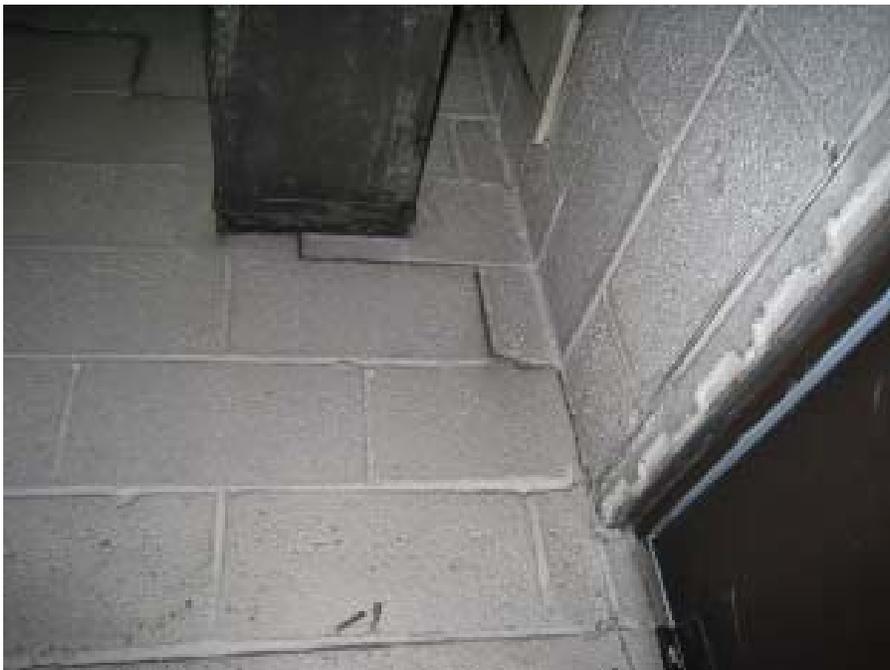
Picture 22

Cracks in Boiler Room Wall

26. Seal the numerous openings, utility holes and cracked mortar which allows soot to migrate from the boiler room to other areas in the building. Ensure a tight seal is installed around boiler room door.

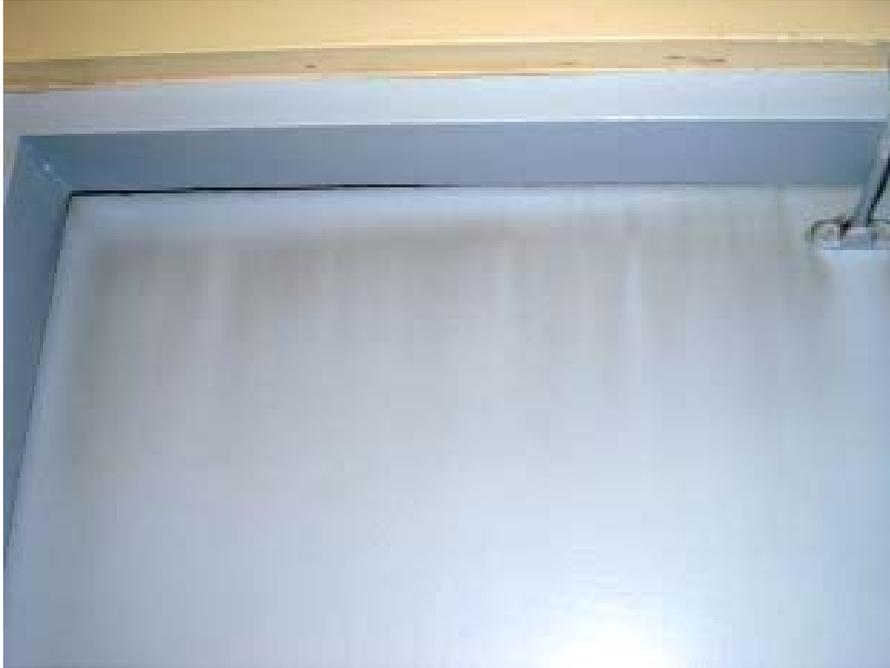
Picture 23

Soot Deposition on the Outside of Boiler Room Door

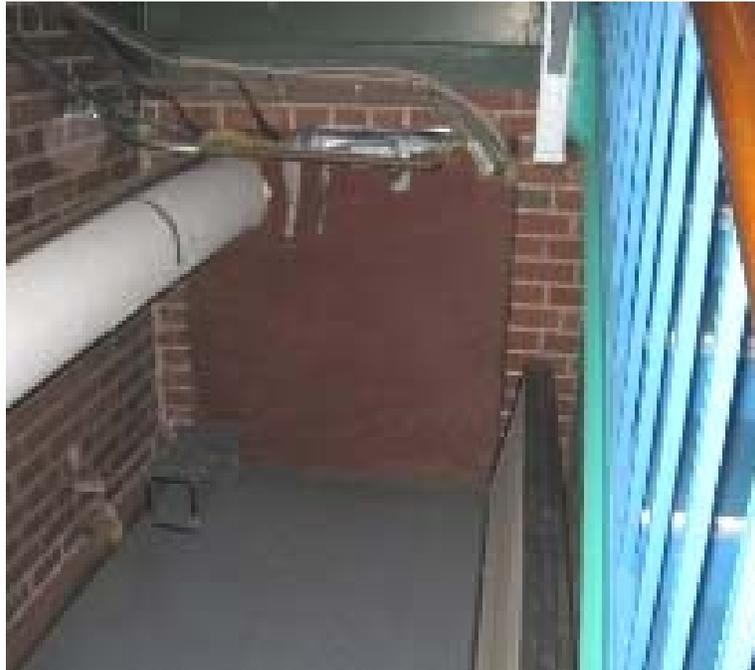
Picture 27

A live animal trap was observed on the floor in front of the crawlspace door. To penetrate the exterior of a building, rodents require a minimal breach of ¼ inch (MDFA, 1996). As previously noted, spaces beneath doors were noted around the exterior of the building, which would be sufficient to allow rodents to enter the building. The door to the crawlspace was not tightly sealed, which also could allow rodent access (Picture 27).

**Duct Tape Used to Seal Top of Crawlspace Access Door
Note Animal Trap on Floor**

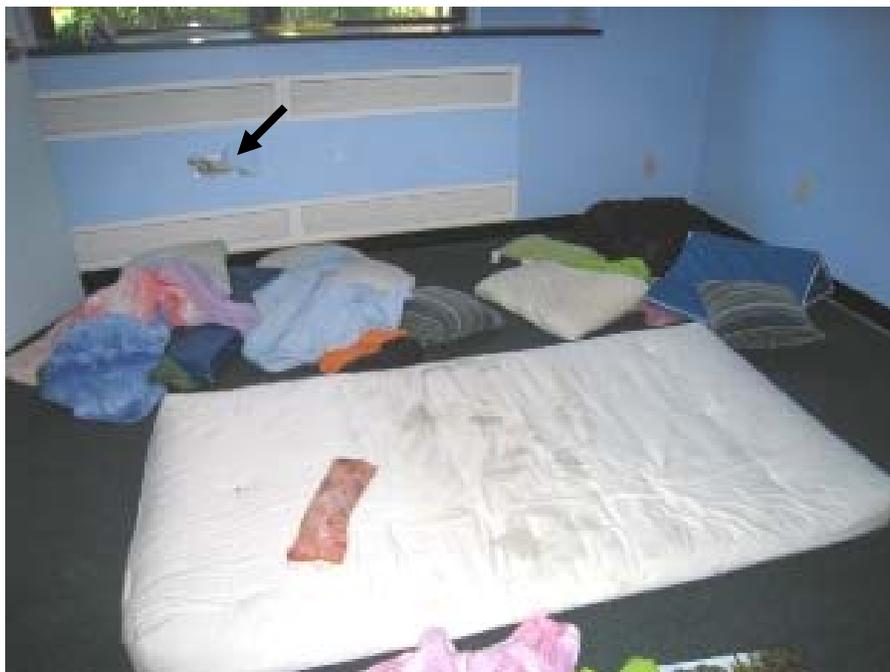
Picture 28

The “time out” room contained pillows, blankets and what appeared to be an old futon mattress (Picture 28). As can be seen in Picture 28, the cotton covering of the mattress was soiled/stained. Blankets used by the children should be washed after each use or at least on a weekly basis. Furthermore, stuffed pillows can be a point for dust collection. Close contact with such items can leave oils, perspiration, hair and skin cells. Dust mites feed upon human skin

**Pillows, Blankets and Mattress in Time-Out Room
Note Broken Gypsum Wallboard**

36. Consider removing pillows, cushions, blankets and mattresses from timeout room. If not feasible, clean on a regular basis. Consider using a zippered, fully enclosing mattress cover that is impervious to moisture.

37. Repair damaged drywall in “time out” room.
38. Clean accumulated dust and debris periodically from the surface of window blinds, exhaust vents and blades of personal fans.

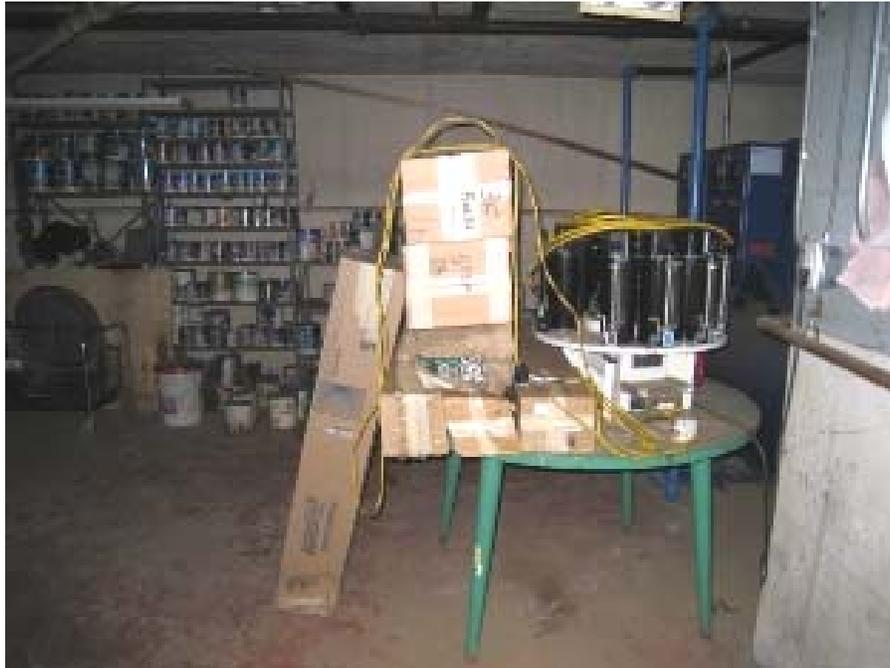
Picture 29

Fluorescent light bulbs were stored in such a manner as to be considered subject to damage (Picture 29). Since these bulbs contain mercury, they must be stored and disposed of in accordance with the Massachusetts Department of Environmental Protection's Guidelines. These guidelines can be found at: <http://www.mass.gov/dep/toxics/stypes/hglamps.htm>.

Fluorescent Light Bulb Storage

41. Store and dispose of fluorescent light bulbs in a manner consistent with DEP guidelines.
42. Determine composition of damaged insulation on pipes and of damaged floor tiles. If they contain ACM, remediate damaged floor tiles in conformance with Massachusetts asbestos remediation and hazardous waste disposal laws (MDLI, 1993).

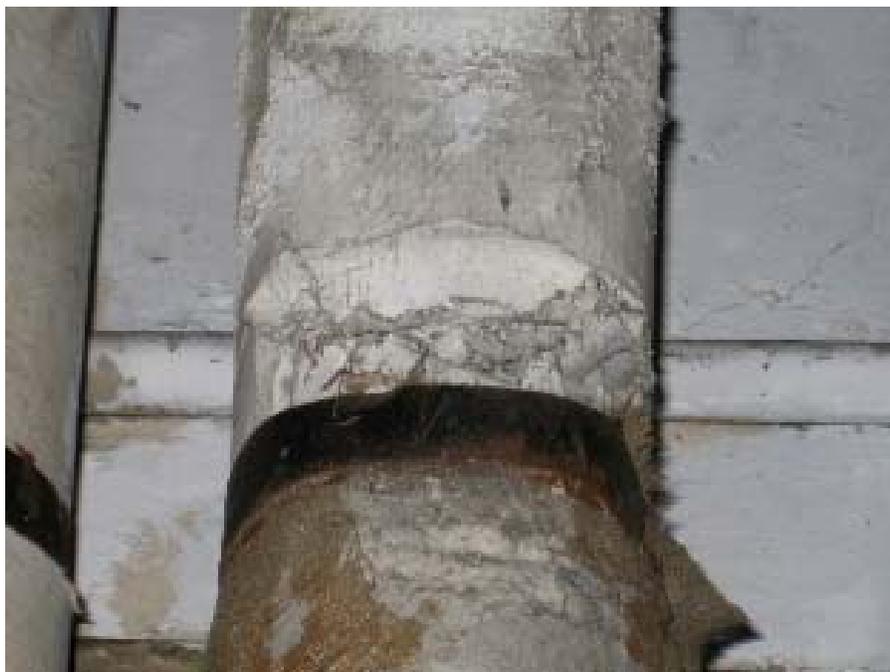
Picture 30

Pipes with damaged insulation that consists of a white, powdered material was found in the boiler room and crawlspace (Picture 30). The material may have asbestos containing material (ACM) and should be remediated in conformance with all applicable Massachusetts asbestos abatement and hazardous materials disposal laws. Damaged or missing floor tiles were also observed in some areas (Picture 31). These floor tiles may also contain asbestos. Intact asbestos-containing materials do not pose a health hazard. If damaged, asbestos-containing materials can be rendered friable and become aerosolized. Friable asbestos is a chronic (long-term) health hazard, but will not produce acute (short-term) health effects (e.g., headaches) typically associated with buildings believed to have indoor air quality problems. Where asbestos-containing materials are found damaged, these materials should be removed or remediated in a manner consistent with Massachusetts asbestos remediation laws (MDLI, 1993).

White, Deteriorated Pipe Insulation

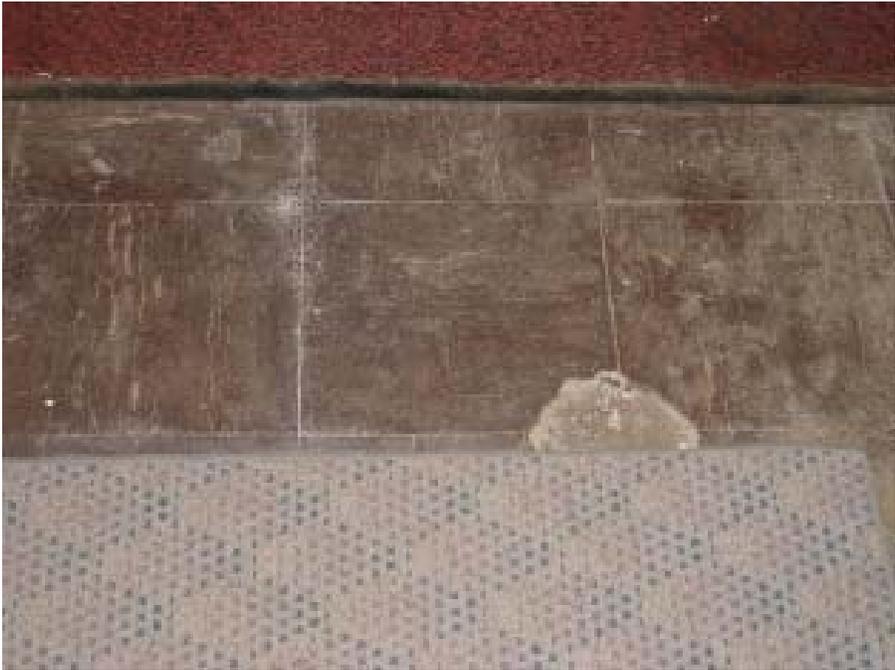
Picture 31

Deteriorated Floor Tiles
