INDOOR AIR QUALITY ASSESSMENT
Hanson Senior Center and Library
132 Maquan Street
Hanson, Massachusetts

Prepared by:
Massachusetts Department of Public Health
Bureau of Environmental Health
Indoor Air Quality Program
April 2010

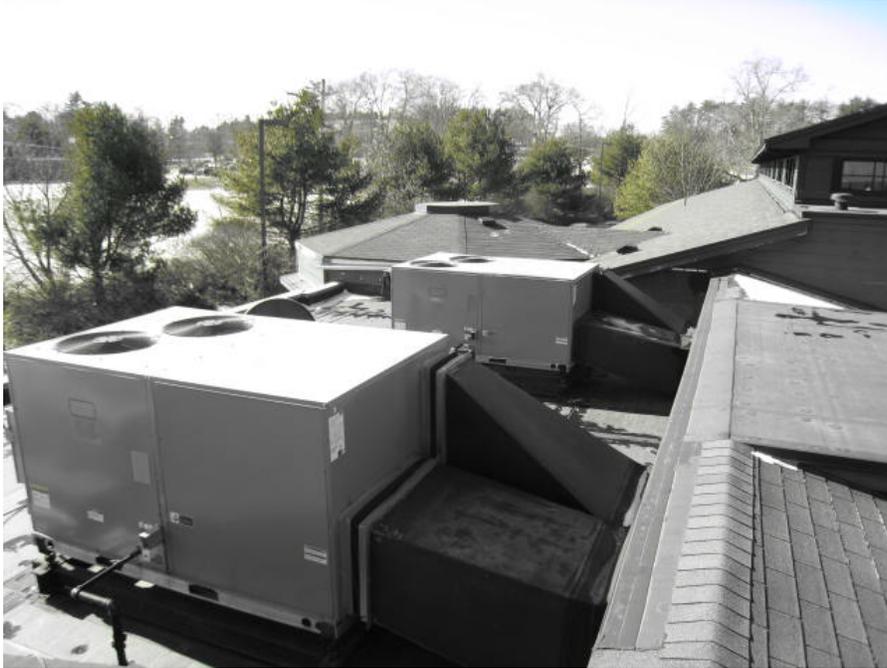
Picture 1

It can be seen from Table 1 that carbon dioxide levels were below 800 parts per million (ppm) in 8 of 10 areas surveyed, indicating adequate air exchange in most areas of the building at the time of the assessment. The heating, ventilation and air conditioning (HVAC) system consists of air-handling units (AHU) located in mechanical rooms or on the roof (Pictures 1 and 2). Conditioned air is distributed to ceiling or wall-mounted air diffusers (Pictures 3 and 4) and ducted back to AHUs via return vents (Picture 4). BEH staff examined the return vent in the HSC office suite and no draw of air could be detected.

Rooftop Air Handling Units

1. Continue to operate all ventilation systems (e.g., AHUs) throughout the building continuously during occupied periods.
2. Examine return vent in HSC office suite for proper function. Make repairs as necessary to restore function.

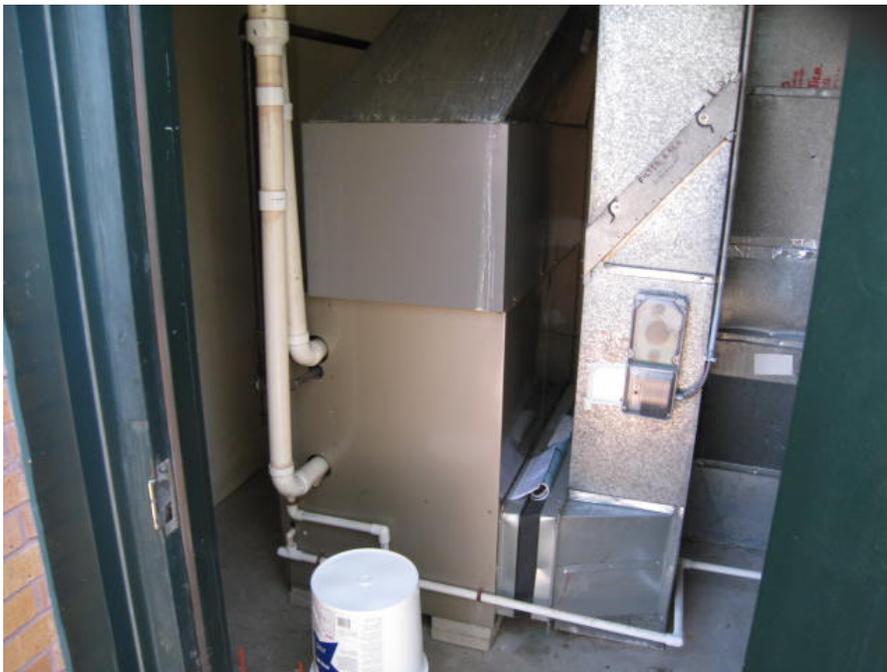
Picture 2

Rooftop Air Handling Units

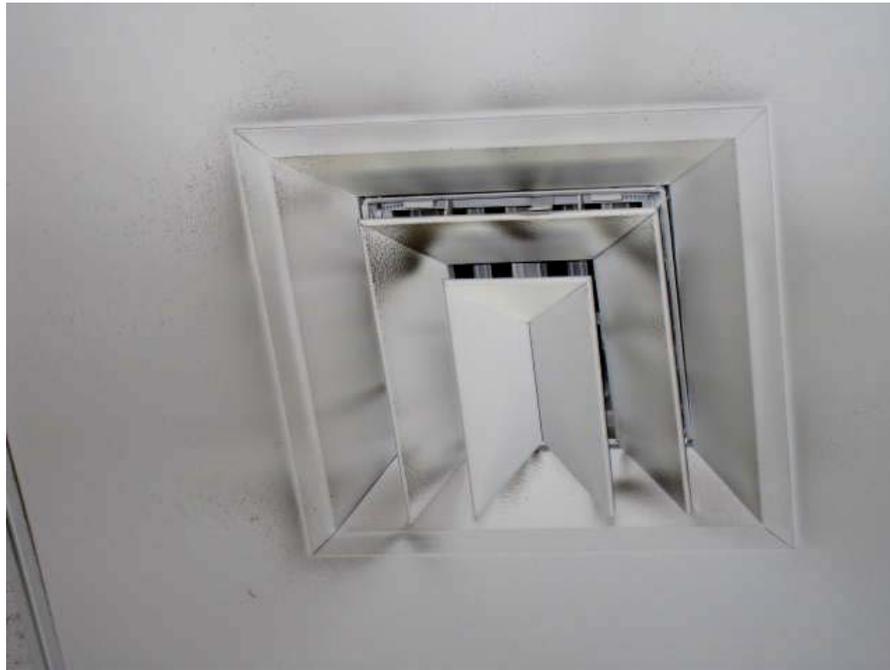
Picture 3

Other conditions that can affect indoor air quality were observed during the assessment. A number of supply diffusers and return vents were observed to have accumulated dust/debris (Picture 3). If return vents are not functioning, backdrafting can occur, which can re-aerosolize dust particles. Dust and allergens can be irritating to the eyes, nose and throat.

Ceiling-Mounted Supply Vent, Note Dust/Debris Accumulation

11. Repaint or replace delaminating exterior wall panels outside of children's library.
12. Once leaks are repaired in the children's library, scrape off efflorescence, clean and refinish walls.
13. Repair/replace faulty/leaking roof flashing.
14. Clean air diffusers and return vents periodically of accumulated dust.
15. Clean carpeting annually or semi-annually in soiled high traffic areas as per the recommendations of the Institute of Inspection, Cleaning and Restoration Certification (IICRC). Copies of the IICRC fact sheet can be downloaded at:
http://www.cleancareseminars.com/carpet_cleaning_faq4.htm (IICRC, 2005)
16. Refer to resource manual and other related indoor air quality documents located on the MDPH's website for further building-wide evaluations and advice on maintaining public buildings. These documents are available at: http://mass.gov/dph/indoor_air.

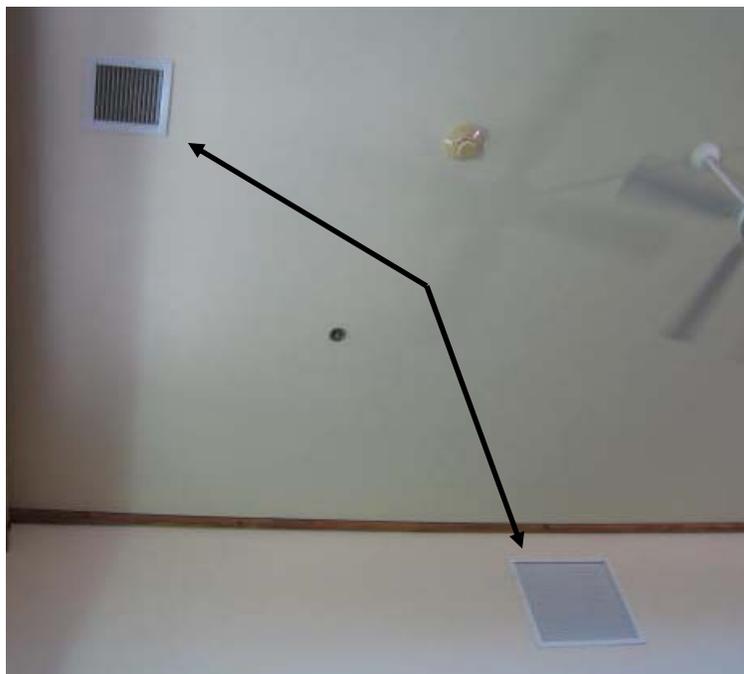
Picture 4

Wall-Mounted Supply Vent (Bottom) and Ceiling Mounted Return Vent

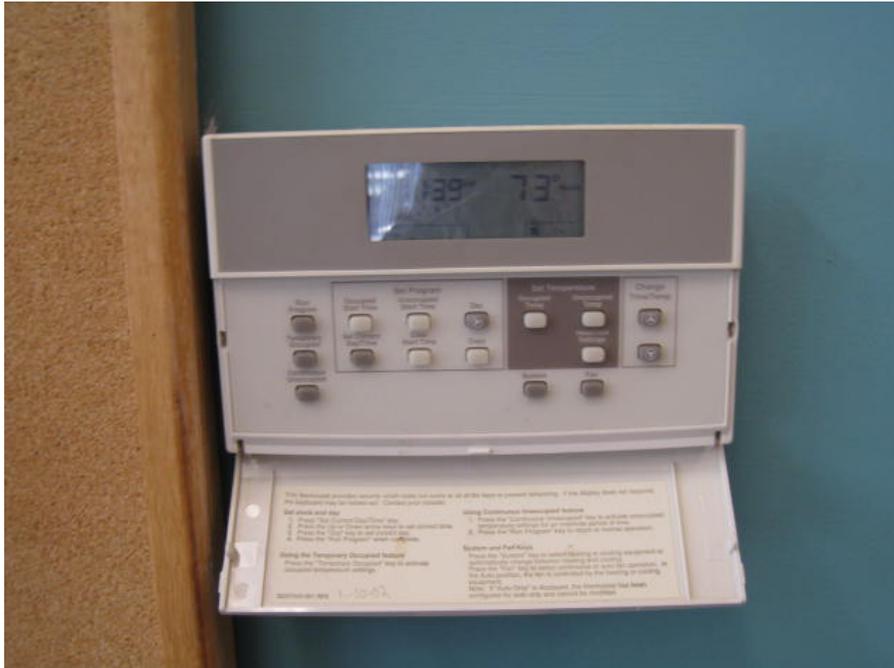
Picture 5

The HVAC system is controlled by digital thermostats (Picture 5). Airflow is controlled using a fan switch that has two settings, *on* and *auto*. When the fan is set to *on*, the system provides a continuous source of air circulation and filtration. The *automatic* setting on the thermostat activates the HVAC system at a preset temperature. Once the preset temperature is reached, the HVAC system is deactivated. Therefore, no mechanical ventilation is provided until the thermostat re-activates the system. This was the case for the thermostat that controls the office area for the HSC. The MDPH recommends that digital thermostats be set to the fan “on” setting to provide continuous air circulation during occupied periods.

Digital Wall-Mounted Thermostat

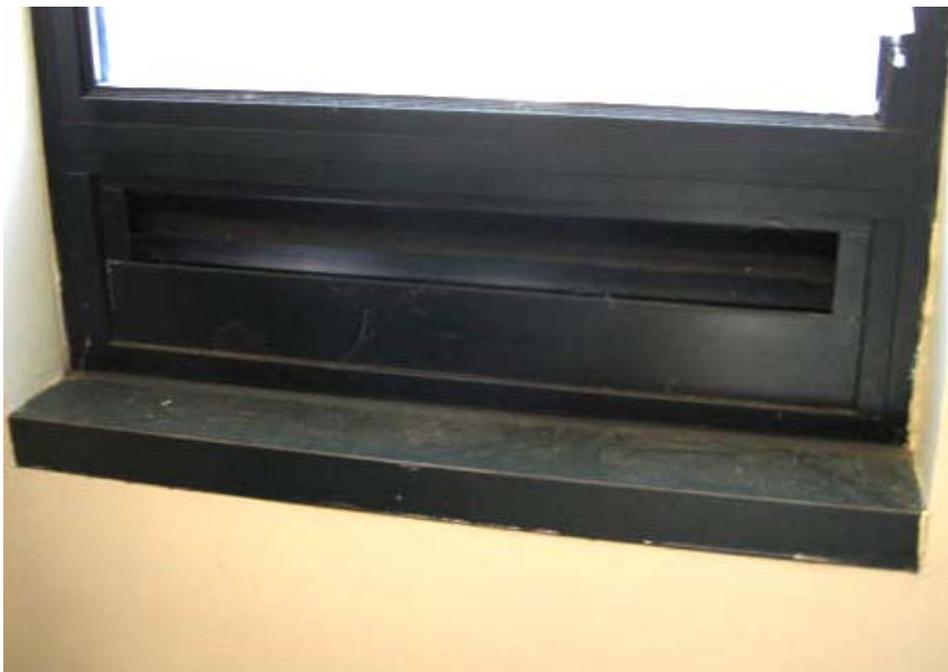
Picture 6

Air circulation is facilitated by the use of downdraft ceiling fans. The introduction of fresh outside air is supplemented by the use of openable windows. As previously mentioned, windows do not fully open but have a slotted design which opens at the bottom to introduce air (Picture 6).

Slotted Window Opening

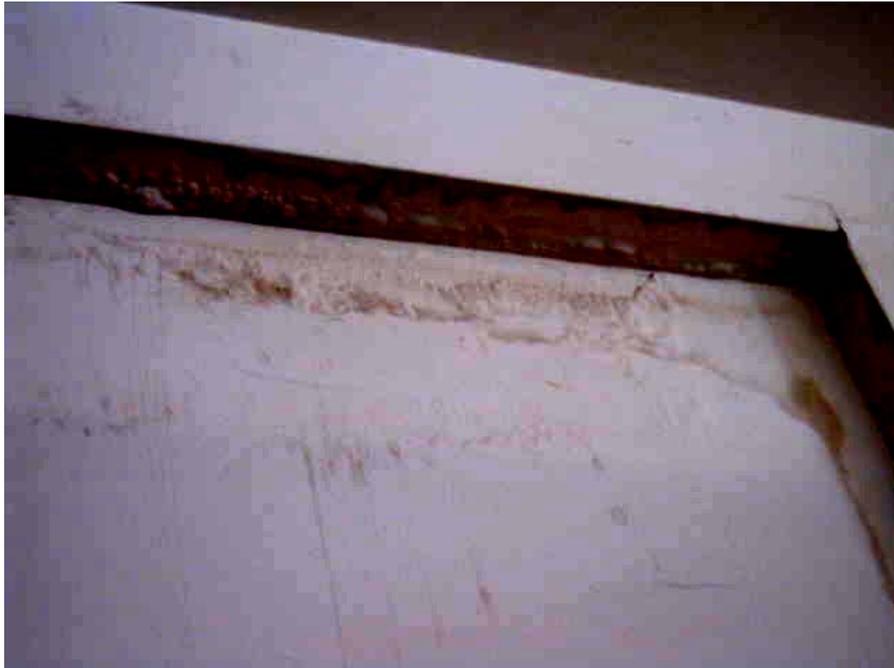
Picture 7

Active roof leaks through the octagonal roof of the children's library were evident by water damaged walls, efflorescence, peeling paint and delaminating bookshelves (Pictures 7 and 8). Efflorescence is a characteristic sign of water damage to brick and mortar, but it is not mold growth. As moisture penetrates and works its way through mortar, brick or plaster, water-soluble compounds dissolve, creating a solution. As the solution moves to the surface of the material, the water evaporates, leaving behind white, powdery mineral deposits. The intricate roofing design of the entire complex, particularly the over the children's library, creates multiple surfaces, peaks, valleys, troughs, and flashing points, which all provide potential entryways for water penetration (Pictures 9 and 10).

Efflorescence on Children's Library Octagonal Walls

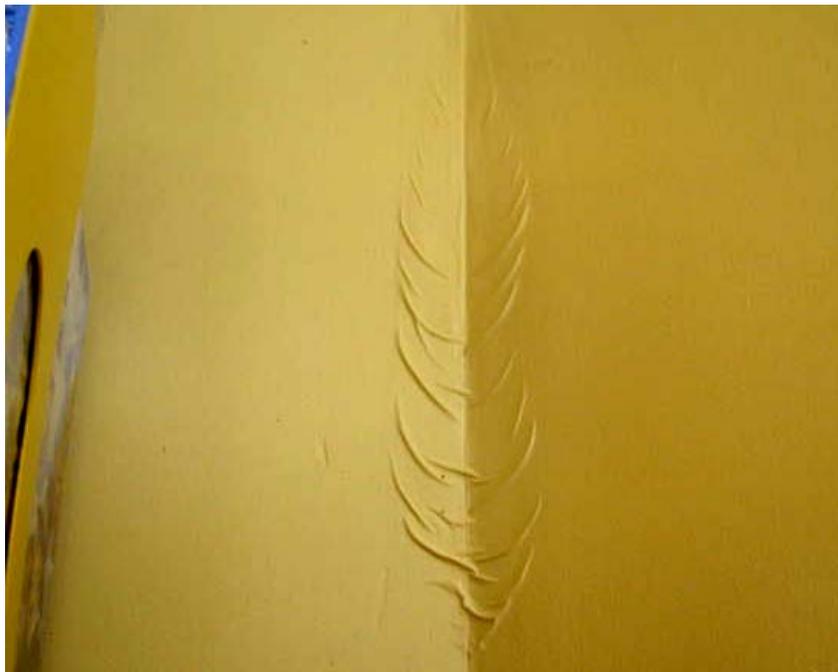
Picture 8

Peeling Paint on Children's Library Octagonal Walls

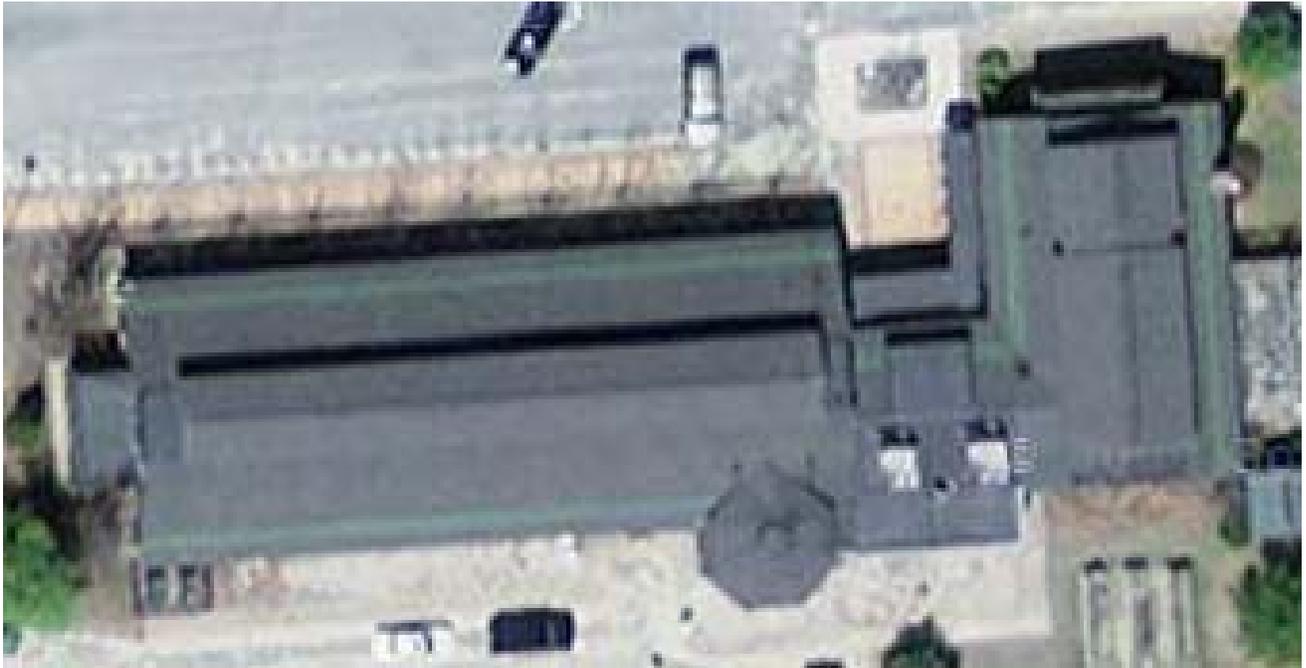
Picture 9

The roofs are reported to be original (~ 19 years old), which puts them toward the end of their useful lifespan (~ 20 years). Although the roof has been patched/repared in several areas to help prevent further leaking, damaged shingles were noted. As mentioned, the HSC is connected to the Hanson Public Library (HPL) by a common hallway found in several areas and/or appeared to be severely degraded, as evidenced by the accumulation of asphalt granules in the gutter system (Picture 12).

Multiple Roof Surfaces of the HSC/HPL Complex

1. Continue to make repairs of roof leaks as necessary. Consideration should be made to replace the roof to prevent chronic roof leaks and further water damage.
2. Consider a long-term plan to replace all carpeting in the building as funds become available. Consider replacing carpeting with a non-porous surface such as vinyl tile.
3. Work with town officials to develop a preventative maintenance program for all HVAC equipment town-wide.

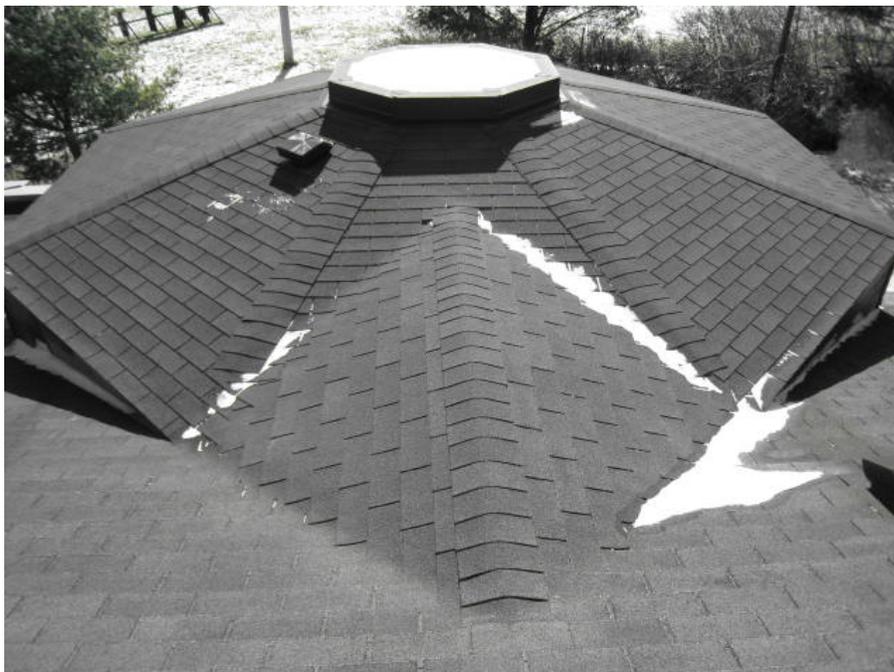
Picture 10

Octagonal Roof of the Children's Library

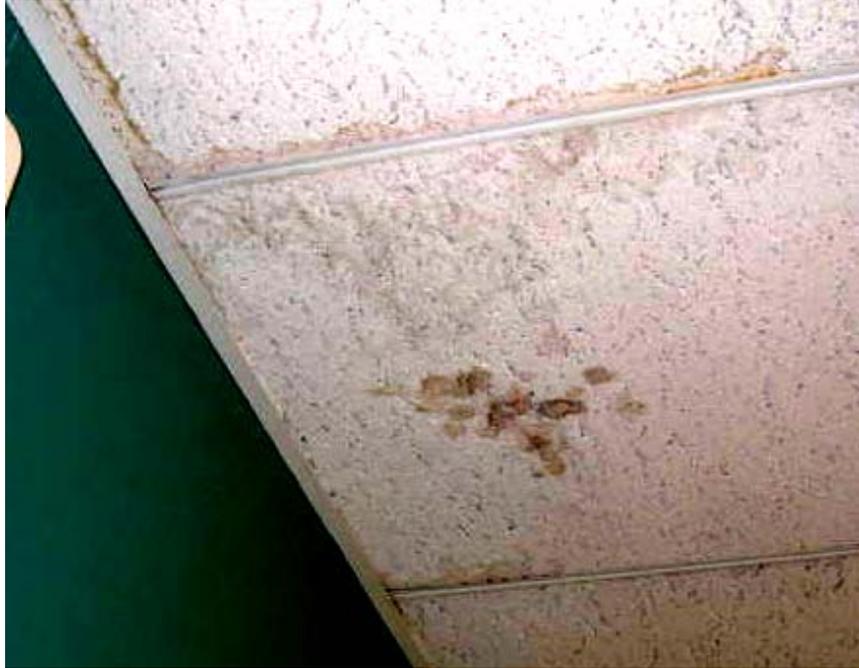
Picture 11

Water damaged ceiling tiles were seen in a number of areas other than the children's library, particularly in the community room (Picture 11). Occasional leaks were reported by HSC staff from the lower roof of the dining room. Active leaks were also observed in the storage closet off the community room. This area had previously been remediated by Service

Master, a flooding restoration firm. Water-damaged ceiling tiles indicate leaks from either the roof or plumbing system and can provide a source for mold growth. Water damaged ceiling tiles should be replaced after a water leak is discovered and repaired.

Water Damaged Ceiling Tiles

6. Continue to monitor areas of the building for roof leaks, make repairs and change ceiling tiles as necessary. Disinfect areas of water leaks with an appropriate antimicrobial.

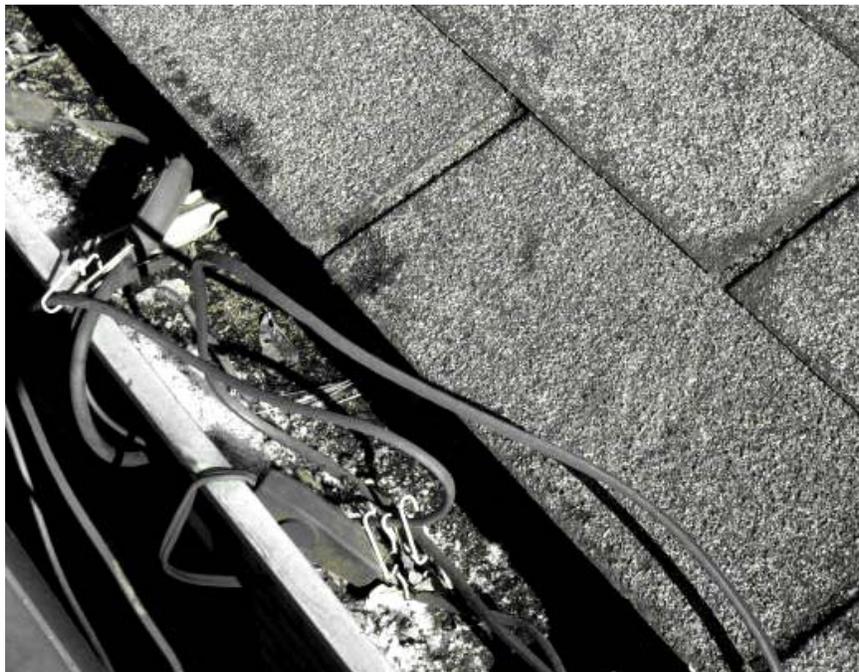
Picture 12

- Gutters contained ice and were clogged with debris (Picture 12);
- Also observed were missing/damaged elbow extensions on downspouts, which cause water to empty against the foundation.

Asphalt Shingle Granules Accumulated in Gutter System

7. Make repairs to gutter and downspout system in order to direct rainwater as far as practicable from the base of the building.
8. Clean gutters periodically of accumulated debris to ensure proper drainage.

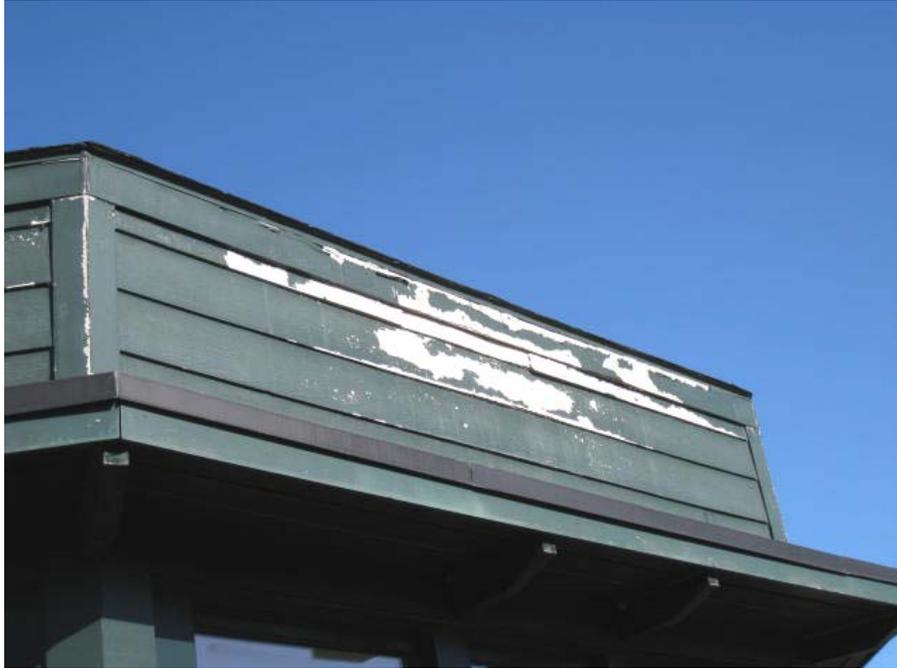
Picture 13

Delaminating Exterior Paint Exposing Exterior Wall Panels

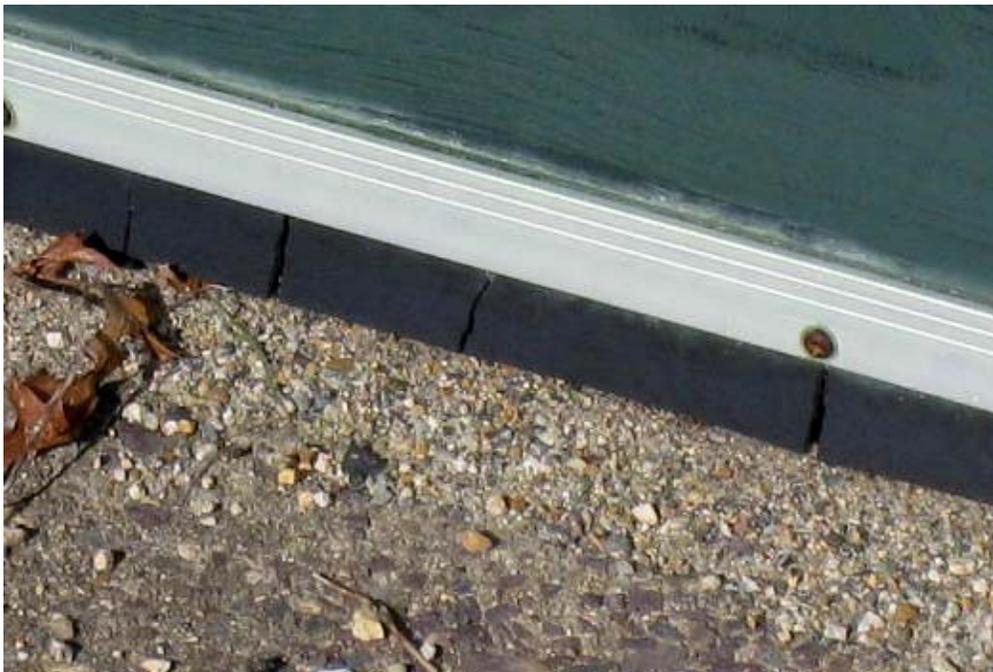
Picture 14

Deteriorating Weather Stripping on Exterior Door

9. Replace weather stripping beneath exterior doors.
10. Trim back trees and ensure exterior plants/shrubbery are located at least five feet away
