# **INDOOR AIR QUALITY ASSESSMENT**

**Pickering Middle School  
70 Conomo Avenue  
Lynn, Massachusetts**

Prepared by:  
Massachusetts Department of Public Health  
Bureau of Environmental Health  
Indoor Air Quality Program  
June 2010

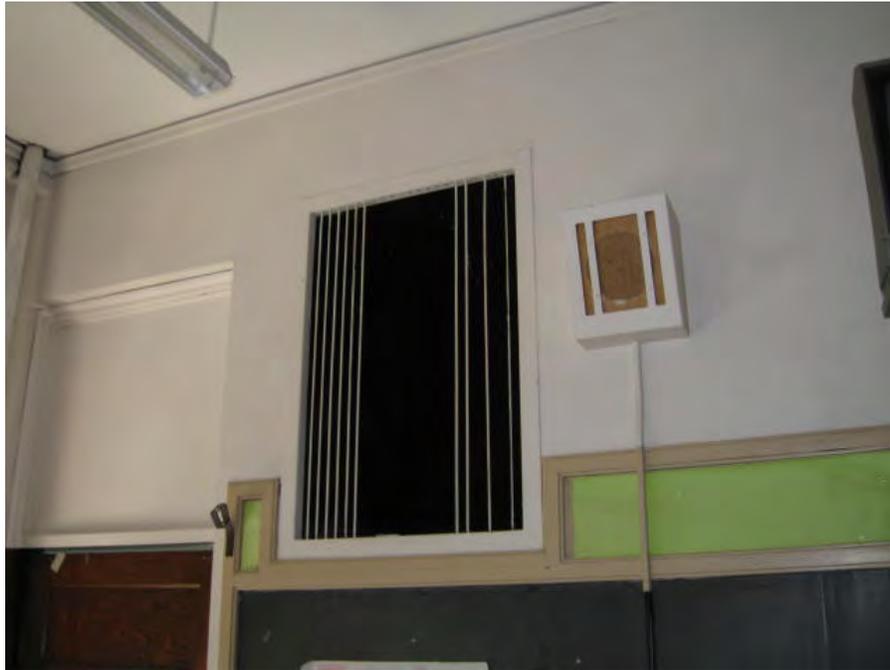
**Picture 3**

The mechanical ventilation system servicing the 1916 wing is currently abandoned. The ventilation system was likely abandoned either as part of an earlier energy conservation project or during the renovations of the 1980s. Fresh air from this system was originally provided by two large fans, which are located in basement fan rooms (Picture 2). In this type of system, the two large fans draw fresh air into the fan rooms through openable windows located at the rear of the building (note: these windows are currently sealed inside storm windows). Typically, air would then be drawn through heating elements in each fan room before distribution to classrooms. Ductwork connecting the fans to wall-mounted fresh air diffusers would have facilitated the distribution of fresh air to classrooms (Picture 3).

**Fresh Air Supplies in 1916 classrooms, Note Missing Louvers**

9. Consider measures to restore existing HVAC equipment in the 1916 wing. If mechanical ventilation systems cannot be restored to their original function, ensure abandoned exhaust and supply vents are properly sealed in classrooms and on the roof. Louvers in each fan room should be sealed to prevent basement air migration into classrooms via the abandoned ventilation system.

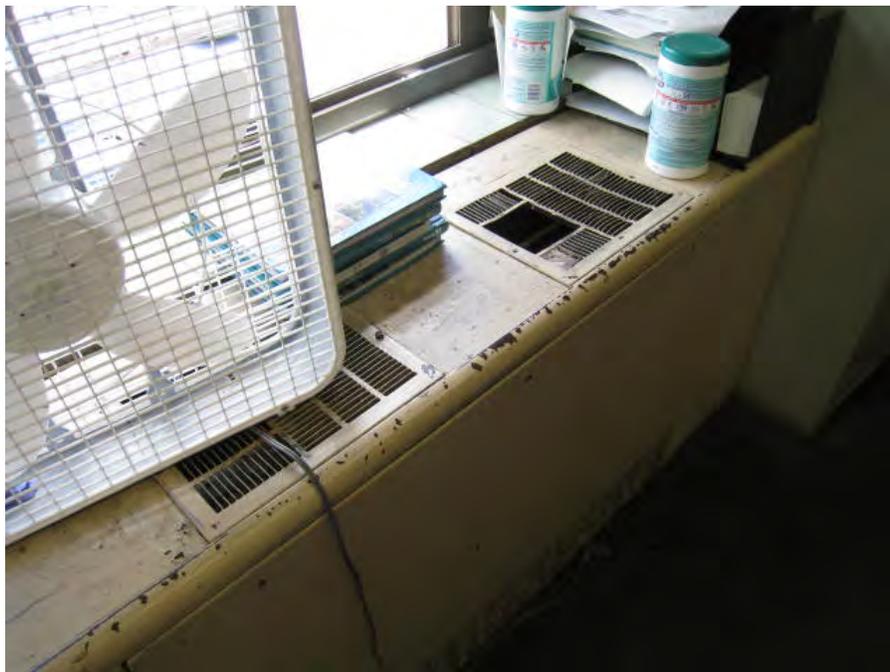
**Picture 4**

Fresh air is provided to classrooms in the 1953 wing by unit ventilator (univent) systems (Picture 4). Univents draw air from outdoors through a fresh air intake located on the exterior walls of the building and return air through an air intake located at the base of each unit (Figure 4). Fresh and return air are mixed, filtered, heated and provided to classrooms through a fresh air diffuser located on the top of the unit. At the time of the assessment, univents were not operating. In order for univents to provide fresh air as designed, units must be allowed to operate while rooms are occupied. Air diffusers and intake vents must also remain free of obstructions. Mechanical exhaust ventilation is provided by wall-mounted exhaust vents. Please note, classroom 206 was subdivided into classrooms 206A and 206B. Subdivision of this room has separated the supply and exhaust systems, with supply in 206A and exhaust in 206B. In cold weather, normally occurring pollutants can accumulate in these rooms due to incomplete set of supply and exhaust in each room.

Univents in the 1953 wing appear to be original equipment and in poor repair or damaged (Picture 4). According to the American Society of Heating, Refrigeration and Air-Conditioning Engineering (ASHRAE), the service life<sup>1</sup> for a unit heater, hot water or steam is 20 years, assuming routine maintenance of the equipment (ASHRAE, 1991). The operational lifespan of this equipment has long passed. Given its age, continuing to maintaining the balance of fresh air to exhaust air will be difficult at best with equipment of this vintage.

**Univent, Note Broken Louvers Indicating Lack of Repair**

10. Examine, maintain and operate univents as designed in the 1953 wing. Ensure these units remain free of blockages.
11. Use open windows and hallway doors to enhance airflow during warm weather. Be sure to close windows and doors at the end of the school day. To aid in the draw of fresh outdoor air in warm weather, use portable fans directing air out windows on the leeward side of the building. Fans positioned in this manner will serve to increase the draw of outdoor air across a floor without interfering with the natural, internal airflow pattern of

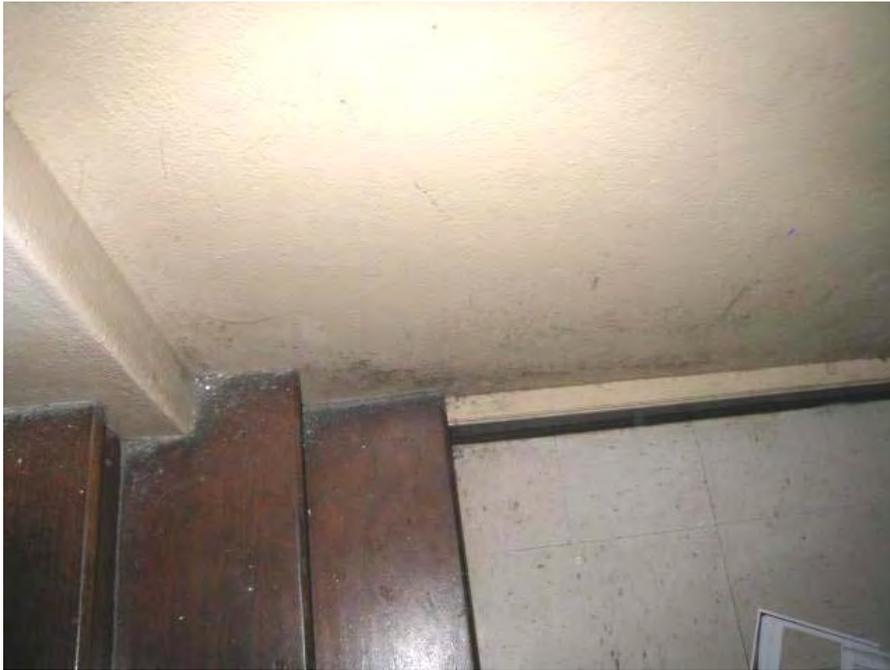
**Picture 5**

**Water-Damaged Paint**

In this particular instance, the discolored paint should be removed (Pictures 5 and 6), and the area should remain unpainted to allow monitoring for any future water penetration. It is also recommended that any remediation of water-damaged/mold contaminated materials be conducted during unoccupied periods and in a manner consistent with recommendations in “Mold Remediation in Schools and Commercial Buildings” published by the US Environmental Protection Agency (US EPA, 2001). The primary purpose in doing so is to protect occupants and prevent exposure.

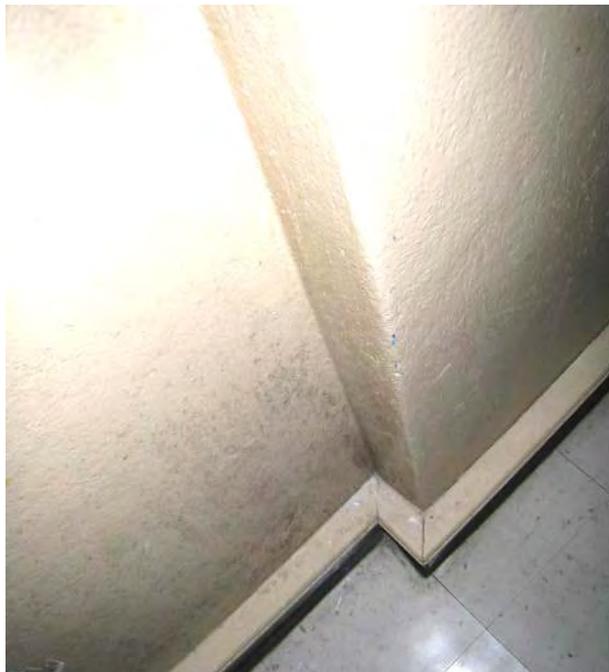
**Picture 6**

**Water-Damaged Paint**

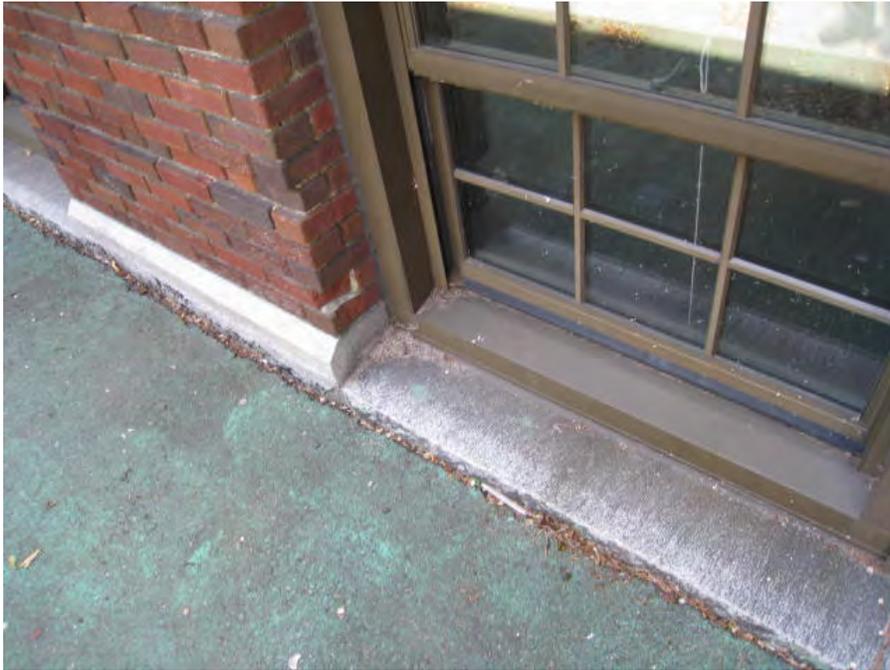
**Picture 7**

**Seam in Tarmac/Exterior Wall, Directly above Classroom with Darkened Paint**

1. Examine and repair breaches in the building's foundation, including areas around the sidewalk/exterior wall seam and exterior wall staircase seam.
2. Remove all materials affixed to below grade exterior walls.
3. Conduct remediation activities in the building in a manner consistent with recommendations in "Mold Remediation in Schools and Commercial Buildings" published by the US Environmental Protection Agency (US EPA, 2001). This document

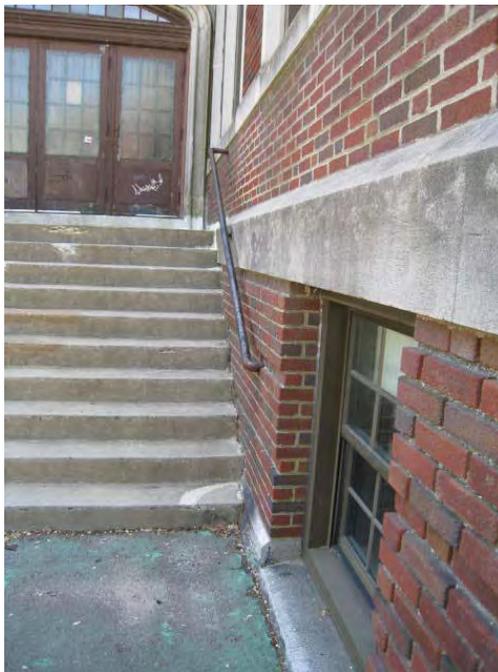
**Picture 8**

As discussed, concerns about IAQ and water damage/potential mold growth and exacerbation of respiratory symptoms prompted the request for an IAQ inspection. The areas of concern involve classrooms located in subdivided space that was previously the building's original gymnasium. At the time of the assessment, BEH staff observed discolored paint at the base of the interior side of an exterior facing wall in classroom B (Pictures 5 and 6). This discolorization may be mold colonization of the wall paint. Mold growth may be the result of water infiltration through the building's foundation, potentially from water penetrating along the sidewalk/exterior wall seam (Picture 7) or exterior wall staircase seam (Picture 8). Of particular note is the stairwell in Picture 8, which shows signs of repeated, failing patching.

**Exterior Stairwell above Classroom with Darkened Paint, Note Patching**

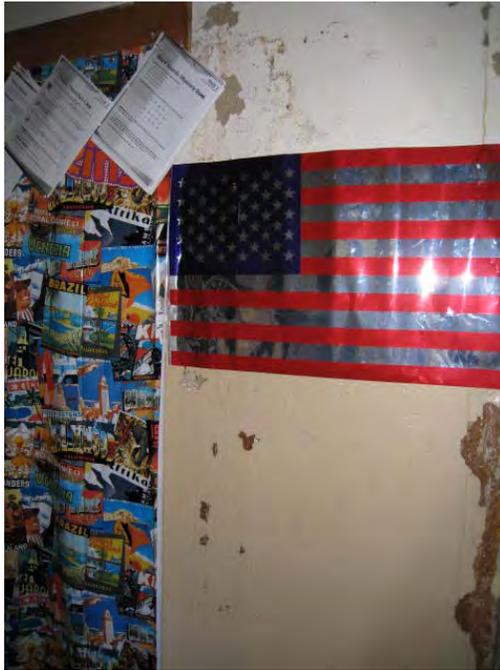
**Picture 9**

BEH staff observed materials that could become moistened and mold colonized (e.g., paper and cork bulletin board) or function as a water impermeable barrier by holding moisture against the wall (e.g., Mylar plastic) affixed to the classroom wall above the area of discolored paint (Picture 9). Materials that hold moisture against the wall can result in further damage to paint/wall brick. Repeated water damage to porous building materials (e.g., paint) can result in microbial growth.

**Bulletin Board and Mylar Plastic on Classroom Exterior Wall, Note Wall Damage**

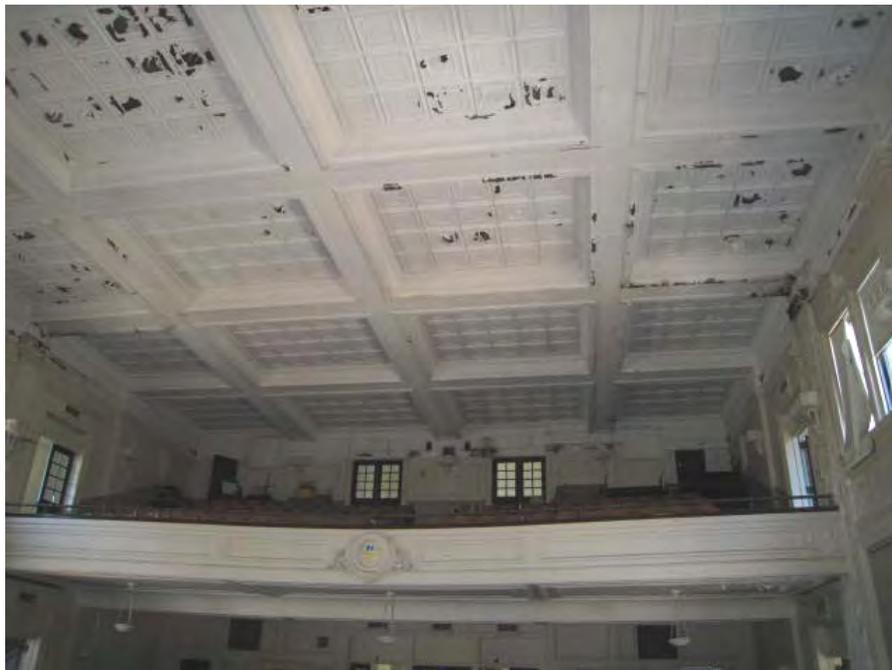
**Picture 10**

The school auditorium also had signs of water damage. This was evidenced by the presence of peeling paint and efflorescence along exterior brick walls (Picture 10). Efflorescence appears as a white, chalky residue and is a characteristic sign of water damage to brick and mortar, but it is not mold growth. As moisture penetrates and works its way through mortar around brick, water-soluble compounds in bricks and mortar dissolve, creating a solution. As the solution moves to the surface of the brick or mortar, the water evaporates, leaving behind white, powdery mineral deposits. A coat of paint can serve as a water impermeable barrier, which can trap moisture. While brick and mortar are not viable sources for mold growth, water trapped in spaces between the paint and brick can become mold growth media. To prevent further damage to exterior brick work, repointing may be necessary to prevent further water penetration.

**Water Damage in Auditorium**

2. Consider consulting a building engineer for permanent methods to repair roof leaks, which may include replacing the roof. Once the leaks are repaired, repair water-damaged plaster and replace missing/water damaged ceiling tiles.
3. Consider consulting a building engineer for methods to reduce water penetration through exterior walls, which may include repointing.

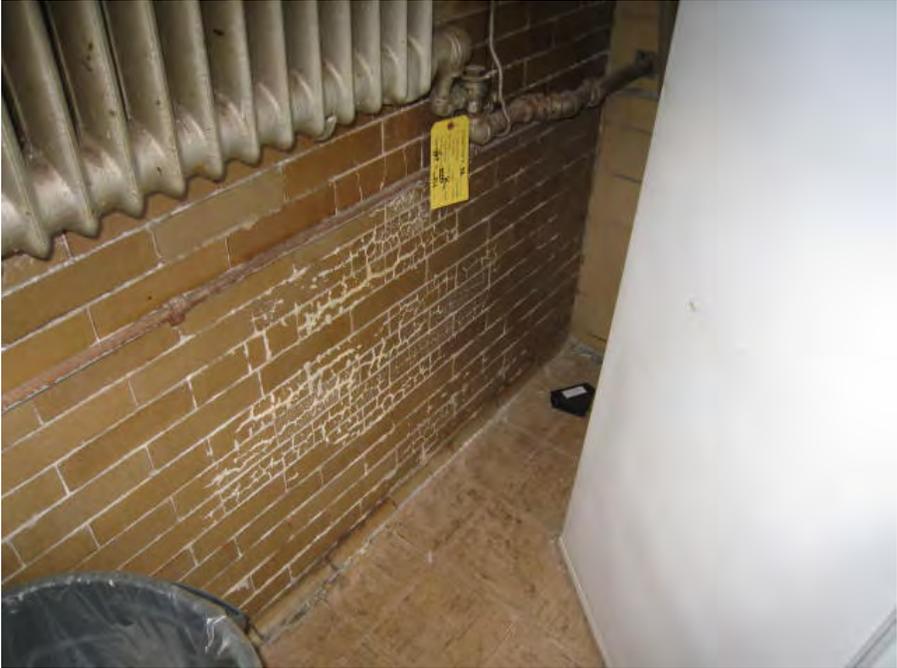
**Picture 11**

A number of pest attractants were identified within or around the building as demonstrated by the use of rodent bait traps in the building (Picture 11). Rodent infestation can result in indoor air quality related symptoms due to materials in their wastes. Mouse urine contains a protein that is a known sensitizer (US EPA, 1992). A sensitizer is a material that can produce symptoms (e.g., running nose or skin rashes) in sensitive individuals.

**Rodent Bait Trap**

17. Use the principles of integrated pest management (IPM) to rid this building of pest. Activities that can be used to eliminate pest infestation may include the following activities.
