INDOOR AIR QUALITY ASSESSMENT MOLD INVESTIGATION

**Pembroke High School
5 Learning Lane
Pembroke, Massachusetts**

Prepared by:
Massachusetts Department of Public Health
Bureau of Environmental Health
Indoor Air Quality Program
August 2010

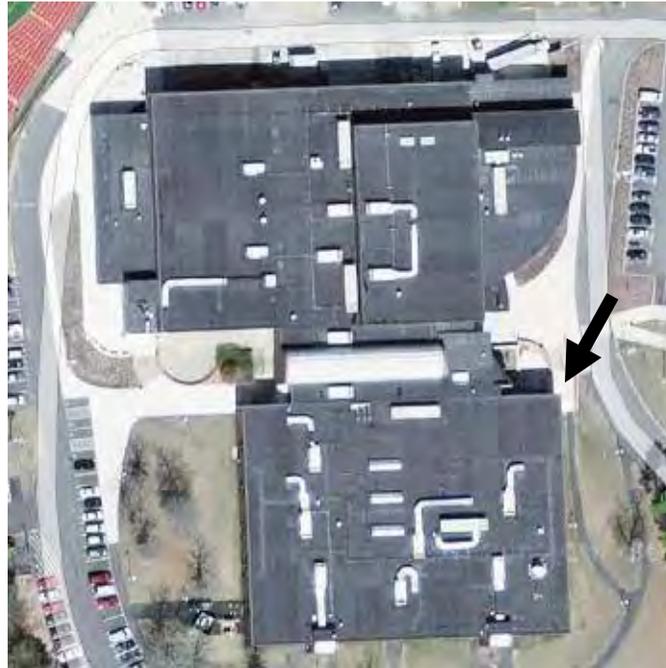
Picture 1

In order for building materials to support mold growth, a source of water exposure is necessary. Identification and elimination of the source of water moistening building materials is necessary to control mold growth. As reported by Mr. Peterson, the northeast corner of the classroom building, particularly classroom A-201, has experienced issues with water infiltration through window frames and sills during heavy wind-driven rain (Pictures 2 and 3). At the time of the assessment Mr. Peterson reported that a work order had been issued to repair/seal window frames/sills for the northeast corner classrooms, including classroom A-201. The work is scheduled for completion over the summer of 2010.

Arrow Indicates Point of Water Infiltration through Window Frames of Classroom A-201

1. Continue with plans to reseal window frames and sills to prevent/reduce further water penetration.
2. Remove vinyl base coving in classroom A-201.
3. Remove/replace mold-colonized GW beneath coving.

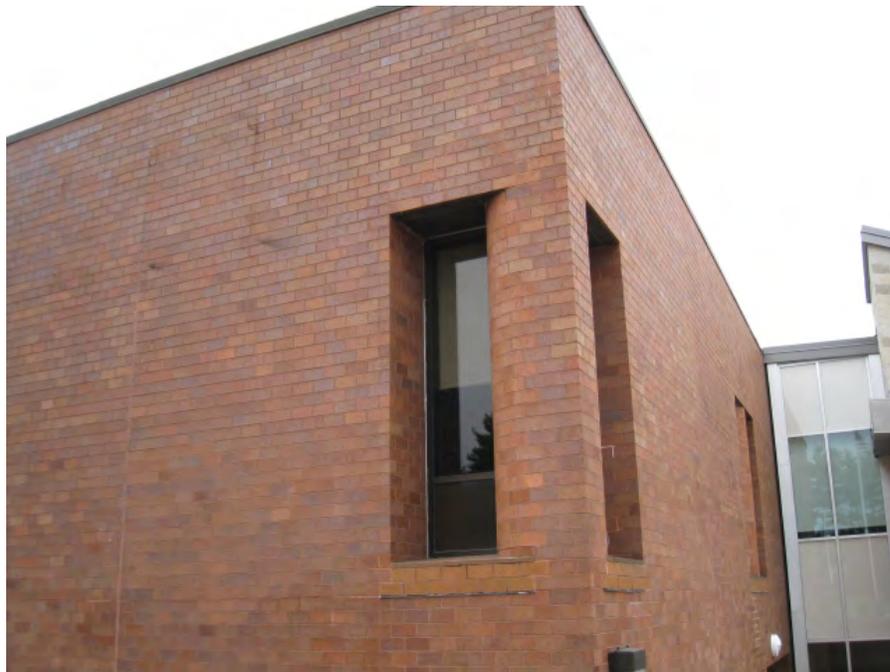
Picture 2

Northeast Corner of Classroom Building, Classroom A-201

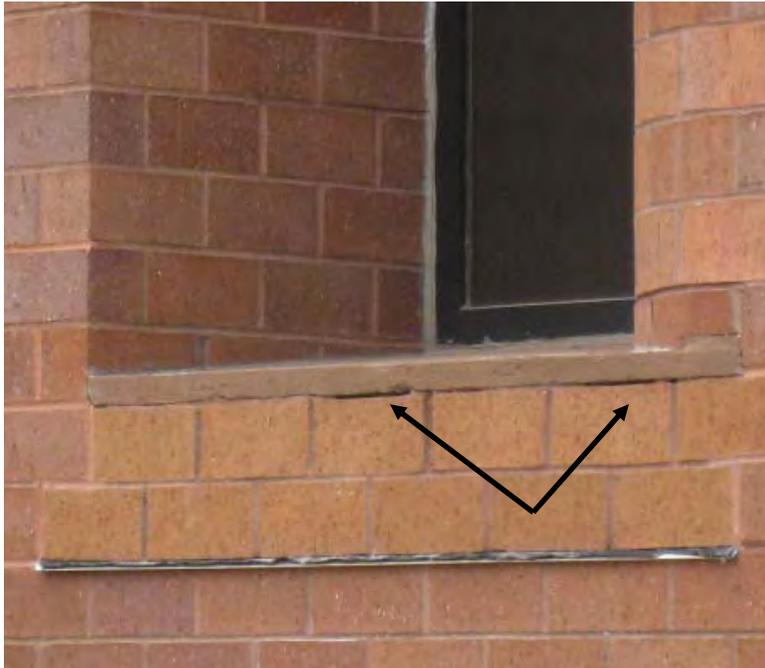
Picture 3

Spaces beneath Stone Windowsill outside of Classroom A-201

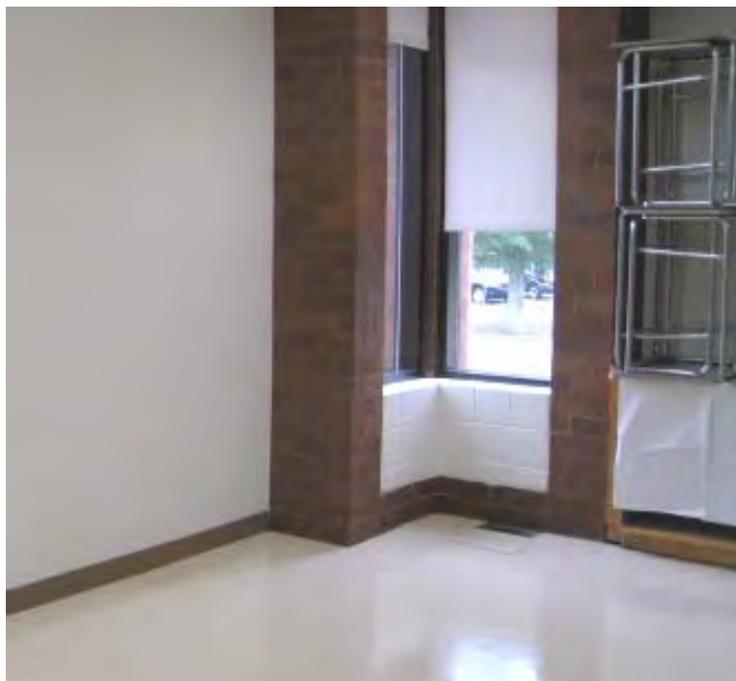
Picture 4

The interior corner of classroom A-201 (the area of reported leaks) is flanked by built-in wooden shelving and GW. Vinyl base coving was installed along the floor in this area (Picture 4). Vinyl base coving is designed to protect the base of walls from damage. However, if porous materials (or semi-porous in the case of wood) get wet, the vinyl base coving can trap moisture behind it as the exposed material dries. To determine if GW and wooden shelving had elevated moisture content that would be conducive to mold growth, BEH staff conducted moisture testing of these materials. No elevated moisture measurements were detected (Table 1), indicating the materials were dry at the time of the assessment.

Northeast Corner of Classroom A-201, Note Wooden Built-In Shelving on Right and Gypsum Wallboard with Vinyl Coving on Left

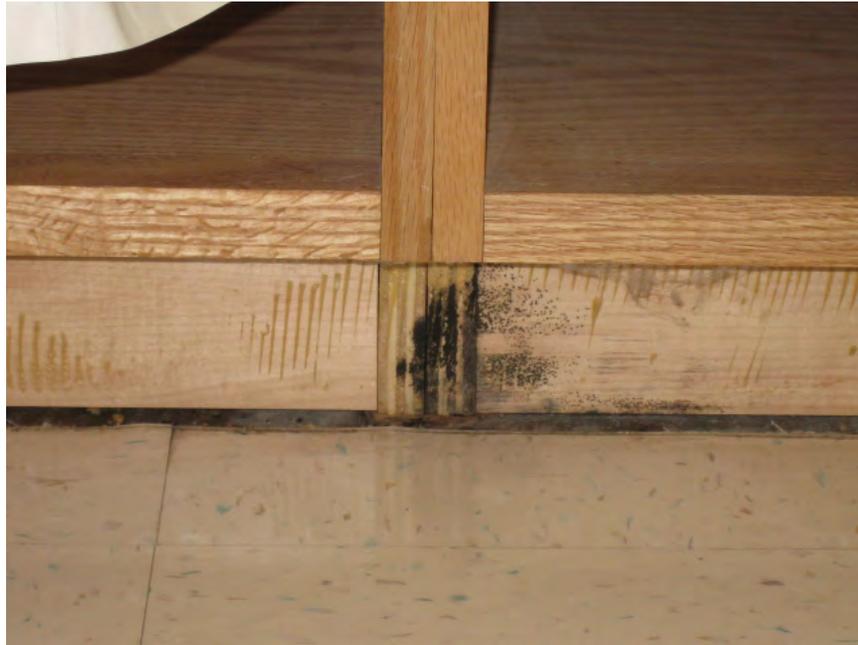
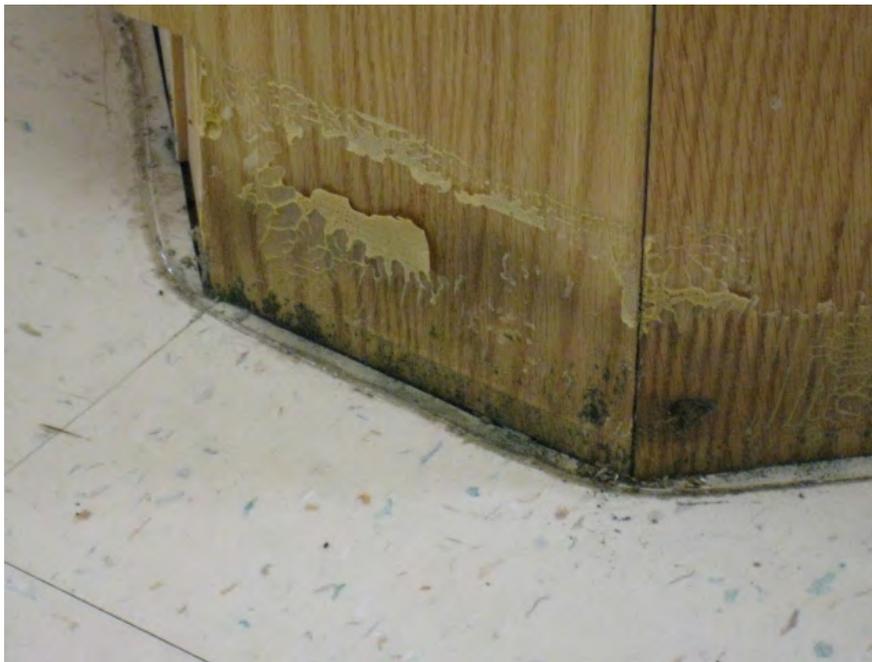
To determine if mold was present behind vinyl base coving, Mr. Peterson removed the coving along the wooden shelving and GW. Dark staining indicating visible mold growth was observed on both shelving wood and GW (Pictures 5 through 7). The US Environmental Protection Agency (US EPA) and the American Conference of Governmental Industrial Hygienists (ACGIH) recommend that porous materials (e.g., GW) be dried with fans and heating within 24 to 48 hours of becoming wet (US EPA, 2001; ACGIH, 1989). If not dried within this

**Dark Staining along Base of Wooden Shelving behind Vinyl Base Coving
Indicating Mold Growth**

time frame, mold growth may occur. Once mold has colonized porous materials, they are difficult to clean and should be removed. BEH staff recommended that the remainder of the vinyl coving be removed and any mold-colonized portions of GW be replaced. Wood is a semi-porous material that can be cleaned with a mild detergent and water and allowed to dry (US EPA, 2001). If cleaning with a detergent solution does not sufficiently remove mold growth, manual abrasion through light sanding and vacuuming with a high efficiency particulate arrestance (HEPA) filter equipped vacuum cleaner can be conducted.

- c. After remediation is complete, clean area with a HEPA filtered vacuum cleaner.
4. Clean base of wooden cabinets with a mild detergent followed by a clean water rinse and allow drying. If mold remains, follow-up with light sanding and vacuuming of debris with a HEPA filtered vacuum cleaner.

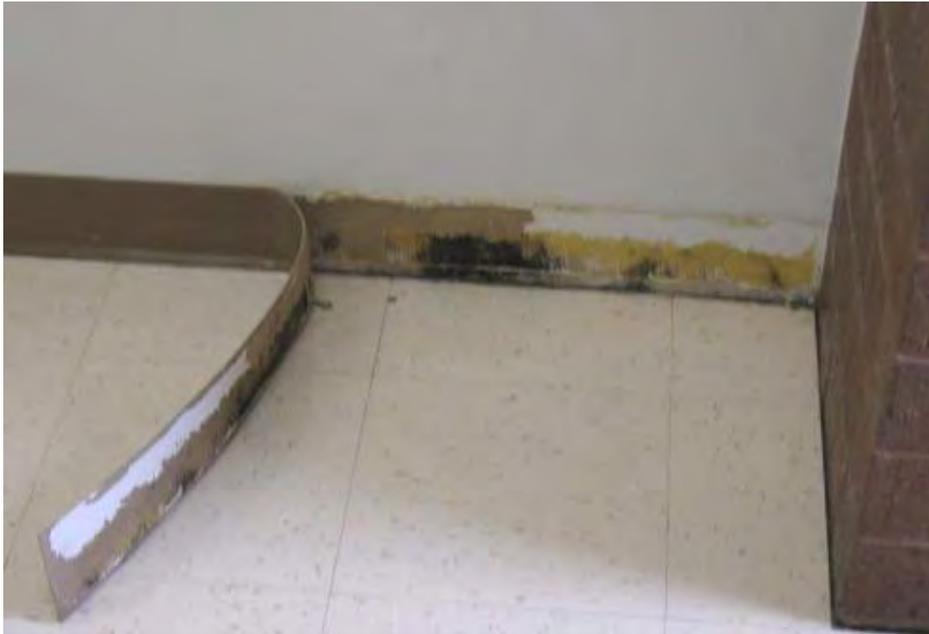
Picture 7

**Dark Staining along Base of Gypsum Wallboard behind Vinyl Base Coving
Indicating Mold Growth**

- a. Ensure ventilation in area is deactivated prior to remediation.
 - b. Seal mold-colonized debris in plastic bags for transport through the building for disposal.

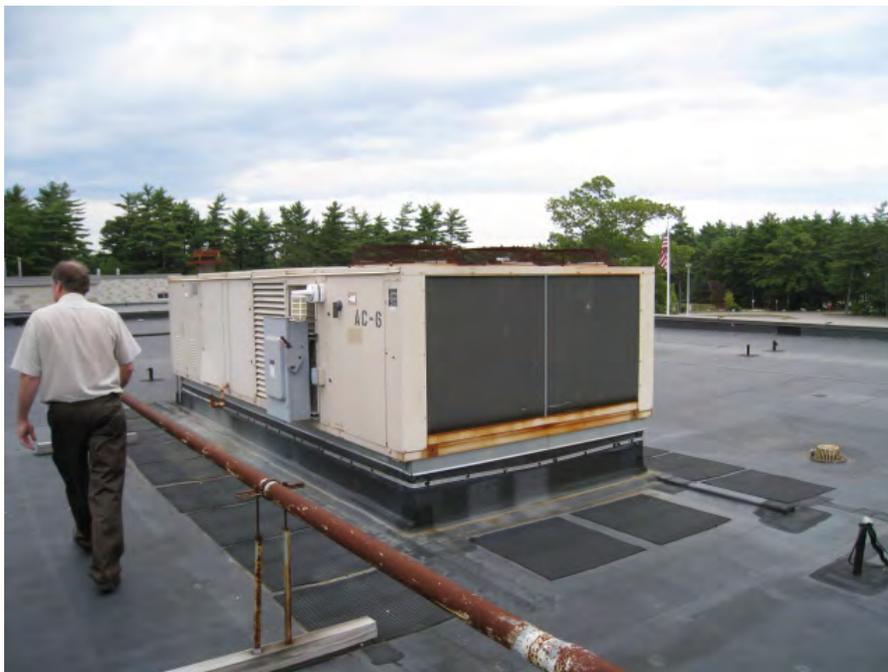
Picture 8

BEH staff also inspected the rooftop air handling unit (AHU) that supplies fresh outside air to classroom A-201 (Picture 8). No signs of water pooling or mold growth were noted inside the units. The AHUs draw in fresh outside air through a bank of pleated filters (Picture 9), which are reportedly, changed 3 to 4 times per year. AHU filters had accumulated dust/debris and appeared in need of changing at the time of the assessment, which was reportedly scheduled to be done over the summer recess. Also noted was a build-up of dirt, dust/debris inside the unit, and in particular the condensate drip pan (Picture 10). Although the drip pan was dry at the time of the assessment, debris accumulated in the drip pan can provide a medium for mold growth if it becomes moistened.

Rooftop AHU

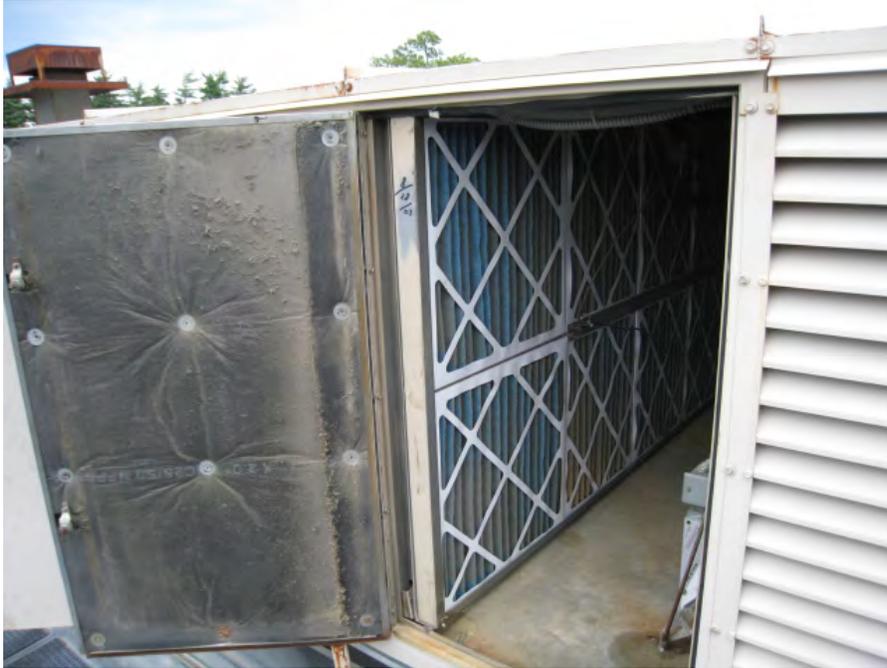
Picture 9

Pleated Filters Installed in Rooftop AHUs

5. Continue to change filters for air-handling equipment (e.g., AHUs) as per the manufacturers' instructions or more frequently if needed. Vacuum interior of units prior to activation, particularly condensate drip pans to prevent mold growth and the aerosolization of dirt, dust and particulate matter.

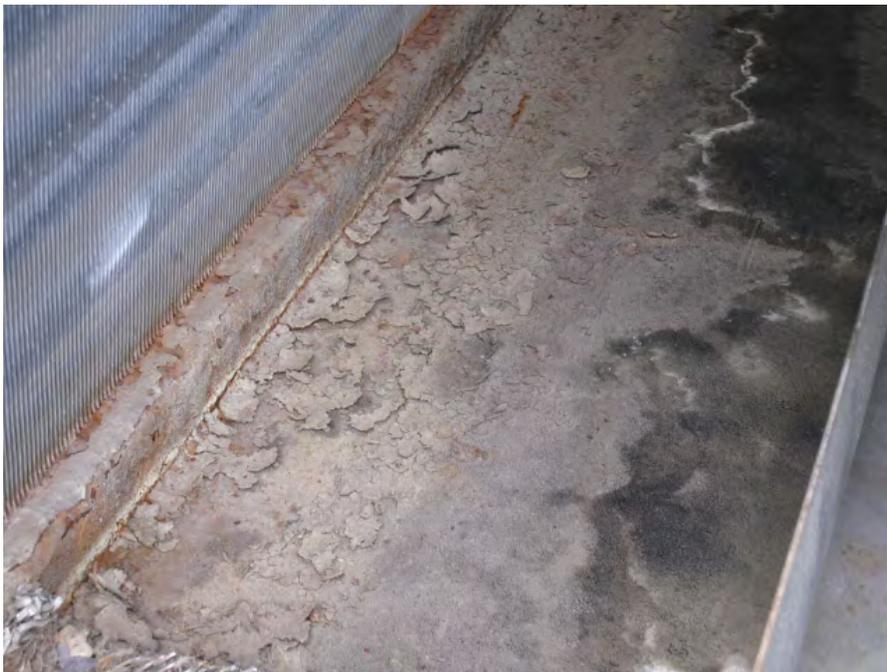
Picture 10

Dust/Debris Accumulation in AHU Condensate Drip Pan
