INDOOR AIR QUALITY REASSESSMENT

**Lynnhurst Elementary School
443 Walnut Street
Saugus, Massachusetts**

Prepared by:
Massachusetts Department of Public Health
Bureau of Environmental Health
Indoor Air Quality Program
June 2010

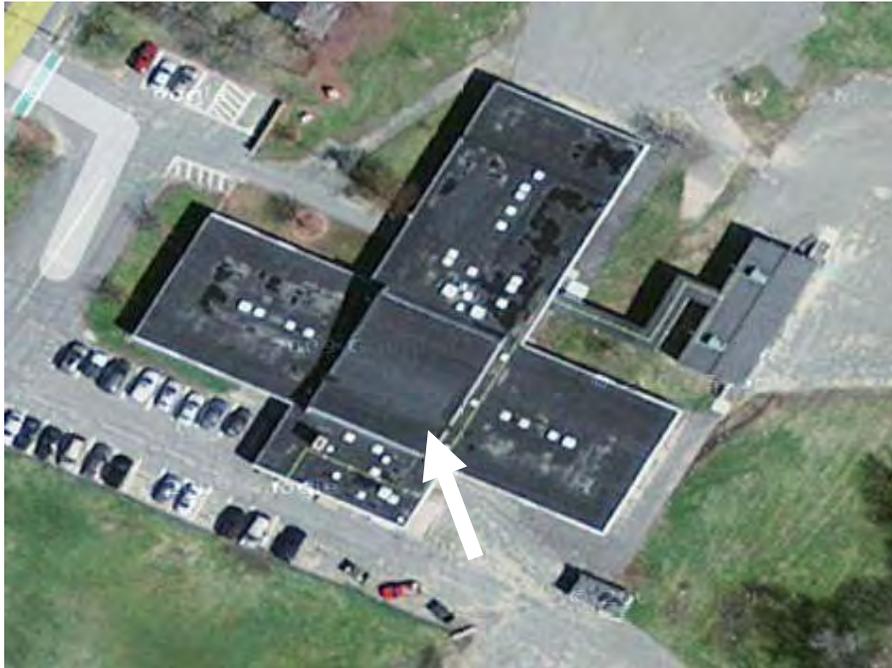
Picture 1

The school is a one-story, multiple wing brick building constructed in 1965 (Picture 1). A set of three modular classrooms were added to the building in the 1990s. The school contains general classrooms, cafeteria/gymnasium, library, health suite and main office. The cafeteria/gymnasium is a two-story structure with a roof in the shape of an asymmetrical trough (Picture 2), which drains water onto the flat roof below its valley (Picture 3). Windows are openable throughout the building.

Aerial View, Arrow Denotes Auditorium/Cafeteria Trough

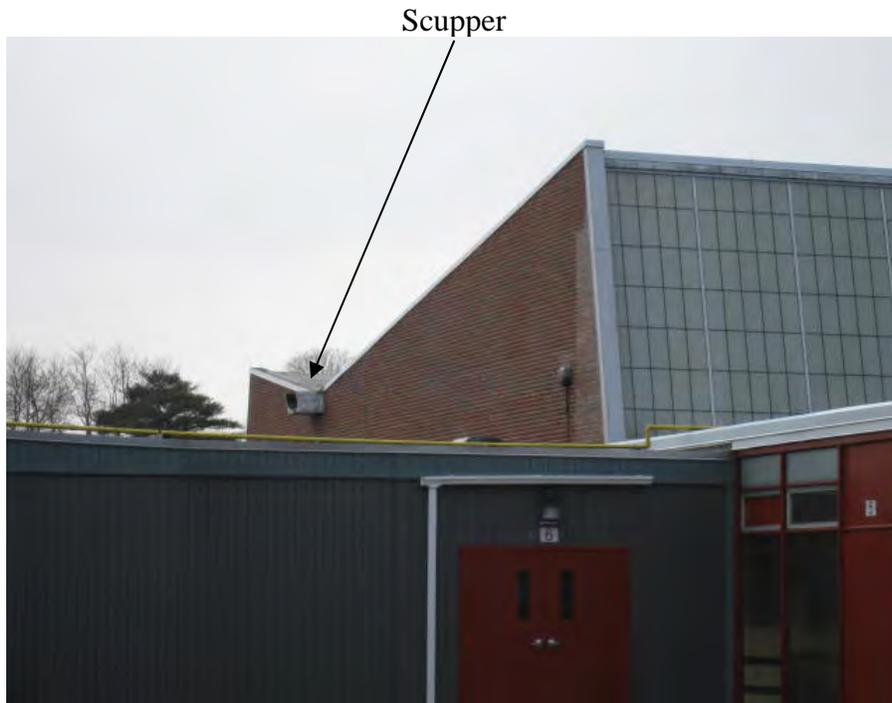
Picture 2

As noted previously, the roof and upper wall of the cafeteria/gymnasium are of an unusual design. Instead of being peaked or flat, the roof in this area forms a trough which then directs water to pour onto the lower flat roofs of the building (Picture 2). The cafeteria/gymnasium has two large window frames which provide natural light. In and around

Asymmetrical Auditorium/Cafeteria Roof, Note Large Scupper That Drains Water onto Flat Roof

12. Consideration should be given to installing gutters/downspouts at the ends of the cafeteria/gymnasium roof trough to reduce water impact on the school's lower flat roof. This system should be designed in a manner to accommodate the capacity of water that can drain from this trough roof system.

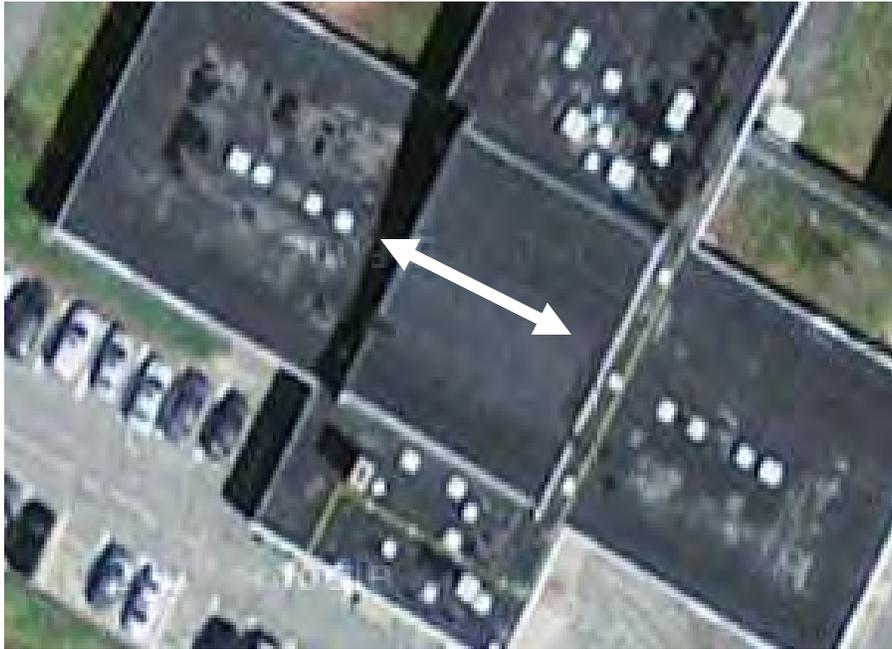
Picture 3

The design of the roof system will tend to accumulate water on the flat roof sections of the building. In addition, areas directly beneath the trough of the cafeteria/gymnasium roof will tend to become eroded which will then lead to water leaks, as evidenced by water-damaged ceiling tiles. Another source of moisture inside the building is water penetration through exterior door frames (Picture 10).

Arrow Notes Water Flow off Trough Roof, Grey Discolorization on Lower Roofs Indicate Water Accumulation

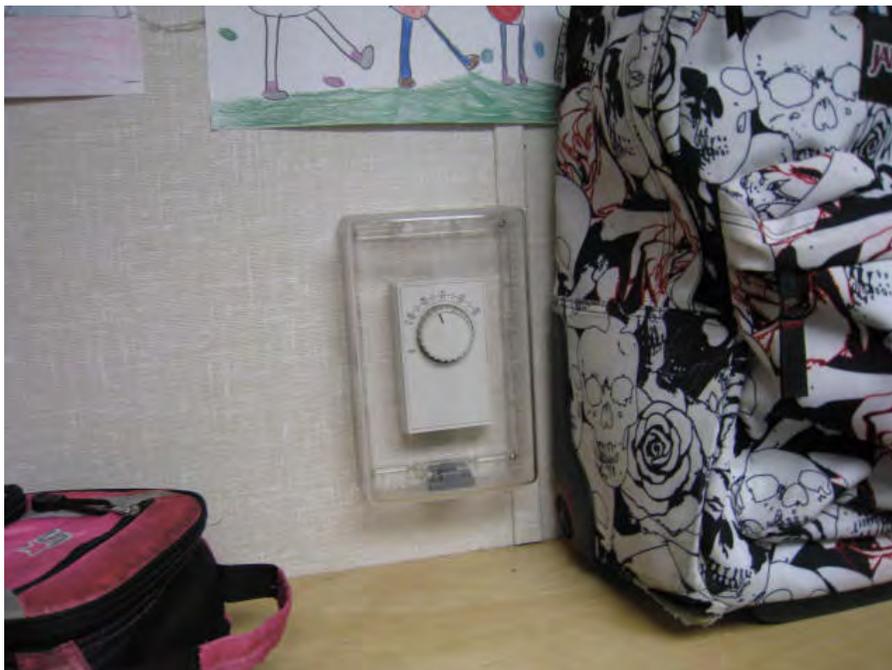
Picture 4

Modular Wing Thermostat over Shelf

4. Set the thermostat for modular classrooms to the fan “on” position to operate the ventilation system continuously during the school day.
5. Remove shelving or relocate thermostats for modular classrooms to facilitate airflow/temperature regulation.

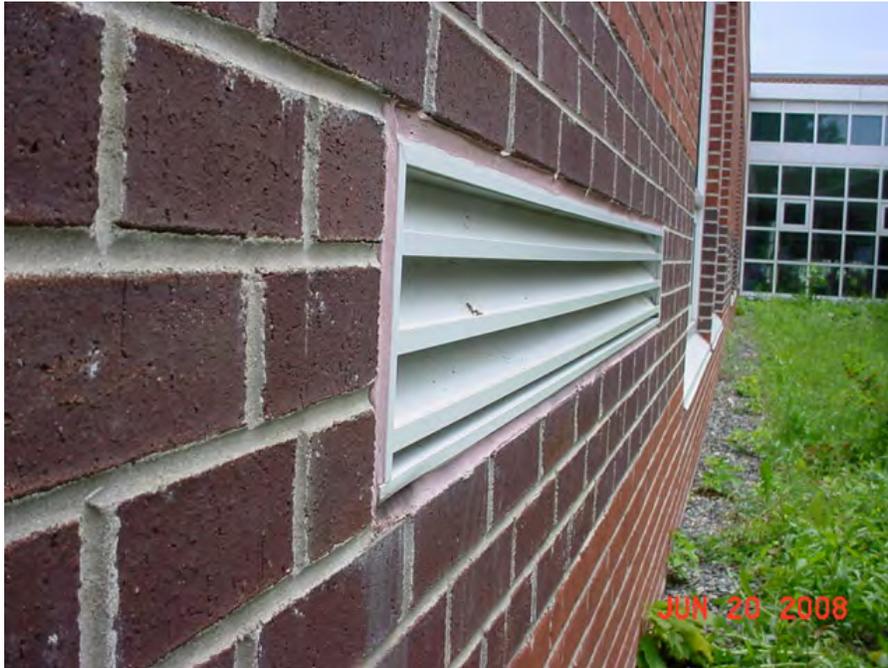
pathways that allow for moisture to penetrate the building interior. Of note is the configuration of the univent fresh air intakes (UFAIs). In most buildings assessed by BEH staff, the exterior grills of the UFAIs are installed with the louvers parallel to the ground (see Picture 5 as an example). These louvers are also usually beveled in a manner for rainwater to pour away from the univent opening, similar to a peaked roof on a house. The UFAI louvers at the LES are perpendicular to the ground (Picture 6). This configuration can allow for driving rain to penetrate into the fresh air intake and accumulate in the floor of the univent instead of rolling off the louver and away from the univent.

Example of a Typical Fresh Air Intake Installation with Louvers Parallel to Ground That Drain Water Out

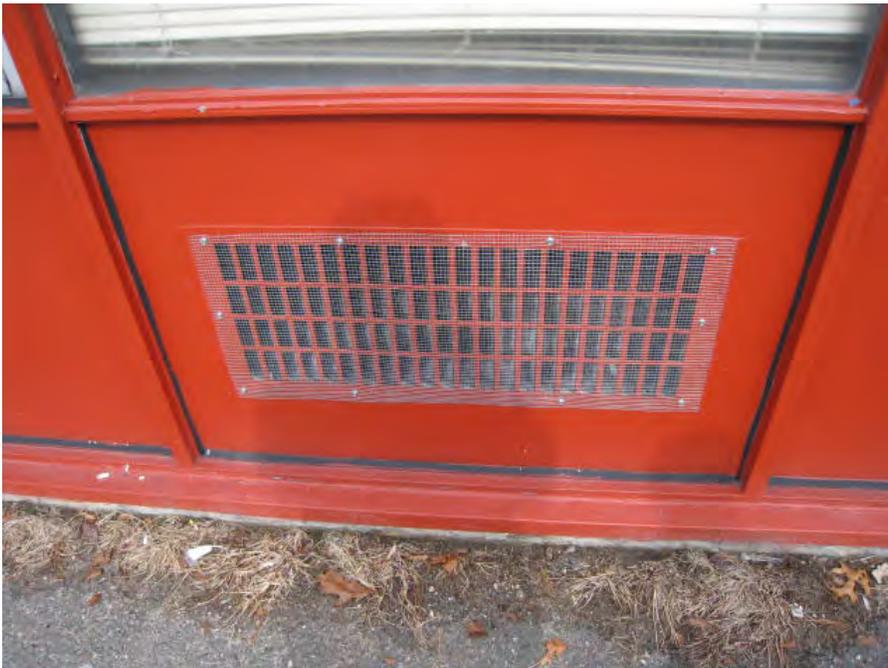
Picture 6

Fresh Air Intake Louvers Installed Perpendicular to Ground

2. All holes inside the univent cabinet (e.g., should also be sealed to prevent draw of air from the exterior wall cavity.
3. Univent fresh air intake grilles should be replaced with a design that prevents water penetration (e.g., louvers should be oriented parallel to the ground, sloped downward to prevent water penetration), particularly in rooms with south and west facing exterior walls. In the interim UFAs should be cleaned on a regular schedule.

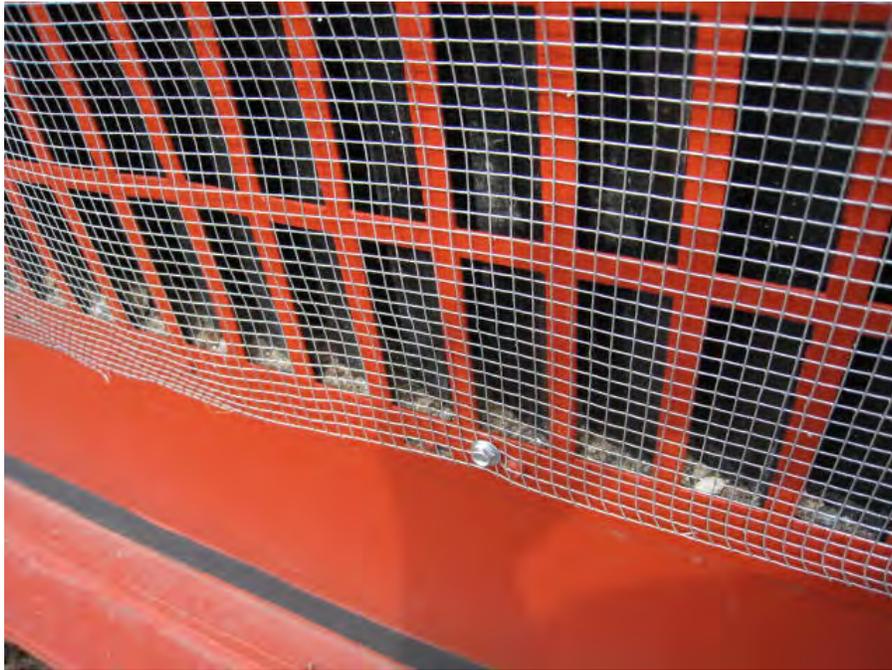
Picture 7

Also of note is the presence of pebbles accumulated in the bottom of the louver frame (Picture 7). The source of the pebbles is likely from sand used during winter months in the parking lot. When plows move snow against the building, such debris remains once snow is thawed. Depositing snow in this manner during the winter months would also limit the intake of fresh air. In addition, the presence of pebbles in the UFAI frame may indicate that water is being introduced into the univent duct from melting snow. Further, just prior to this assessment, New England had been subjected to a series of rainstorms with a driving wind. Moist weather tends to travel in a northeasterly track up the Atlantic Coast towards New England (Trewartha, 1943). Wet weather systems generally produce south/southwesterly winds, which can impact on westerly and southerly facing UFAIs. UFAIs are also prone to accumulating outdoor debris, dirt and other materials that can serve as mold growth media. With repeated water penetration, these accumulated materials can become moistened, resulting in potential mold growth, particularly within several days after rainstorms.

Pebbles Accumulated in Base of Fresh Air Intake Vent Shown in Picture 6

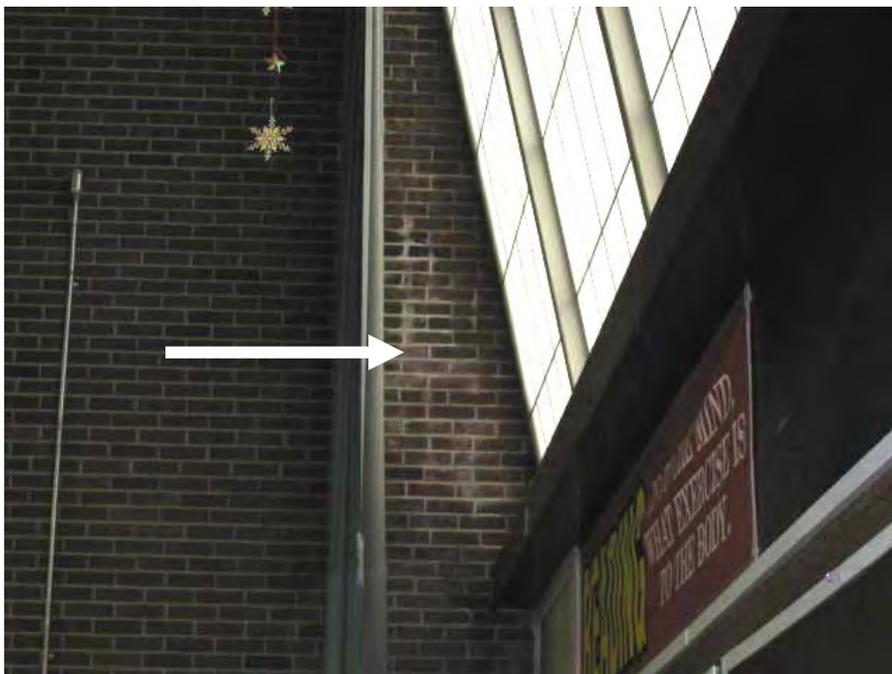
Picture 8

the edges of the south window, a white, powdery coating was identified and suspected to be mold growth. This white coating is not mold colonization, but rather efflorescence (Picture 8). Efflorescence is a characteristic sign of water damage to brick and mortar, but it is not mold growth. As moisture penetrates and works its way through mortar, brick or plaster, water soluble compounds dissolve, creating a solution. As the solution moves to the surface of the material, the water evaporates, leaving behind white, powdery mineral deposits. Efflorescence in the cafeteria/gymnasium is on brick and mortar which is not a material that typically can serve as a mold growth medium. Numerous efforts to stem water penetration through the brick/window frame area have been attempted as evidenced by the discoloration of exterior wall brick from repeated coating with water proofing material (Picture 9).

Efflorescence on Auditorium/Cafeteria Wall

13. Periodically clean/vacuum efflorescence and loose debris from walls in areas of leaks.
14. It is highly recommended that the principles of integrated pest management (IPM) be used to rid the building of pests. A copy of the IPM recommendations can be obtained from the Massachusetts Department of Food and Agriculture (MDFA) website at the following website: http://www.state.ma.us/dfa/pesticides/publications/IPM_kit_for_bldg_mgrs.pdf. Activities that can be used to eliminate pest infestation may include the following activities.

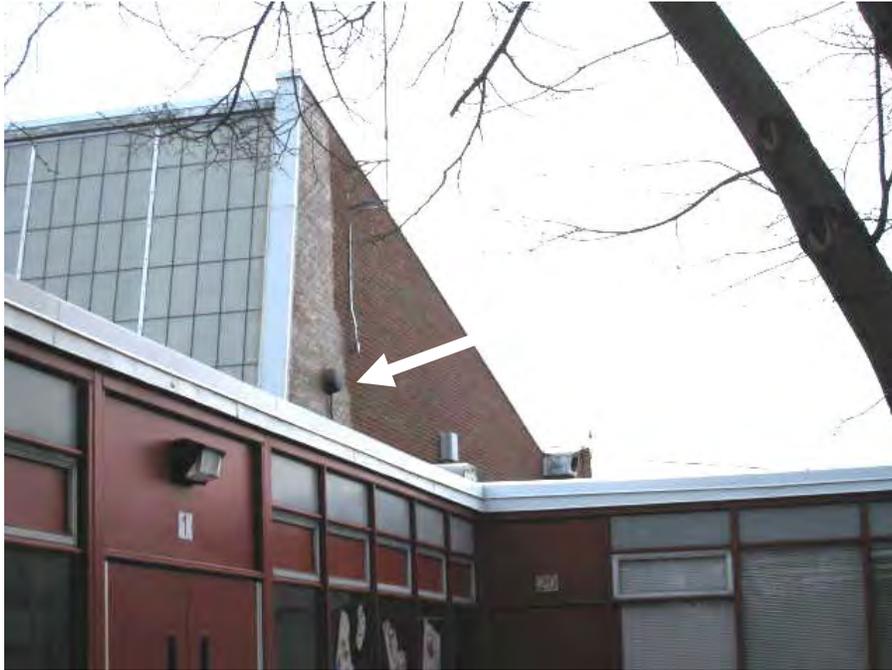
Picture 9

**Exterior Wall Brick Discolored from Repeated Coating
with Water Proofing Material**

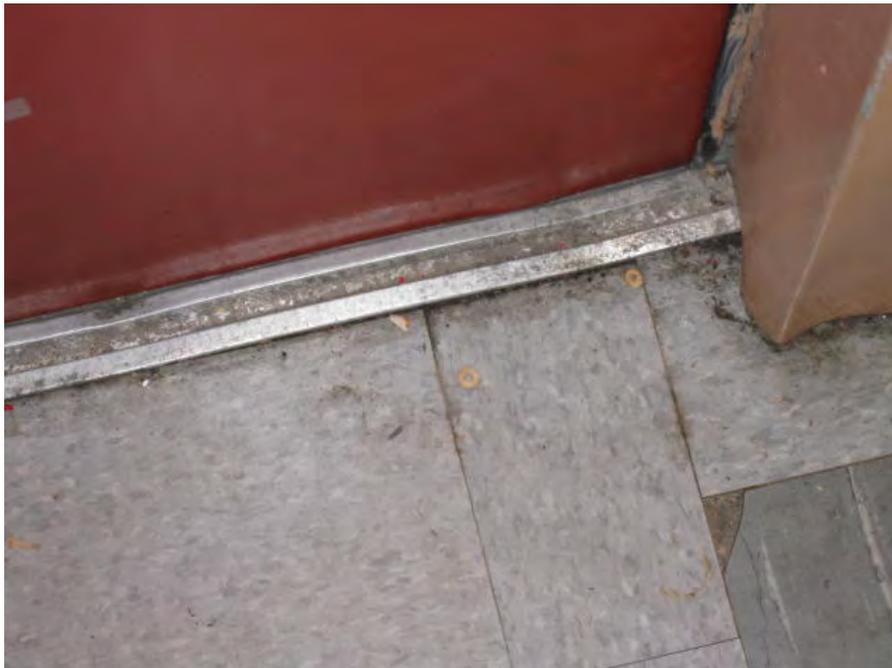
Picture 10

Space in Exterior Wall Door Frame

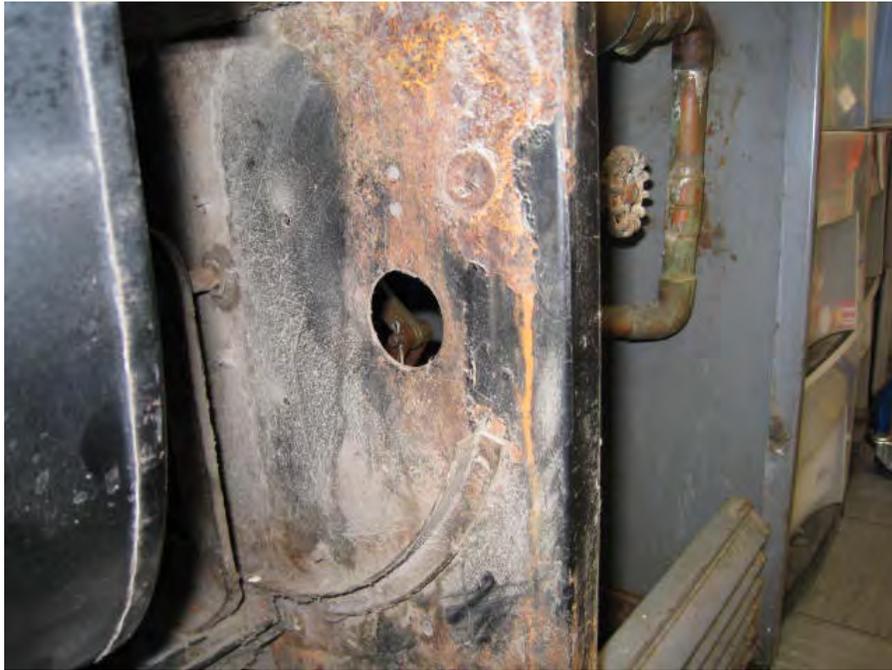
Picture 11

A number of conditions were observed during the assessment related to unit ventilators. The interior wall of the unit ventilators in classrooms has holes that are located between the filter and fans (Picture 11). As the unit ventilators operate, air is drawn through these holes instead of through the filter, which allows for particulates in the cabinet to become aerosolized. This condition was noted in room 5. A hole was also observed in the rear of the unit ventilator which appears to open into the wall cavity (Picture 12). Under these conditions, it is possible for the unit ventilator to draw unfiltered air from the exterior wall cavity which would then be distributed into the air of rooms with this configuration. The unit ventilator cabinet walls (where the filter and fan exist) should be airtight in order to draw air into the filter to remove particulates.

Hole in Univent Wall, Post Filter

1. Seal all holes in the walls of the univent air handling cabinets to limit filter bypass. Double sided, foil faced insulation with adhesive or aluminum insulation tape can be applied in a manner to create an airtight seal.

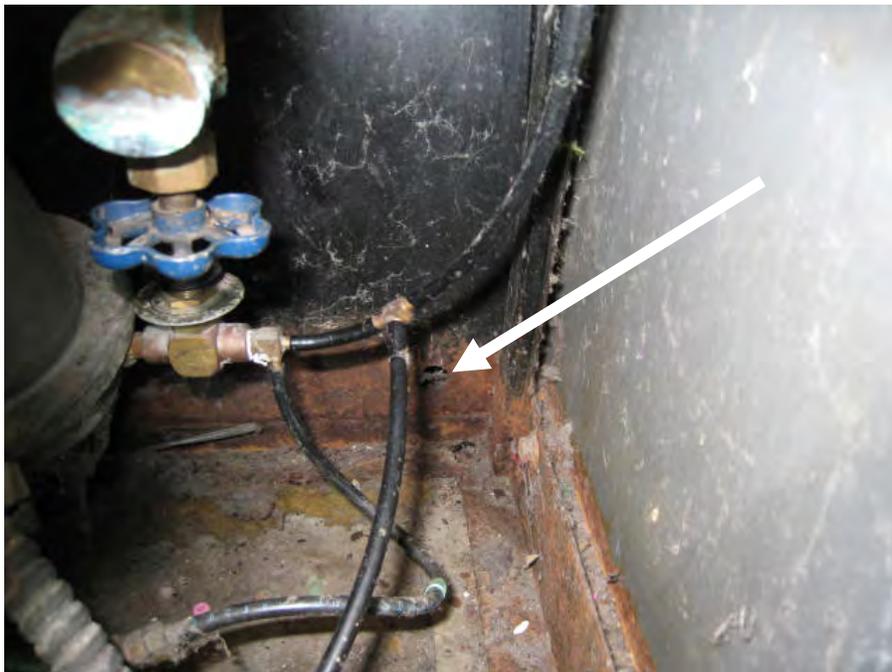
Picture 12

Hole in Univent Cabinet to Exterior Wall

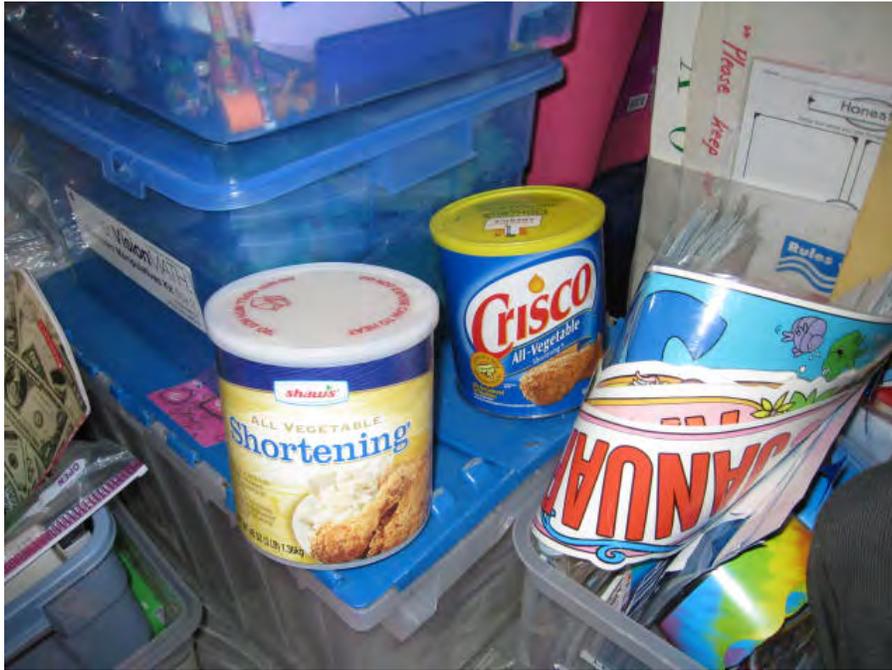
Picture 13

Of note was the use of food containers and storage of bird seed in classroom areas (Pictures 13 and 14). Exposed food products and reuse of food containers can attract a variety of pests. The presence of pests inside a building can produce conditions that can degrade indoor air quality. For example, rodent infestation can result in indoor air quality related symptoms due to materials in their wastes. Mouse urine is known to contain a protein that is a known sensitizer (US EPA, 1992). A sensitizer is a material that can produce symptoms in exposed individuals, including nasal and skin irritation/rashes. Pest attractants should be reduced/eliminated. Proper food storage is an integral component in maintaining indoor air quality. Food should be properly stored and clearly labeled. Reuse of food containers (e.g., for art projects) is not recommended since food residue adhering to the container surface may serve to attract pests.

Food Containers

- b. Rinse out recycled food containers. Seal recycled containers in a tight fitting lid to prevent rodent access.
 - c. Store foods in tight fitting containers.
 - d. Avoid eating at workstations. In areas where food is consumed, periodic vacuuming to remove crumbs are recommended.
 - e. Regularly clean crumbs and other food residues from ovens, toasters, toaster ovens, microwave ovens coffee pots and other food preparation equipment;
 - f. Holes as small as ¼” are enough space for rodents to enter an area. Examine each room and the exterior walls of the building for means of rodent egress and seal. If doors do not seal at the bottom, install a weather strip as a barrier to rodents.

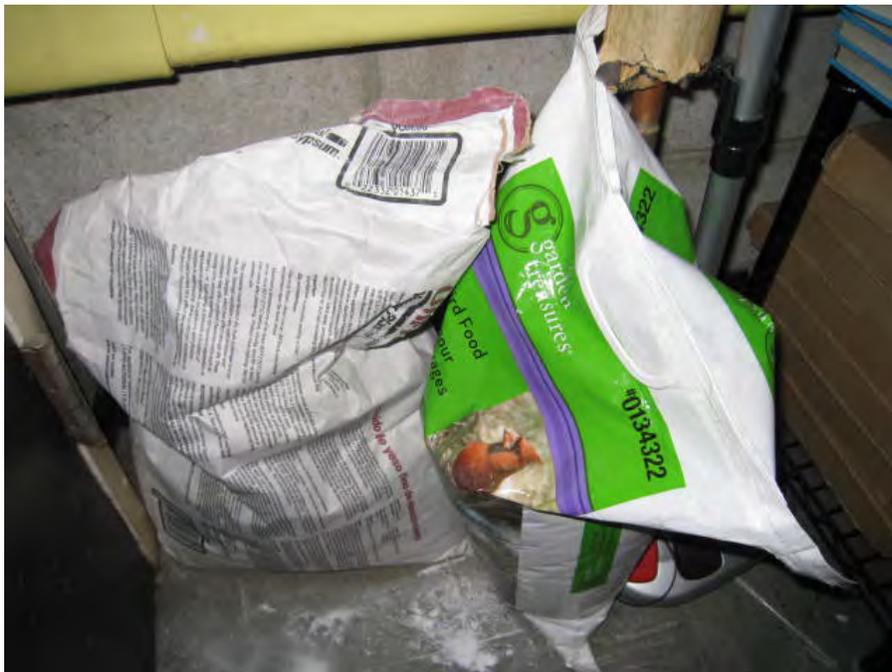
Picture 14

Bag of Bird Seed in Storage Closet
