INDOOR AIR QUALITY ASSESSMENT

**Massachusetts Board of Registration in Medicine
200 Harvard Mill Square, Suite 330
Wakefield, MA**

Prepared by:
Massachusetts Department of Public Health
Bureau of Environmental Health
Indoor Air Quality Program
September 2010

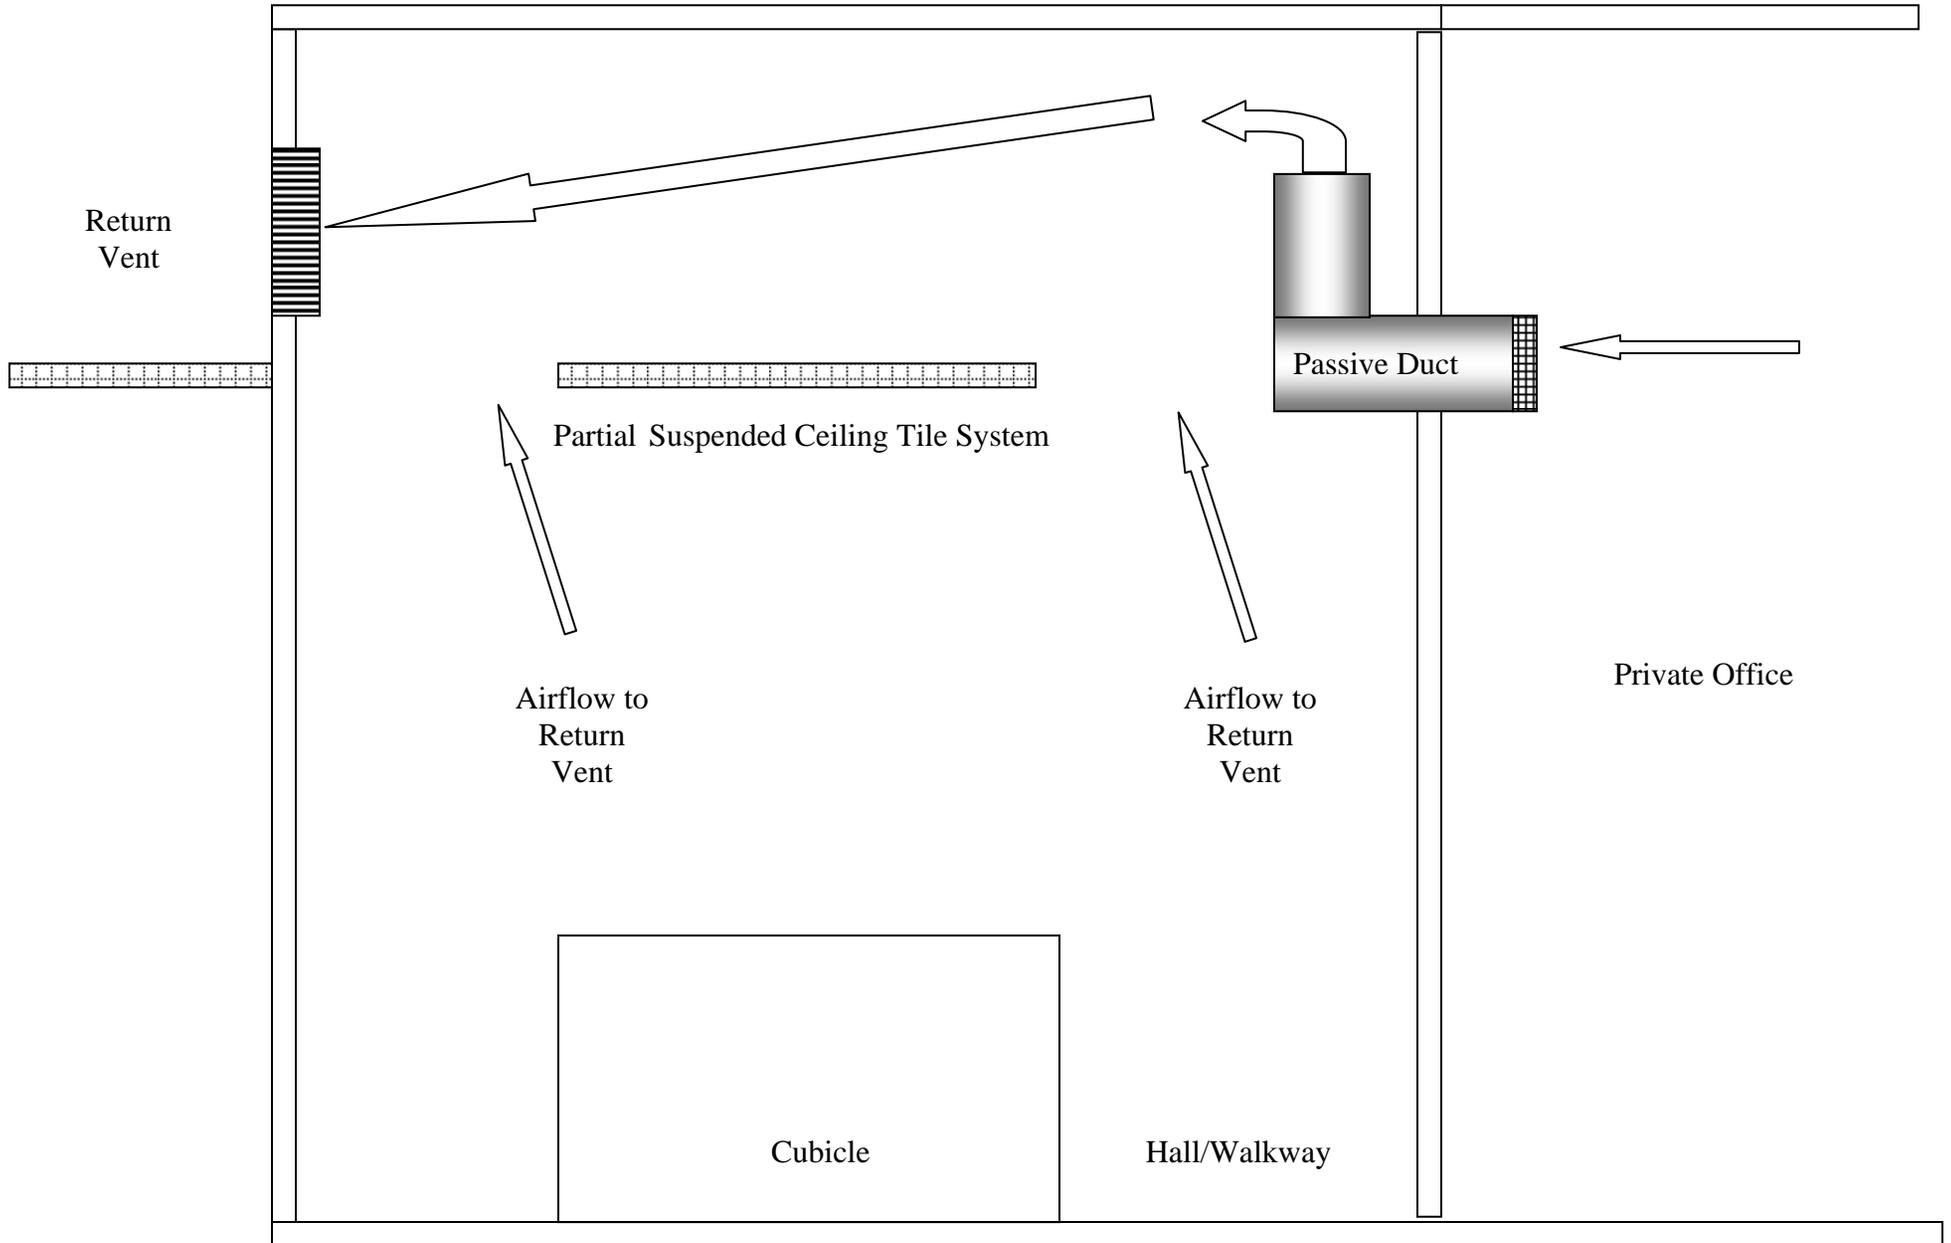
Figure 1: Return Airflow for Cubicles and Private Offices

The return air system uses an unusual method of partial duct ceiling plenum to return air back to the mechanical rooms. Offices along the southern exterior wall have wall-mounted passive return vents connected to ducts that traverse the interior wall and terminate in the walkway in a 90° angled vent (Pictures 5 and 6; Figure 1). A partially suspended ceiling installed over cubicles appears to act like a duct, creating a space through which return air can be drawn into wall-mounted return vents on the wall opposite from the 90° angled vents for offices along the south wall (Picture 7; Figure 1). Based on HVAC plans provided to BEH staff, it appears that a full ceiling plenum in offices near the mechanical room serves as a conduit for air to enter mechanical rooms through the aforementioned wall-mounted return vents (Figure 1). Each mechanical room essentially functions as an air mixing room that contributes to the overall HVAC system. In this configuration, there appears to be minimal control over the ratio of fresh air to return air.

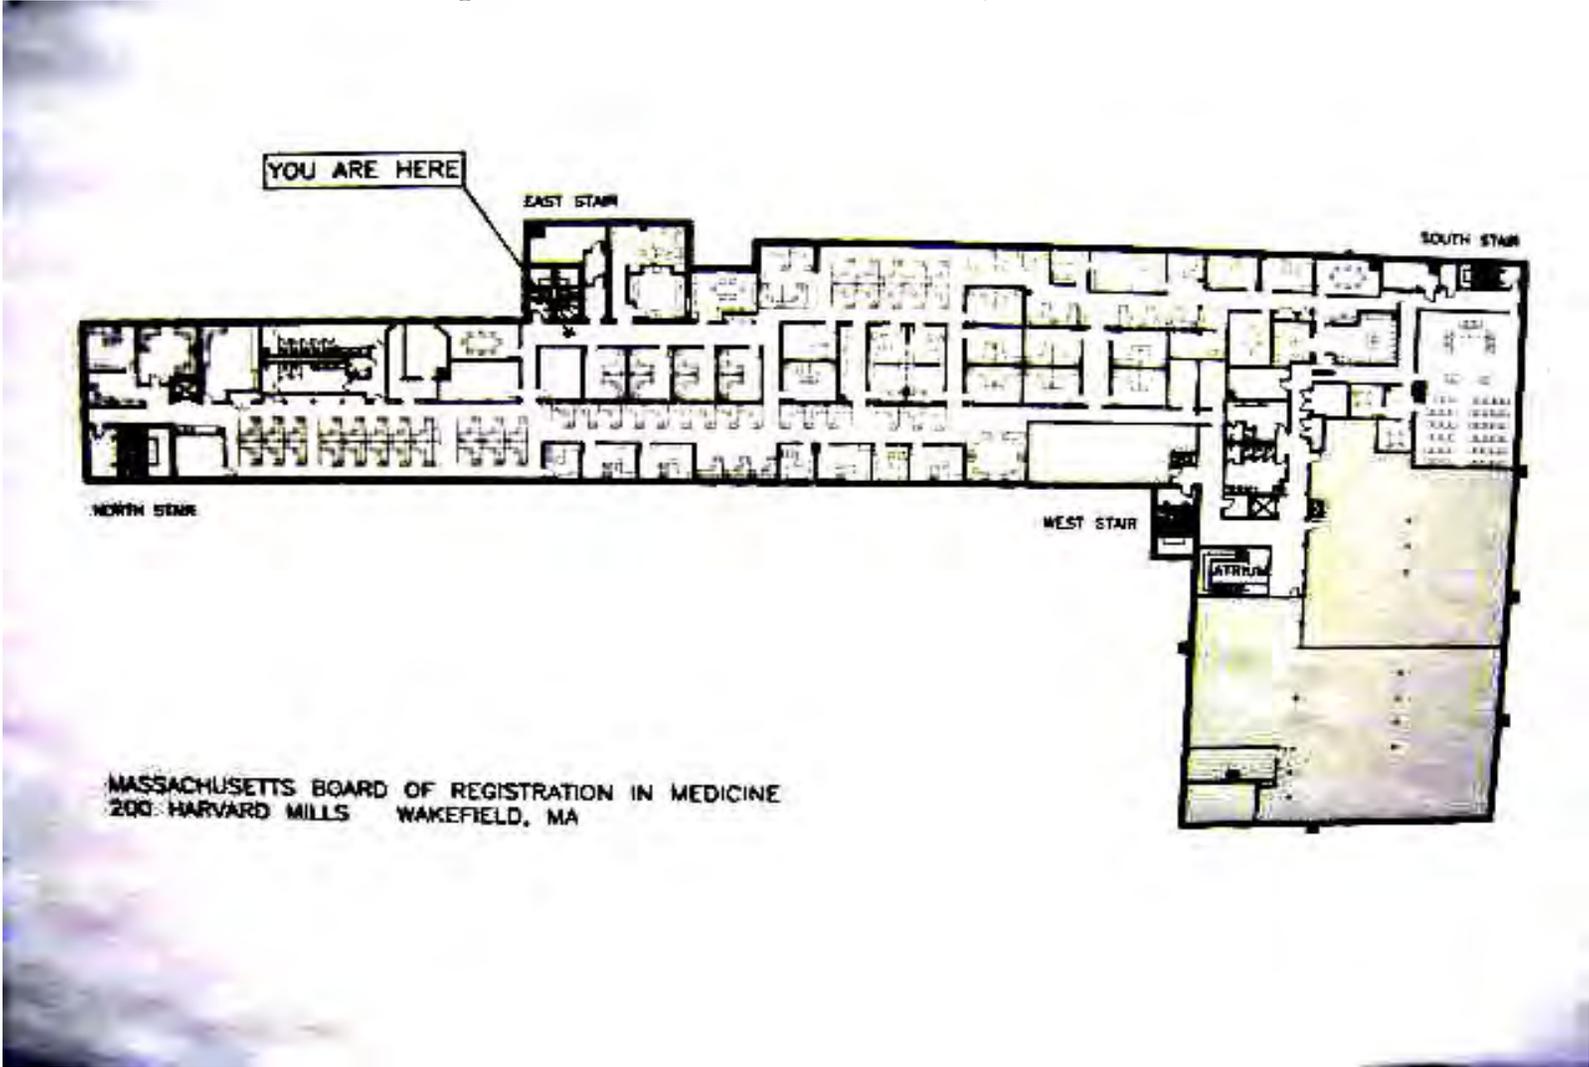
Figure 2: Location of Mechanical Rooms, Main Office

Absent from this design is an obvious means for air to be exhausted from the building. In Mechanical Room A (Figure 2), a small fan was operating intermittently. The size of this fan does not appear to be sufficient to exhaust air from the mechanical room and the area serviced by the system in Mechanical Room A. For areas serviced by mechanical room B, no means to exhaust air was observed. It is possible that exhaust ventilation in this area was intended to be provided by the restroom exhaust vents. However, the restroom exhaust was not operating at the time of assessment; therefore, no exhaust ventilation was being provided. Based on the current configuration, it does not appear that the HVAC system provides even minimum exhaust ventilation to remove normally occurring pollutants from the indoor environment. Without appropriate exhaust ventilation, normally occurring environmental pollutants can accumulate, which may cause eye, nose and respiratory irritation.

6. Operate restroom vents continuously during business hours to provide exhaust ventilation.
7. Examine the feasibility of increasing the exhaust ventilation capabilities of the HVAC system.

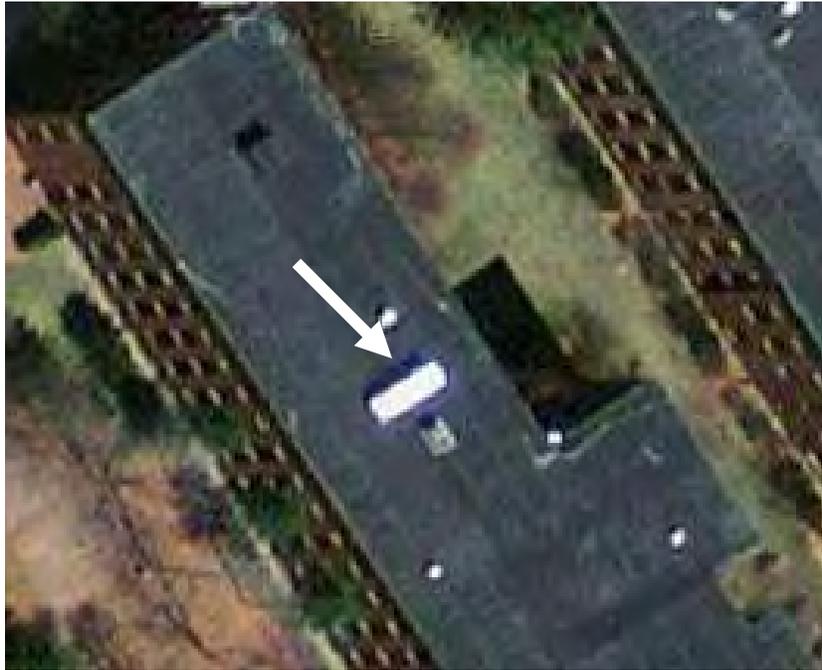
Picture 1

The configuration of the mechanical supply system is atypical of those generally observed by BEH staff. A rooftop air-handling unit (AHU) delivers fresh air to two mechanical rooms on the MBRM floor as well as other floors of the building through ductwork (Pictures 1

Rooftop Air Handling Unit (AHU)

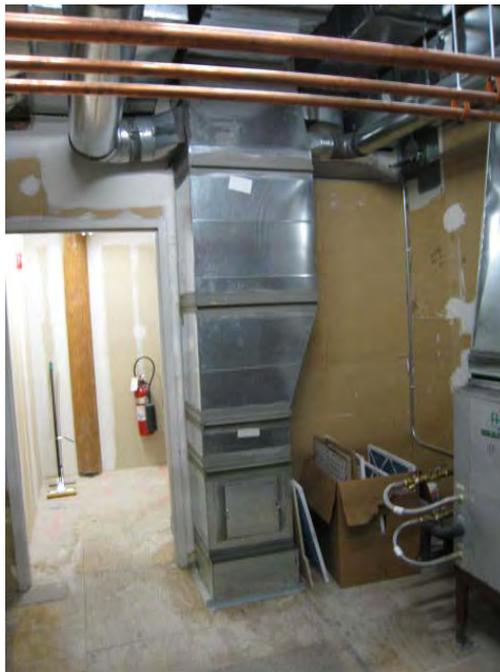
Picture 2

and 2); ductwork branching from the main trunk provides air to smaller AHUs within each of the two mechanical rooms on the third floor. However, the round ductwork branching from the main trunk is not connected directly to the mechanical room AHUs, but rather these round ducts empty air in front of the AHU intake vents (Pictures 3 and 4). Fresh, tempered air drawn into the AHUs is distributed to occupied areas via ceiling and wall-mounted air diffusers (Pictures 5 and 6).

Ductwork Connected To Rooftop AHU That Distributes Fresh Air to All Floors

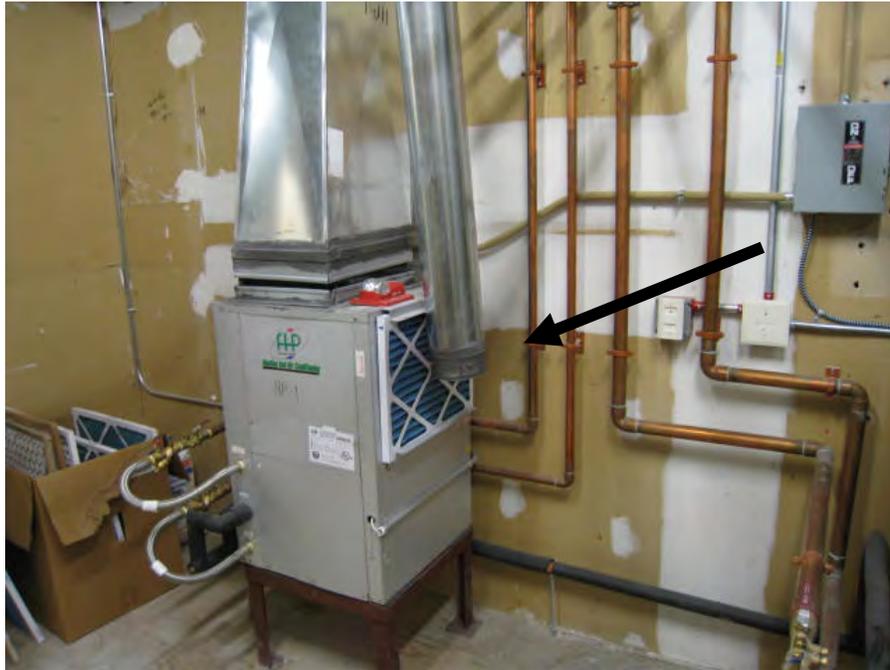
Picture 3

Fresh Air Supply Vent Duct (Arrow) That Deposits Air In Front Of the Intake of the AHU

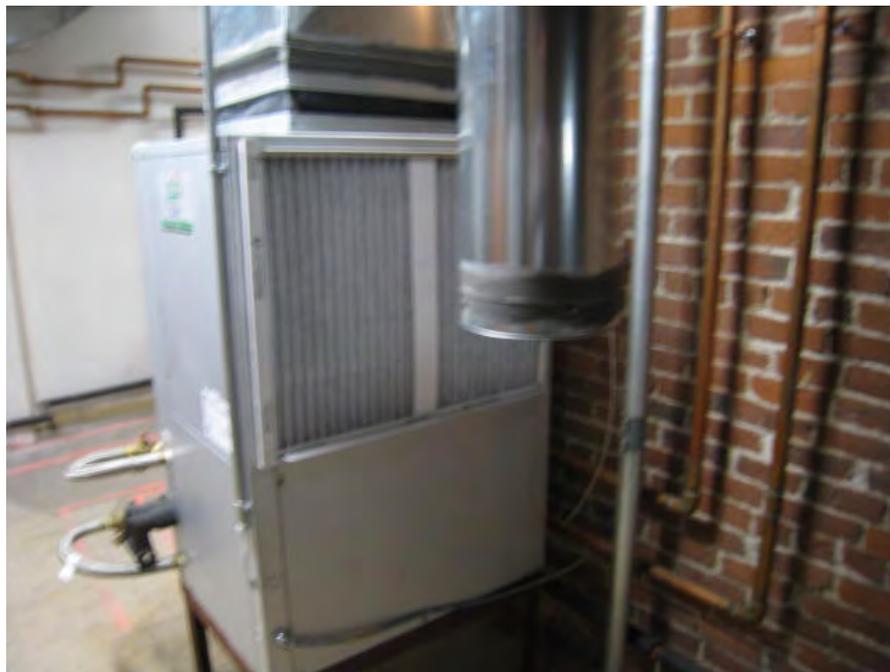
Picture 4

Fresh Air Supply Vent Duct That Deposits Air In Front Of the Intake of the AHU

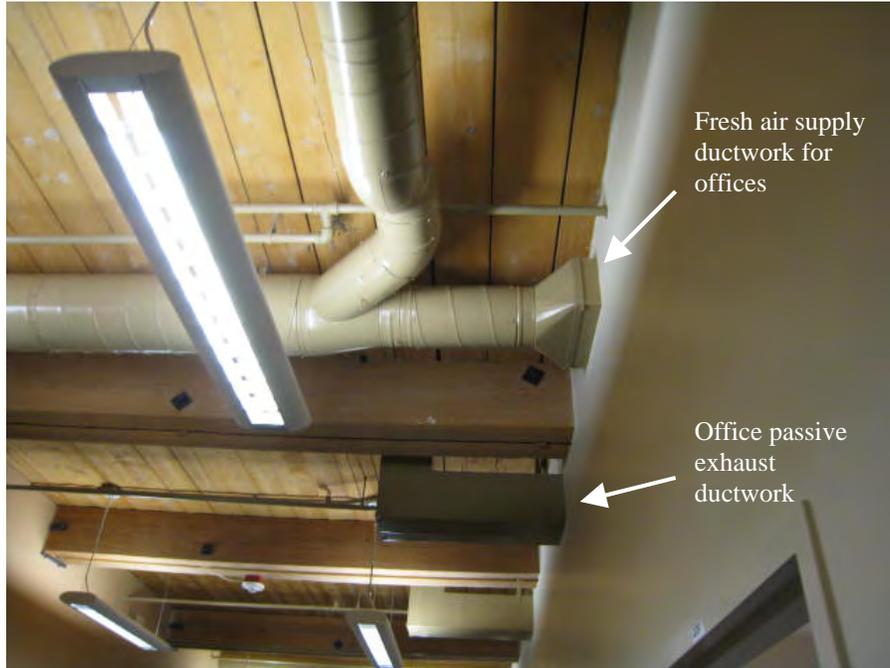
Picture 5

Office Supply and Passive Exhaust Ductwork

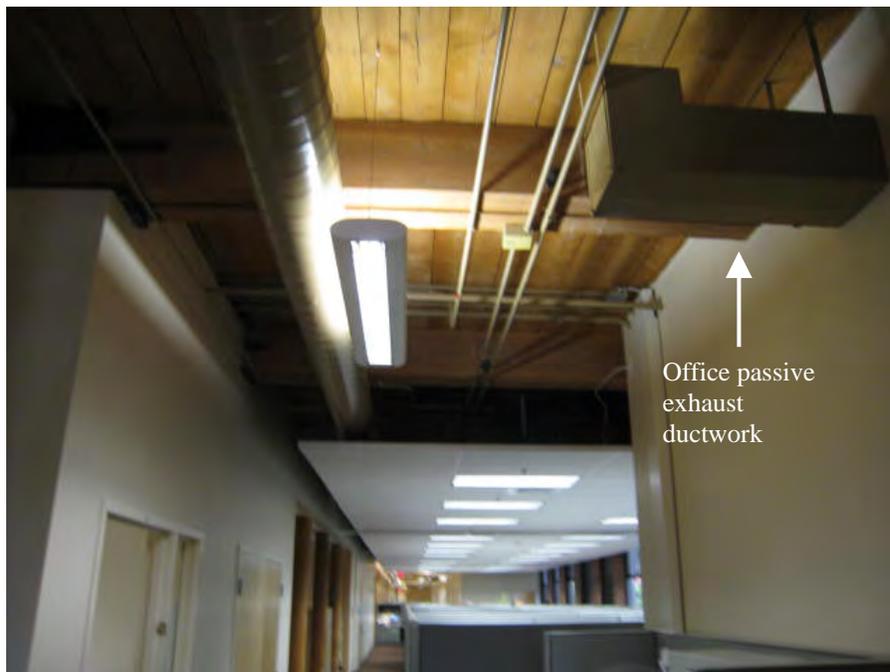
Picture 6

Office Passive Exhaust Ductwork Terminating At 90° and Partial Drop Ceiling Plenum

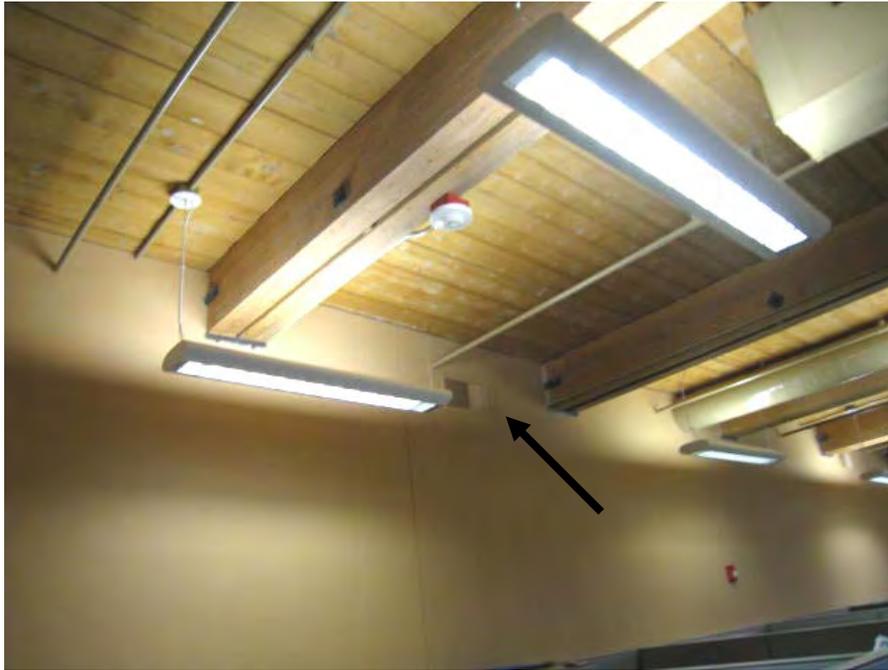
Picture 7

Wall-Mounted Return Vent

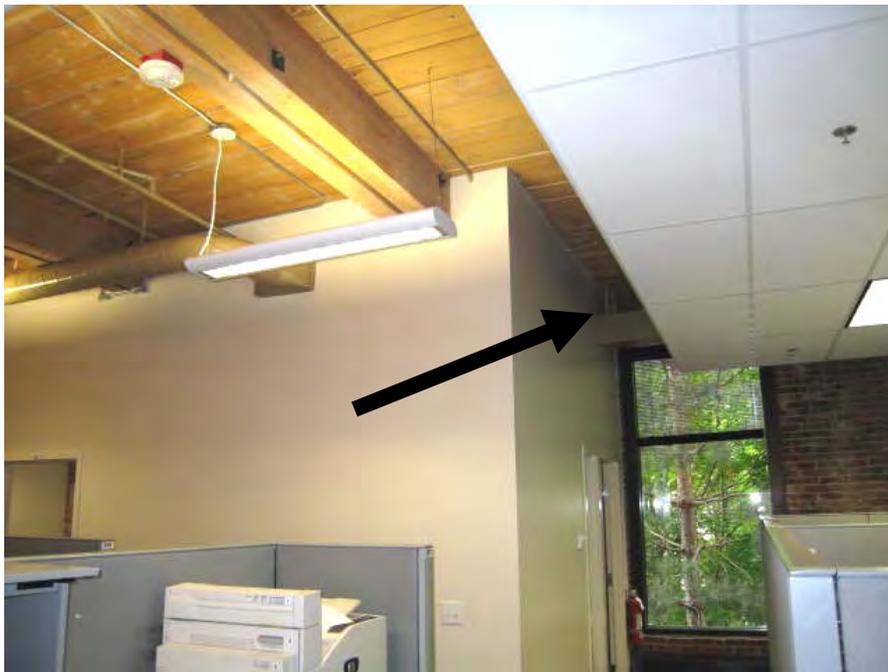
Picture 8

Of note is the passive exhaust vent for room 315. As discussed, ductwork for passive exhaust vents of offices exit out the office wall and terminate at a 90° angle. A similar vent exists for room 315; however, the duct work vent is oriented in a manner that results in decreased draw of air from this room (Picture 8).

Wall-Mounted Return Vent for Room 315

8. Re-orient the exhaust vent for room 315 to be on the same wall as rooms 316-318.
9. Clean dust from mechanical rooms and the fourth floor.
10. Refer to resource manuals and other related indoor air quality documents for further building-wide evaluations and advice on maintaining public buildings. Copies of these materials are located on the MDPH's website: http://mass.gov/dph/indoor_air.

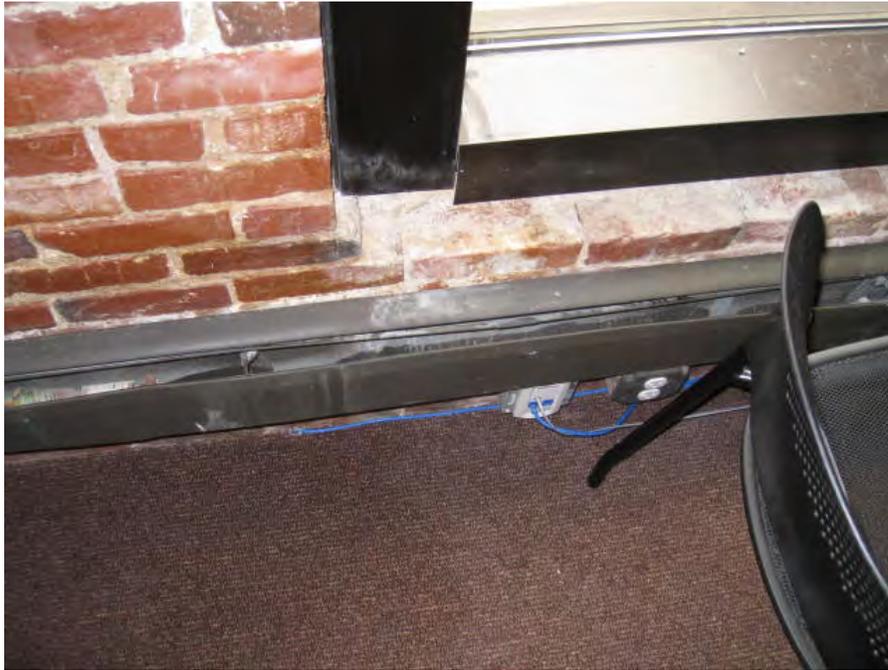
Picture 9

Evidence of water penetration was observed on the exterior walls in the form of efflorescence (Picture 9). Efflorescence is a characteristic sign of water damage to brick and mortar, but it is not mold growth. As moisture penetrates and works its way through mortar, brick or plaster, water-soluble compounds dissolve, creating a solution. As the solution moves to the surface of the material, the water evaporates, leaving behind white, powdery mineral deposits.

Efflorescence and Brick Dust

5. Consult a building engineer concerning the best method for reducing water penetration through exterior walls, particularly in areas with bricked-in windows.

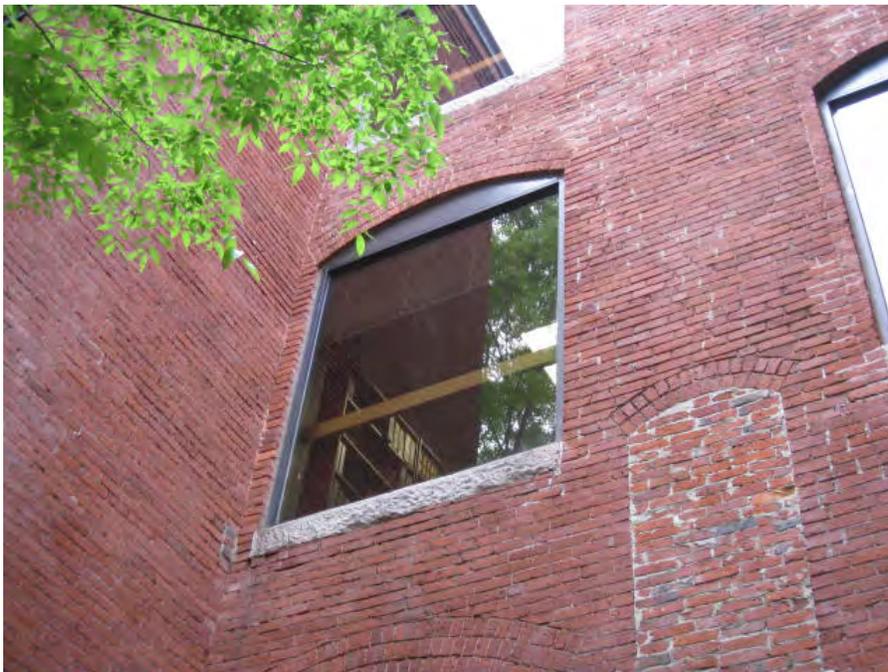
Picture 10

Another point of water penetration is through seams around windows. Energy-efficient windows (Picture 10) were installed in the openings the original windows, which appear unaltered from the original construction of the building. Each window is rendered weather-tight

Energy-Efficient Window System

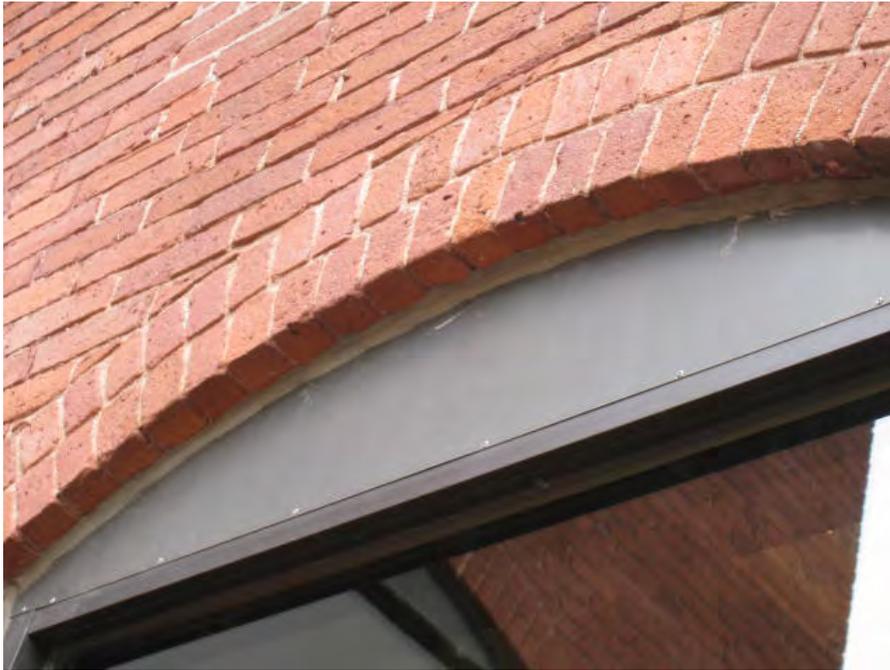
Picture 11

by the application of caulking around three sides of the frame (Pictures 11 and 12). An opening exists at the bottom of the window frame, a feature likely designed to aid in draining rainwater away from the frame (Pictures 13 and 14). Since the underside of the frame in contact with the windowsill does not appear to have sealant, driving rain can penetrate the building through this space.

Window Caulking

3. Move furniture and book shelves away from exterior walls to allow airflow/drying.
4. Consult a building engineer concerning the best method for rendering the window frames and windowsill water-tight to prevent moisture penetration.

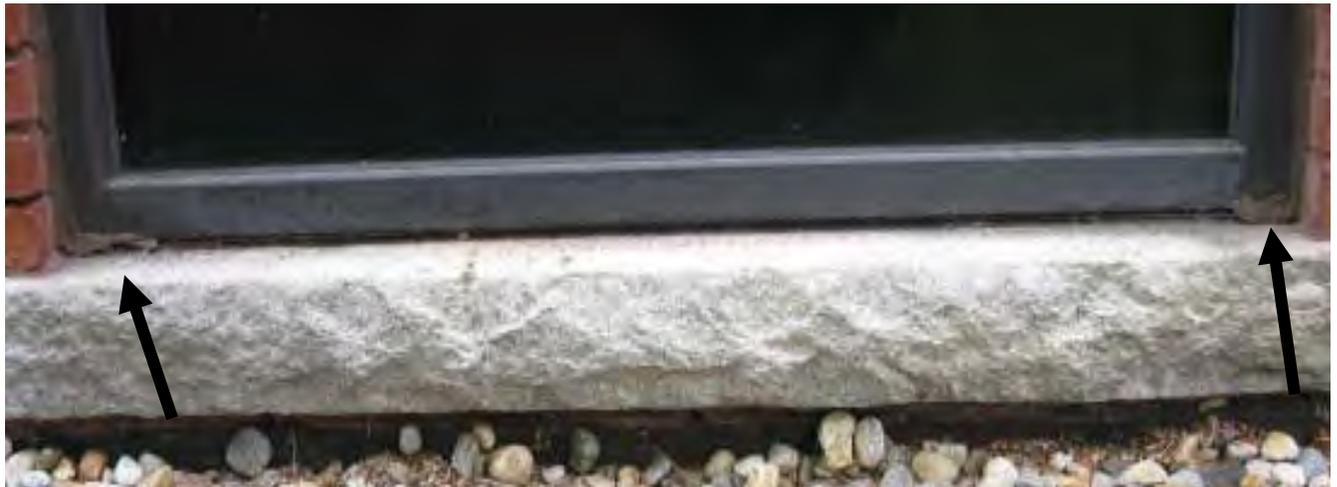
Picture 12

Window Caulking, Note That It Does Not Extend Across the Frame/Sill Junction

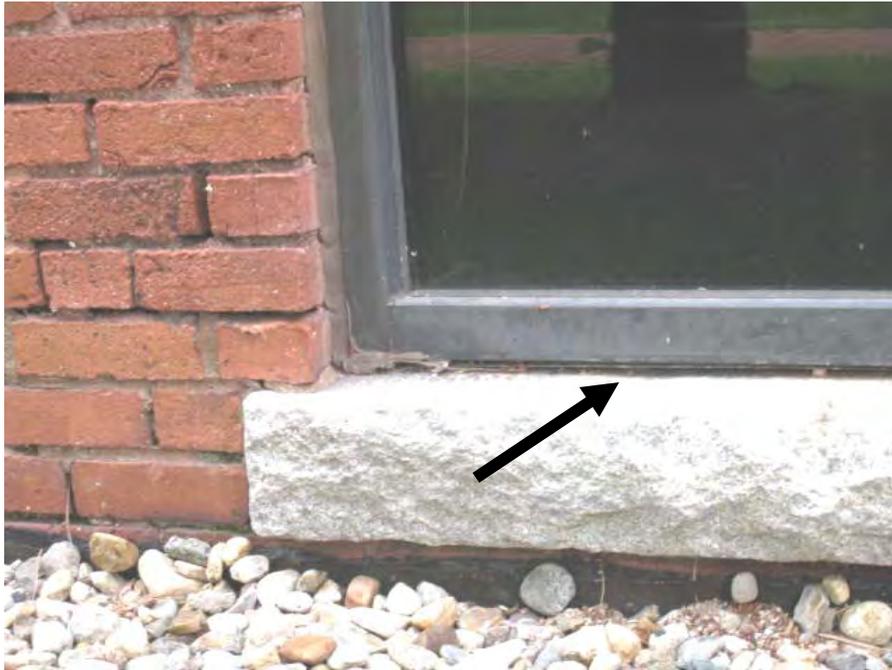
Picture 13

The windowsill consists of two materials; the exterior is a single slab of granite and the interior is brick (Pictures 13 and 14). The seam formed by the granite and brick is located beneath the window frame, where accumulating rainwater can enter and subsequently moisten building materials.

Opening Below Window Frame to Drain Water, Note Lack of Sealant Between Flange and Sill

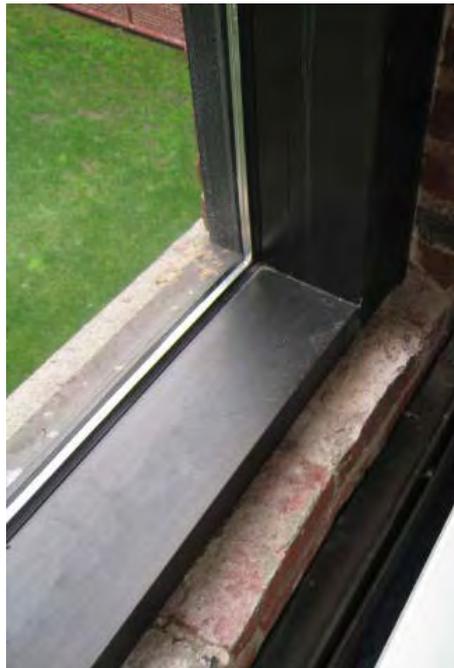
Picture 14

Window Sill Consists Of Granite Slab (Outside) and Brick (Inside)

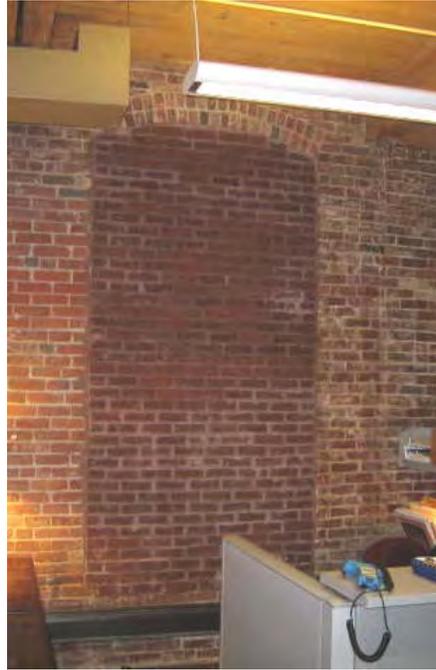
Picture 15

In several areas windows panes were removed and the space was filled with brick. These areas also show signs of significant water penetration and efflorescence (Picture 15). In this current state, any porous material (e.g., carpeting) in direct contact with exterior walls is likely to become chronically dampened, creating a source of mold colonization.

Bricked-In Window with Heavy Efflorescence

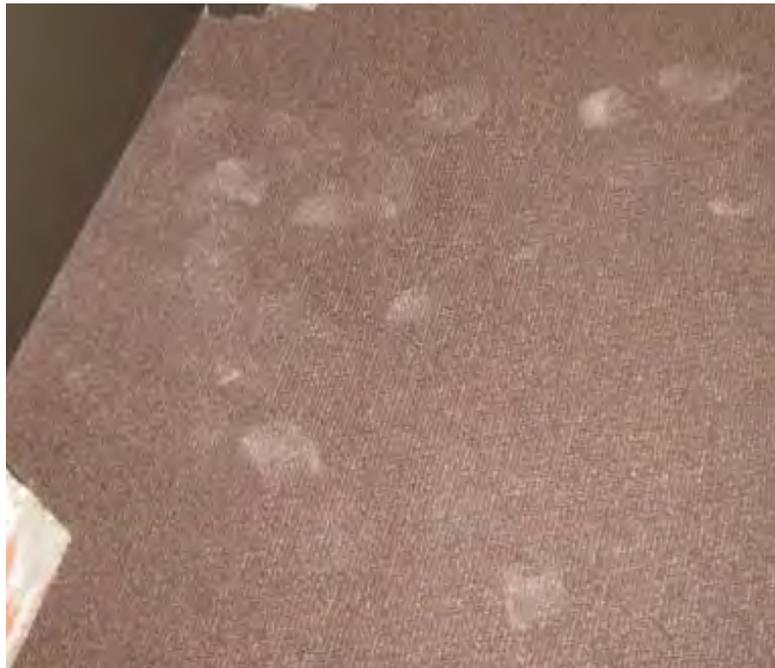
Picture 16

Of note was a visible, yellowish dust that had accumulated on the mechanical room floors to an extent that this dust produced visible footprints on hallway carpet (Picture 16). The color of the dust appears to match that of dust on the fourth floor, which is an unoccupied floor where wall-to-wall carpeting had been removed (Pictures 17 and 18). This dust seems to have been drawn into the mechanical rooms through spaces around the original wooden floorboards that serve as the ceiling for the MBRM occupied third floor. No similar type of dust was observed in occupied areas, indicating that the HVAC filters were removing this particulate from the airstream.

Visible Footprints from Dust on Carpet

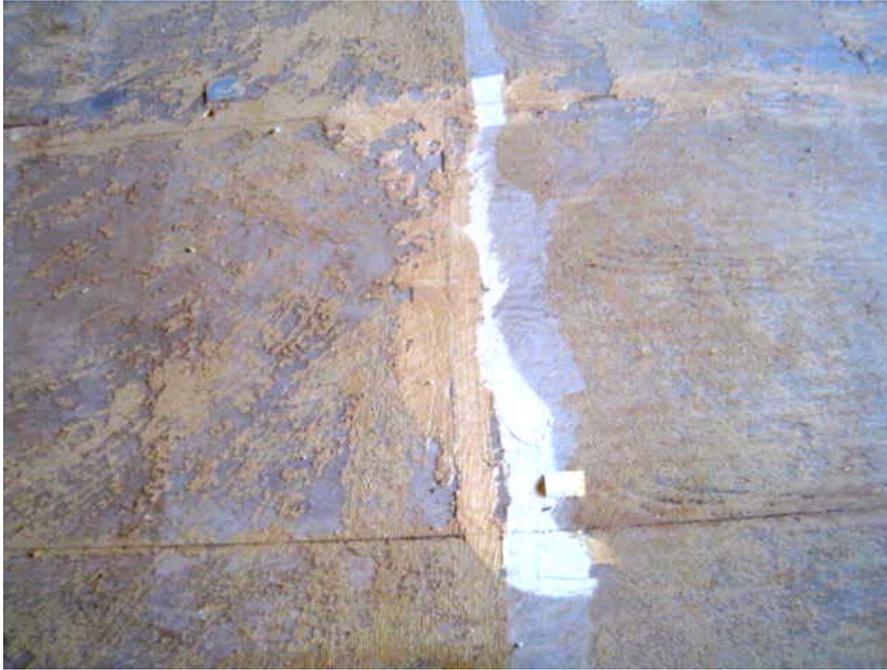
Picture 17

Accumulated Dust on Fourth Floor from Carpet Removal

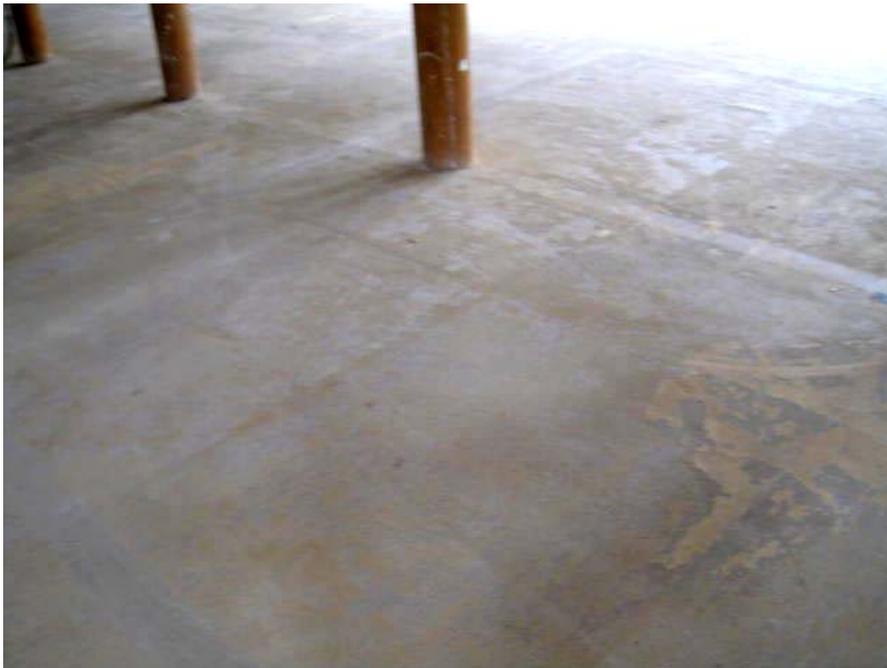
Picture 18

Accumulated Dust on Fourth Floor from Carpet Removal
