INDOOR AIR QUALITY ASSESSMENT

**Massachusetts Department of Public Health
Central Regional Health Office
180 Beaman Street
West Boylston, Massachusetts**

Prepared by:
Massachusetts Department of Public Health
Bureau of Environmental Health
Indoor Air Quality Program
August 2010

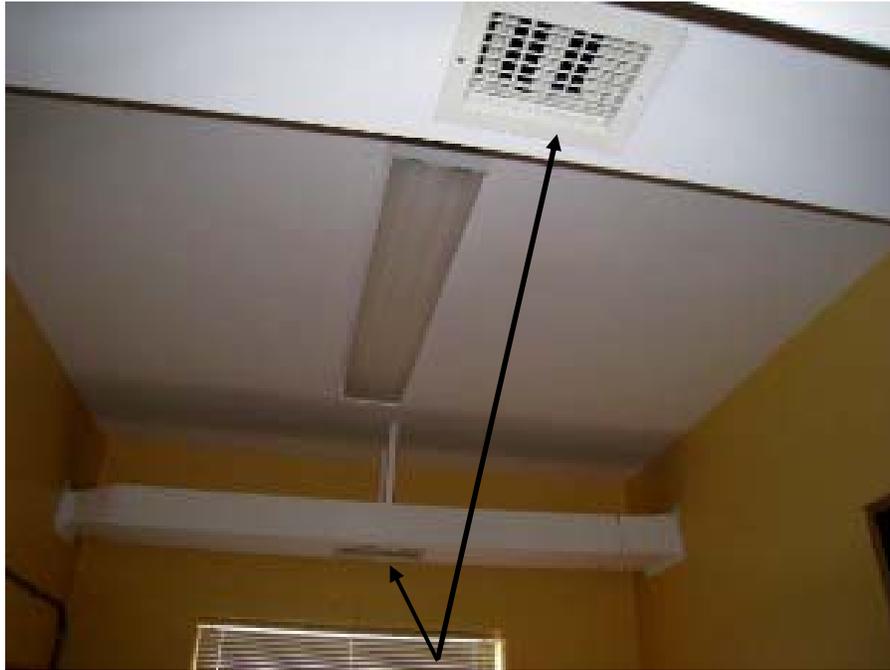
Picture 1

Air Supply Diffuser and Return

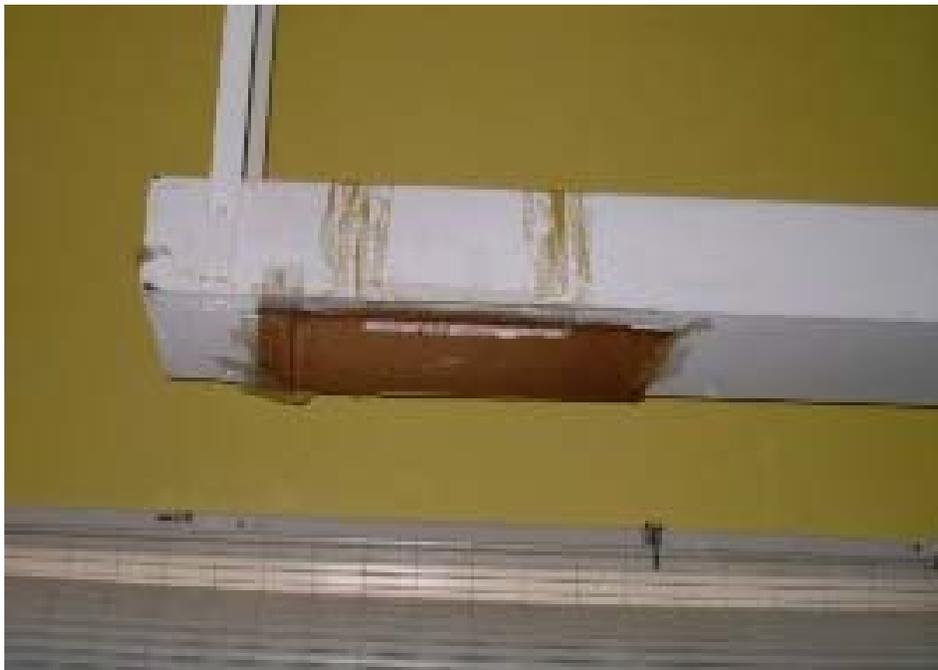
Picture 2

Obstructed Air Diffuser

2. Remove obstructions from passive wall vents and/or open office doors in order to facilitate airflow within the building.
3. Supplement fresh air by operating window-mounted air conditioners in the “fan only” “fresh air” mode, which introduces outside air by mechanical means.

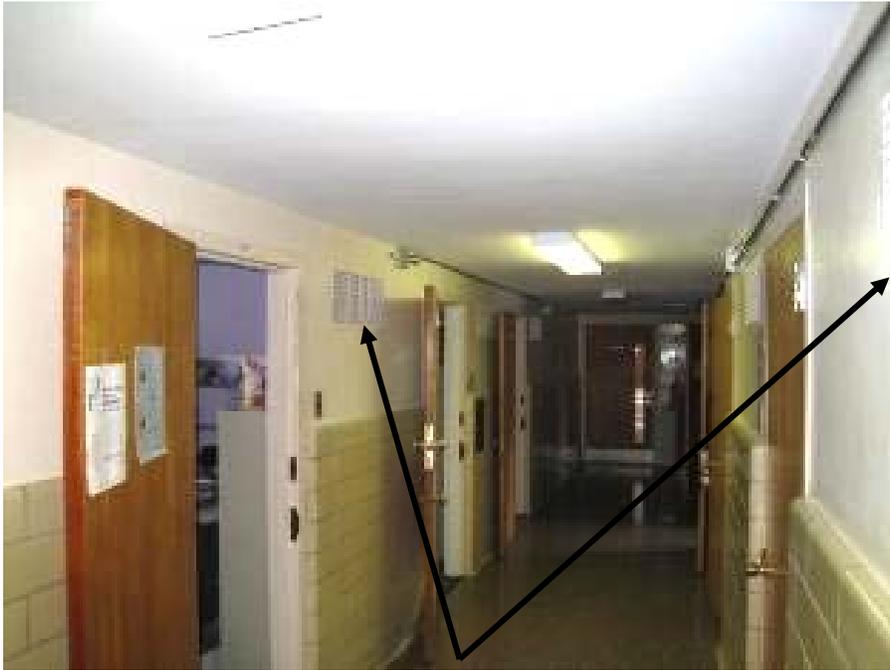
Picture 3

Passive Wall Vents in Hallway

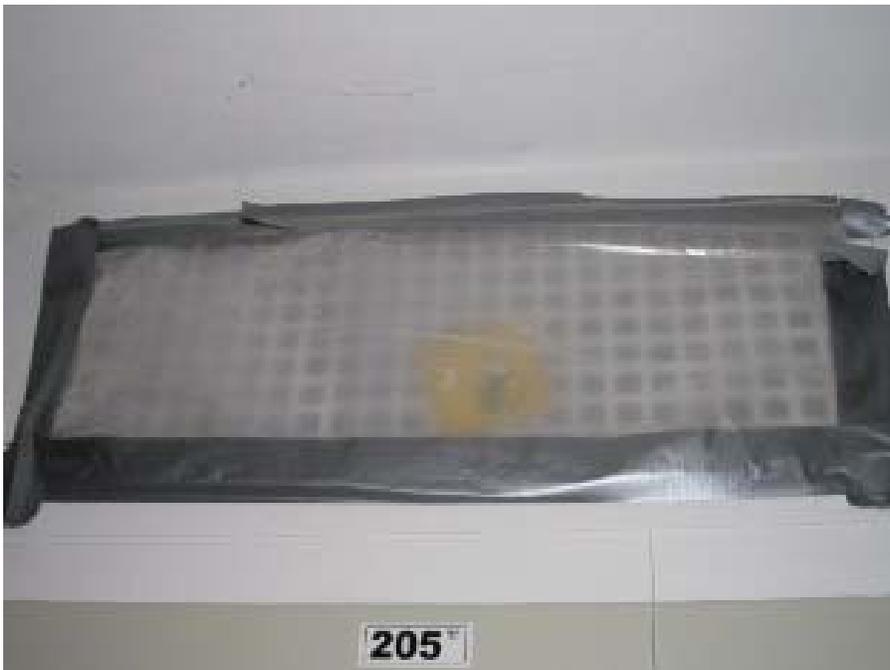
Picture 4

Passive Wall Vent Obstruction

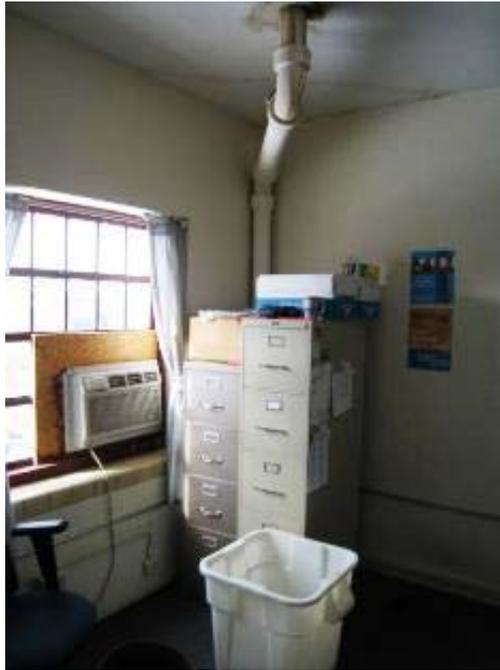
Picture 5

The assessment was prompted by concerns of water infiltration from chronic roof leaks. One leak was impacting the Rural Health Office (Room 202) (Picture 5). As a result, rain water has repeatedly entered the building and spilled onto the carpeted floor. Water damage was visible on the ceiling, vent pipe and carpeting (Pictures 5 and 6). BEH staff were informed that several repairs had been made to address the leak, including replacing a sizable section (~120 square feet) of the roof only months earlier.

At the time of the preliminary assessment, CRHO staff indicated that the problem had been resolved. However, since that time, it has become apparent to staff that the leak has recurred. Efforts to pursue funding for replacement of the entire roof are reportedly underway. A roof leak is also apparent over the hallway that connects the CRHO with the building to its west. Water-damaged ceiling tiles, peeling paint and efflorescence were observed in this hall (Picture 7). Efflorescence is a characteristic sign of water intrusion, but it is not mold growth.

Water Damaged Ceiling, Note Bucket to Collect Water

5. Continue to monitor areas of the building for roof leaks, make repairs and change water-damaged ceiling tiles as necessary. Disinfect areas of water leaks with an appropriate antimicrobial.

1. Consider replacing roof.
2. Consider installing HVAC system to introduce fresh air into the building and exhaust stale air out of the building.
3. Consider removal of carpets in offices with radiant heat. Prior to removal, determine whether the floor tiles beneath contain asbestos, and if so, their condition. If necessary, asbestos floor tiles must be remediated in compliance with applicable state and federal regulations.

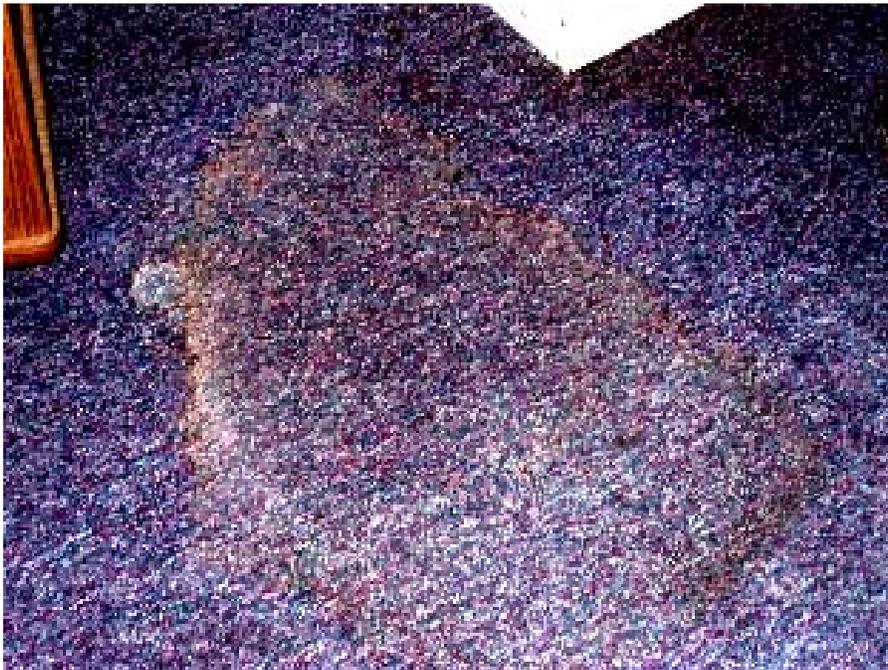
Picture 6

Water Damaged Carpet

6. Remove water-damaged carpeting from room 202 and consider replacing with a floor covering that is impervious to water (i.e. floor tiles).
7. Remove space heater from room 205.

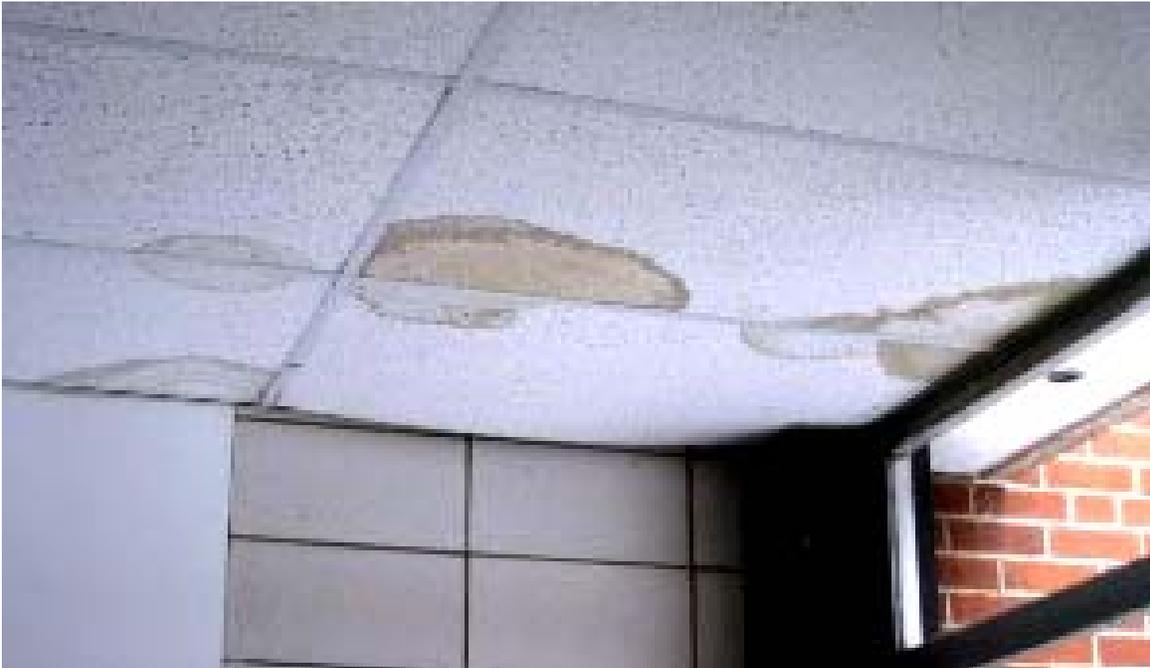
Picture 7

Water Damaged Ceiling Tiles

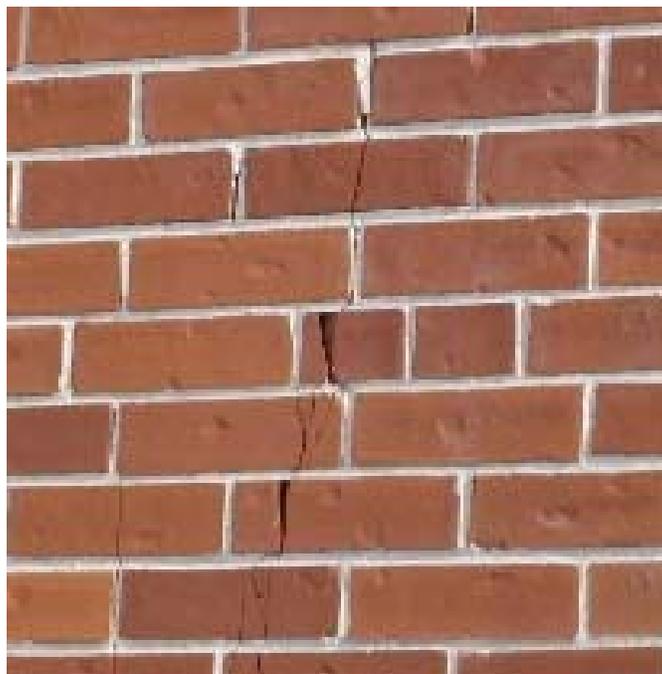
Picture 8

- Cracked masonry and missing mortar were observed (Picture 8);
- Efflorescence was observed on exterior brick;
- Window sealant and expansion joint sealant were deteriorated;
- Sealant on rear door casing was in disrepair;
- Peeling paint was identified on windows;
- Moss was observed on the ground adjacent to the building. Moss is a sign of chronic dampness and can hold moisture against brick to accelerate decomposition of the curtain wall;
- The area surrounding some ACs has been retrofitted with plexiglass. In some cases, the sealant has deteriorated, (both interior and exterior) (Picture 9);
- Plywood surrounding some ACs was saturated with water. ACs were not covered for the winter; and

The aforementioned conditions represent potential water penetration sources. Over time, these conditions can undermine the integrity of the building envelope and provide a means of water entry into the building via capillary action through foundation concrete and masonry (Lstiburek & Brennan, 2001). In addition, these breaches may provide a means for pests/rodents to enter the building.

Cracked Masonry and Mortar

8. Repair cracked masonry and missing/damaged mortar.
9. Repair deteriorated window, door casing and expansion joint sealant in accordance with EPA regulations.

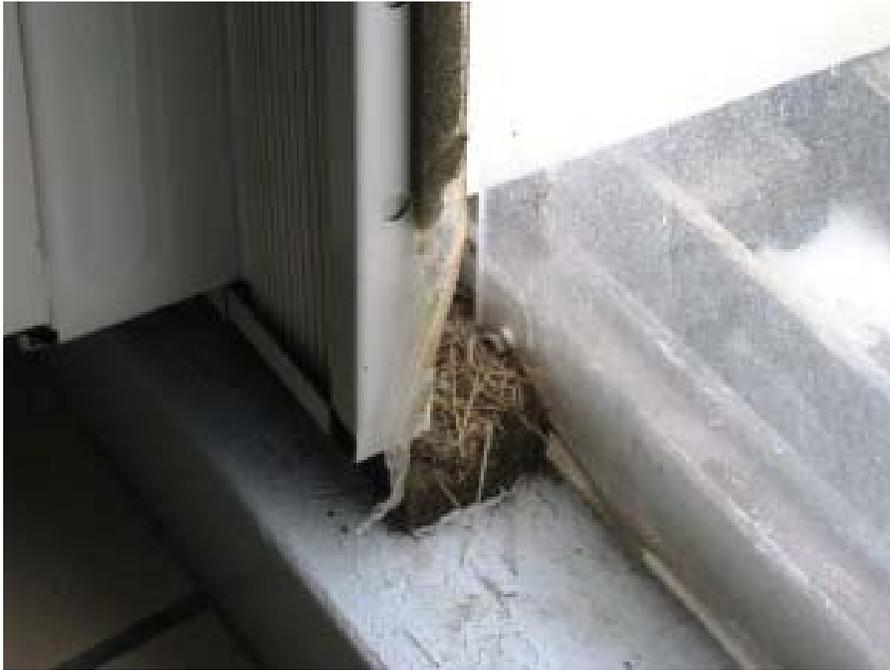
Picture 9

Signs of bird roosting and nesting materials were observed beneath ACs on the exterior of the building (Pictures 9 and 14). Birds can be a source of disease, and bird wastes and feathers can contain mold and bacteria, which can be irritating to the respiratory system. No obvious signs of bird roosting inside the building or in ventilation components were noted by BEH staff or reported by occupants.

Deteriorated Sealant Adjacent to Plexiglass, Note Bird Nesting Materials

10. Repair or replace deteriorated sealant on plexiglass windows.
11. For buildings in New England, periods of low relative humidity during the winter are often unavoidable. Therefore, scrupulous cleaning practices should be adopted to

16. Remove bird roosting and nesting materials from beneath air conditioners. Clean and disinfect surfaces with an appropriate antimicrobial.
 17. Relocate or consider reducing the amount of materials stored in offices to allow for more thorough cleaning. Clean items regularly with a wet cloth or sponge to prevent excessive dust build-up.

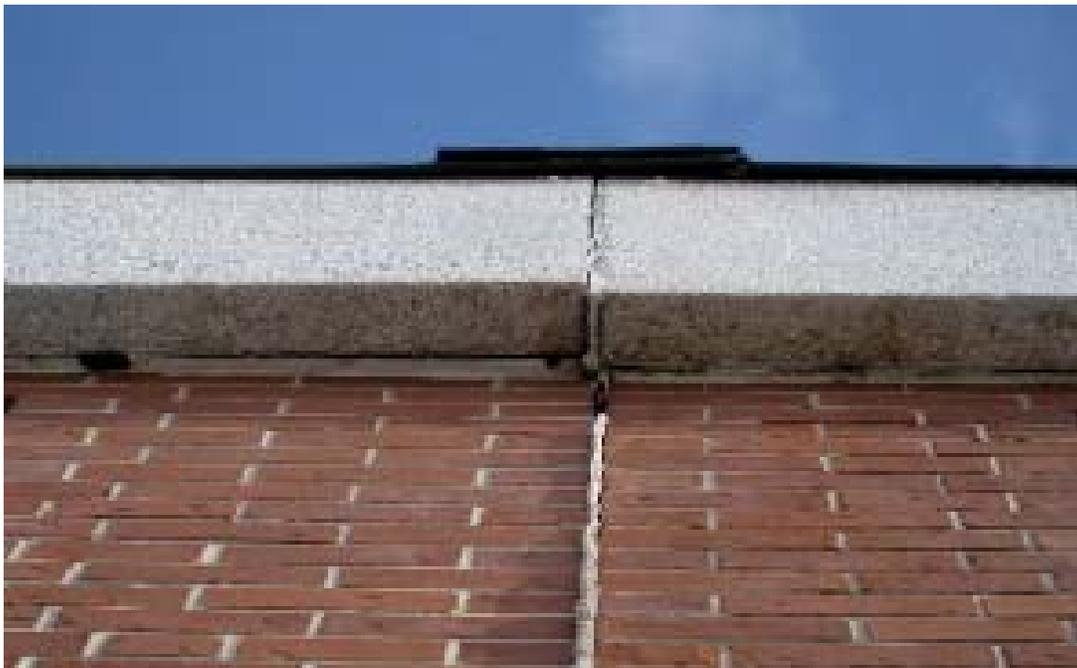
Picture 10

- At the juncture of masonry and expansion joints, roof components do not meet in the same plane and adjacent sealant is in disrepair (Picture 10).

Junction of Expansion Joint and Roof

12. Seal exterior portion of air conditioners in order to prevent unconditioned air and moisture from entering the building envelope.
 13. Contact local building commissioner to evaluate the structure of the roof at expansion joint on the west side of the building. Make repairs as needed.

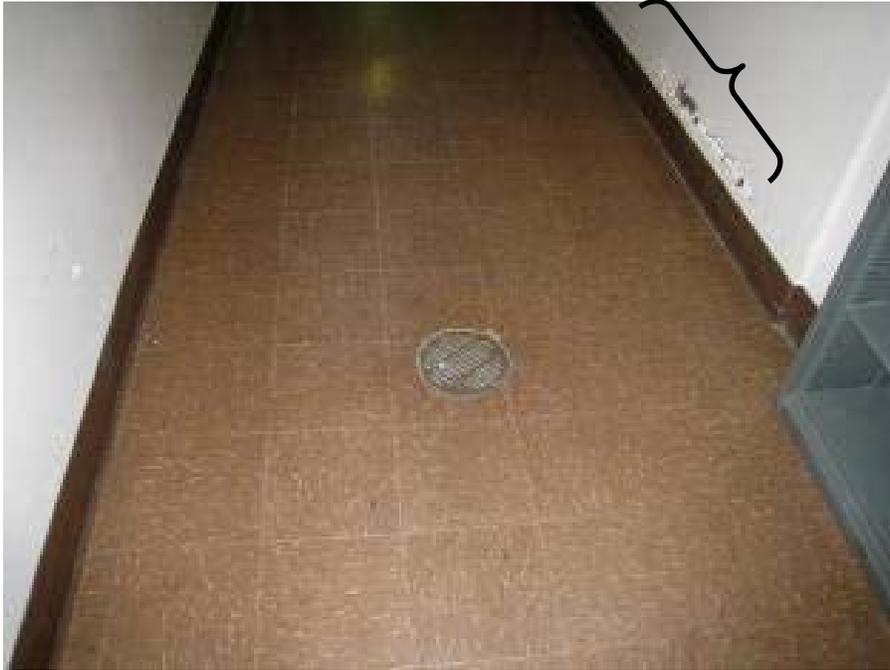
Picture 11

Floor drains and a nonfunctioning water fountain were both observed to have dry traps (Picture 11). The purpose of a drain trap is to prevent drainage system gases and sulfur-like odors from entering the occupied space. When water is poured into a trap, an air-tight seal is created by the water in the U-bend section of the pipe. These drains must have water poured into the traps at least twice a week to maintain the integrity of the seal. Without water, the drain opens the room to the drainage system. If a mechanical device (e.g., a fan) depressurizes the room, air, gas and odors can be drawn from the drainage system into the room. The effect of this phenomenon can be increased if heavy rains cause an air backup in the drainage system. These gasses/odors can also potentially enter the CRHO via an improperly capped sewer line observed in the vaccine storage area (Picture 12).

floor hallway is in disrepair (Picture 11). This condition may allow dust and debris to enter the occupied space.

**Floor Drain With Dry Trap
Note Broken Sheetrock on Adjacent Wall**

14. Pour water into drains twice a week (or as needed) to maintain an airtight seal. Properly cap open drain lines.
 15. Seal spaces around utility holes and breaches in walls/floors and ceilings with an appropriate fire-rated sealant.

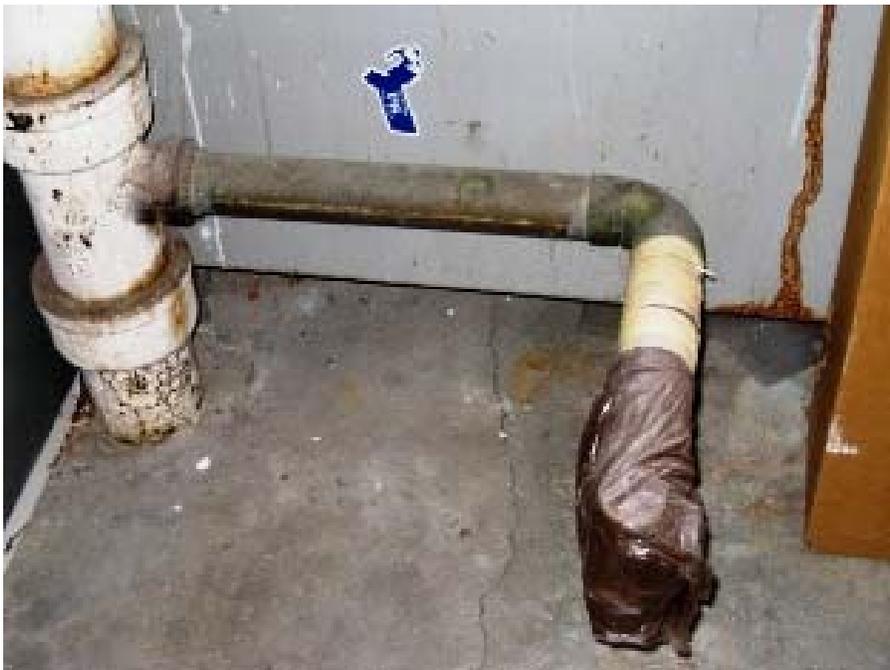
Picture 12

Improperly Sealed Plumbing into Drain Line

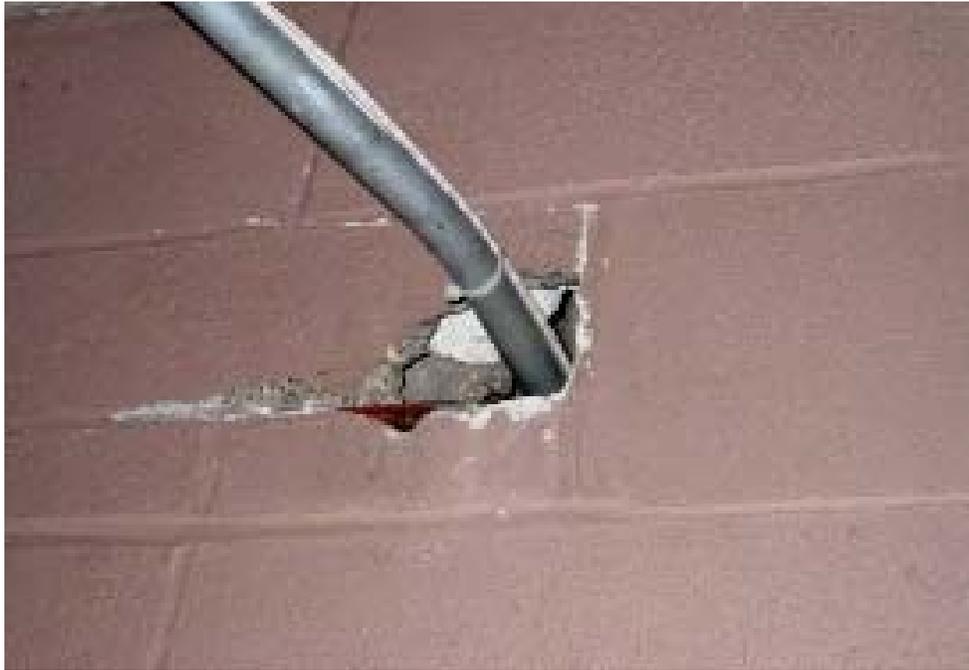
Picture 13

Open utility holes were observed throughout the building (Picture 13). An open pipe was also observed in the foyer which terminated in one of the storage areas. Open utility holes can provide a means of egress for odors, fumes, dusts and vapors between rooms and floors.

Open Utility Hole

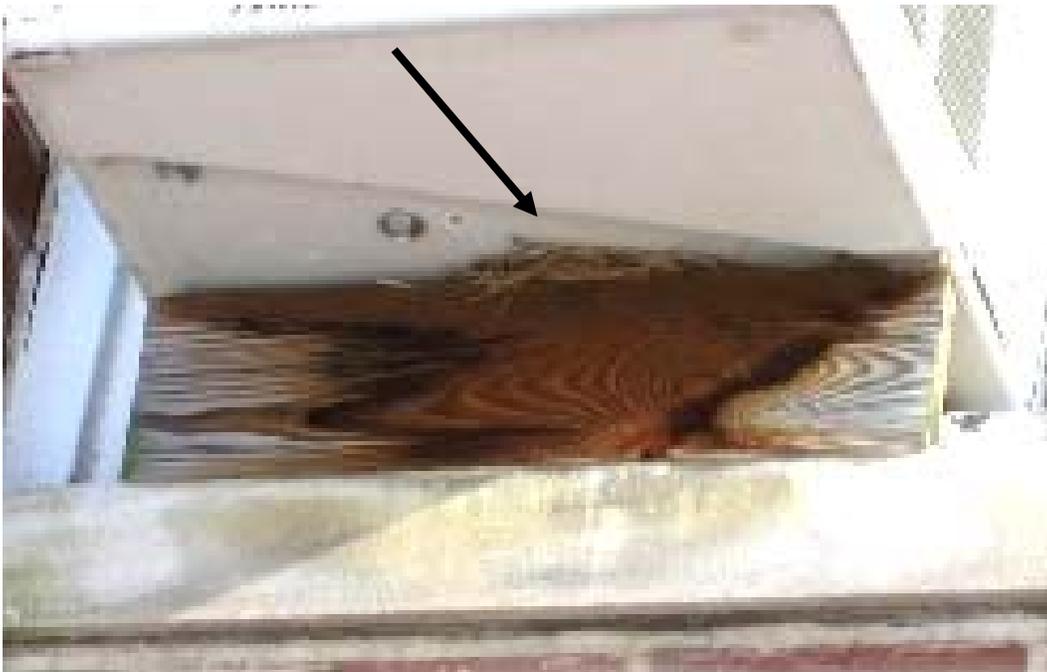
Picture 14

Bird Nesting Material Below Air Conditioner

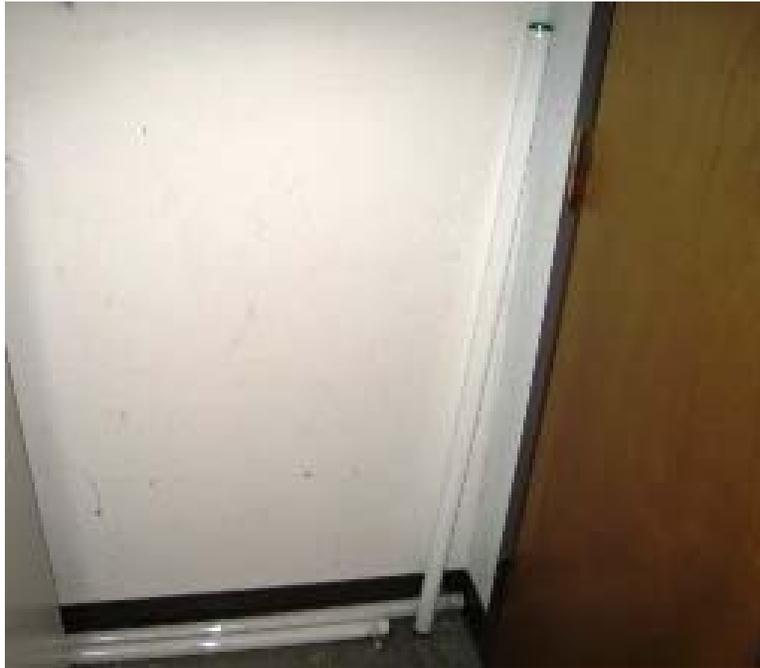
Picture 15

Fluorescent light bulbs were stored in an area subject to damage (Picture 15). These bulbs contain and release mercury when broken; therefore, they must be stored, utilized and disposed of with care. The Massachusetts Department of Environmental Protection's guidance document may be found at: <http://www.mass.gov/dep/toxics/stypes/cflclnup.htm> .

Fluorescent Light Bulb Storage

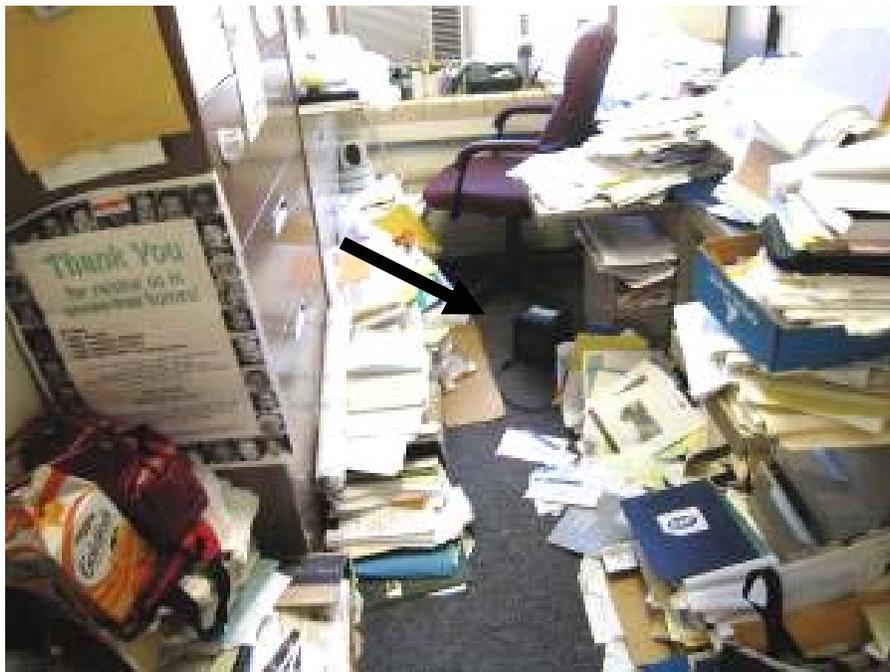
Picture 16

Papers, files and cardboard were observed on flat surfaces in some offices. Stored items provide a source for dusts to accumulate. Items should be relocated and/or be cleaned periodically to avoid excessive dust build up, which can cause respiratory irritation. In addition, a small space heater was noted on the floor in close proximity to documents. This condition constitutes a fire hazard (Picture 16).

**Paper Accumulation in Office
Note Electric Heater in Close Proximity**
