INDOOR AIR QUALITY ASSESSMENT MOLD INVESTIGATION

**Executive Office of Health and Human Services
600 Washington Street
Boston, Massachusetts**

Prepared by:
Massachusetts Department of Public Health
Bureau of Environmental Health
Indoor Air Quality Program
February 2011

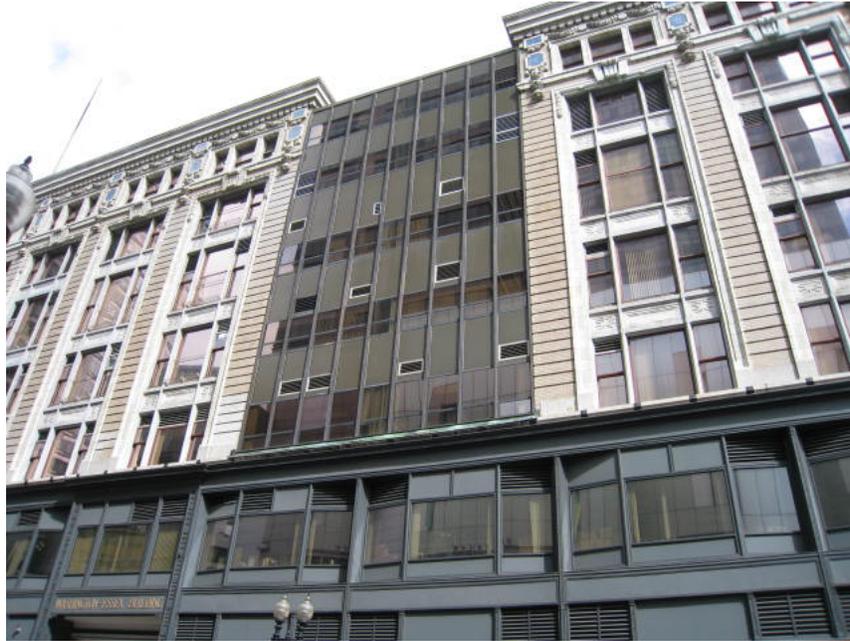
Picture 1

The building was constructed originally in a U-shape design. The building was renovated in the 1970s to fill in the open space, which is behind a metal/glass exterior on the front of the building (Picture 1). The area with the water penetration is directly below the metal/glass exterior wall. The building was retrofitted into office space with the installation of an HVAC system above the suspended ceiling. With the exception of the rear of the building, windows in the EOHHS space do not open.

**Exterior Metal/Glass Wall Installed above 2nd Floor Offices
Experiencing Water-Damaged Ceiling Tiles**

1. Examine the exterior wall assembly above the second floor offices with water damaged ceiling tiles and repair damaged caulking/sealant. Any re-caulking work should be done when the building is not occupied and measures need to be taken to reduce/minimize building occupant exposure to caulking odors.

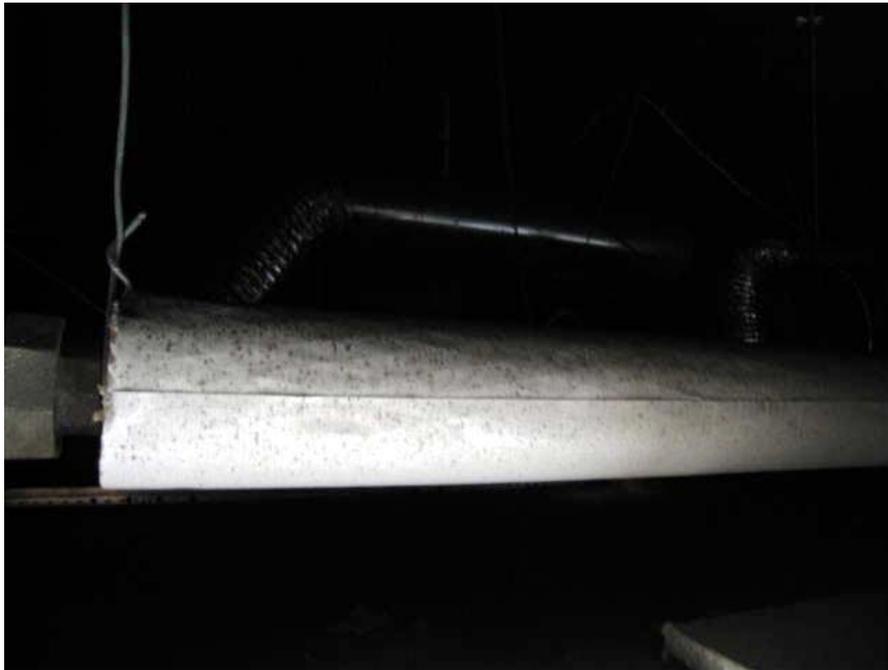
Picture 2

Ceiling tiles on the second floor beneath the metal/glass exterior wall were examined and found water stained without visible mold growth. Insulation on pipes servicing the air handling units (AHUs) however were found to be mold-contaminated (Picture 2). The source of moisture wetting ceiling tiles is likely penetration beneath a small ledge located above the second floor office (Picture 3). Rainwater impinging on the metal/glass exterior wall runs down this surface, impacts a stone ledge, and then rolls off the ledge onto a metal-on-stone seam (Picture 3). Over time this action may have eroded sealant. Without intact sealant, water can then enter the ceiling plenum causing moistened ceiling tiles. In hot, humid weather, moist air can also enter the ceiling plenum to cause condensation on cold surfaces, such as chilled water pipes and insulation.

Mold-Contaminated Pipe Insulation above 2nd Floor Ceiling Tiles

2. Remove water damage insulation in the ceiling above the areas with water damaged ceiling tiles. Reinsulated the chilled water pipes with insulation of an appropriate R rating. Ensure the installation is done in a manner to prevent condensation generation between the pipe and the insulation.

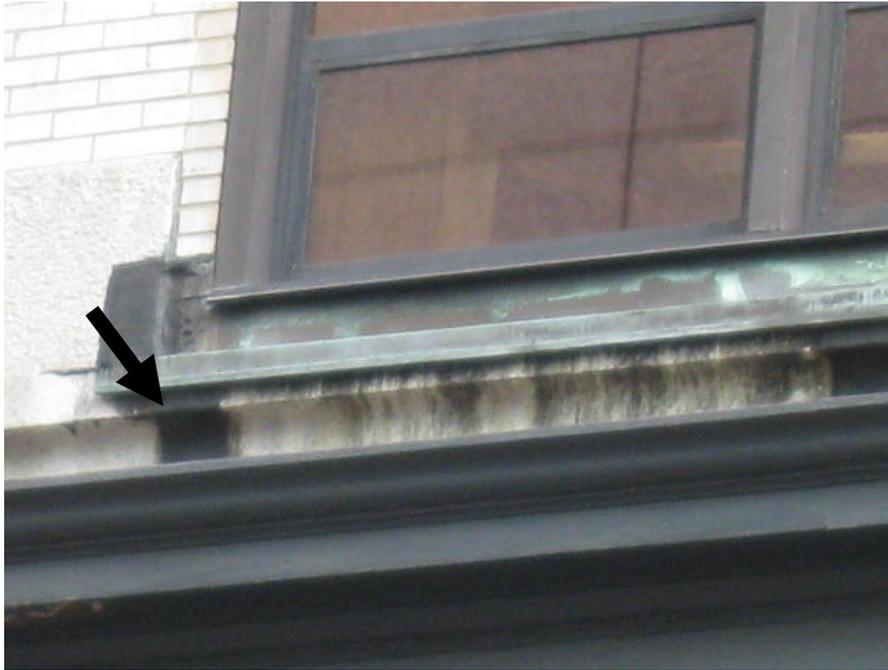
Picture 3

**Stone Ledge above 2nd Floor Offices, Note Heavy Water Markings
below Metal-on-Stone Seam**
