INDOOR AIR QUALITY ASSESSMENT MOLD INVESTIGATION

**Department Of Children and Family
810 Memorial Drive
Cambridge, Massachusetts**

Prepared by:
Massachusetts Department of Public Health
Bureau of Environmental Health
Indoor Air Quality Program
February 2011

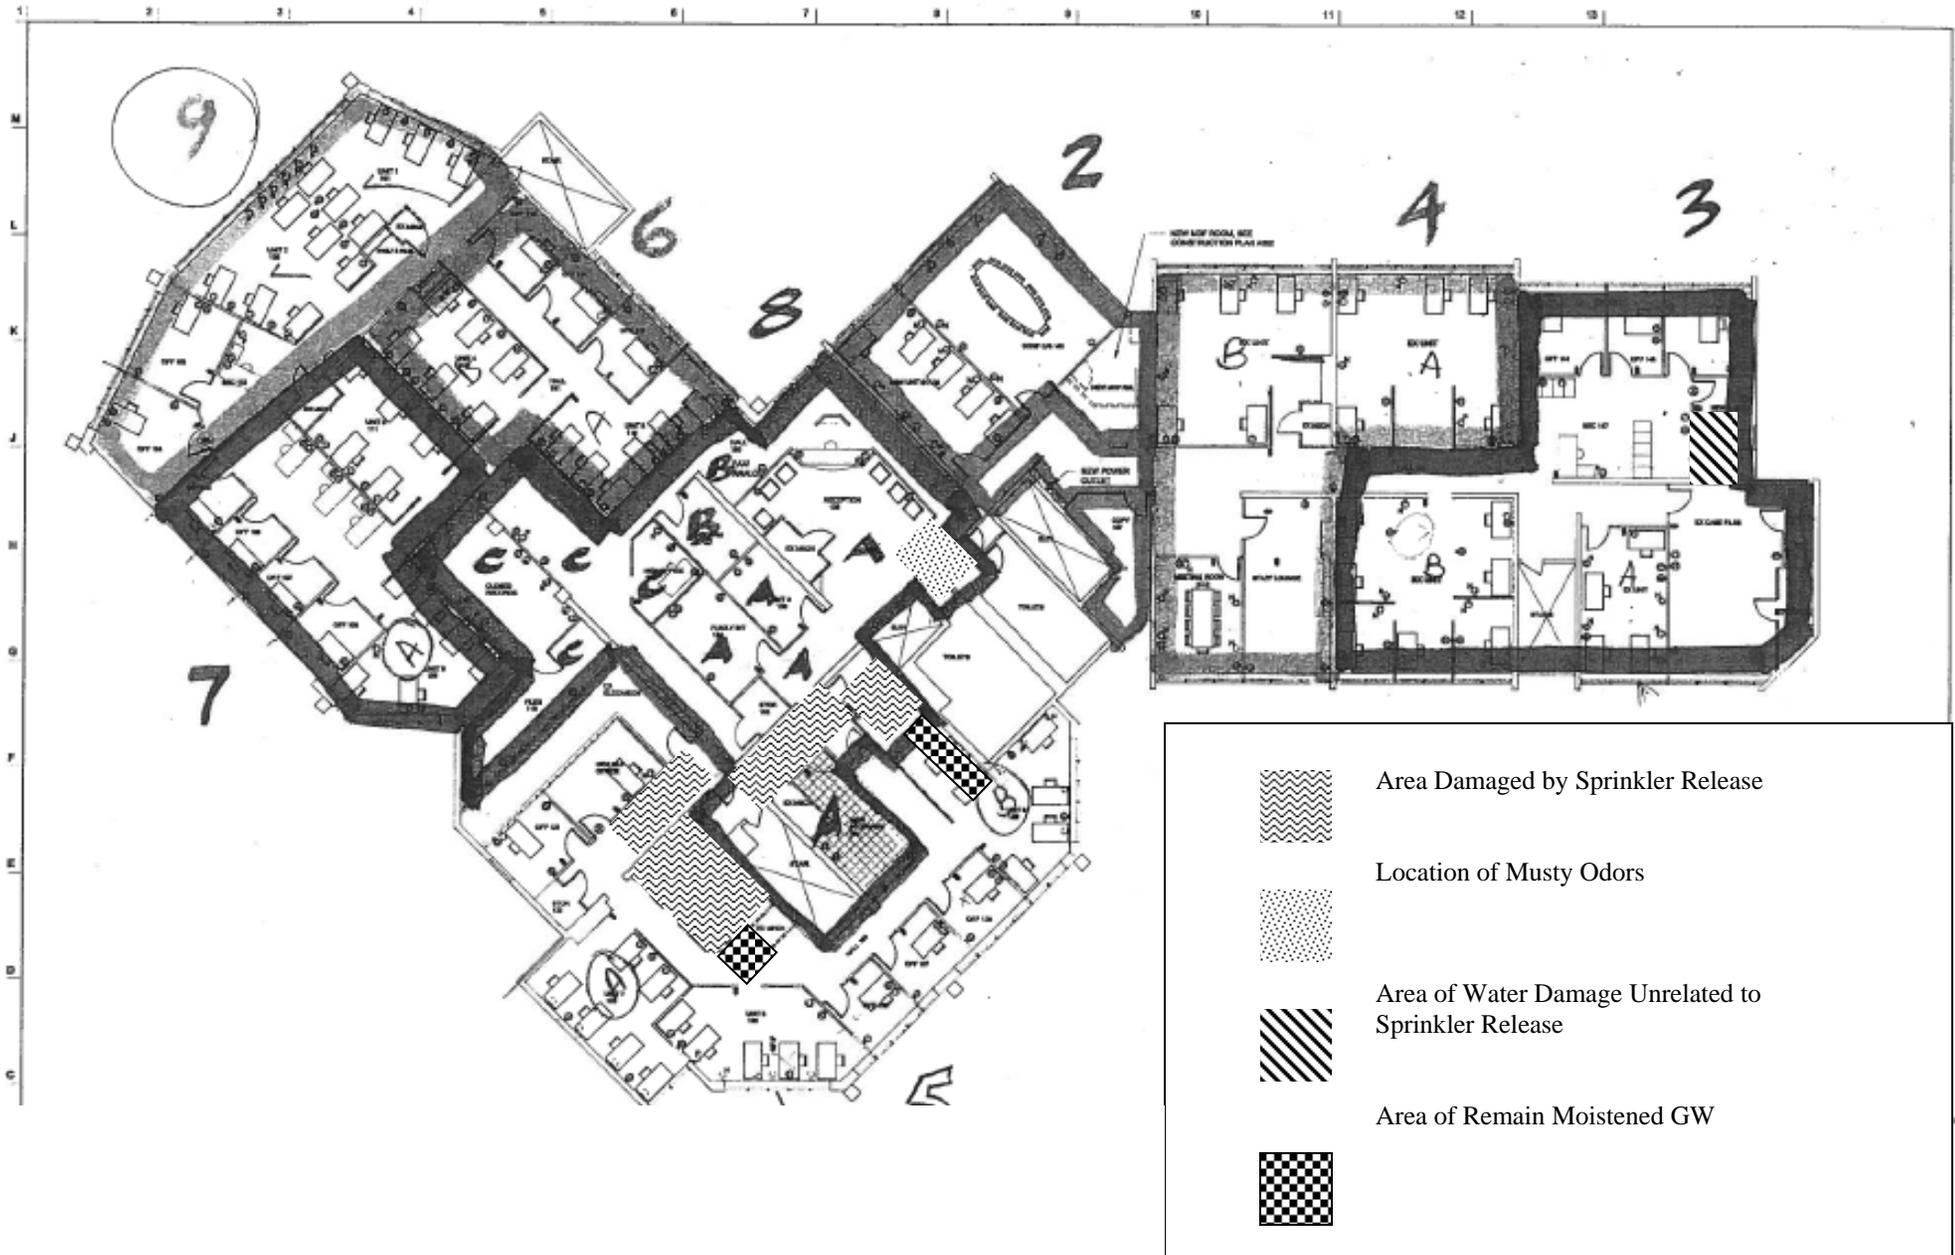
Figure 1
Third Floor Office Layout divided into Areas 1-9; Areas with Water Damage and Reported Odors

A section of offices and hallways on the second and third floors (Figure 1) were damaged by the water resulting from the fire mentioned previously. At the time of the MDPH assessment, restoration efforts were underway in DCF space. GW and carpeting had been removed, and fans/dehumidifiers were operating to aid the drying of building materials. BEH staff conducted moisture sampling of GW in areas under renovation and found no measureable levels of moisture. In areas adjacent to the renovation areas, moist GW was found behind plastic wall coving (Figure 1, Pictures 1 and 2). MDPH/IAQ staff recommended to DCF staff that coving in these areas be removed and dried in a manner similar to other areas where remediation was underway.

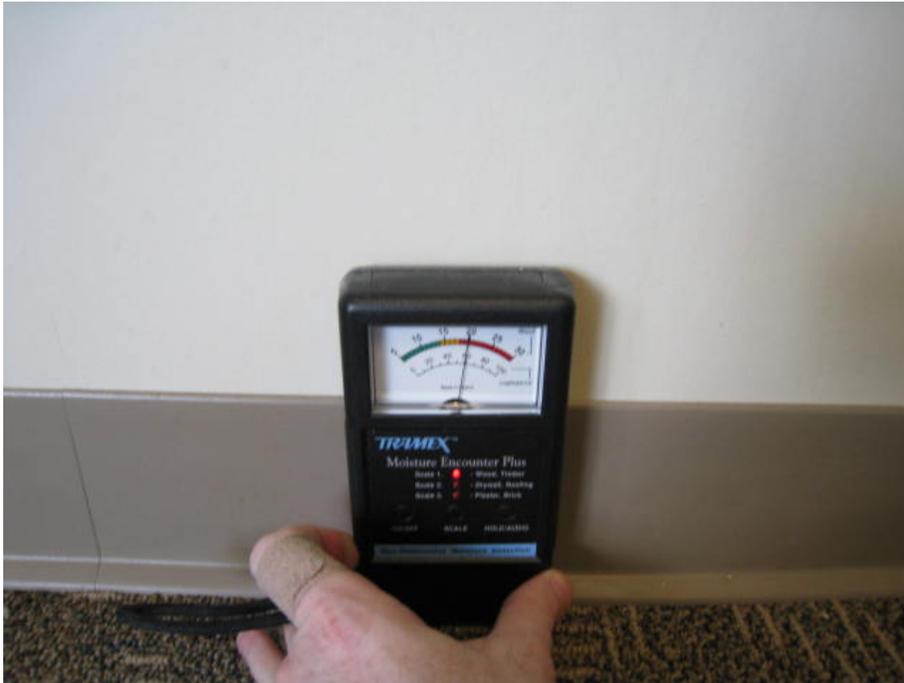
Picture 1

**Wet GW behind Coving next to Mechanical Room in Area 5
(Note indicator needle in red zone, indicating moisture)**

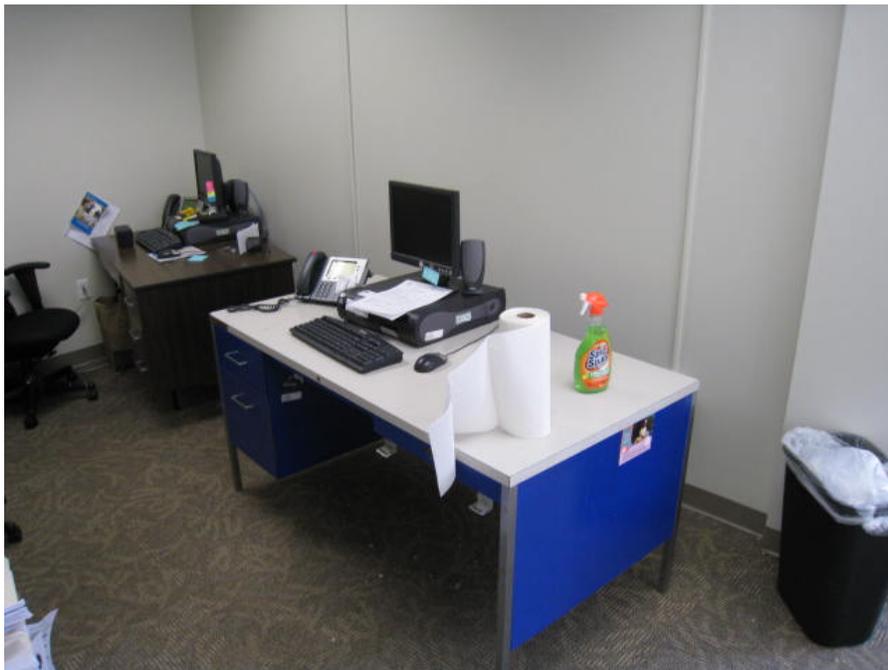
Picture 2

Moistened GW behind Desk in Area 5A

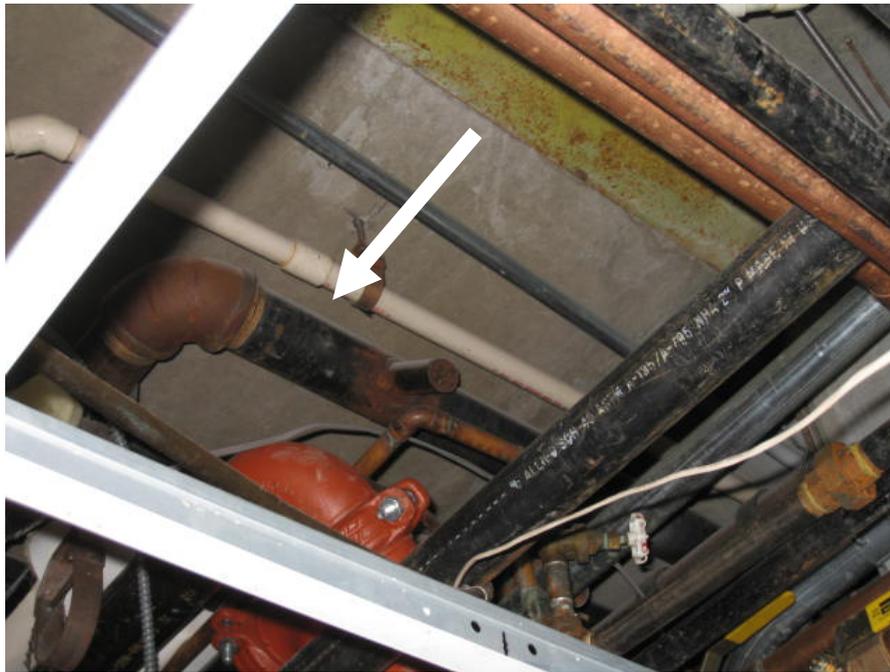
Picture 3

Of note is the route of water entry to the DCF space. Floor decking above the water-damaged area appeared free of water staining (Picture 3). A pipe (the function of which was unknown) was observed above the area where DCF staff identified the point of water entry. This pipe had two openings. The interior of the pipe appeared corroded, indicating the pipe is likely used for water drainage from upper stories. These pipe openings are the most likely source of

water that caused the damage observed on the third floor. Water that pooled on the third floor likely passed through spaces in the floor/decking, resulting in damage to the second floor.

Open Drain Pipe in Ceiling Plenum

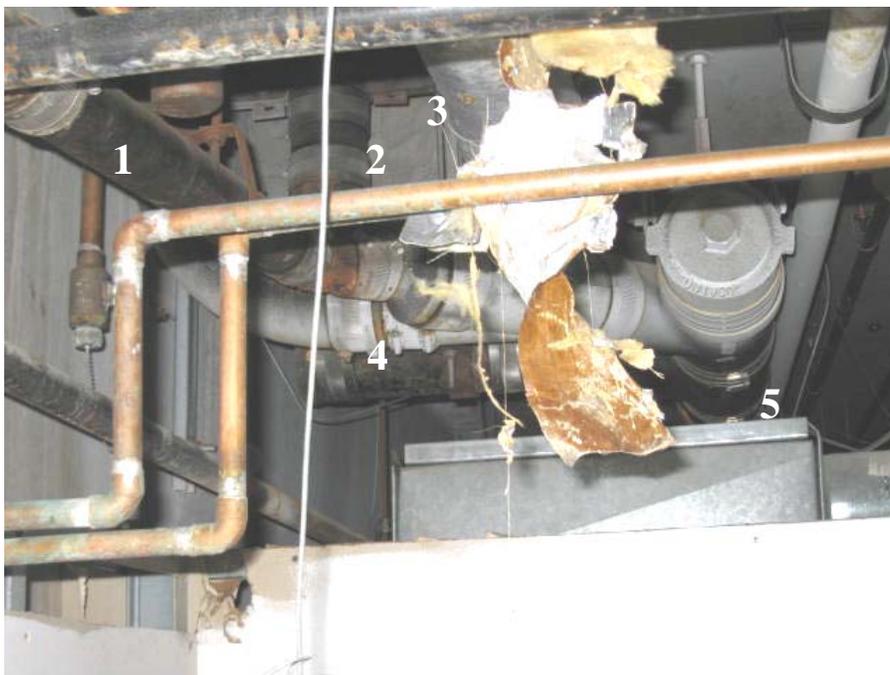
Picture 4

In Area 3 (Figure 1), an office appeared to have significant water staining. This damage is likely related to a series of drain pipes located above the suspended ceiling (Picture 4). Two conditions noted likely play a role in pipe leakage. First, the pipes are held together using screw clamps with a rubber gasket (Picture 5). Secondly, Pipe 1 appears to be “draining upward” into the main drain pipe (Pipe 5). The direction water is flowing from Pipe 1 to Pipe 5 suggests that a device is pumping water into this drain system, thereby pressurizing the pipes. The use of rubber screw clamps in a pressurized drain system like this can lead to spaces between the gasket and pipe joint, since the pipes are not coupled and sealed in a manner to render the joints airtight. Once gaps are created, repeated water leakage will occur, resulting in water damage to ceiling tiles, GW and carpeting, all of which can support mold growth.

**Drain Pipes above Water Damage in Area 3
(Note Pipes (Numbered 1-5), all feed into Pipe 5)**

1. Install appropriate filter in air intake in mechanical room. Remove filter that is in contact with heating coils.
2. Continue to remediate water damaged areas, including those identified by BEH staff.
3. Fix plumbing leaks in ceiling noted in Pictures 4 and 5.
4. Examine gaskets/caulking around windows where stained ceiling tiles exist.
5. Reconfigure the filter on the AHU in Picture 8 so that it is not held in place by the heating coil.
6. Refer to resource manuals and other related indoor air quality documents for additional building-wide evaluations and advice on maintaining public buildings. These materials are located on the MDPH's website: <http://mass.gov/dph/iaq>.

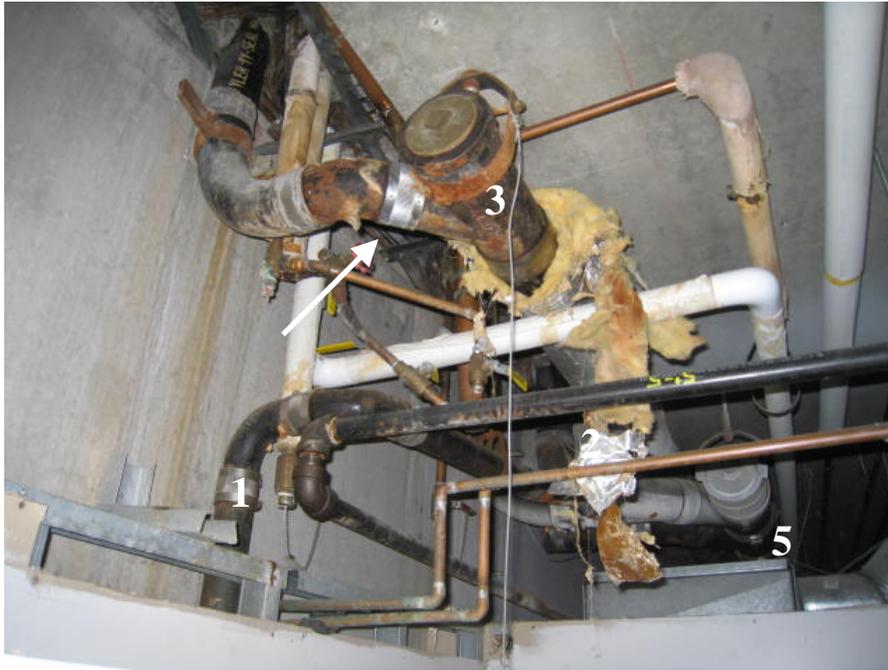
Picture 5

Clamp and Gasket holding pipe together. Note Drain Pipe #1 is “Draining” *Upwards*, Which Likely Indicates Pressurization of the Main Drain Pipe)

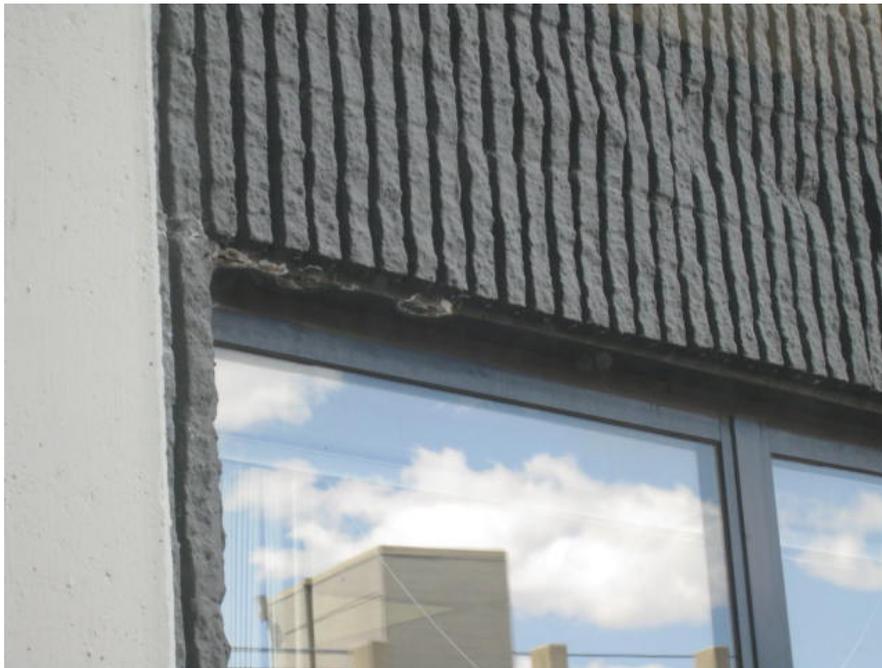
Picture 6

Some ceiling tiles in offices along exterior windows were found water-damaged. It is likely that the window frame sealant has eroded over time (Picture 6). Efflorescence was observed above window frames near the aforementioned damaged ceiling tiles, indicating water

Possible Eroded Gaskets in Location of Water Damaged Ceiling Tiles

is concentrating at the wall/window frame seam. Window frames should be re-caulked when water damage is apparent around sill and adjacent ceiling tiles.

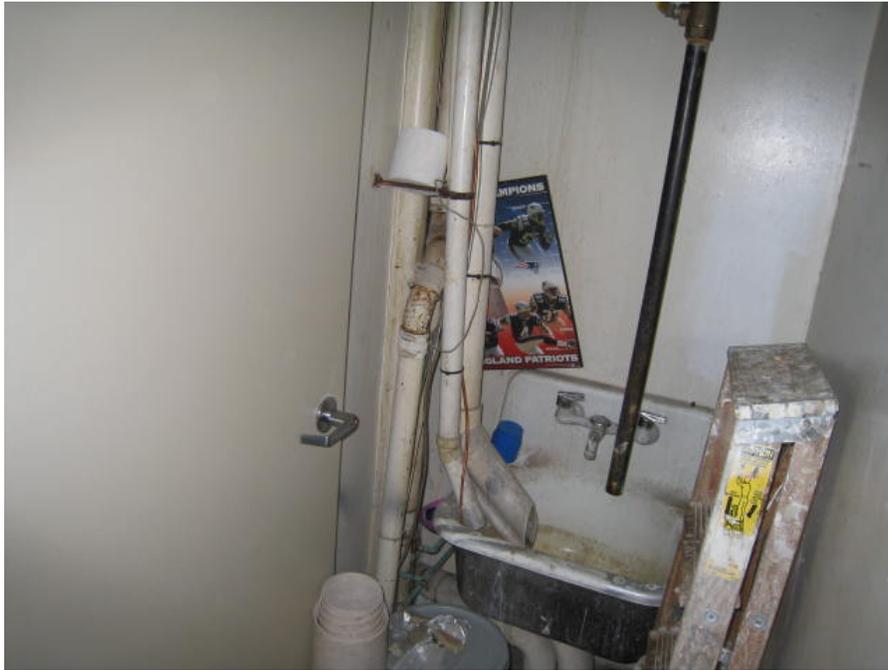
Picture 7

Office staff report that the reception area in Area 8 experiences pungent odors (Figure 1). A pair of restrooms is located in this general area. Each restroom has functioning exhaust ventilation. A custodial closet adjacent to the restrooms has a sink and various drain pipes (Picture 7). The custodial closet does not have a mechanical exhaust vent. Of note are pipes that empty into the mop sink. These pipes are the most likely sources of reported odors. When the restroom exhaust vents are operating, odors are drawn out of the custodial closet into the waiting room.

Sink and Pipes in Custodial Closet

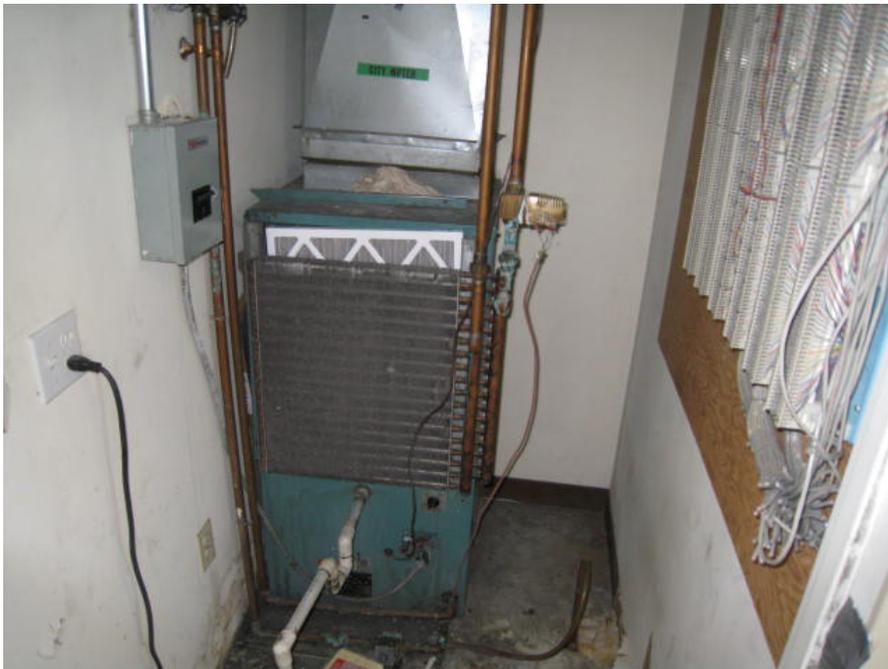
Picture 8

Another issue of concern is the condition of mechanical rooms. Of note is an AHU that has a filter held in place by a heating coil (Picture 8), which is installed over the air intake for the unit. The filter does not completely cover the air intake opening, which can result in airborne dirt, dust, odors and particulates being drawn into the HVAC system and distributed to occupied areas. The filter is in contact with a radiant heat source, which poses a fire hazard. Disposable filters are not designed to be in contact with HVAC system heating coils.

Filter Held in place by Heating Coil
