INDOOR AIR QUALITY ASSESSMENT

**Neil A. Pepin School
4 Park Street
Easthampton, Massachusetts**

Prepared by:
Massachusetts Department of Public Health
Bureau of Environmental Health
Indoor Air Quality Program
August 2011

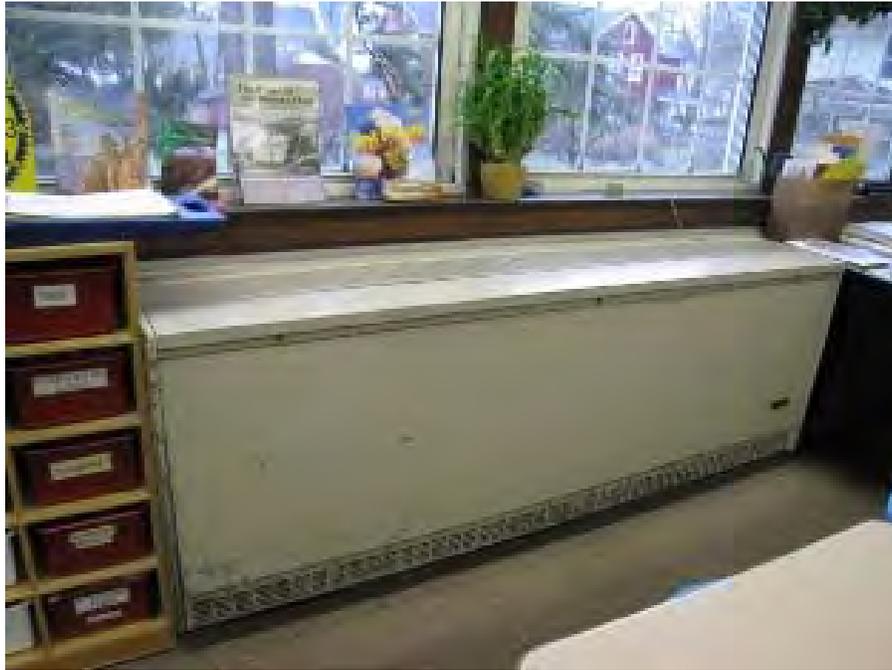
Picture 1

Fresh air in classrooms is supplied by unit ventilator (univent) systems (Picture 1). A univent draws air from outdoors through a fresh air intake located on the exterior wall of the building (Picture 2) and returns air through an air intake located at the base of the unit ([Figure 1](#)). Fresh and return air are mixed, filtered (Picture 3), heated and provided to classrooms through an air diffuser located in the top of the unit. In several classrooms, items were seen on and/or in front of univents obstructing airflow (Picture 4). In order for univents to provide fresh air as designed, air diffusers, intakes and return vents must remain free of obstructions. Importantly, these units must remain “on” and be allowed to operate while rooms are occupied.

Unit Ventilator (univent)

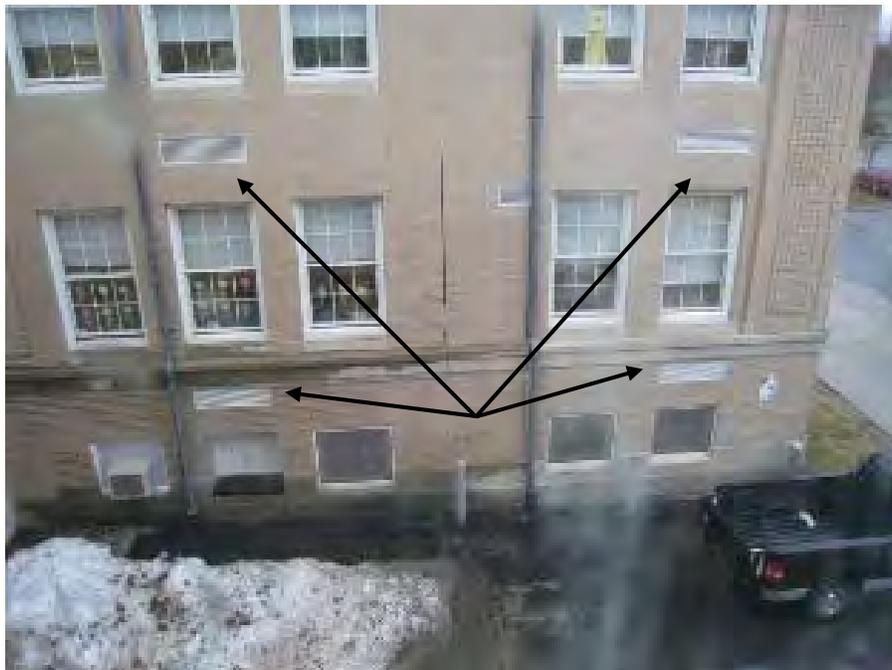
Picture 2

While no carbon monoxide was measured in the building, conditions that would allow vehicle exhaust entrainment by univents existed. As can be seen in Picture 2, a truck was parked in close proximity to univent fresh air intakes. While the truck was not idling at the time of the assessment, steps should be taken to ensure motor vehicle idling does not occur near any fresh air intakes in the building to eliminate the possibility of the uptake of vehicle exhaust (called entrainment) by the fresh air intakes of the univents.

**Univent Fresh Air Intakes (Arrows)
Note Truck beneath Fresh Air Intake**

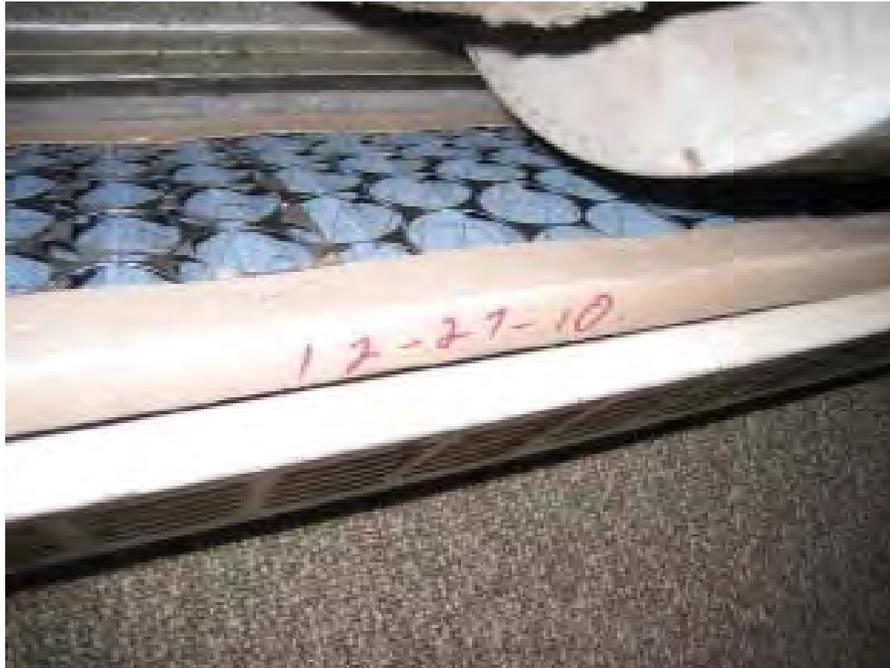
Picture 3

Univent Filter

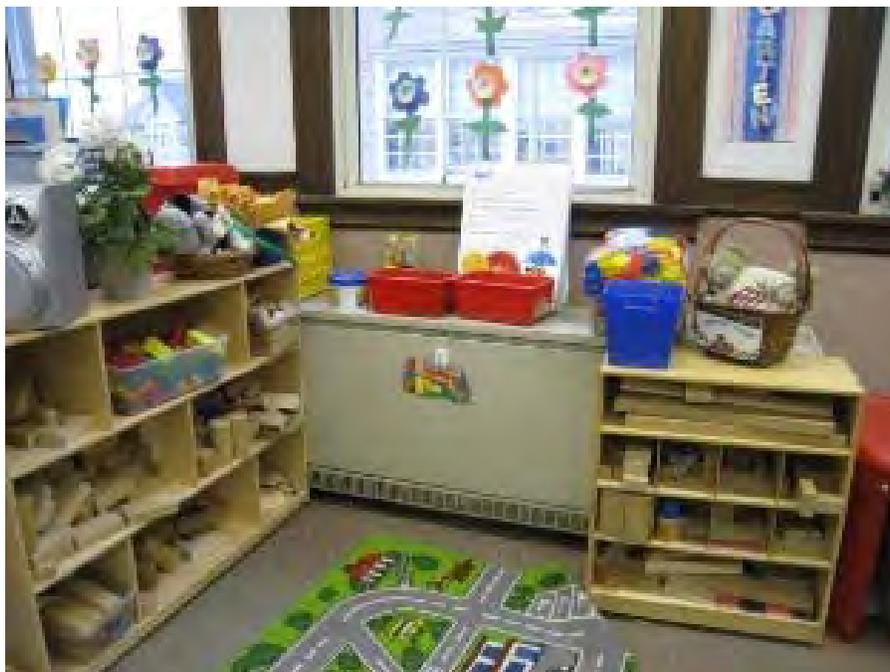
Picture 4

Univent Obstructed by Furniture and Classroom Materials

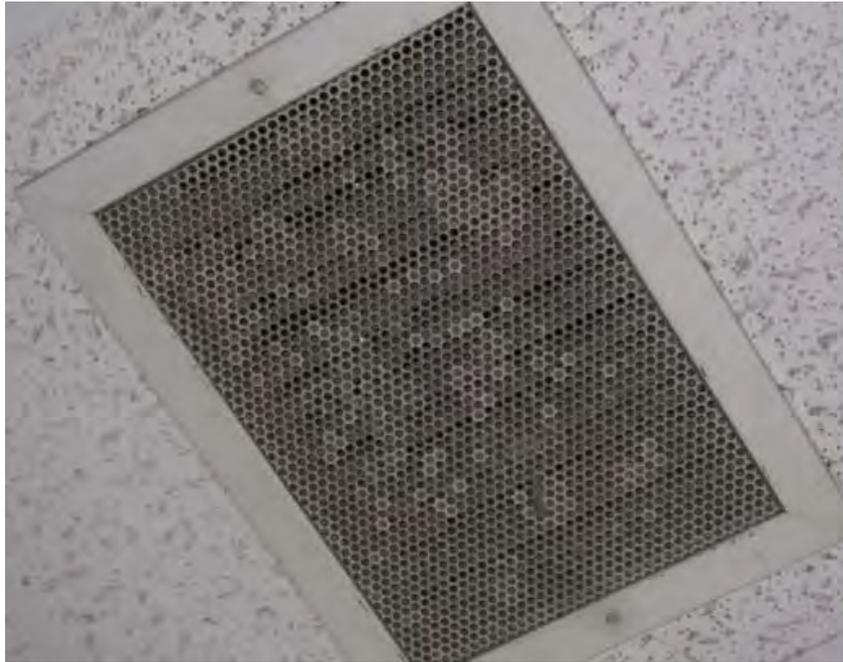
Picture 5

Air is exhausted to the roof by means of ducted, ceiling-mounted exhaust vents. Some exhaust vents were partially obstructed reportedly by a product called “plastic bubbles.” These bubbles were reportedly that were made in the classroom, and floated to the exhaust vent, where they have settled and hardened (Picture 5).

Exhaust Vent Partially Obstructed by Dried “Plastic Bubbles”

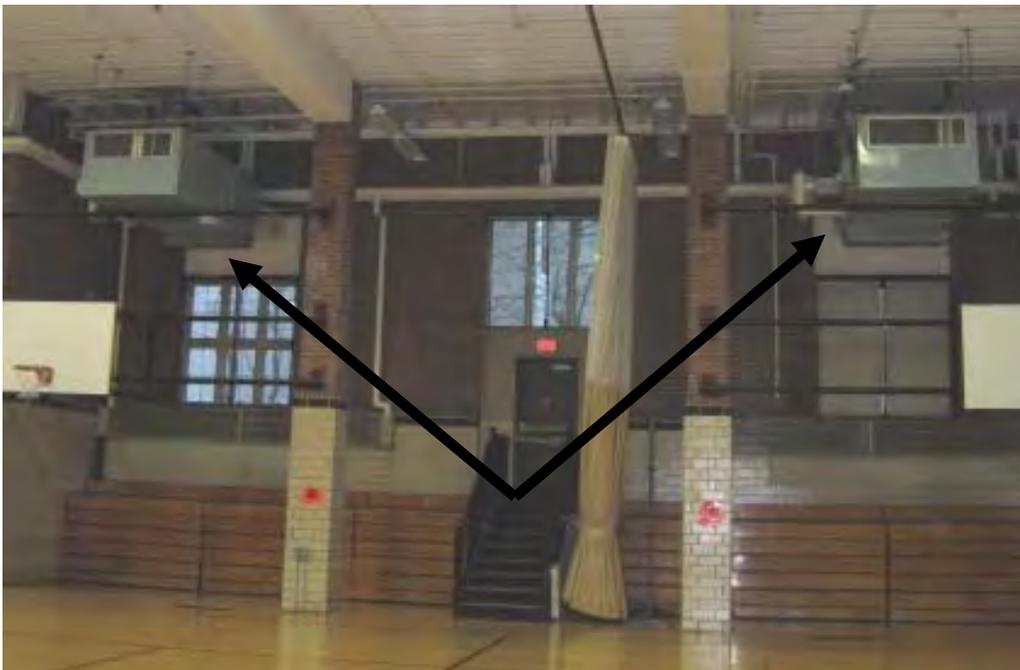
Picture 6

Ceiling-Mounted AHUs in Gym (Arrows)

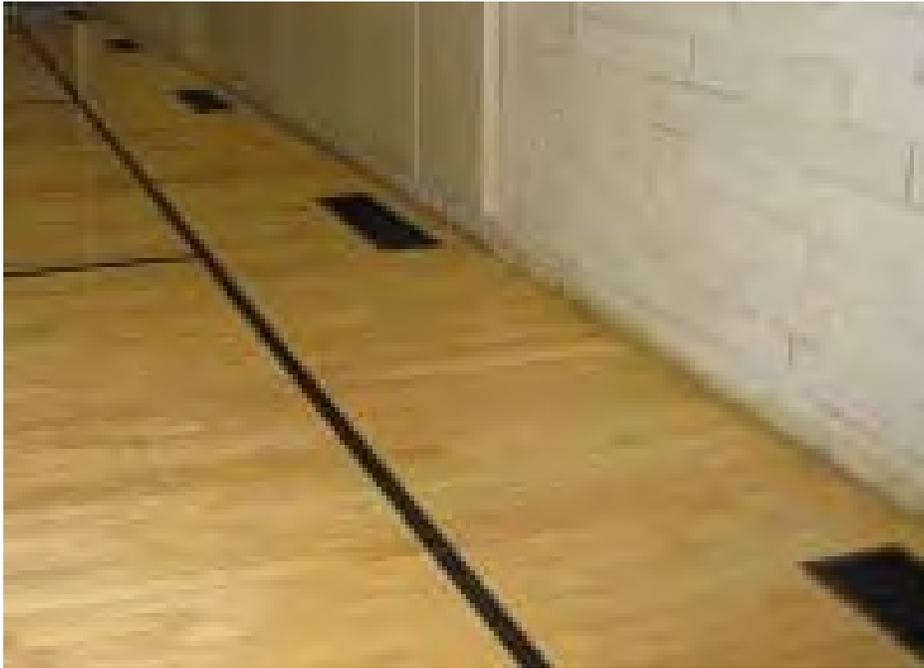
Picture 7

approximately two feet above a crawlspace. Air is exhausted from the gym by means of approximately 20 floor-mounted exhaust vents (Picture 7). Air is pulled from the gym through these vents into the crawlspace and is exhausted outside of the building by means of a ducted mechanical exhaust. It was reported that at one time, the exhaust system for the gym/crawlspace operated continuously. However, in order to reduce operating costs, a humidistat was installed which measures the humidity in the crawlspace (Picture 8). If the humidity in the crawlspace exceeds 55%, the exhaust will begin to operate. When the exhaust is not operating, the gym lacks mechanical exhaust ventilation, with the exception of two large exhaust fans which were not in use at the time of the survey.

Exhaust Vents in Gymnasium Floor

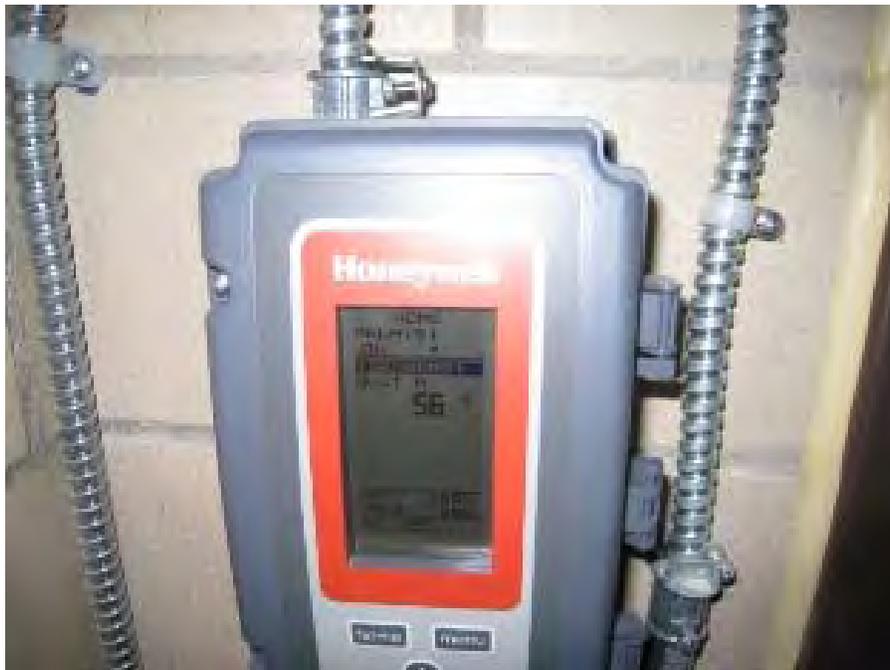
Picture 8

Control Panel to Monitor Crawlspace Humidity

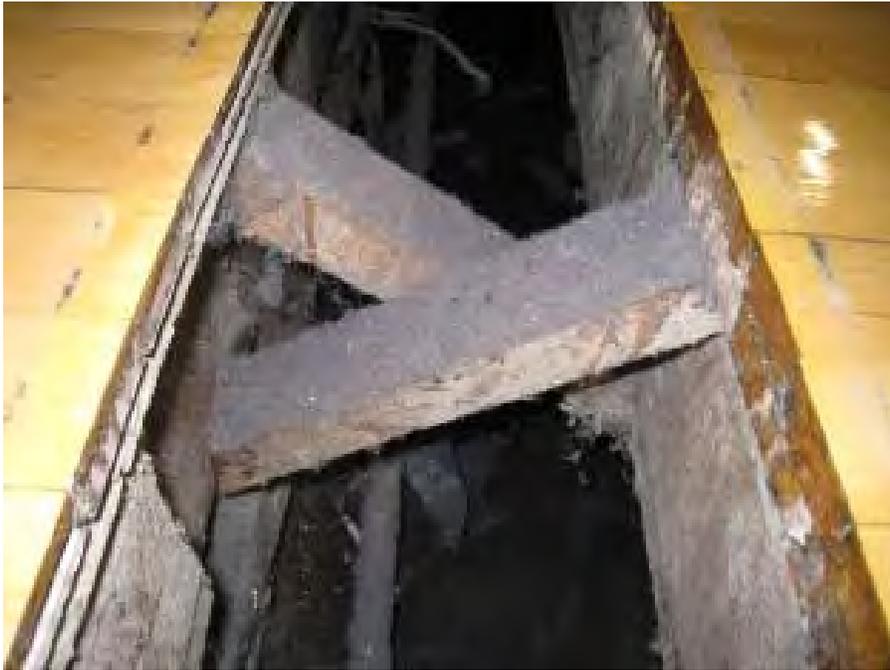
Picture 9

Water damage was evident throughout the building. Standing water was observed in the crawlspace beneath the gymnasium floor. Numerous exhaust vents in this floor were opened and dust, hair and other organic debris was noted within (Pictures 9 and 10). When the crawlspace exhaust is not operating, the gym is open to the moisture in the crawlspace below.

Standing Water in Crawlspace below Gym Floor Exhaust Vents

1. Consider operating the gymnasium/crawlspace exhaust system during school hours to remove water vapor and associated odors from the gymnasium. Due to the standing water observed in the crawlspace below the gym floor, determine whether two separate ventilation systems, (one for the crawlspace and one for the gym) would be better suited for the gymnasium rather than opening the gymnasium up to the moisture in the crawlspace through the exhaust vents in the floor. If this is the case, consider sealing all penetrations in the gymnasium floor.
2. Remedy all exterior building envelope conditions that contribute to water infiltration into the building, such as:
 - a. Repair roof leaks;
 - b. Repair downspout and gutter system and ensure rainwater is deposited as far away from the building as practicable;
 - c. Seal open penetrations into the building;

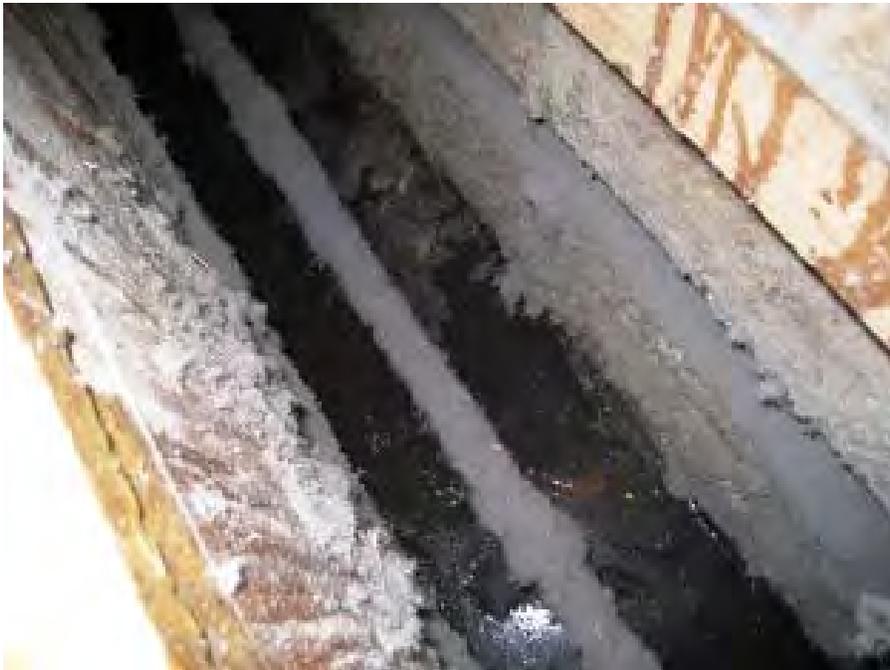
Picture 10

**Standing Water and Heavy Dust Accumulation in
Crawlspace below Gym Floor**

3. Repair all sources of water damage on the interior of the building.
 4. Prior to occupancy this fall, clean dust and organic debris from below crawlspace exhaust vents in the gym.

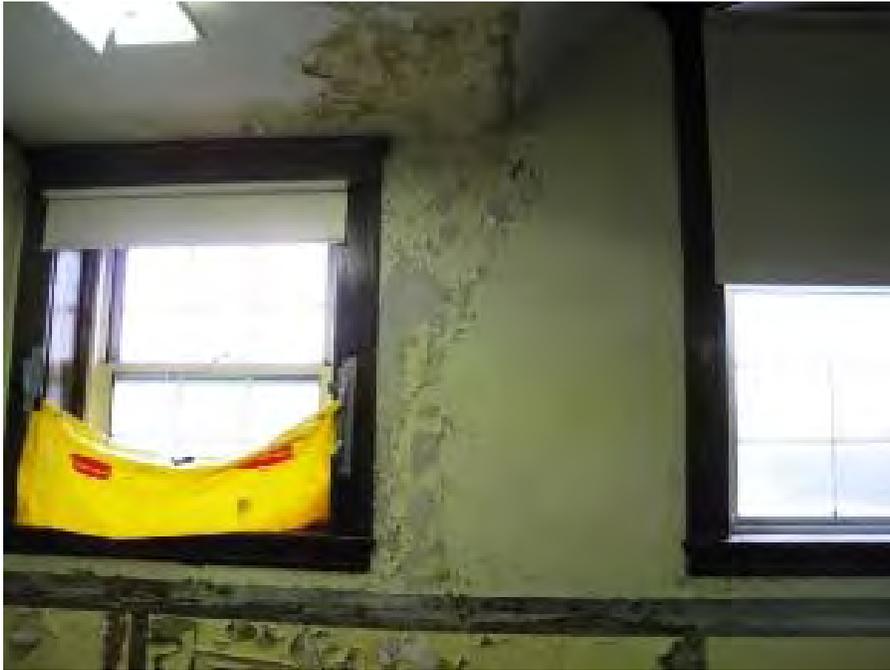
Picture 11

The attic/storage area which had been formally utilized as a science lab was highly impacted by water infiltration (Pictures 11 through 14). Severe water damage and efflorescence¹ was evident on the ceiling and walls which, in turn, resulted in chipping, peeling paint observed on the floor and on stored materials. Due to the age of the building, it is likely that this paint contains lead, and if so, must be managed/abated accordingly. The window sills and floor were wet to the touch due to heavy rains and some of the plaster walls were cracked and deteriorating. The floor boards were substantially buckled and plywood flooring had delaminated, likely due to prolonged exposure to moisture (Pictures 15 and 16). Numerous water-damaged, porous materials were also found stored in the attic (Picture 17).

**Water-Damaged Ceiling and Walls in Attic
Note Peeling Paint**

17. Consult a specialist in building construction to determine if water-damaged attic area is structurally sound. Make repairs as required.
 18. Determine if chipping, peeling paint contains lead and if so remove/abate lead paint from walls, floors and stored materials in accordance with applicable lead paint laws and regulations.

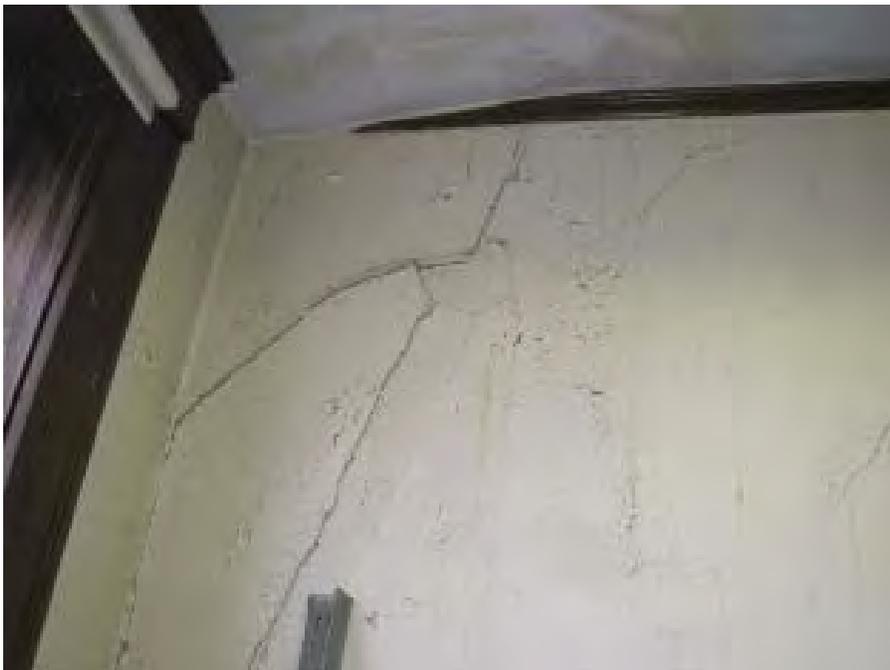
Picture 12

Water-Damaged, Cracked Plaster Walls in Attic

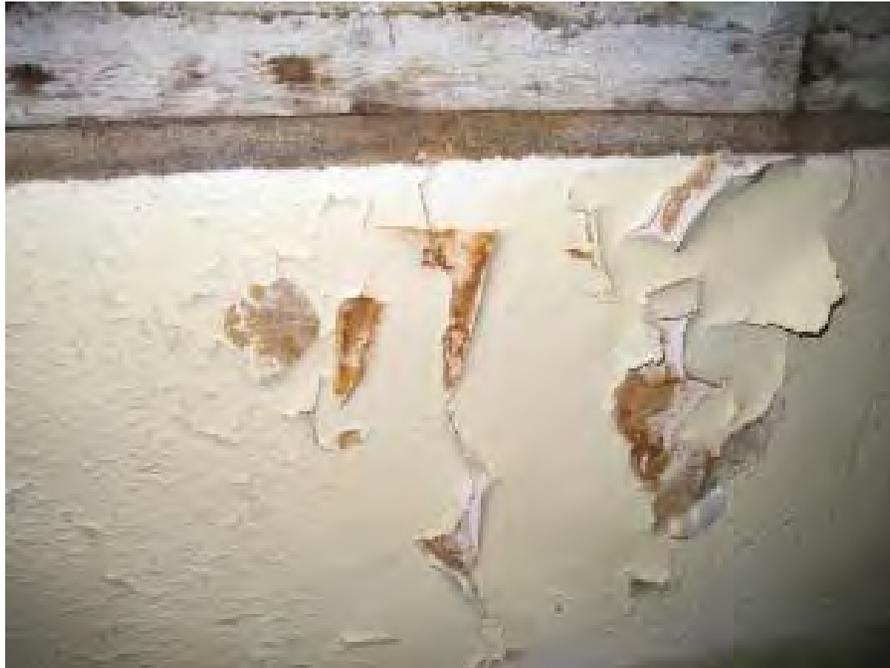
Picture 13

Peeling Paint and Efflorescence in Attic

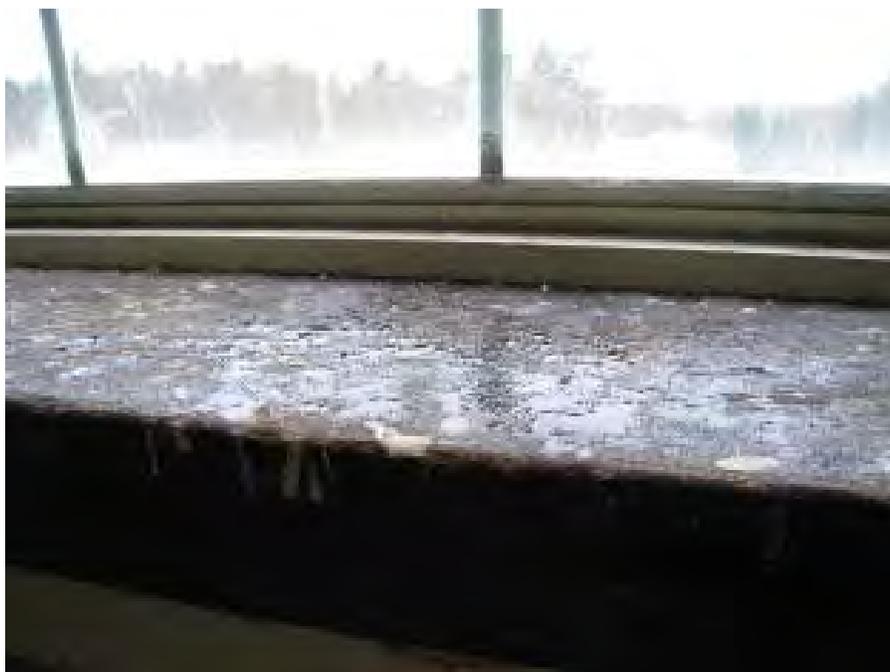
Picture 14

Water Infiltration on Interior Window Sill in Attic

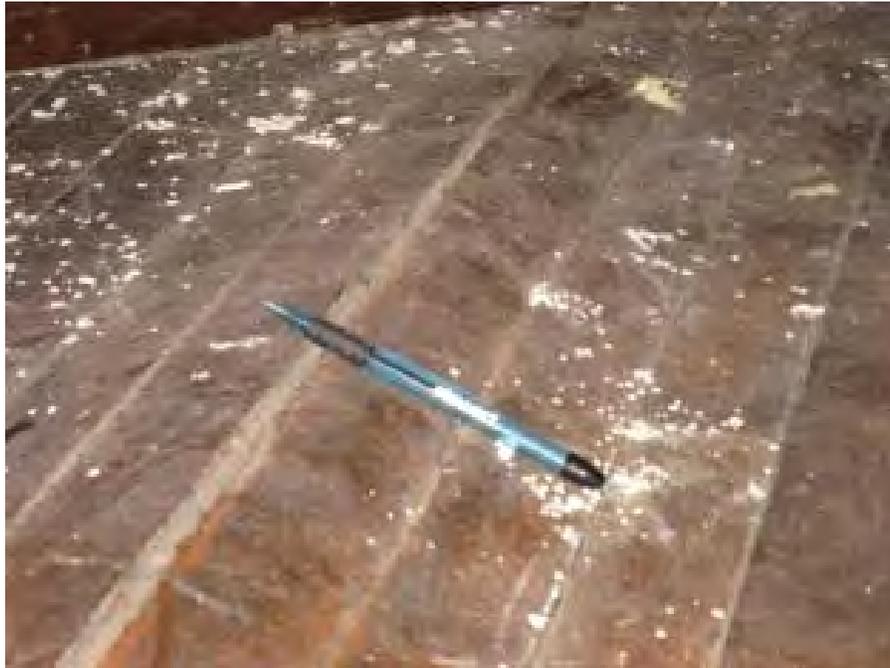
Picture 15

Buckled Wooden Floor in Attic

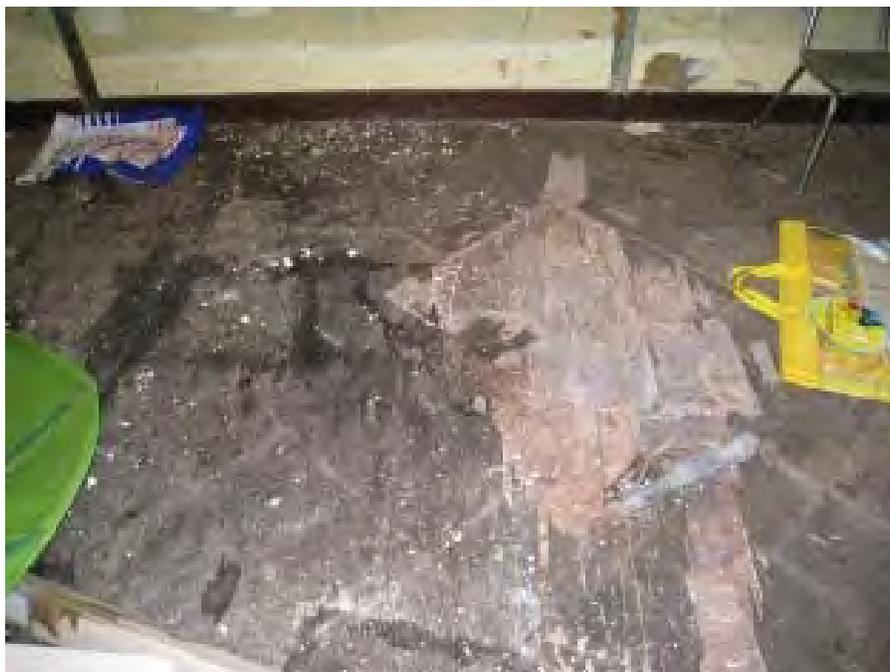
Picture 16

Water-Damaged, Delaminating Plywood in Attic

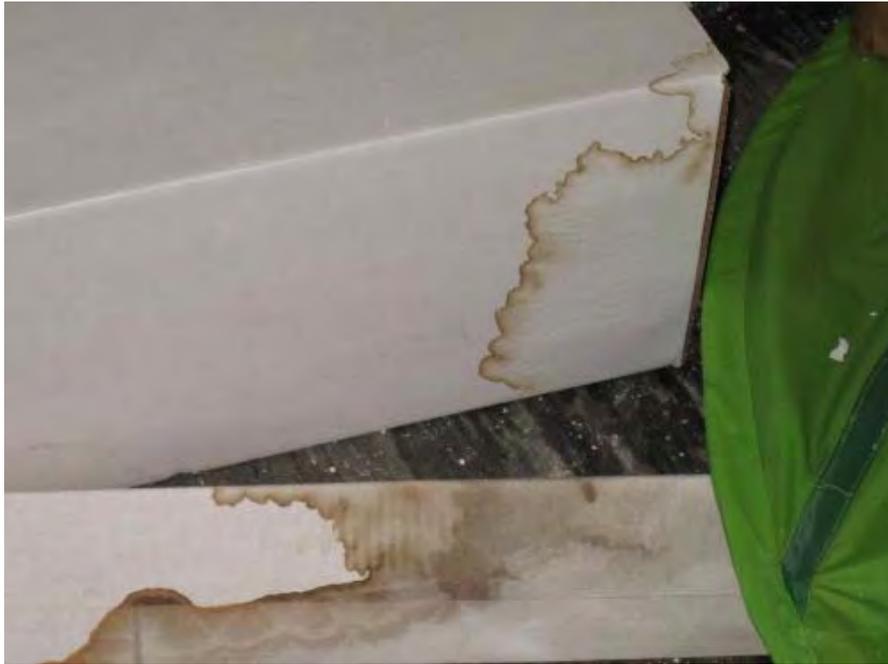
Picture 17

Water-Damaged Porous Materials Stored in Attic

5. Remove and dispose of water-damaged porous materials in attic and throughout the school.
 6. Dispose of any water-damaged cardboard boxes. Ensure documents stored within them have not been water-damaged or colonized by mold. Restore/replace records as necessary.

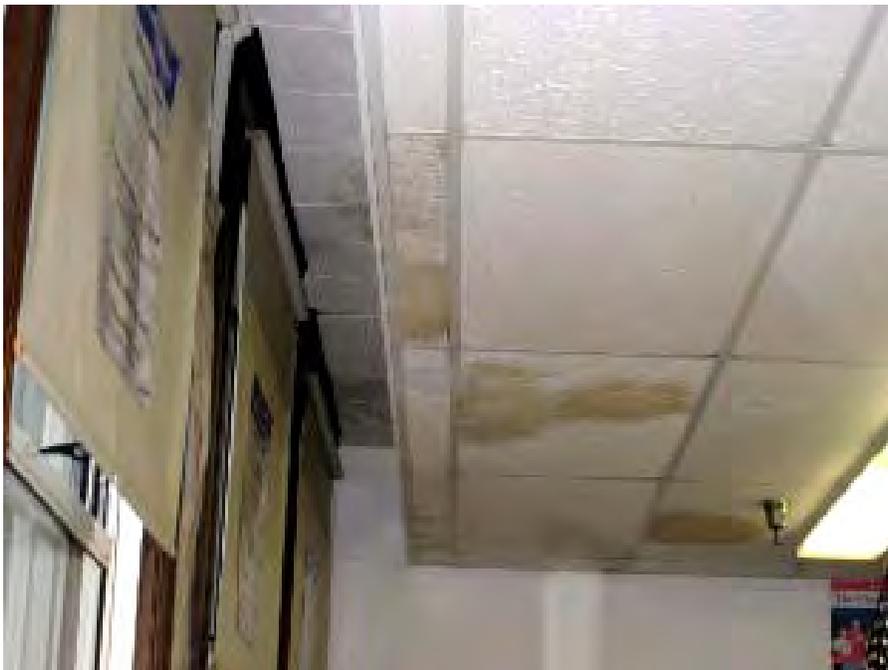
Picture 18

It appears that at some point suspended ceilings were installed beneath the original ceiling tile system (Picture 18). Several classrooms had two layers of water-damaged ceiling tiles which can indicate sources of water penetration from either the building envelope or

Two Layers of Water-Damaged Ceiling Tiles

8. Discontinue practice of painting water-damaged ceiling tiles and replace after the source of water damage is identified and remedied.
9. Regularly clean the interior of univents (e.g., with regular filter changes).

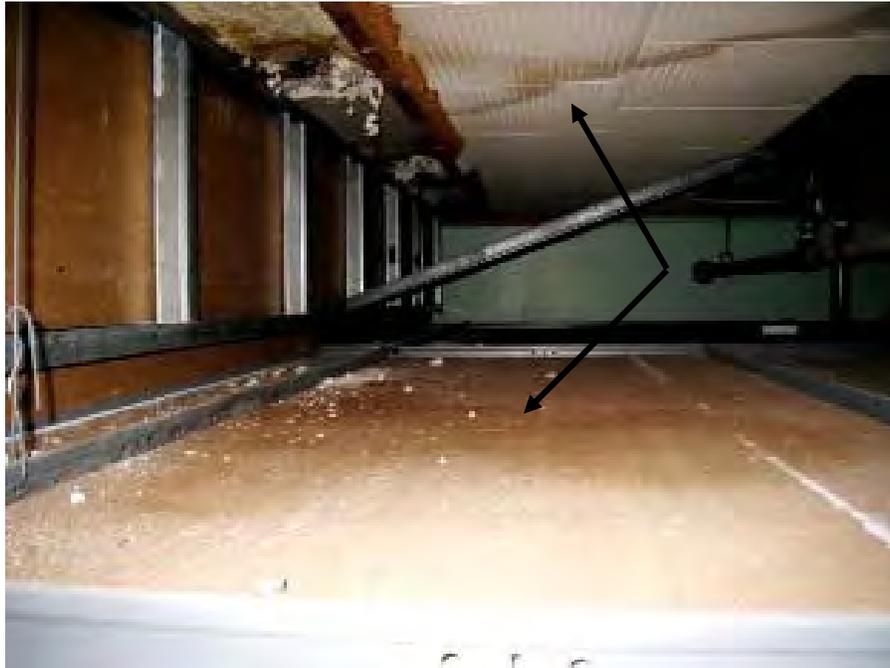
Picture 19

plumbing system (Picture 19). Water-damaged ceiling tiles can provide a source of mold and should be replaced after a water leak is discovered and repaired. In classroom 208, substantial water damage has occurred above the suspended ceiling adjacent to what appears to be a plumbing cleanout and along the wall below (Picture 20). If this is a plumbing cleanout that leaked, water damage should be considered as “black water” and thereby contaminated. Porous materials exposed to black water must be removed and disposed of. Possible mold colonization was noted on a small area of bubbled paint located above a wooden storage cabinet. Edges of ceiling tiles in this room were buckled as well, likely indicating prolonged exposure to moisture.

**Substantially Water-Damaged Original Ceiling Tiles
Note Water Damage on Suspended Ceiling Tile below (Arrows)**

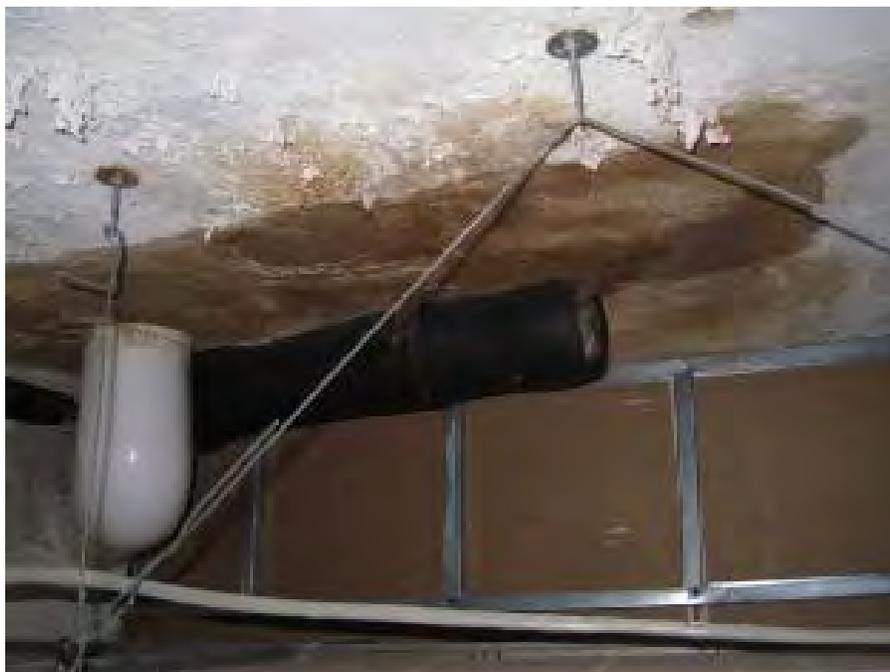
Picture 20

Water Damage above Ceiling in Room 208

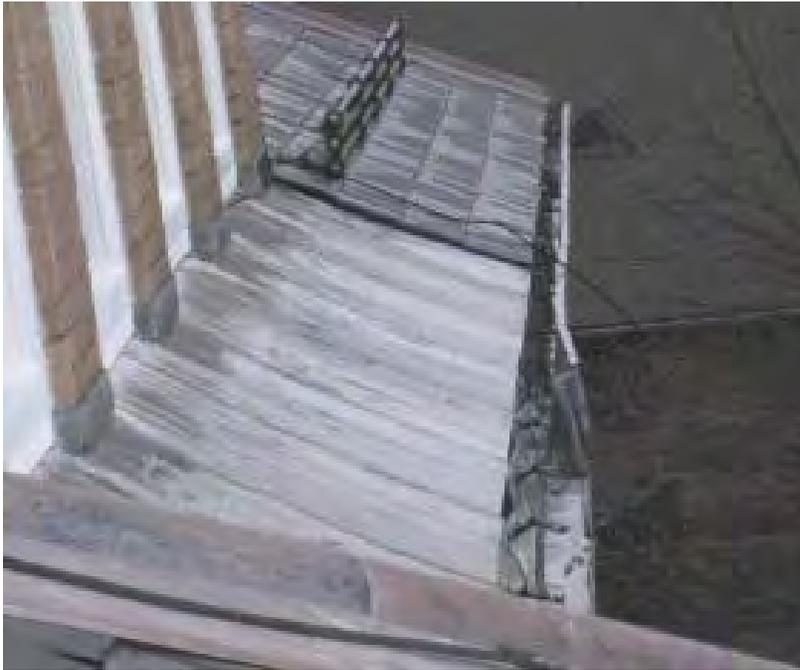
Picture 21

- Cracked, broken slate roofing;
- Gutters and downspouts in disrepair resulting in rain deposition on the sides of the building and on the ground adjacent to the foundation (Picture 21);
- Broken exterior windows;
- Deteriorated sections of upper wall and edge of trim under roof;

Damaged Portion of Gutter System

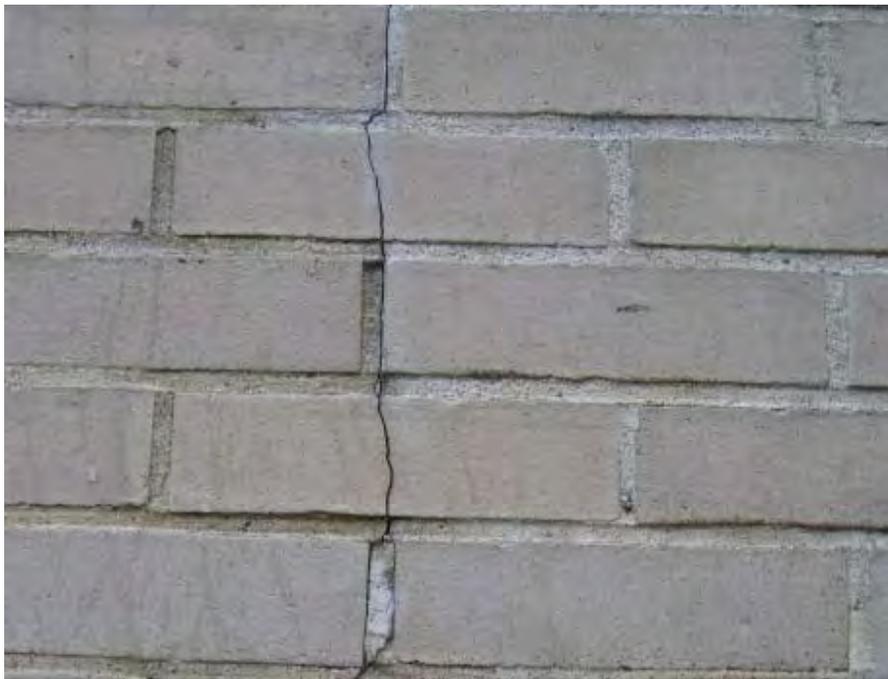
Picture 22

- Cracked and deteriorated brick and mortar (Picture 22);
- Cracks were evident in the concrete walkway and the tarmac adjacent to the building;
- A large gap between exterior doors (Picture 23);

Cracked Masonry and Mortar

- d. Repair or replace broken/leaking windows;
 - e. Repair cracked masonry and broken, missing mortar;
 - f. Seal gaps between exterior doors;
 - g. Seal cracks in sidewalks and tarmac and between tarmac and building components;

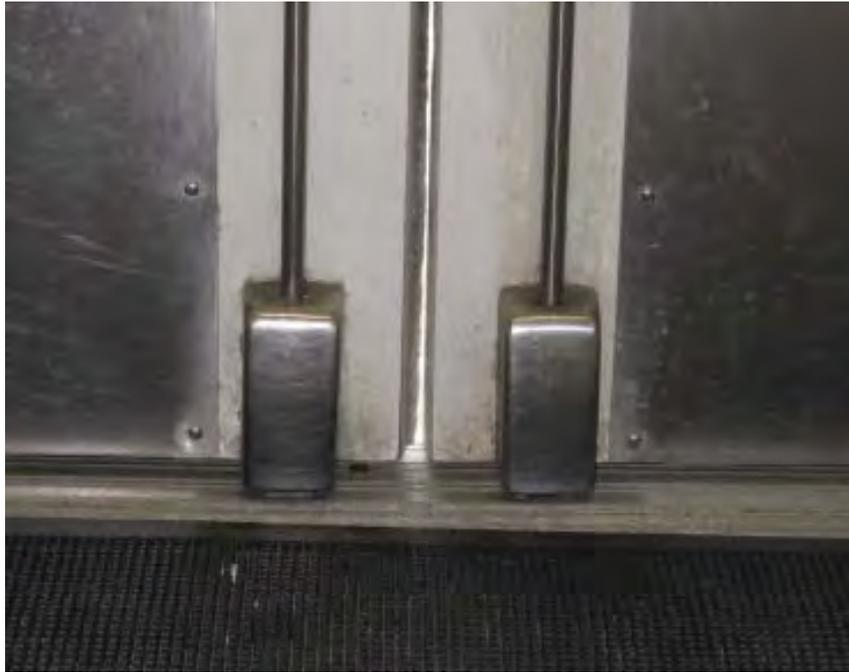
Picture 23

Gap between Exterior Doors

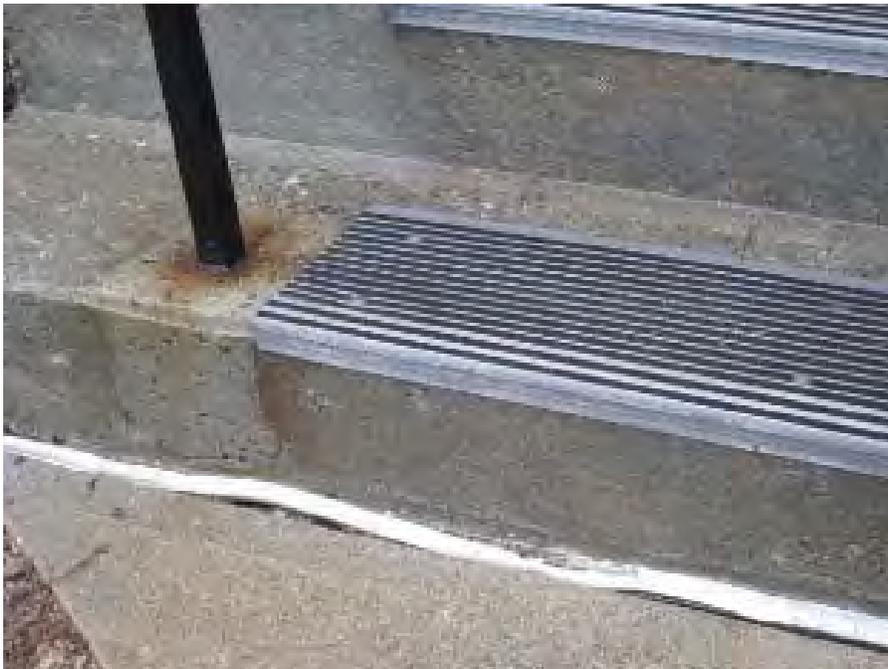
Picture 24

- Crumbling concrete on stairs;
- Sealant at the base of stairs was not in good repair (Picture 24). Depending on its age, this sealant may contain regulated materials (e.g., asbestos, polychlorinated biphenyls or PCBs). If so, materials should be addressed in accordance with state and federal regulations/guidance. For guidance on addressing PCB-containing materials in schools, consult MDPH guidance (Appendix B). Information on regulatory compliance with asbestos and/or PCBs, is available from the US Environmental Protection Agency (US EPA), Massachusetts Department of Environmental Protection (MA DEP) and the Massachusetts Department of Occupational Safety (MA DOS);

Sealant in Disrepair at Base of Stairs

- h. Repair crumbling concrete stairs;
 - i. Determine if sealant on stairs is composed of regulated materials, if so, consult DPH guidance regarding PCBs in schools and EPA regulations;

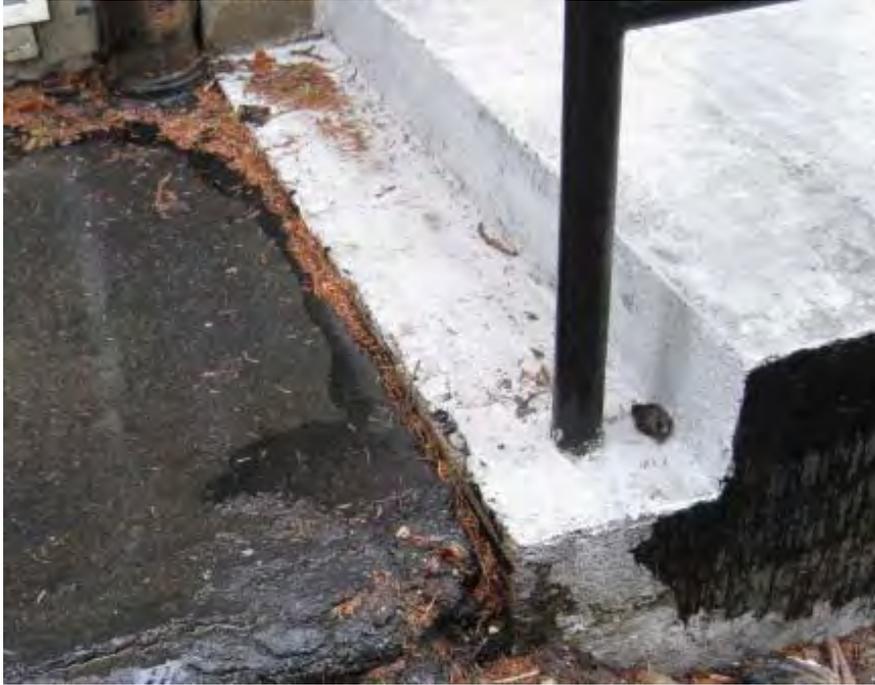
Picture 25

**Sealant Lacking between Stairs and Tarmac
Note Gym Instructor's Office is Directly below Stairs**

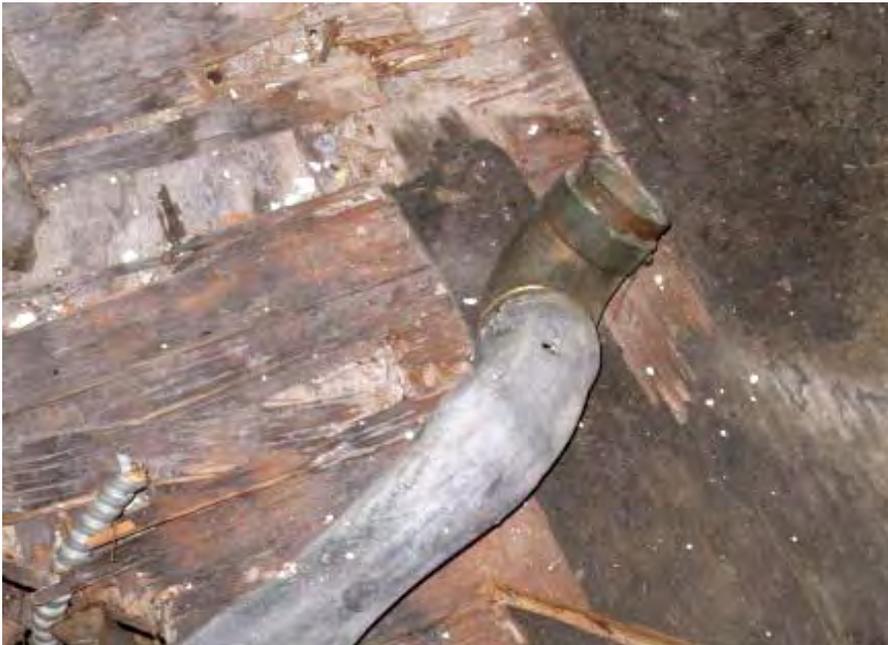
Picture 26

Other conditions that can affect indoor air quality were observed during the assessment. A pipe was observed in the attic storage area that may have once been the drain line for the laboratory sink (Picture 26). If still connected to the school's drainage system, sewer gas could be entering the building through the uncapped pipe.

Open Drain in Old Science Lab

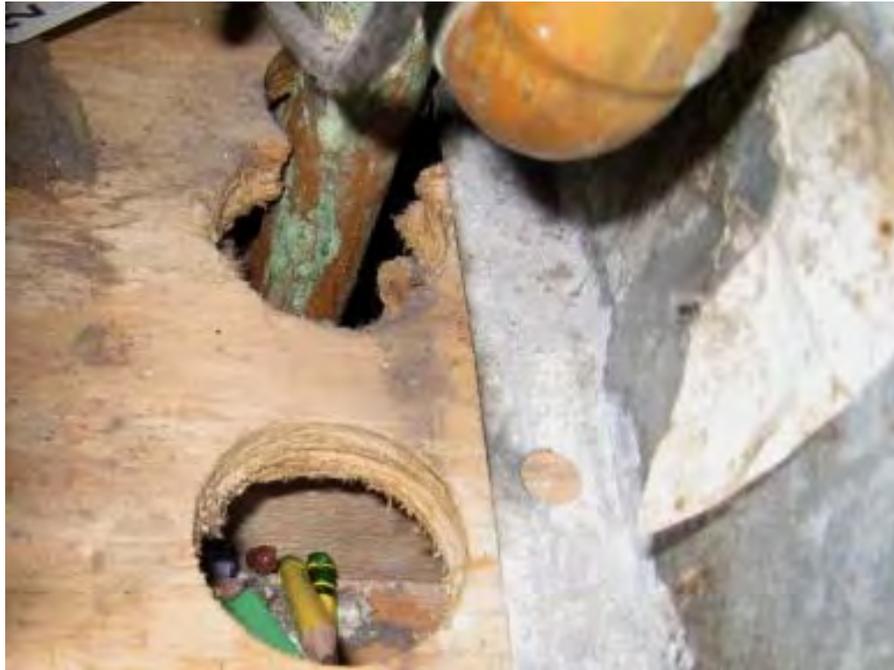
Picture 27

Large penetrations around utility pipes through walls and floors of univent cabinets were observed (Picture 27). Open utility holes can allow dusts, particulates, odors and vapors to move throughout the building. Measures to seal these breaches should be implemented.

Utility Holes at Base of Univent

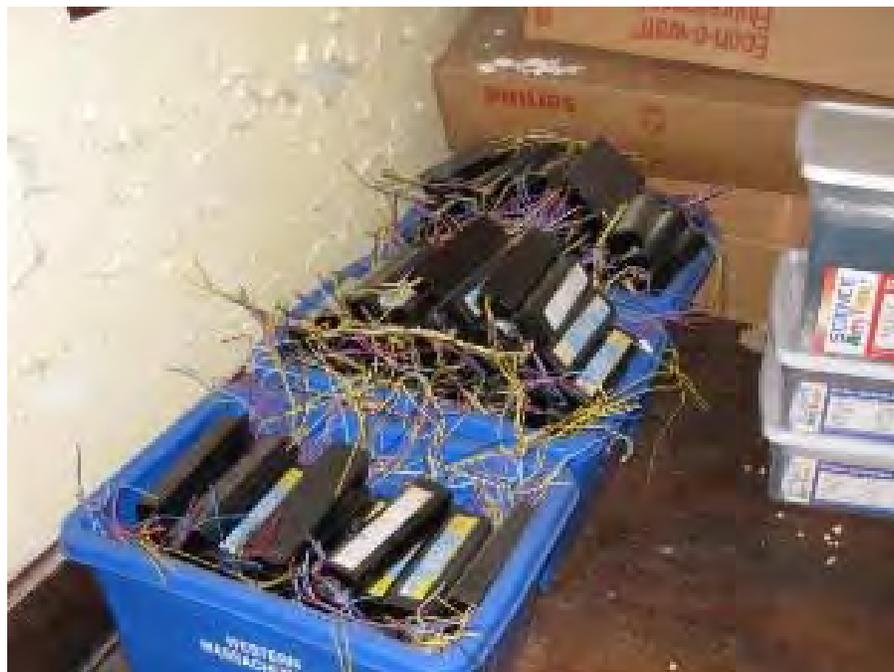
Picture 28

disposed of with care and in accordance with Department of Environmental Protection guidelines. Three plastic recycle bins of what appear to be old light ballasts were observed in the attic (Picture 28). The visible units displayed stickers indicating that they did not contain PCBs. The status of all of these ballasts should be determined and the ballasts should be disposed of accordingly.

Old Light Ballasts
