INDOOR AIR QUALITY ASSESSMENT MOLD INVESTIGATION

**Miscoe Hill School
148 North Street
Mendon, Massachusetts**

Prepared by:
Massachusetts Department of Public Health
Bureau of Environmental Health
Indoor Air Quality Program
October 2011

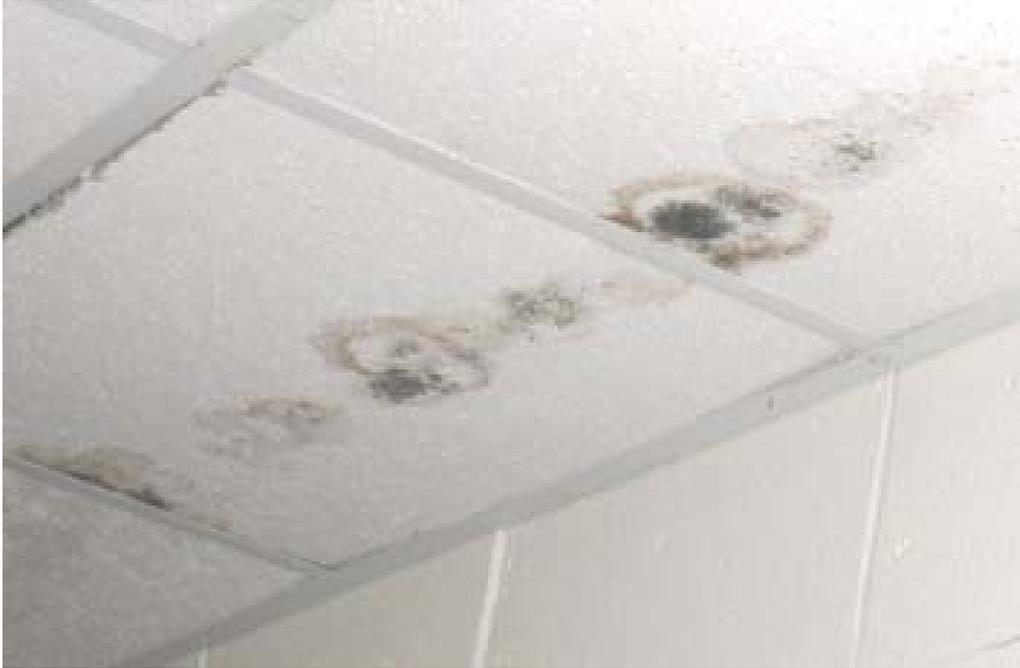
Picture 1

Several water-damaged/mold-colonized dropped ceiling tiles were observed in the library along the interior wall adjacent to room 113 (Picture 1). The damage to these tiles appeared to be a result of previous leaks. At the time of the assessment BEH staff recommended that the tiles be removed, sealed in plastic bags for transport and that the area be monitored for further leaks.

Water-Damaged/Mold Colonized Ceiling Tiles in Library

2. Remove/replace water-damaged/mold-colonized dropped ceiling tiles. Seal moldy tiles in plastic bags for transport. Examine the area above and around these areas for mold growth. Disinfect areas of water leaks with an appropriate antimicrobial as necessary.

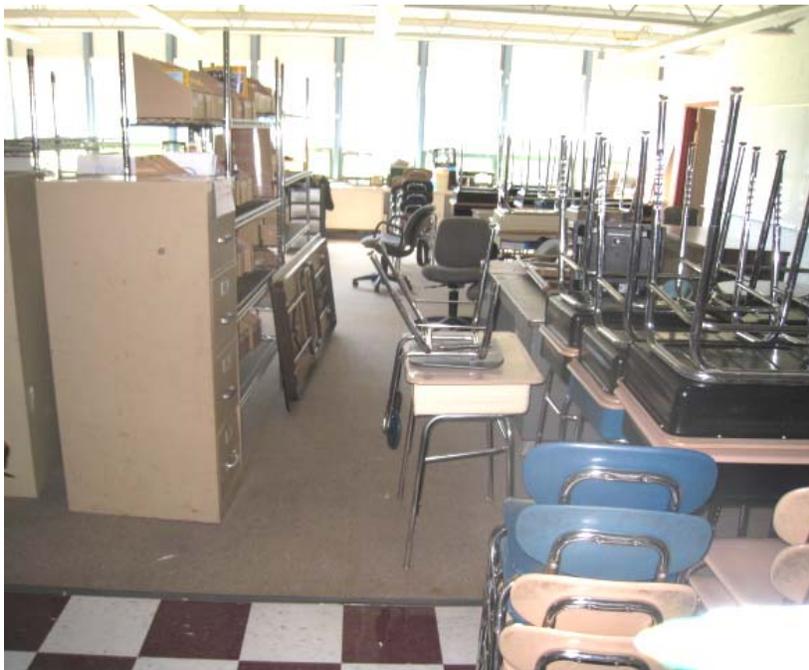
Picture 2

Room 224 is currently unoccupied and is reportedly being used as a storage area until the roof is replaced (Picture 2). Room 224 had a musty odor, which is likely due to the combination of moistened carpeting and lack of air exchange, since both the supply and exhaust ventilation were deactivated at the time of the inspection. Also of note was a light staining of ceiling panels which may have been surface mold (Picture 3). These panels are adhered directly to the roof substrate; removal will require destruction of the ceiling tile (unlike dropped ceiling tiles, which can be easily removed/replaced).

Room 224 Used as Storage

4. Once roof repairs are made, remove carpeting in room 224; consider replacing with a non-porous flooring material (e.g., tile).
5. Clean surface of ceiling panels in room 224 (and any other affected areas) with a vacuum cleaner equipped with a high efficiency particulate arrestance (HEPA) filter using the brush attachment. Once cleaning is complete, seal surface and repaint.

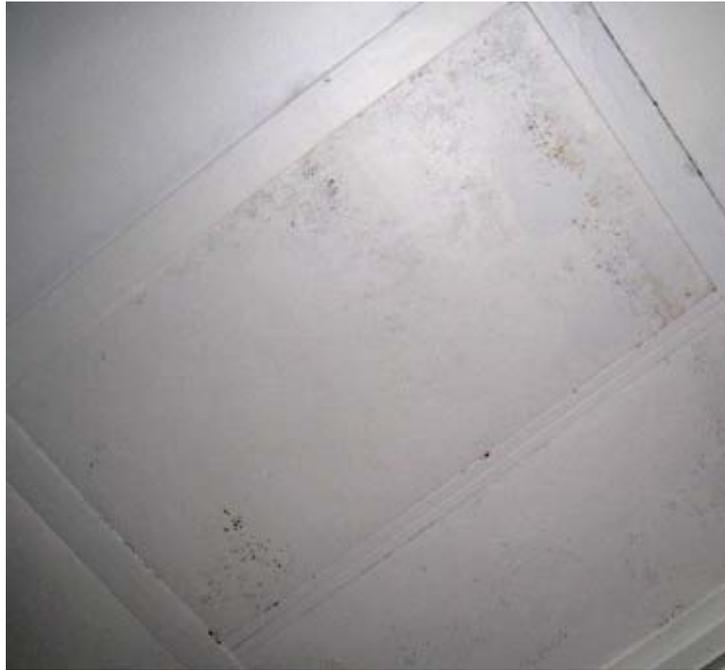
Picture 3

Light Staining of Ceiling Panels in Room 224

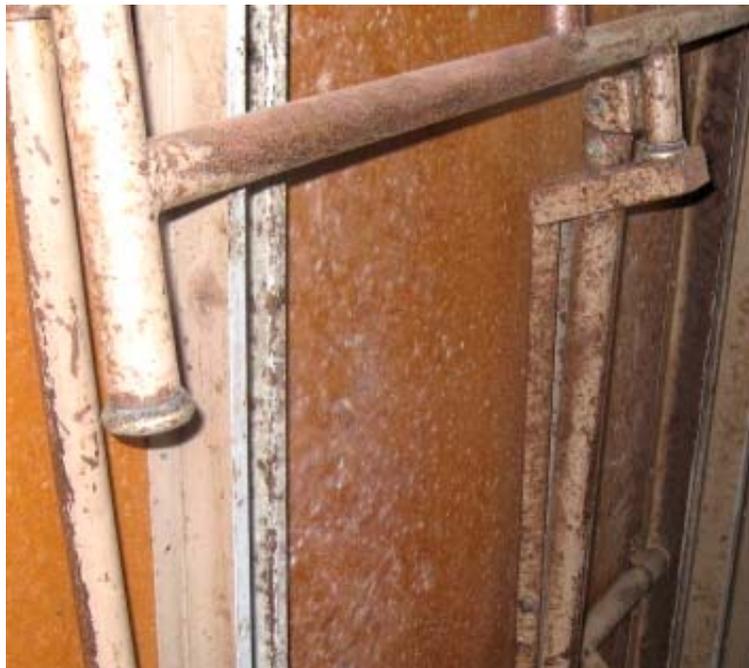
Picture 4

Also of note were water-damaged/mold contaminated materials stored in an area known as “the bowling alley”. Items included tables, furniture, cardboard boxes, ceiling tiles and books (Pictures 4 through 6). During periods of high relative humidity (> 70%), condensation can form on the cool surface of the floor wetting the bottom of these materials, which can lead to mold growth. Porous items (e.g., cardboard boxes and paper) should not be stored directly on the concrete floor in order to prevent moistening from condensation (Picture 7).

Mold Growth on the Underside of Table in “Bowling Alley” Storage Area

3. Remove/discard water-damaged/mold-colonized items in the “Bowling alley storage area. Seal moldy materials in plastic bags for transport. For large items (e.g., tables) cover with plastic sheeting and duct tape for transport.

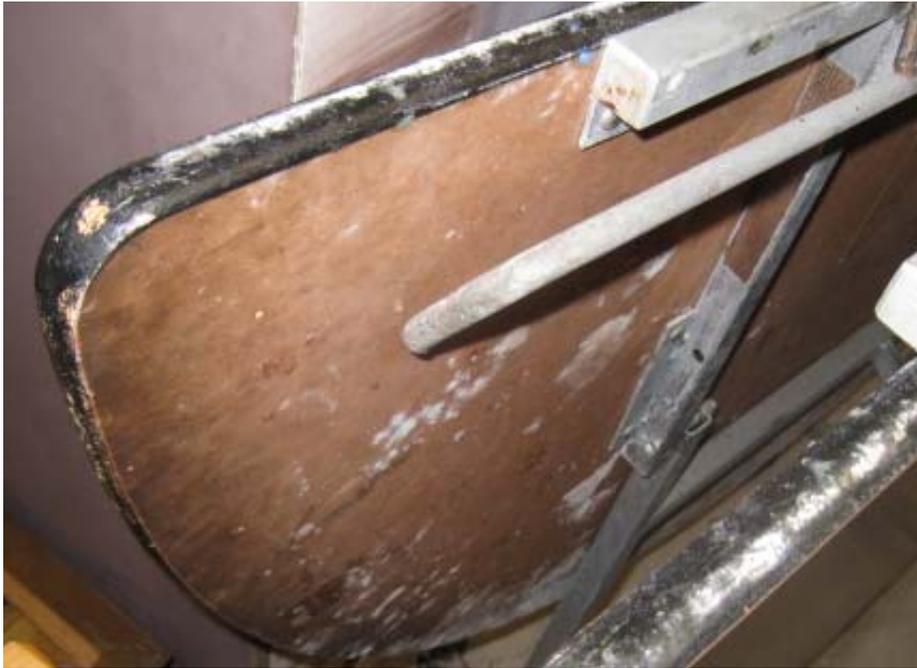
Picture 5

Mold Growth on Sides and Underside of Table in “Bowling Alley” Storage Area

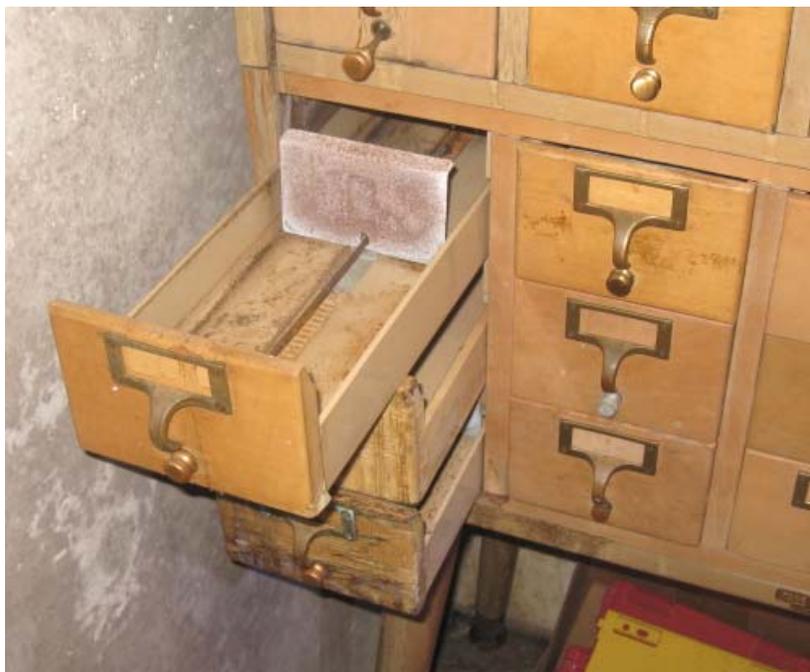
Picture 6

Water-Damaged/Mold Colonized Card Catalog Cabinet in “Bowling Alley” Storage Area

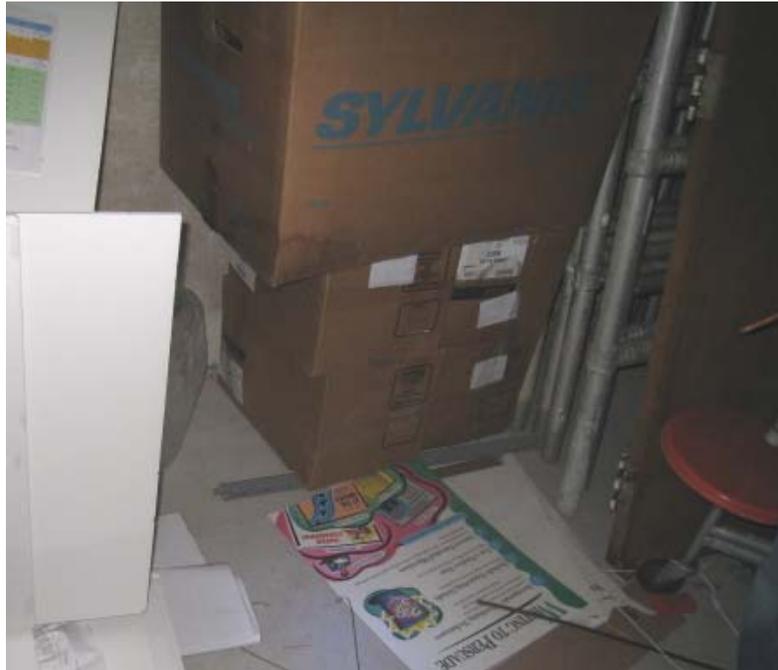
Picture 7

Cardboard Boxes and Papers Directly on Concrete Floor in “Bowling Alley” Storage Area

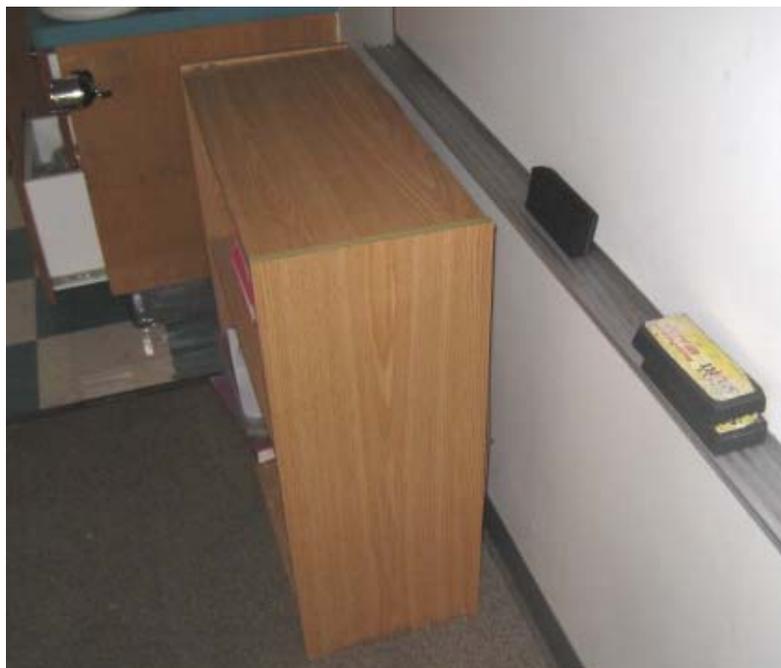
Picture 8

BEH staff also noticed that classroom furniture (e.g., bookcases, shelving) and other items were stationed directly against classroom walls. This condition can trap moisture between the object and the wall over the summer where elevated relative humidity conditions (> 70%) can create conditions for mold growth. Classroom furniture and other items should be pulled away from interior walls approximately 2 to 4 inches to allow airflow to prevent this potential for mold growth (Picture 8).

Bookcase near Interior Wall, Note ~ two-inch Space Allowing Airflow behind Bookcase

6. Ensure classroom furniture and other items are not placed directly against interior walls; allow approximately 2 to 4 inches for airflow.
7. Continue to operate dehumidifiers in below grade areas with portable dehumidifiers as needed during humid, spring/summer months. Ensure dehumidifiers are cleaned and maintained as per the manufacturer’s instructions to prevent standing water and mold growth.

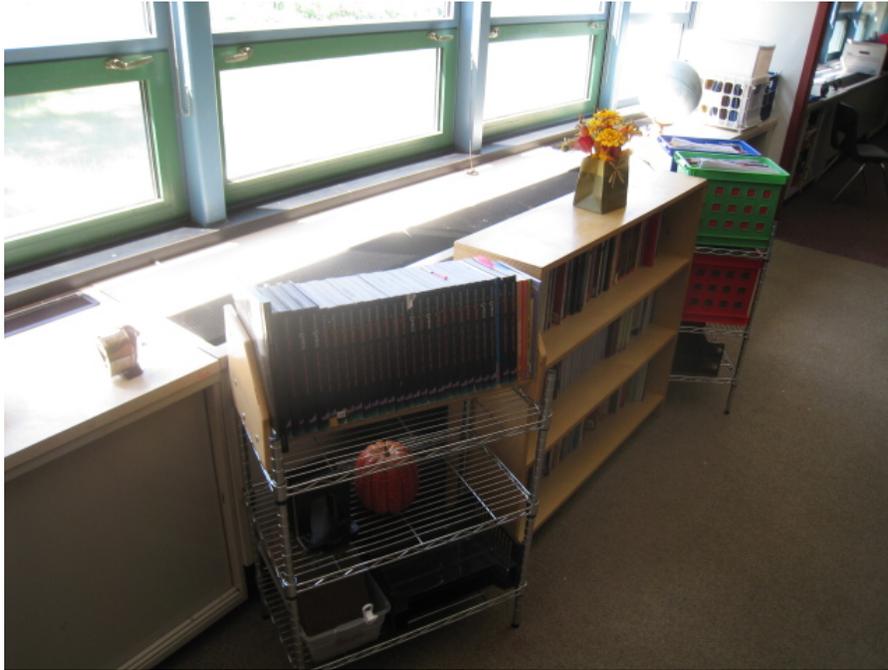
Picture 9

Univent Return Vent (Bottom Front) Obstructed by Classroom Furniture

10. Operate all ventilation systems throughout the building (e.g., gym, cafeteria, classrooms) continuously during periods of school occupancy to maximize air exchange.
11. Examine exhaust vent/motor for room 224 for proper operation, make repairs as needed.
12. Remove all blockages from univents and exhaust vents to ensure adequate airflow.
13. Refer to resource manuals and other related indoor air quality documents for further building-wide evaluations and advice on maintaining public buildings. These materials are located on the MDPH's website at <http://mass.gov/dph/iaq>.

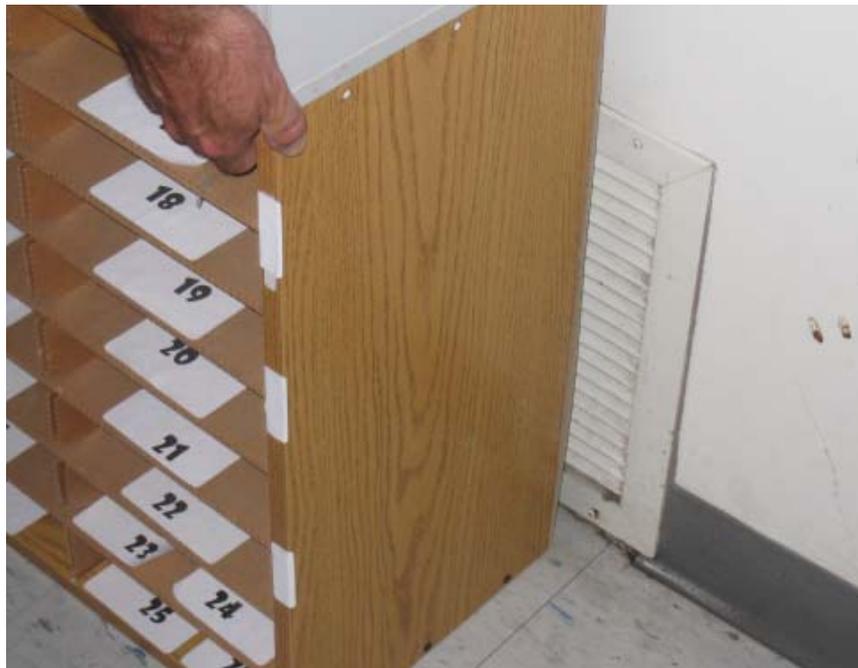
Picture 10

Wall-Mounted Exhaust Vent Obstructed by Classroom Furniture
