# **INDOOR AIR QUALITY ASSESSMENT MOLD INVESTIGATION**

**Golden Living Center at Oak Hill  
76 North Street  
Middleborough, Massachusetts**

Prepared by:  
Massachusetts Department of Public Health  
Bureau of Environmental Health  
Indoor Air Quality Program  
December 2011

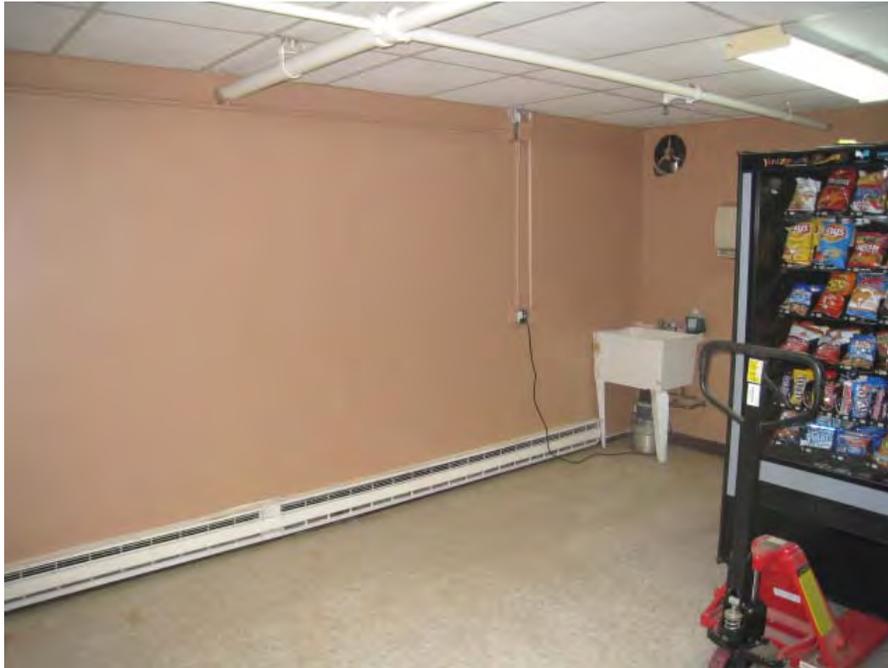
**Picture 1**

mold growth observed on concrete walls, building materials and stored items, primarily within basement areas of the GLC. At the time of the IAQ Program visit, basement walls had been reportedly cleaned and disinfected with a one in ten bleach/water solution and painted (Pictures 1 and 2). Water-damaged stored items (some with mold colonization) were observed in the housekeeping store room and maintenance shop (Pictures 3 through 5). Mold growth was also observed on fiberglass pipe insulation in the housekeeping store room (Pictures 6 and 7). All water-damaged materials should be removed and discarded. The pipe insulation should be replaced.

**Cleaned and Painted Basement Break Room Walls**

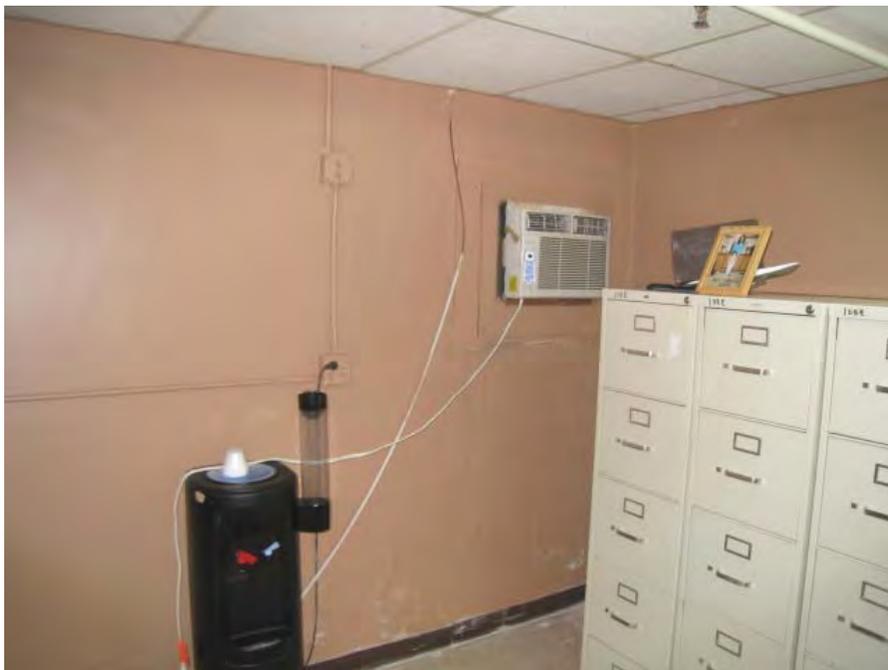
**Picture 2**

**Cleaned and Painted Basement Break Room Walls**

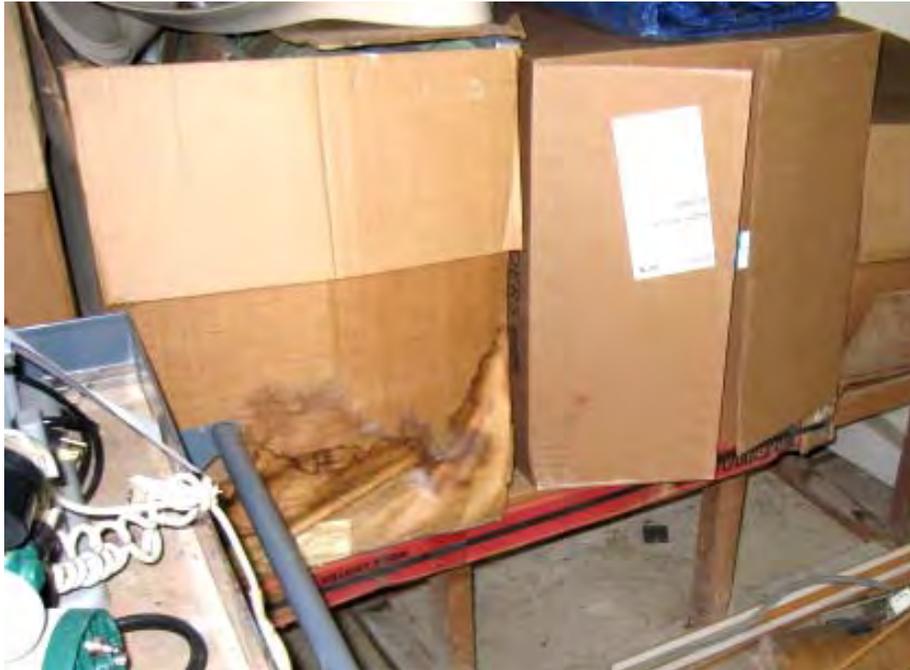
**Picture 3**

**Water-Damaged/Mold Colonized Box in Maintenance Shop**

1. Discard any remaining water-damaged/mold-colonized porous materials (e.g., cardboard, paper).
2. Remove/replace water-damaged/mold-colonized pipe insulation in the housekeeping store room.

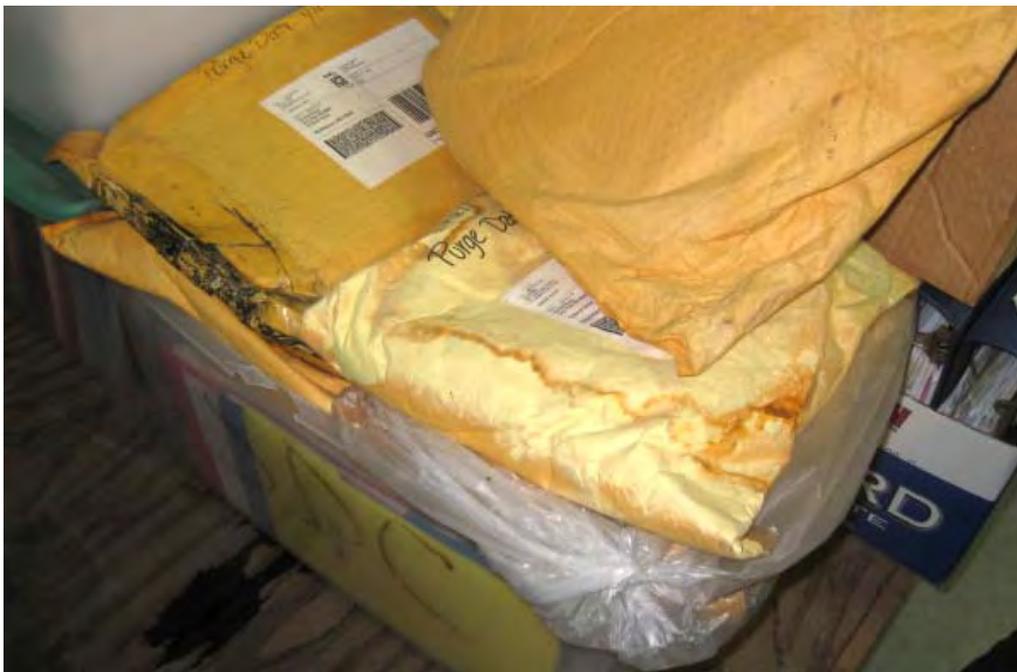
**Picture 4**

**Water-Damaged/Mold Colonized Materials in Housekeeping Store Room**

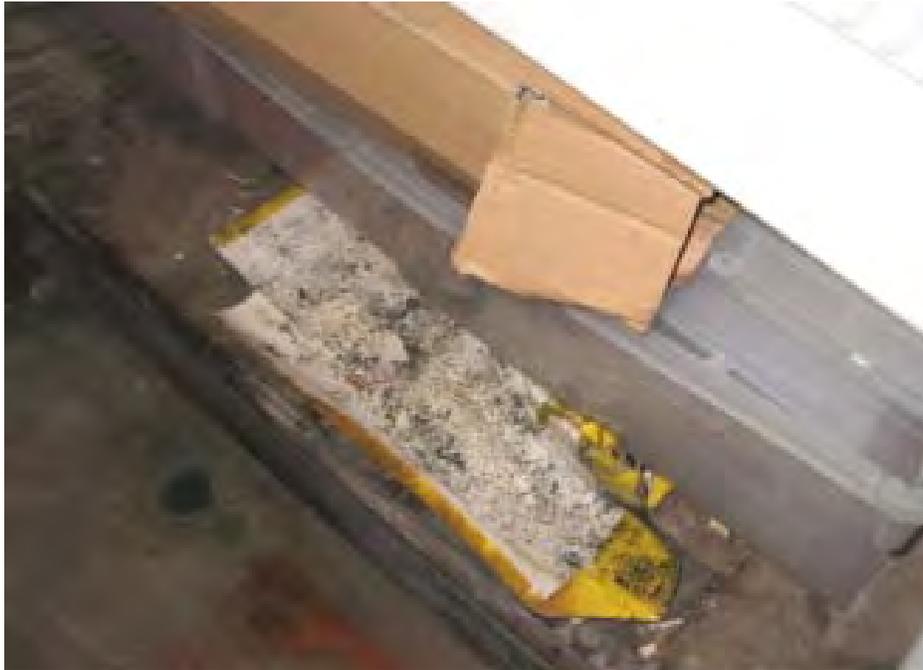
**Picture 5**

**Water-Damaged/Mold Colonized Materials in Housekeeping Store Room**

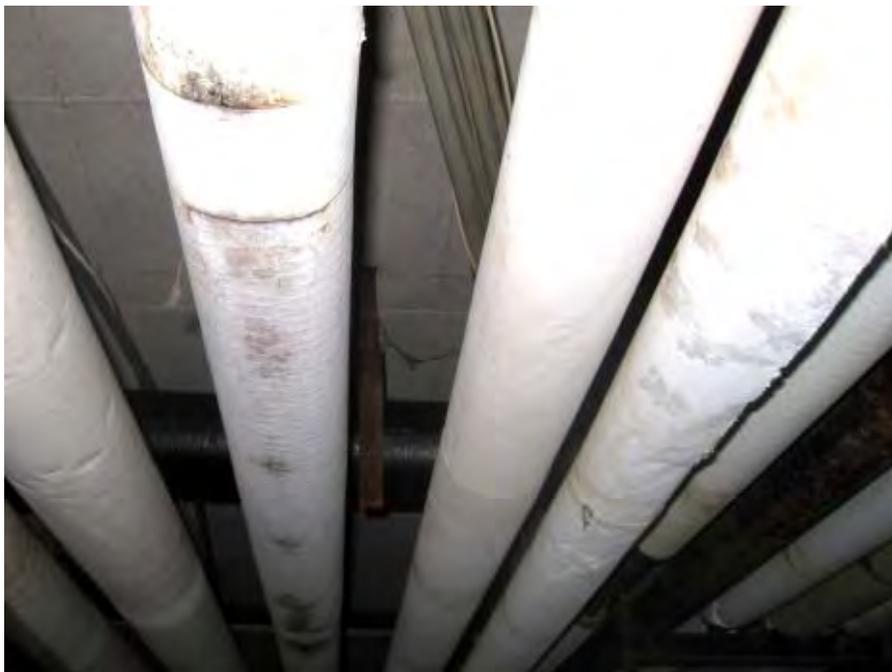
**Picture 6**

**Water-Damaged/Mold Colonized Pipe Insulation in Housekeeping Store Room**

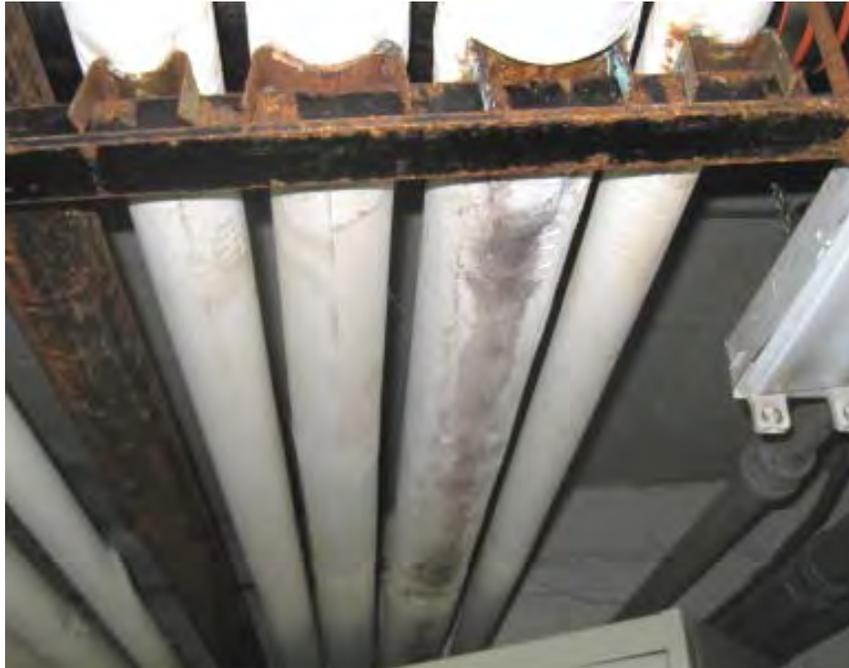
**Picture 7**

**Water-Damaged/Mold Colonized Pipe Insulation in Housekeeping Store Room**

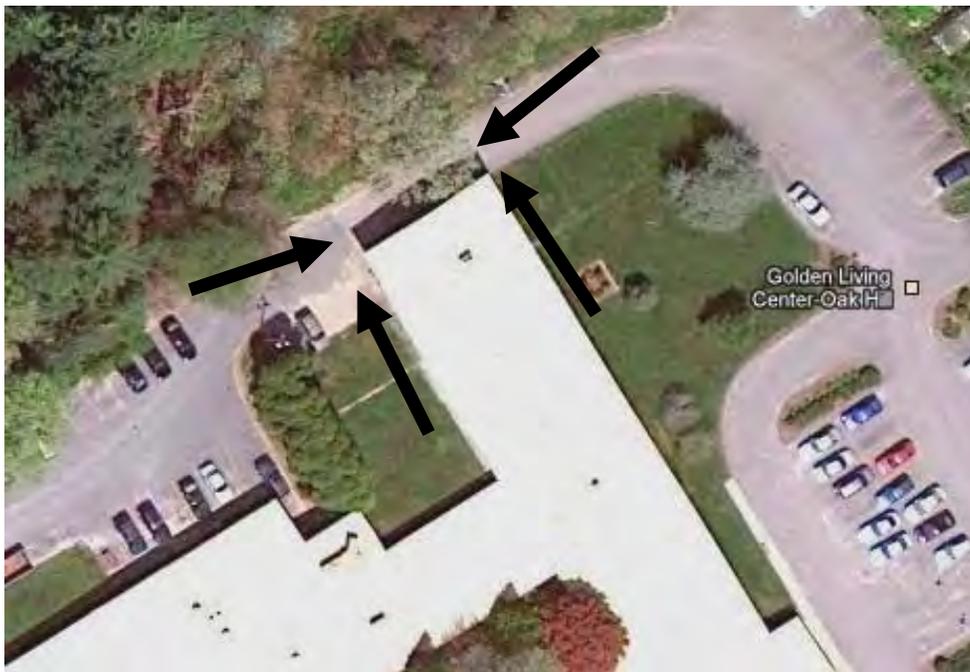
**Picture 8**

In order for building materials to support mold growth, a source of water exposure is necessary. Identification and elimination of the source of the water moistening building materials is necessary to control mold growth. The most likely sources of chronic moisture conditions in the basement are water infiltration and elevated relative humidity. Due to a high water table in the area and the contour of the land around the GLC (grounds and paved areas sloping toward the basement, Picture 8) the building foundation is subjected to chronic water impingement, resulting in moisture infiltration. Sump pumps are reportedly used as needed to remove standing water from the basement. The slope adjacent to the building has been covered with tarmac which directs rainwater away from the building foundation (Pictures 9 and 10). At the time of the IAQ inspection, the tarmac on the southwest side was damaged and in need of sealant between the tarmac and foundation (Picture 10). Without sealant, water can penetrate through the junction between the tarmac and the foundation.

**Basement Wing, Where Water Accumulates (Arrows Indicate Water Flow)**

1. Contact an HVAC engineering firm to (a) determine best methods to provide mechanical ventilation to occupied basement areas (i.e., break room and maintenance shop) and (b) determine best methods to provide local exhaust ventilation to crawlspace.
2. Contact a landscaping specialist, town DPW and/or a hydro-geological firm to inspect/redesign drainage system around building to mitigate flooding/water infiltration.

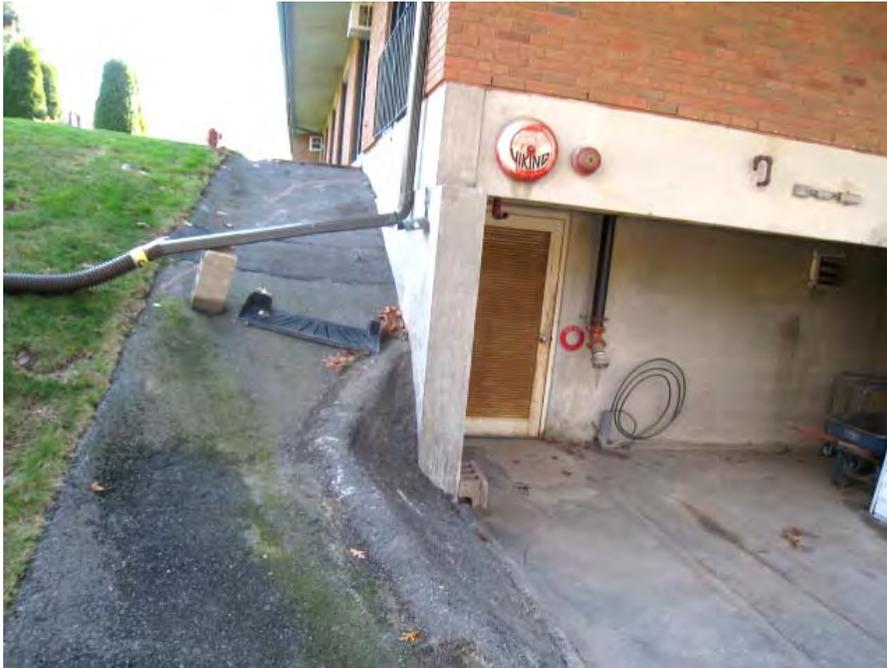
**Picture 9**

**Northeast Side Sloped Tarmac**

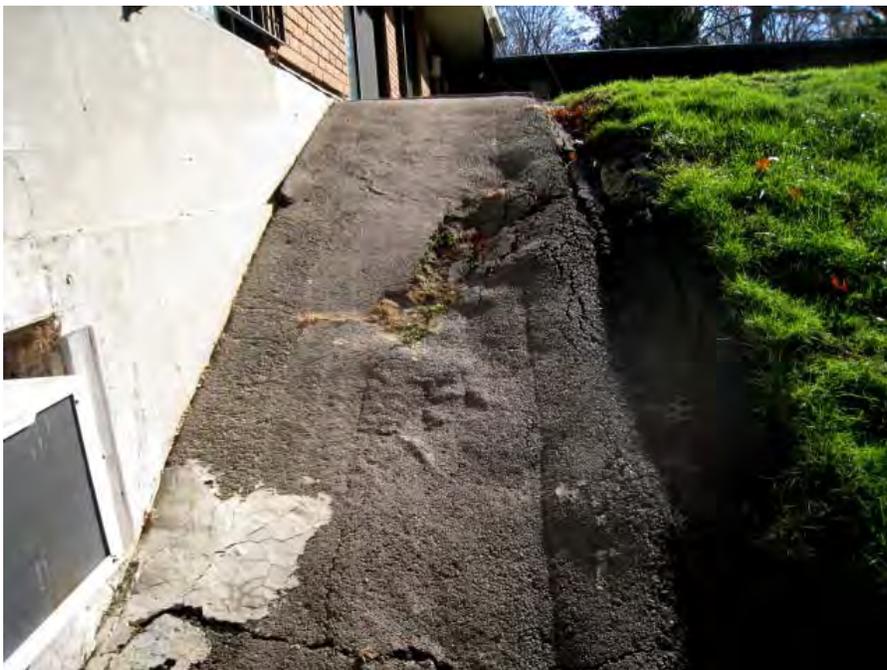
**Picture 10**

**Southwest Side Sloped Tarmac, Note Damage and Space between Tarmac and Foundation**

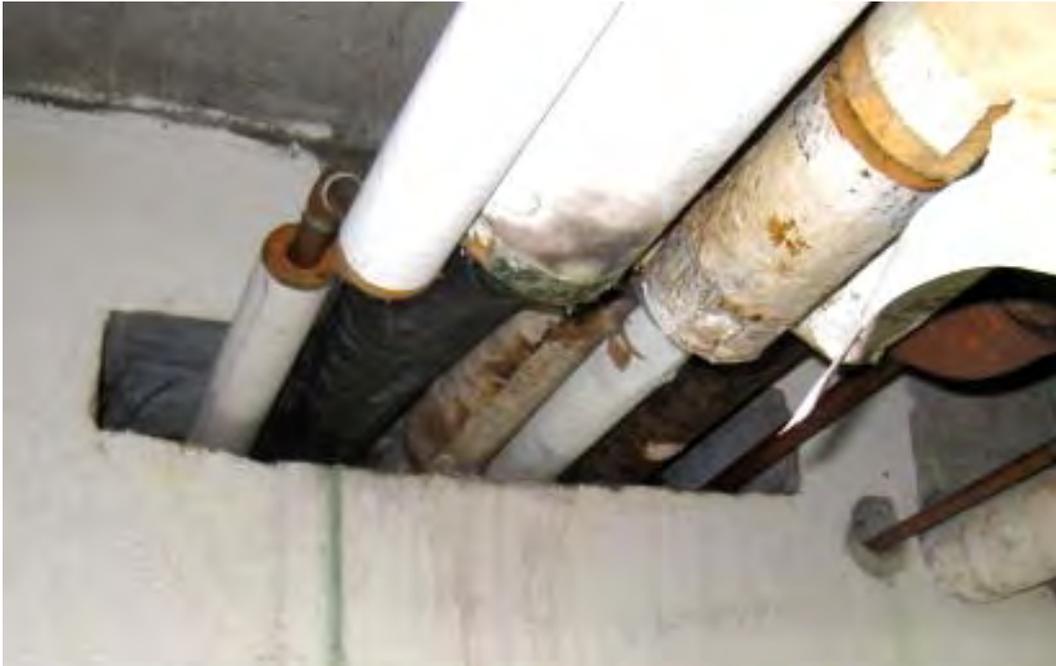
**Picture 11**

It is likely that relative humidity levels in the basement are elevated and compounded by a lack of mechanical ventilation in occupied areas of the basement (i.e., break room and maintenance shop) as well as a lack of dehumidification. An additional source of moisture in the basement is the crawlspace. Breaches exist in several areas that share a common wall with the crawlspace, including utility holes (Pictures 11 through 13), an access hatch sealed with

**Breach in Common Wall for Utility Pipes between Housekeeping Store Room and Crawlspace**

3. Ensure leaks are repaired and remove/discard water-damaged/mold-colonized ceiling tiles throughout the building.
4. Seal all wall penetrations and breaches in common wall between the crawlspace and adjacent areas with an appropriate fire-rated sealant.

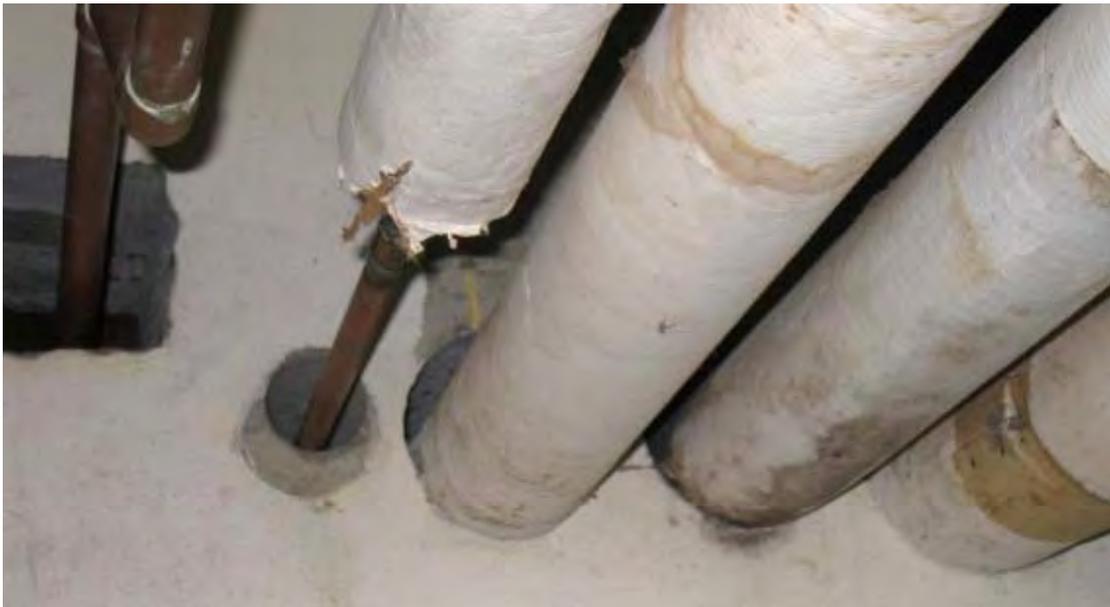
**Picture 12**

**Breaches in Common Wall for Utility Pipes between Housekeeping Store Room and Crawlspace**

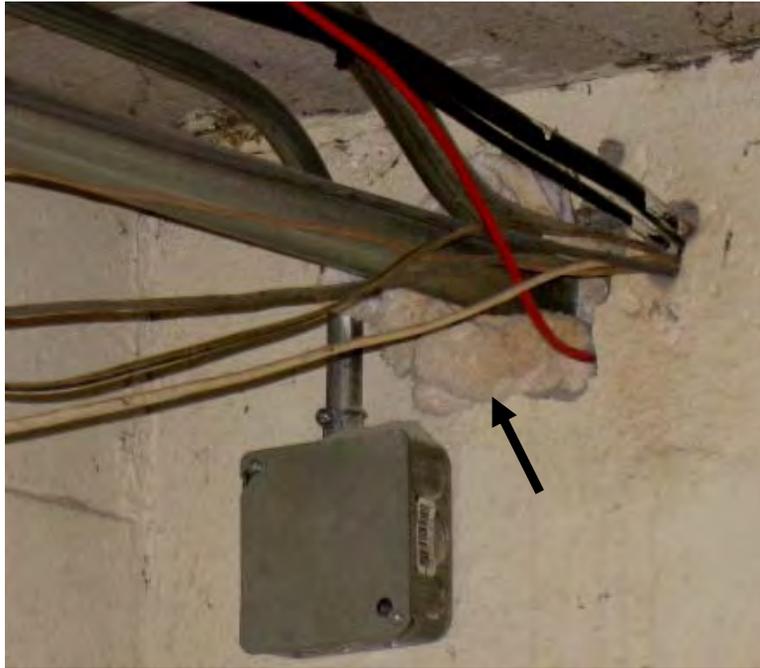
**Picture 13**

**Breach in Concrete Crawlspace Wall, Note Towel Stuffed into Hole**

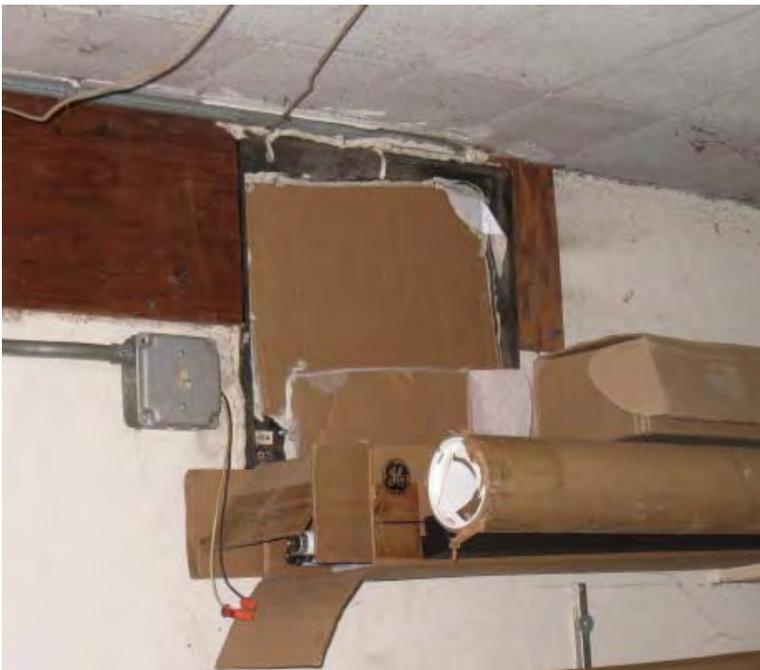
**Picture 14**

cardboard (Picture 14) and the access door that did not shut properly (Picture 15). Each of these breaches may act as pathways for moisture, odors, mold spores and insects in the crawlspace to migrate into adjacent areas (Picture 16).

**Cardboard Sealing Crawlspace Access Hatch in Maintenance Shop**

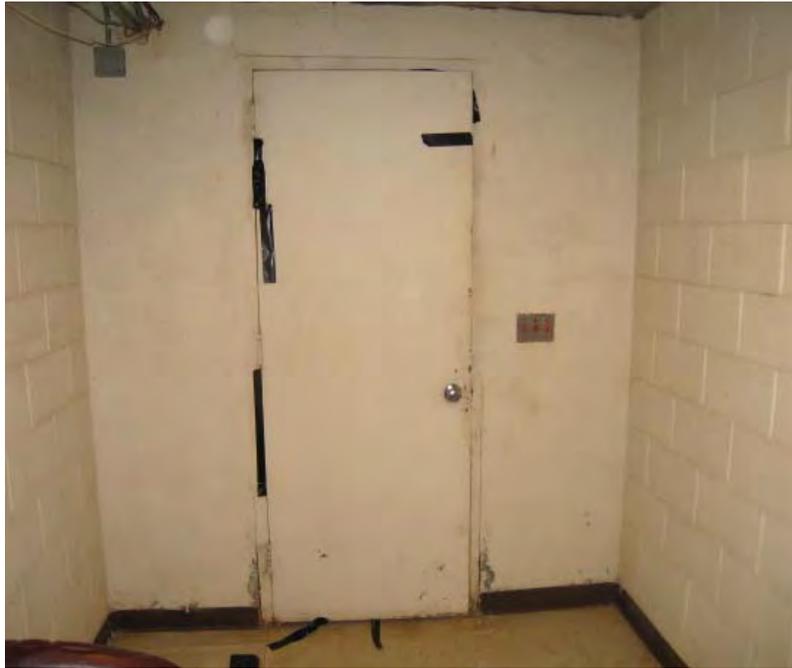
**Picture 15**

**Ill-Fitting Door to Crawlspace, Note Duct Tape around Door**

6. Repair or replace crawlspace door. Ensure door fits flush with threshold. Seal doors on all sides with foam tape and/or weather-stripping. Ensure tightness of doors by monitoring for light penetration and drafts around doorframes.

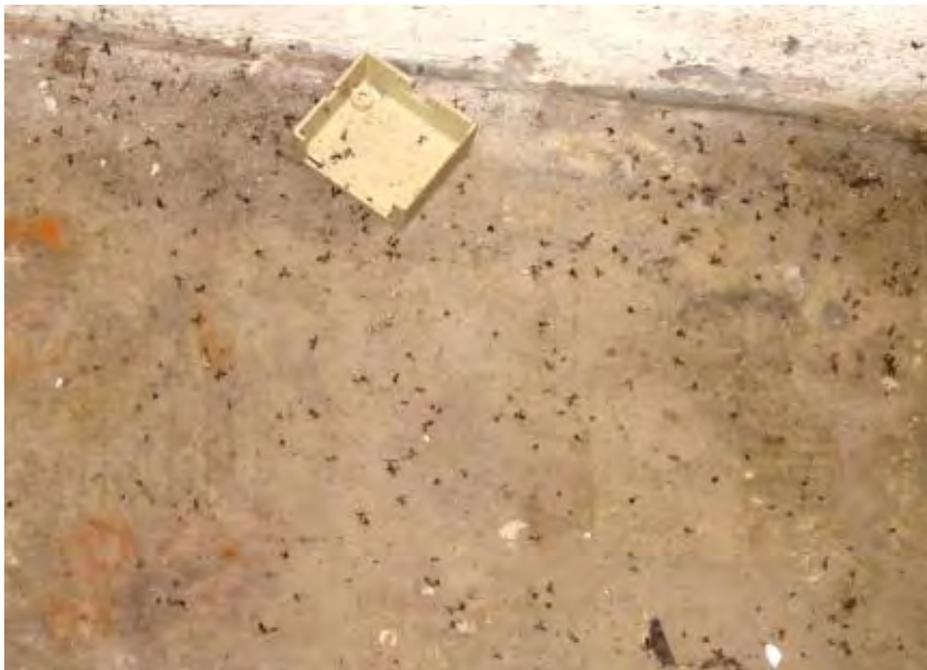
**Picture 16**

**Dead Insects (Dark Spots) on Floor of Maintenance Shop**

7. Remove dead insects and clean/disinfect floors.

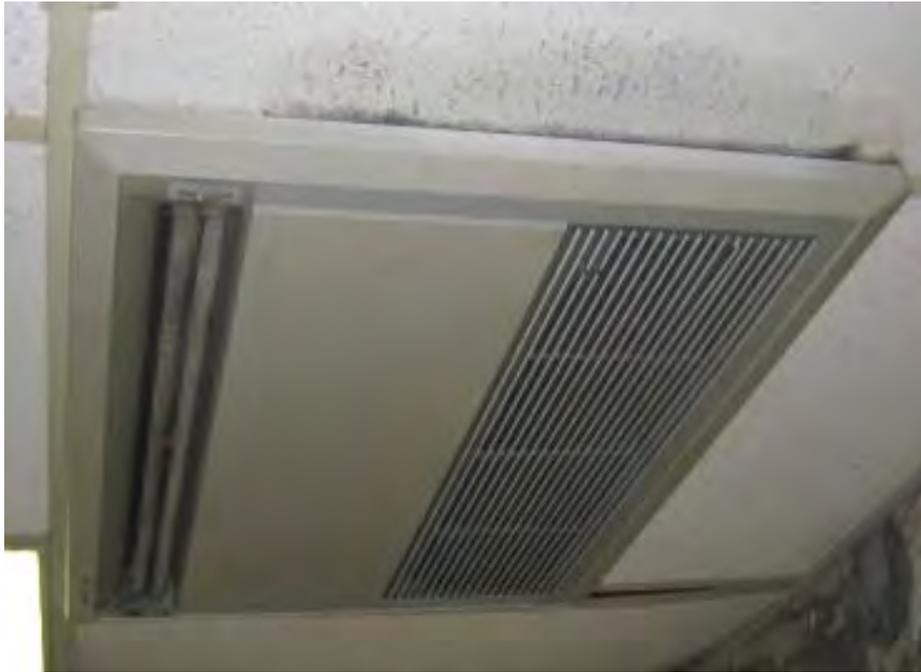
**Picture 17**

Several water-damaged ceiling tiles were observed in the basement and around the ceiling-mounted AC unit in the ground floor “men’s shop” (Picture 17). Water-damaged ceiling tiles can provide a source of mold. As water leaks are discovered they should be repaired and any impacted ceiling tiles should be replaced.

**Water-Damaged/Mold Colonized Ceiling Tiles around AC Unit in Men's Club**

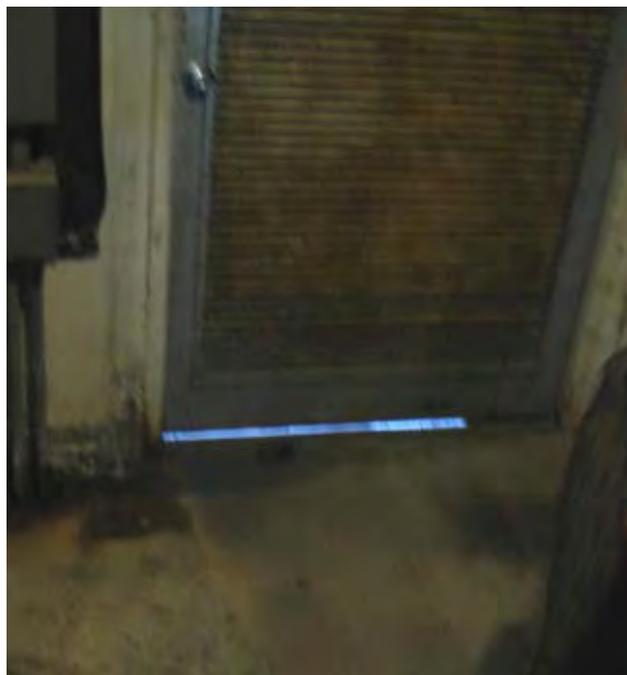
**Picture 18**

Light could be seen penetrating beneath the boiler room door (Picture 18). This type of space can provide access for rodents and insects to enter the building. To penetrate the exterior of a building, rodents require a minimal breach of ¼ inch (MDFFA, 1996).

**Light Penetrating under Boiler Room Exterior Door**

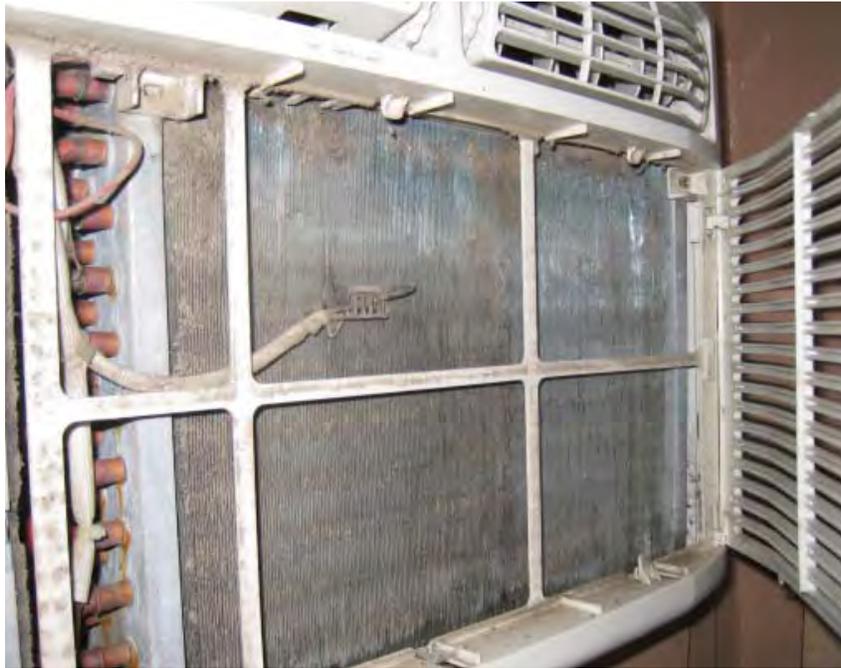
**Picture 19**

Window-mounted air conditioners (ACs) were observed in several areas. These units are normally equipped with filters, which should be cleaned or changed as per manufacturer’s instructions to avoid the build-up and re-aerosolization of dirt, dust and particulate matter. Filters in several of the units were in need of cleaning. In addition, the cooling fins were occluded with dust and debris (Picture 19), which can provide a mold growth media when moistened. Spaces were also noted around the ACs, which can allow for uncontrolled drafts, moisture and pest entry into the building.

**Cooling Fins for Breakroom AC Occluded with Dust and Debris**

11. Clean/change filters in AC units per the manufacturer's instructions or more frequently if needed. Clean and disinfect cooling coils with an appropriate antimicrobial. If ACs cannot be adequately cleaned/maintained consider replacing units.
