# **Mold/Water Damage Remediation Assessment**

**Massachusetts Registry of Motor Vehicles  
278 Union Street  
New Bedford, Massachusetts**

**Prepared by:  
Massachusetts Department of Public Health  
Bureau of Environmental Health  
Indoor Air Quality Program  
May 2011**

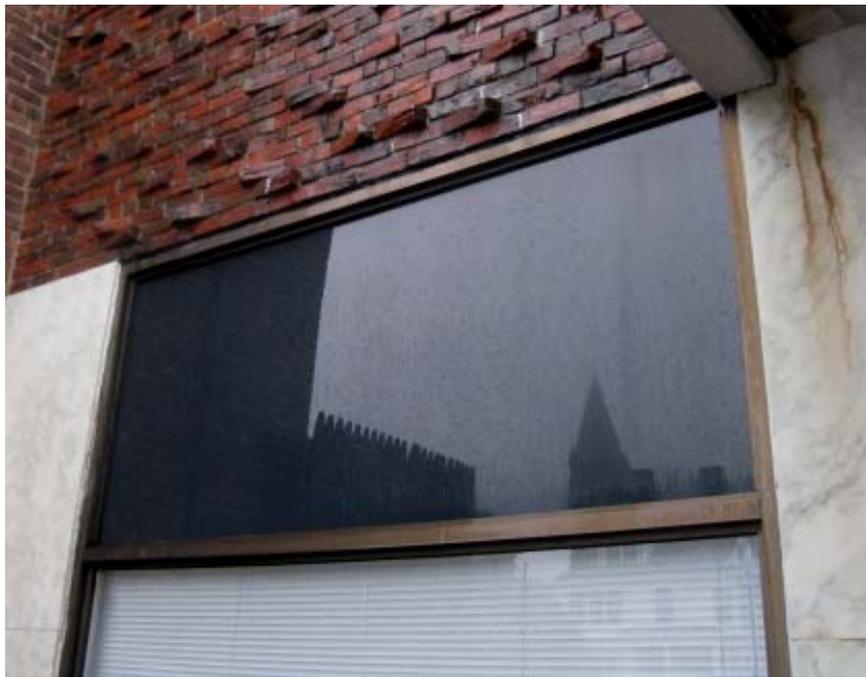
**Picture 4**

Water damaged building materials in the form of stained ceiling tiles, wooden window trim and gypsum wallboard (GW) around the window frame in the breakroom was observed (Pictures 1 through 3). The most likely source of water penetration was missing/damaged exterior caulking/flashing around the window (Picture 4). Elevated moisture content and visible water damage/mold growth was observed on GW beneath vinyl wall covering along the base of the window frame (Picture 3). Vinyl wallpaper is a water impermeable material that can “trap” moisture. Although water-damaged, wooden window trim and ceiling tiles were dry (i.e., low moisture) at the time of the assessment (Table 1).

**Exterior View of Leaking Breakroom Window**

1. Make repairs to exterior window caulking/flushing around breakroom window. Use high pressure water to check repairs/identify further leakage.
2. Replace water-damaged ceiling tiles, wooden window trim, and mold-colonized vinyl wallpaper and GW at the base of the breakroom window.
3. Refer to resource manual and other related indoor air quality documents located on the MDPH's website for further building-wide evaluations and advice on maintaining public buildings. These documents are available at: <http://mass.gov/dph/iaq>.
