INDOOR AIR QUALITY ASSESSMENT

**Massachusetts Department of Children and Families
185 Church Street
Village of Whitinsville
Northbridge Massachusetts**

Prepared by:
Massachusetts Department of Public Health
Bureau of Environmental Health
Indoor Air Quality Program
May 2011

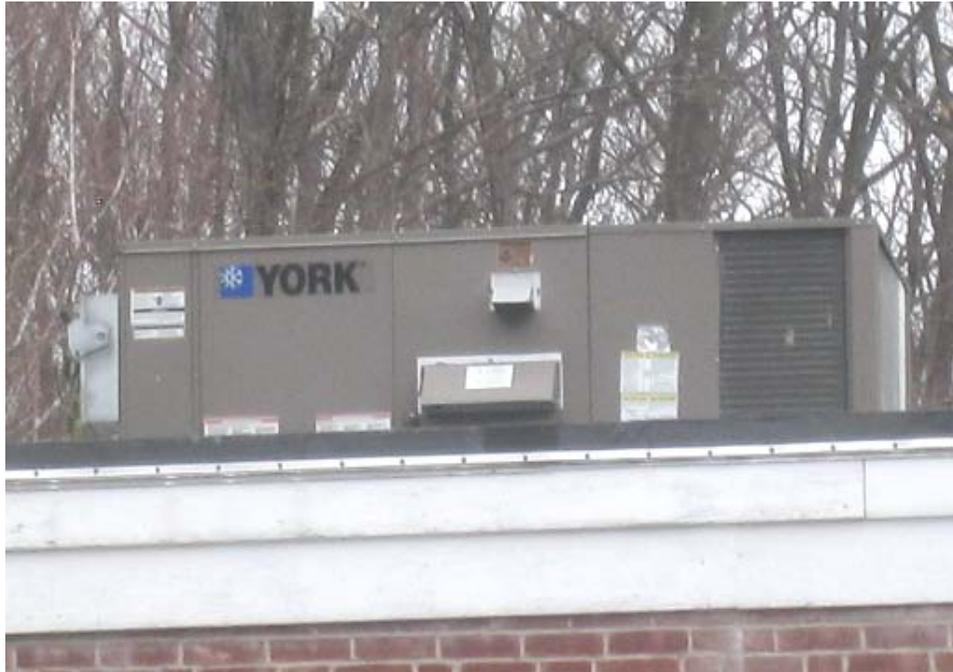
Picture 1

Rooftop Air Handling Unit

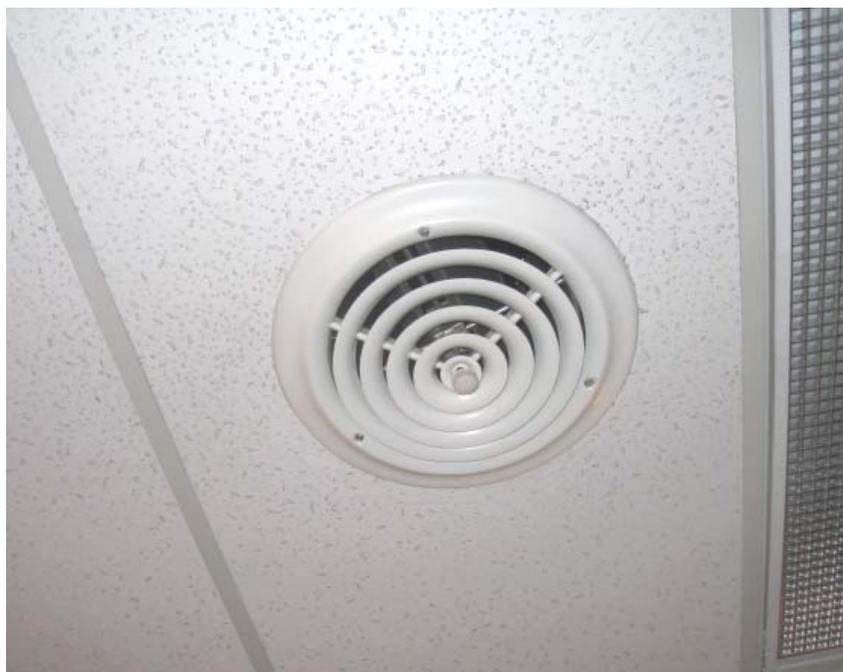
Picture 2

Ceiling-Mounted Supply Diffuser

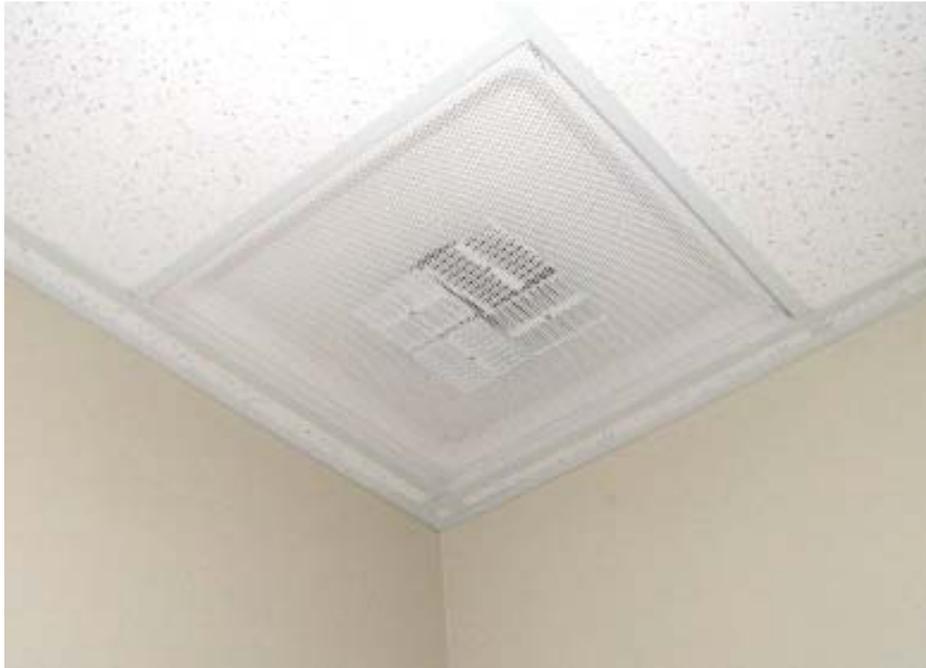
Picture 3

Ceiling-Mounted Supply Diffuser

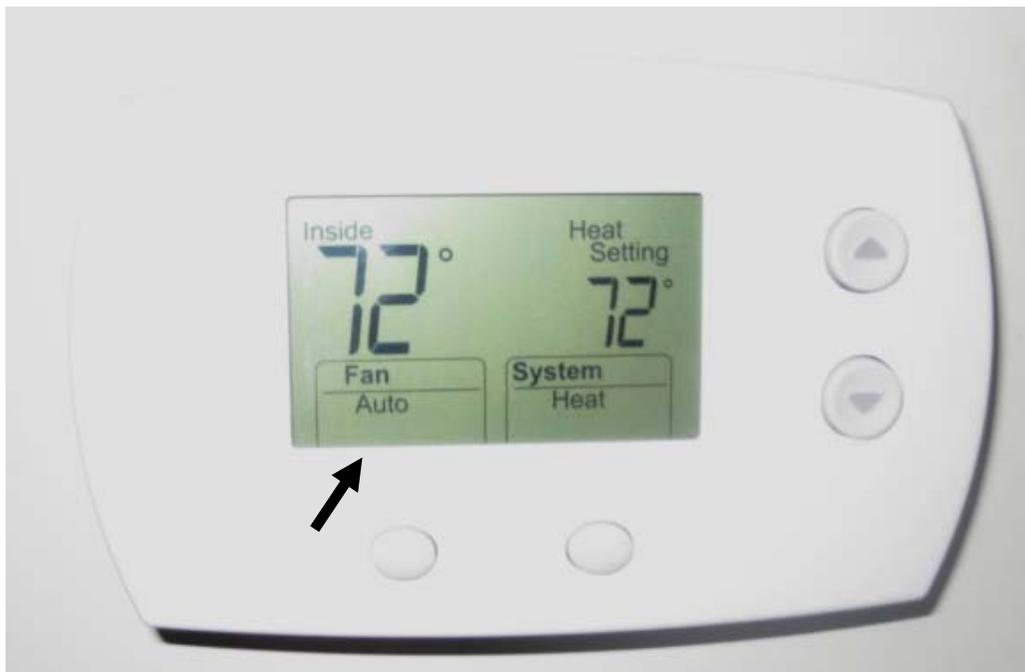
Picture 4

The HVAC system is controlled by digital thermostats. Thermostats examined had a fan switch that has two settings, *on* and *auto* (Picture 4). When the fan is set to *on*, the system

provides a continuous source of air circulation and filtration. The *automatic* setting on the thermostat activates the HVAC system at a preset temperature. With this setting, once the preset temperature is reached, the HVAC system is deactivated. Therefore, no mechanical ventilation is provided until the thermostat re-activates the system. All thermostats in the DCF were set to the “auto” setting at the time of the assessment. The MDPH recommends that thermostats be set to the fan “on” setting during occupied hours to provide continuous air circulation.

Digital Thermostat for HVAC System, Note Fan in “Auto” Position

1. Operate the HVAC system continuously in the fan “on” mode during periods of occupancy to maximize air circulation and filtration.
2. Work with HVAC vendor to adjust/increase percentage of fresh air supply and/or exhaust capabilities to improve air exchange.

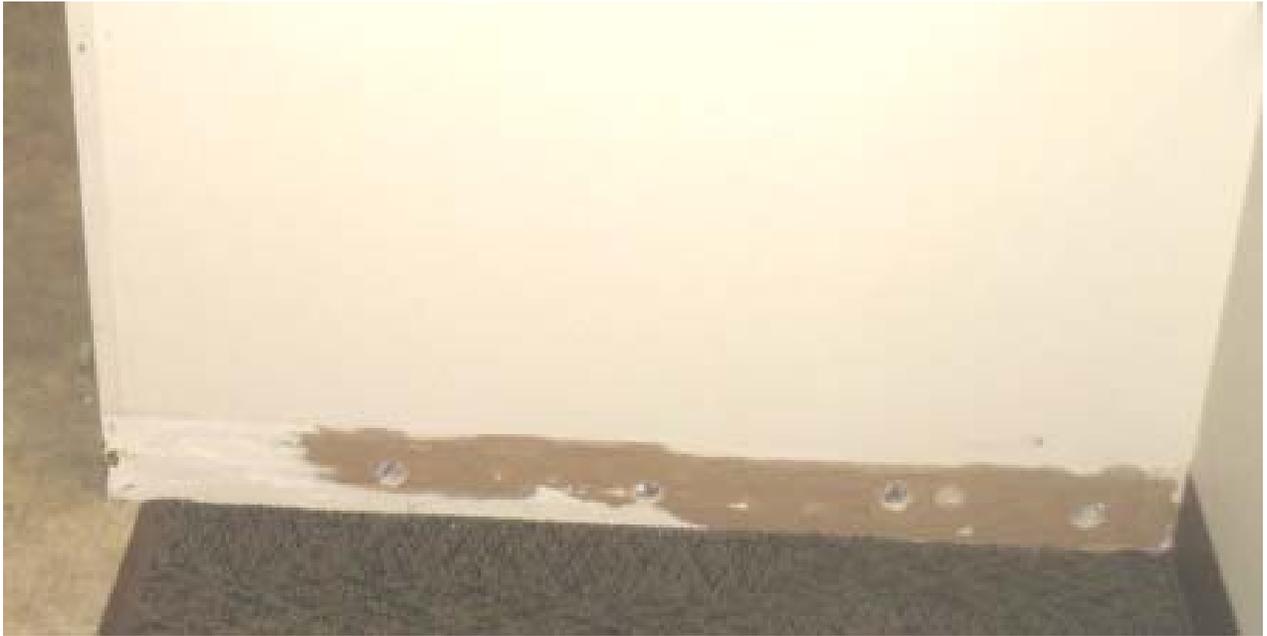
Picture 5

building. At the time of the assessment the building was in the final stages of flood remediation, which consisted of drying out carpeting, removing vinyl coving at the base of walls and drying out gypsum wallboard (GW) by drilling holes to facilitate airflow into the wall cavity (Picture 5). BEH staff conducted moisture testing of carpeting, and GW in the rear areas of the building affected by flooding and found that all materials were dry with the exception of a small area of carpeting directly inside the rear exterior door (Picture 6). In addition, no visible mold was observed nor were any musty/mold-like odors detected at the time of the assessment.

Vinyl Base Coving Removed and Holes Drilled into Gypsum Wallboard to Facilitate Drying

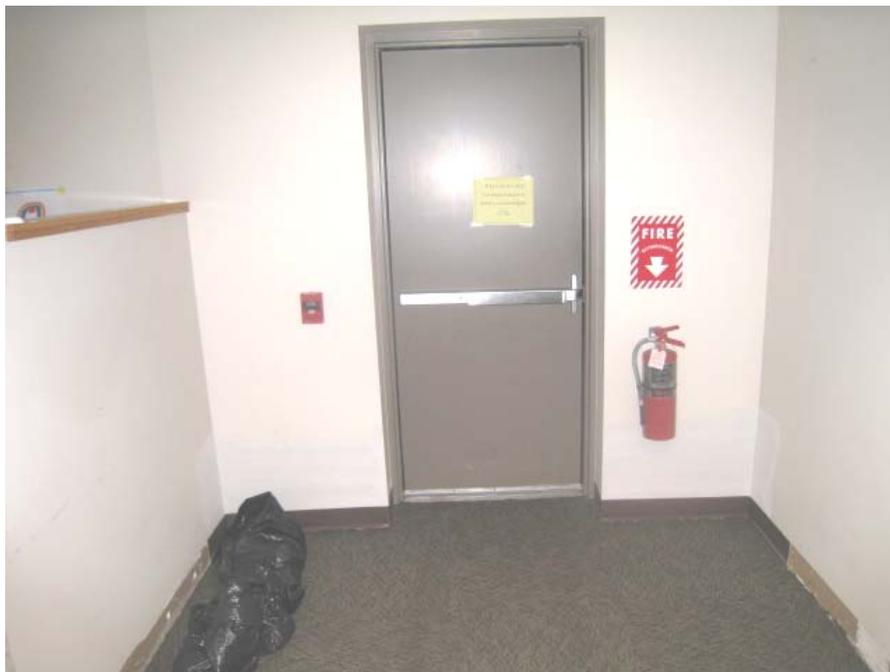
Picture 6

Moistened Carpeting Directly inside Rear Exterior Door Prone to Flooding

9. Inspect drains behind building on a regular basis to ensure proper drainage, clear debris as needed.
 10. Consider removing carpeting from along exterior walls and around exterior doors prone to flooding. Consider replacing carpeting in these areas with tile to prevent chronic moistening of porous materials and potential mold growth conditions.

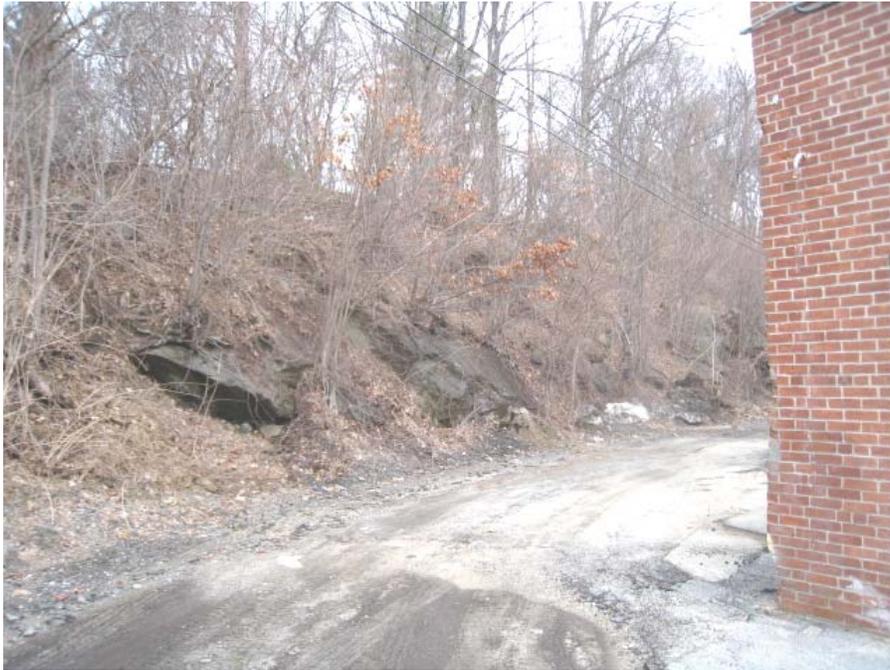
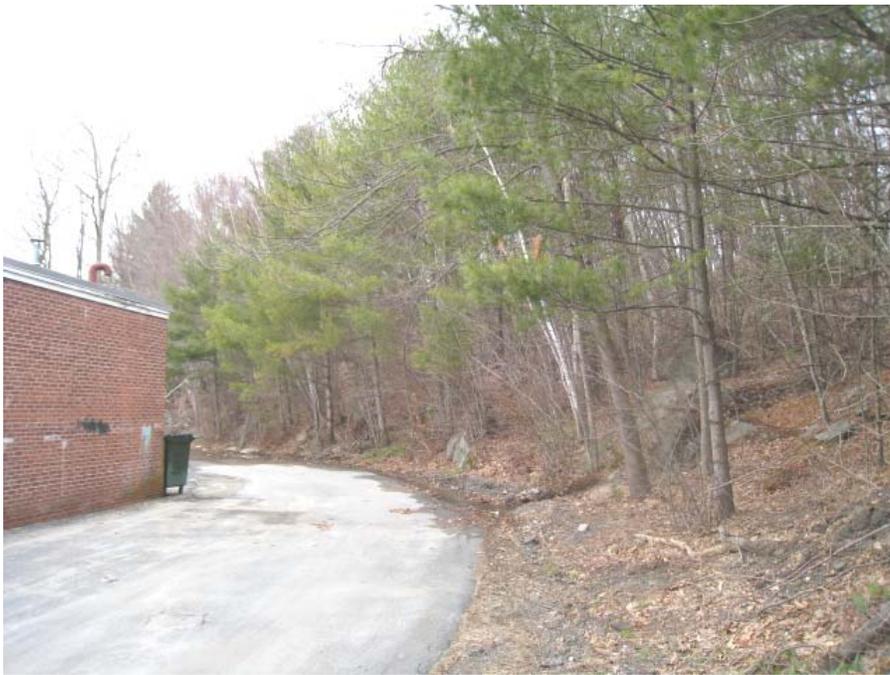
The terrain at the rear of the building consists of rock ledge, which causes water to run down and collect into a series of drains behind the building (Pictures 7 and 8). It appears that at times of sustained rainfall or melting snow conditions, the capacity of the drainage system is exceeded, which leads to flooding inside the building.

Rock Ledge/Terrain behind Building

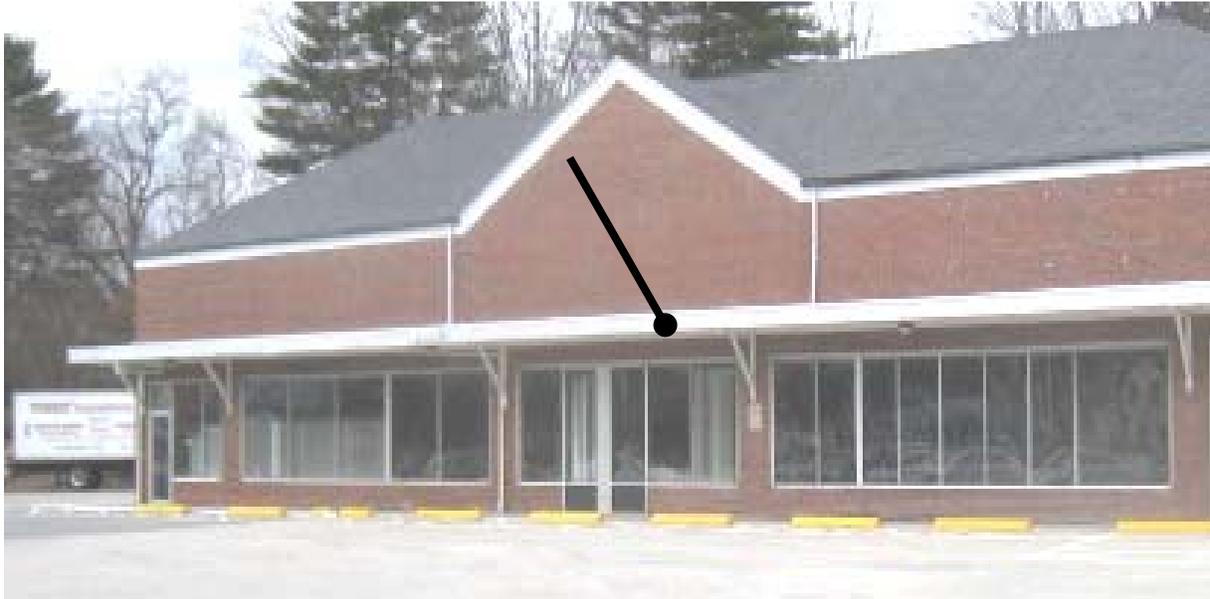
Picture 9

Water-damaged ceiling tiles and paint were reported in offices and conference rooms along the front of the building, where ice dams are said to occur along an awning-type roof (Picture 9). At the time of the assessment, the ceiling tiles had been replaced. BEH staff removed ceiling tiles in these areas to observe conditions above the ceiling plenum, which appeared dry with no visible mold growth.

Awning-Type Roof along Front Façade of Building

4. Contact a roofing contractor to investigate causes of ice dam formation along front of building and make repairs to roof/exterior brick and flashing/drainage as needed. Repair

- or replace areas of rotted wood at roof line. Once repairs are completed, water-damaged walls should be prepped and refinished and water-damaged ceiling tiles replaced.

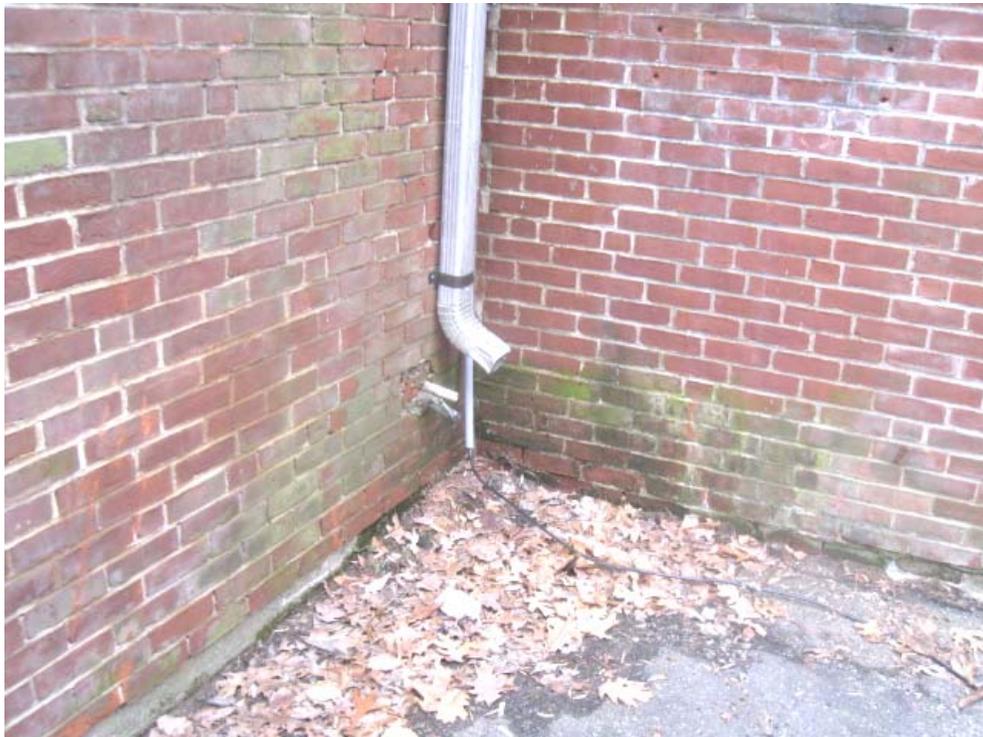
Picture 10

- Rainwater accumulating against exterior walls/foundation due to missing/damaged gutters and downspouts (Pictures 10 through 12);
- Missing/damaged mortar around exterior brick and foundation (Pictures 13 and 14);
- Light penetration/spaces beneath exterior doors;

Downspout Emptying against Exterior Walls, Note Moss Growth (Dark Staining)

8. Repair/replace missing/damaged gutters, downspouts and elbow extensions. Extend downspouts to empty at least 5 feet away from the foundation (if possible).

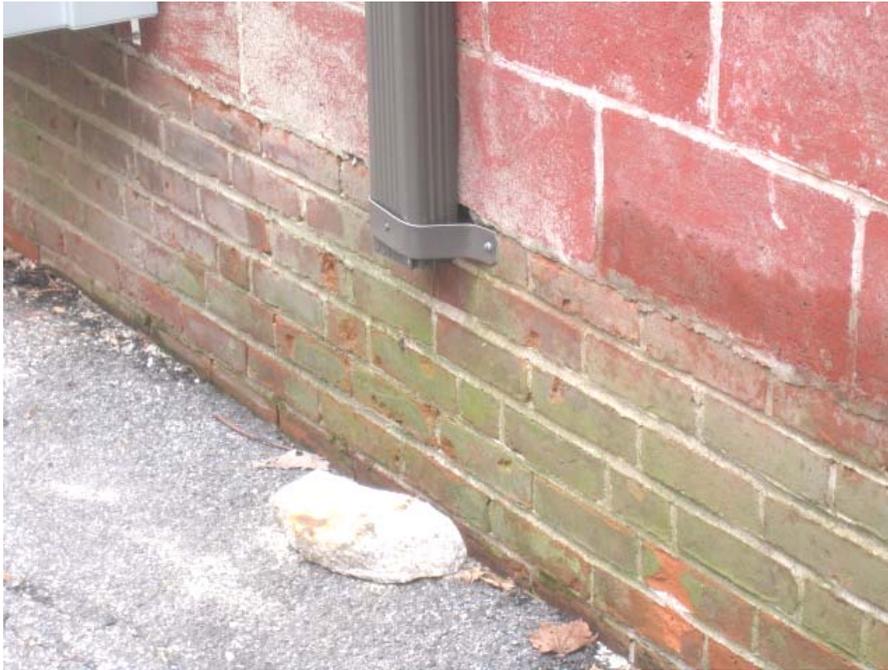
Picture 11

Downspout Emptying against Exterior Walls, Note Missing Elbow Extension and Moss Growth (Dark Staining)

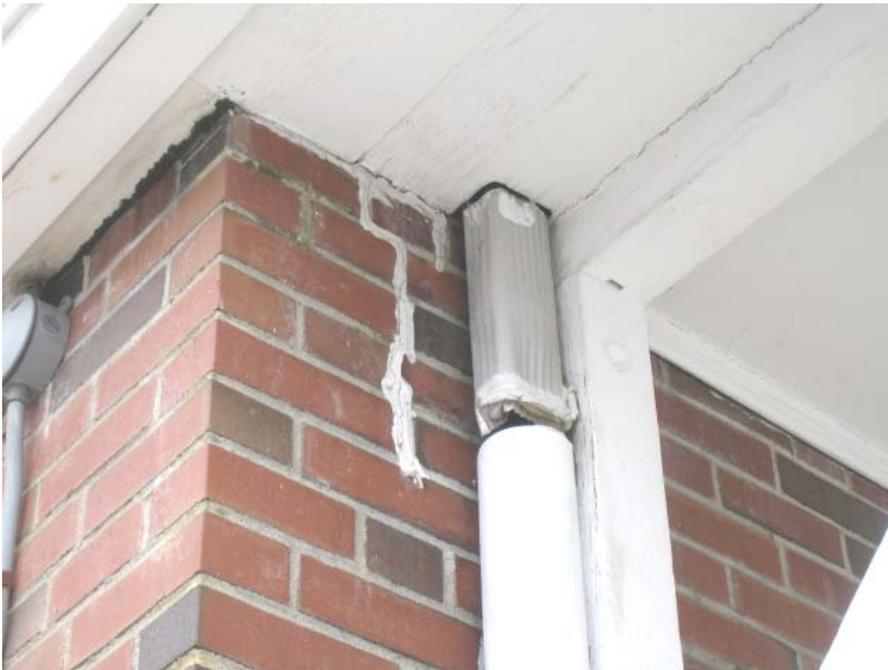
Picture 12

Disconnected Downspout

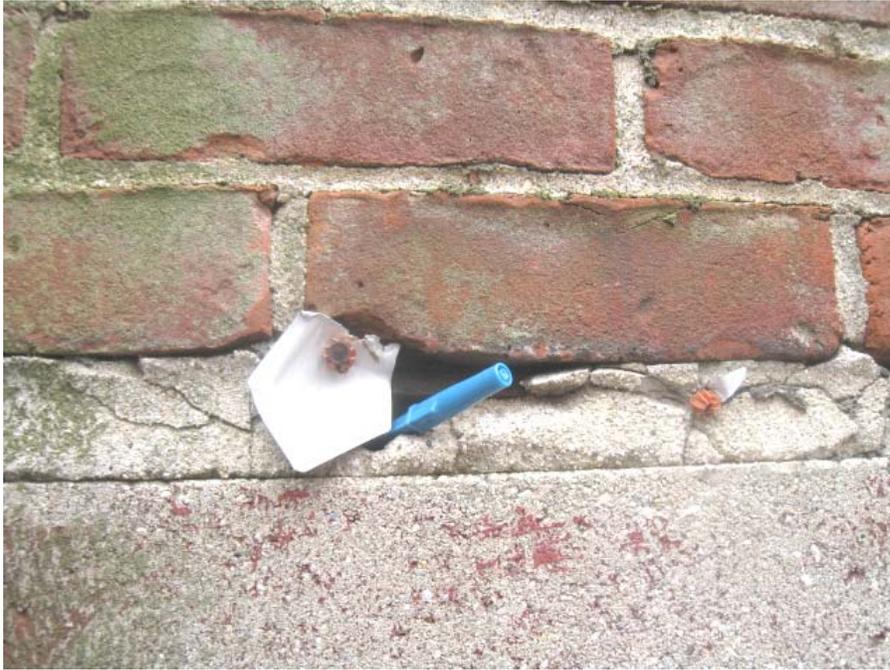
Picture 13

Missing/Damaged Mortar, Pen Inserted to Show Depth

6. Contact a masonry firm or general contractor to repair holes/breaches in exterior walls to prevent water penetration, drafts and pest entry.
 7. Address deteriorated window/joint sealant in accordance with EPA regulations/MDPH guidance.

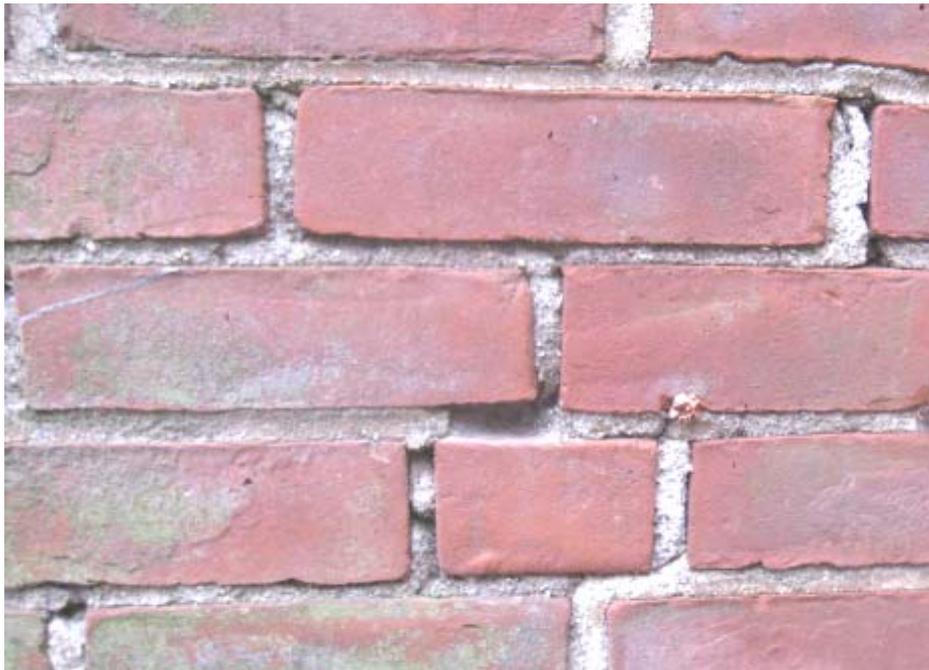
Picture 14

Missing/Damaged Mortar

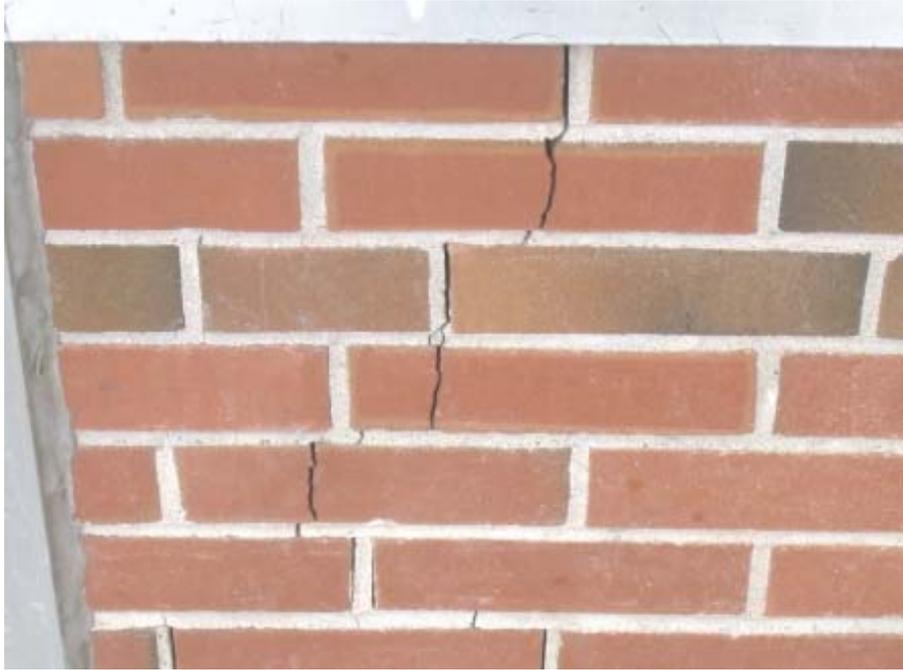
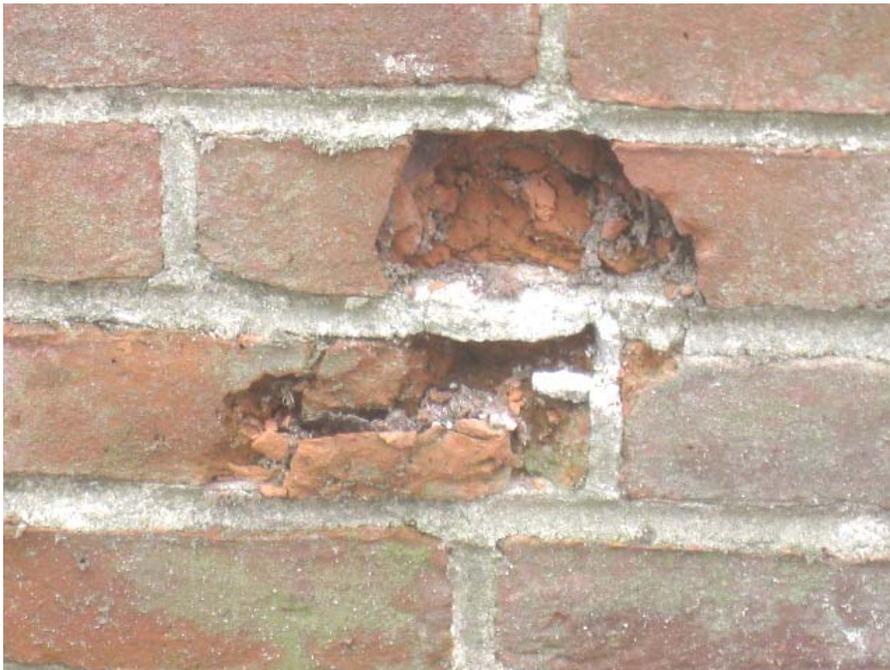
- Missing/damaged brickwork and open utility holes (Pictures 15 through 19)
- Rotted decomposing wood at roof line; and
- Missing/damaged window caulking, joint sealant and damage/breaches in wooden window frames (Pictures 20 through 23). Window and expansion joint sealant may be composed of regulated materials [e.g., asbestos, polychlorinated biphenyls (PCBs)]. For information regarding PCBs, please consult MDPH guidance (Appendix B).

Damaged Exterior Brick

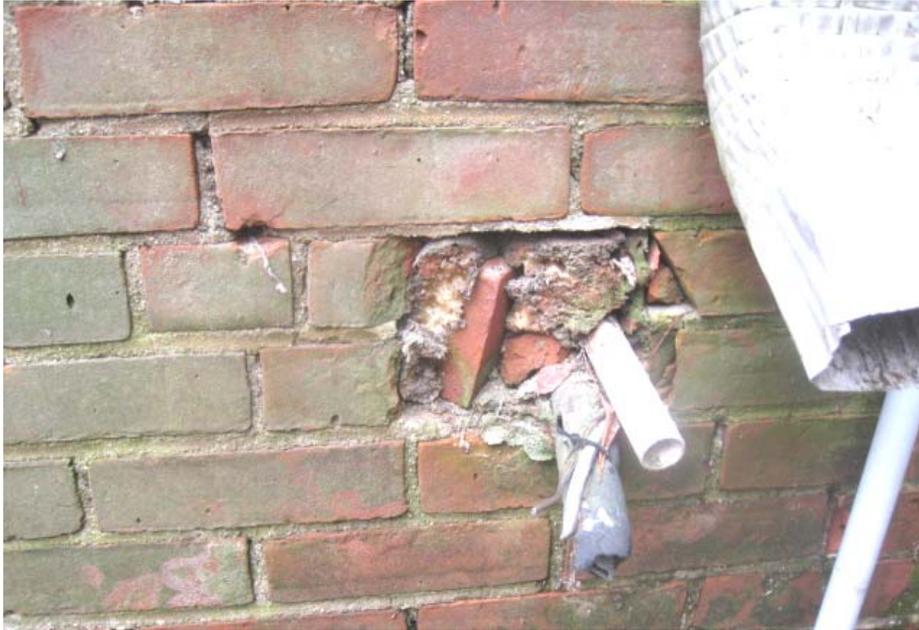
Picture 17

Damaged Exterior Brick/Utility Hole

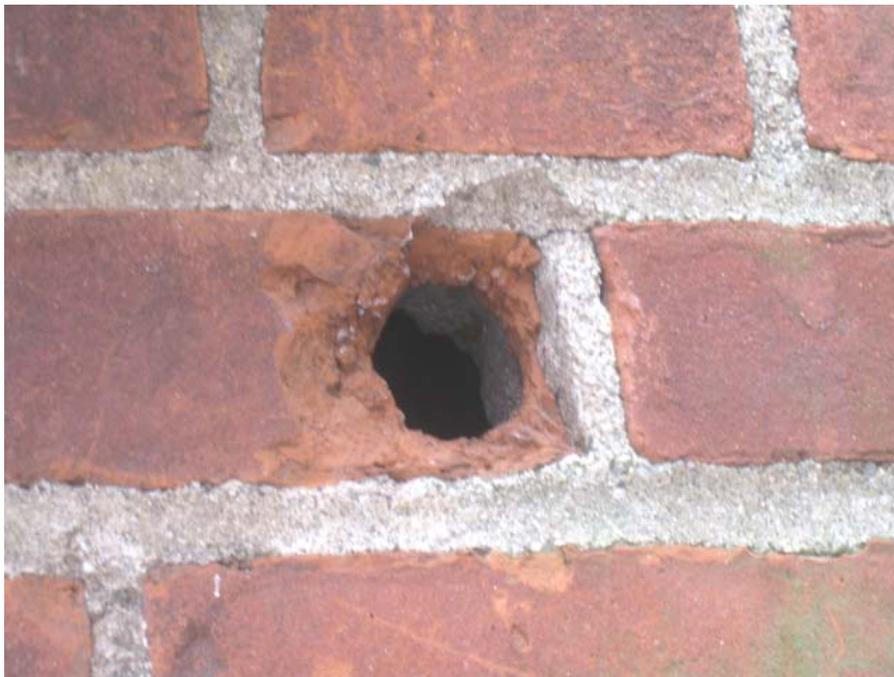
Picture 18

Open Utility Hole

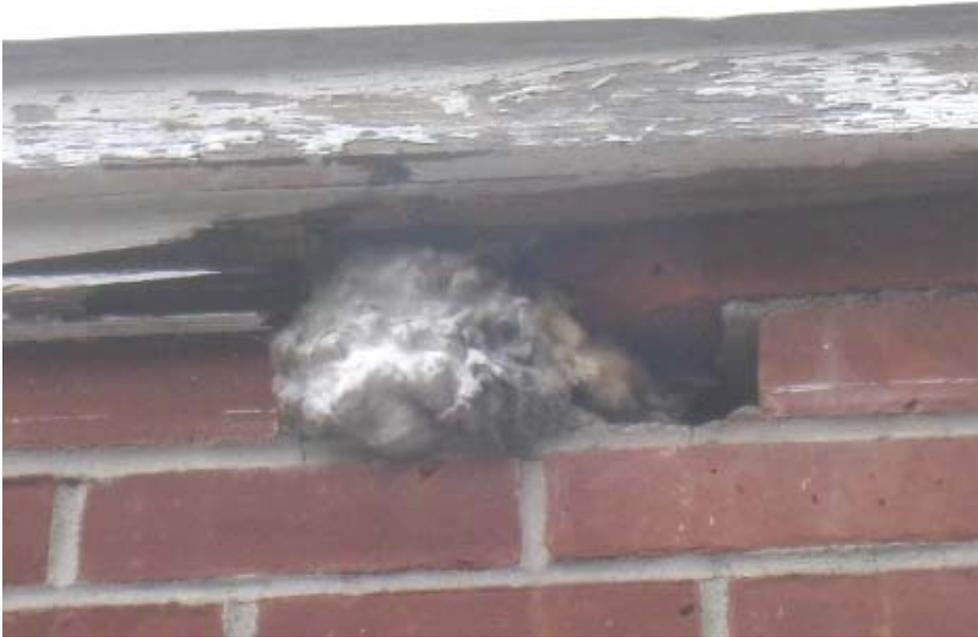
Picture 19

**Damaged Brickwork and Hole Stuffed with Insulation Material
Note Rotted, Decomposing Wood at Roof Line**

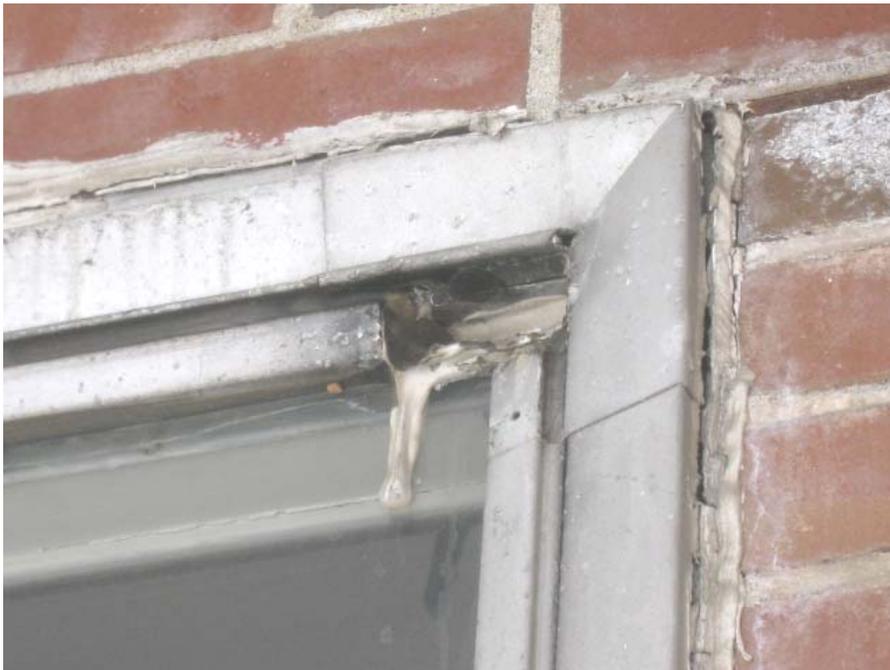
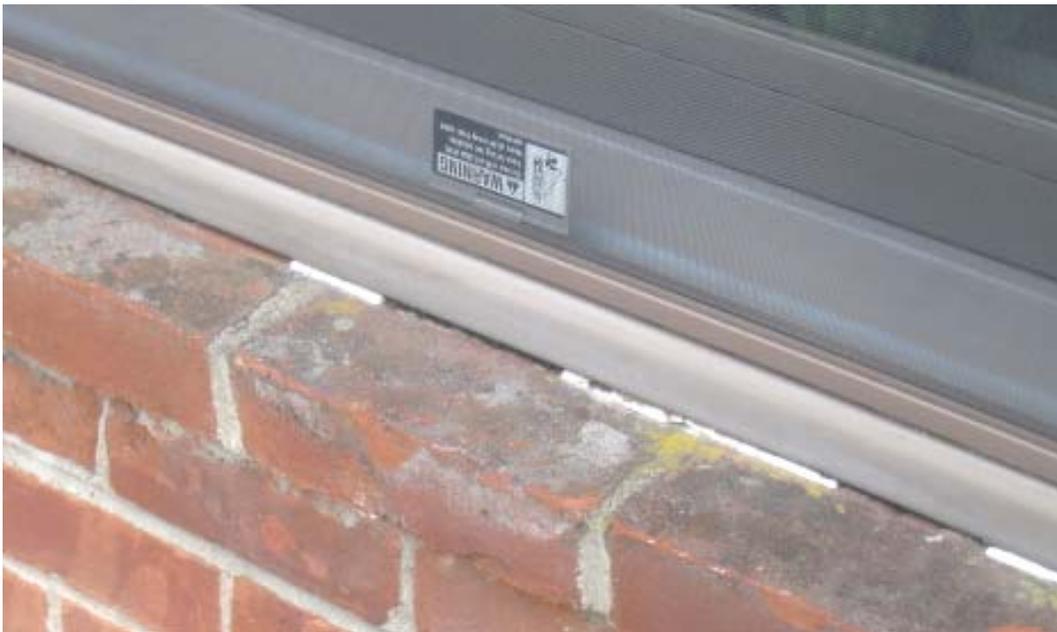
Missing/Damaged Caulking around Window Frame

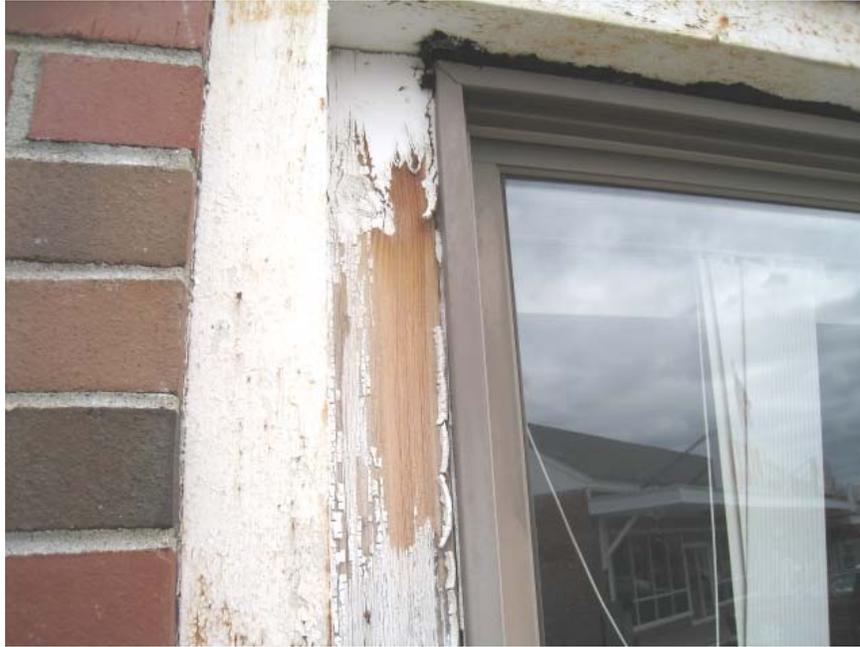
Picture 21

**Missing/Damaged Caulking around Window Frame,
Also Note Peeling Paint and Exposed Wood**

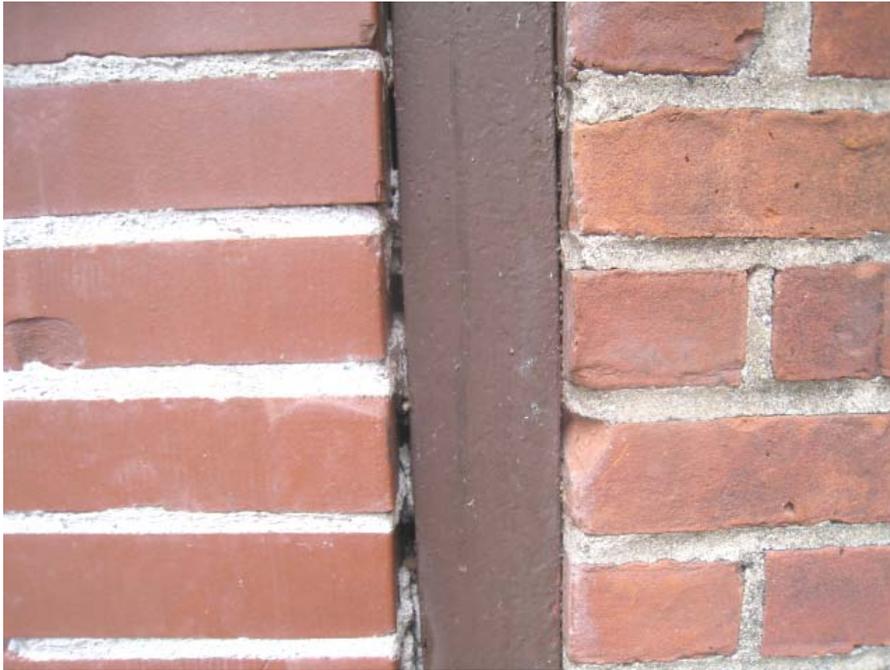
Picture 23

Missing/Damaged Sealant/Joint Compound

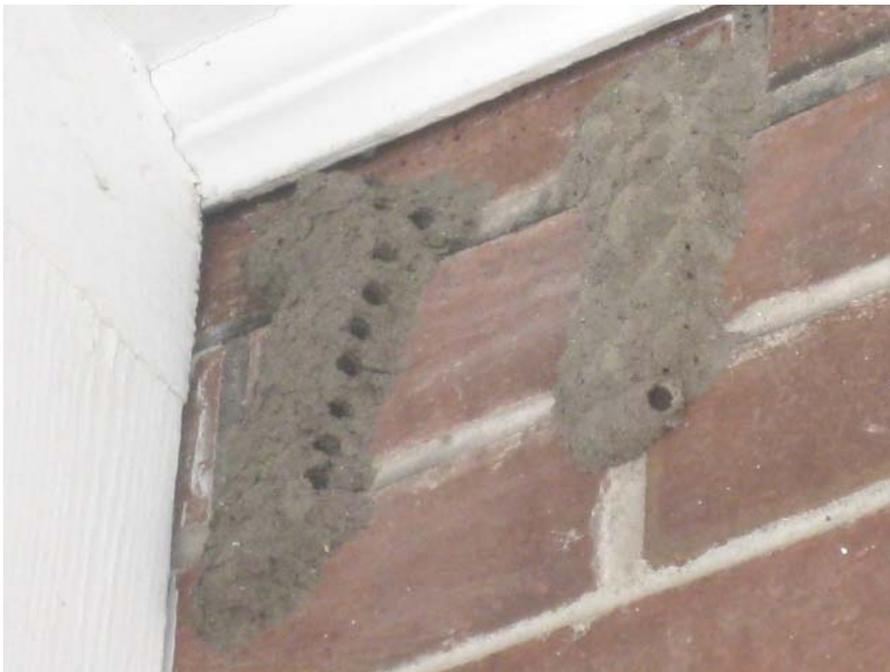
Picture 24

Finally a large number of hornet/wasp nests were observed along the exterior of the building (Picture 24). These nests should be removed in a manner that does not introduce pesticides and/or insects into the building.

Numerous Hornets/Wasps Nests Were Observed along the Exterior of the Building
