INDOOR AIR QUALITY ASSESSMENT

**Baldwinville Elementary School
16 School Street
Templeton, Massachusetts**

Prepared by:
Massachusetts Department of Public Health
Bureau of Environmental Health
Indoor Air Quality Program
June 2011

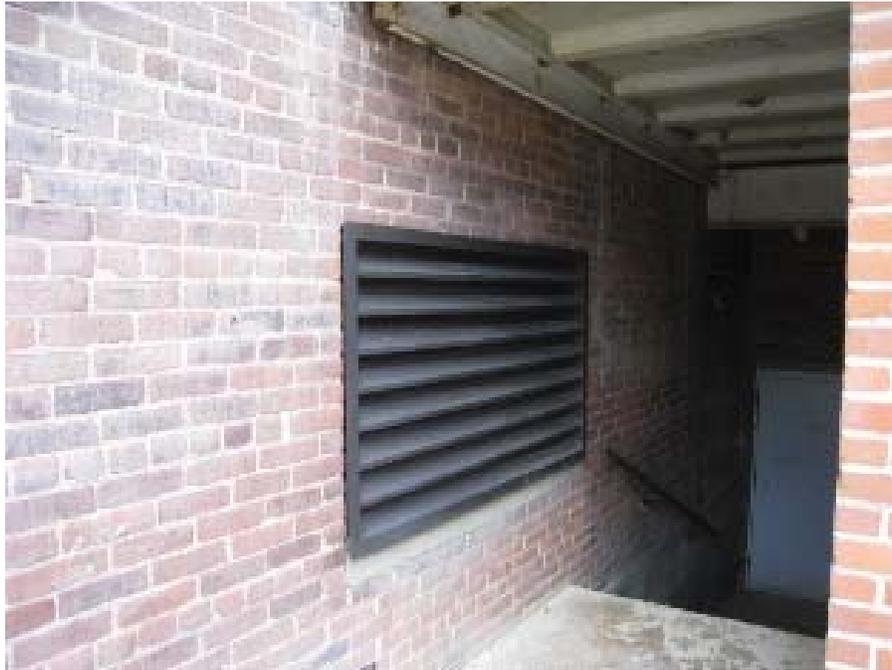
Picture 1

Fresh air is supplied to the main building by means of a fresh air intake on the rear exterior wall. Air is drawn by heating coils and supplied to classrooms by means of wall-mounted vents. Air is exhausted by rooftop motors by means of either wall-mounted vents located near the floor or in closets (Pictures 1 through 4).

Fresh Air Intake

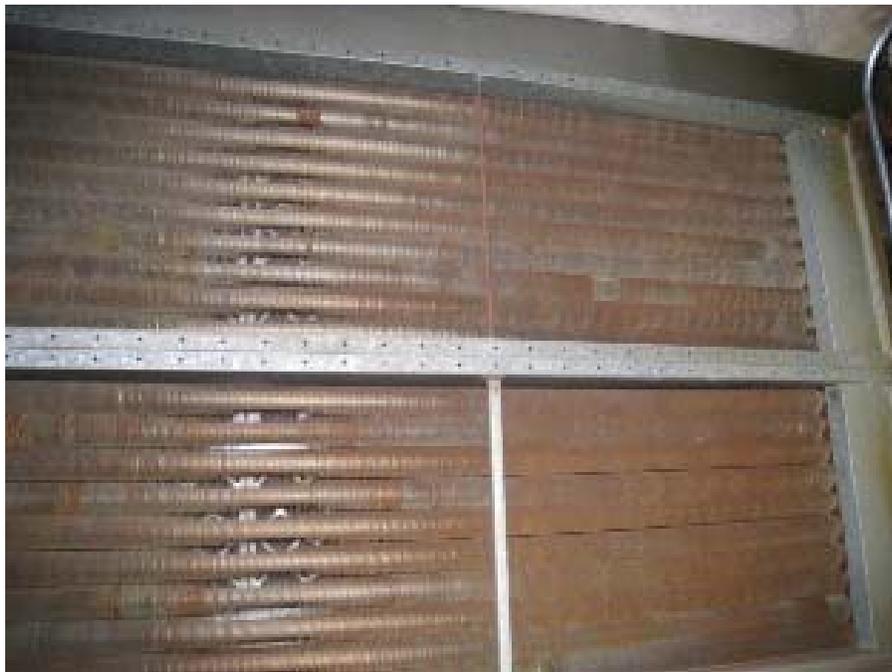
Picture 2

**Heating Coils on AHU
Note Filters behind Coils**

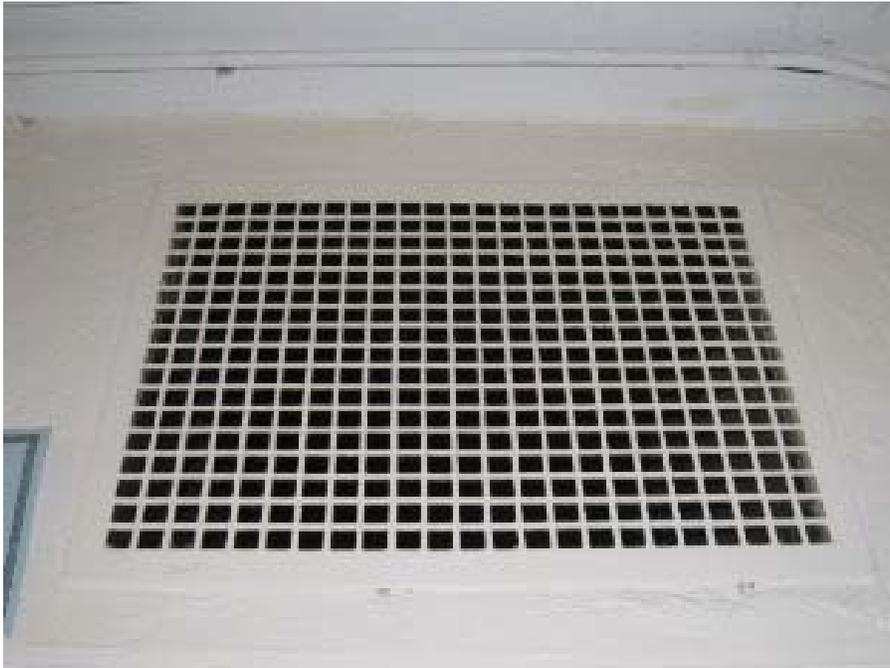
Picture 3

Air Supply Vent

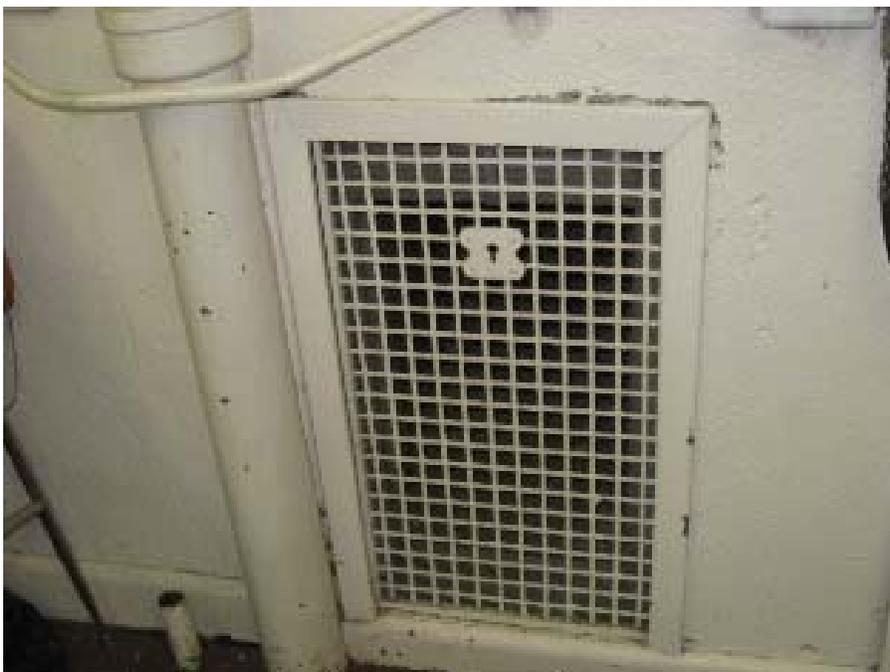
Picture 4

Exhaust Vent

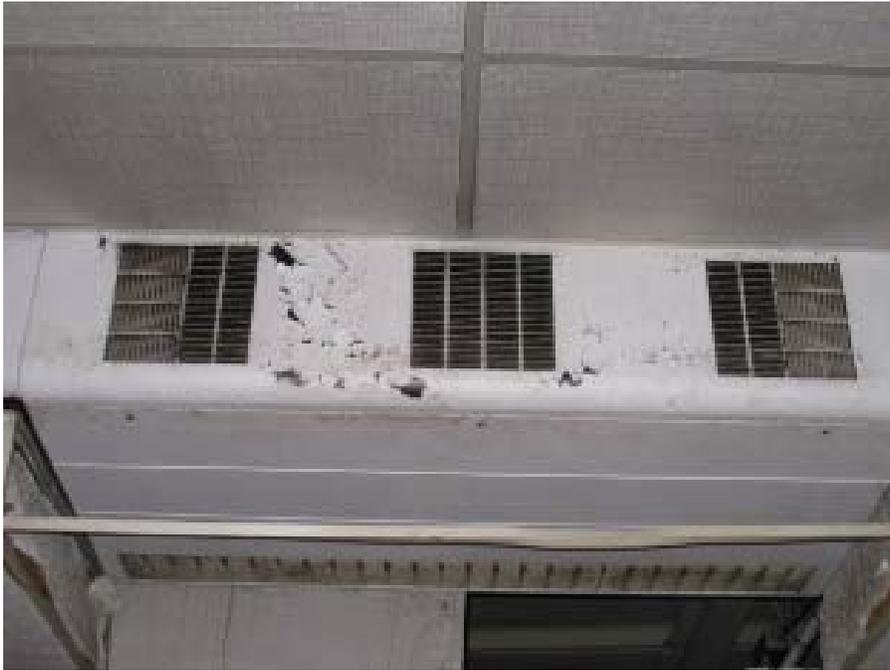
Picture 5

Unit ventilators (univents) supply fresh air to rooms in the rear addition (Picture 5). Air is exhausted by ceiling-mounted exhaust vents. A univent draws air from the outdoors through a fresh air intake located on the exterior wall of the building and returns air through an air intake located at the base of the unit. Fresh and return air are mixed, filtered, heated and provided to classrooms through an air diffuser located in the top of the unit ([Figure 1](#)). Please note that the univents were likely installed when the building was originally constructed (i.e., over 60 years ago). According to the American Society of Heating, Refrigeration and Air-Conditioning

Engineers (ASHRAE), the service life¹ for a unit heater, hot water or steam is 20 years, assuming routine maintenance of the equipment (ASHRAE, 1991). Despite attempts to maintain the univents, the operational lifespan of this equipment has been exceeded. Maintaining the balance of fresh air to exhaust air will be difficult with univents and exhaust vent motors/equipment of this vintage.

Unit Ventilator (Univent)

1. Consider developing a schedule for replacing aging univents.
2. Consider consulting a building envelope specialist to assess water infiltration and to assess the cause of damage to exterior window sills.
3. Consider installing dedicated exhaust ventilation for copiers/laminator in teachers’ room.

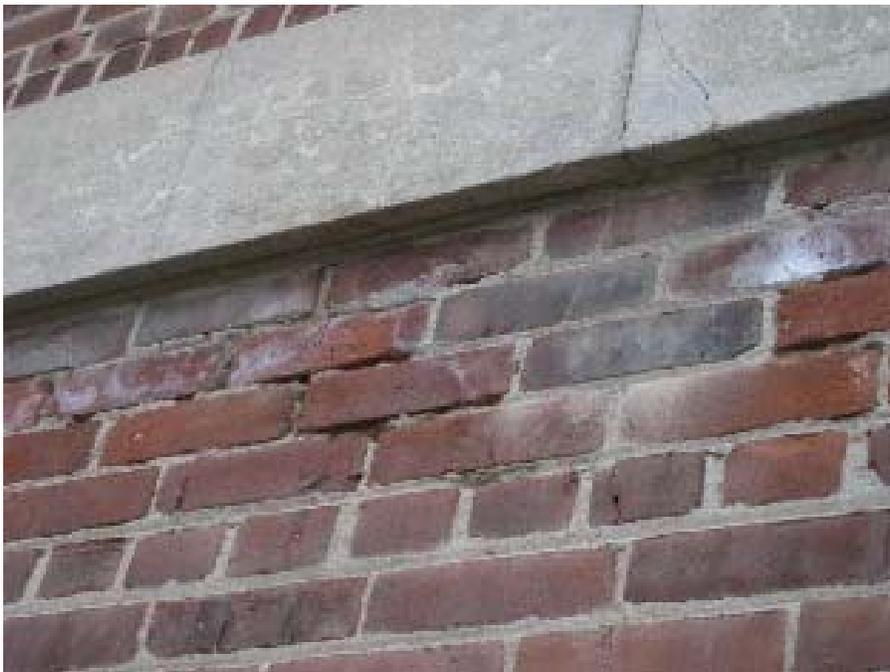
Picture 6

- Cracked, missing mortar was observed around masonry (Picture 6);
- Cracked, deteriorated brick was noted (Picture 7);
- Efflorescence² was observed on several exterior walls (Picture 8);

Cracked, Missing Mortar, Note Efflorescence

7. Consider the following measures to minimize opportunities for water to penetrate the building envelope:
 - Repair all cracked, missing mortar and cracked, deteriorated masonry;

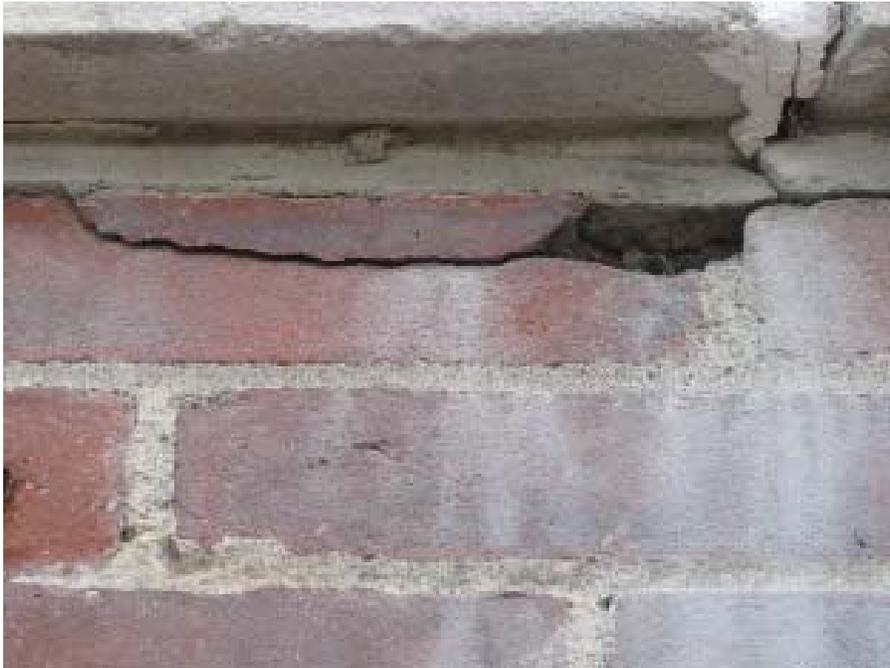
Picture 7

Cracked, Deteriorated Brick

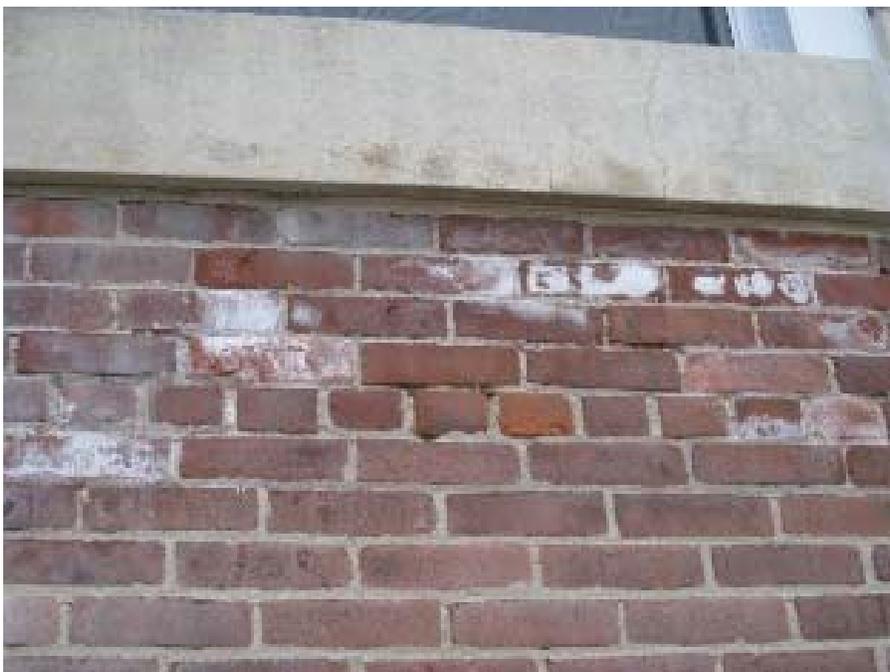
Picture 8

² Efflorescence is a characteristic sign of water damage to building materials, but it is not mold growth. As moisture penetrates and works its way through building materials (e.g., brick), water-soluble compounds dissolve, creating a solution. As this solution moves to the surface, the water evaporates, leaving behind white, powdery mineral deposits.

Efflorescence on Masonry

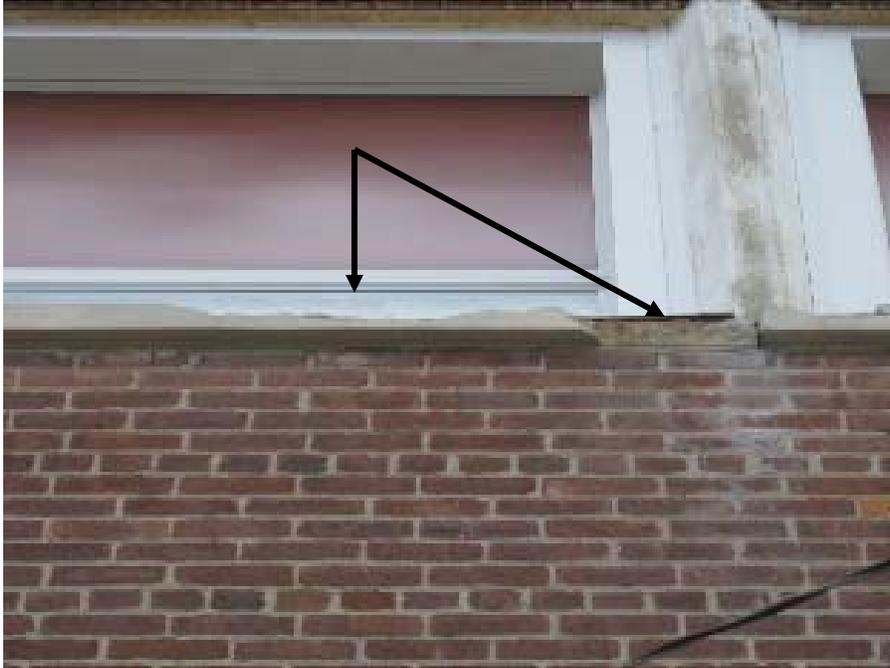
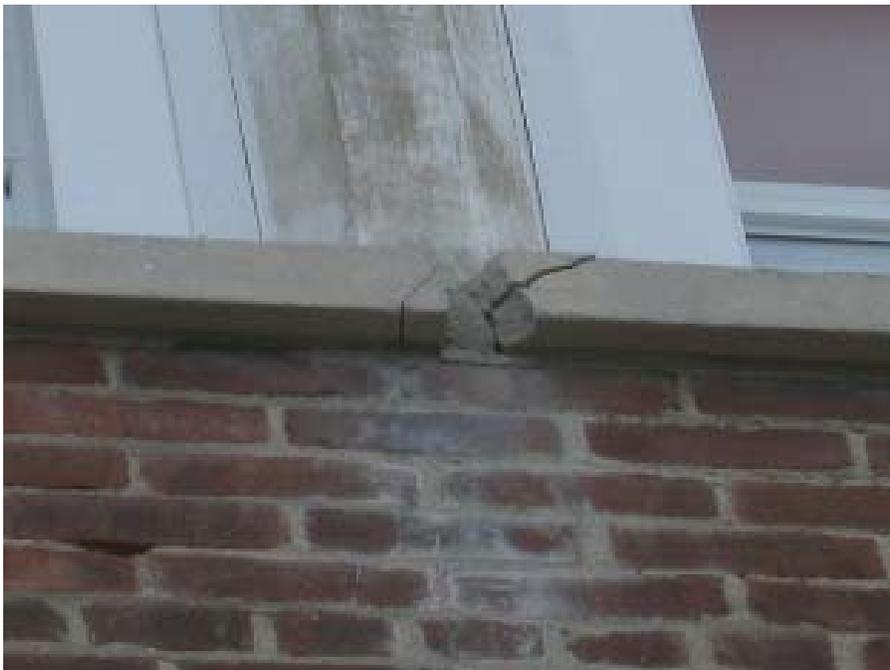
- Cracked, broken exterior window sills were observed, pieces of which appeared loose (Pictures 9 and 10). (BES staff was informed of this observation);

Window Sills in Disrepair (Arrows)

Deteriorating Exterior Sills

- Eliminate gaps on exterior doors;
 - Ensure deteriorated window sills are not in danger of falling off the building; and
 - Continue to address water infiltration within the building as it occurs.

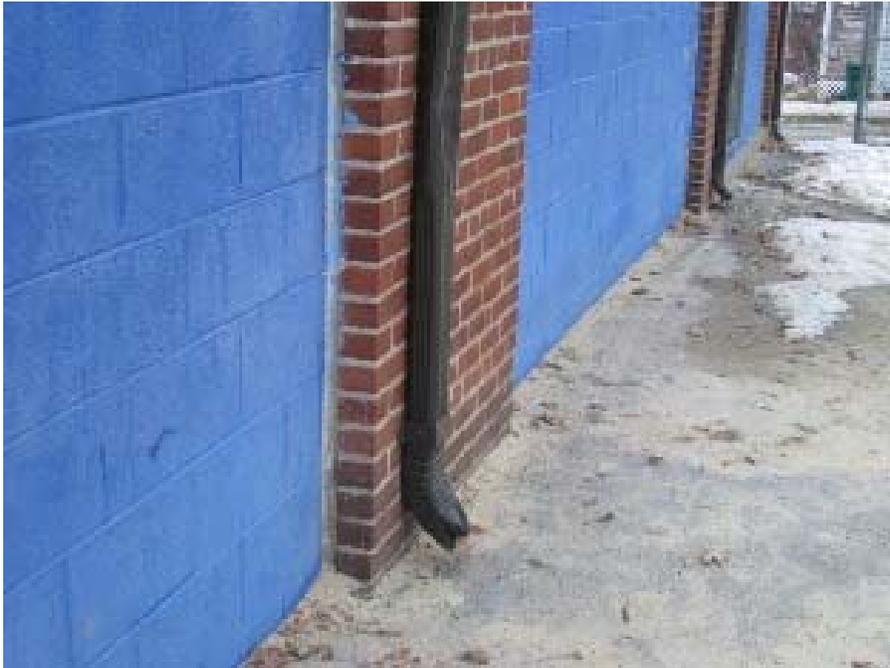
Picture 11

- Downspouts empty water adjacent to the foundation of the rear addition (Picture 11);
- Shrubs are located in close proximity to the building (Pictures 12 and 13). The growth of roots against exterior walls can bring moisture in contact with the foundation. Plant roots can eventually penetrate, leading to cracks and/or fissures in the sublevel foundation. Over time, this process can undermine the integrity of the building envelope, providing a means of water entry into the building via capillary action through foundation concrete and masonry (Lstiburek & Brennan, 2001);

Downspouts Deposit Water in Close Proximity to Building

- Extend downspouts to deposit rainwater as far as possible from the building's base;

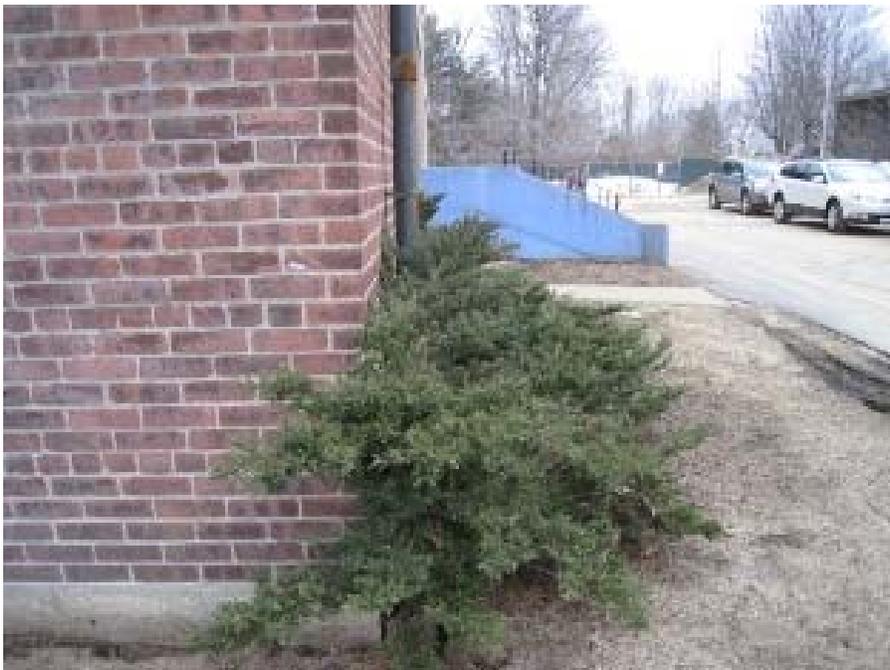
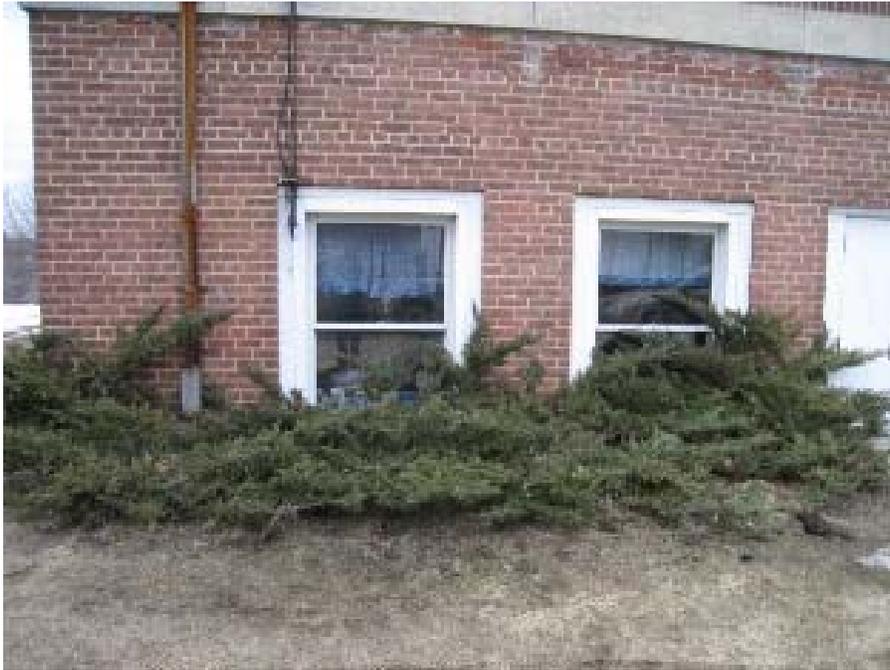
Shrubs Resting Against Masonry

Shrubs Obscuring Basement Windows

- All plants in contact with the foundation or walls of the BES should be removed. Cut shrubbery in a manner to maintain a space of ~ 5 feet from the building. Improve the grading of the ground away from the foundation at a rate of 6 inches per every 10 feet where practicable (Lstiburek & Brennan, 2001);

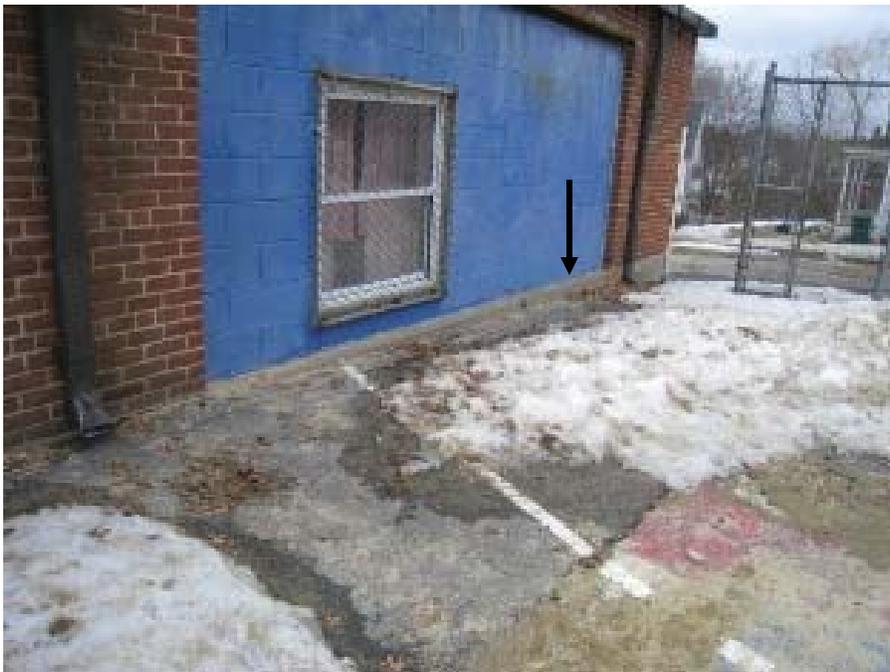
Picture 14

- When the garage bays on the addition were enclosed, a ledge was created on some sections that may allow snow and moisture to accumulate at the bottom seam (Picture 14);

Recessed Cinderblocks Create Small Ledge (Arrow)

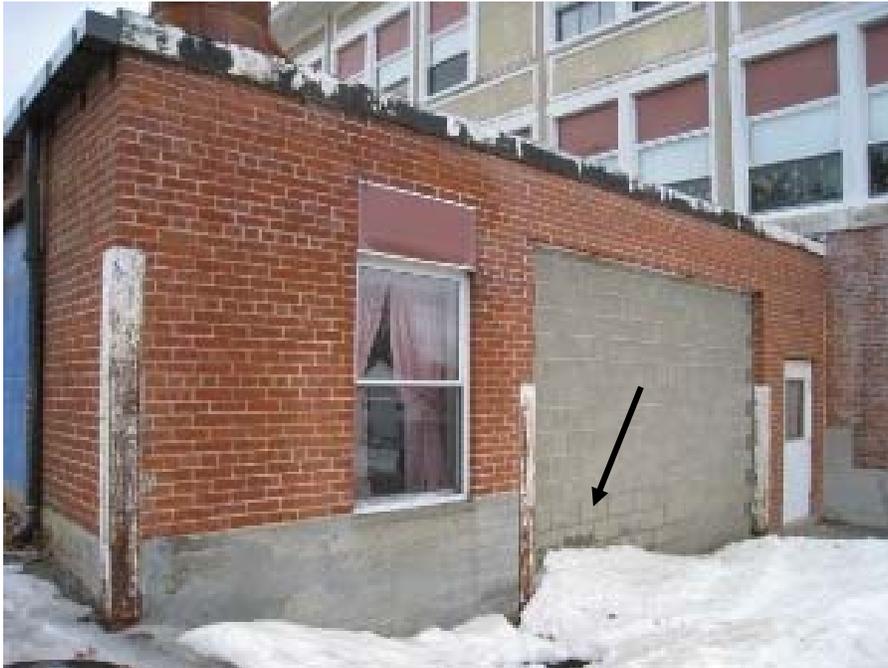
Picture 15

- Accumulated ice and snow was observed impacting the exterior wall of the rear addition (Picture 15); and
- Cracks were noted in the tarmac at the rear of the building, which may allow surface water to impact the rear addition (Picture 16).

**Accumulated Snow and Ice against Building
Note Moistened Joints between Cinderblocks (Arrow)**

- During the winter months, endeavor to eliminate snow and ice from accumulating against the building, particularly the rear addition;
 - Repair cracks in tarmac at rear of building;

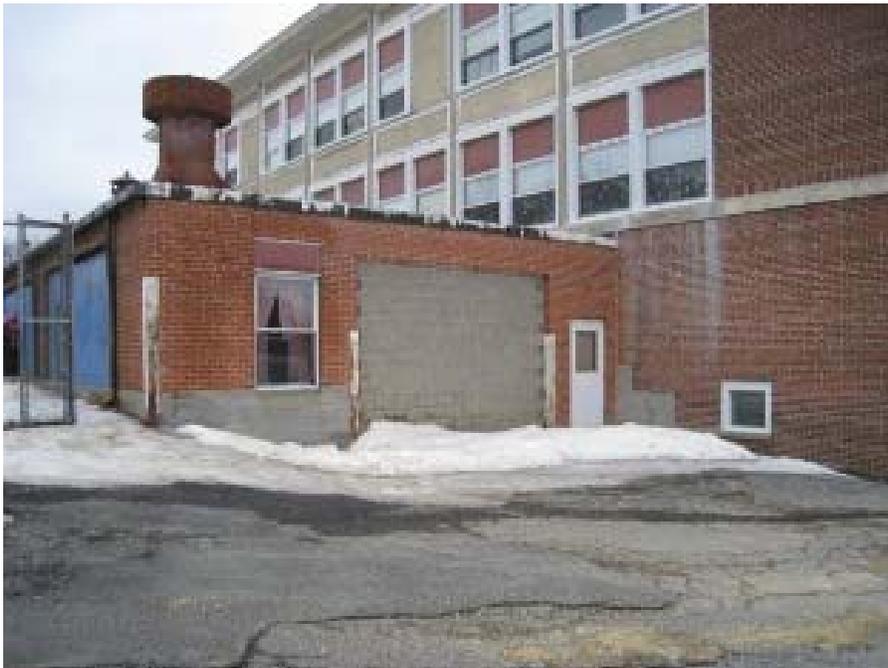
Picture 16

Deteriorated Tarmac

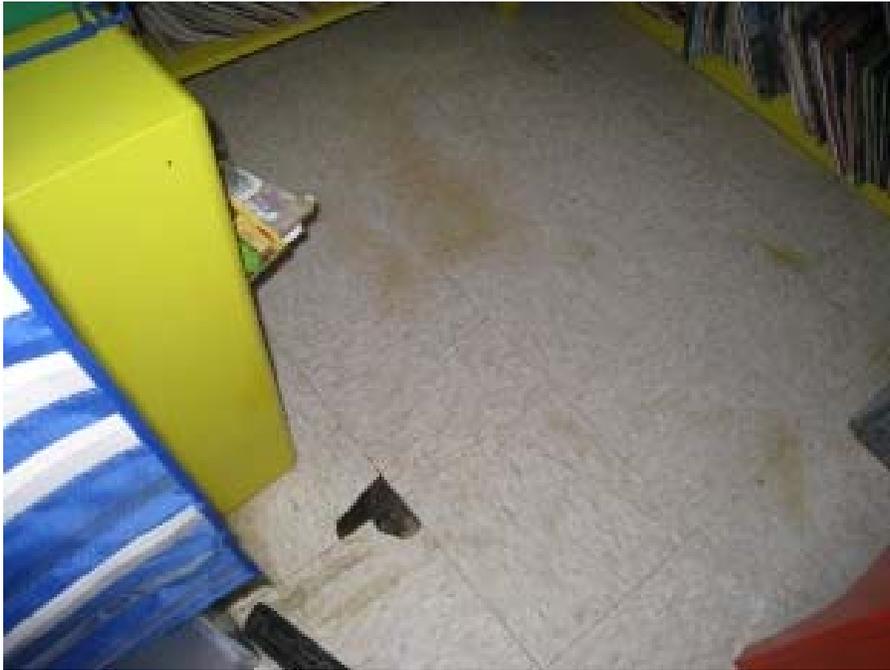
Picture 17

Moisture was also evident inside the BES. Standing water was observed on one basement classroom floor and another floor, although dry, exhibited water damage to numerous floor tiles (Pictures 17 through 19). As can be seen in Picture 19, the water damage has caused the upper layer of floor tiles to become loose. Underneath these tiles is a second layer of floor tiles. Due to chronic moisture exposure, these underlying tiles have begun to curl and lift. These floor tiles may contain asbestos. Intact asbestos-containing materials do not pose a health hazard. If damaged, asbestos-containing materials can be rendered friable and become aerosolized. Friable asbestos is a chronic (long-term) health hazard, but will not produce acute (short-term) health effects (e.g., headaches) typically associated with buildings believed to have indoor air quality problems. Where asbestos-containing materials are found damaged, these materials should be removed or remediated in a manner consistent with Massachusetts asbestos remediation laws (MDLI, 1993). At the time of the assessment the classroom was not in use and was to be utilized as an emergency exit only. Damaged or missing floor tiles potentially containing asbestos were also observed in additional areas of the BES (Table 1/Picture 20).

Standing Water on Floor

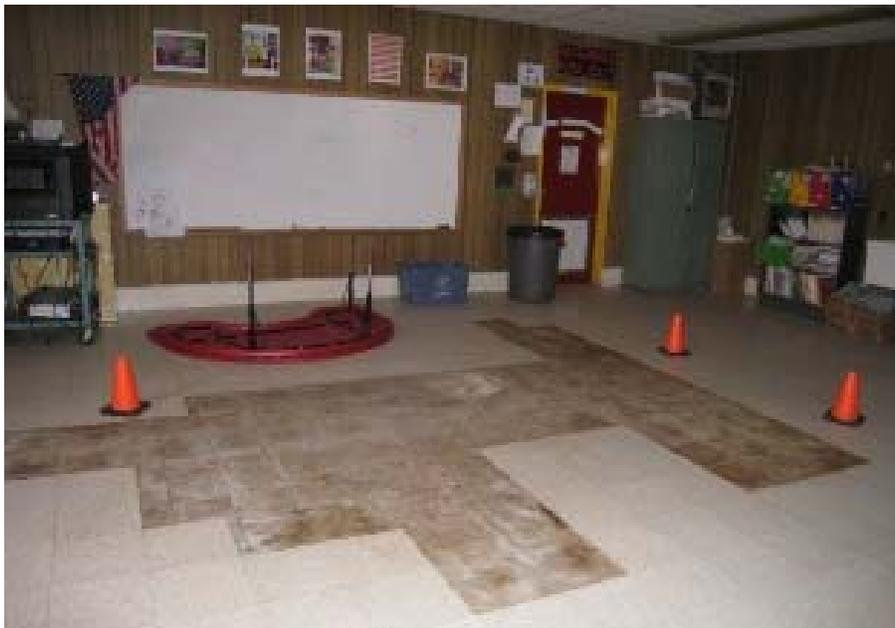
Picture 18

**Missing Vinyl Floor Tiles Due to Water Damage
Note Layer of Floor Tiles Underneath**

8. Remediate all damaged floor tiles containing ACM in conformance with Massachusetts asbestos remediation and hazardous waste disposal laws.
 9. Eliminate peeling paint on surfaces of pipes and equipment in accordance with applicable state and federal renovation regulations and guidelines.

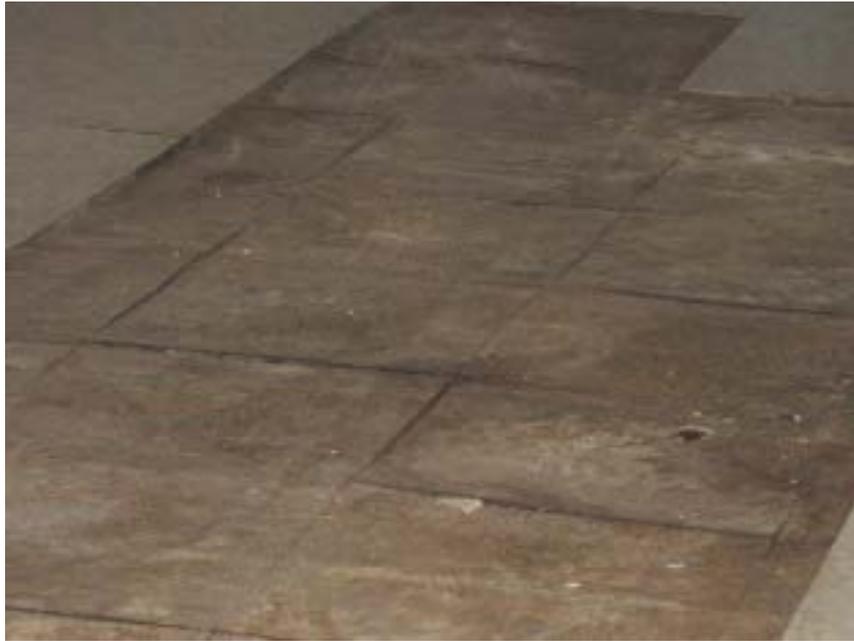
Picture 19

Lifting and Curling Edges of Underlying Floor Tiles which may Contain Asbestos

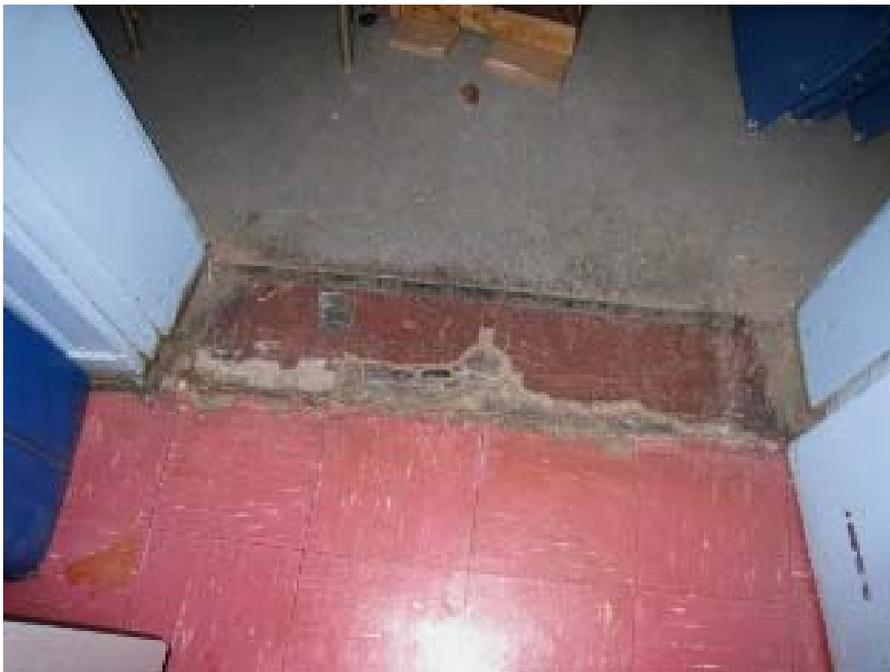
Picture 20

Cracked, Broken Floor Tiles

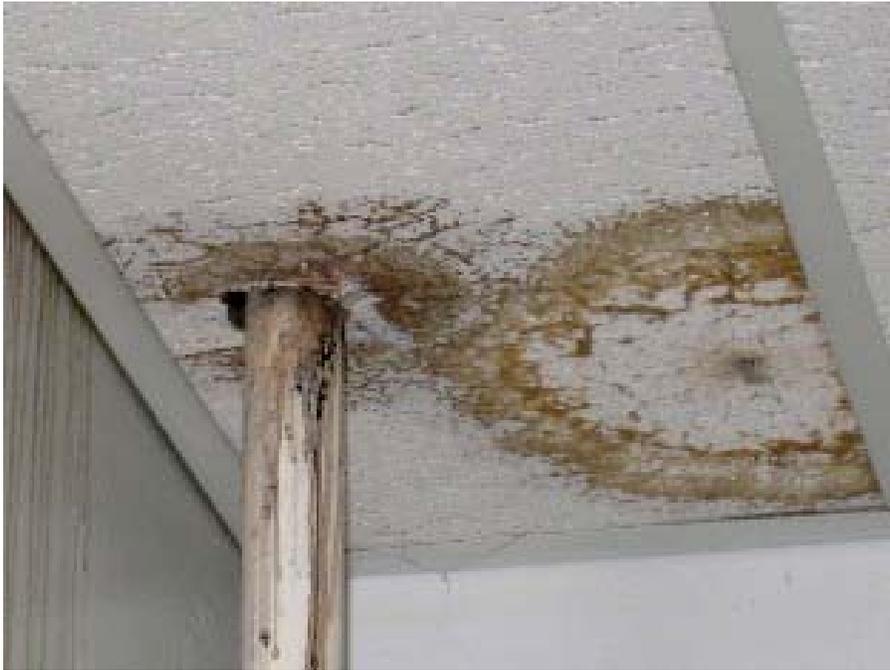
Picture 21

Several classrooms had water-damaged ceiling tiles, ceilings and plaster which can indicate sources of water penetration from either the building envelope or plumbing system (Picture 21; Table 1). Water-damaged ceiling tiles can provide a source of mold and should be replaced after a water leak is discovered and repaired.

Water-Damaged Ceiling Tile and Wall Surface

10. Repair any existing water leaks and replace any remaining water-damaged ceiling tiles. Examine the area above these tiles for mold growth. Disinfect areas of water leaks with an appropriate antimicrobial, as needed.

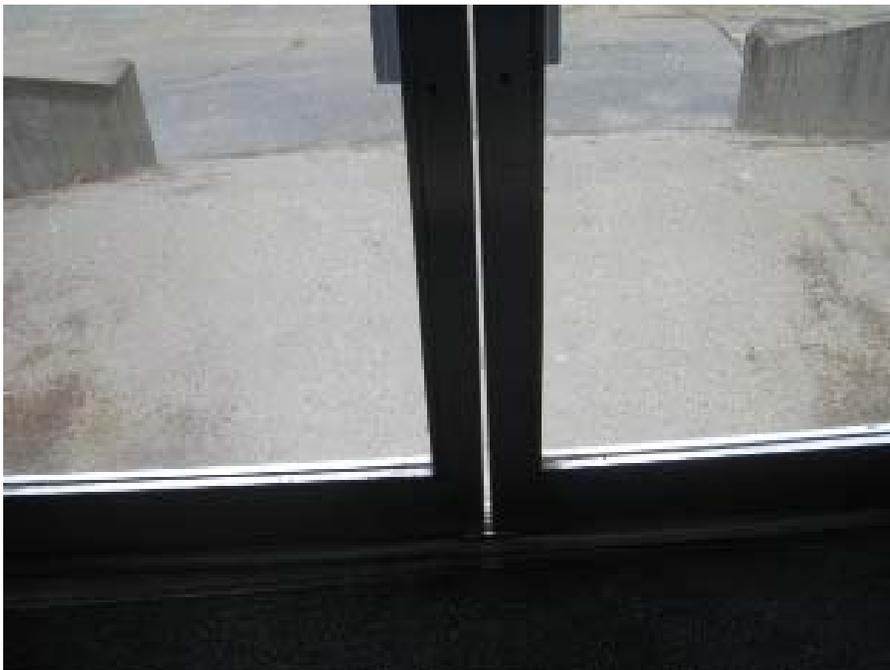
Picture 22

Large gaps were observed around some exterior doors (Picture 22), which can allow moisture and unconditioned air to enter the building. In addition, these breaches can allow insects and rodents access to the building.

Gap between Exterior Doors

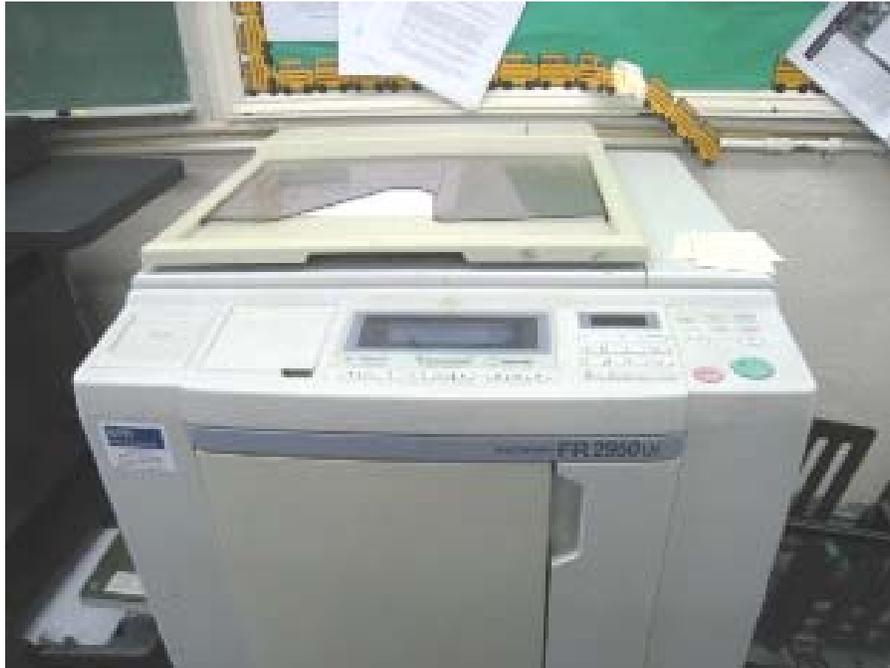
Picture 23

Located in the copier room are a number of photocopying machines and a laminator. Of note is that at least one printer (Risograph[®]) uses a liquid toner (Picture 23). This product contains petroleum distillate, which is a VOC which is an irritant to the eyes, nose and respiratory system. Photocopiers can also produce VOCs and ozone, particularly if the equipment is older and in frequent use. Lamination machines melt plastic and give off odors and

VOCs. VOCs and ozone are respiratory irritants (Schmidt Etkin, D., 1992). It is recommended that local separate exhaust systems that do not re-circulate into the general ventilation system be used (US DOE, unknown).

Risograph Copier

15. Refrain from using air fresheners or other air deodorizers.
16. Consider opening a window and operating a fan in a manner that removes odors and waste heat when operating the laminator.

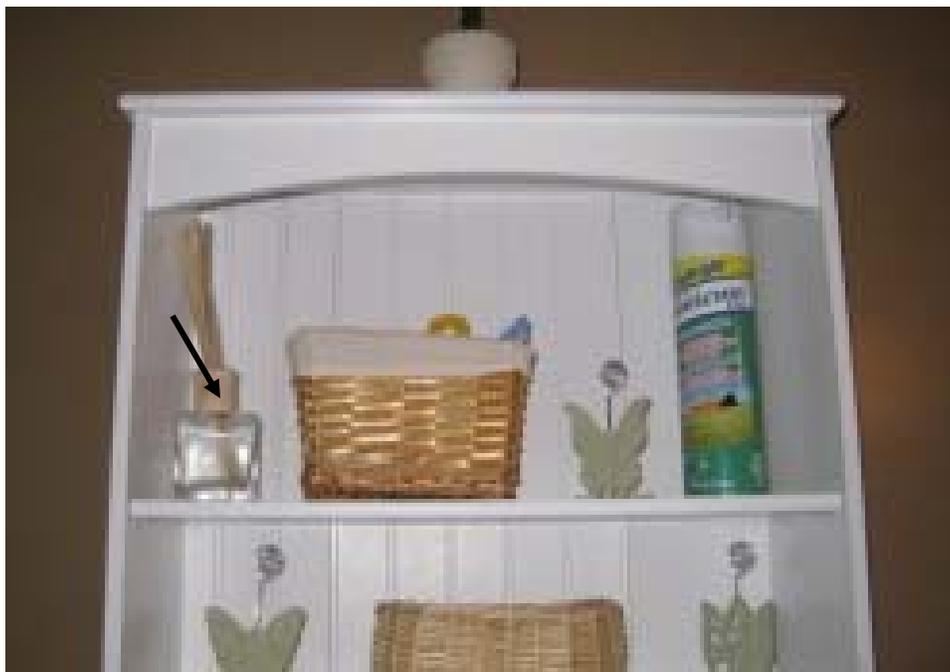
Picture 24

Air fresheners and deodorizing materials were observed in a number of areas (Picture 24). Air deodorizers contain chemicals that can be irritating to the eyes, nose and throat of sensitive individuals. Many air fresheners contain 1,4-dichlorobenzene, a VOC which may cause reductions in lung function (NIH, 2006). Furthermore, deodorizing agents do not remove materials causing odors, but rather mask odors that may be present in the area.

Air Fresheners/Deodorizers, Note Reed Diffuser (Arrow)

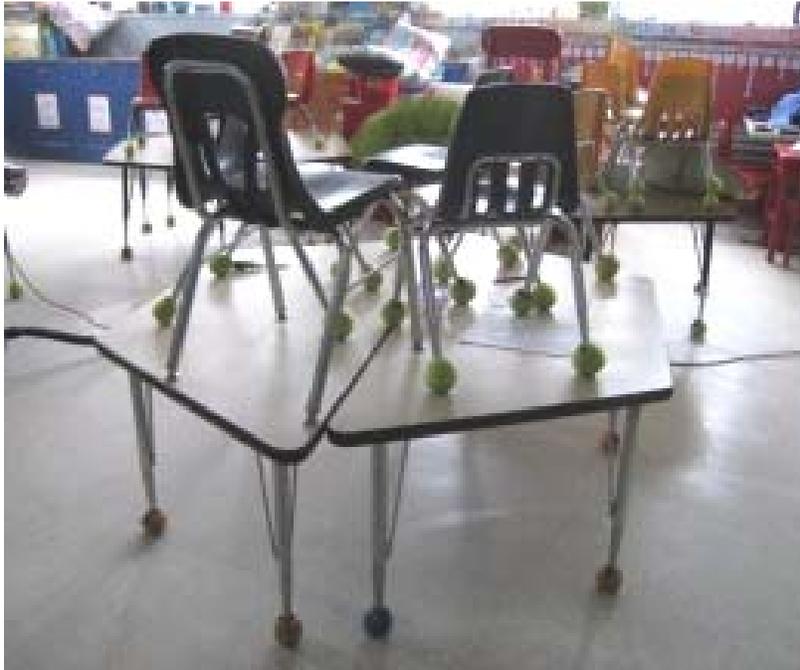
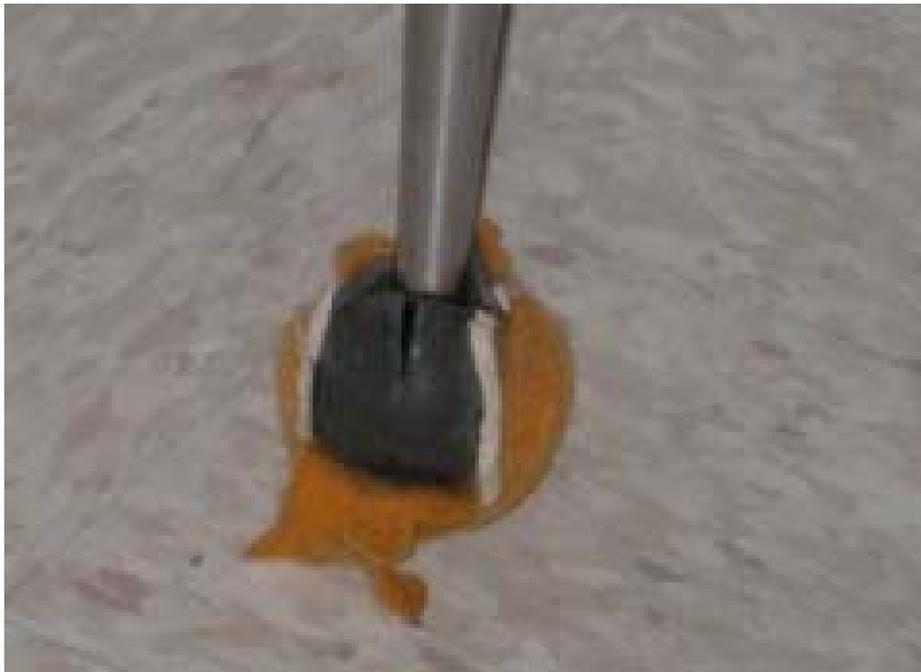
BEH staff observed tennis balls which had been sliced open and placed on chair and/or table legs (Pictures 25 and 26). Tennis balls are made of a number of materials that are a source of respiratory irritants. Constant wearing of tennis balls can produce fibers and cause VOCs to off-gas. Tennis balls are made with a natural rubber latex bladder, which becomes abraded when used as a chair leg pad. Use of tennis balls in this manner may introduce latex dust into the school environment. Some individuals are highly allergic to latex (e.g., spina bifida patients) (SBAA, 2001). It is recommended that the use of materials containing latex be limited in buildings to reduce the likelihood of symptoms in sensitive individuals (NIOSH, 1997).

Tennis Balls used as Glides on Table and Chair Legs

Worn Tennis Ball used as Glide

17. Consider replacing tennis balls with latex-free tennis balls or glides.
18. Clean stuffed animals, blankets and pillows on a weekly basis.
19. Clean accumulated dust and debris periodically from exhaust vents.

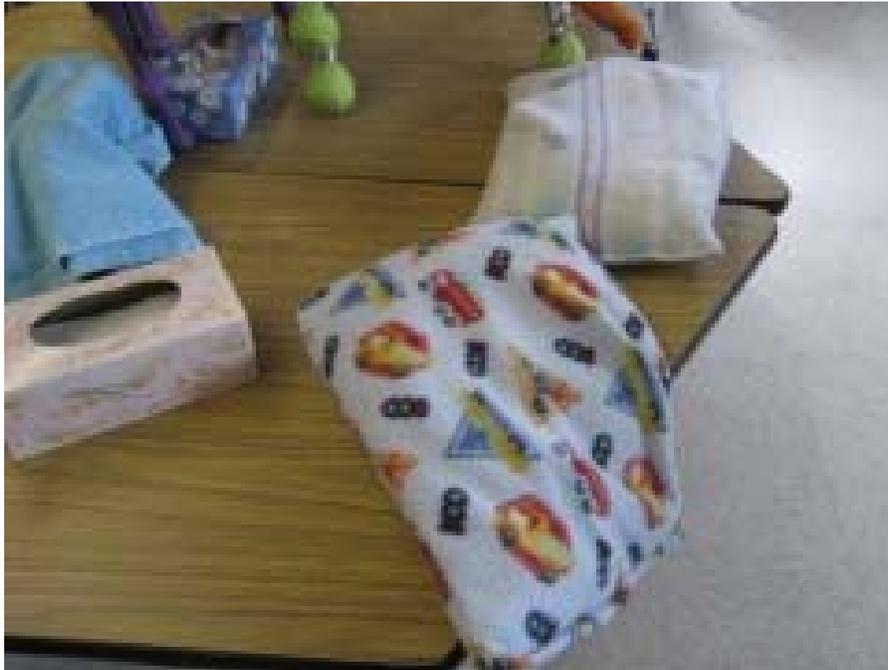
Picture 27

Stuffed pillows/toys and upholstered furniture were noted in some classrooms (Picture 27). Stuffed toys used by an individual child should be washed on a weekly basis to prevent disease (Hale and Polder, 1996). Furthermore, stuffed pillows/toys can be a point for dust collection. Close contact with such items can leave oils, perspiration, hair and skin cells. Dust mites feed upon human skin cells and excrete waste products that contain allergens. As discussed, dust can be irritating to the eyes, nose and respiratory system.

Pillows and Blankets in Classroom

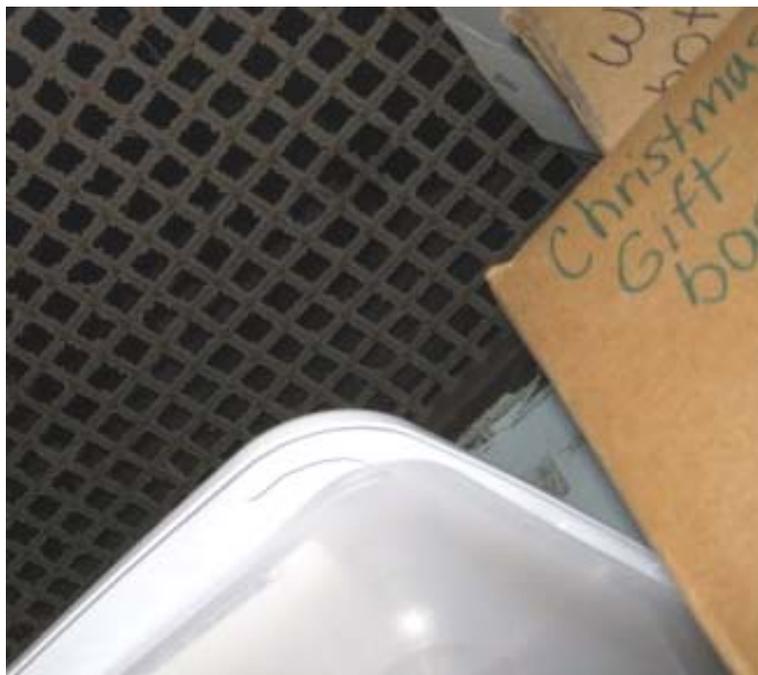
Picture 28

A number of exhaust vents were observed to be obstructed and to have accumulated dust/debris (Picture 28). These vents should remain unobstructed in order for the ventilation system to function as designed and vents should be routinely cleaned in order to prevent dust/debris from being aerosolized and redistributed throughout the room. Numerous BES staff also reported difficulties in opening many of the windows.

Dust Accumulation on Exhaust Vent

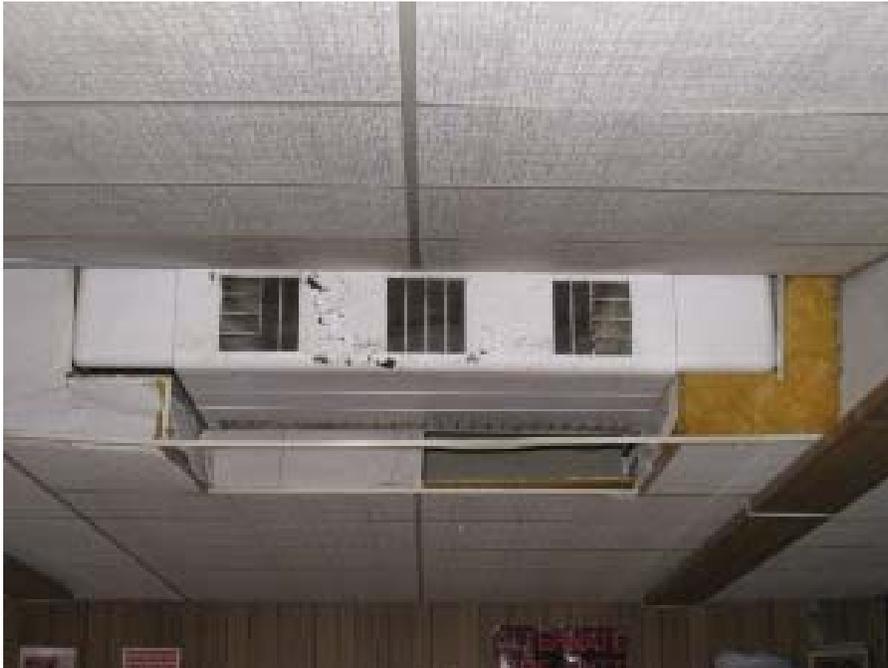
Picture 29

Missing/damaged ceiling tiles were observed in some areas (Picture 29). Some utility pipes into ceilings are not properly sealed (Picture 30). These conditions can allow dust, odors and vapors to migrate into occupied areas.

Missing and Deteriorated Ceiling Tiles

20. Seal all open utility holes.
21. Replace missing and deteriorated ceiling tiles.
22. Routinely clean cloth curtains and upholstered furniture.
23. Consider adopting the US EPA (2000) document, “Tools for Schools”, as an instrument for maintaining a good indoor air quality environment in the building. This document is available at: <http://www.epa.gov/iaq/schools/index.html>.

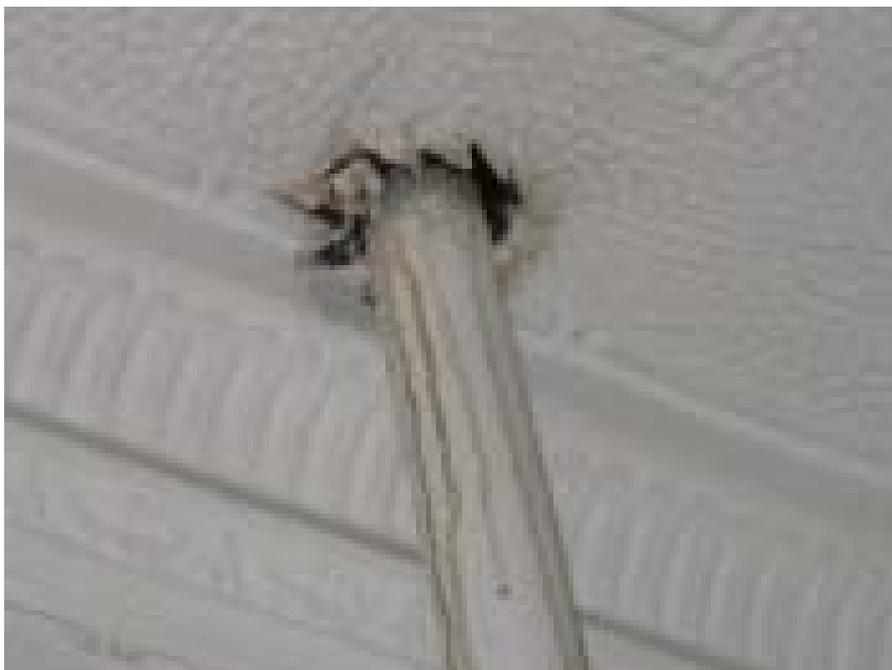
Picture 30

Open Utility Hole, Note Evidence of Leak
