INDOOR AIR QUALITY ASSESSMENT

**Howard School
70 Howard Street
West Bridgewater, Massachusetts**

Prepared by:
Massachusetts Department of Public Health
Bureau of Environmental Health
Indoor Air Quality Program
August 2011

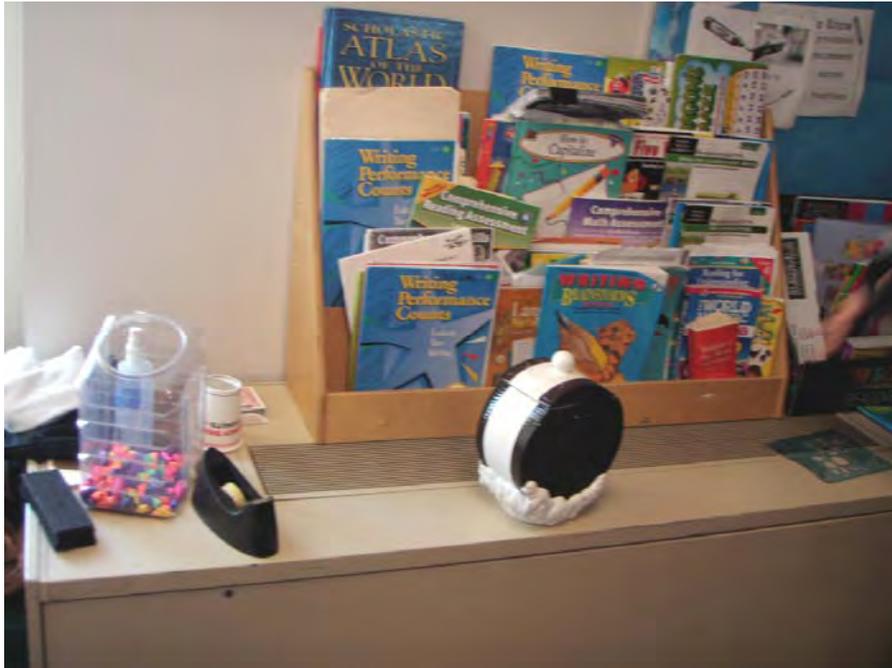
Picture 3

Other conditions that can affect indoor air quality were observed during the assessment. In several classrooms, items were observed on windowsills, tabletops, counters, bookcases and desks (Pictures 3 and 24). The large number of items stored in classrooms provides a source for dusts to accumulate. These items (e.g., papers, folders, boxes) make it difficult for custodial staff to clean. Items should be relocated and/or be cleaned periodically to avoid excessive dust build up. In addition, these materials can accumulate on flat surfaces (e.g., desktops, shelving and carpets) in occupied areas and subsequently be re-aerosolized causing further irritation.

Univent with Obstructions

24. Relocate or consider reducing the amount of materials stored in classrooms to allow for more thorough cleaning of classrooms. Clean items, including chalk trays, pencil shaving trays and dry erase marker trays regularly with a wet cloth or sponge to prevent excessive dust build-up.

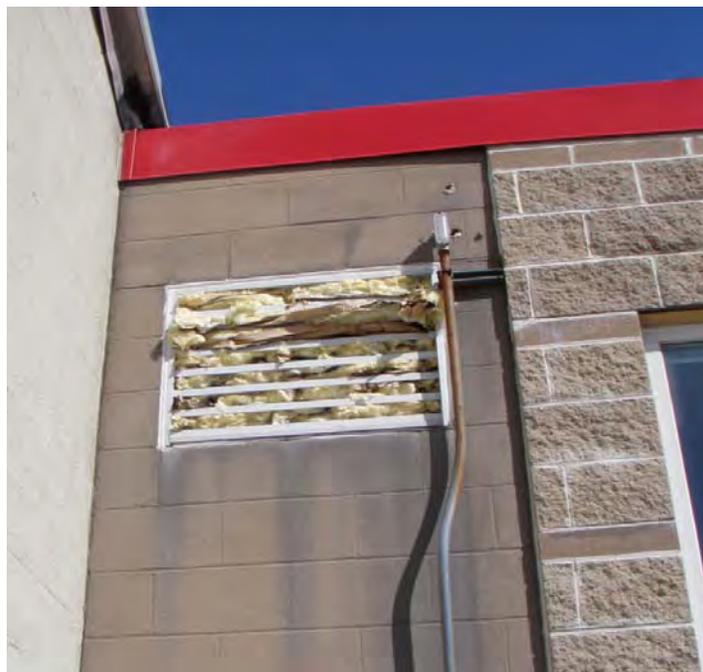
Picture 4

The fresh air intake for the univent in classroom 16 is not in a location typical for these units (i.e., directly outside from the unit as shown in Picture 2). Instead, the fresh air intake is

ducted to a location above the unit. While observing the intake from the building exterior, the fresh air intake vent was found to be blocked with insulation (Picture 4) to prevent pipes freezing, which previously resulted in flooding (See Microbial/Moisture Concerns discussion). A blocked vent cannot supply fresh air as designed. Insulation should be removed from the fresh air intake and the duct interior should be cleaned. Measures should be made to properly insulate pipes, and the system should be examined to ensure proper function.

Outside Vent Blocked with Insulation

10. Seal spaces between compartments and around pipes in univent cabinets with a fire-rated sealant.
11. Remove insulation from the univent to the special education classroom and restore proper function of the unit. Consider alternate means for insulating/preventing freezing.

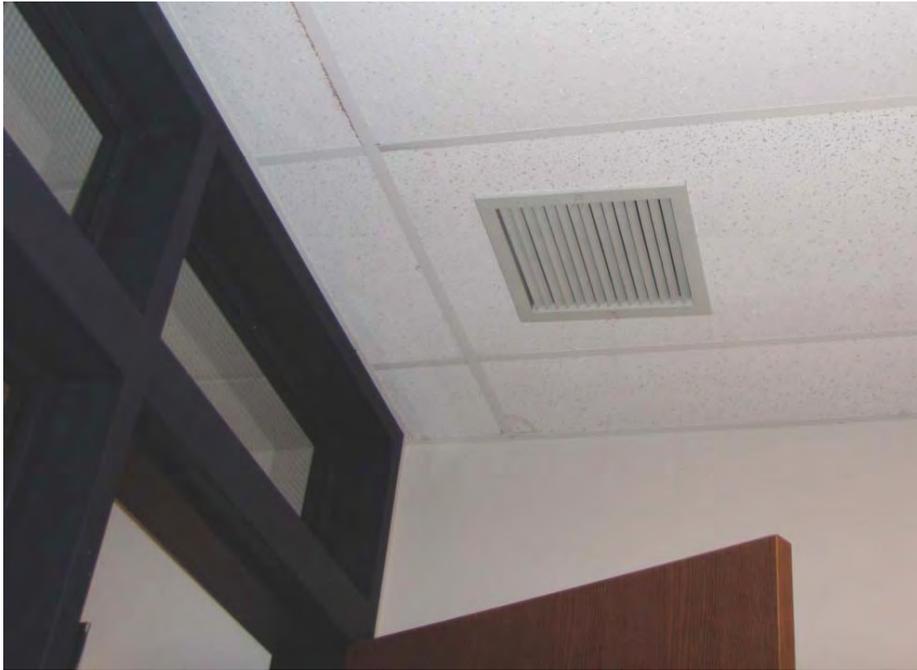
Picture 5

Exhaust Vent Close to Classroom Door (note door is also open)

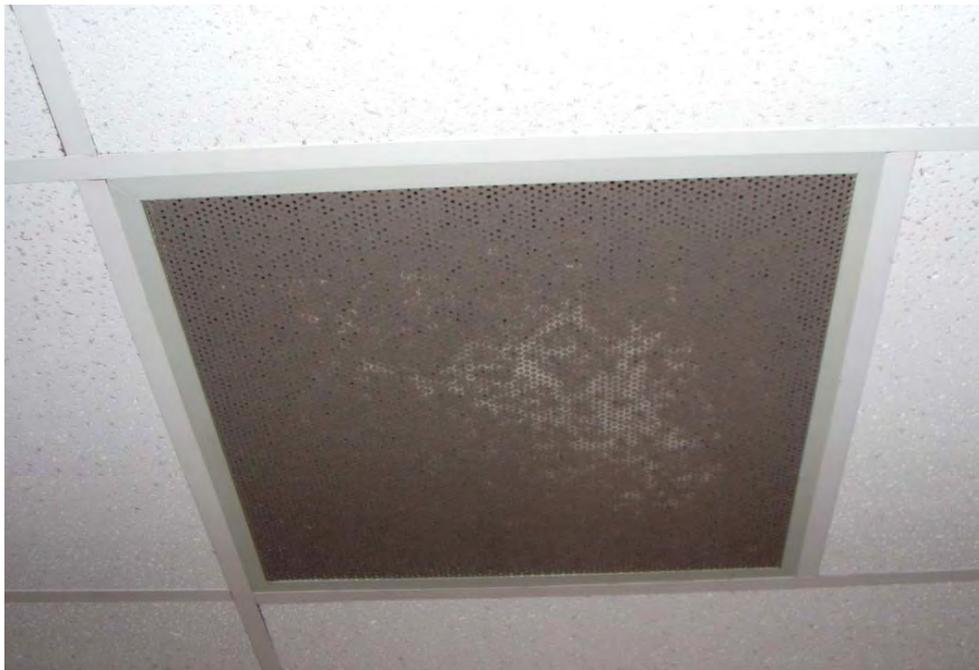
Picture 8

Ceiling-Mounted Return Vent, Note Presence of Occluding Dust

25. Clean personal fans, univent air diffusers, return vents and exhaust vents periodically of accumulated dust.

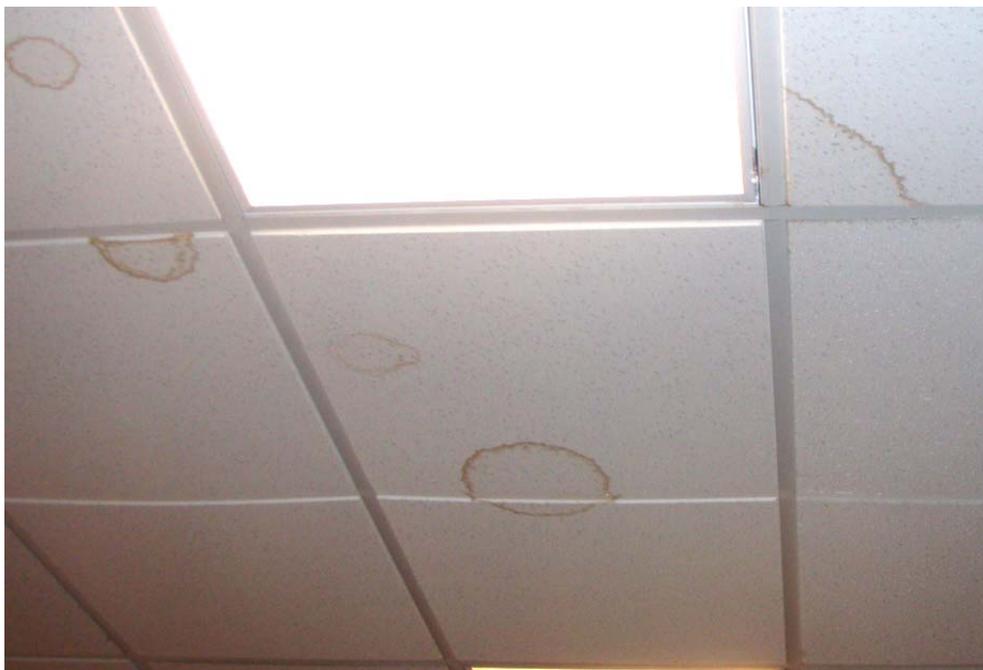
Picture 10

Water-damaged ceiling tiles were observed in a number of areas (Table 1; Pictures 10 and 11), possibly resulting from leaks through roof joints during periods of rain with heavy winds. In the main lobby, the plenum above the drop ceiling was examined in the area of a stained tile and evidence of leaking was noted by staining on a support column where water

Water-Damaged Ceiling Tiles

15. Examine methods to reduce/prevent water pooling on the roof (e.g., re-pitch roof, improve drainage).
16. Replace water-damaged ceiling tiles. Examine the area above these tiles for mold growth. Disinfect areas of water leaks with an appropriate antimicrobial, as needed.

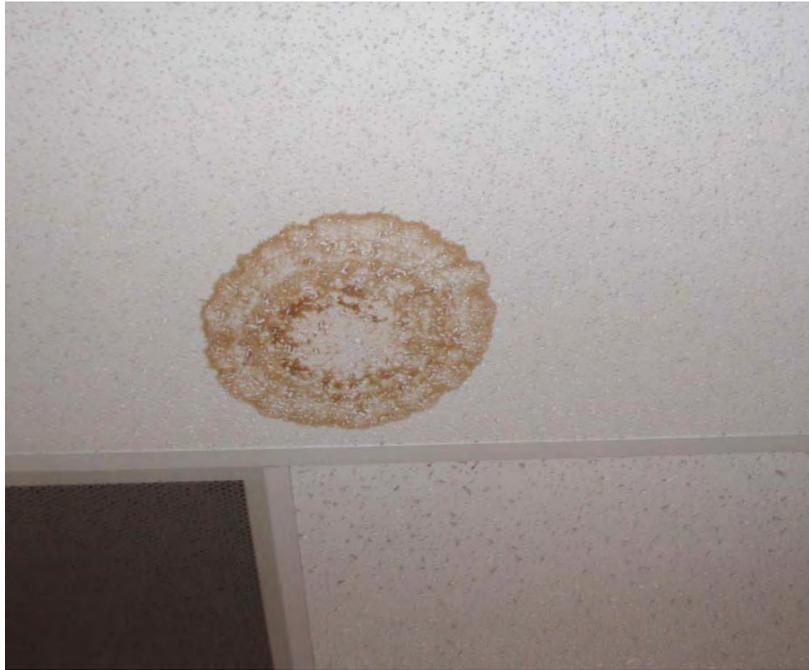
Picture 11

Water-Damaged Ceiling Tile

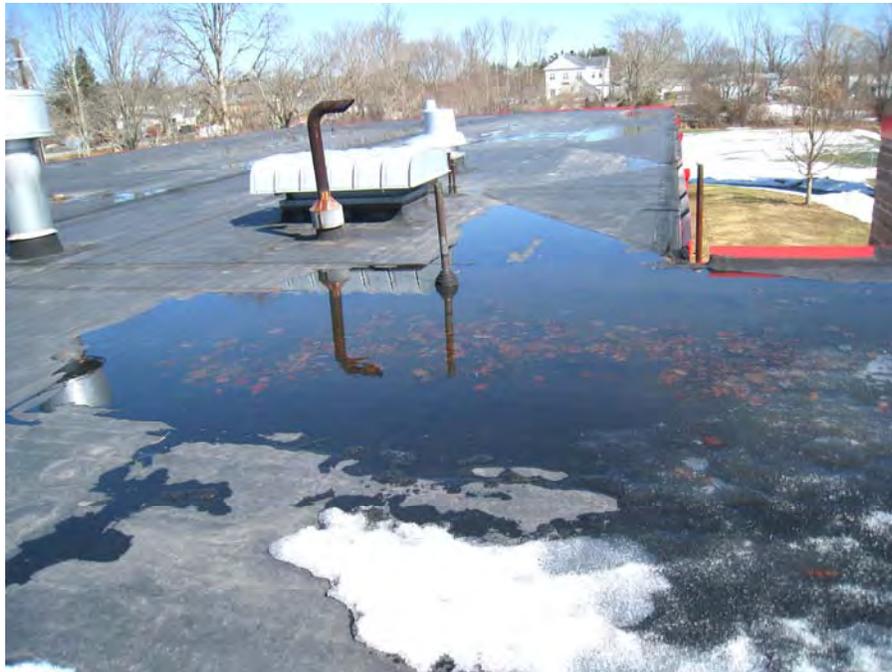
Picture 12

Pooling water/ice was observed in a number of areas (Picture 12). WBPS staff indicated that the building periodically experiences leaks where two different sections of the building are joined (Picture 13). Leaks from this area likely contribute to water-damaged ceiling tiles observed in the building, including those in the main lobby. Roof leaks should be repaired promptly and regular inspections of the roof should be carried out to detect and repair future leaks. Measures should also be taken to pitch the roof in a manner that improves drainage.

Pooled Water and Ice on the Roof

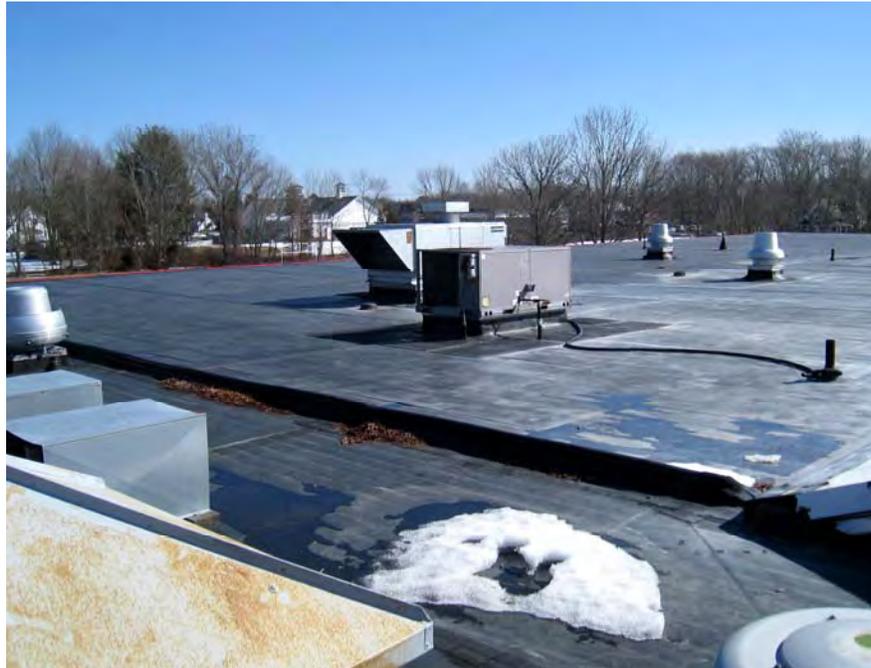
Picture 13

Joint in Roofs where Leaks are Believed to Occur

13. Ensure roof leaks are repaired, particular attention should be made to examine/repair the area between roof surfaces shown in Picture 13.
14. Until leak is repaired in main lobby, trim and remove water-damaged wallboard around structural column above ceiling plenum to prevent future water damage and potential mold growth.

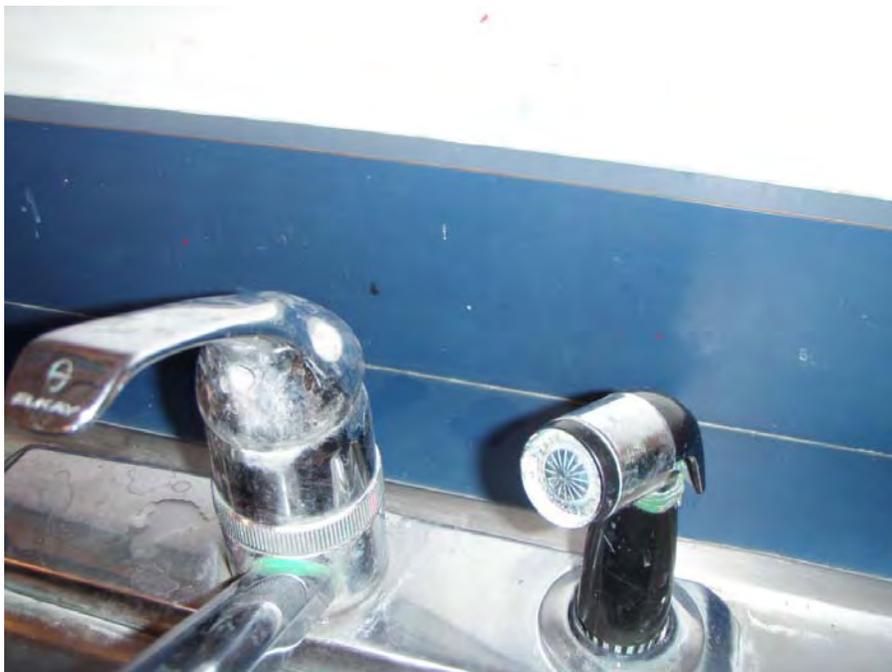
Picture 14

Sinks were observed in many classrooms. In some cases open or weakly-sealed seams were observed between backsplashes and countertops (Picture 14). If these areas are not made watertight, water can penetrate through the seam, causing water damage to the material under or behind the sink. Improper drainage or sink overflow can lead to water penetration into the countertop, cabinet interior and areas behind cabinets. Water penetration and chronic exposure of porous and wood-based materials can cause these materials to swell and show signs of water damage.

Example Backsplash/Countertop Seam

21. Seal areas around sinks to prevent water damage to the interior of cabinets and adjacent wallboard. Repair/replace countertop as necessary. Consider replacing these with a one piece/seamless molded countertop.

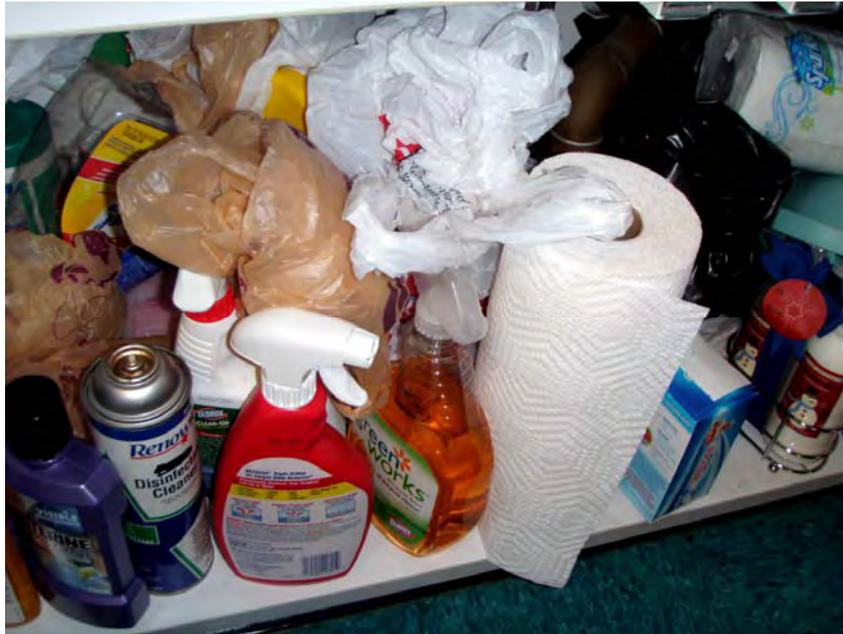
Picture 15

Many classrooms were also found to have porous materials (e.g., paper towels, cloth) stored beneath sinks, which is a humid environment (Picture 15). Repeated moistening of porous materials can result in mold growth. Storage of large amounts of material under the sinks can also prevent rapid detection of leaks.

Storage of Materials, Including Porous (Paper Towels) and Cleaning Products under Classroom Sink

22. Refrain from storing porous items (e.g., cardboard, paper) or large amounts of material beneath sinks.
23. Store cleaning products properly and out of reach of students. Ensure spray bottles are properly labeled. Consider providing standard school-issued cleaning products to staff.

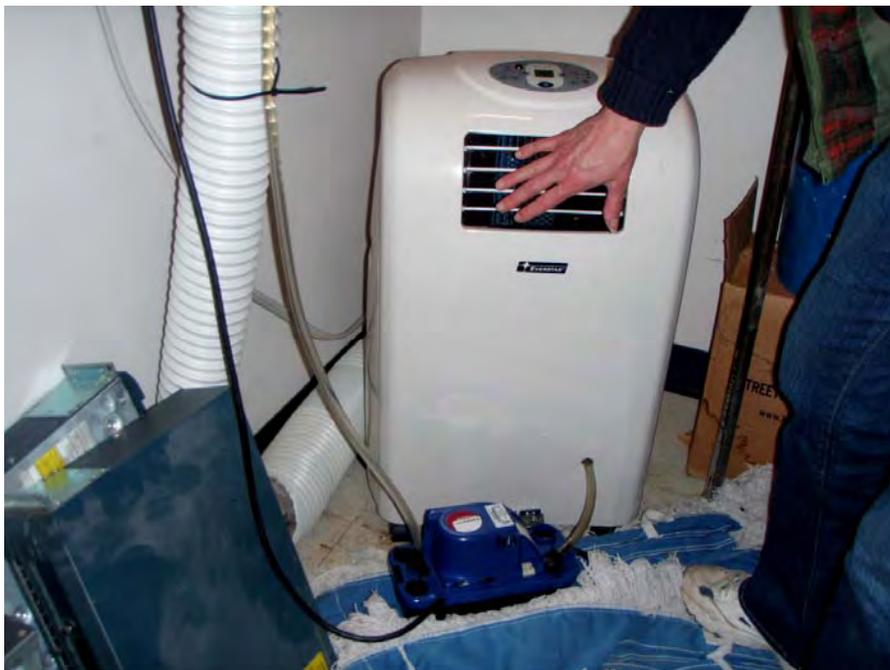
Picture 16

A portable air-conditioner was observed in the server room (Picture 16). At the time of assessment, the drainage system for the air-conditioner was not connected properly, allowing water to leak/empty onto the floor. Measures should be taken to ensure that these pipes are properly connected to prevent moistening of building materials, which can result in mold growth.

Portable Air Conditioner in Server Room

17. Provide proper drainage for portable air-conditioner in the server room (Picture 16).
18. Ensure plants have drip pans and avoid over-watering. Examine drip pans periodically for mold growth. Disinfect with an appropriate antimicrobial where necessary. Remove plants from near air diffusers.

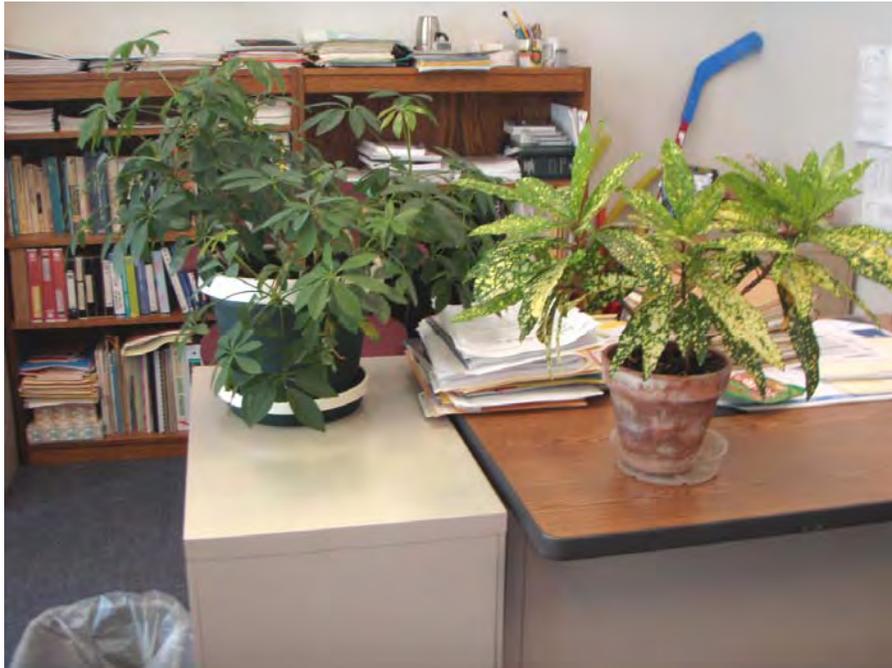
Picture 17

Plants were observed in several areas (Table 1; Picture 17). Plants should be properly maintained and equipped with washable drip pans. Some of the plants were located on or directly adjacent to univents (Picture 18). Plants should be located away from ventilation sources to prevent aerosolization and distribution of dirt, pollen or mold. Finally, they should not be placed on porous materials, since water damage to porous materials may lead to microbial growth.

Example of Plants in Building

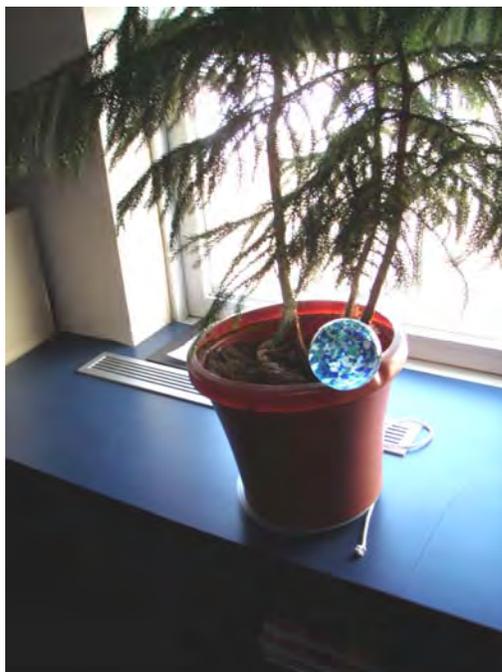
Picture 18

Plant Adjacent to Air Vent

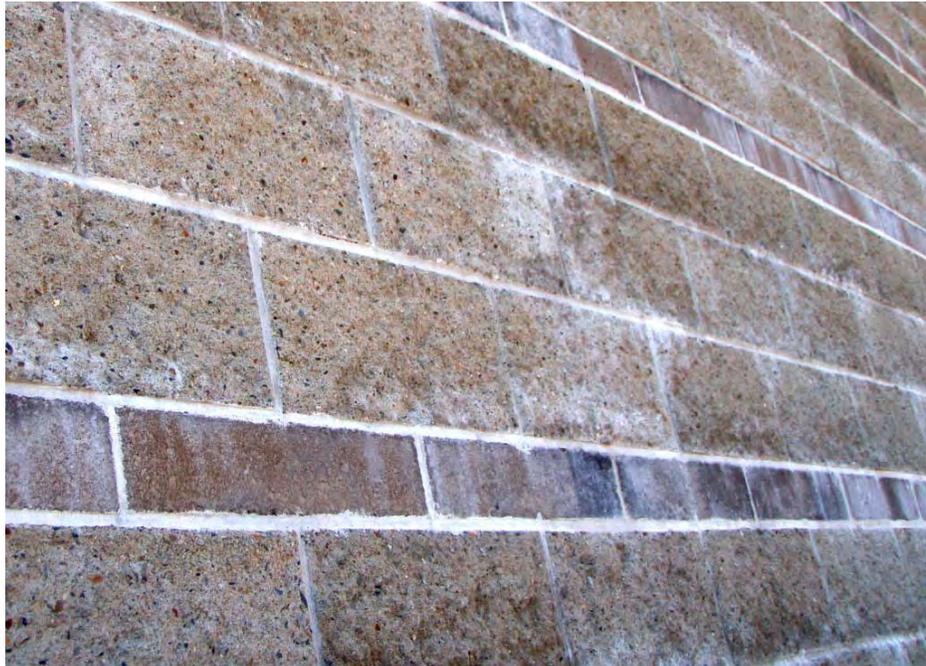
Picture 19

BEH staff examined the outside perimeter of the building to identify breaches in the building envelope and/or other conditions that could provide a source of moisture. Efflorescence was noted on the exterior masonry of the building (Picture 19). Efflorescence is a characteristic sign of water infiltration but it is not mold growth. As moisture penetrates and works its way through mortar, brick or plaster, water-soluble compounds dissolve, creating a solution. As the solution moves to the surface of the material, the water evaporates, leaving behind white, powdery mineral deposits. It was also noted that in some areas, exterior masonry did not appear to have the expected weep holes, which would let moisture penetrating through the masonry drain from the base of the wall; lack of these holes may have contributed to the efflorescence. See Figures [2](#) and [3](#) for illustration of the function of weep holes.

Masonry Wall Showing Efflorescence (white material)

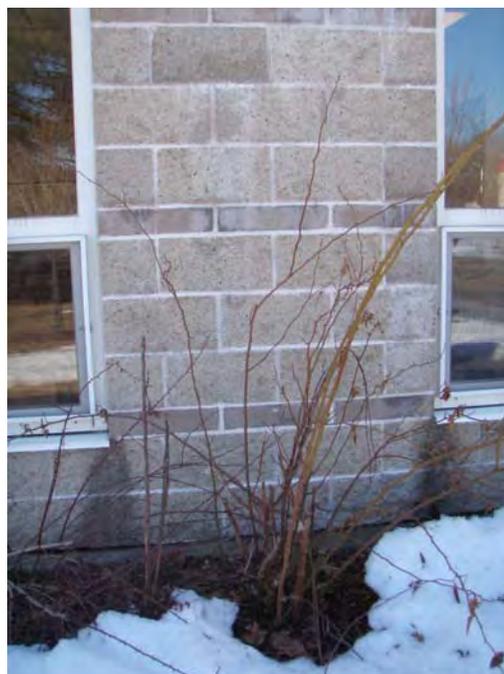
Picture 20

Plants were also observed growing in close proximity to the building's exterior (Picture 20), in some instances near univent fresh air intakes. Univents can draw in pollen and mold from

these plants and distribute them throughout the classroom. Furthermore, the growth of roots against exterior walls can bring moisture in contact with the foundation. Plant roots can eventually penetrate the wall, leading to cracks and/or fissures in the sublevel foundation. Over time, these conditions can undermine the integrity of the building envelope and provide a means of water entry into the building via capillary action through exterior walls, foundation concrete and masonry (Lstiburek & Brennan, 2001). At the base of exterior walls, some of the masonry had deteriorated (Picture 21), which can provide a means of drafts, moisture and pest entry into the building.

Plants Close to Building Foundation

19. Remove plants growing in close proximity of the building.
20. Repair damage to the building's foundation to prevent water/pest intrusion (Picture 21).

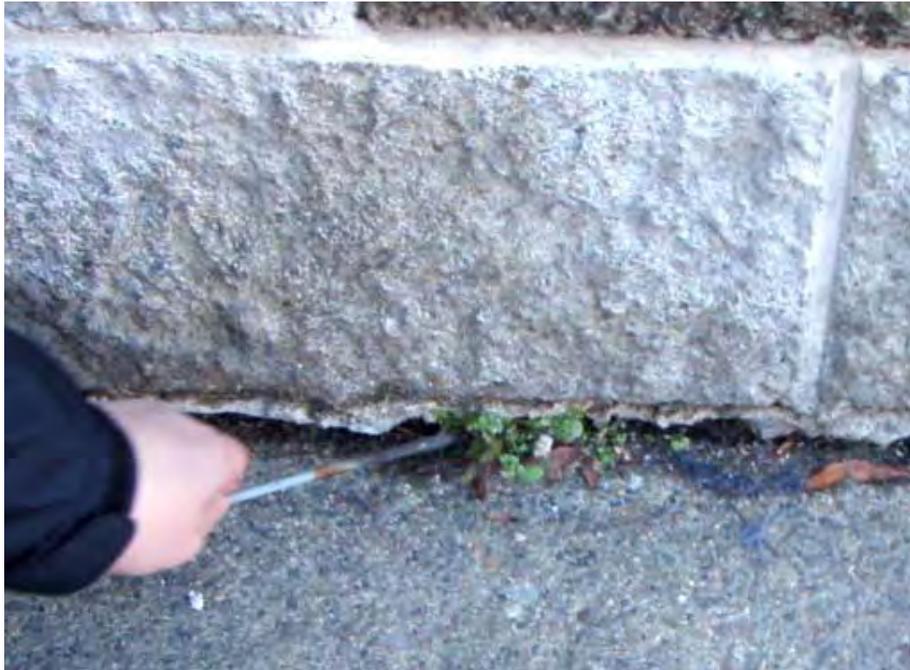
Picture 21

Deteriorating Masonry at Base of Exterior Wall

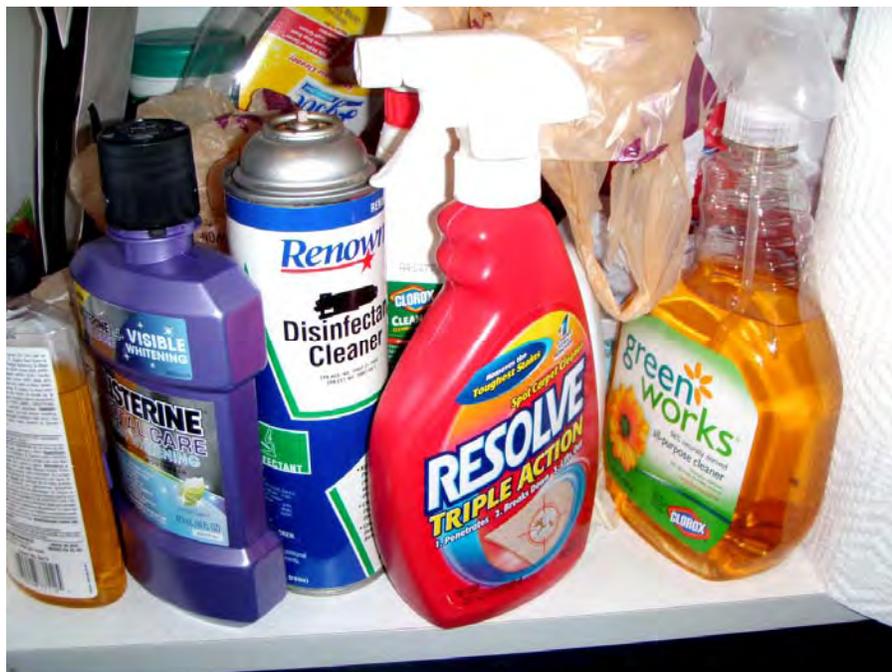
Picture 22

Cleaning products were found in a number of rooms throughout the building (Picture 22; Table 1). Cleaning products contain chemicals that can be irritating to the eyes, nose and throat of sensitive individuals. These products should be properly labeled and stored in an area inaccessible to children. In addition, a Material Safety Data Sheets (MSDS) should be available at a central location for each product in the event of an emergency. Consideration should be given to providing teaching staff with school issued cleaning products and supplies to prevent any potential for adverse chemical interactions between residues left from cleaners used by the facilities staff and those left by cleaners brought in by others.

Example of Cleaning Products Found in Classroom

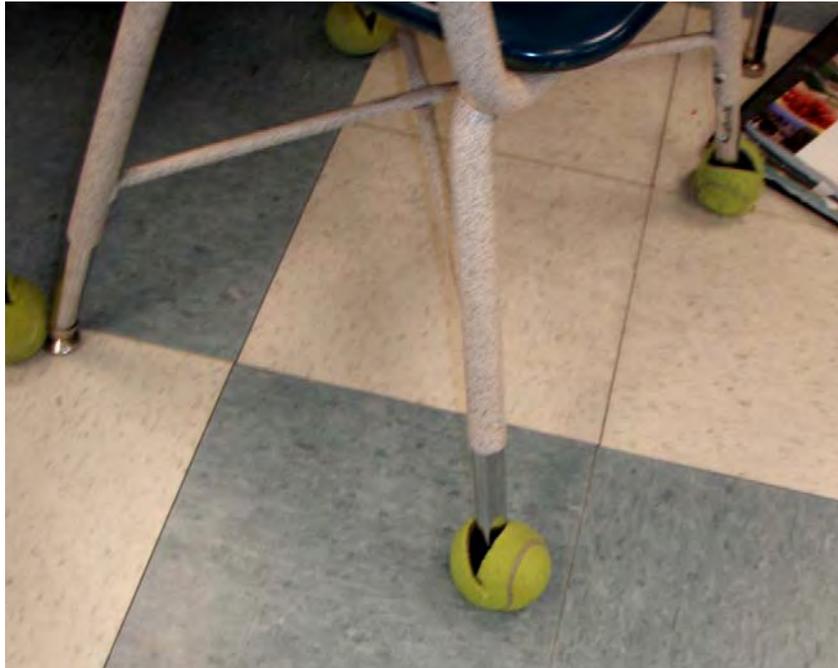
Picture 23

In an effort to reduce noise, tennis balls had been sliced open and placed on the base of desk/chair legs in some classrooms (Picture 23). Tennis balls are made of a number of materials that are a source of respiratory irritants. Constant wearing of tennis balls can produce fibers and cause VOCs to off-gas. Tennis balls are made with a natural rubber latex bladder, which becomes abraded when used as a chair leg pad. Use of tennis balls in this manner may introduce latex dust into the school environment. Some individuals are highly allergic to latex (e.g., spina bifida patients) (SBAA, 2001). It is recommended that the use of materials containing latex be limited in buildings to reduce the likelihood of symptoms in sensitive individuals (NIOSH, 1997).

Tennis Balls Used as Chair Glides

26. Refrain from using air fresheners and deodorizers to prevent exposure to VOCs.
27. Consider replacing latex-based tennis balls with latex-free tennis balls or glides.

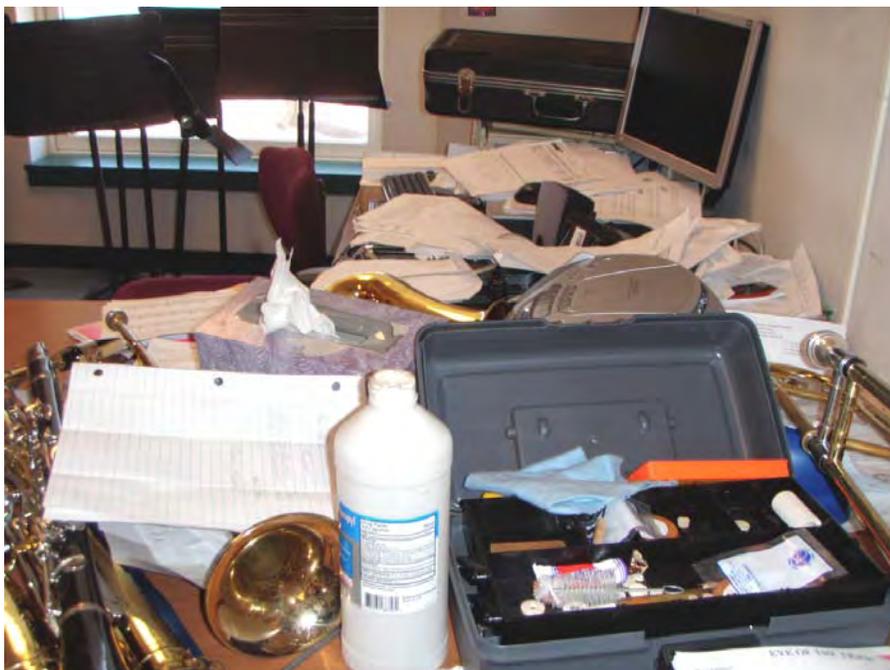
Picture 24

Items (Clutter) in the Band Room

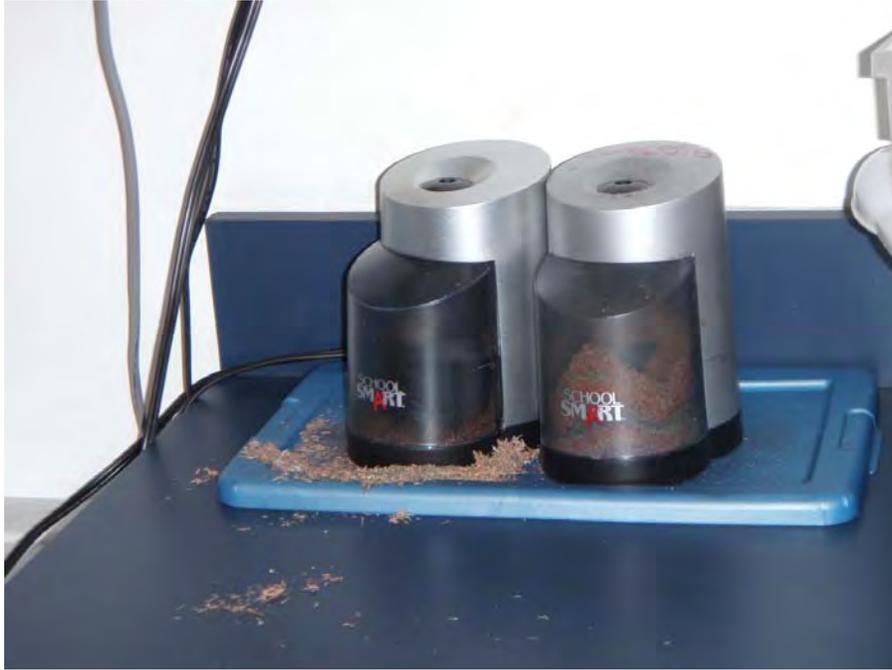
Picture 25

BEH staff observed pencil sharpeners with catch trays underneath them containing a large amount of pencil shavings (Picture 25). Chalk and dry erase board trays were also observed with a build up of chalk dust and whiteboard marker debris. These materials can be aerosolized by air movement from the ventilation system, doors opening and closing, or foot traffic and may present an eye or respiratory irritant.

Pencil Shavings
