# **INDOOR AIR QUALITY ASSESSMENT MOLD INVESTIGATION**

**Worcester County District Attorney's Office  
180 Main Street  
Worcester, Massachusetts**

Prepared by:  
Massachusetts Department of Public Health  
Bureau of Environmental Health  
Indoor Air Quality Program  
July 2011

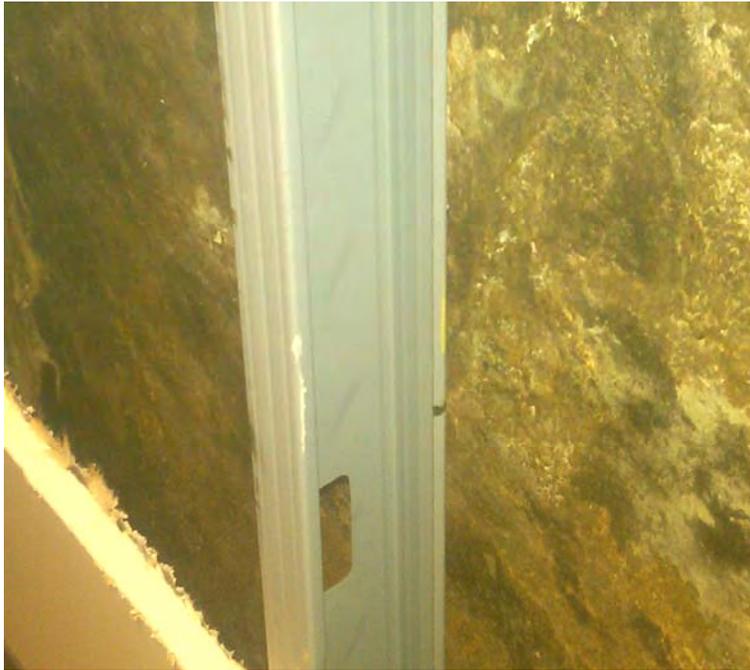
**Picture 1**

As previously discussed, the assessment was requested due to concerns of water damage to GW along the south exterior wall of the ground floor. At the time of the assessment the

affected areas had GW removed (Picture 1). The water-damaged areas are located along the south wall of the building that is buried under a slope, which has a paved parking lot at the top (Picture 2). The slope that buries the below grade portions of the building consists of soil and old brickwork which is not a water resistant surface (Picture 3). The parking lot has a small portion of its tarmac slightly pitched down slope (Picture 2). Rainwater has eroded soil adjacent to the building's exterior wall (Picture 3), which has created the conditions resulting in water penetration into the ground floor.

**Removed Gypsum Wallboard Revealing Interior Side of Foundation Wall**

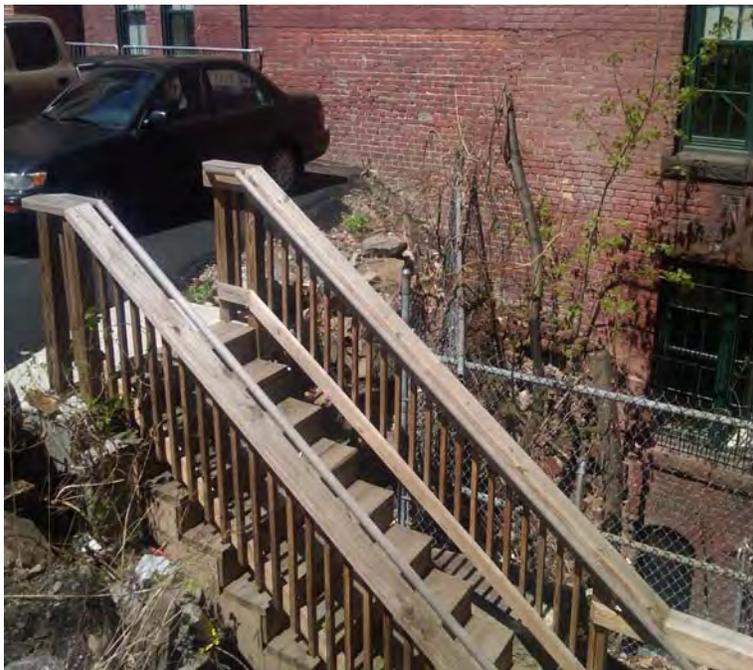
**Picture 2**

**Tarmac Parking Lot above First Floor (Note Slight Downhill Slope)**

1. A sloped apron to direct water away from the south exterior wall shown in Picture 3 should be installed. In addition, proper means of drainage for water that reaches the bottom of the slope needs to be addressed.

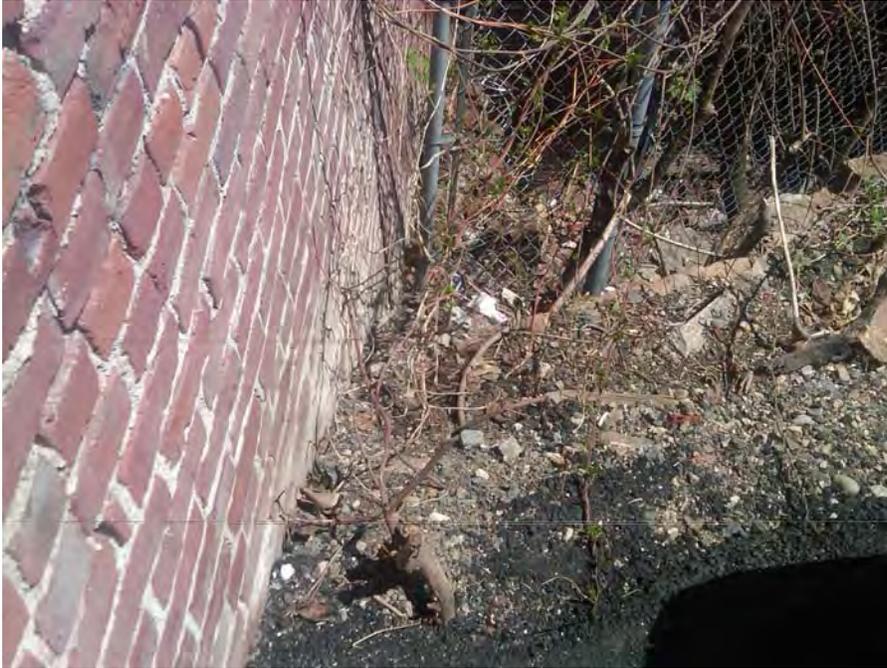
**Picture 3**

**Exterior Wall Buried beneath Soil**

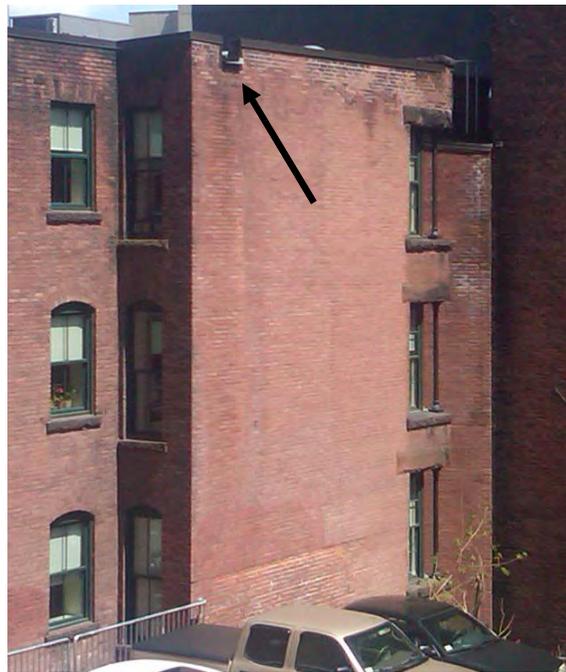
**Picture 4**

Adding to the water load above the ground floor offices is a scupper located on the roof parapet that pours water onto the tarmac in this area (Picture 4). This scupper appears to be the sole means for rainwater to drain from the flat lower roof. As water pours from the parapet, it is likely that brick directly below is routinely wet through seams between the tarmac and exterior wall (Picture 5). Repeated wetting of the exterior wall may also be producing moisture-related odors in the third floor office directly below the scupper. The office contains wood wainscoting, which is likely to produce a wet/woody odor if moistened chronically.

**Scupper that Drains Roof (Arrow)**

2. A downspout should be installed on the scupper to drain water from the lower roof. The downspout should be installed in a manner to direct rainwater away from the south exterior wall. Installing the downspout in a manner to drain rainwater into the cement lined pit below the parking lot may be an option. With installation of a downspout, the odor in the third floor office will likely resolve.
3. Remove unnecessary plastic coving from interior brick walls to prevent moisture trapping.
4. Consider installing a water-impermeable wall material (e.g., cement board) in below grade offices which have a history of water damage.

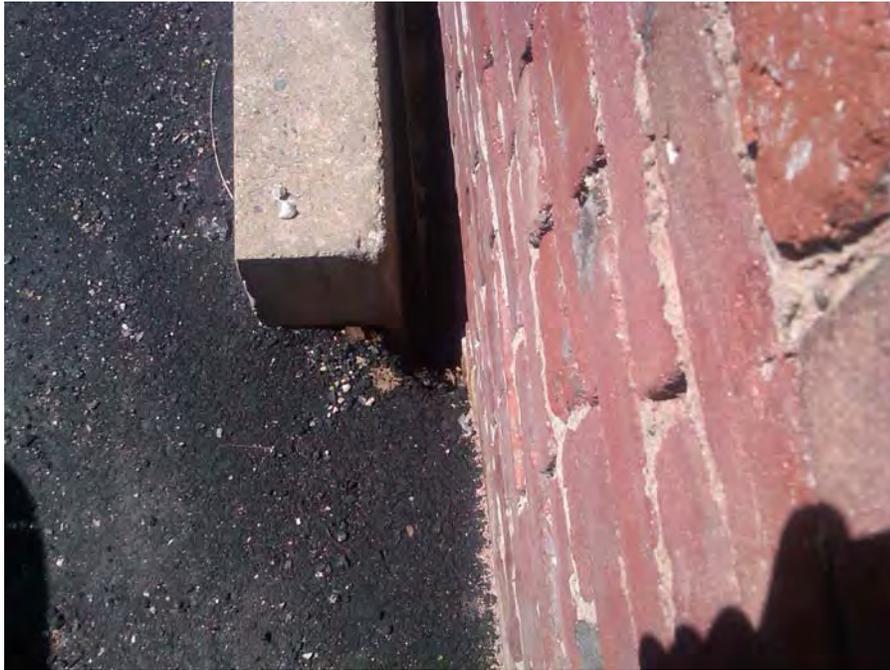
**Picture 5**

**Tarmac/Wall Seams below Scupper**
