# **INDOOR AIR QUALITY ASSESSMENT**

**Horace Mann Charter School  
730 Osterville West Barnstable Road  
Marston Mills, Massachusetts**

Prepared by:  
Massachusetts Department of Public Health  
Bureau of Environmental Health  
Indoor Air Quality Program  
June 2012

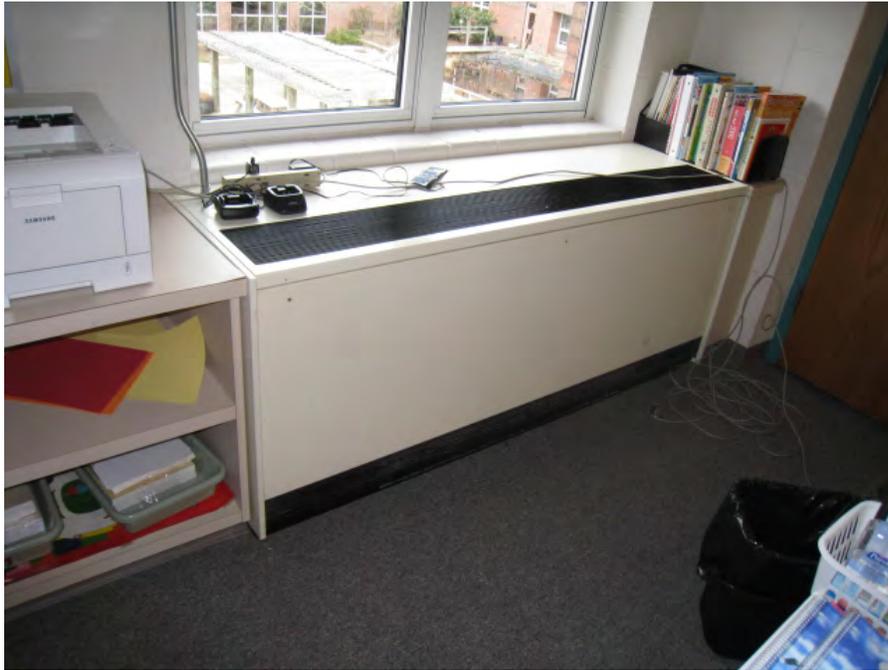
**Picture 1**

Fresh air in classrooms is supplied by unit ventilators (univents) (Picture 1). A univent is designed to draw air from outdoors through a fresh air intake located on the exterior wall of the building (Picture 2). Return air is drawn through an air intake located at the base of each unit where fresh and return air are mixed, filtered, heated and provided to classrooms through an air diffuser located in the top of the unit ([Figure 1](#)).

**Classroom Univent**

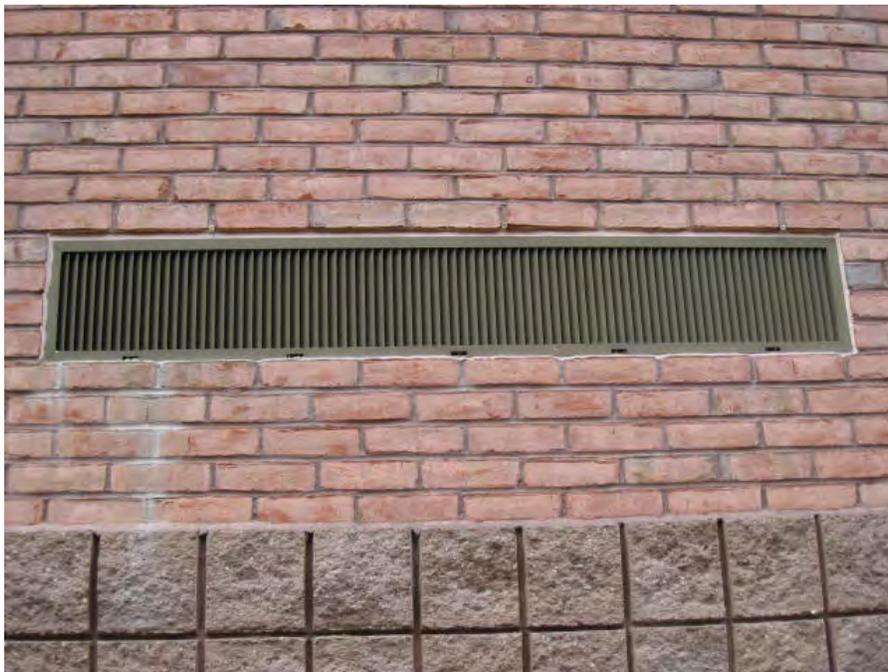
**Picture 2**

**Univent Fresh Air Intake**

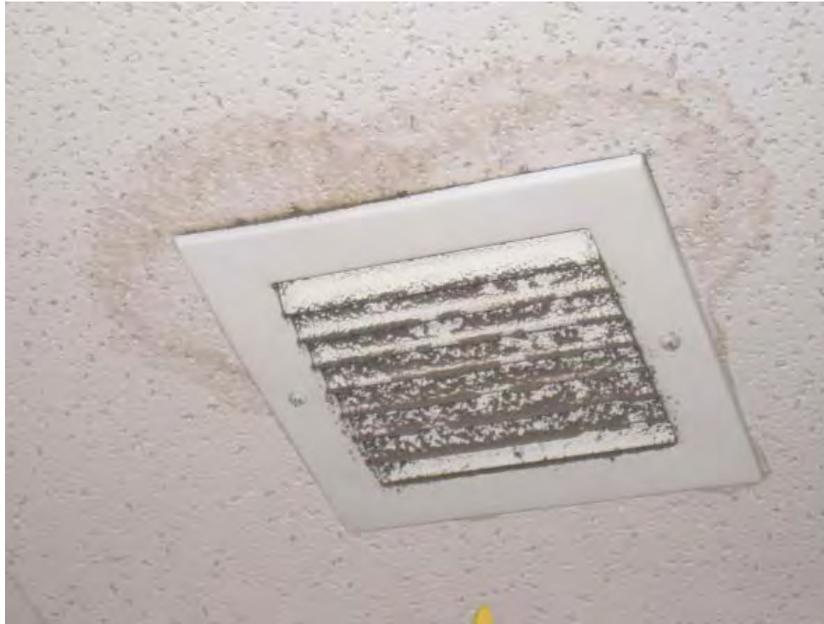
**Picture 3**

Exhaust ventilation in classrooms is provided by wall or ceiling vents ducted to rooftop motors (Picture 3). Exhaust ventilation was found deactivated in a number of areas during the assessment (Table 1), which may indicate that they were shut off or in need of repair. As with univents, in order to function properly, exhaust vents must be activated and allowed to operate while rooms are occupied. Without adequate supply and exhaust ventilation, excess heat and environmental pollutants can build up and lead to indoor air/comfort complaints. In addition, some return/exhaust vents are located near classroom doors (Table 1). Due to their location, the exhaust capabilities of these vents can be diminished when the doors are open. With the classroom doors open, the return/exhaust vent tends to draw air from the hallway *into* the classroom rather than remove stale air *out* of the classroom.

A number of air diffusers, exhaust/return vents and personal fans were found to have accumulated dust/debris (Picture 3). If exhaust vents are not functioning, backdrafting can occur, which can re-aerosolize accumulated dust particles. Re-activated supply, exhaust/return vents and fans can also aerosolize dust accumulated on vents/fan blades.

**Ceiling-Mounted Exhaust Vent in Library Office, Note Dust/Debris Accumulation on Vent and Water-Damaged Ceiling Tile**

23. Clean air diffusers, exhaust/return vents and personal fans periodically of accumulated dust.
24. Clean carpeting annually or semi-annually in soiled high traffic areas as per the recommendations of the Institute of Inspection, Cleaning and Restoration Certification (IICRC). Copies of the IICRC fact sheet can be downloaded at:  
[http://www.cleancareseminars.com/carpet\\_cleaning\\_faq4.htm](http://www.cleancareseminars.com/carpet_cleaning_faq4.htm) (IICRC, 2005)

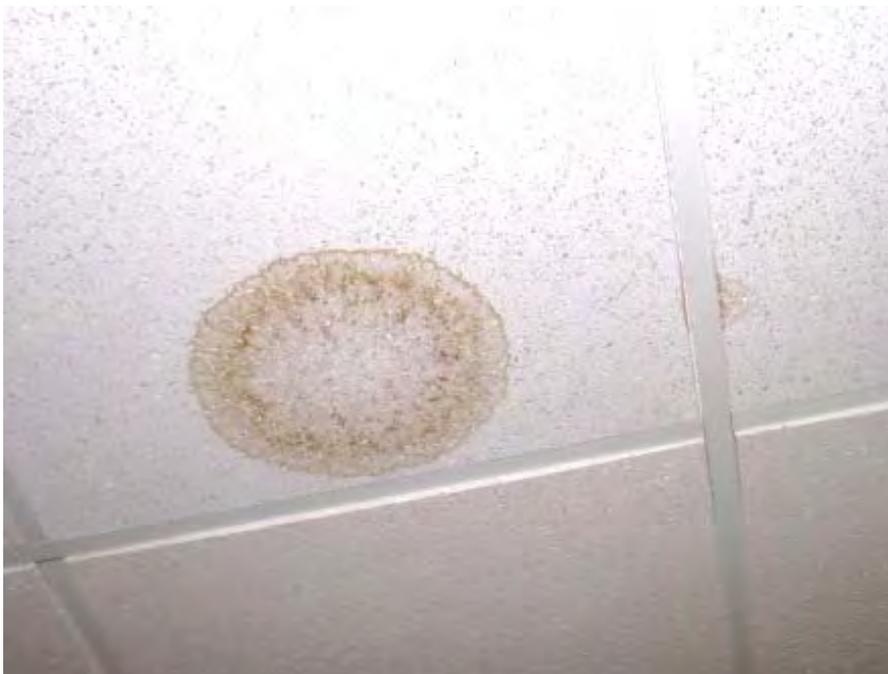
**Picture 4**

Water-damaged ceiling tiles were observed in a number of areas and peeling paint and water-damaged ceiling material was observed adjacent to the rotunda in the library. These indicate current/historic plumbing and/or roof leaks (Pictures 3 through 6, Table 1). Water-damaged ceiling tiles can provide a source of mold and should be replaced after a water leak is discovered and repaired. Bowed/warped ceiling tiles and wrinkled carpeting was also observed in a number of areas throughout the building indicating chronic issues with moisture/humidity control (Pictures 7 through 9).

**Water-Damaged Ceiling Tile**

14. Ensure roof/plumbing leaks are repaired and replace any remaining water-damaged ceiling tiles. Examine the area above these tiles for mold growth. Disinfect areas of water leaks with an appropriate antimicrobial, as needed.

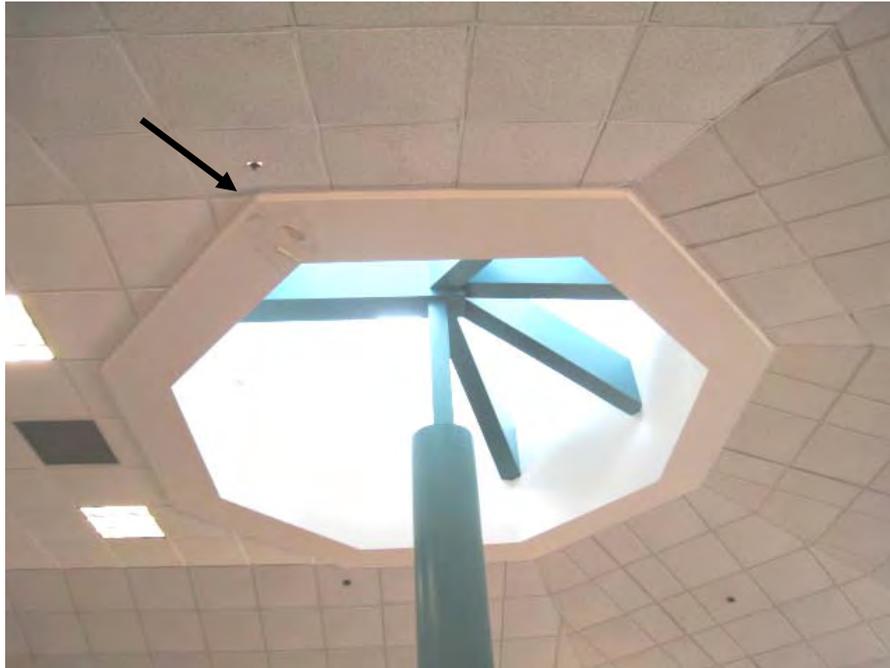
**Picture 5**

**Peeling Paint and Water-Damaged Ceiling Material (Arrow) near Library Rotunda**

15. Refinish water-damaged ceiling in library near rotunda.
16. Consider discontinuing use of manmade pond in courtyard.

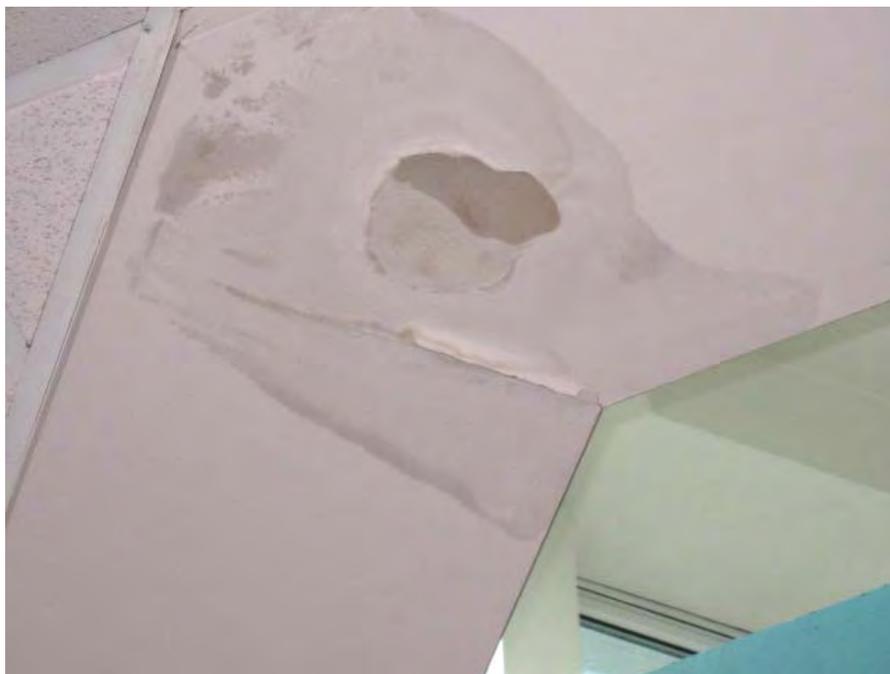
**Picture 6**

**Close-up of Peeling Paint and Water-Damaged Ceiling Material near Library Rotunda**

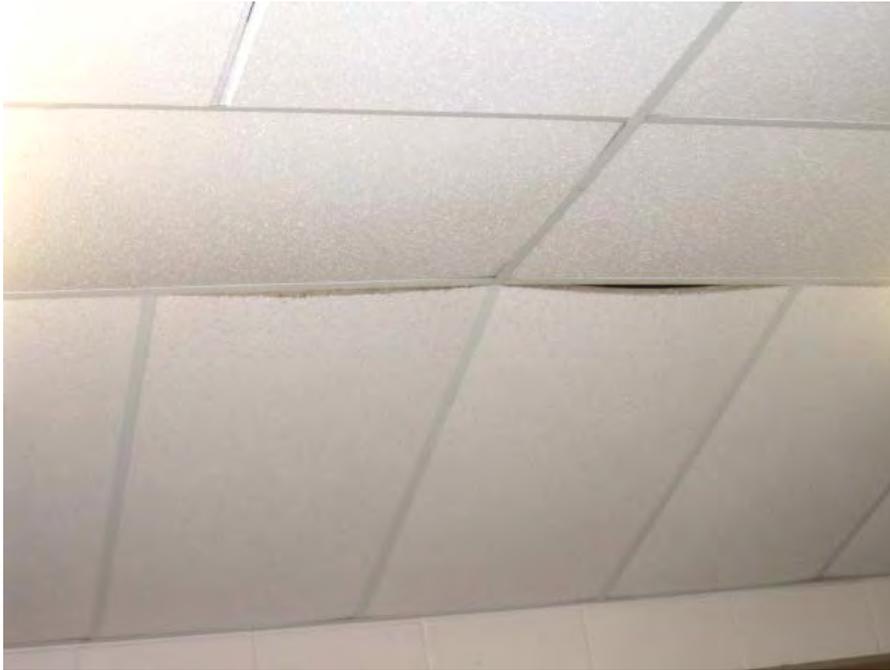
**Picture 7**

**Bowed Ceiling Tiles in Classroom**

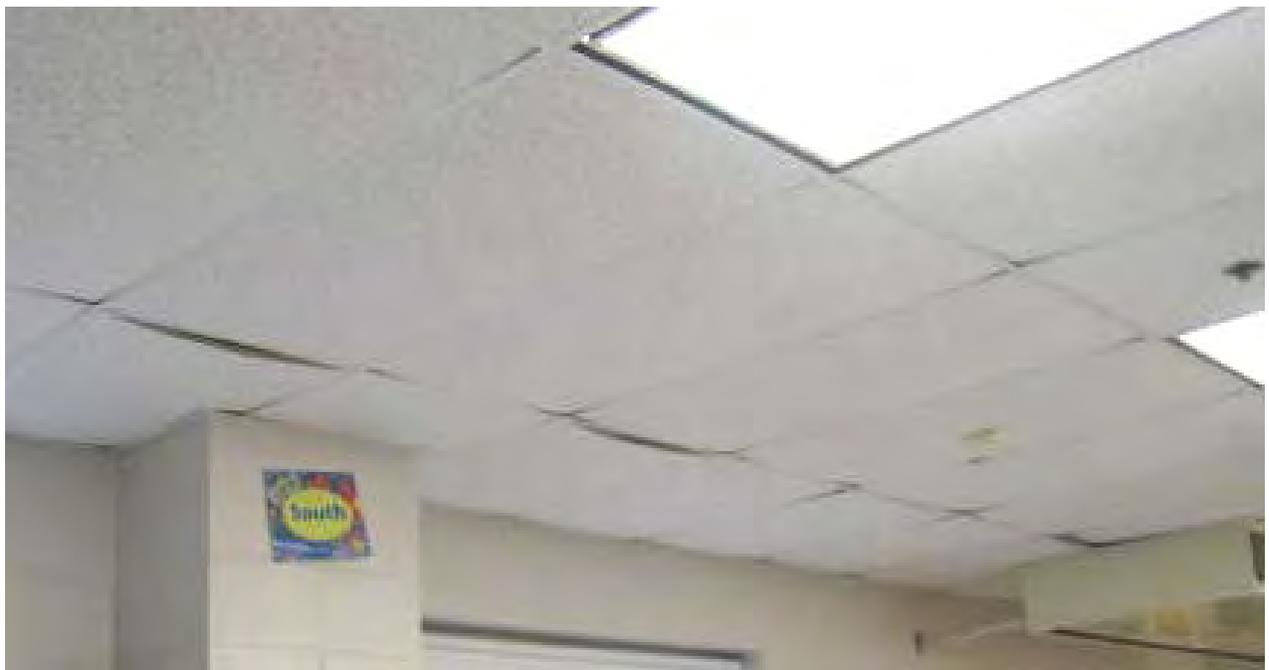
**Picture 8**

**Bowed Ceiling Tiles in Classroom**

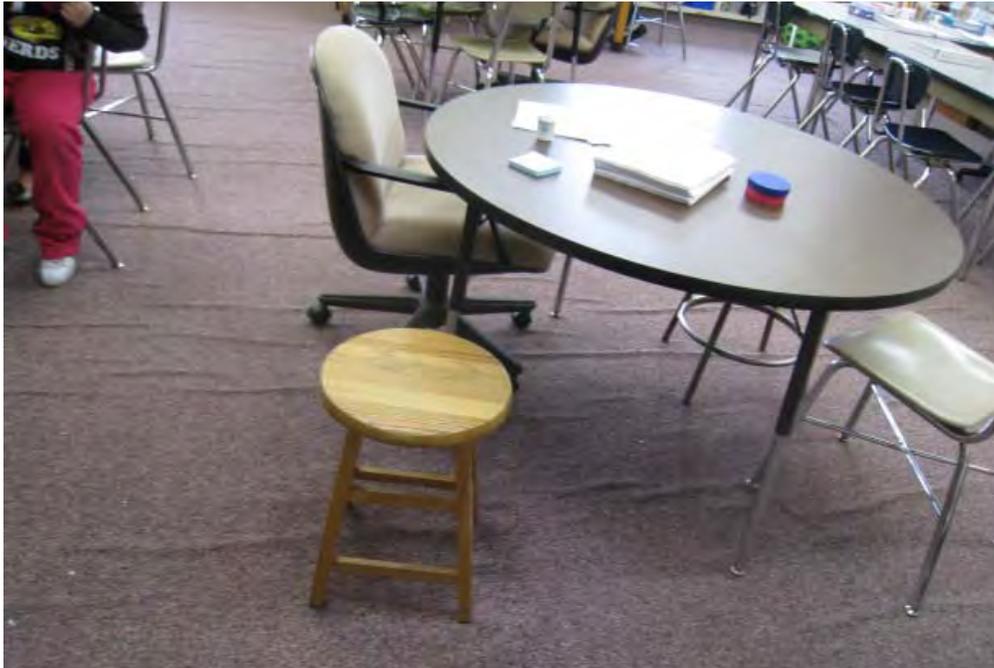
**Picture 9**

**Wrinkled Carpeting in Classroom**

25. Consider a long-term plan to replace all carpeting in the building as funds become available. Consider replacing carpeting with a non-porous surface such as vinyl tile particularly in below-grade areas.

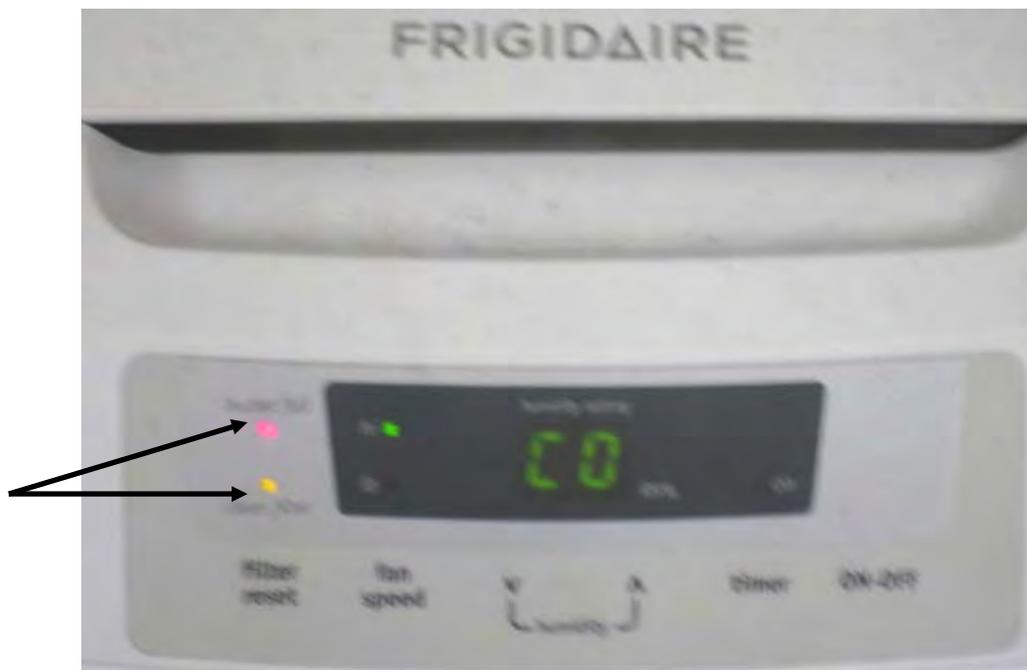
**Picture 10**

Several areas had dehumidifiers present (Table 1), in one case, a dehumidifier had both the “bucket full” and “clean filter” indicator lights on (Picture 10). Dehumidifiers should be cleaned and maintained as per the manufacturer’s instructions to prevent standing water and mold growth.

**Dehumidifier in Classroom, Note “Bucket Full” and “Clean Filter” Lights are Lit (Arrows)**

12. Do not open windows if HVAC system is in its air-conditioning setting to avoid condensation.
13. Continue to supplement the HVAC system, as needed, in susceptible/problem areas with portable dehumidifiers during humid months. Ensure that dehumidifiers are cleaned and maintained per the manufacturer's instructions, to prevent standing water and mold growth.

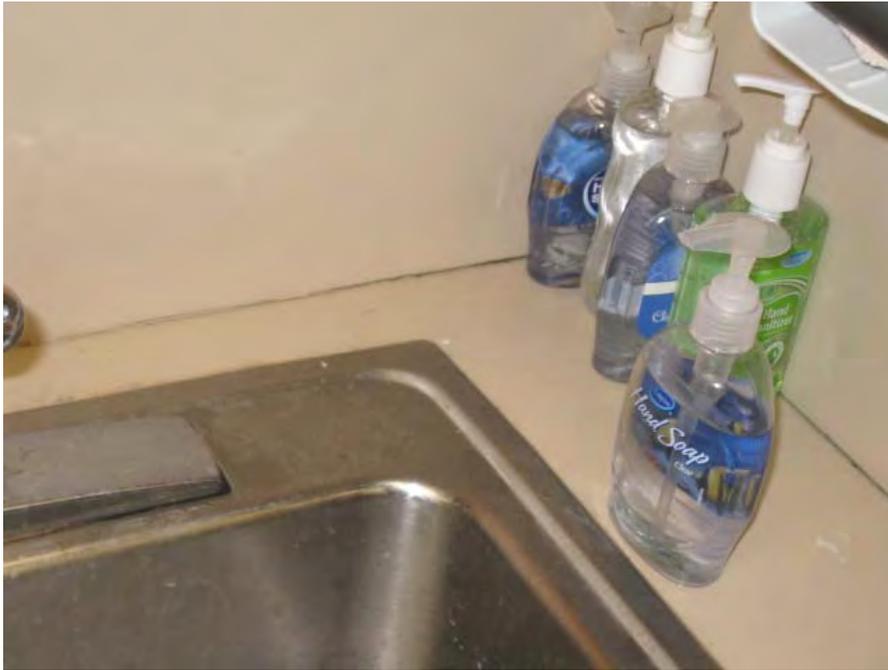
**Picture 11**

Breaches exist between countertops and sink backsplashes in a number of classrooms (Picture 11; Table 1). Water can penetrate through backsplash seams if they are not watertight. Water penetration and chronic exposure of porous and wood-based materials can cause these materials to swell and show signs of water damage. As discussed, moistened materials that are not dried within 24 to 48 hours can become potential sources for mold growth.

**Spaces between Sink Countertop and Backsplash**

19. Seal breaches, seams and spaces between sink countertops and backsplashes to prevent water damage.
20. Store cleaning products properly and out of reach of students. All cleaning products used at the facility should be approved by the school department with MSDS' available at a central location.

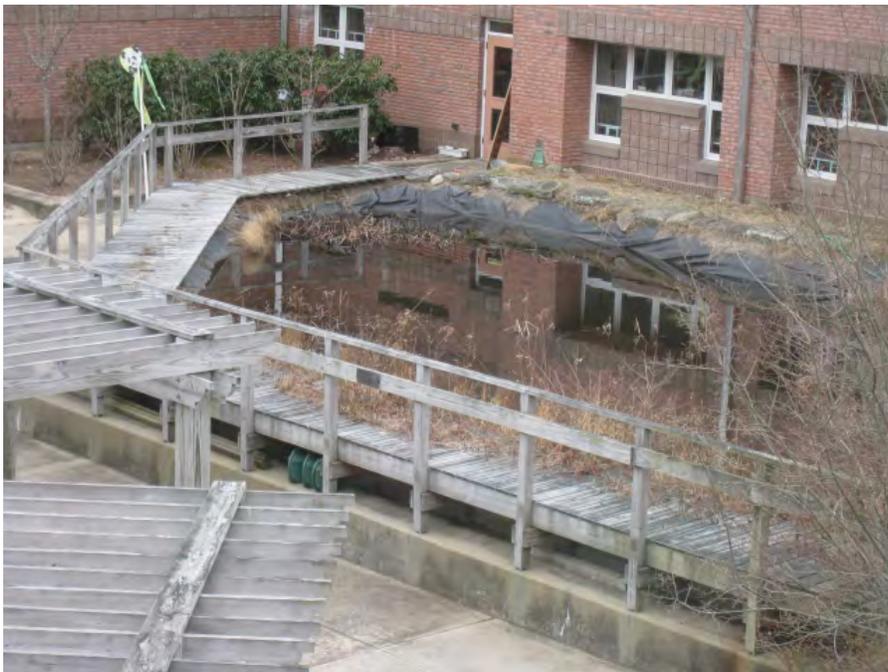
**Picture 12**

BEH staff conducted a perimeter inspection of the building’s exterior to identify other potential sources of water penetration. A likely source of moisture contributing to elevated relative humidity in the building is a man-made pond that is located in the central courtyard (Pictures 12 through 14). This body of water can become stagnant providing a source of mold, bacteria and associated odors. It can also serve as an attractant to aquatic bird life (e.g., geese, ducks) and the waste products associated with these animals. Finally, the manmade structure can

flood during heavy rain events. If its capacity were to be exceeded or its structural integrity fails, it could result in a tremendous water load on the exterior walls of the building and lead to water penetration and damage to interior building materials.

**Manmade Marsh in Central Courtyard, Note Build-up of Material against Exterior Wall**

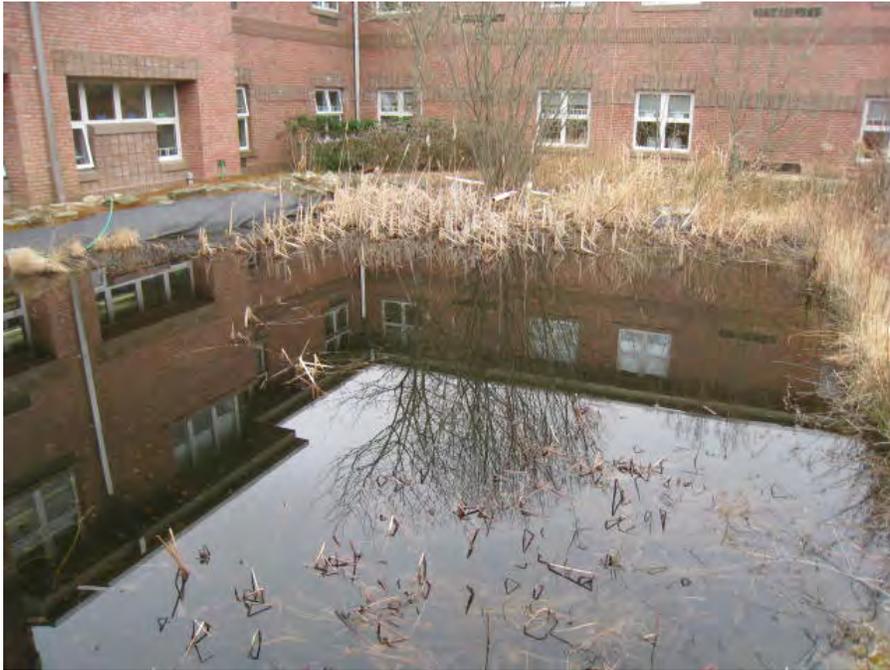
**Picture 13**

**Manmade Marsh in Central Courtyard, Note Build-up of Material against Exterior Wall**

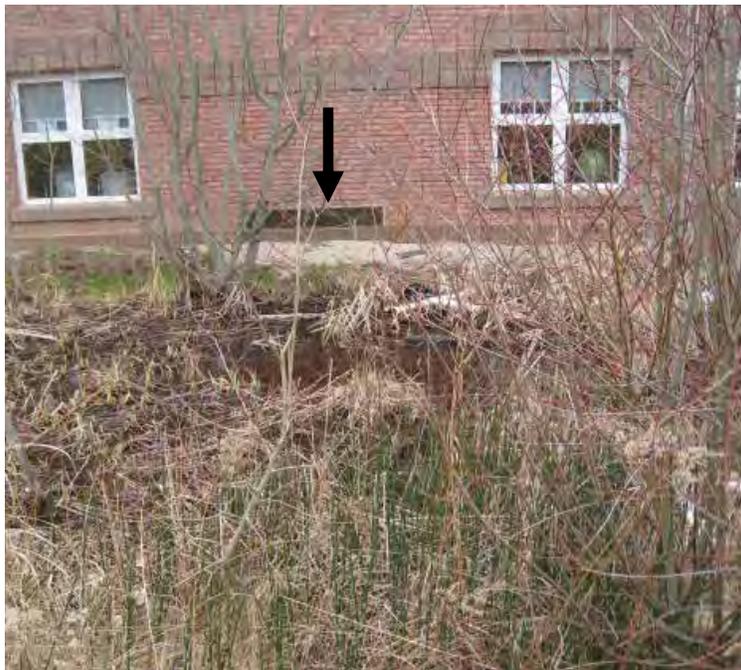
**Picture 14**

Other issues can be associated with the man-made pond that is located in the central courtyard. The pond does not appear to have a means to circulate or drain/refill the water, which can lead to stagnation, algae growth and odors. In addition, standing water can serve as a breeding ground for mosquitoes and should be removed where found.

**Manmade Marsh near Univent Fresh Air Intake (Arrow)**

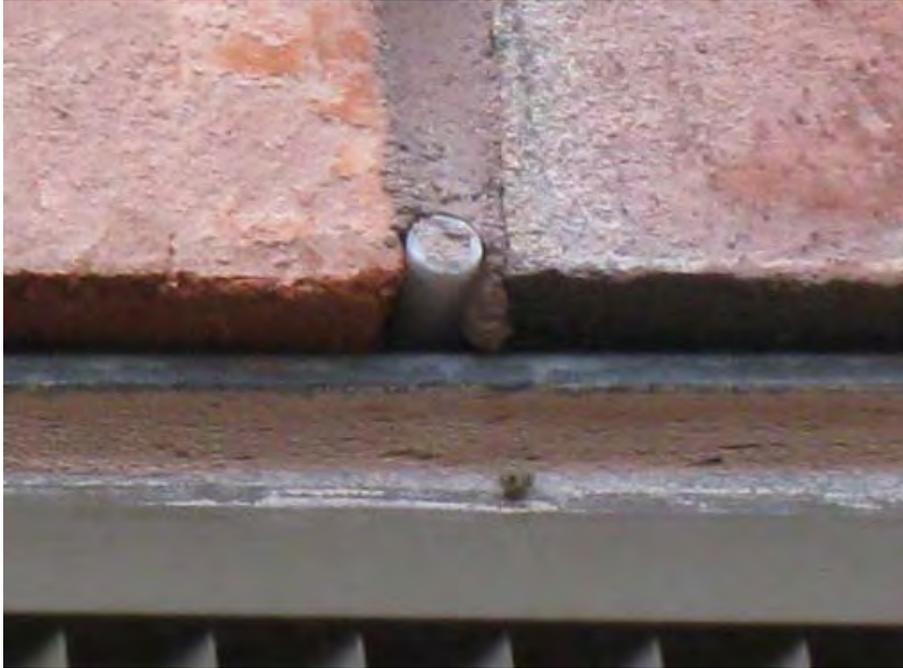
**Picture 15**

During the BEH assessment, water staining was observed on exterior walls. This pattern of staining may result from water trapped behind the exterior wall. During an examination of the building's exterior, BEH staff found weep holes closed with cement (Pictures 15 and 16).

Failure to install weep holes in brickwork or clogging/burial of weep holes below grade will allow water to accumulate in the base of walls, resulting in seepage and possible moistening of building components ([Figure 3](#)).

Over time, these conditions can undermine the integrity of the building envelope and provide a means of water entry into the building via capillary action through foundation concrete and masonry (Lstiburek & Brennan, 2001). The freezing and thawing action of water during the winter months can create cracks and fissures in the foundation. In addition, these breaches may provide a means for pests/rodents to enter the building.

**Weep Holes Sealed with Cement**

9. Remove blockages from affected weep holes to ensure proper operation of drainage plane.
10. Consider contacting a building engineering firm, public works and/or building envelope specialist to determine methods of preventing chronic water infiltration/condensation in below grade areas.

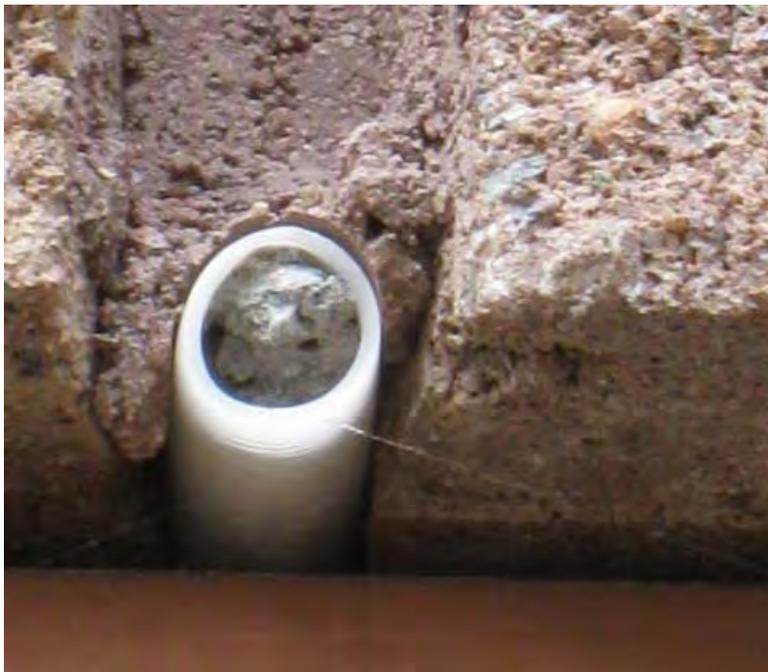
**Picture 16**

**Close-up of Weep Holes Sealed with Cement**

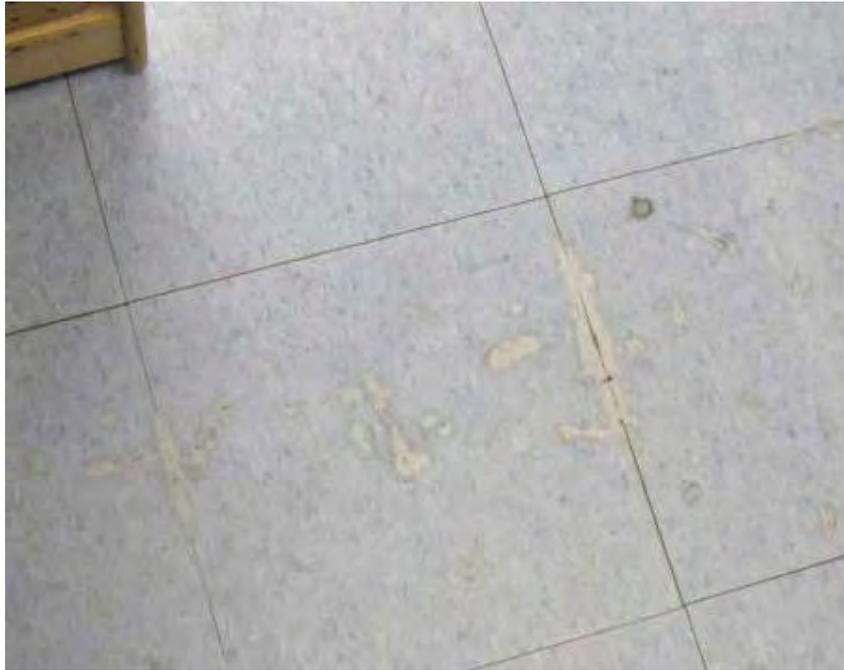
**Picture 17**

As mentioned, concerns regarding water damage and mold prompted the visit to the HMCS. The specific concerns related to dark staining and black substances on and around floor tiles in some of the ground floor classrooms (Picture 17). MDPH staff could not confirm if a vapor barrier was installed beneath the slab to prevent the seepage of moisture from sub-slab areas through the floor. Without a vapor retarder moisture can be drawn upward through the concrete slab by hydrostatic pressure and/or capillary action. Moisture can dissolve alkalis in concrete to form a solution, resulting in higher pH levels beneath flooring that can lead to the breakdown of adhesives (Donnelly, 2005). Since mastic material is sticky, it may collect dirt, dust and debris and provide a medium for mold growth, especially if wetted repeatedly (e.g., mopping, high humidity over an extended period/several days). Mastic residue, however, is not mold growth.

If a nearby water source exists to increased localized hydraulic pressure on the underside of a building's slab, water penetration may increase. Although water infiltration may be a possible source of moisture impacting floor tiles, humidity during summer months also appears

to be a potential source for moisture in the building. In particular, it was reported that the issues with the floor tiles may have coincided with humid weather. Since the floor is on slab, the temperature of the floor may be lower than that of the air. Under conditions of high humidity, a colder floor may be lower than the dew point of the air. The dew point is used as a way to describe humidity—the dew point is the temperature at which the water in the air will start to condense. If there are surfaces with temperatures below the dew point, water condensation may occur. If the floor tiles at HMCS are at a lower temperature than the dew point during warm, humid weather, this may contribute to moistening of the materials with associated mastic integrity problems, other water damage, and potential mold growth. The location of the affected rooms along the northern side of the building, which is shaded by the building, and is near an adjacent forested area, may also subject this area of the building to more condensation/moisture than other parts of the building. Keeping the floors clean of dust and debris, using cleaning practices that dry floors thoroughly, and limiting the introduction of humid air into the building, are all steps that will help prevent water damage and mold on floor tiles in these locations.

**Damaged Floor Tile**

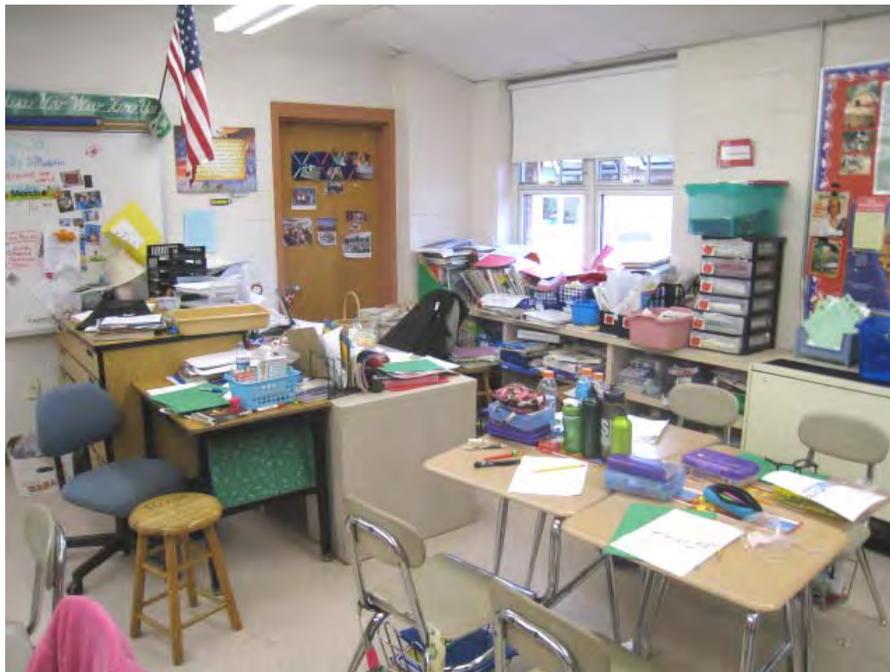
**Picture 18**

**Accumulated Items on Flat Surfaces in Classroom**
