INDOOR AIR QUALITY POST-FLOODING ASSESSMENT

**Massachusetts Department of Developmental Services
100 Cummings Center
Suite 150B
Beverly, Massachusetts**

Prepared by:
Massachusetts Department of Public Health
Bureau of Environmental Health
Indoor Air Quality Program
January 2012

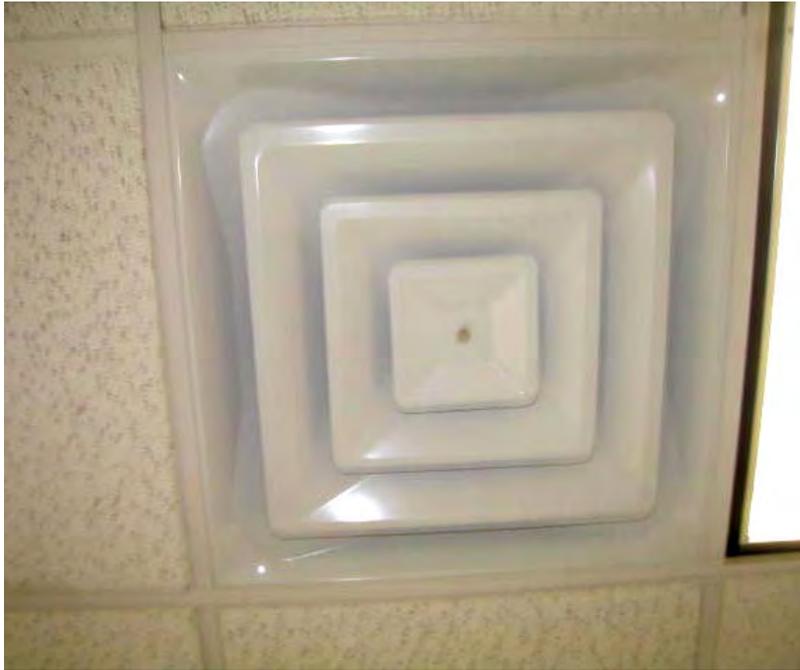
Picture 1

Ceiling-Mounted Supply Diffuser

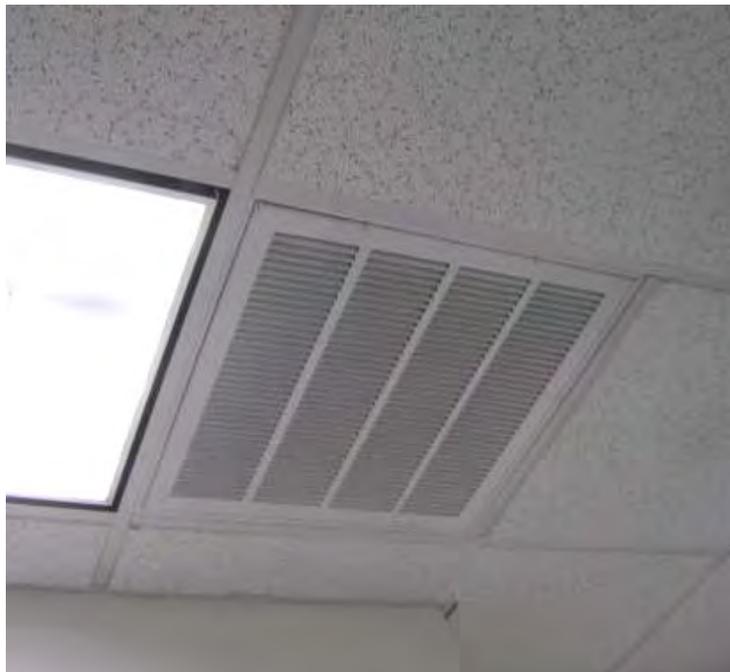
Picture 2

Ceiling-Mounted Return Vent

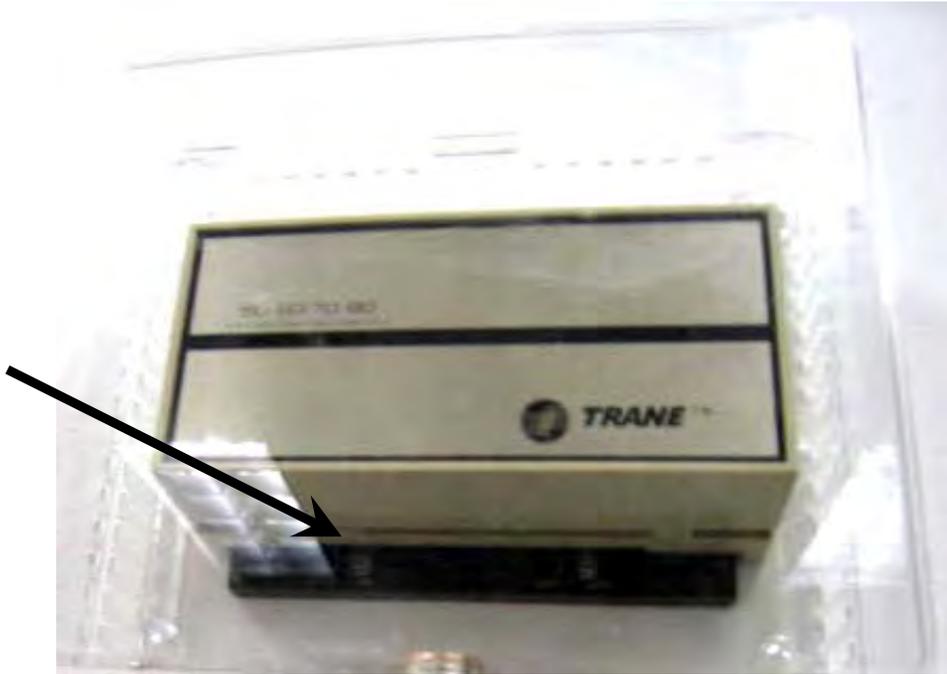
Picture 3

The HVAC system is controlled via wall-mounted thermostats located around the office (Picture 3). The thermostats examined at the DDS office were set in the *on* position which is the MDPH recommended setting to provide continuous air circulation.

Thermostat, Fan set to “On” (arrow)

1. Continue operating the HVAC system in fan “on” mode during occupied hours to maximize air circulation and filtration.
2. Repair the leaking kitchen faucet and the broken window in office 2 to prevent any water infiltration and damage.

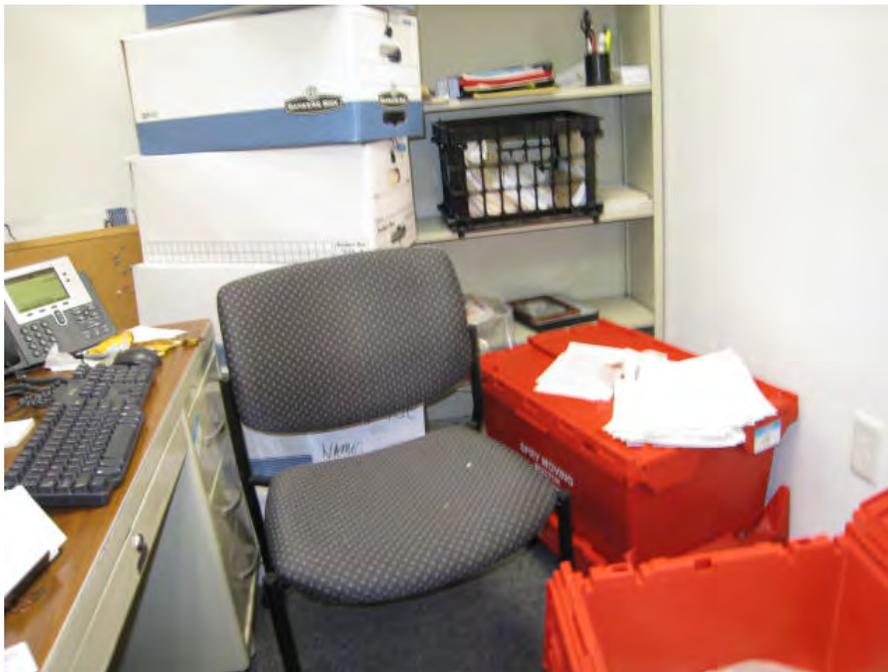
Picture 4

Several other conditions that can potentially affect indoor air quality were identified during the assessment. In a number of areas, items were observed on the floor, windowsills, tabletops, counters, bookcases and desks (Pictures 4 and 5). Many of these items were still being unpacked from boxes. The large number of items stored provides a source for dusts to accumulate. These items (e.g., papers, folders, boxes) make it difficult for custodial staff to clean. Items should be relocated and/or be cleaned periodically to avoid excessive dust build up. In addition, dusts can accumulate on flat surfaces (e.g., desktops, windowsills and carpets) in occupied areas and subsequently be re-aerosolized causing further irritation (Picture 6).

Still Packed Boxes and Items in Office

8. Clean stored and personal items regularly to prevent excessive dust build-up.
9. Refrain from burning candles in building.
10. Clean carpeting annually or semi-annually in soiled high traffic areas as per the recommendations of the Institute of Inspection, Cleaning and Restoration Certification (IICRC). Copies of the IICRC fact sheet can be downloaded at:
http://www.cleancareseminars.com/carpet_cleaning_faq4.htm (IICRC, 2005)

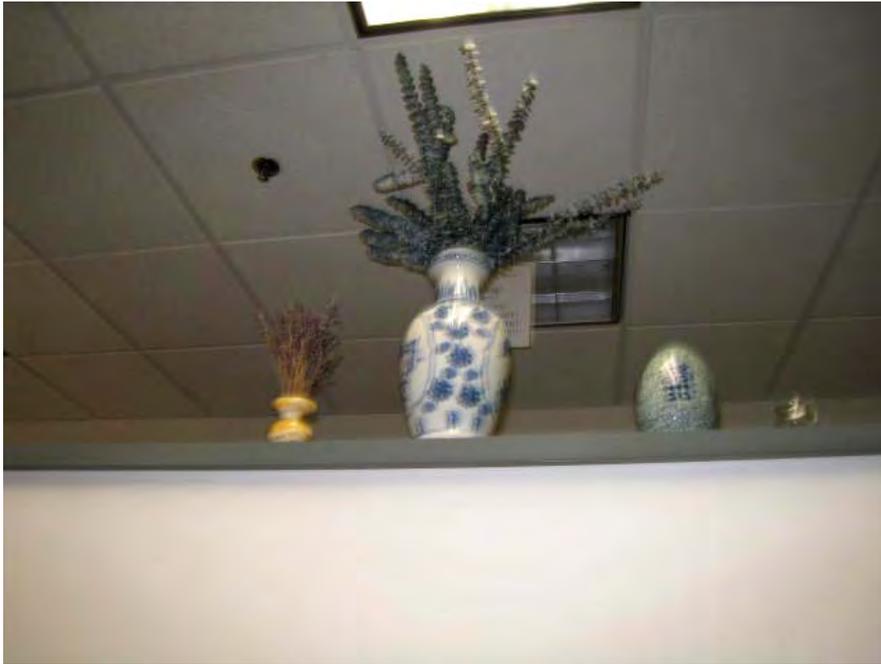
Picture 5

Decorative Items on Cubicle Divider

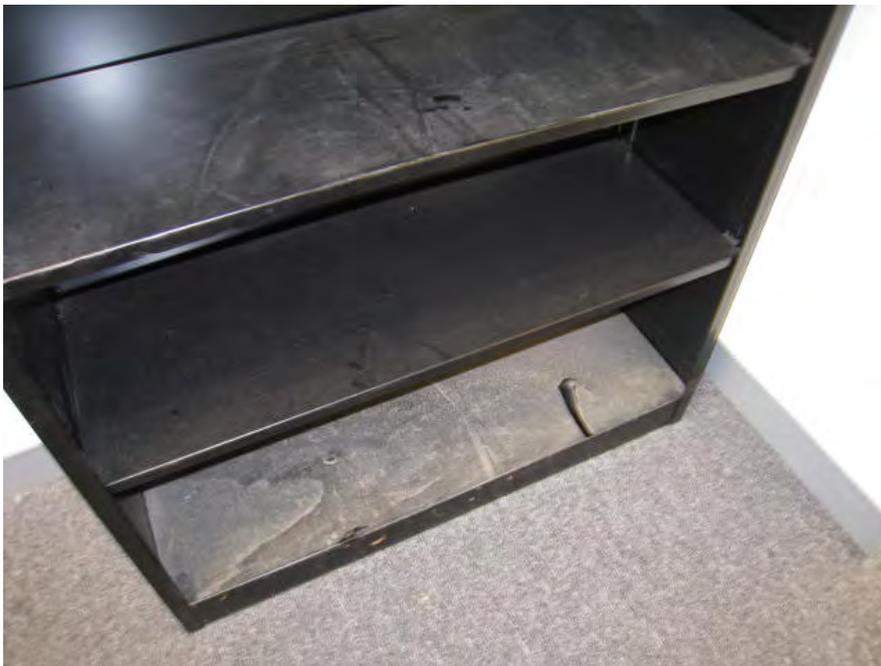
Picture 6

Dusty Bookshelf

common indoor air contaminants whose irritant effects can be enhanced when the relative humidity is low. To control for dusts, a high efficiency particulate arrestance (HEPA) filter equipped vacuum cleaner in conjunction with wet wiping of all surfaces is recommended. Avoid the use of feather dusters. Drinking water during the day can help ease some symptoms associated with a dry environment (throat and sinus irritations).

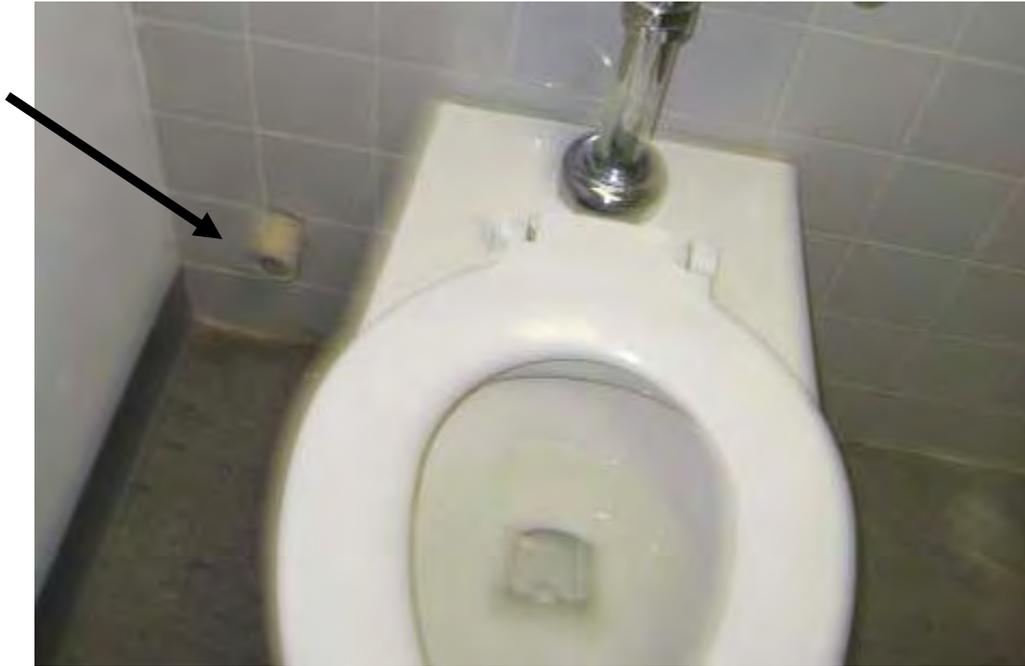
Picture 7

A pipe of unknown use was found in one of the women's restrooms (Picture 7). Pipes or other breaches can provide a pathway for migration of odors and other pollutants from unconditioned areas to occupied areas. This pipe should be investigated to determine its purpose and/or ensure it is properly capped or removed.

Unknown Pipe in a Women's Restroom (Arrow)

3. Use drip pans for plants and clean them regularly to prevent water damage and mold growth.
4. Determine the function and outlet for the pipe noted in the women’s restroom and ensure it is properly capped or removed.

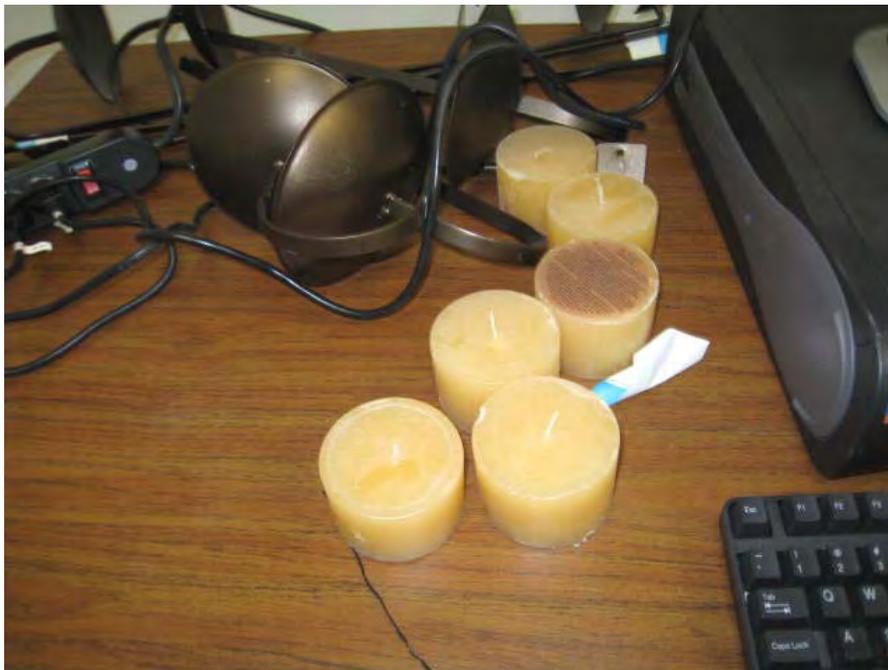
Picture 8

Scented Candles
