ODOR ASSESSMENT

**Brookfield Historical Commission Building
7 Prouty Street
Brookfield, Massachusetts**

Prepared by:
Massachusetts Department of Public Health
Bureau of Environmental Health
Indoor Air Quality Program
July 2012

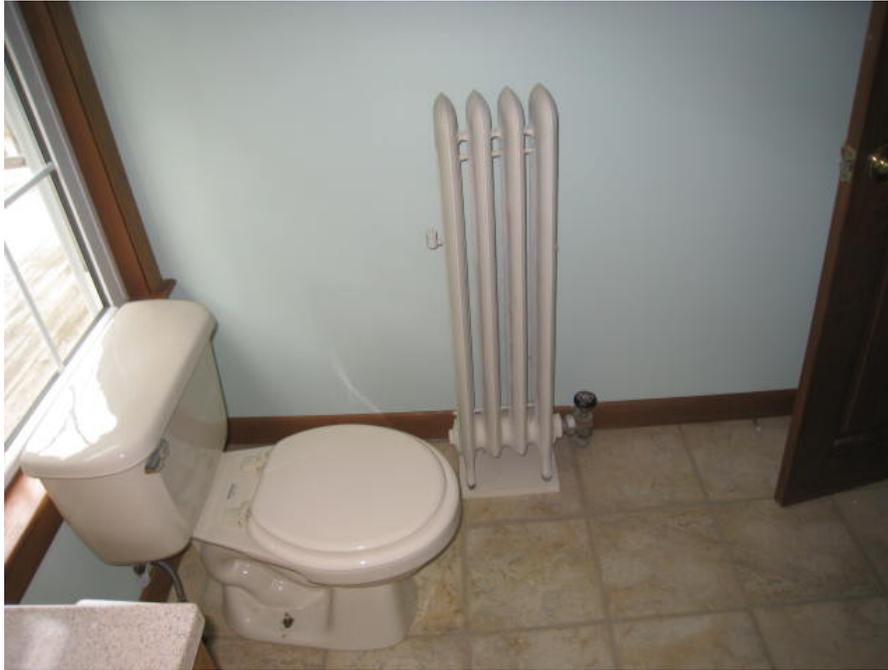
Picture 1

Upon entering the building a distinct odor was detected by BEH staff. Brookfield town officials reported that the odors seem to be more prevalent during the heating season. BEH staff identified the wall-to-wall carpet as the source of this odor. The renovation of the building envelope likely reduced air infiltration/exfiltration¹ in the building. With no mechanical ventilation, and reduced natural ventilation, indoor pollutants cannot be removed from the building and can build up and become irritating to the eyes, nose and respiratory system. Both heat and moisture can exacerbate odors from wall-to-wall carpeting. The lower side of the wall-to-wall carpeting installed on the first floor is repeatedly exposed to water vapor/moisture present in the basement through space in the floor boards (Picture 2).

Vinyl Linoleum in Bathroom

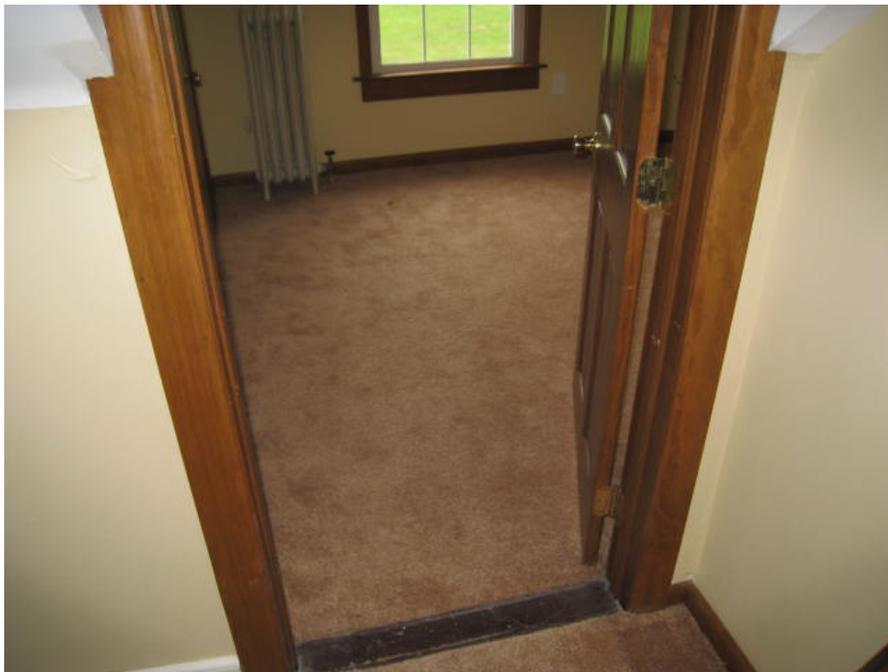
Picture 2

Wall-to-Wall Carpeting

1. Remove the wall-to-wall carpeting from the building to remedy odors. Clean residue from floor beneath the carpet and allow to air dry. Replace with a nonporous material.
2. Repair or replace deteriorated basement windows.
3. Seal all holes and cracks in the interior basement walls to reduce water intrusion and vapor migration.
4. All floor penetrations in the office space should be sealed using an appropriate fire-rated sealing compound.
5. In order to aid in the prevention of water vapor accumulation in the basement, the portable window fan should exhaust air from the basement to the outdoors.
6. Consider using dehumidifiers in the basement area during hot, humid weather to reduce relative humidity. Ensure that dehumidifiers are maintained and cleaned as per manufacture's instructions to prevent mold growth.

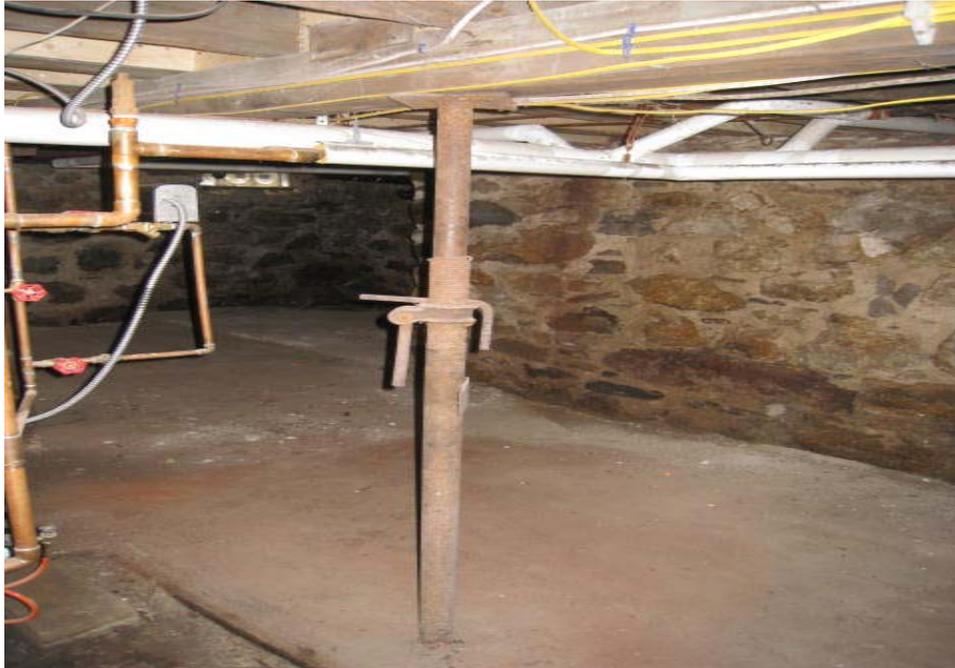
Picture 3

There was a musty odor on entering the basement and evidence of moisture and water damage on the foundation walls and wood beams. The basement did not contain any stored porous materials or items, but visible mold was present on pipe insulation (Pictures 3 and 4).

Building Basement

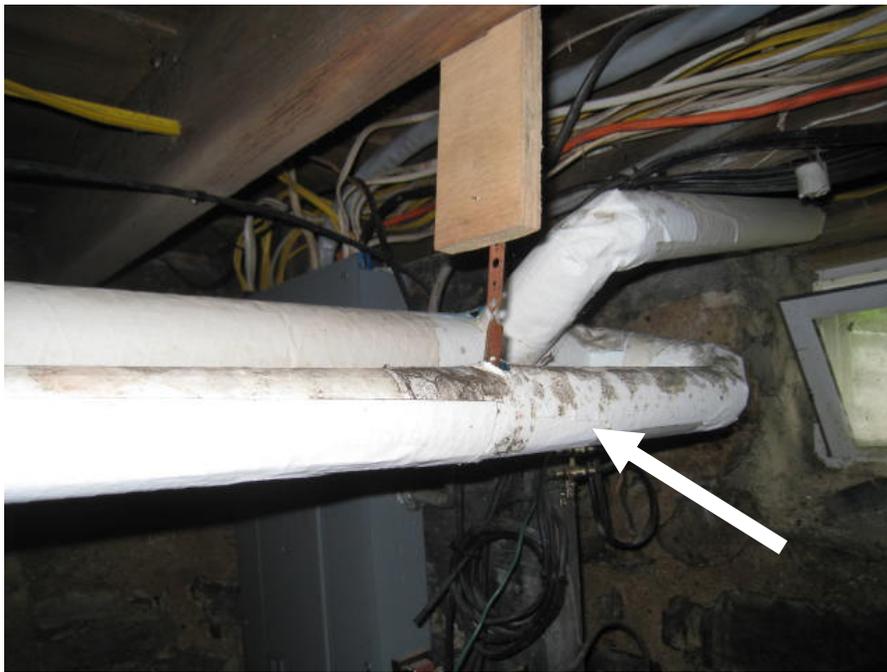
Picture 4

Pipe Insulation with Visible Mold (Arrow)

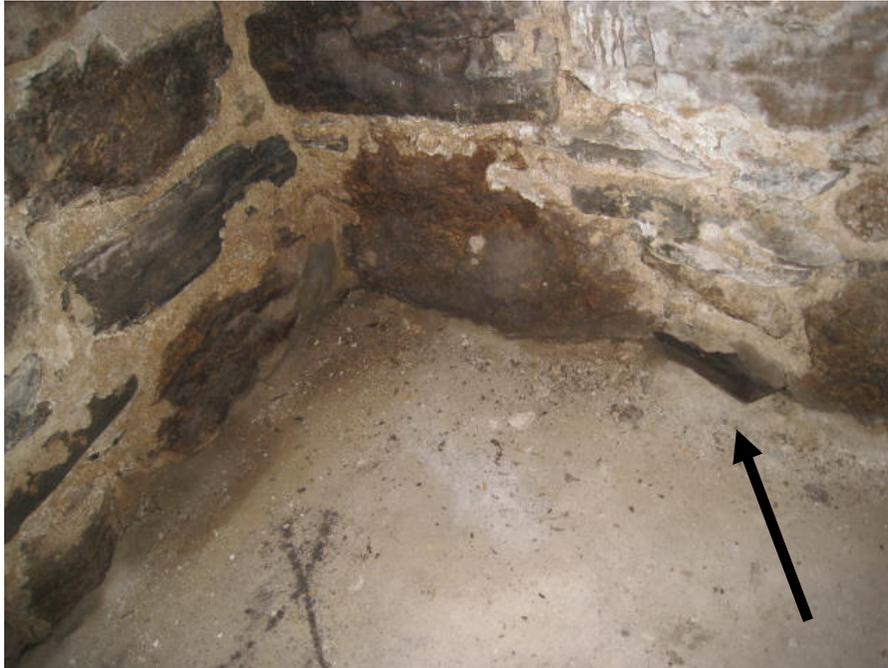
Picture 5

The basement is subject to water penetration through the foundation's southern wall. The stone foundation walls may be water penetrable and allow accumulated surface water (pooling rain) from the exterior of the building to enter the basement. Cracks and crevices in the foundation (Picture 5) as well as damaged/deteriorated windows (Picture 6) can undermine the integrity of the exterior walls and provide a means of water entry by capillary action into the building.

Water-Damaged Foundation and Crevice (Arrow) in Interior Corner of Basement

8. Remedy all exterior building envelope conditions that contribute to water infiltration into the building, such as:
 - a. Seal cracks in the exterior foundation of the building.

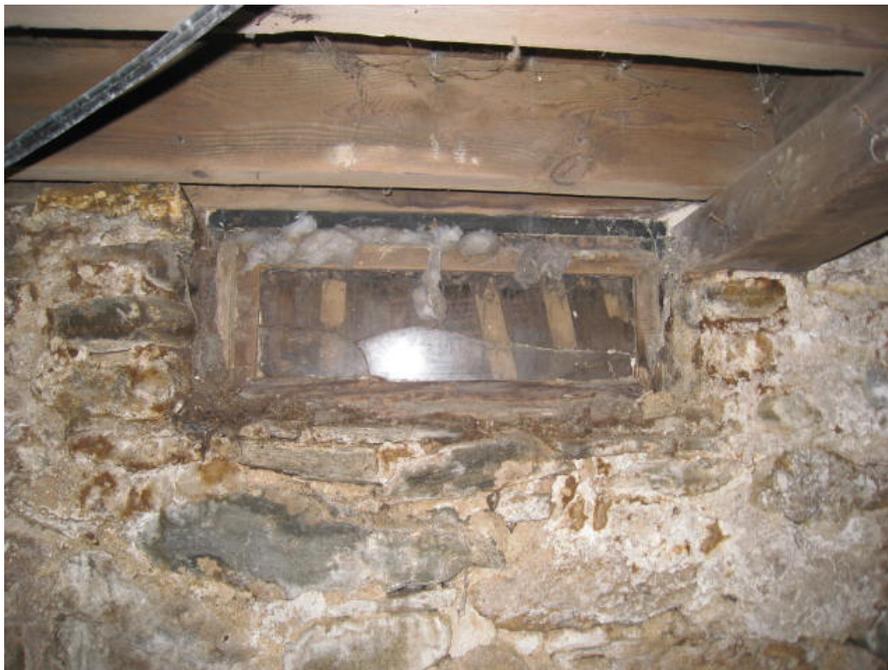
Picture 6

Deteriorated Basement Window

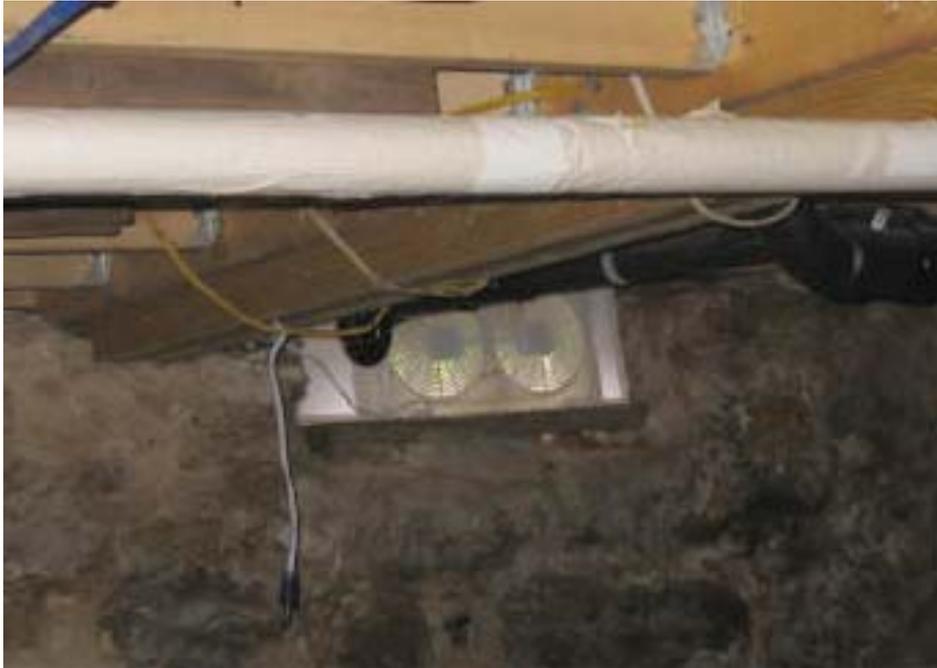
Picture 7

Three basement windows were sealed with plywood. The remaining two windows were open with one containing a portable fan (Picture 7) that was not operating at the time of assessment. The fan was positioned to draw outside air *into* the basement. BEH staff recommended that the fan be positioned to exhaust air *from* the basement to the outdoors instead. According to Mr. Thompson, the basement windows are open during the spring and summer. This practice may increase moisture and allow water penetration into the basement during hot, humid weather.

Window Fan in Basement

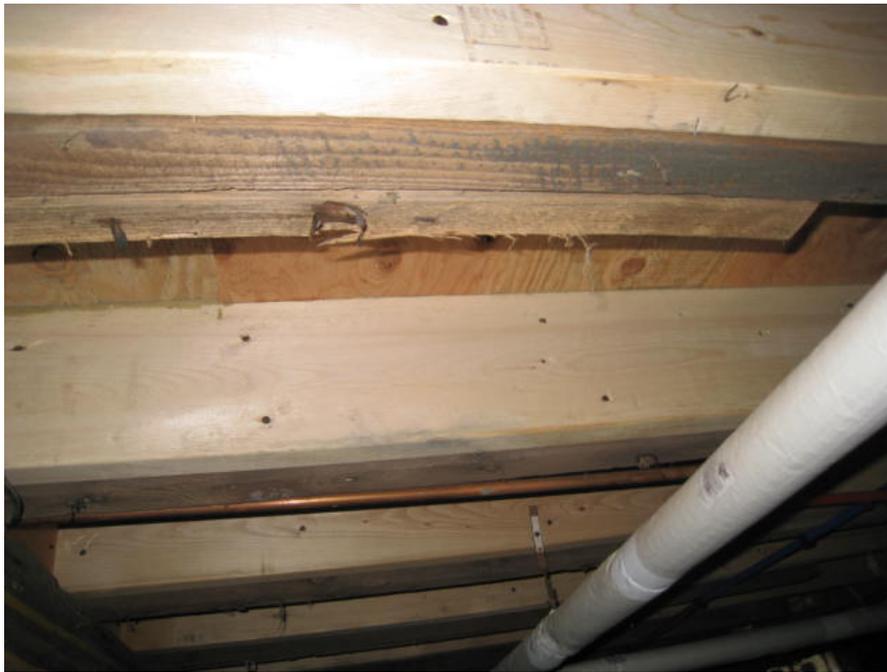
Picture 8

The first floor carpet was installed over the existing wood flooring that has gaps between the floor slats (Pictures 8 and 9) providing a means for mold-associated odors/particulates, and water vapor in the basement to migrate into first floor carpeted areas of the building. This condition can moisten wood below the carpet with the underside of the carpet creating a vapor barrier, which prevents drying. Moistened carpeting/wood can provide suitable conditions for

Sub-Flooring below First Floor Kitchen Area

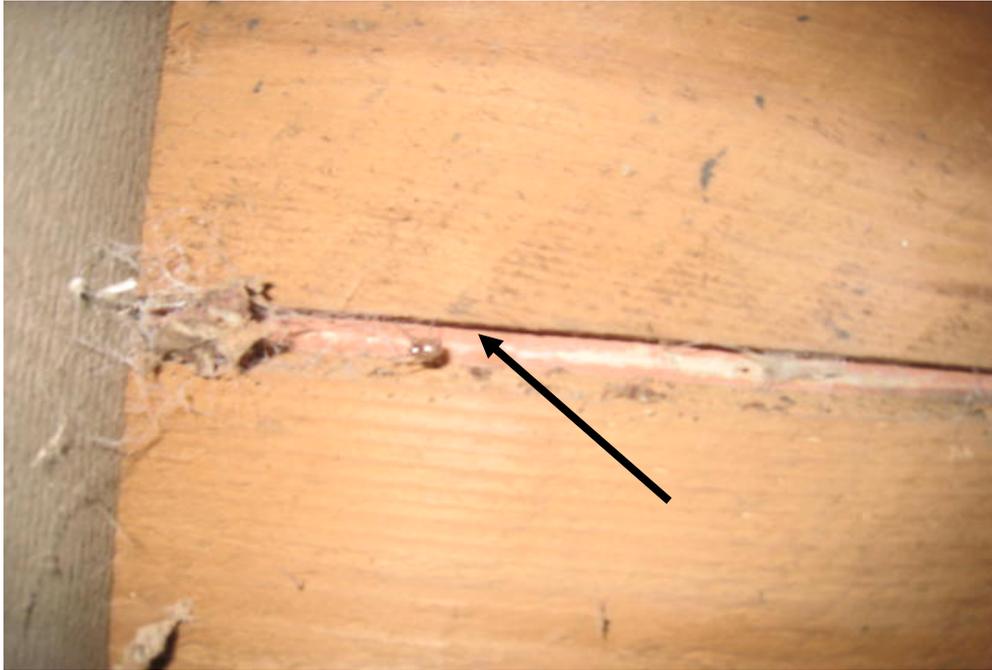
Picture 9

Gaps in First Floor Wood Slats below Carpeted Area (Arrow)

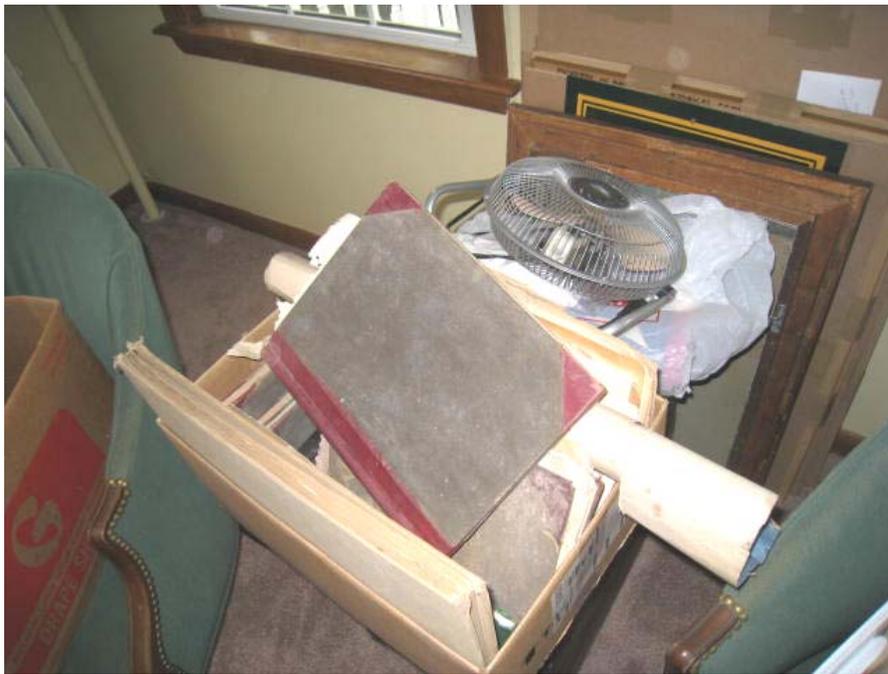
Picture 10

It was noted that, boxes of papers, books, picture frames and other porous materials were being stored in the first floor office space that appeared to be mold colonized (Picture 10). According to Mr. Thompson, these items had been stored previously in the basement of the Merrick Library and had been recently transferred to the BHCBC.

Books, Paper and other Porous Materials in First Floor Office Space

7. Remove water-damaged or mold-contaminated porous materials stored in the first floor office space. Documents of historical significance may be stored in air-tight containers to prevent mold colonization/growth and distribution of spores and odors to the space. A professional restoration contractor may be able to provide services to remediate water-damaged historical documents.

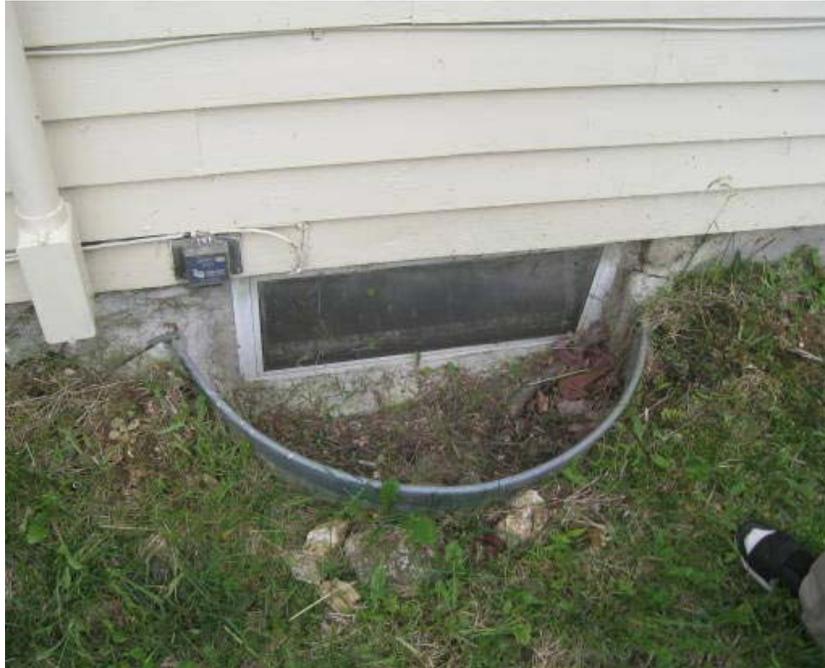
Picture 11

BEH staff conducted a perimeter inspection of the building's exterior to identify potential sources of water penetration. Basement windows are below grade and surrounded by window wells that contain grass, plant growth and debris (Pictures 11 and 12), which can result in the accumulation of rainwater and potential water penetration into the basement. In addition, the growth of grass and roots against exterior walls can bring moisture in contact with the foundation, eventually leading to cracks and/or fissures in the below ground level. Over time, these conditions can undermine the integrity of the building envelope and provide a means of water entry into the building through capillary action through foundation concrete and/or masonry (Lstiburek & Brennan, 2001).

Below-grade Window Well with Grass and Debris

- c. Remove grass, plants and debris from window wells. Consider installing rain shields over basement window wells to prevent water penetration into the basement.

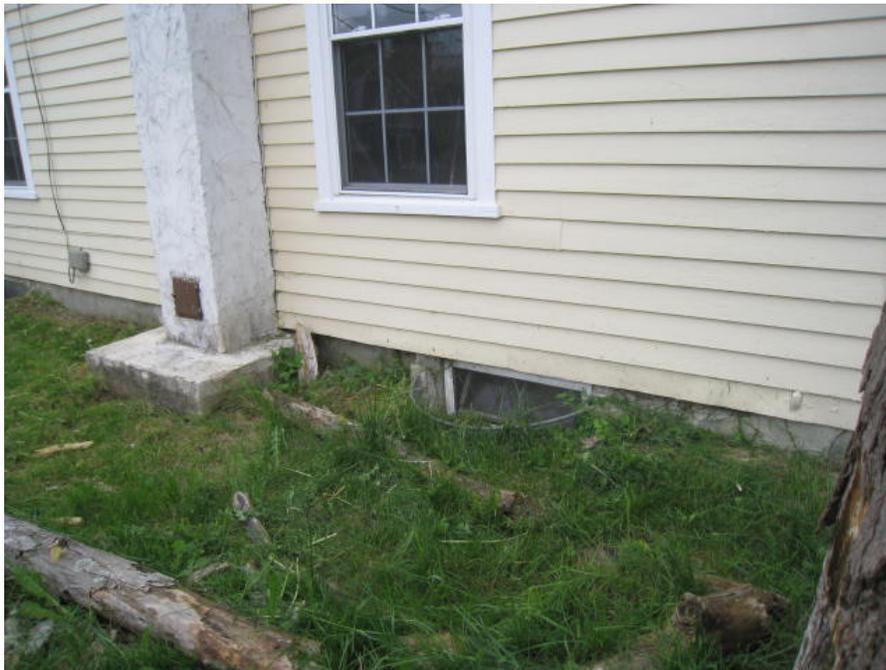
Picture 12

Grass, Plants and Debris Surrounding Basement Window
