INDOOR AIR QUALITY ASSESSMENT INCIDENT RESPONSE

**Kindred Nursing & Rehabilitation Walden Branch
785 Main Street
Concord, Massachusetts**

Prepared by:
Massachusetts Department of Public Health
Bureau of Environmental Health
Indoor Air Quality Program
November 2012

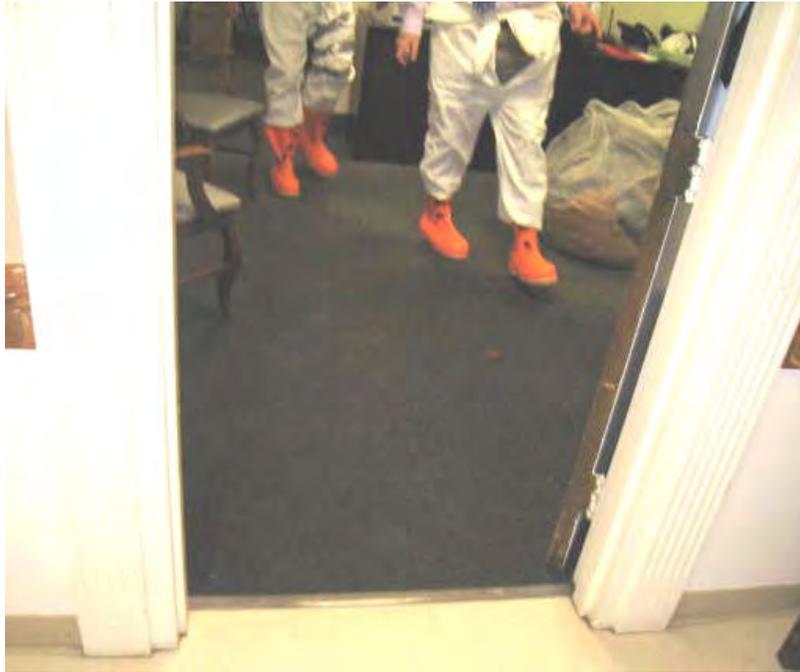
Picture 1

Water-damaged/contaminated carpeting

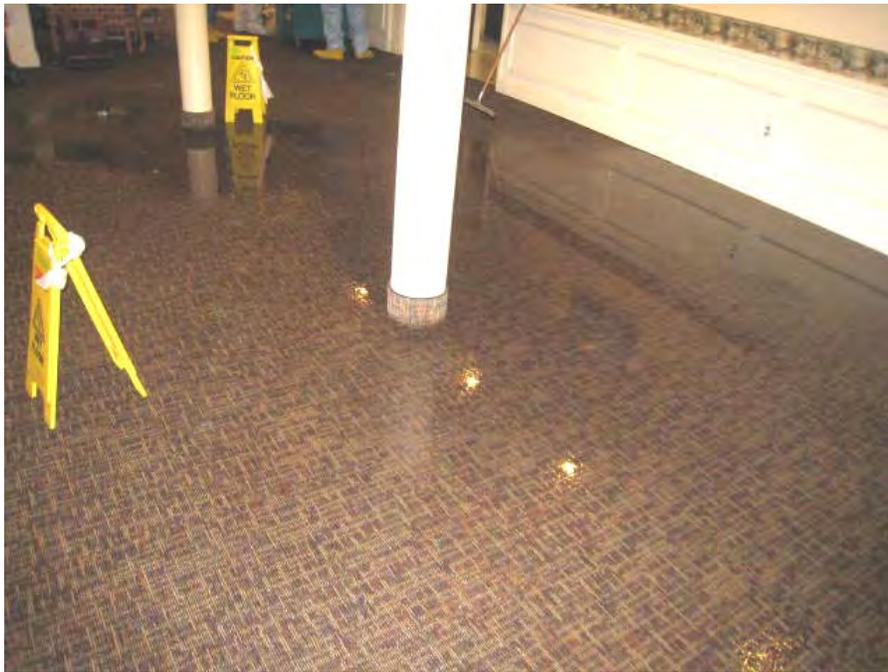
Picture 2

Water-damaged/contaminated carpeting

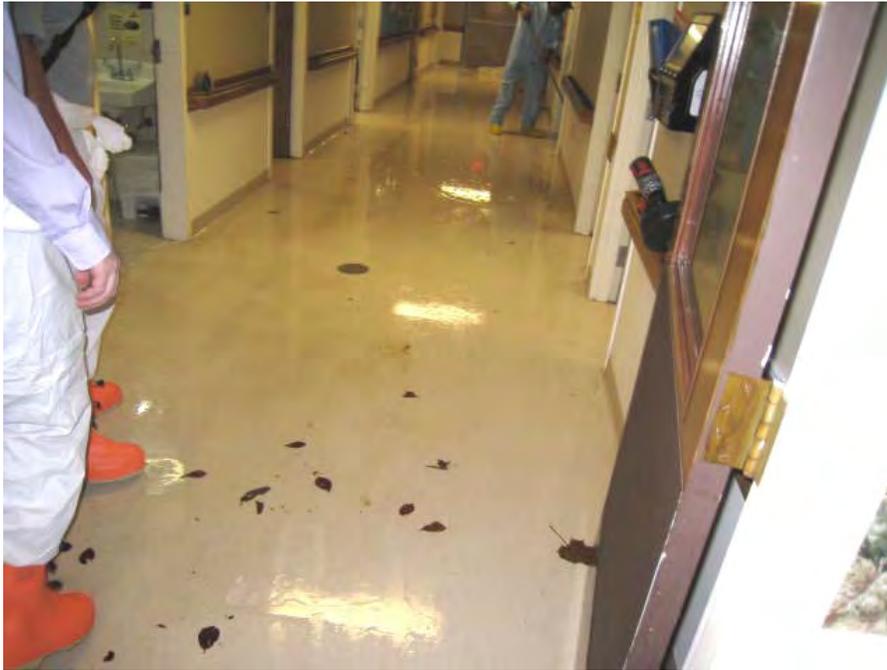
Picture 3

Water-damaged/contaminated gypsum wallboard in hallway

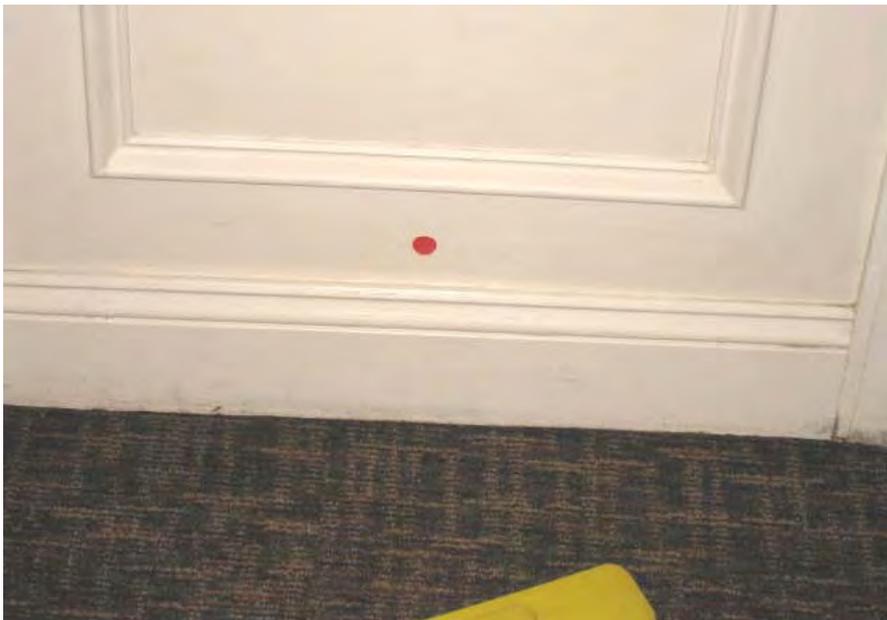
Picture 4

Water-damaged/contaminated carpeting and wood, dot/sticker placed by ServiceMaster indicating moisture testing

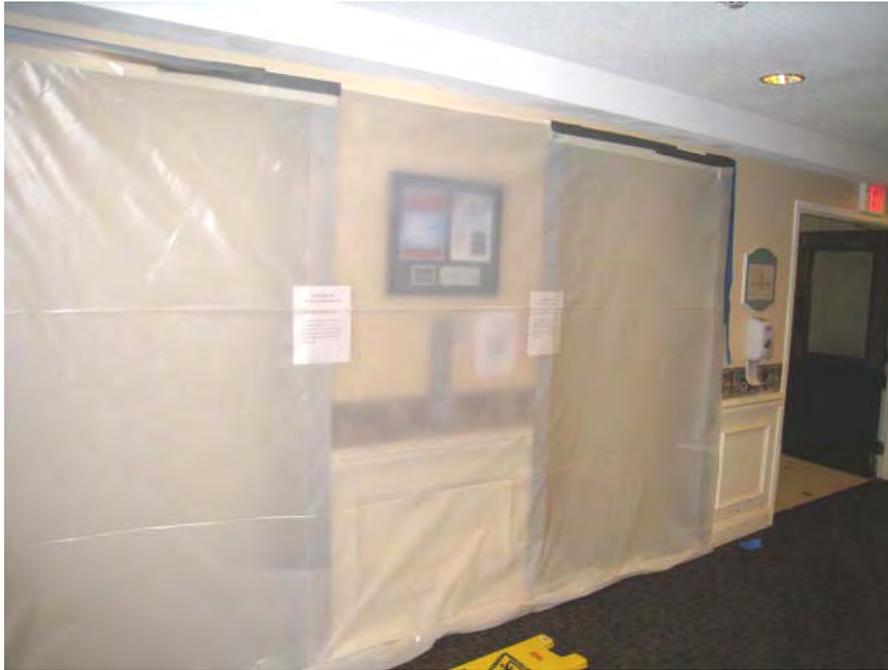
Picture 5

Affected areas isolated by plastic poly sheeting and tape

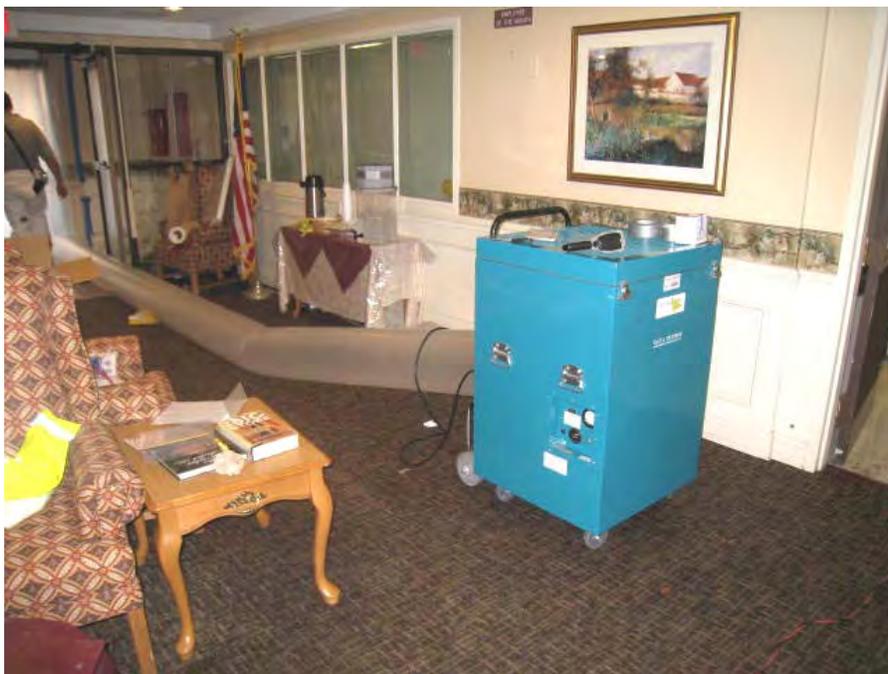
Picture 6

HEPA-filtered air scrubber ducted to outside

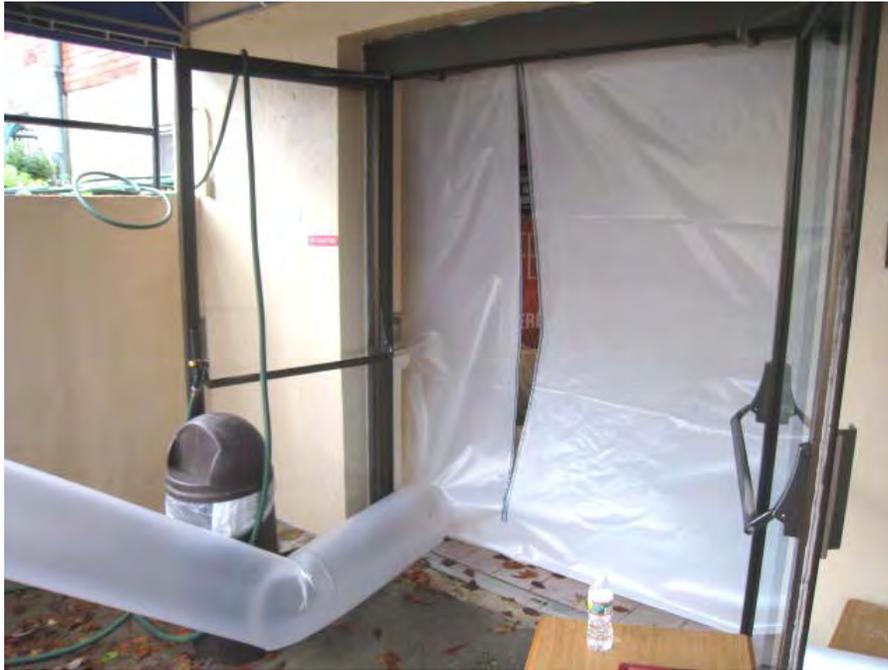
Picture 7

HEPA-filtered air scrubber ducted to outside

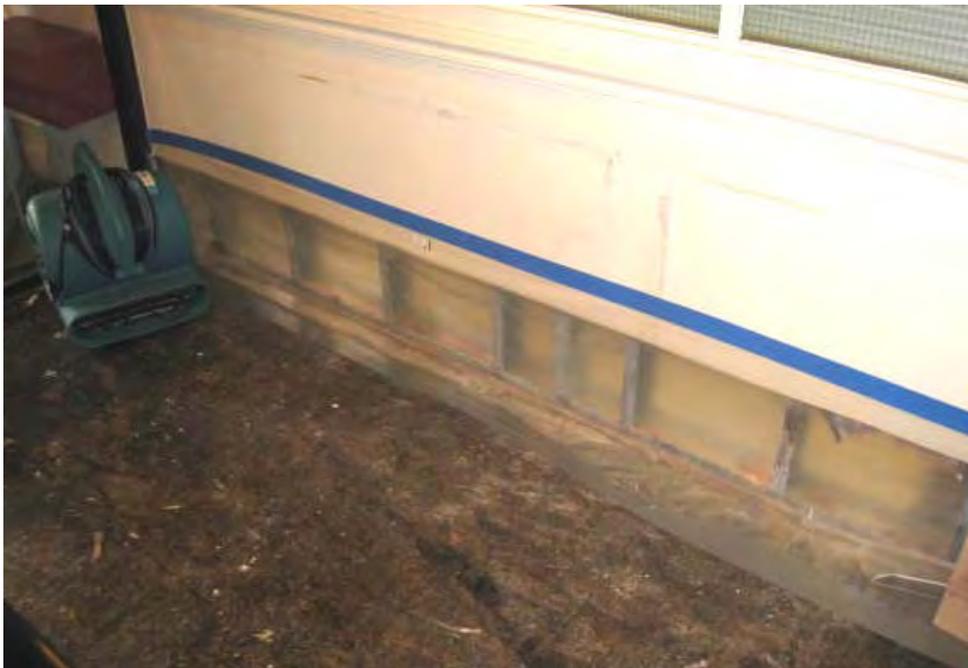
Picture 8

Water-damaged/contaminated gypsum drywall and carpeting removed, floor sanitized

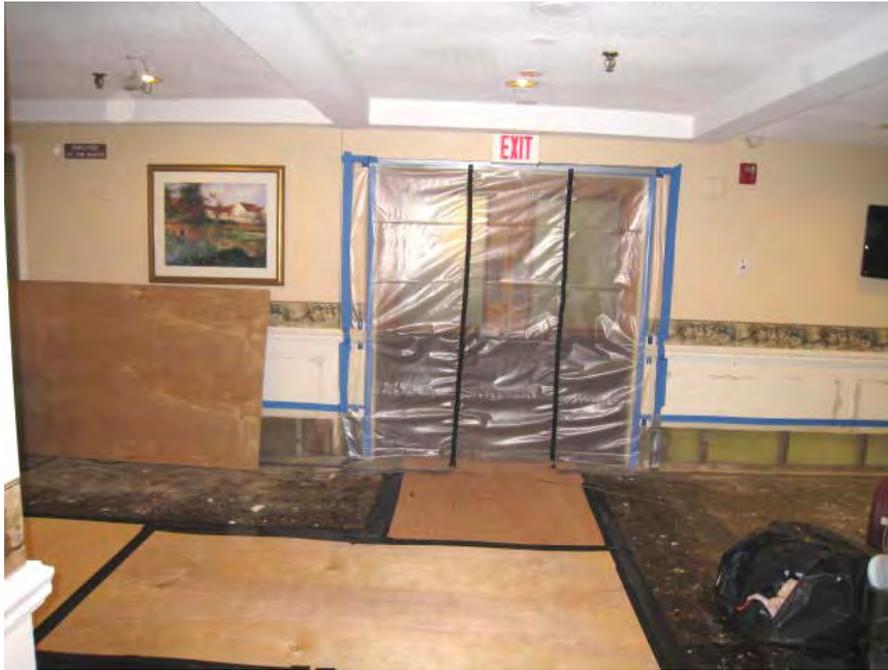
Picture 9

Water-damaged/contaminated gypsum drywall and carpeting removed, floor sanitized

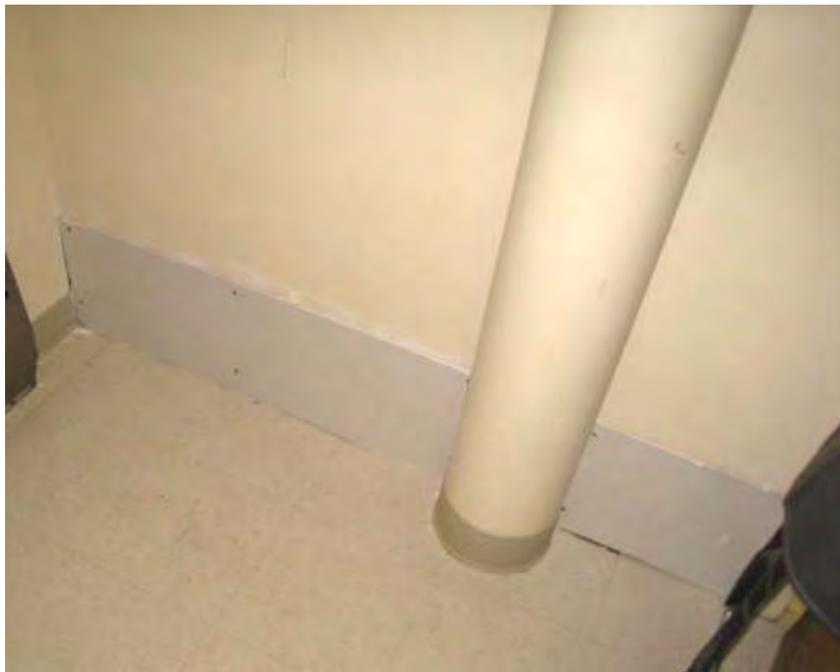
Picture 10

Water-damaged/contaminated gypsum drywall removed/replaced

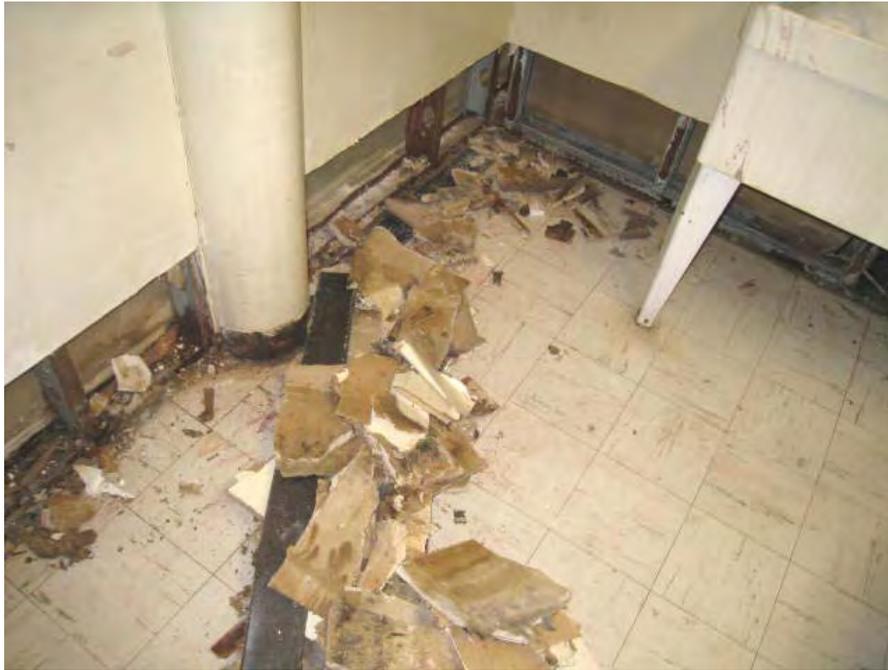
Picture 11

Area of west wing under remediation

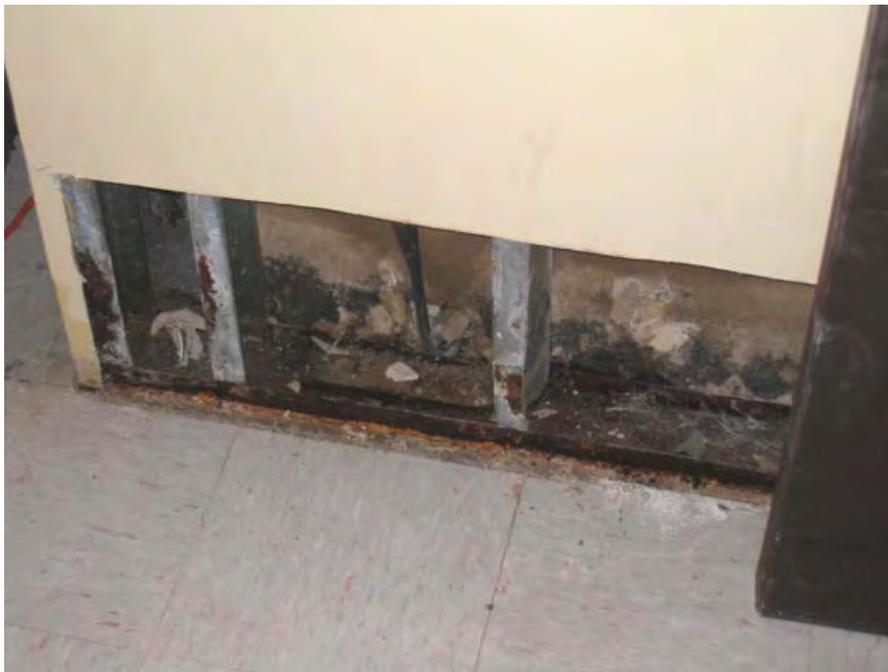
Picture 12

Contaminated gypsum drywall in west wing under remediation

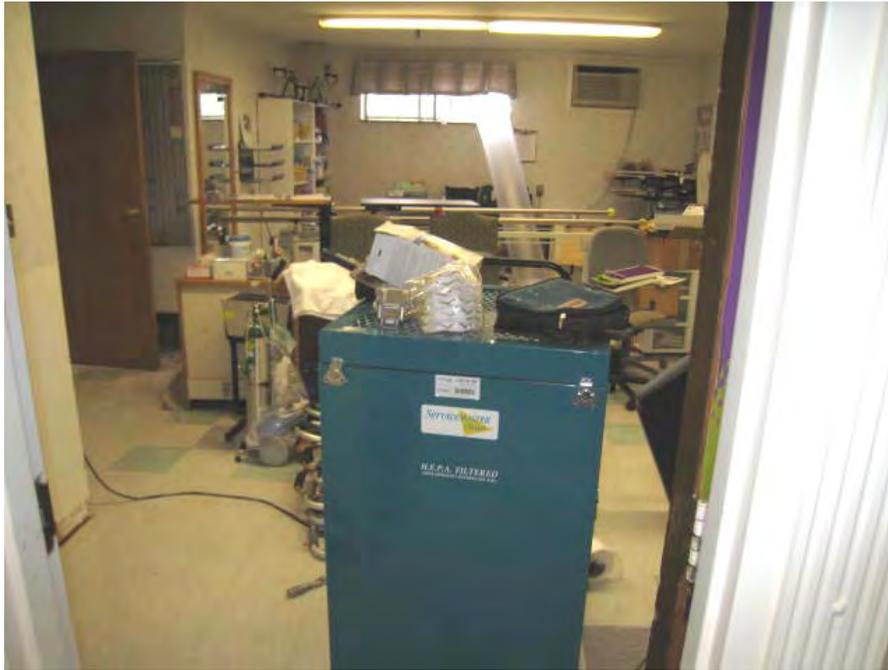
Picture 13

Area of west wing under remediation, note HEPA-filtered air scrubber ducted to outside
