INDOOR AIR QUALITY ASSESSMENT

**West Parish Elementary School
10 Concord Street
Gloucester, Massachusetts**

Prepared by:
Massachusetts Department of Public Health
Bureau of Environmental Health
Indoor Air Quality Program
August 2012

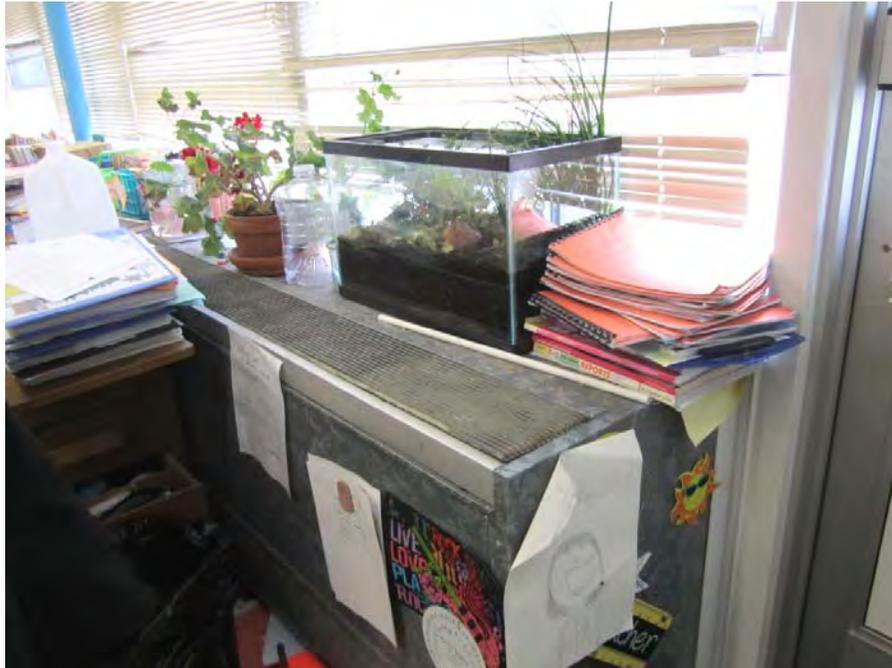
Picture 1

Fresh air to classrooms in the original building, as well as 2002 addition, is supplied by unit ventilator (univent) systems (Picture 1). A univent draws air from the outdoors through a fresh air intake located on the exterior wall of the building (Picture 2). Return air from the classroom is drawn through an air intake located at the base of the unit (Figure 1). Fresh and return air are mixed, filtered, heated and provided to classrooms through an air diffuser located in the top of the unit. As mentioned, univents were found deactivated in the majority of rooms/areas in the school at the time of assessment (Table 1). In addition, several univents were found obstructed by furniture and other items on top of air diffusers and/or in front of return vents along the bottom of the units (Pictures 1 and 3). In order for univents to provide fresh air

Plants were observed in several areas, including on univents (Table 1). One area also had a terrarium (Picture 1). Plants should be properly maintained and equipped with drip pans. Plants should also be located away from ventilation sources to prevent aerosolization of dirt, pollen or mold. Plants should not be placed on porous materials, since water damage to porous materials may lead to microbial growth.

Classroom univent, note plants, terrarium and other items

3. Remove all blockages/items from the surface of univent air diffusers and return vents (along front/bottom) to ensure adequate airflow. Remove all blockages from unit exhaust equipment and wall-mounted exhaust vents.

13. Examine and seal cracks around the building's foundation.
14. Check integrity of gutter and downspout systems and repair as needed.
15. Ensure indoor plants are equipped with drip pans. Examine drip pans periodically for mold growth and disinfect with an appropriate antimicrobial, as needed. Move plants away from the air stream of mechanical ventilation equipment.

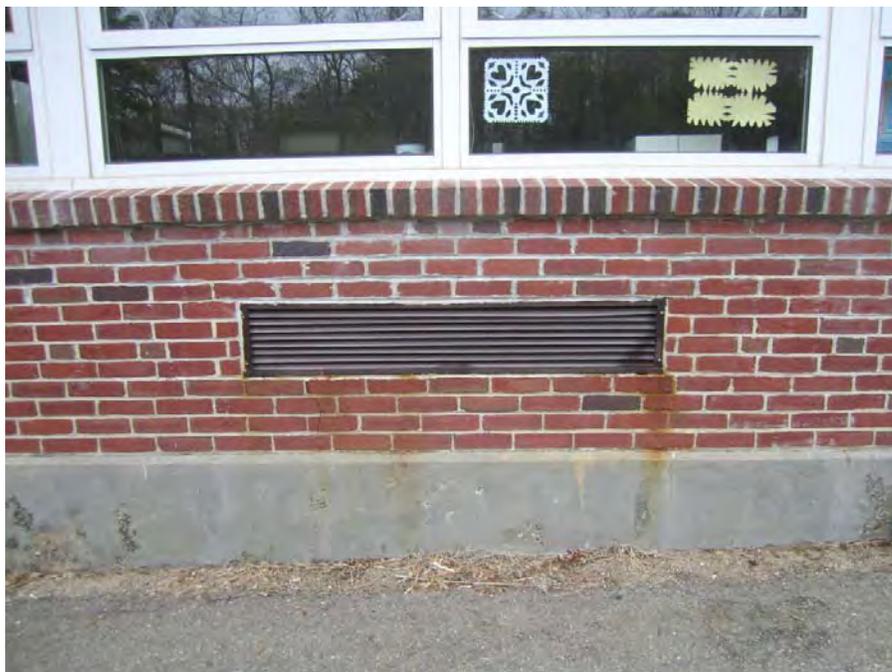
Picture 2

Univent fresh air intake

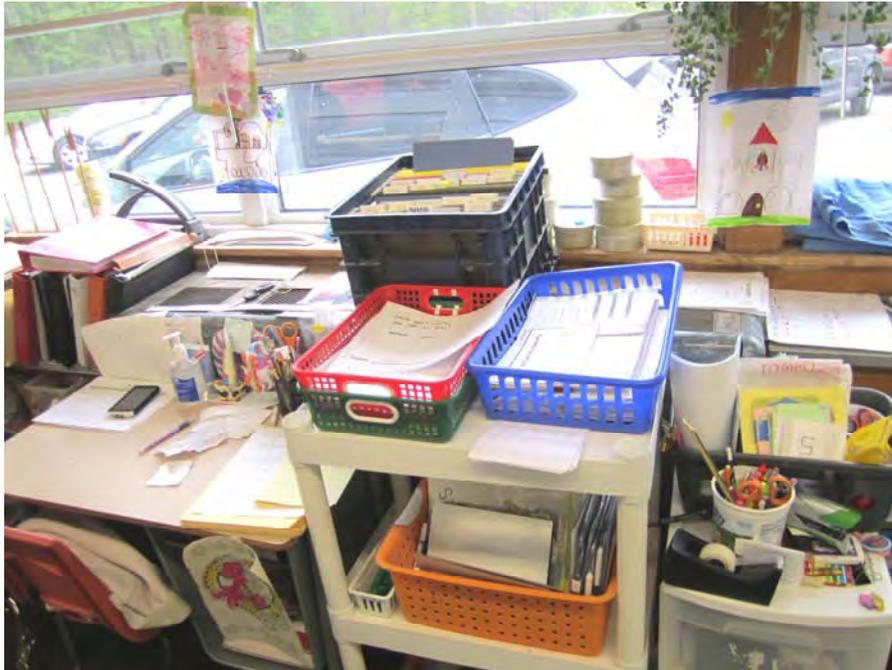
Picture 3

Univent behind furniture and other items

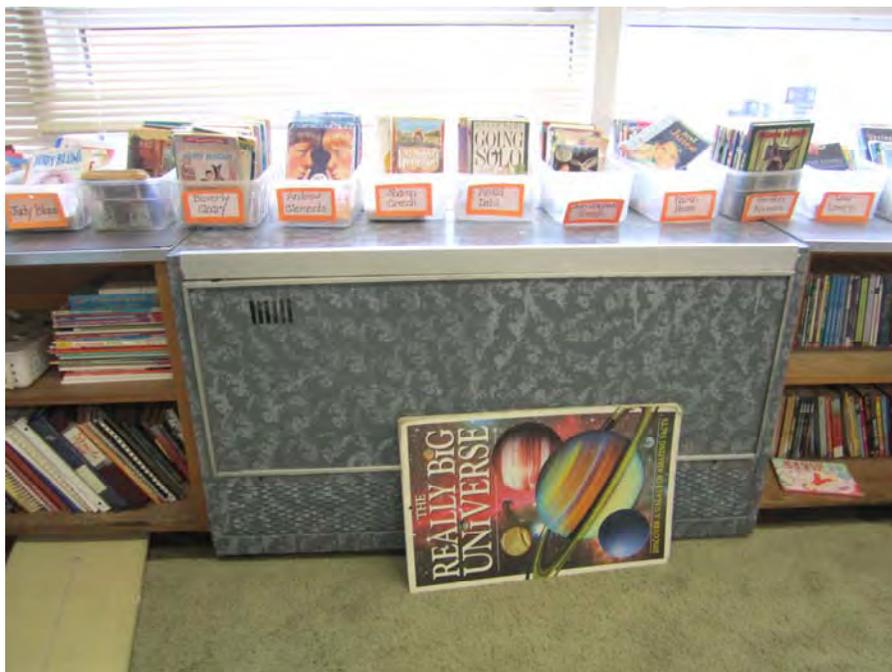
Picture 4

Exhaust ventilation for classrooms in the 1949 and 2002 portions of the building is provided by either unit exhaust ventilators or wall-mounted exhaust vents ducted to rooftop motors. While similar to appearance to a univent, unit exhaust ventilators lack a fresh air supply on the top of the unit and are designed to draw air directly to the outside of a building (Picture 4). The majority of unit exhaust ventilators have reportedly not been functional for some time. In addition, a number of wall-mounted exhaust vents were blocked at the time of assessment (Picture 5). As with supply ventilation, exhaust ventilation must be free of blockages and allowed to operate while the building is occupied.

Unit exhaust ventilator

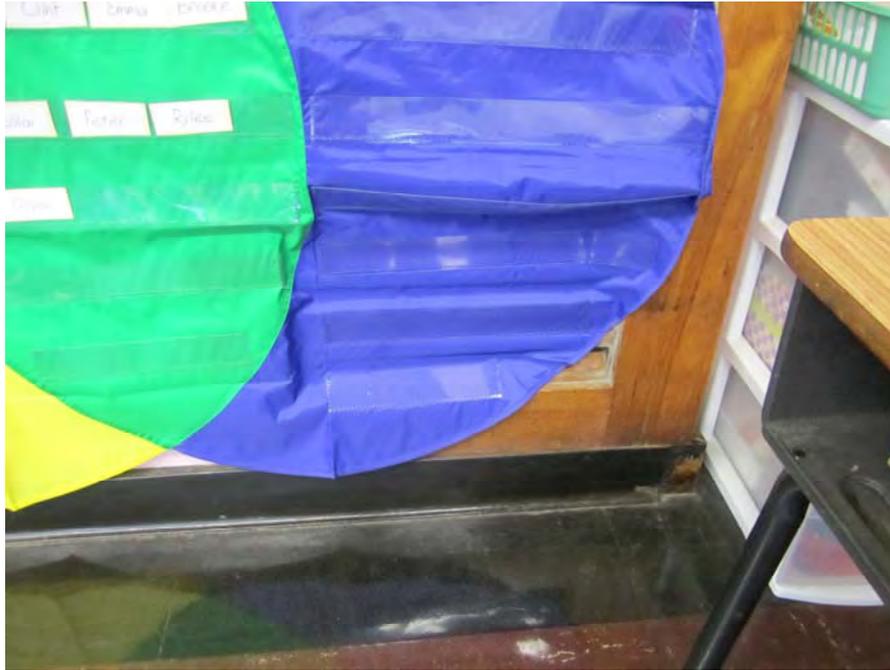
Picture 5

Wall exhaust vent blocked by vinyl wall hanging

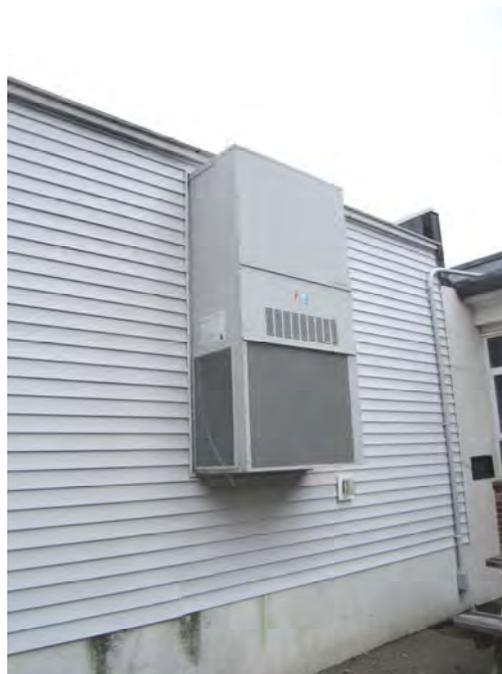
Picture 6

Mechanical ventilation for the modular classroom and common areas (e.g., auditorium, cafeteria) is provided by rooftop or side-mounted air-handling units (AHUs) (Picture 6). Fresh air is distributed via ceiling-mounted air diffusers and ducted back to AHUs via ceiling or wall-

mounted return vents. The AHU for the modular classroom is controlled by a thermostat, which has fan settings of “on” and “auto”. The automatic setting on the thermostat activates the heating, ventilation and air-conditioning (HVAC) system at a preset temperature. Once a preset temperature is measured by the thermostat, the HVAC system is deactivated. Therefore, no mechanical ventilation is provided until the thermostat re-activates the system. The thermostat was set to the “auto” setting in the modular classroom surveyed during the assessment. Consideration should be given to setting thermostat controls for modular classrooms to the fan “on” setting.

AHU for modular classroom

1. Operate all ventilation systems throughout the building (e.g., gym, cafeteria, classrooms) continuously during periods of occupancy to maximize air exchange. Set digital thermostat for AHU in modular classroom in fan “on” setting.

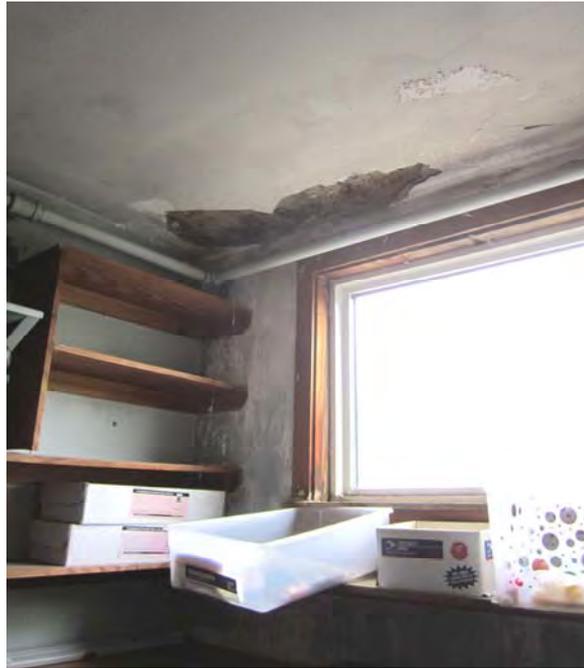
Picture 7

Evidence of a water leak was observed in a storage closet for classroom 1 (Picture 7). The ceiling had crumbled, and efflorescence was observed on both the ceiling and the walls. Efflorescence is not mold but a characteristic sign of water intrusion. As moisture works its way through mortar around brick, it leaves behind characteristic mineral deposits. A variety of items were stored in the closet, including paper goods and stuffed animals (Picture 8), which can be sources of mold growth if moistened for a prolonged period of time. Items showing water staining or damage should be discarded and salvageable items should be stored in resealable plastic containers away from the area of leakage. Measures to identify and remediate the area of water penetration should be taken. Such measures may include examining the roof, drainage, and flashing along the exterior of the building.

Damaged plaster reportedly from water leaks

7. Repair damaged plaster in the closet of classroom 1. Discard materials that appear to be water-damaged. Store items in re-sealable plastic bins to guard against future damage and to prevent settling of dust/debris that can accumulate during storage.

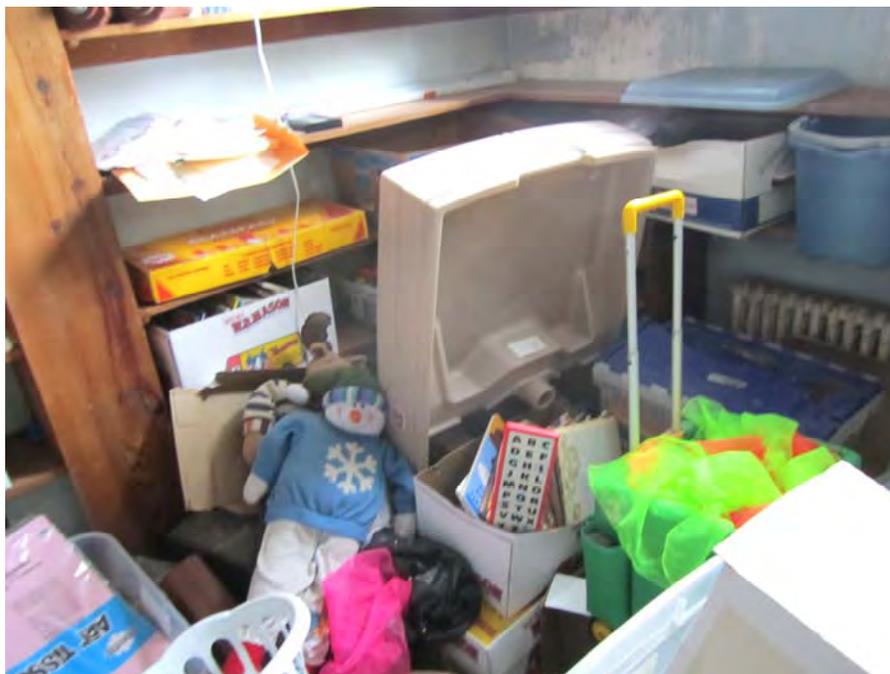
Picture 8

Items stored in closet with water leak

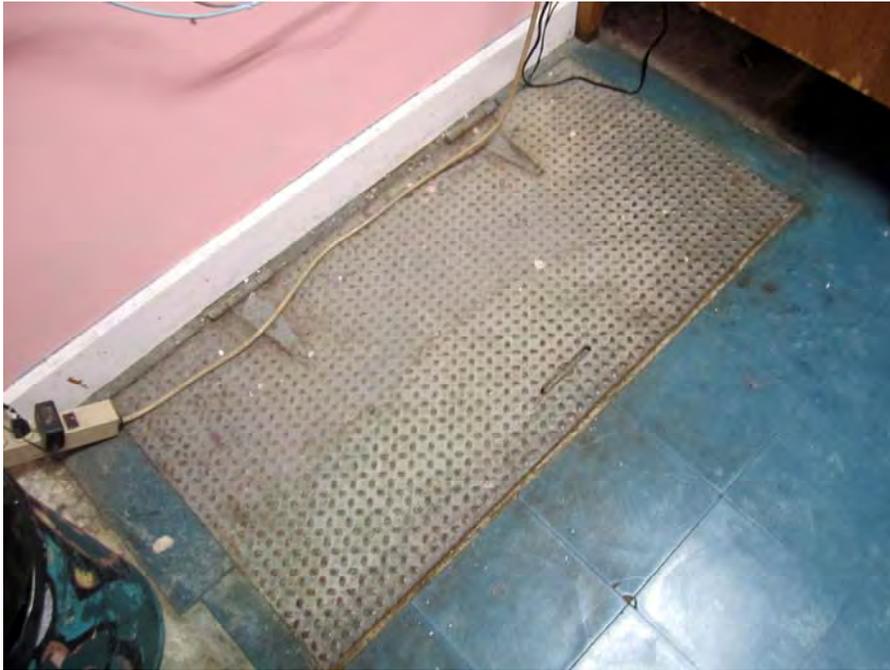
A crawlspace access door was not flush with the floor (Picture 9), which can allow materials/odors from the crawlspace to migrate into occupant areas. Measures, such as the installation of a gasket or membrane, should be taken to render the access door airtight to prevent penetration of odors.

Crawlspace access door

10. Seal crawlspace access door shown in Picture 9 with gasketing. Seal other holes/breaches where pipes from univents and sinks penetrate into the crawlspace or wall cavity with appropriate fire-rated sealant to prevent movement of odors/particles from the crawlspace.

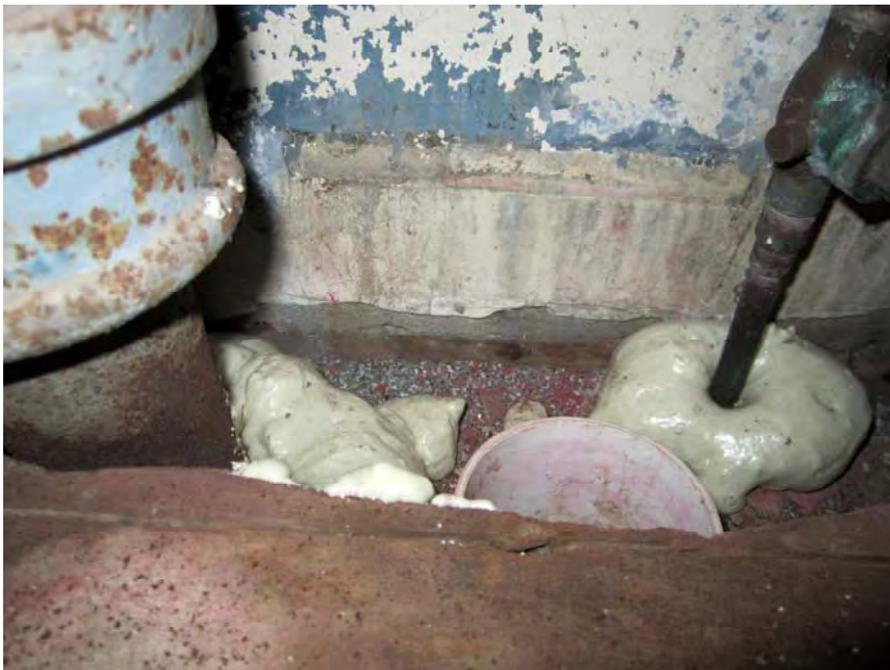
Picture 10

Similarly, spaces were observed around pipes under sinks and in the univent cabinets. Breaches around pipes can allow odors and materials from the crawlspace to penetrate occupant areas. It appears that some of these breaches were sealed with spray foam insulation in the past (Picture 10); however, the foam was not completely adhered to the pipe at the time of assessment. As with the crawlspace access, measures should be taken to reduce movement of air from the crawlspace into occupant space.

Spray foam insulation around pipes leading to crawlspace

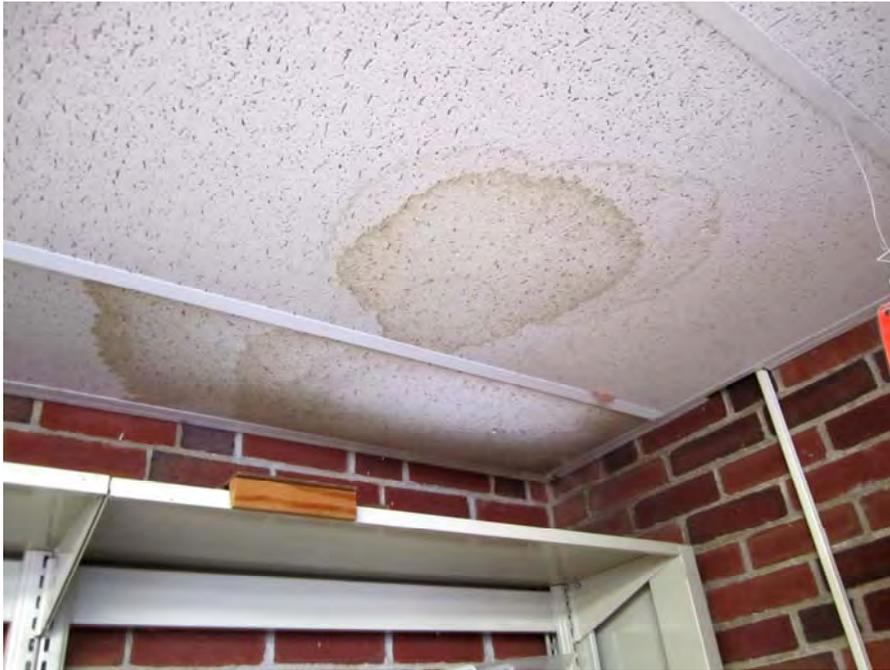
Picture 11

Water-stained ceiling tiles were observed in some classrooms (Picture 11). Water damage was noted on some interlocking ceiling tiles as well. This type of ceiling tile can be difficult to replace. These interlocking mineral tiles may also contain asbestos mastic (Picture 12). It was reported to BEH staff that this water damage occurred some time ago and the leaks have been repaired. A determination should be made concerning whether these tiles contain asbestos. If they do, the tiles should be left in place until they can be removed by a licensed asbestos remediation contractor.

Water-stained ceiling tiles

8. Ensure roof/plumbing leaks are repaired and replace any remaining water-damaged ceiling tiles. Examine the area above these tiles for mold growth. Disinfect areas of water leaks with an appropriate antimicrobial, as needed.

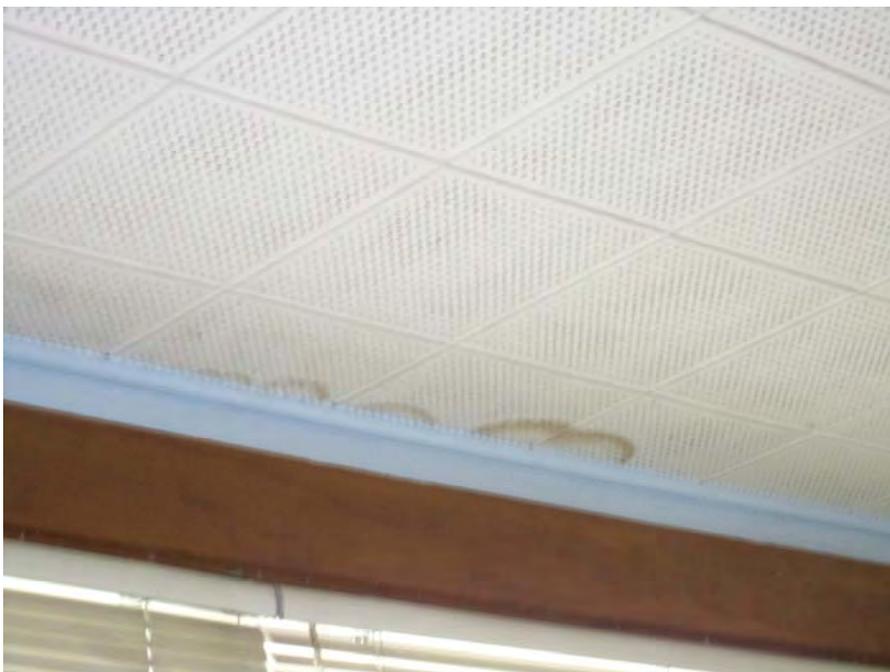
Picture 12

Water-stained interlocking ceiling tiles

9. Determine whether interlocking ceiling tiles contain asbestos. If so, remediate damaged floor tiles in conformance with Massachusetts asbestos remediation and hazardous waste disposal laws.

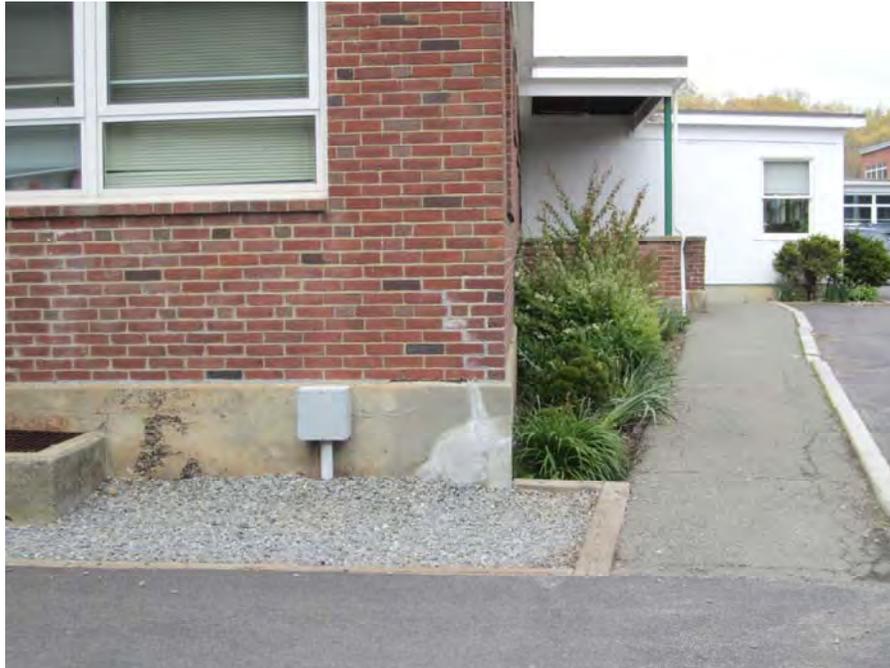
Picture 13

During an examination of the exterior, BEH staff observed trees, shrubs and other plants in close proximity to the building (Pictures 13 and 14). In addition, bark mulch is used as part of the landscaping to protect and add nutrients to the soil below. Shrubs/trees and mulch in close proximity to the building holds moisture against the building exterior and prevents drying. The growth of roots against exterior walls can bring moisture in contact with the foundation. Plant

BEH staff also observed cracks in the building's exterior wall and foundation (Picture 13), which can undermine the integrity of the building envelope and provide a means of water entry by capillary action into the building (Lstiburek & Brennan, 2001). The freezing and thawing action of water during the winter months can create cracks and fissures in the foundation. In addition, they can serve as pathways for insects, rodents and other pests into the building.

Plants in close proximity to building, note cracks in foundation

11. Ensure plants, trees and shrubs are located at least five feet away from exterior walls/foundation of the building. Remove any growth observed between the foundation wall and tarmac.

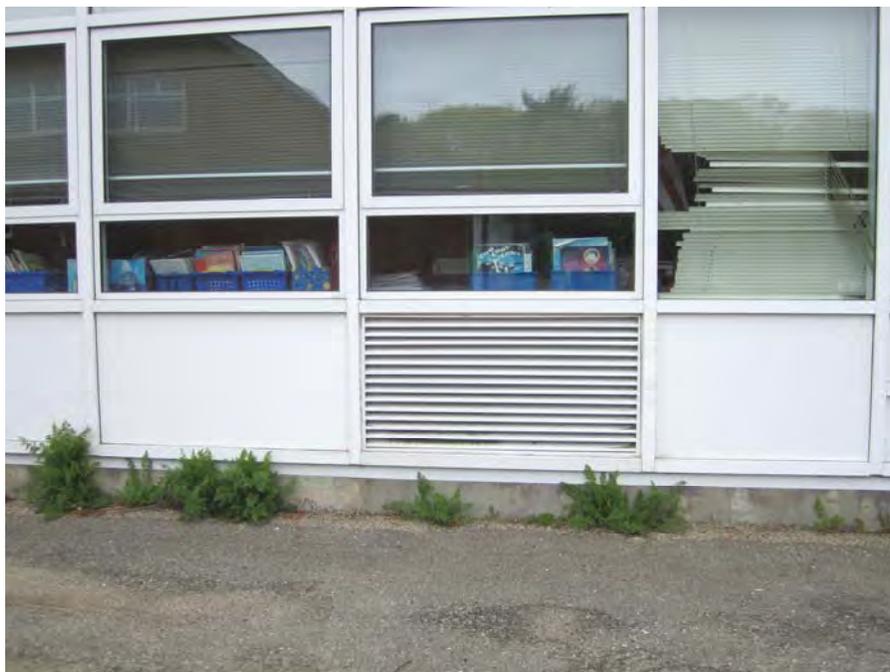
Picture 14

Plant growth against foundation and tarmac

12. Consider paving around the apron of the building to ensure proper drainage. If possible, improve the grading of the ground away from the foundation at a rate of 6 inches per every 10 feet (Lstiburek & Brennan, 2001).

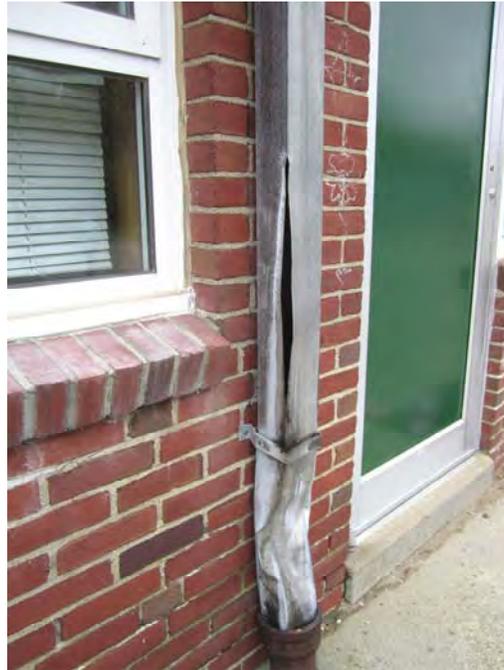
Picture 15

Some downspouts for the gutter system appeared damaged (Picture 15). Downspouts are designed to allow water to drain away from the building. Damage to downspouts can result in water impacting the ground repeatedly. Over time, depressions can form, which can cause water to pool against the building.

Damaged downspout

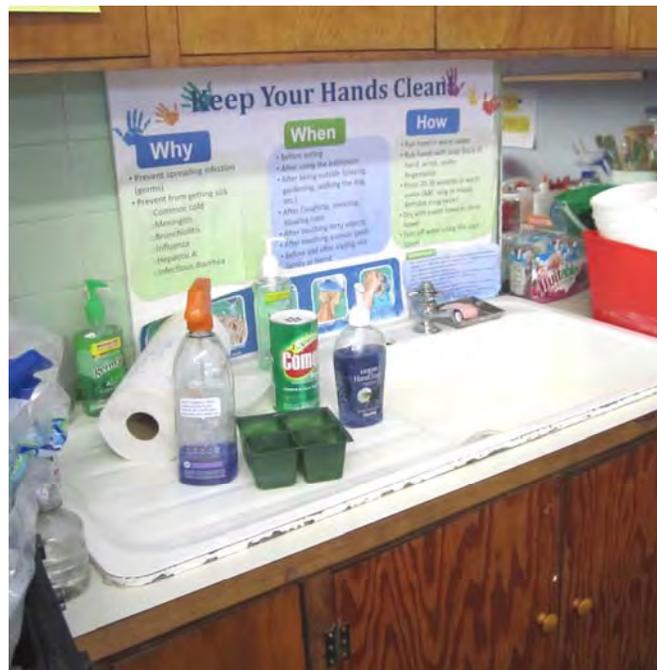
Picture 16

Cleaning products were found in a number of rooms throughout the building (Picture 16; Table 1). Cleaning products contain chemicals that can be irritating to the eyes, nose and throat of sensitive individuals. These products should be properly labeled and stored in an area inaccessible to children. In addition, a Material Safety Data Sheets (MSDS) should be available at a central location for each product in the event of an emergency. Consideration should be given to providing teaching staff with school issued cleaning products and supplies to prevent any potential for adverse chemical interactions between residues left from cleaners used by the facilities staff and those left by cleaners brought in by others.

Cleaning products in classroom

16. Store cleaning products properly and out of reach of students. All cleaning products used at the facility should be approved by the school department with MSDS' available at a central location.

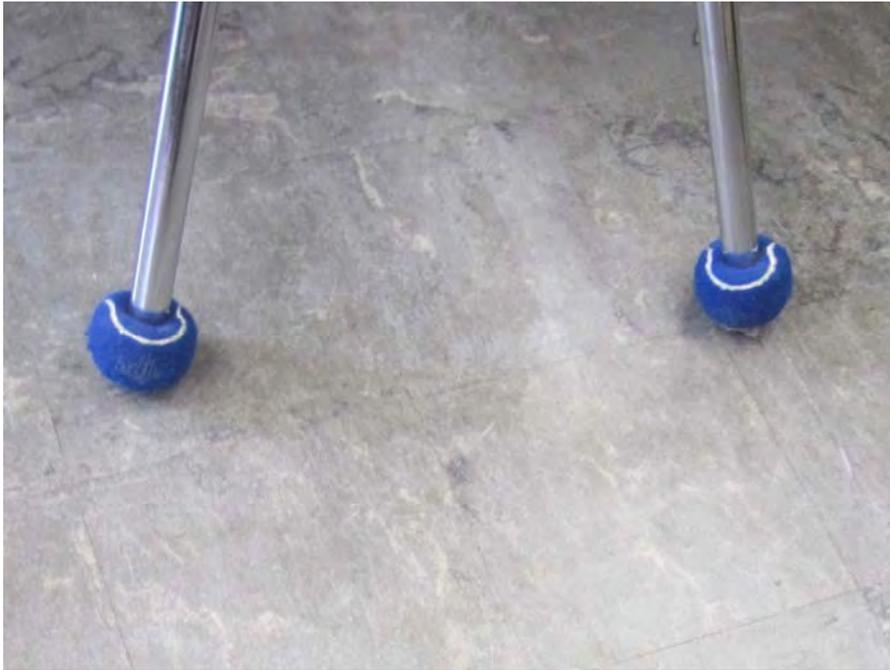
Picture 17

In an effort to reduce noise, tennis balls had been sliced open and placed on the base of desk/chair legs in some classrooms (Picture 17). Tennis balls are made of a number of materials that are a source of respiratory irritants. Constant wearing of tennis balls can produce fibers and cause VOCs to off-gas. Tennis balls are made with a natural rubber latex bladder, which becomes abraded when used as a chair leg pad. Use of tennis balls in this manner may introduce latex dust into the school environment. Some individuals are highly allergic to latex (e.g., spina bifida patients) (SBAA, 2001). It is recommended that the use of materials containing latex be limited in buildings to reduce the likelihood of symptoms in sensitive individuals (NIOSH, 1997).

Tennis balls on chair legs

21. Consider replacing tennis balls with latex-free tennis balls or glides.
22. Consider adopting the US EPA (2000) document, "Tools for Schools", as an instrument for maintaining a good indoor air quality environment in the building. This document is available at: <http://www.epa.gov/iaq/schools/index.html>
