# **INDOOR AIR QUALITY ASSESSMENT**

**Groton-Dunstable Regional Middle School  
South Building  
344 Main Street  
Groton, Massachusetts**

Prepared by:  
Massachusetts Department of Public Health  
Bureau of Environmental Health  
Indoor Air Quality Program  
May 2012

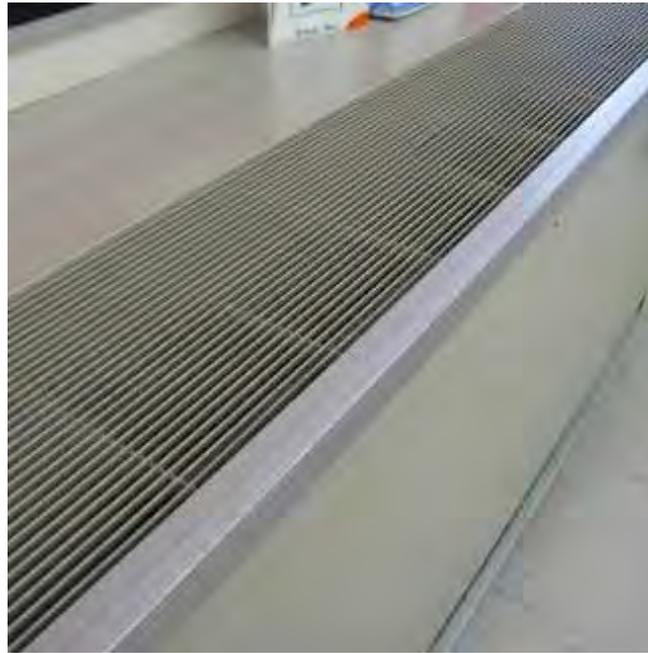
**Picture 1**

Fresh air in exterior classrooms is supplied by unit ventilator (univent) systems (Picture 1). A univent is designed to draw air from outdoors through a fresh air intake located on the exterior wall of the building. Return air is drawn through an air intake located at the base of the unit (Figure 1). Fresh and return air are mixed, filtered, heated and provided to classrooms through an air diffuser located in the top of the unit. In a few areas, univents were blocked by various items, limiting airflow in these rooms, and univents were found to be turned off in other areas. In order for univents to provide fresh air as designed, air intakes and returns must remain free of obstructions and the units must be operating.

**Unit Ventilator (Univent)**

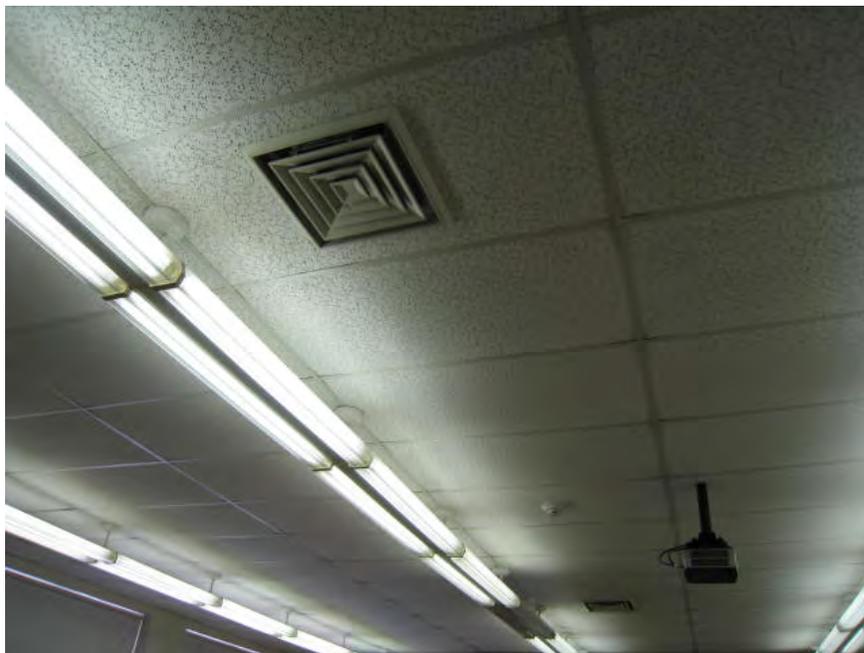
**Picture 2**

In some areas, such as offices, the gym, and some classrooms, supply ventilation is provided by centralized air handling units located in mechanical rooms or on the roof. Fresh air in these rooms enters through ceiling-mounted supply diffusers (Picture 2).

**Ceiling-Mounted Supply Vent**

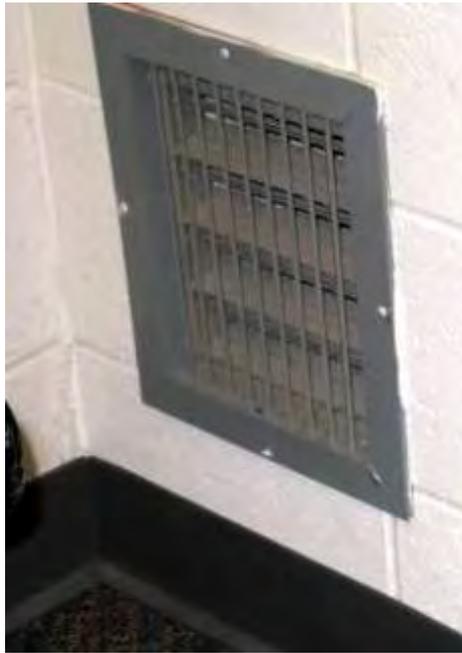
**Picture 3**

Exhaust ventilation to most classrooms is provided by wall or ceiling-mounted vents powered by rooftop motors. It is important to note that many classroom wall exhaust vents are located near hallway doors, which can limit exhaust efficiency. When classroom doors are open, exhaust vents tend to draw air from the hallway, thereby reducing the effectiveness of the vents in removing common environmental pollutants from classrooms. Some of the exhaust vents were also located in areas partially or fully obstructed by the door when the door is open (Pictures 3 and 4).

**Wall-Mounted Exhaust Vent behind Closed Classroom Door**

and exhaust vents are removed. Keep classroom doors closed when possible to maximize the ability of the exhaust vents to remove pollutants from classrooms.

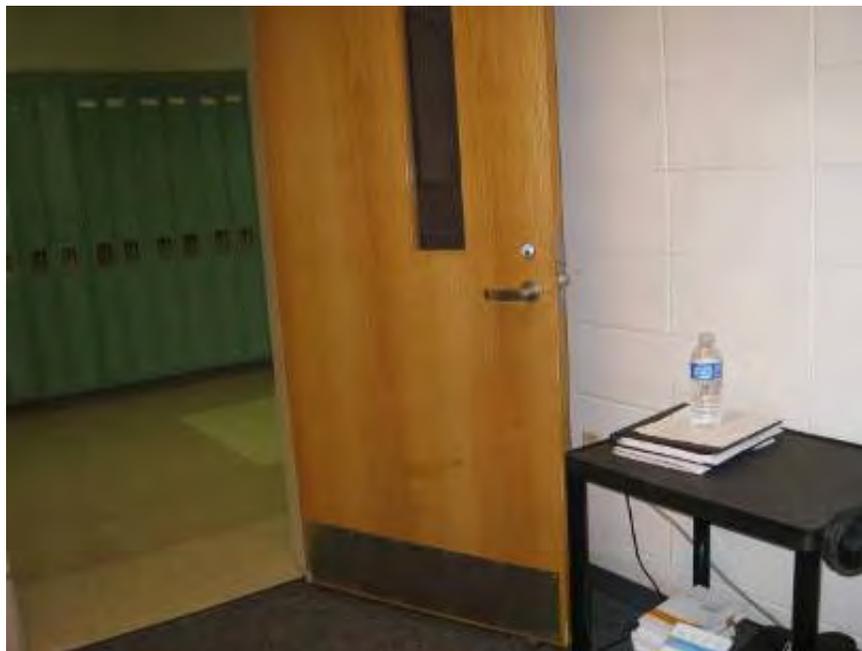
**Picture 4**

**Same Exhaust Vent Obscured behind Open Classroom Door**

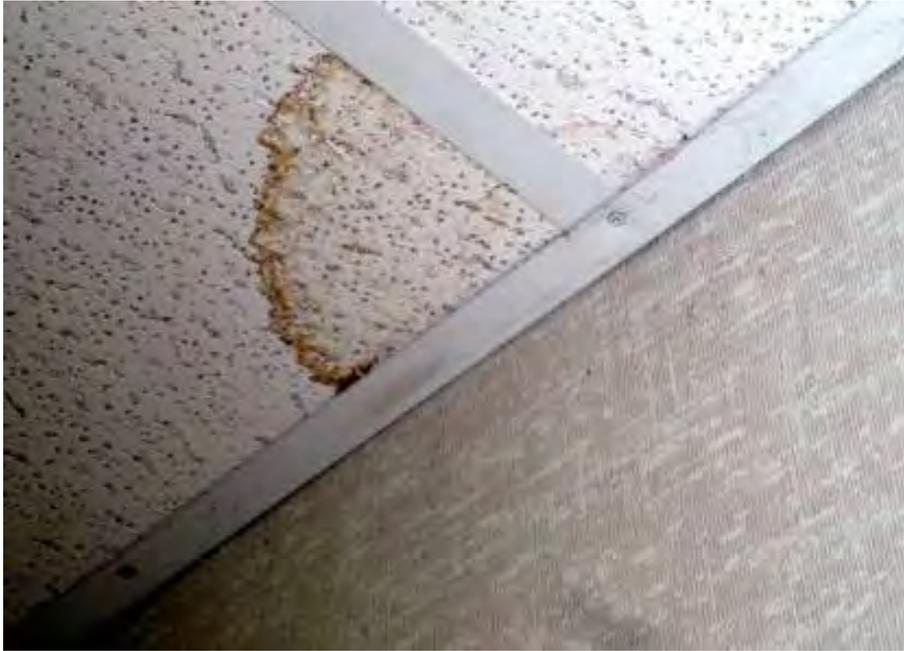
**Picture 5**

Water-damaged ceiling tiles were observed in some rooms (Picture 5). Water-damaged ceiling tiles can provide a source for mold growth and should be replaced after a water leak is discovered and repaired.

**Water-damaged Ceiling Tile**

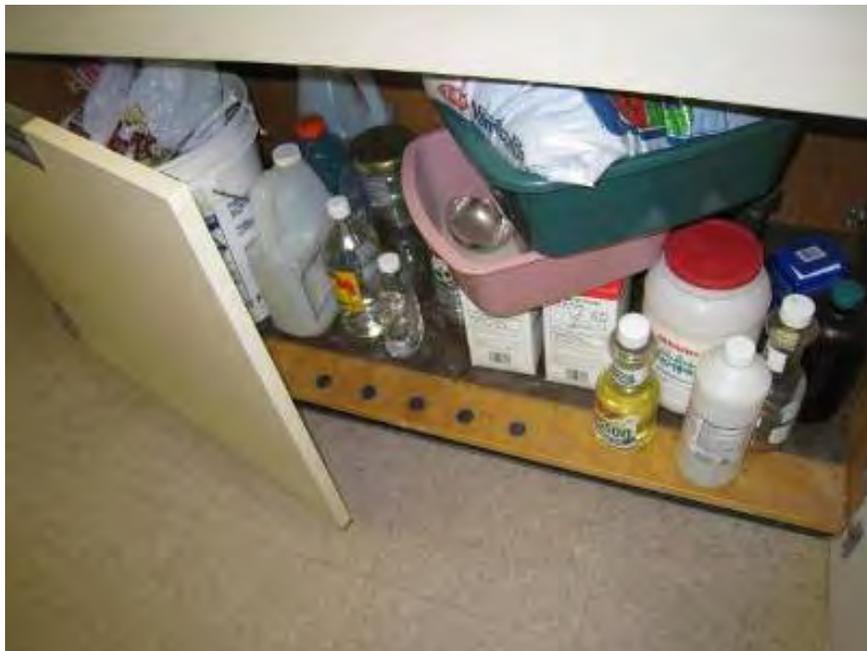
**Picture 6**

penetrate through the seam, causing water damage. Improper drainage or sink overflow can lead to water penetration into the countertop, cabinet interior and areas behind cabinets. Water penetration and chronic exposure of porous and wood-based materials can cause these materials to swell and result in water damage. Classroom sinks were also found to have porous materials (e.g., paper, cloth, bags of potting soils) stored beneath them where they may be subject to moistening (Pictures 6 and 7). Repeated moistening of porous materials can result in mold growth.

**Various Items Stored under Sink**

7. Repair any plumbing leaks (e.g., first floor women's bathroom) and ensure that resultant moistened materials are properly dried.
8. Seal breaches between sink countertops and backsplashes to prevent water damage and repair damaged backsplashes. Avoid storage of porous materials under sinks.

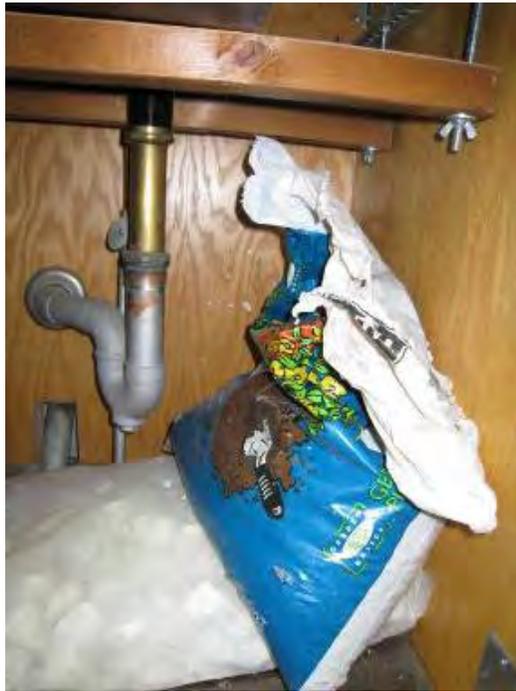
**Picture 7**

**Potting Soil Stored under Sink**

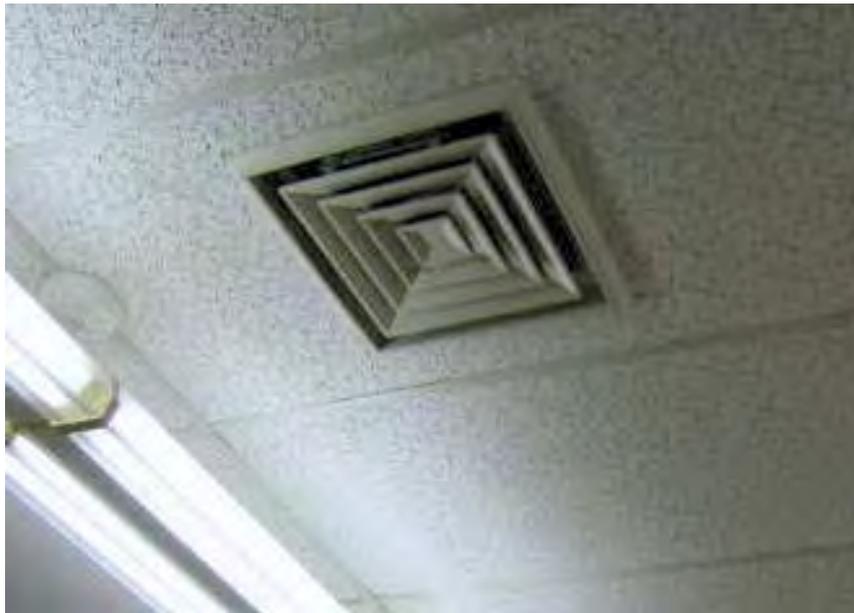
**Picture 8**

A leak was noted from the ceiling vent in the 1<sup>st</sup> floor ladies restroom resulting in moisture and water accumulation on the floor which can provide a source of mold growth (Picture 8). The source of the leak should be identified and repaired.

**Leaking Ceiling Vent in 1<sup>st</sup> Floor Restroom**

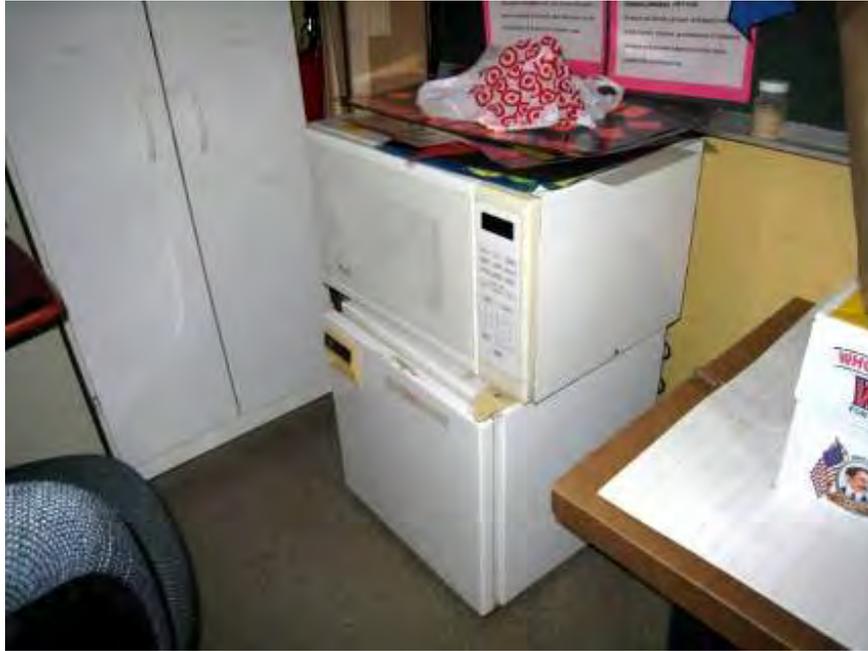
**Picture 9**

Several small refrigerators were noted in classrooms and offices, some of which were located on carpet (Picture 9). Appliances that can condense or leak water should be located on an impermeable surface such as a tiled floor or a plastic mat to prevent water damage to the carpeting.

**Mini Refrigerator on Carpet**

9. Consider relocating refrigerators to areas with tile floors, or use impermeable mats to contain potential spills or leaks.

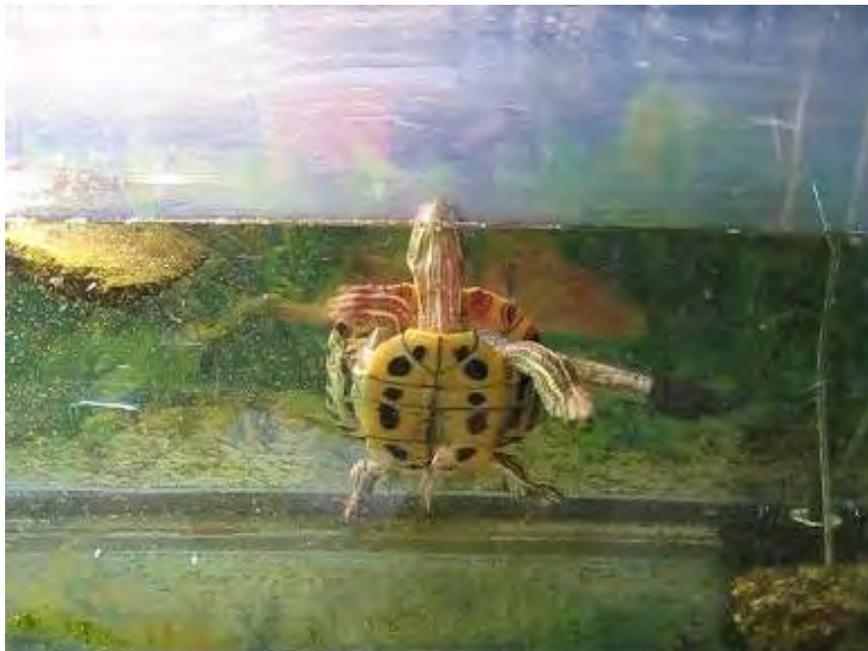
**Picture 10**

An aquarium containing several turtles was noted in one of the science classrooms (Picture 10). Another covered aquarium was also noted. Aquariums should be properly maintained to prevent microbial/algal growth as they can emit unpleasant odors into the classroom.

**Turtle Aquarium in Science Lab**

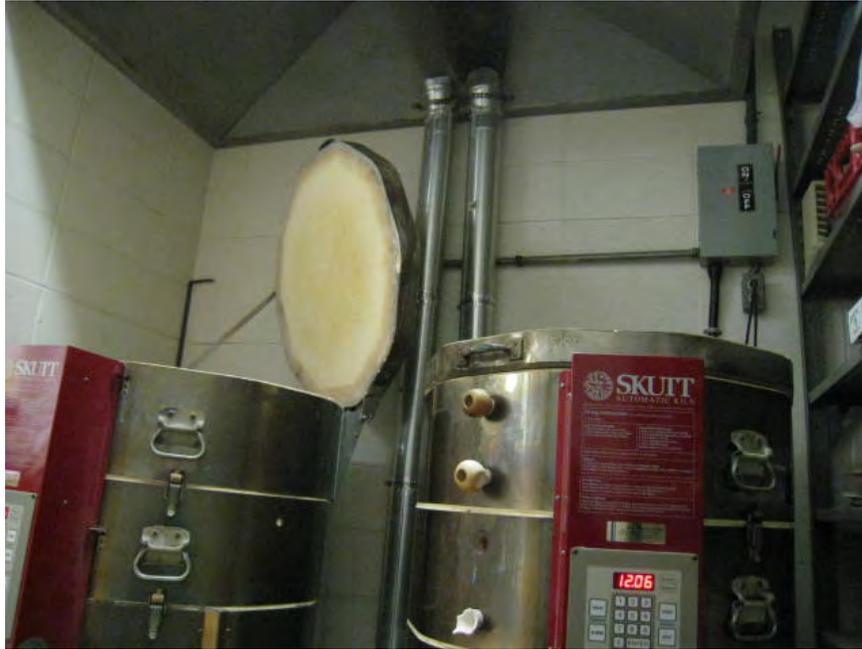
**Picture 11**

Two kilns were observed in a small room off one of the art rooms (Picture 11). A hood-style dedicated exhaust vent was observed for the kilns and determined to be functional, operating on a thermostatically-controlled switch. Kilns require dedicated exhaust ventilation to remove heat, gases and particulates generated from the process of firing clay. The door to the kiln room should be undercut by a few inches to allow for air to penetrate the room so that the exhaust ventilation can function effectively in removing the byproducts from kiln use.

**Pottery kilns and dedicated exhaust ventilation**

12. Undercut the door to the kiln room by up to three inches to allow for airflow so that the exhaust hood can operate effectively.
13. Routinely clean particulate accumulation in chalk/dry erase board trays.

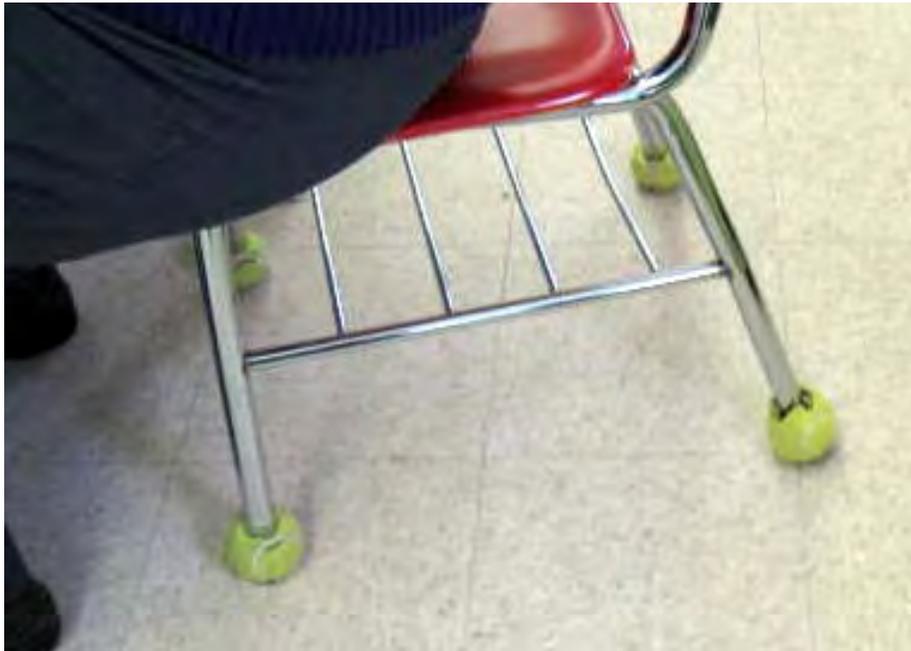
**Picture 12**

In one classroom, a chair was outfitted with tennis balls that had been sliced open and placed on the base of the legs (Picture 12). Tennis balls are made of a number of materials that are a source of respiratory irritants. Constant wearing of tennis balls can produce fibers and cause VOCs to off-gas. Tennis balls made with a natural rubber latex bladder become abraded when used as a chair leg pad. Use of tennis balls in this manner may introduce latex dust into the school environment. Some individuals are highly allergic to latex (e.g., spina bifida patients) (SBAA, 2001). It is recommended that the use of materials containing latex be limited in buildings to reduce the likelihood of symptoms in sensitive individuals (NIOSH, 1997).

**Tennis Balls on Classroom Chair**

15. Consider replacing tennis balls with latex-free tennis balls on furniture legs or glides.
16. Routinely clean accumulated dust and debris periodically from the surface of exhaust vents, supply fans and blades of personal fans.

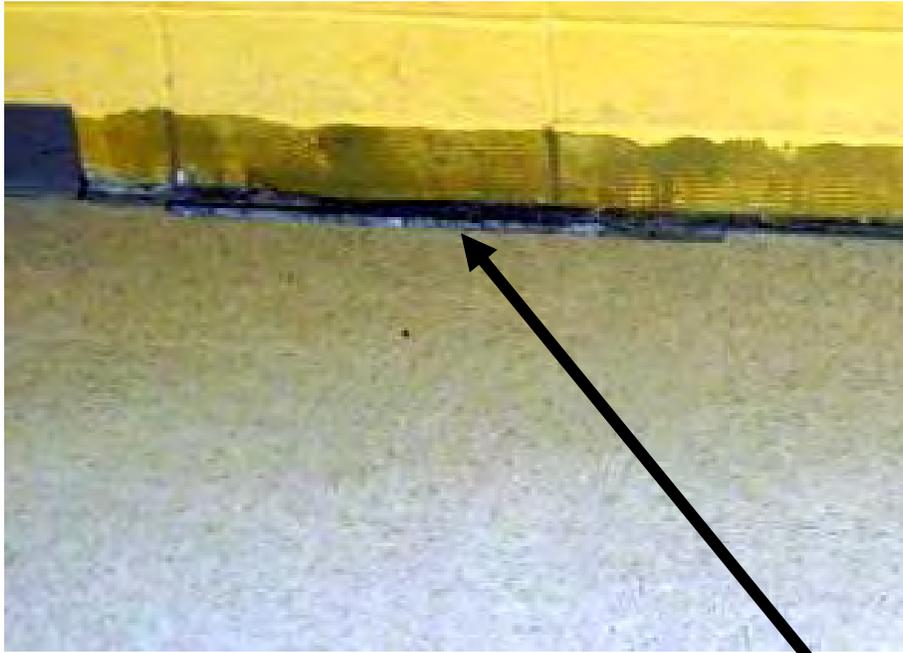
**Picture 13**

In classroom 95, a section of the coving (the plastic edging material along the bottom of the wall) had been damaged and/or removed. There was a two-foot-long hole in the floor where the floor met the wall. Part of the hole was open through the floor and into the slab resulting in air movement/draft into the room. Other sections of the hole were sealed with expanding foam to fill the holes/gaps (Pictures 13 and 14) however, air movement was still detected. The source/cause of this breach should be identified and be repaired to prevent air, dust and/or odors moving from the building cavity into the occupied space.

**Missing Coving with Hole in Floor: Note Arrow Depicting Hole/Gap**

19. Identify areas where coving has been damaged or removed and repair breaches/holes.

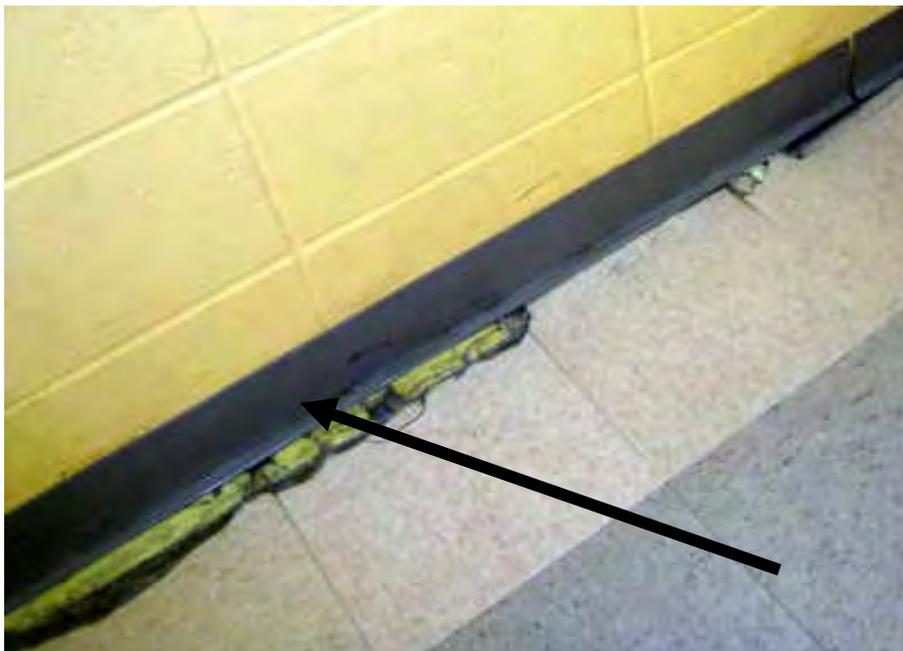
**Picture 14**

**Missing Coving: Note Arrow Depicting Expanding Foam Partially Filling Hole/Gap**

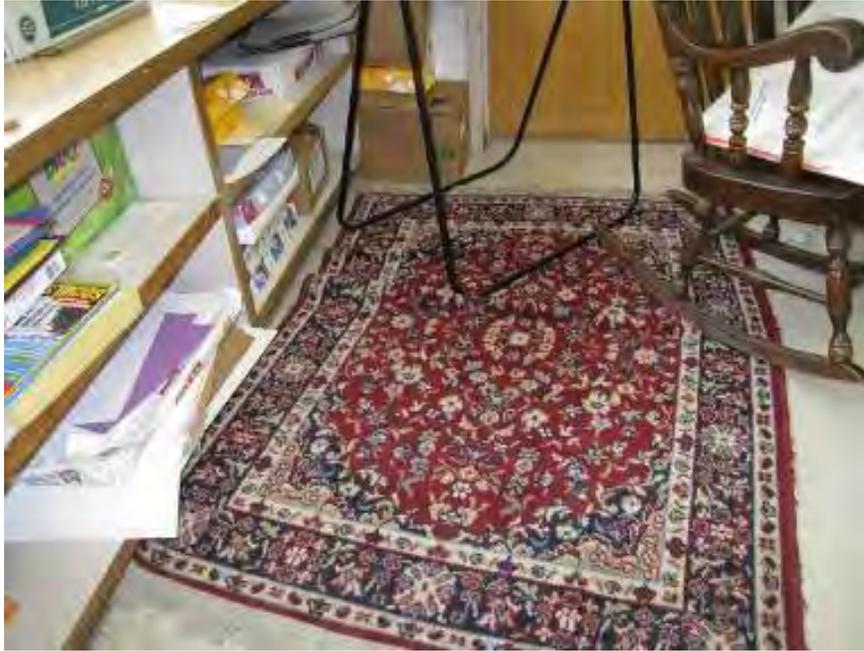
**Picture 15**

Floors in some classrooms are covered by wall-to-wall carpeting. It was not clear whether a carpet cleaning program is in place at the GDRMS. Area carpets were observed in several other classrooms (Picture 14). The Institute of Inspection, Cleaning and Restoration Certification (IICRC), recommends that carpeting be cleaned annually (or semi-annually in soiled high traffic areas) (IICRC, 2005). Where an excessively dusty environment exists due to outdoor conditions or indoor activities (e.g., renovations), cleaning frequency should be increased (every six months) (IICRC, 2000).

**Area Carpet in Classroom**

17. Clean carpeting annually or semi-annually in soiled high traffic areas as per the recommendations of the Institute of Inspection, Cleaning and Restoration Certification (IICRC). Clean carpeting annually or semi-annually in soiled high traffic areas as per the recommendations of the Institute of Inspection, Cleaning and Restoration Certification (IICRC). Copies of the IICRC fact sheet can be downloaded at:  
<http://www.certifiedcleaners.org/faq.shtml>
