# **INDOOR AIR QUALITY ASSESSMENT**

**Massachusetts Department of Children and Families  
261 High Street  
Holyoke, Massachusetts**

Prepared by:  
Massachusetts Department of Public Health  
Bureau of Environmental Health  
Indoor Air Quality Program  
December 2012

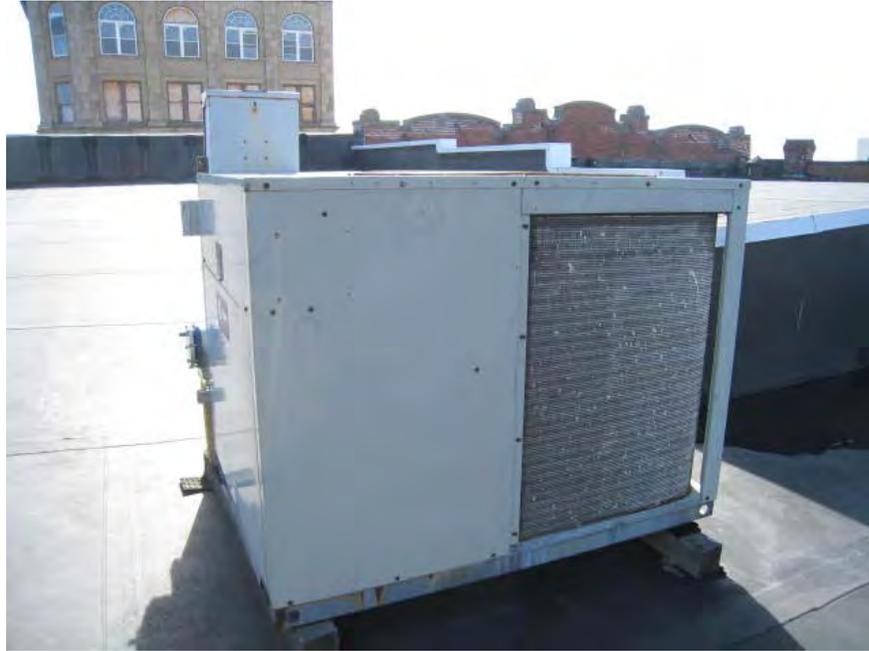
**Picture 1**

Mechanical ventilation is provided by rooftop air-handling units (AHUs) (Picture 1). Fresh air is drawn into the AHUs and delivered to occupied areas via ceiling-mounted air diffusers (Picture 2). Return air is drawn through ceiling-mounted exhaust grills and directed back into the AHU (Picture 3).

**Roof-top AHU**

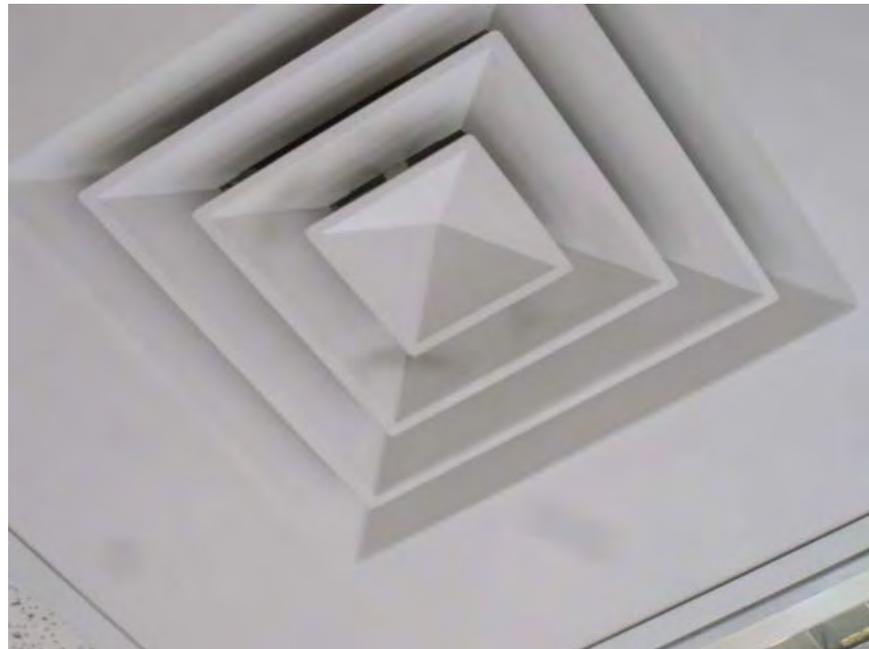
**Picture 2**

**Fresh Air Supply Vent**

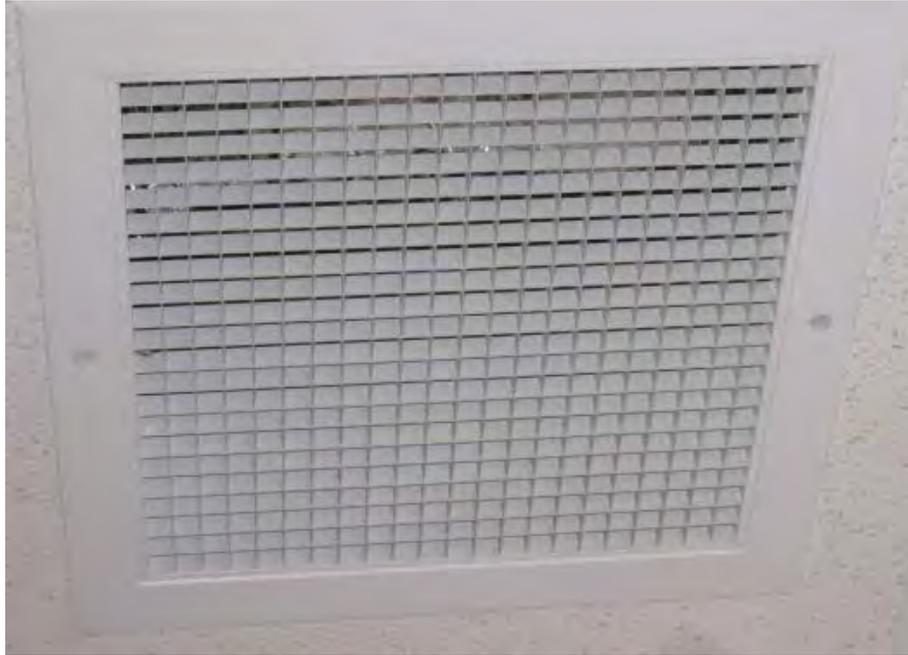
**Picture 3**

It was noted that in many offices, the exhaust vents were located near the doors, most of which were open. This may reduce the effectiveness of the exhaust vents to remove air from the inside of the room, since air from the hallways outside may preferentially be drawn into the room.

**Return Air Exhaust Vent**

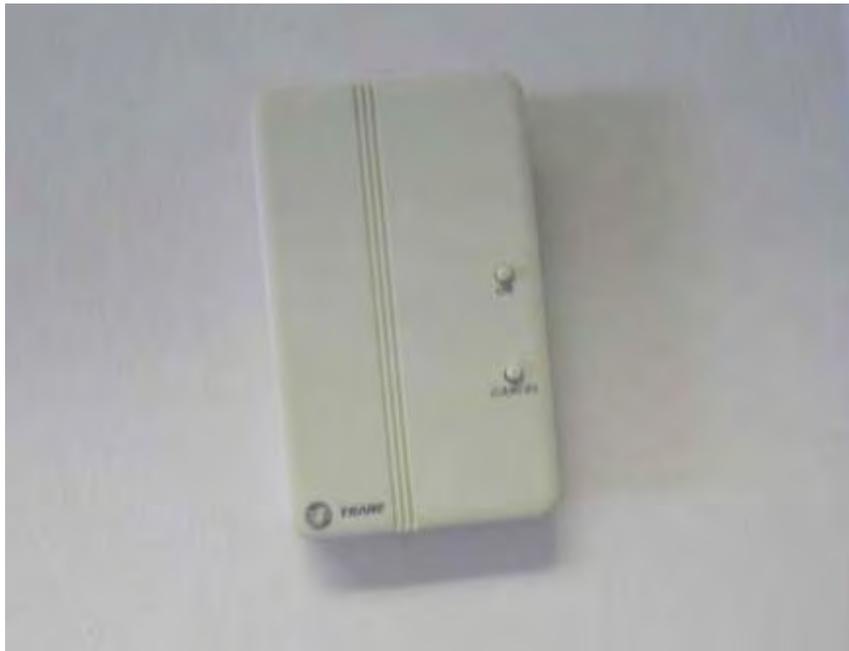
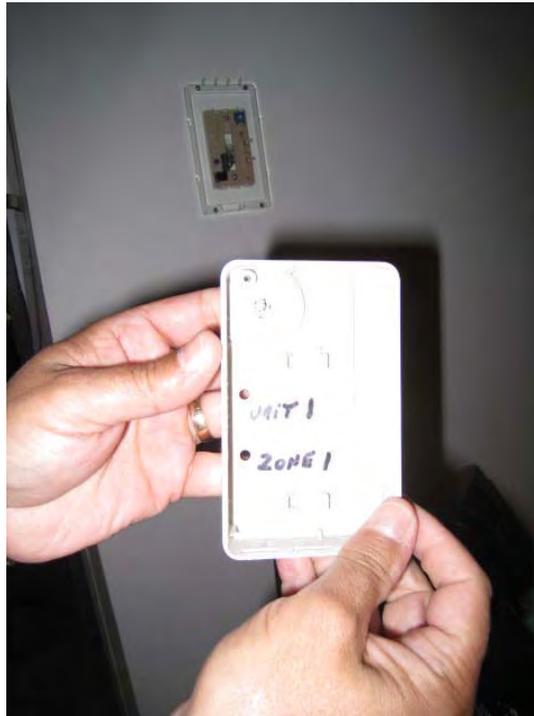
Air circulation is controlled by wall-mounted thermostats and connected sensors (Pictures 4 and 5). Reportedly they are set to circulate air only when heating or cooling is called for rather than operating continuously during occupied hours. When the AHUs on the roof were examined, the fans on many of them were not operating, indicating either the zones to which they were connected were not calling for air circulation, or that they were in need of maintenance. Weak or nonexistent air flow was detected in many locations from both the supply and exhaust vents (Table 1).

**Wall-mounted Thermostat**

**Thermostat Showing Zone Setting**

1. To maximize air exchange, set thermostats to the fan “on” position to operate the ventilation system continuously during business hours.
2. Ensure that thermostats are operable and are placed in a location to readily measure room temperature. The areas around and beneath thermostats should be clear of obstructions, and heat-producing office equipment should not be located in close proximity.

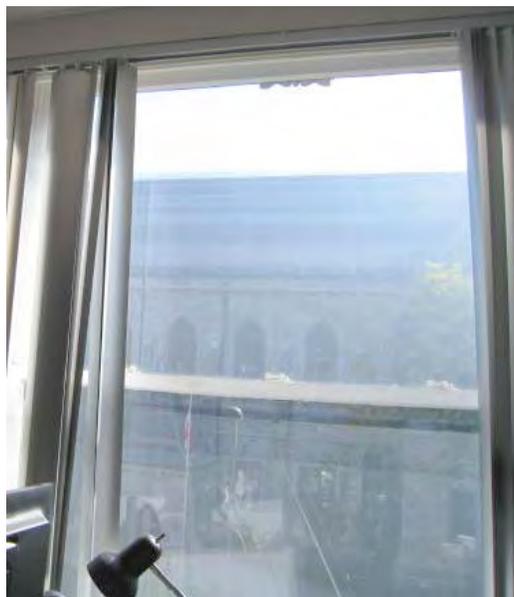
**Picture 6**

Although temperature readings were within recommended levels, building occupants reported that temperatures were uncomfortable in the building, which is likely related to the location of cubicles/office space adjacent to windows. The windows are composed of a single pane in metallic frames, most covered with Plexiglas, which may subject portions of office space to solar gain in direct sunlight and chilling in cold weather. This phenomenon was confirmed by building occupants reports of warm temperatures and thermal discomfort in the south-facing portion of the building during the late morning through the early afternoon during sunny weather. With this build-up of heated air, return ventilation is needed to create airflow and increase the comfort of building occupants. Although most windows were equipped with vertical shades, BEH/IAQ staff observed that many were open or pulled aside to allow light into the office on the day of the assessment (Picture 6). The adjustment of shades to modulate solar heat gain in the office is recommended to reduce this effect.

**Window Shades Open on South Side of Building**

3. To reduce the potential for temperature fluctuations due to solar gain, adjust window blinds as needed.
4. For buildings in New England, periods of low relative humidity during the winter are often unavoidable. Therefore, scrupulous cleaning practices should be adopted to minimize common indoor air contaminants whose irritant effects can be enhanced when the relative humidity is low. To control for dusts, a high efficiency particulate arrestance (HEPA) filter equipped vacuum cleaner in conjunction with wet wiping of all surfaces is recommended. Avoid the use of feather dusters. Drinking water during the day can help ease some symptoms associated with a dry environment (throat and sinus irritations).

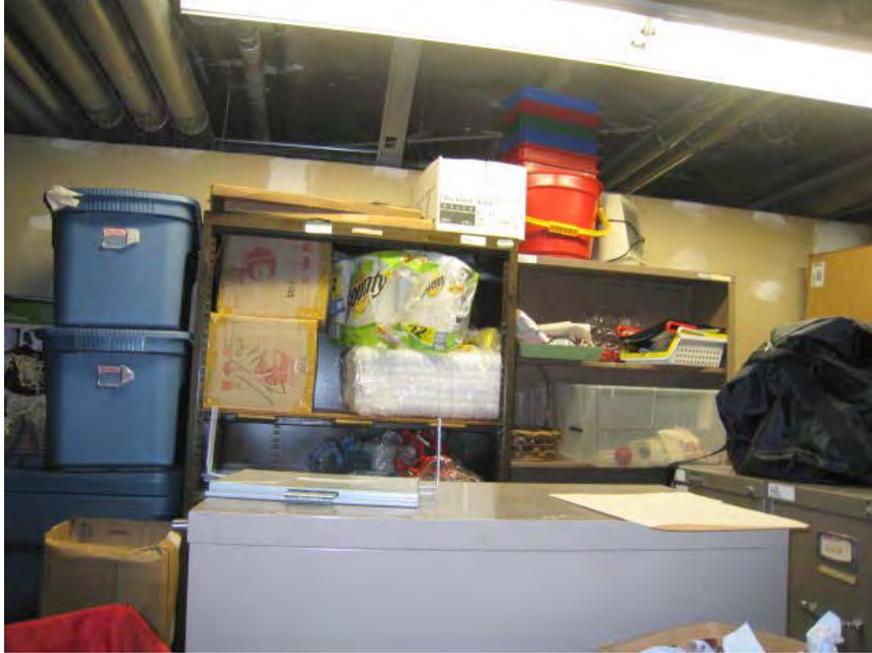
**Picture 7**

The basement of the building is unoccupied, however portions of the space is used as storage space for DCF files and other items (Picture 7). Upon entering the basement, a musty odor was detected. There had reportedly been a significant flood from a water main break approximately two months prior to the BEH/IAQ visit, which had reportedly resulted in water to a depth of several inches on the floor. The floor is composed of a combination of cement in some areas, and dirt covered with wooden flooring over it in others. The flooring was not moist at the time of the BEH/IAQ assessment. Items that had been water-damaged from the flood had reportedly been discarded and the area had been dried out with fans. Although the wooden flooring was water-damaged (Picture 8), it did not appear to be colonized with mold. Most of the water had reportedly drained rapidly into a sub-basement area; an access door to this area was open (Picture 9) and a musty odor was detected from within it. It is recommended that this door remain closed at all times and that it be modified to be air tight to prevent odors from migrating from the sub-basement into the basement. According to the building management employees, the subbasement is still being cleaned/repared from the flooding.

**Storage Space in Basement**

7. Store all paper and porous materials in basement on shelving, in file cabinets and/or in plastic bins to reduce potential exposure to moisture and potential mold colonization/growth.

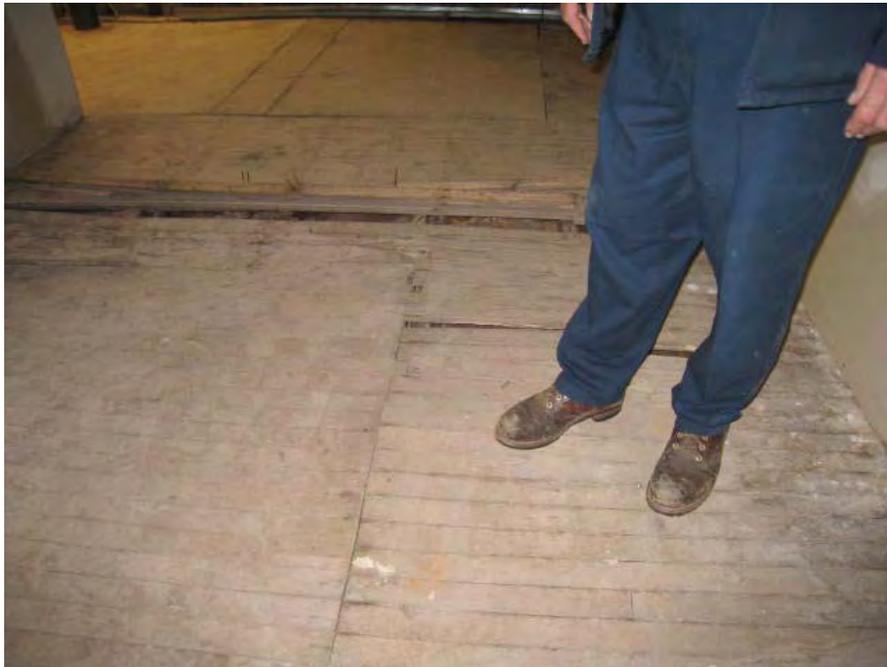
**Picture 8**

**Water-damaged Wooden Floor in Basement**

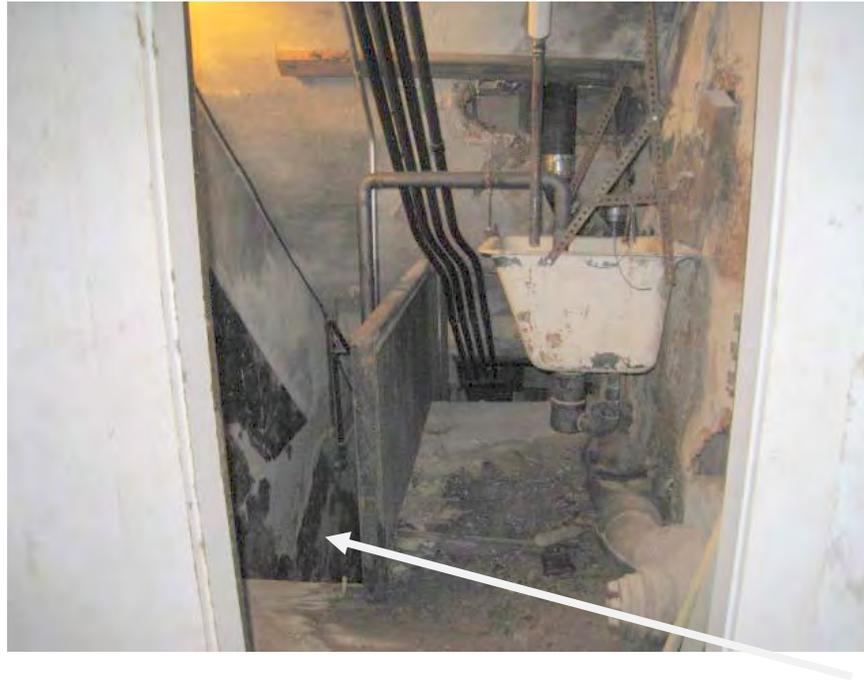
**Picture 9**

**Open Door to Subbasement: Note Stairway**

8. Keep door to the sub-basement closed and install weather-stripping to limit air penetration through the doorframe. Check for air-tightness by monitoring for light and/or drafts around door. Monitor repairs to sub-basement.

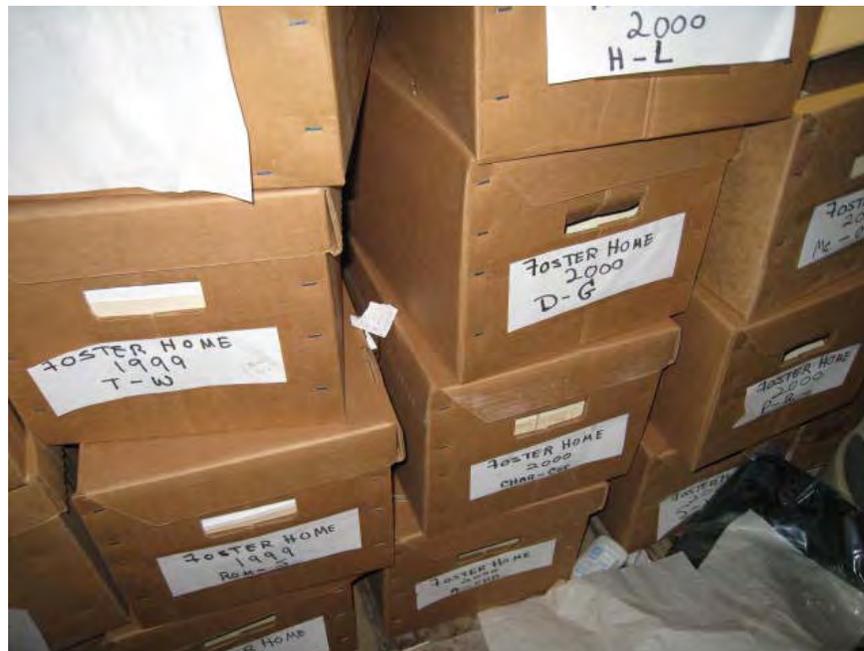
**Picture 10**

Although most DCF cardboard boxes, paper files and other porous items were stored on metal shelving or in file cabinets, BEH/IAQ staff observed boxes on the floor (Picture 10). The DCF storage space was not directly adjacent to the flood areas and did not appear to have been

water-damaged or colonized with mold. It should be noted that the basement has no mechanical ventilation and is subject to moisture infiltration during hot, humid weather which may result in moistening of stored materials and potential mold colonization.

**Boxes Stored on Basement Floor**

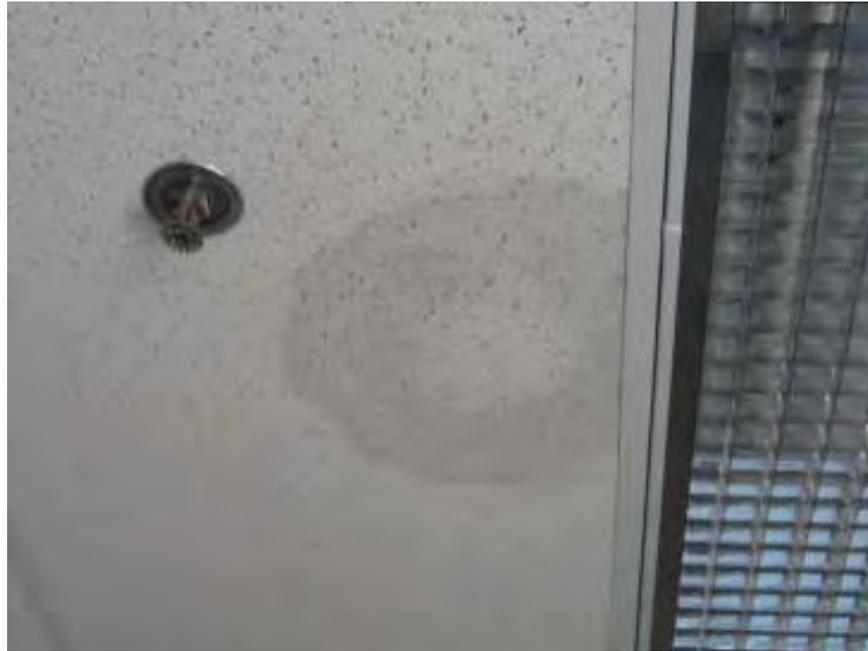
**Picture 11**

Water-damaged ceiling tiles were observed in some other areas (Picture 11). Water-damaged ceiling tiles can stem from roof leaks, leaks in the plumbing system and/or leaks and condensation from air-conditioning systems. Water-damaged ceiling tiles can provide a source of mold. These tiles should be replaced after a water leak is discovered and repaired.

**Water-damaged Ceiling Tile**

5. Consider adopting a balancing schedule of every 5 years for all mechanical ventilation.
6. Remove water-damaged ceiling tiles and examine for source of water. Monitor for future leaks.

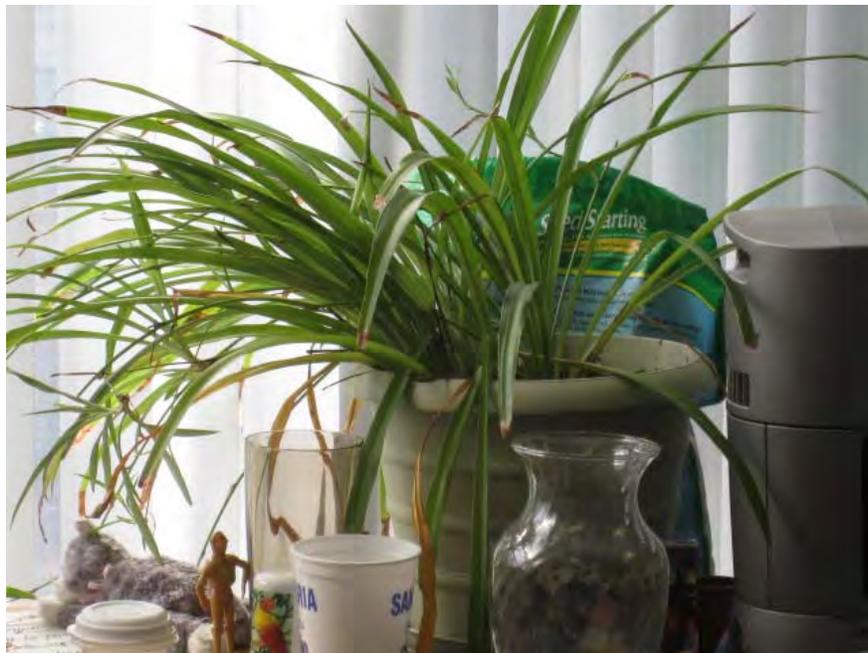
**Picture 12**

Plants were observed in many cubicles/offices (Picture 12). Plants can be a source of pollen and mold, which can serve as respiratory irritants for some sensitive individuals. Plants should be properly maintained and equipped with drip pans to prevent water damage to porous building materials. Plants should also be located away from ventilation sources (e.g., air diffusers, portable fans) to prevent the aerosolization of dirt, pollen or mold.

**Plant Located in Office Space**

9. Ensure all plants are equipped with drip pans. Examine drip pans for mold growth and disinfect areas of water leaks with an appropriate antimicrobial where necessary.

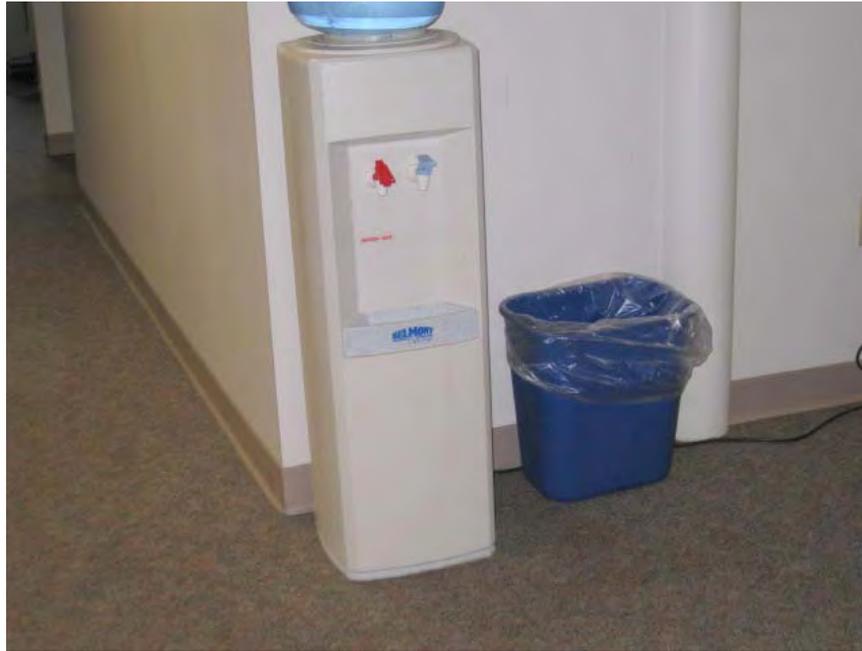
**Picture 13**

A water dispenser was located in a carpeted area (Picture 13). BEH/IAQ staff also noted that refrigerators, microwaves and coffee machines were located in many areas of the office (Table 1), often on carpet. Water dispensers, refrigerators and cooking equipment can be a source of condensation and spills, which can moisten carpeting and may lead to microbial growth. Refrigerators that are not maintained can also become contaminated with mold, and be a source of odors. BEH/IAQ recommends that sources of moisture and spills not be located on carpeting, and that any spills be cleaned up promptly.

**Water Cooler Located on Carpet**

10. Consider moving water dispensing and cooking equipment to areas with tiled floors instead of carpeting, or installing waterproof mats to prevent leaks from damaging carpet. Clean refrigerators and cooking equipment regularly.

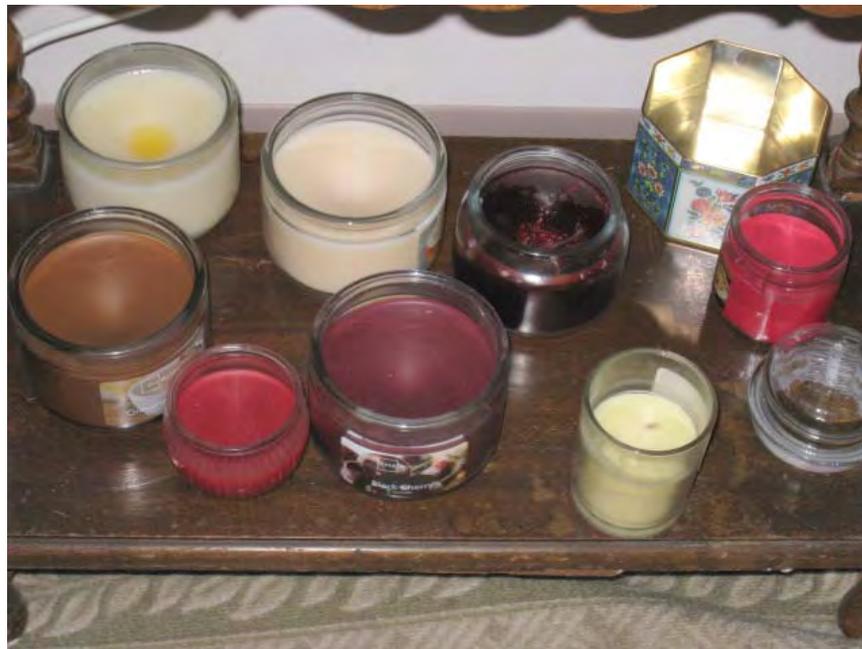
**Picture 14**

Scented candles (Picture 14) were noted in an administrative office. Scented candles contain chemicals that can be irritating to the eyes, nose and throat of sensitive individuals. Scented products were also noted in restrooms. Deodorizing agents do not remove materials causing odors, but rather mask odors that may be present in the area.

**Scented Candles in Office Space**

12. Refrain from having scented candles or using air fresheners/deodorizers to prevent exposure to VOCs.
13. Ascertain whether insulation on the heating unit shown in Picture 20 contains asbestos and encapsulate or remove in conformance with Massachusetts law. Other areas of the basement should also be inspected, including pipe insulation and floor tile. Consult with a licensed asbestos inspector for the most appropriate course of action concerning remediation.

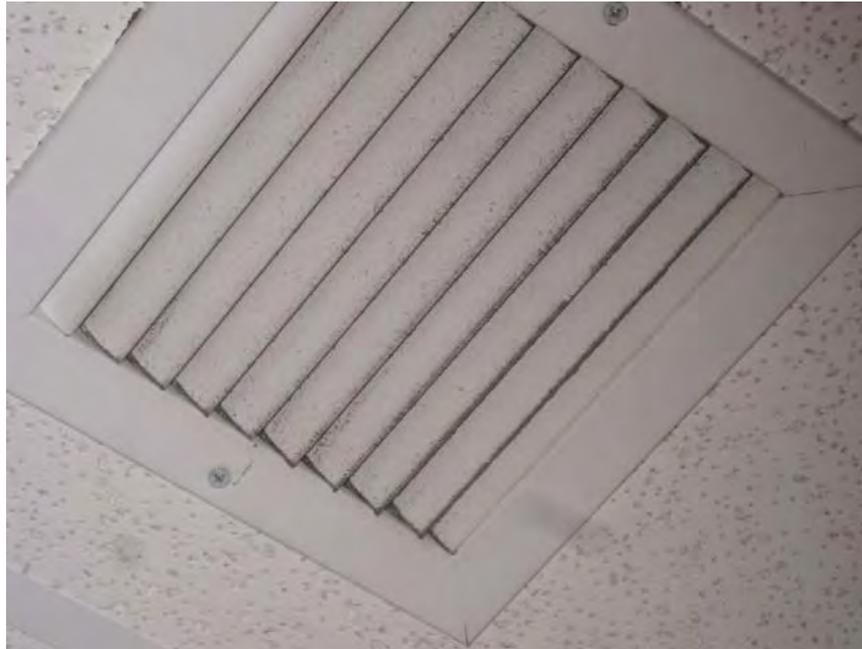
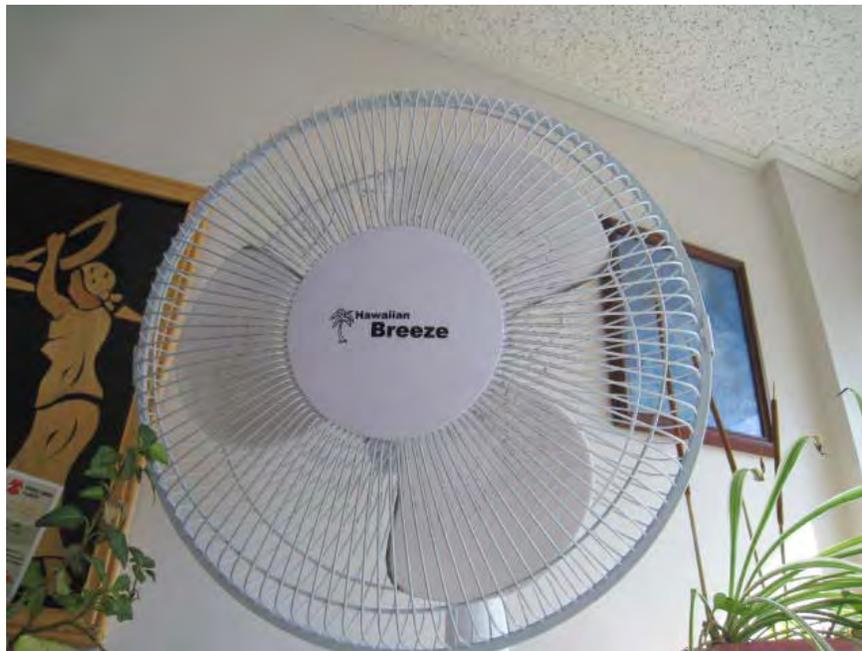
A number of exhaust vents and personal fans had accumulated dust/debris (Pictures 15 and 16). Vents and fans should be cleaned periodically in order to prevent them from serving as a source of aerosolized particulates.

**Exhaust Vent Showing Dirt/Debris**

**Personal Fan with Dirt/Debris**

14. Relocate or consider reducing the amount of materials stored in offices and common areas to allow for more thorough cleaning.
15. Clean AHU air intake, air diffusers, return vents and personal fans periodically of accumulated dust/debris.

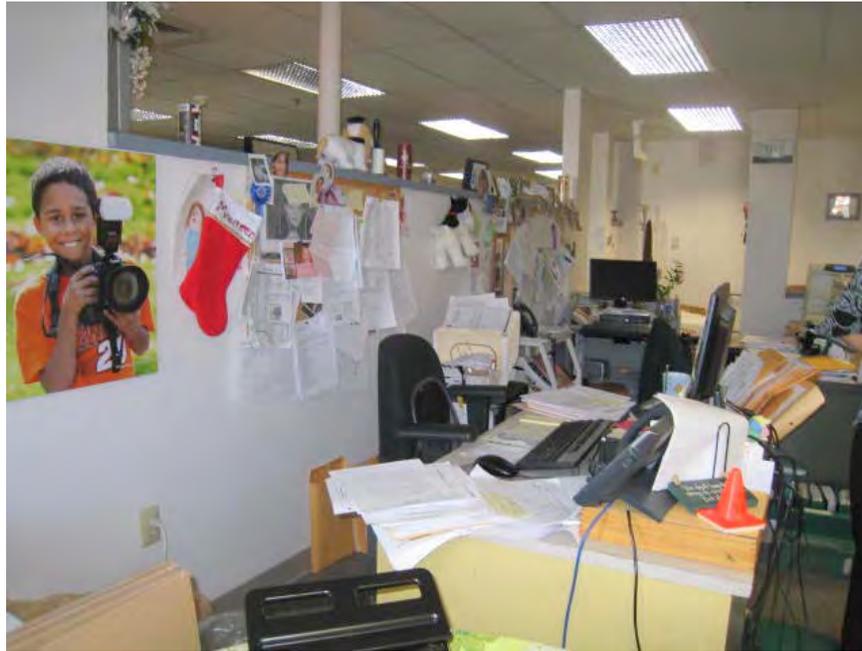
**Picture 17**

In many offices, items were observed on the floors, windowsills, tabletops, counters, bookcases and desks (Picture 17). These items included holiday decorations which were hanging from the ceiling, draped over desks and on other surfaces. Stored and decorative items provide a source for dusts to accumulate. These items (e.g., papers, folders, boxes) make it difficult for custodial staff to clean. Items should be relocated and/or be cleaned periodically to avoid excessive dust build up. In addition, dust can accumulate on flat surfaces (e.g., desktops, shelving and carpets) in occupied areas and subsequently be re-aerosolized causing further irritation.

**Clutter in Third Floor Office Space**

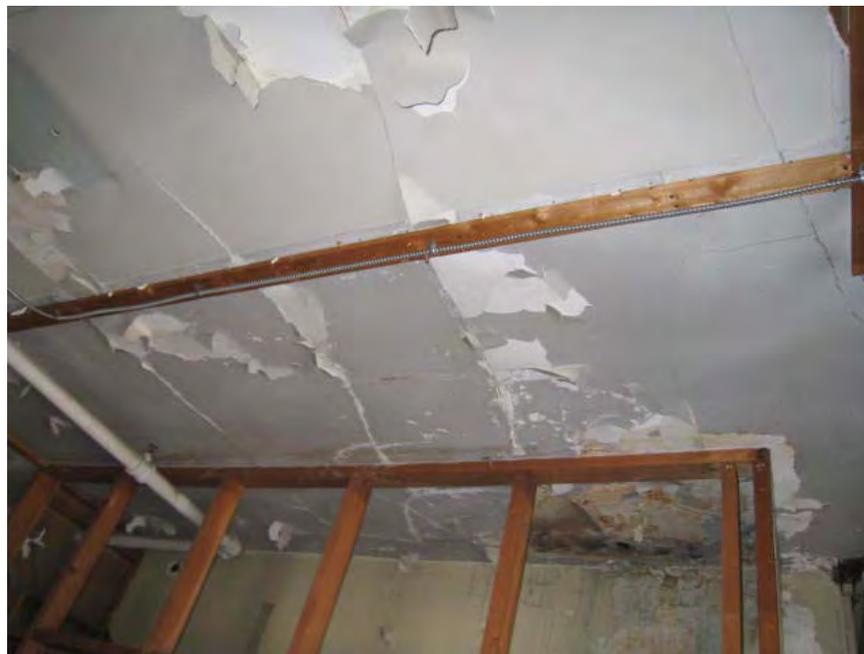
**Picture 18**

used by DCF is an open area. BEH/IAQ staff observed peeling paint in the space (Picture 18) and there was some accumulation of dust and debris, which may include flakes of paint dust. It is not known if the paint dust contains lead.

**Peeling Paint on Fourth Floor**

11. Store materials such as plush toys in the attic in an enclosed form of storage to protect items from dust, dirt and moisture. Consider having the peeling paint tested for lead to eliminate a source of hazardous materials.

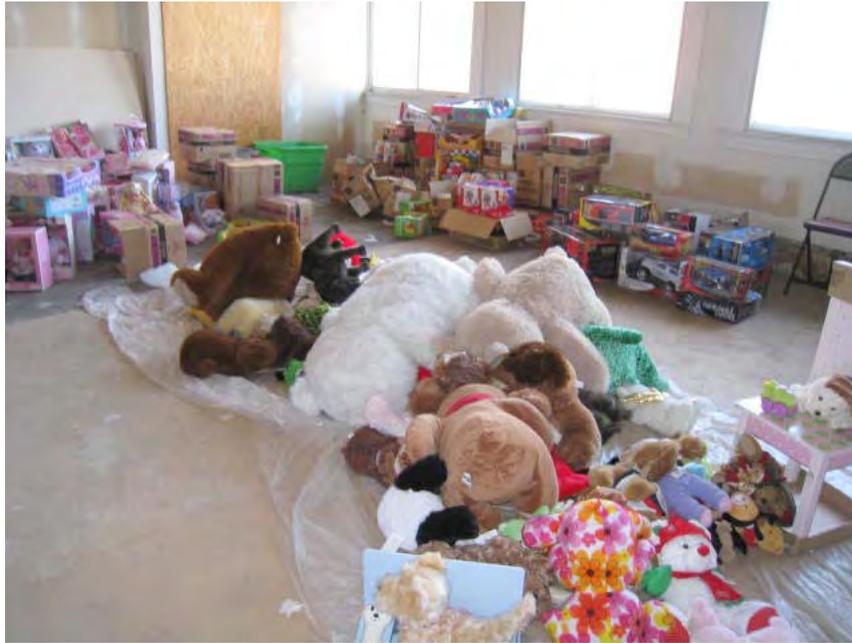
**Picture 19**

The area was reportedly cleaned out recently and appeared relatively neat and organized. However, items including toys, were stored on the floor on top of a tarp (Picture 19). Given the lack of climate control in this area, and the potential for paint flakes and other dust, a more enclosed method of storing items, particularly unwrapped plush toys is recommended. Dust can be irritating and allergenic to both the staff handling the toys and to the children to whom the toys are given. Additional structured storage, such as shelving, and/or enclosed bins or drawers would improve the organization and protection of stored materials from dust.

**Toys and Items Stored in the Fourth Floor Storage Space**

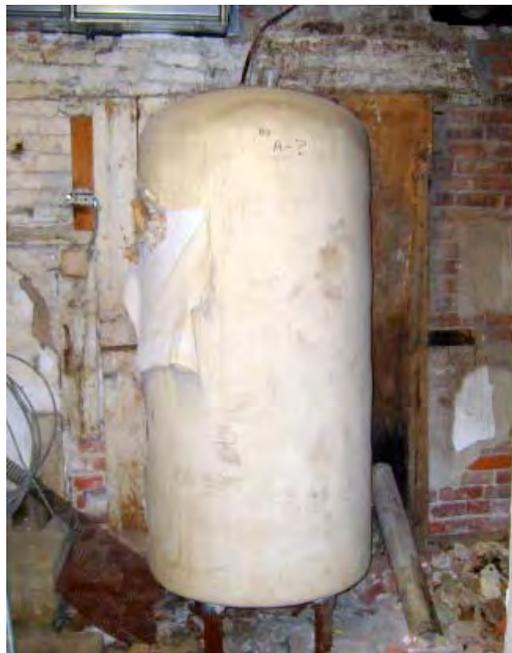
**Picture 20**

In the basement, an old heating/water heating component with exposed insulation material was marked with an “A” (Picture 20). Due to the potential for these materials to contain asbestos, testing to should be done by a licensed contractor. If asbestos is present, it should be remediated in conformance with all applicable Massachusetts asbestos abatement and hazardous materials disposal laws.

**Heating Component with Exposed Insulation**
