INDOOR AIR QUALITY ASSESSMENT

**Leicester High School
170 Paxton Street
Leicester, MA**

Prepared by:
The Massachusetts Department of Public Health
Bureau of Environmental Health
Indoor Air Quality Program
February 2012

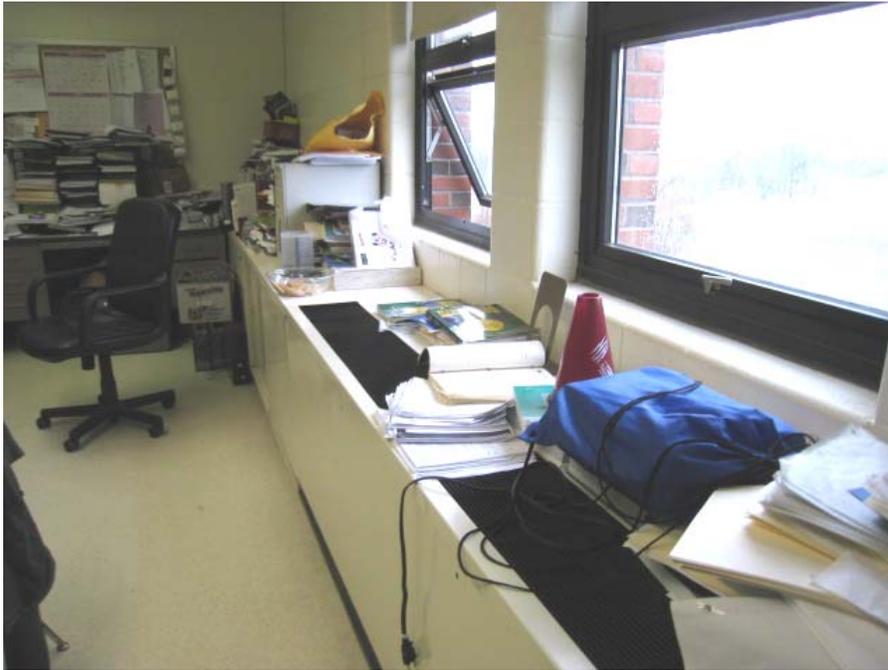
Picture 1

Items placed on univents

1. Operate all mechanical ventilation systems throughout the building (e.g., cafeteria, classrooms) continuously during periods of occupancy.
2. Remove all blockages from univents and closet exhaust vents to ensure adequate airflow.

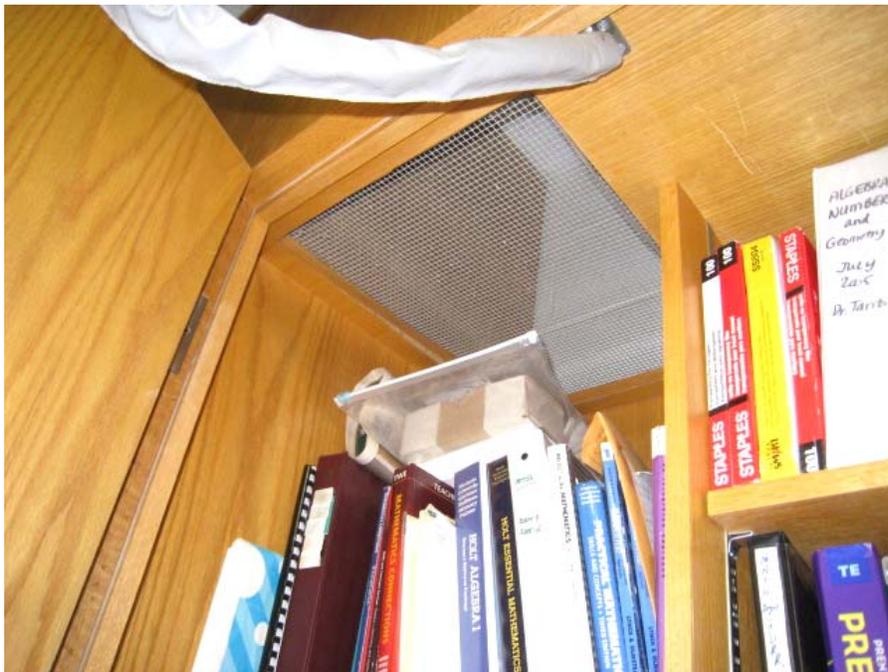
Picture 2

Exhaust ventilation in classrooms is provided by a mechanical exhaust system. The exhaust vents are located in the upper portion of coat closets (Picture 2). Classroom air is drawn into the coat closet via a grate mounted on the closet door. In some rooms, exhaust ventilation was found blocked either in front of the closet door or within the closet itself (Picture 3). Such blockage can prevent draw of air, reducing the ability of the exhaust system to remove normally-occurring pollutants from the classroom.

Exhaust vent located in closet

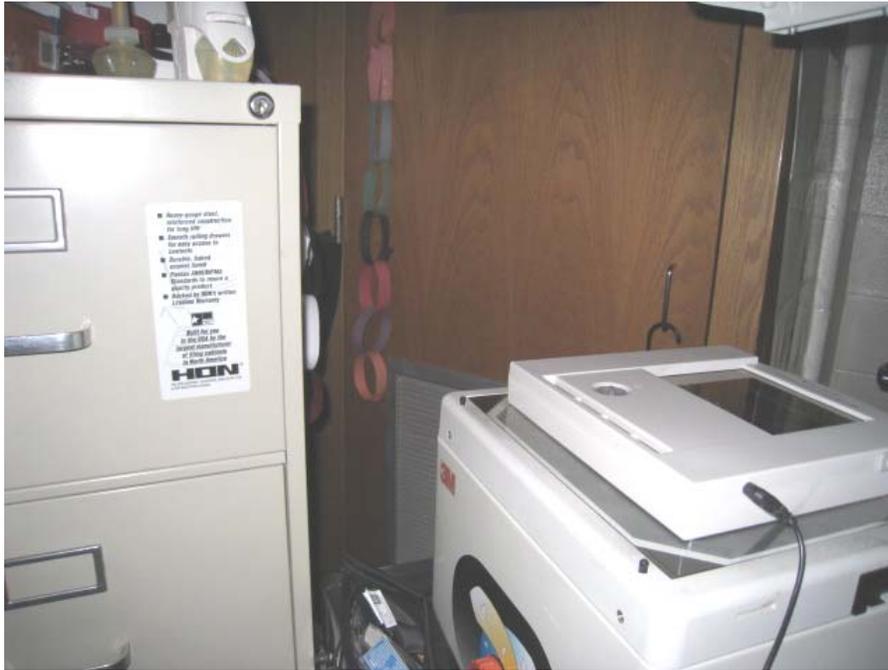
Picture 3

Air deodorizers were observed in some classrooms (Picture 3; Table 1). Like dry erase materials, air deodorizers contain chemicals that can be irritating to the eyes, nose and throat of sensitive individuals. Many air fresheners contain 1,4-dichlorobenzene, a VOC which may cause reductions in lung function (NIH, 2006). Furthermore, deodorizing agents do not remove materials causing odors, but rather mask odors that may be present in the area.

Items located in front of closet exhaust grate, note air deodorizers on cabinet

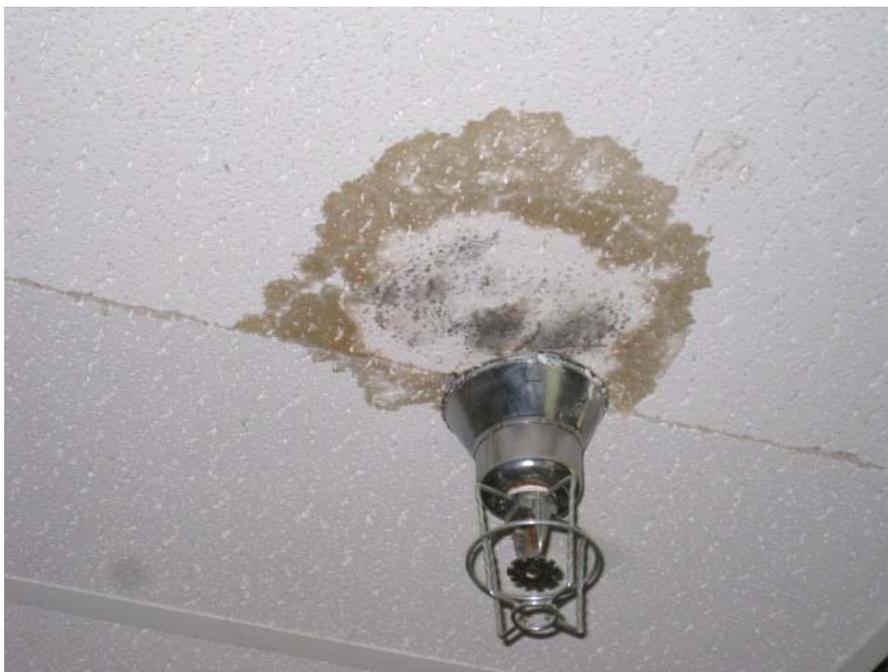
Picture 4

A number of water penetration problems have been reported at the LHS. BEH staff observed a barrel being used to catch water, indicating an active leak. Water-damaged ceiling tiles were observed in several areas within the building (Table 1), further indicating current/historic plumbing and/or roof leaks. A mold-colonized ceiling tile was observed in classroom 210 (Picture 4). In other areas, damaged ceiling tiles had been painted. Water-damaged ceiling tiles can provide a source of mold and should be replaced after a water leak is discovered and repaired. Mr. Wicklund and his staff have reportedly made a number of attempts to mitigate/limit water penetration; efforts are on-going.

Water-damaged/mold colonized ceiling tile in room 210

7. Work with staff to identify and repair any remaining leaks. Replace any water-damaged ceiling tiles (e.g., room 210). Examine the area above these tiles for mold growth. Disinfect areas of water leaks with an appropriate antimicrobial, as needed.

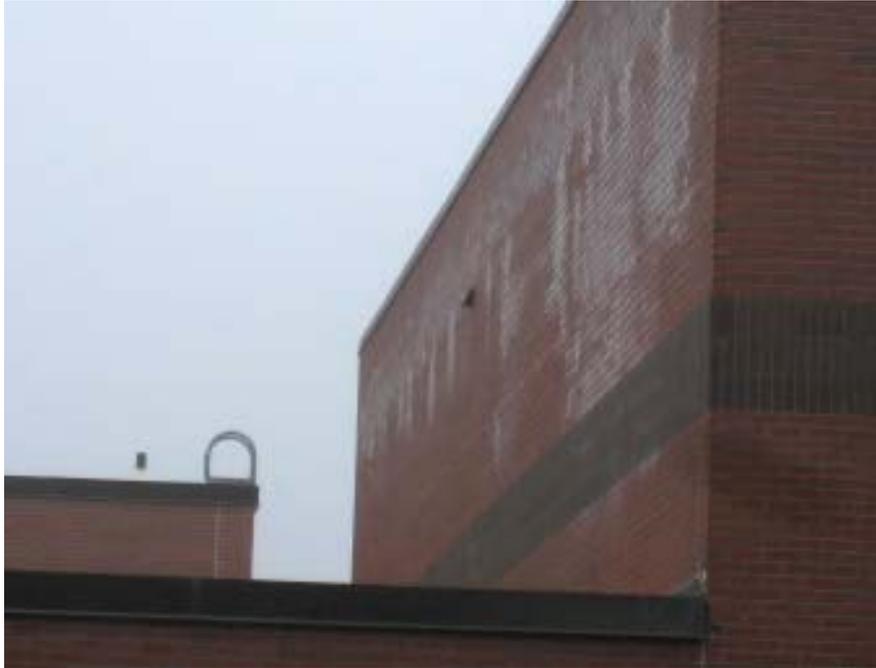
Picture 5

BEH staff observed a number of conditions to the building exterior that may be contributing to water/moisture damage in the building. Exterior walls in a number of areas exhibited efflorescence on brickwork (Picture 5). Efflorescence is a characteristic sign of water intrusion. As penetrating moisture works its way through mortar around brick, it leaves behind characteristic mineral deposits. On closer inspection, exterior brickwork in several areas appeared to be bowing (Picture 6); indicating water is likely being retained between the exterior wall and the moisture barrier.

Efflorescence (white mineral deposits) on exterior brickwork

- Make repairs to missing/damaged mortar/brick;
 - Ensure proper drainage of weep holes; and
 - Repair foundation cracks/damage.
9. Consider contacting a structural engineer/building envelope specialist for an examination of the exterior brick work of the building, especially in areas where the exterior wall is “bowing” outwards. This measure should include a full building envelope evaluation.

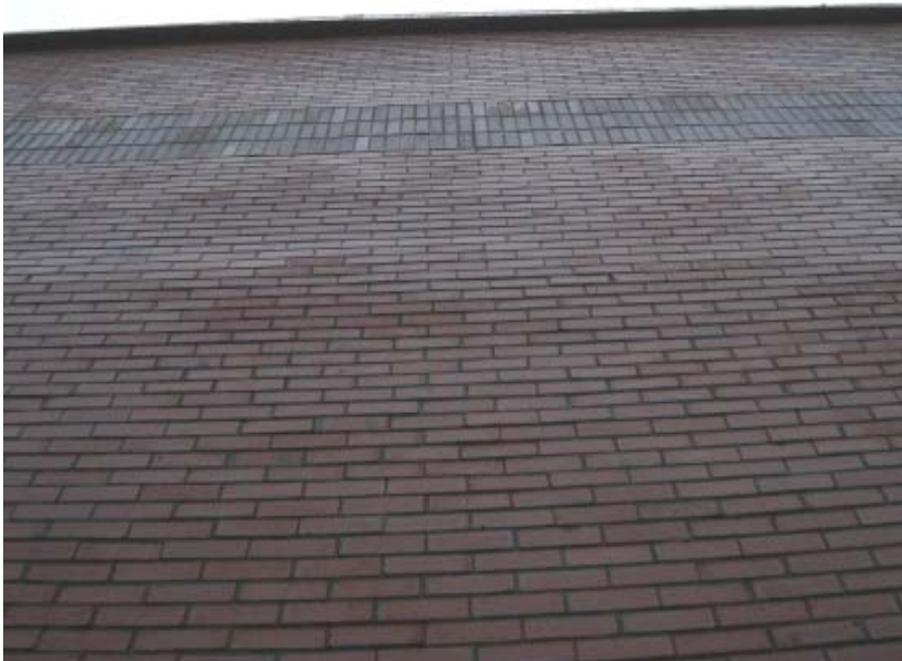
Picture 6

Mr. Wicklund reported a number of issues regarding water leakage near the band room entrance. Measures to address leakage included repairing the roof line and waterproofing brickwork. Please note, waterproofing sealers applied to masonry can cause water vapor to become trapped. Without an immediate means to escape, water will seek alternate routes which can cause damage to masonry similar to the efflorescence and bowing observed.

Warped/bowing exterior brickwork

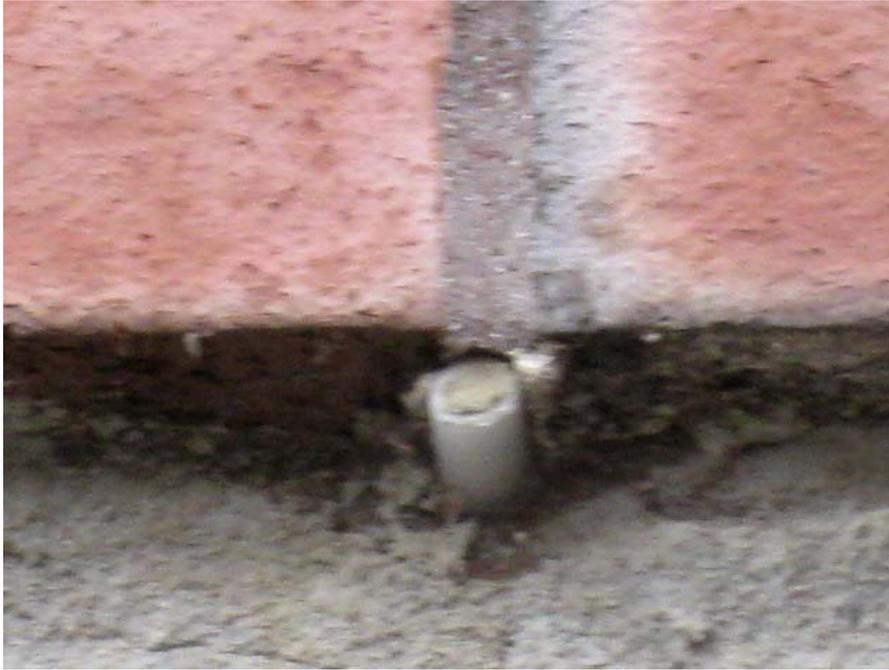
Picture 7

Moisture retention may also be related to clogged weep holes (Picture 7). Exterior wall systems should be designed to prevent moisture penetration into the building interior. An exterior wall system should consist of an exterior curtain wall (Figure 2). Behind the curtain wall is an air space that allows for water to drain downward and for the exterior cladding system to dry. In order to allow for water to drain from the exterior brick system, a series of weep holes is customarily installed in the exterior wall, at or near the foundation slab/ exterior wall system junction. Weep holes allow for accumulated water to drain from a wall system (Dalzell, 1955). Failure to install weep holes in brickwork or improper drainage from clogged weep holes will result in water accumulation at the base of walls, resulting in seepage and possible moistening of building components (Figure 3).

Clogged weephole

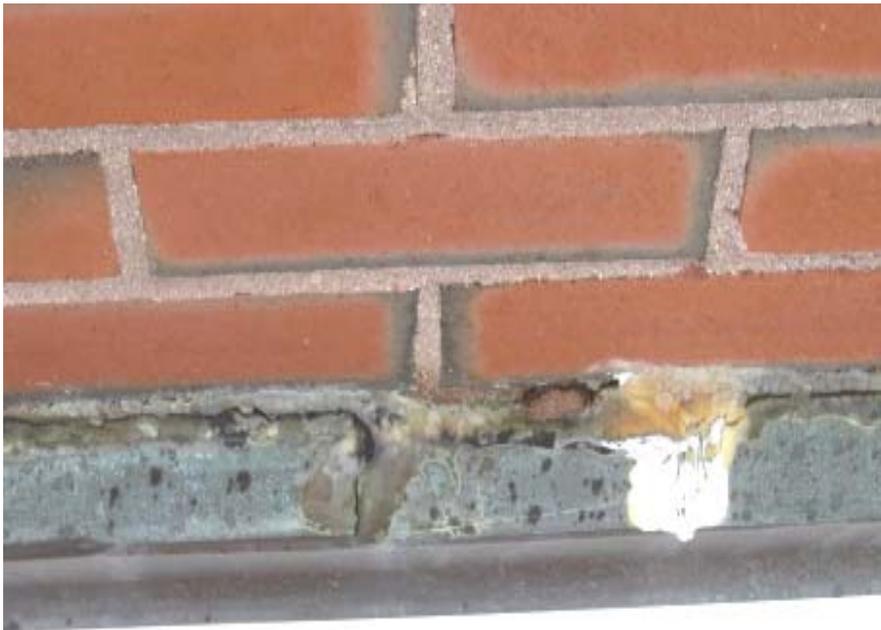
Picture 8

Upon examining the building's roof, BEH staff observed some damage in and around flashing (Picture 8). Further examination of the roof should be conducted to ensure that both the flashing and roof membrane are installed through masonry. A through-wall installation will allow water to divert from the exterior wall and onto the roof for drainage. Additional breaches in the building envelope and other concerns that could provide a source of water penetration include damaged/deteriorated brick and mortar (Picture 9) and cracks in the foundation (Picture 10).

Damaged roof flashing

8. Remedy all exterior building envelope conditions that contribute to water infiltration into the building, such as:
 - Repair/replace missing/damaged flashing;

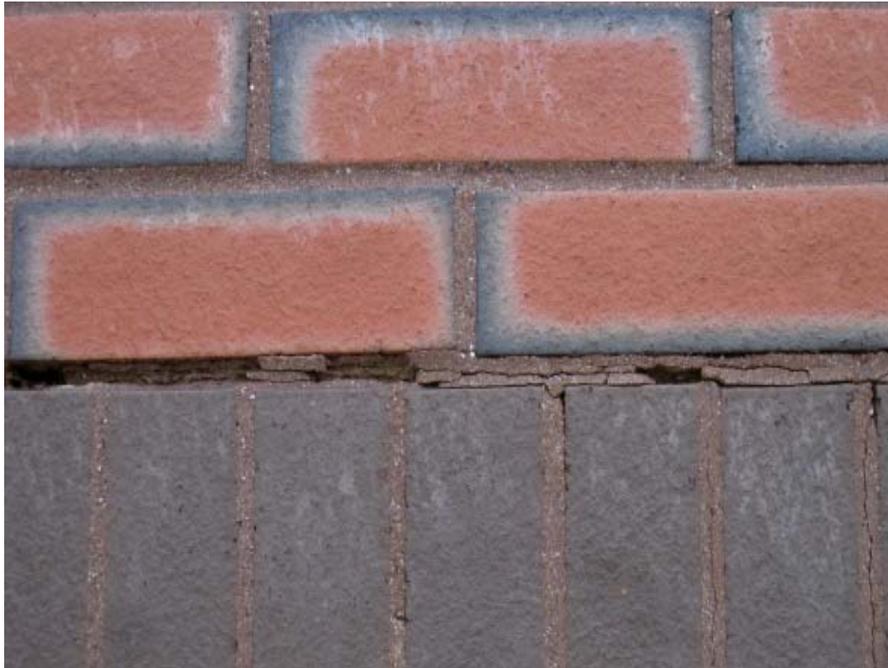
Picture 9

Missing/damaged mortar around exterior brickwork

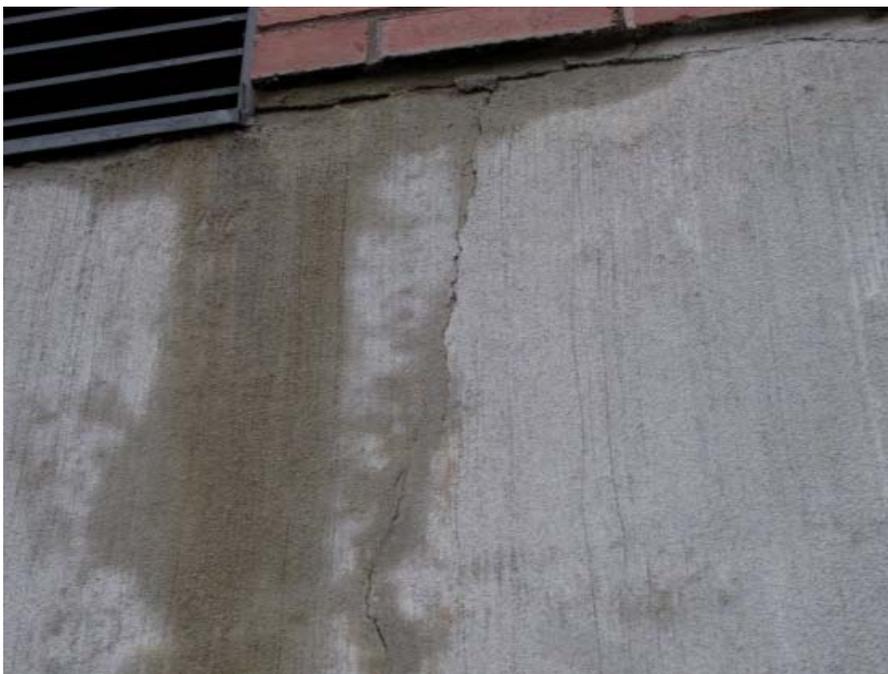
Picture 10

Cracked/damaged foundation

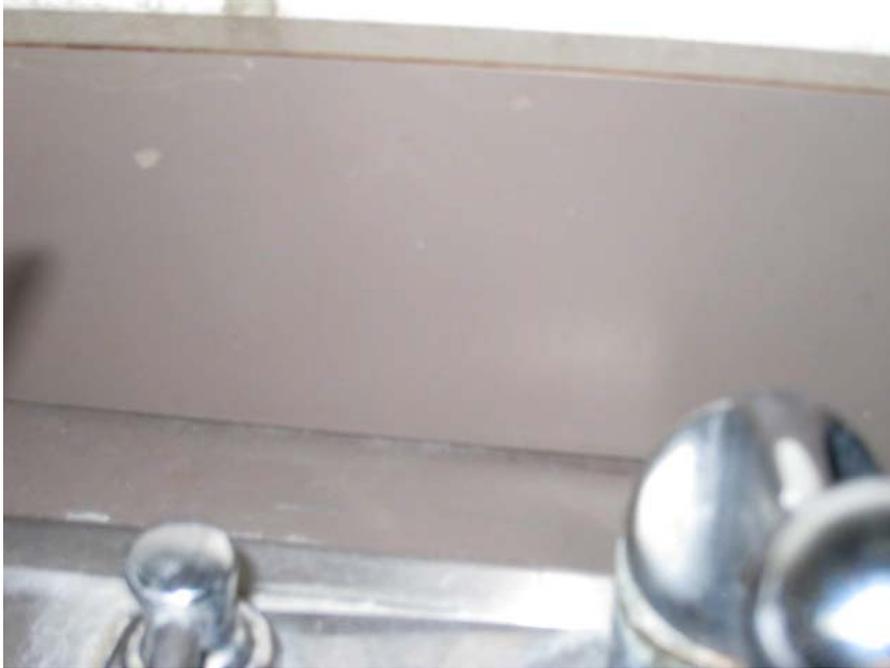
Picture 11

Breaches were observed between countertops and sink backsplashes in a few classrooms (Picture 11; Table 1). If not watertight, water can penetrate through backsplash seams or can leak from plumbing. Water penetration and chronic exposure of porous and wood-based materials can cause these materials to swell and show signs of water damage.

Breach in sink backsplash

11. Seal breaches, seams and spaces between sink countertops and backsplashes to prevent water damage.
12. Pour water into floor drains twice a week (or as needed) to maintain an airtight seal.

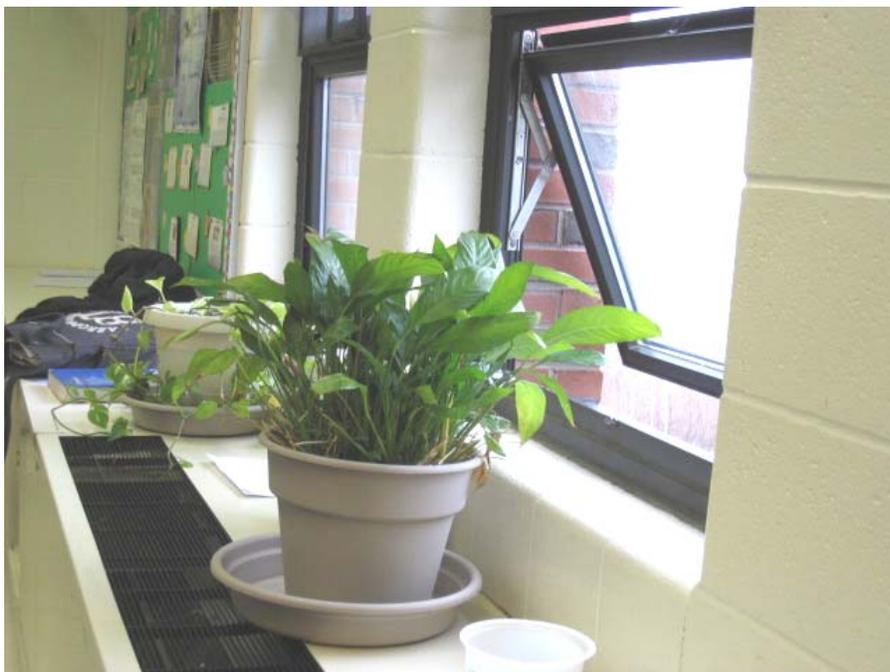
Picture 12

Plants were noted in a few classrooms, in some cases placed on top of ventilation equipment (Picture 12). Plants can be a source of pollen and mold which can be respiratory irritants to some individuals. Plants should be properly maintained and equipped with drip pans and located away from univents to prevent the aerosolization of dirt, pollen and mold.

Plants on univent

10. Ensure plants are equipped with drip pans. Examine drip pans periodically for mold growth and disinfect with an appropriate antimicrobial, as needed. Move plants away from fresh air supply sources.

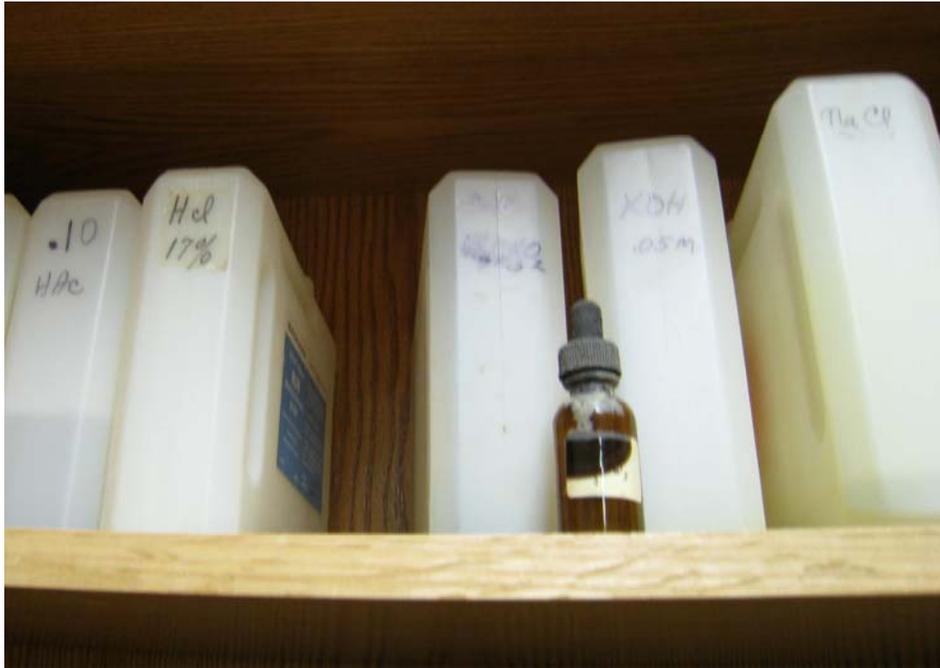
Picture 13

- Items labeled with chemical formula rather than name (Picture 13);
- Crystallization observed on one bottle, likely related to leakage;
- Containers sealed with tape;
- Shelves crowded in a manner that prevents container labels from being read without moving bottles; and
- Chemicals stored on shelves without any barriers/guardrails to prevent bottles from falling.

Science chemicals labeled by chemical formula

16. Properly label all chemicals. Labels should include: Chemical name, concentration, target organ, effect, and date prepared; hazards, both physical and health; and, name and address of manufacturer.

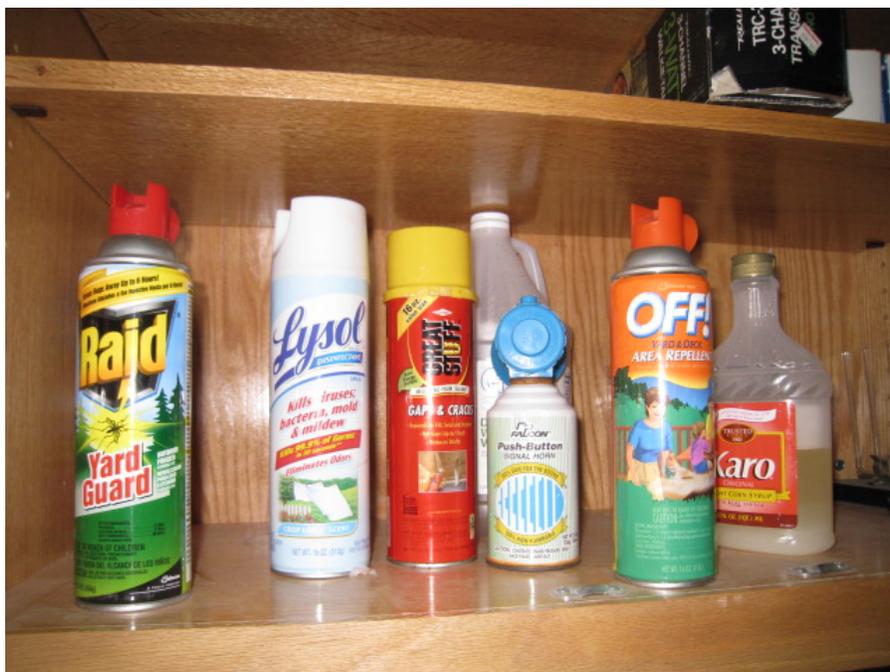
Picture 14

Pyrethrin-based insecticides/outdoor foggers were noted in the chemical store room (Picture 14). Pyrethrins have been associated with cross sensitivity with individuals who have ragweed allergy (US EPA, 1989). Applicators of this product should be in full compliance with federal and state rules and regulations that govern pesticide use including posting and

Pesticides stored in cabinet

13. Locate spill mat near chemical safety shower to prevent water damage during use.
14. Remove any pesticides observed in the school. Have staff report any bugs/pests observed in the building, and contact pest management firm to augment existing integrated pest management program.

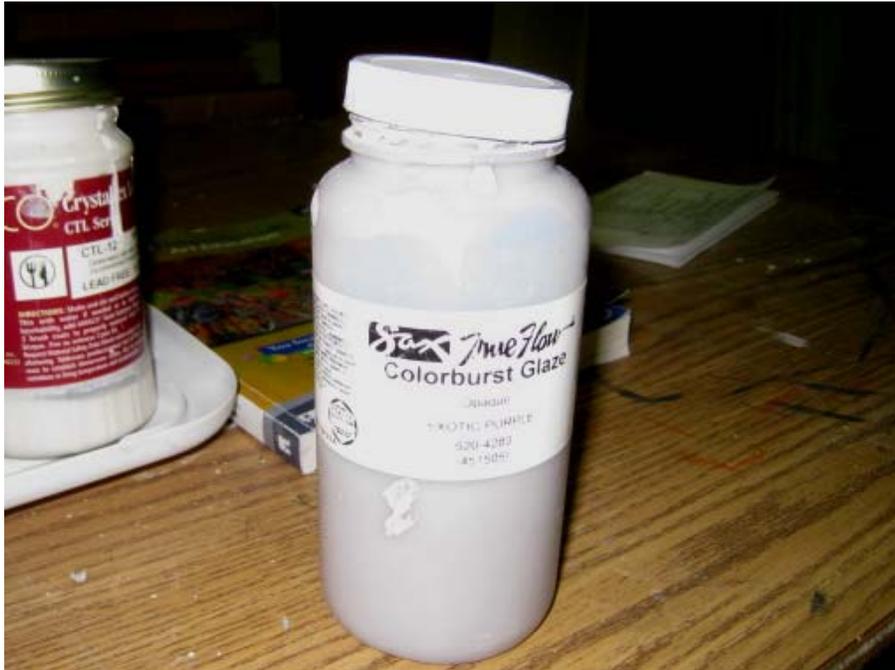
Picture 15

Other conditions that can affect indoor air quality were observed during the assessment. BEH staff observed lead and cadmium-containing pottery glazes in the art room (Picture 15). During the pottery firing process, lead fumes can be emitted from kilns. Lead exposure to women of reproductive age poses a number of risks to developing fetuses (ATSDR, 1999). Lead exposure, particularly in the early stages of pregnancy when a woman may not know that she is pregnant, may result in adverse effects from *in utero* exposure to lead. Lead exposure in males has been associated with reduced fertility because of effects on sperm (ATSDR, 1999). It is highly recommended that the use of non-lead containing materials be substituted for lead-containing glazes/materials. A complete inventory of glazes should be conducted to ensure that *all* lead-containing glazes have been removed/replaced by lead-free products.

Pottery glaze containing lead and cadmium

17. Consider installing guard rails or barriers on chemical storage shelves.
18. Conduct a complete inventory of pottery glazes to ensure that all lead-containing glazes have been removed/replaced by lead-free products.

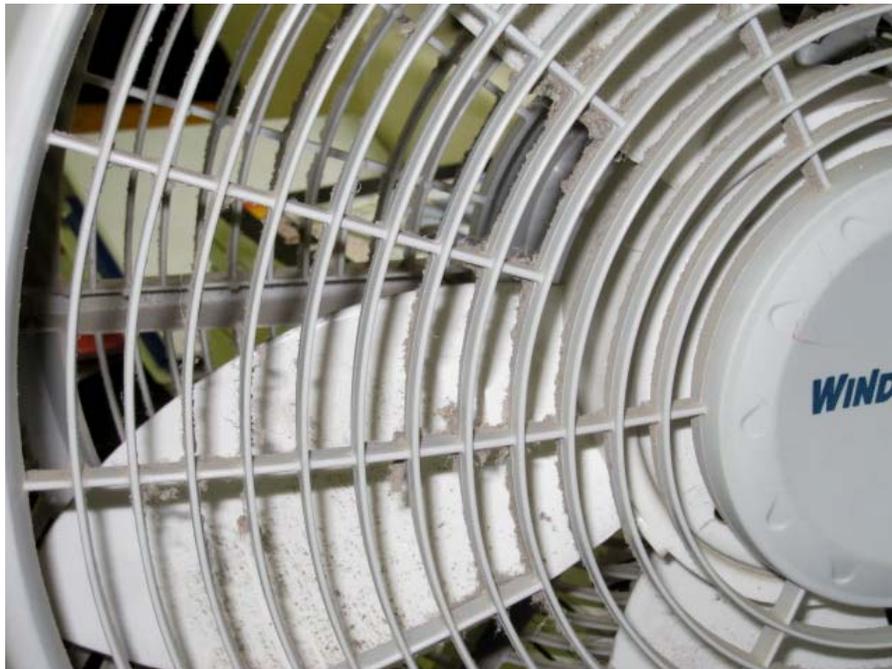
Picture 16

A number of univents, exhaust vents and personal fans were observed to have accumulated dust/debris (Picture 16). These diffusers, vents and fans should be cleaned in order to prevent dust/debris from being aerosolized and redistributed throughout the room.

Personal fan occluded with dust

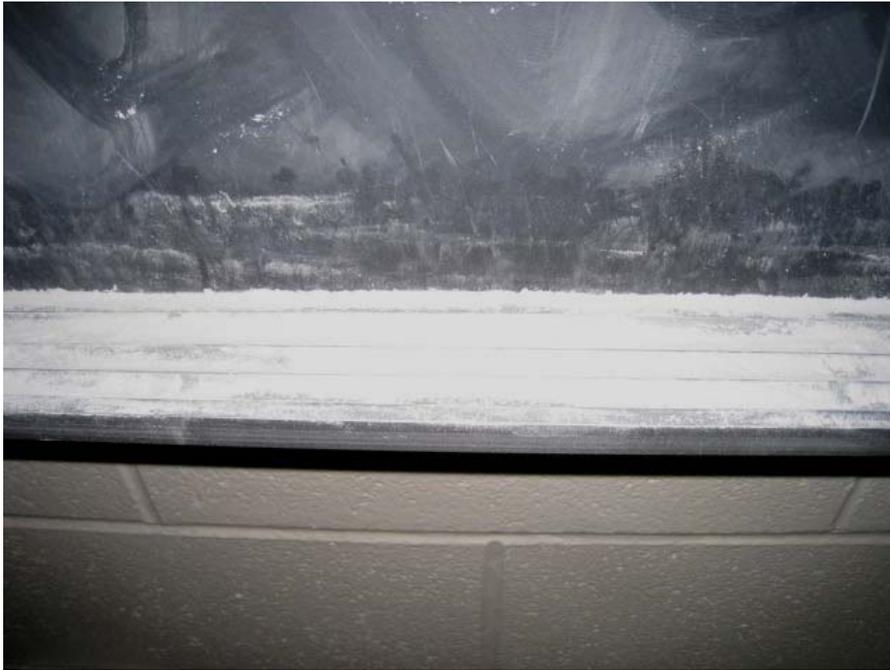
Picture 17

A build up of chalk dust in chalk trays was observed in several classrooms (Picture 17; Table 1). These materials can be aerosolized by air movement from the ventilation system, doors opening and closing, or foot traffic and may present an eye or respiratory irritant.

Chalk dust collected on tray

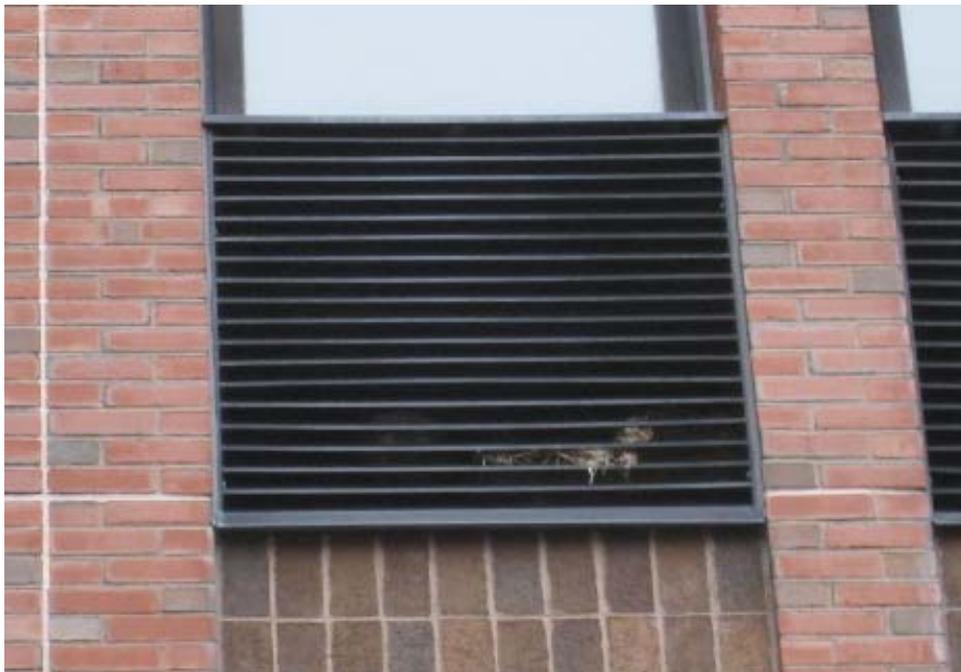
Picture 18

Finally, signs of bird roosting and nesting materials were observed in univent intake louvers along the exterior of the building (Picture 18). If the ventilation system is activated, the possibility exists for nesting materials, bird waste and other related particulates to be drawn into the system and be distributed to occupied areas. Birds can be a source of disease, and bird

Bird's nest in vent

22. Remove birds' nests from fresh air intake vents and clean with an appropriate antimicrobial. Consider installing wire mesh bird screens over air intakes to prevent further roosting as necessary.
