# **INDOOR AIR QUALITY ASSESSMENT**

**Lowell District Court  
41 Hurd Street  
Lowell, Massachusetts**

Prepared by:  
Massachusetts Department of Public Health  
Bureau of Environmental Health  
Indoor Air Quality Program  
August 2012

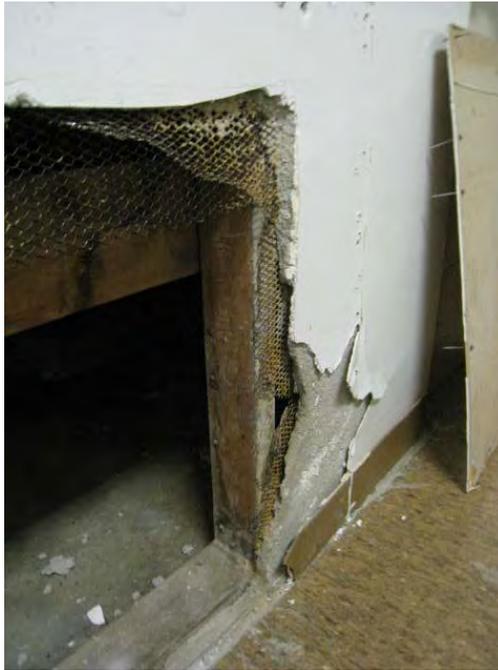
**Picture 1**

The primary purpose of this assessment was for BEH staff to examine water damage in a crawlspace adjacent to the clerk's kitchen (Picture 1). This crawlspace is accessible via an opening in a wall in the room. As mentioned, a bathroom leak resulted in water entering the crawlspace. At the time of the inspection, BEH staff found the crawlspace to be clean and free of odors and observed no mold growth. Moisture testing of the walls surrounding the crawl space indicated that moisture levels were normal (i.e., dry). It is important to note that moisture content of materials measured represents a real-time measurement of the conditions in the building at the time of the assessment.

**Crawlspace access in the break room (note plaster and wire lathe)**

1. Consider installing an access door in the kitchen wall to allow periodic inspections of the crawlspace. Ensure this access door is air tight to prevent crawlspace odors/materials and pests from migrating into occupant space.
2. Seal breaches around FCU pipes to prevent movement of odors, materials and pests into occupied areas.

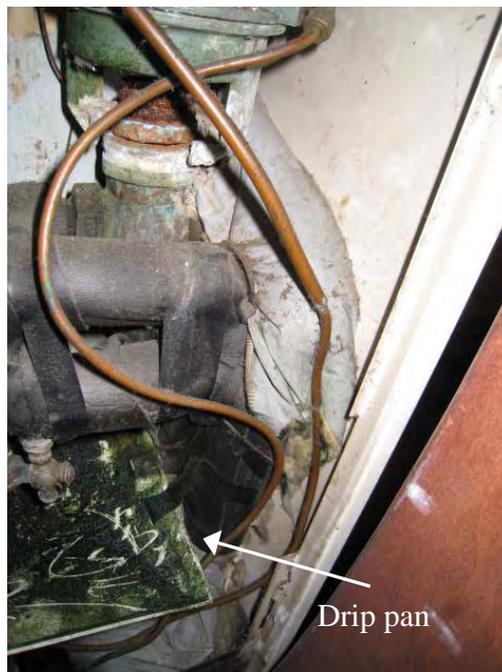
**Picture 2**

As mentioned, FCUs are designed to provide air-conditioning during the summer months. BEH staff observed the condition of a typical FCU and noted a layer of accumulated materials in a drip pan (Picture 2). The debris observed indicates that water may periodically stagnate in the pan, allowing materials to settle and proliferate in the water. Measures should be taken to ensure drip pans drain properly and debris is cleared from the pan to prevent odors and mold growth.

**Growth in drip pan**

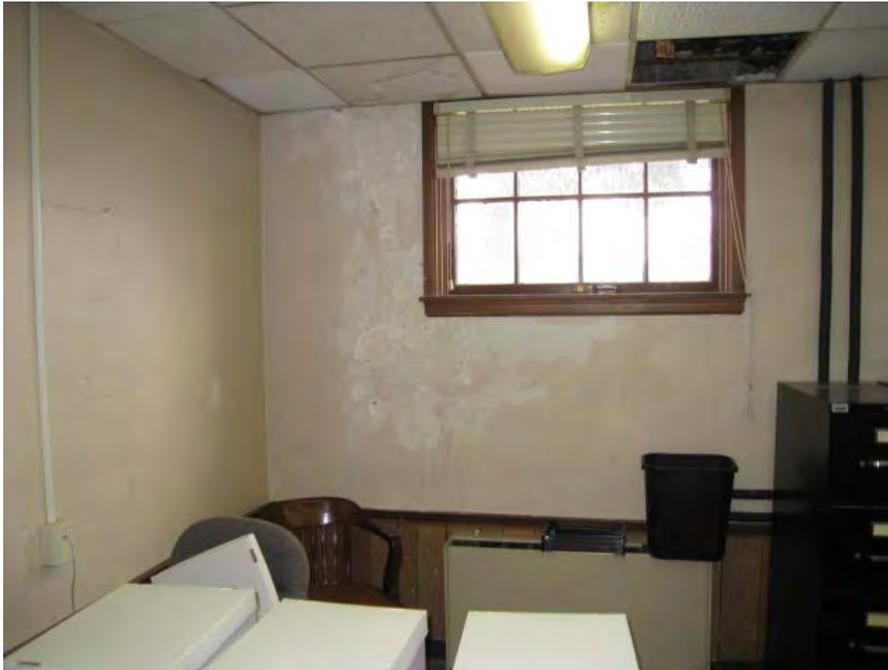
**Picture 3**

Water-damaged wall plaster, peeling paint and efflorescence were observed in a number of areas (Picture 3). Water damage is most likely the result of historic water penetration through the building envelope. Efflorescence is a characteristic sign of water damage to brick and mortar, but it is not mold growth. As moisture penetrates and works its way through mortar, brick or plaster, water-soluble compounds dissolve, creating a solution. As the solution moves to the surface of the material, the water evaporates, leaving behind white, powdery mineral deposits.

**Water-damaged wall plaster and ceiling tile (note missing tile and basket for catching water)**

7. Repair water-damaged wall plaster.
8. Replace water-damaged ceiling tiles.
9. Ensure all plants are equipped with drip pans that are made of a *non-porous* material. Examine drip pans for mold growth and disinfect areas of water leaks with an appropriate antimicrobial where necessary. Move plants away from ventilation sources.

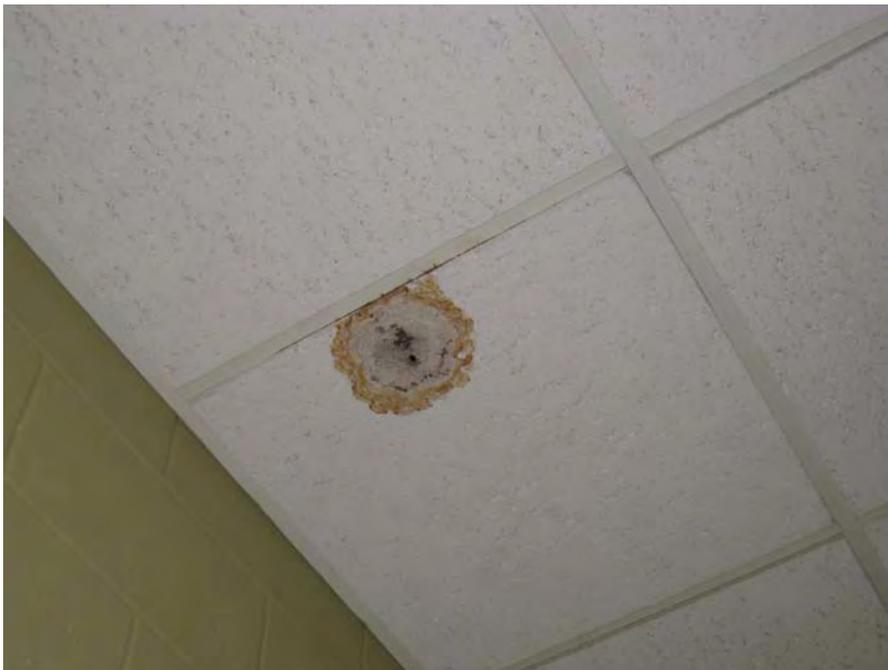
**Picture 4**

Water-damaged ceiling tiles were observed throughout the building, which can indicate a roof or exterior wall leak or plumbing problem. Missing and water-damaged ceiling tiles in the Clerk's Office were attributed to leaking valves in the heating system. In another area, a waste basket was observed in an area where a ceiling tile was missing, suggesting that the receptacle was being used to catch water leaks (Picture 3). In some areas, repeated exposure to moisture has resulted in mold growth on ceiling tiles (Picture 4). Water-damaged ceiling tiles should be replaced after a water leak is discovered and repaired.

**Darkening of a water-damaged ceiling tile suggesting mold growth**

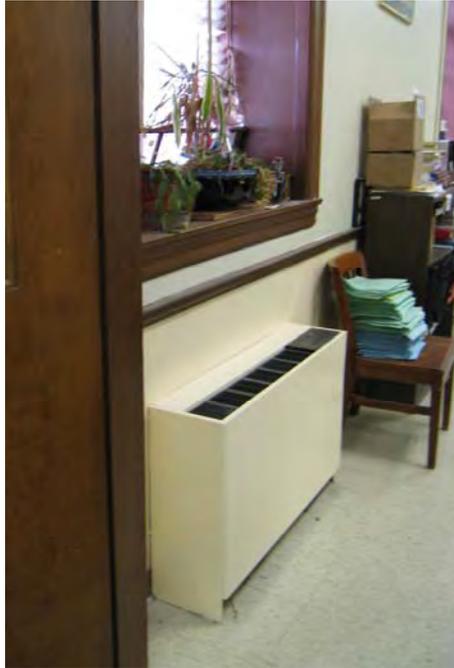
**Picture 5**

Plants were noted in several areas (Picture 5). Plants should be properly maintained and equipped with drip pans made of a non-porous material. Drip pans should be cleaned and

**Plants on windowsill near a FCU**

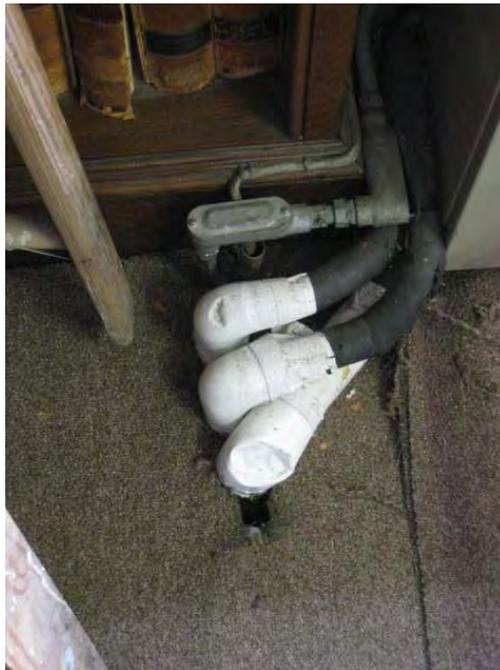
**Picture 6**

Of note were numerous holes in floors around retrofitted FCUs in the old building (Pictures 6 and 7). Such breaches can allow for odors and particles to migrate between floors and also serve as a means for pests to migrate.

**Breaches around pipes**

- e. Holes as small as ¼” provide enough space for rodents to enter. Examine each room and the exterior walls of the building for means of pest egress and seal any breaches found. If doors do not seal at the bottom, install a weather strip as a barrier to pests.

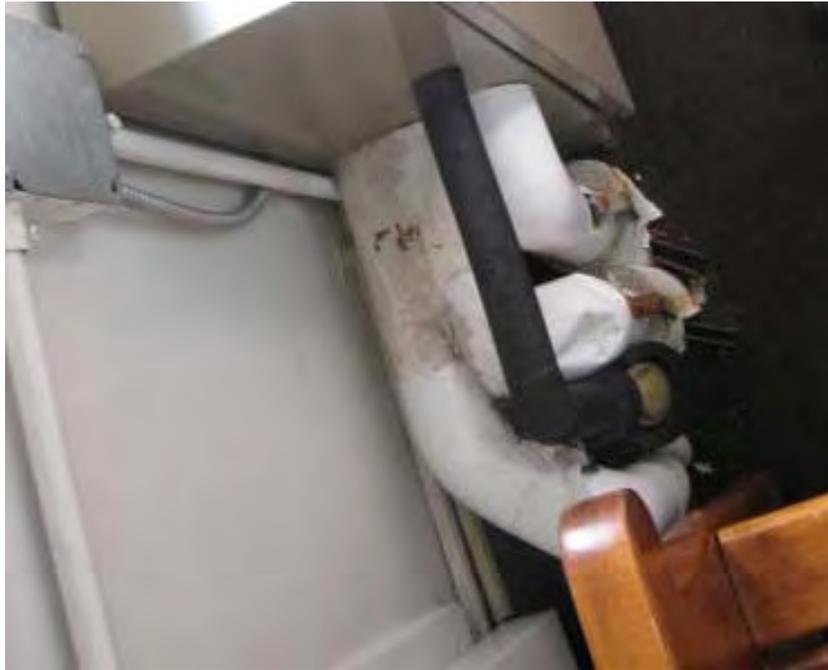
**Picture 7**

**Breaches around pipes**

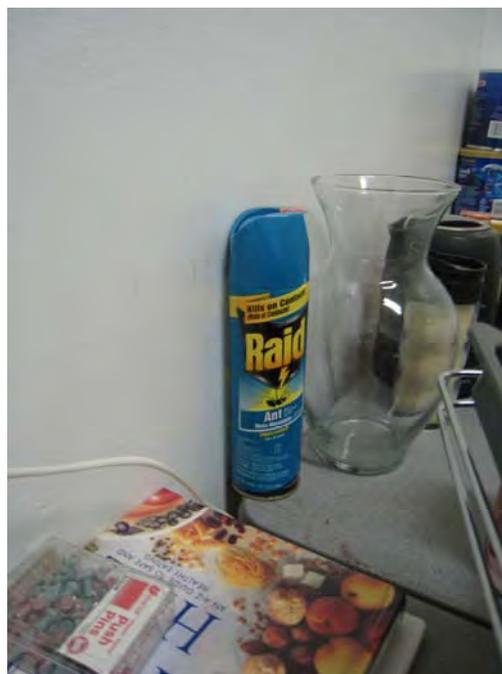
**Picture 8**

A container of permethrin/pyrethrin-based pesticide was observed in the staff kitchen (Picture 8). Pyrethrins have been associated with cross sensitivity with individuals who have ragweed allergy (US EPA, 1989). Applicators of this product should be in full compliance with federal and state rules and regulations that govern pesticide use including posting and notification requirements (333 CMR 13.10). Under no circumstances should untrained personnel apply this material. This product should not be applied prior to or during normal work hours. Under current Massachusetts law (effective November 1, 2001), the principles of integrated pest management (IPM) must be used to remove pests in state buildings (Mass Act, 2000). Pesticide

**Pesticide in kitchen**

10. Remove all pesticide products from the building. Implement the principles of integrated pest management (IPM) to rid this building of pest. A copy of the Massachusetts IPM plan is available from the Massachusetts Department of Agricultural Resources:  
[http://www.mass.gov/agr/pesticides/publications/docs/IPM\\_kit\\_for\\_bldg\\_mgrs.pdf](http://www.mass.gov/agr/pesticides/publications/docs/IPM_kit_for_bldg_mgrs.pdf).

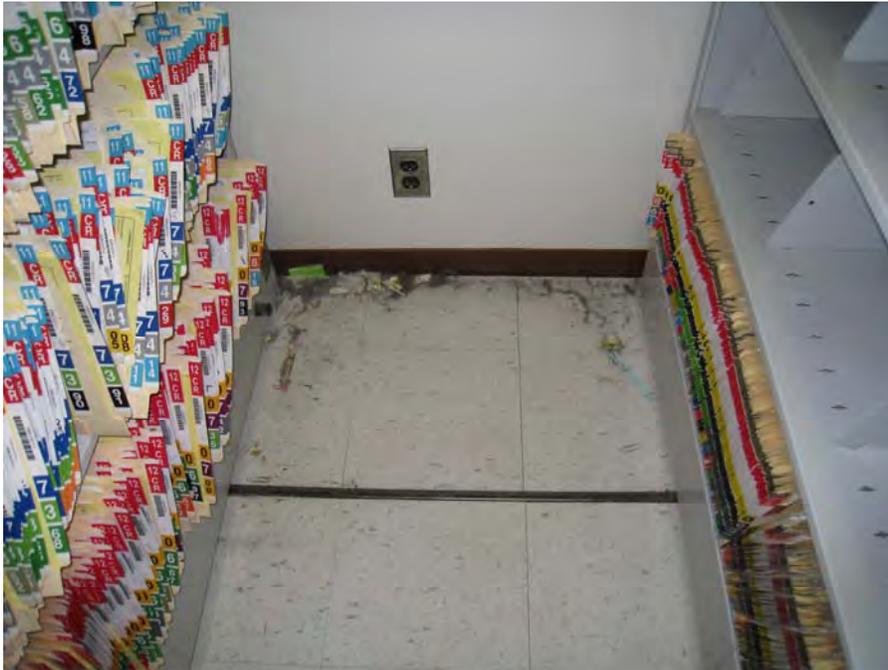
**Picture 9**

Excessive dust was observed in the file storage room (Picture 9). Dust was observed on the blades of personal fans (Picture 10). Dust was also observed on ceiling tiles around fresh air diffusers, which results when dust particles in a room can becoming positively charged. Over time, the charged particles are deposited on the ceiling tiles due to attraction to the negatively charged ceiling tile. A greater charge, hence greater deposition, occurs when the humidity is lower during the heating season. Dust can be an irritant to the eyes and respiratory system. Measures should be taken to increase cleaning and reduce the accumulation of dust in the building. Fans should be cleaned periodically in order to prevent them from serving as a source of aerosolized particulates.

**Dust accumulation in file storage room**

- f. Reduce harborages (cardboard boxes) where pests may reside (MDFA, 1996).
11. Routinely clean accumulated dust and debris periodically from the surface of supply/exhaust vents and blades of personal fans.

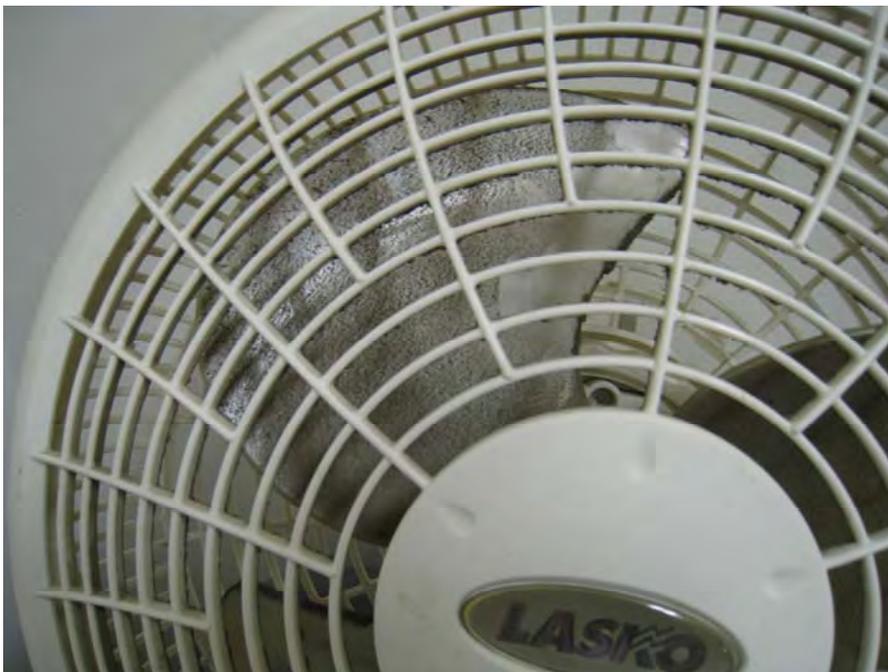
**Picture 10**

**Dust on fan blade**
