INDOOR AIR QUALITY ASSESSMENT

**Carbuncle House
495 Main Street
Oxford, Massachusetts**

Prepared by:
Massachusetts Department of Public Health
Bureau of Environmental Health
Indoor Air Quality Program
August 2012

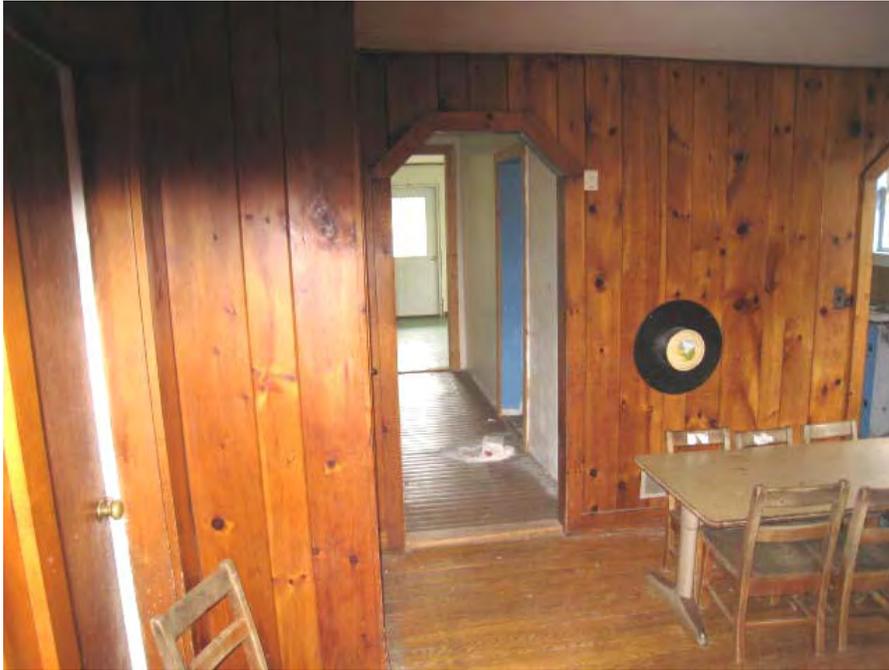
Picture 1

Two rooms finished in pinewood on the upper level are used for camp programs (Picture 1). All other upper and lower level rooms are either not used or not open to the public. A structure was added to the original building, which contains restrooms and changing areas for beach patrons. Windows are openable throughout the building. The furnace/forced hot air system ductwork are abandoned and not in use.

Finished Pinewood Room on Upper Level

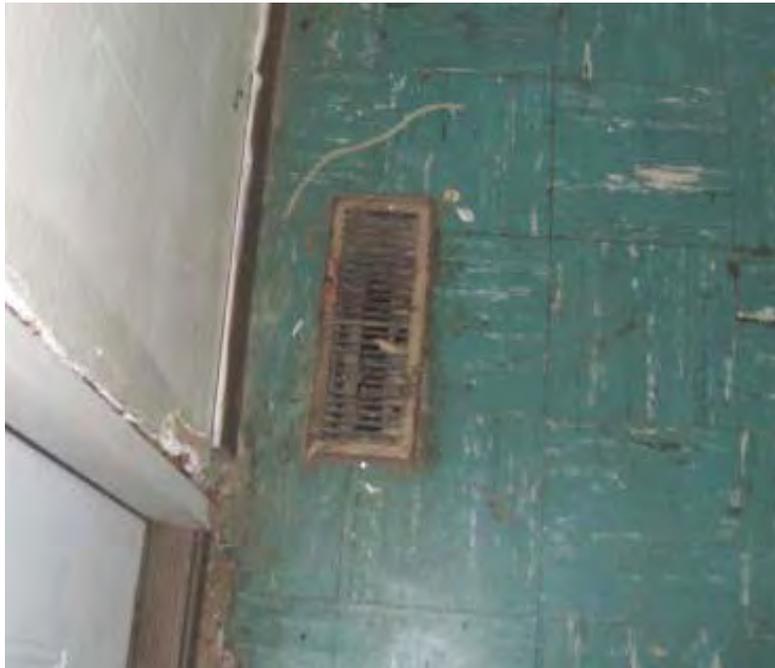
Picture 2

A musty odor was detected upon entering the upper level rooms. The odor was traced to heating registers, return vents and holes (Pictures 2 through 4) located in the floor and walls of the upper level. The heating registers are connected to forced hot air system/furnace located in the basement that is not currently in use. Open ducts (Picture 5) and duct vents (Picture 6) in the lower level can serve as a means for mold associated odors/particulates to enter the vents and migrate to the upper level of the building.

Heating Register in Upper Level Floor

1. Permanently seal heating register openings in rooms used by the public in the upper level floors.
2. Remove water-damaged gypsum wallboard from the lower level and ceiling in the upper level in a manner consistent with the US Environmental Protection Agency's guidance "Mold Remediation in Schools and Commercial Buildings", published by the US Environmental Protection Agency (US EPA, 2001). This document can be downloaded from the US EPA website: http://www.epa.gov/iaq/molds/mold_remediation.html.

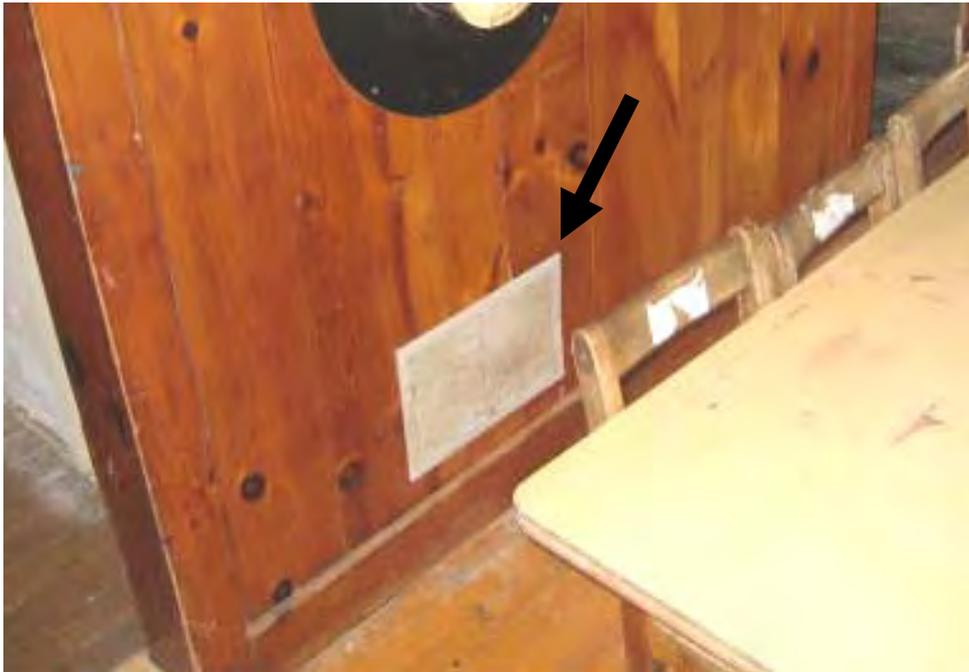
Picture 3

Return Vent in Upper Level (Arrow)

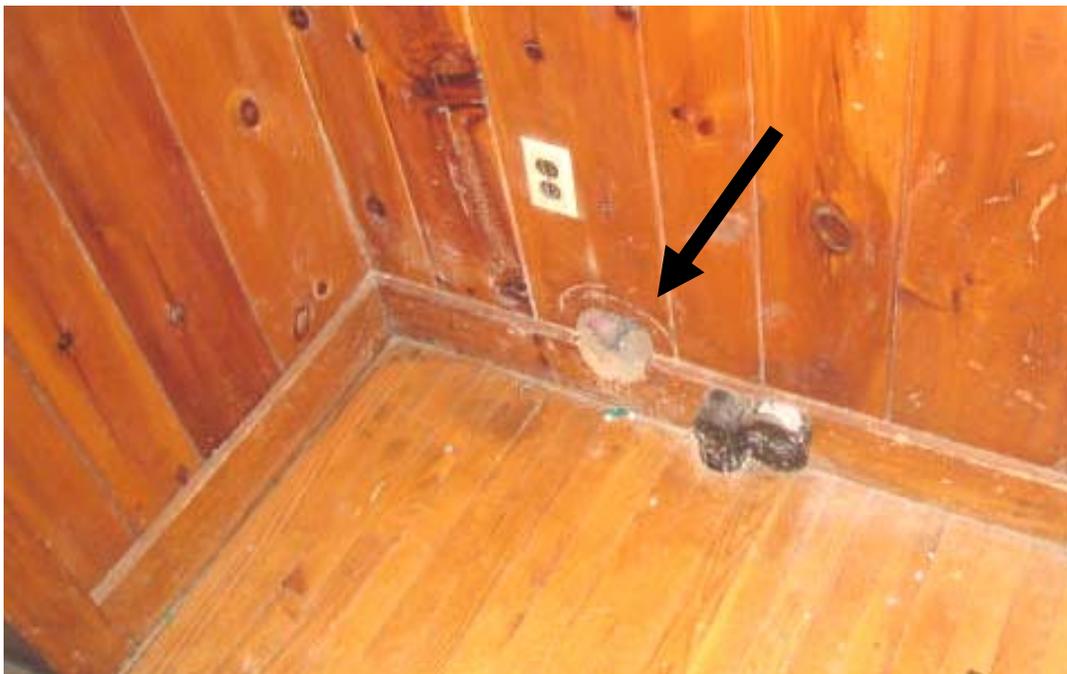
Picture 4

Hole in Wall in Upper Level (Arrow)

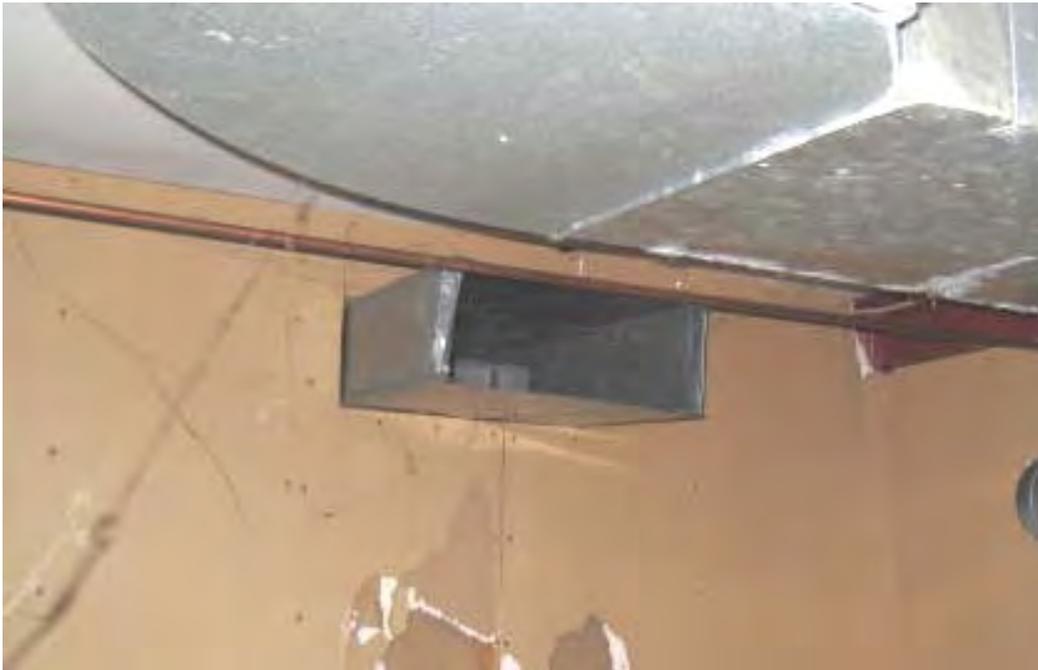
Picture 5

Open Duct in Lower Level

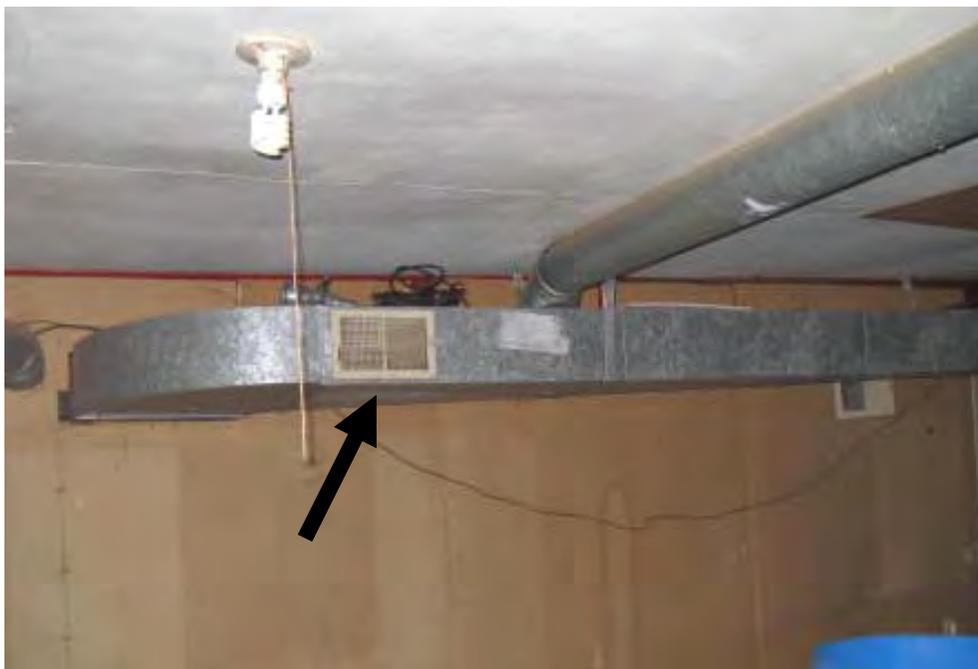
Picture 6

Duct Vent Opening in Lower Level (Arrow)

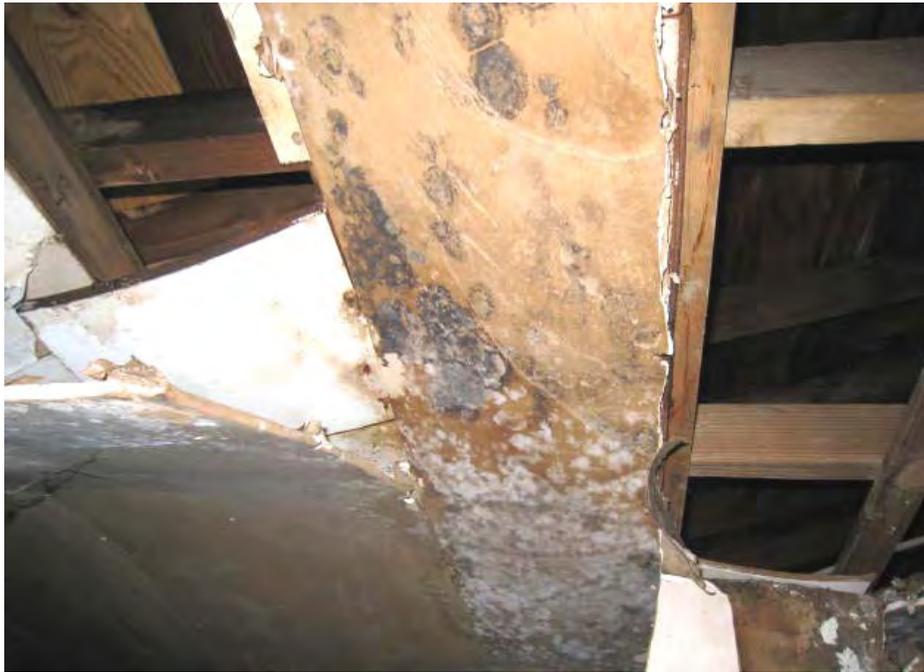
Picture 7

The lower level contains water-damaged gypsum wallboard with visible mold (Picture 7) likely due to roof leaks from the peak of the changing area/restroom structure (Picture 8), which is missing shingles. Water damage also exists in the ceiling of the upper level former kitchen (Picture 9).

Mold-Colonized Gypsum Wallboard

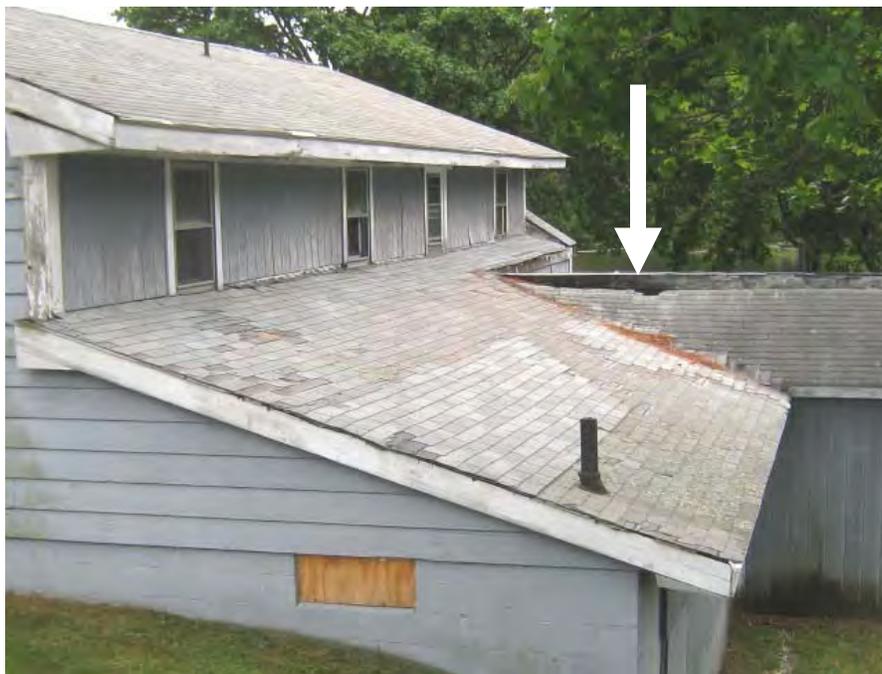
Picture 8

Roof Peak of Changing Area/Rest Rooms Missing Shingles (Arrow)

4. Repair roof leaks.
5. Remove wall-to-wall carpeting.
6. Consideration should be given to supplying mechanical exhaust ventilation for the changing areas/restrooms. This can be achieved by using floor or pedestal fans to exhaust air via the entrances.

1. Repair or replace the roof.
2. Install rain gutters and downspouts.
3. Replace rotted wall exterior.
4. Replace the heating system.

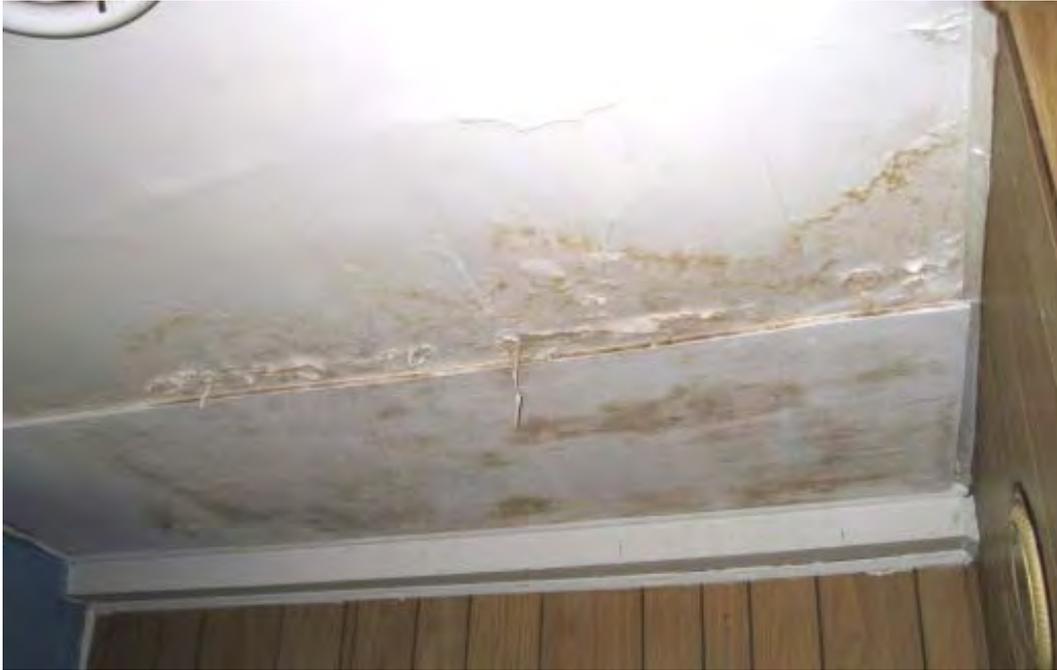
Picture 9

Water-damaged Ceiling in Kitchen

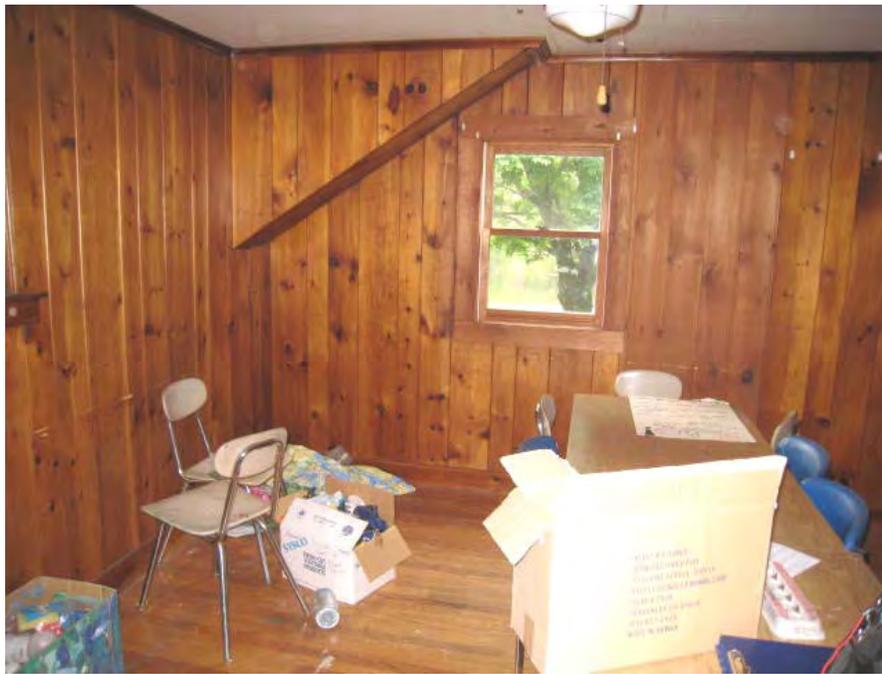
Picture 10

BEH staff identified other conditions that can potentially affect indoor air quality. In the rooms occupied by the summer camp programs, items and materials (e.g., papers, folders, boxes and art supplies) were observed (Pictures 10 and 11). The large number of stored items provides a source for dusts to accumulate, making it difficult for custodial staff to clean. Items should be discarded, relocated and/or cleaned periodically to avoid excessive dust build up. In addition, these materials can accumulate on flat surfaces (e.g., tables, shelving and carpets) in occupied areas and subsequently be re-aerosolized causing further irritation.

Items Stored on Floor and Tables of Room Used by Summer Camp Programs

7. Examine rooms and the exterior walls/doors of the building for means of rodent egress and seal appropriately. If doors do not seal at the bottom, install a weather strip as a barrier to rodents.
8. Relocate or consider reducing the amount of materials stored in occupied rooms to allow for more thorough cleaning. Clean items regularly with a wet cloth or sponge to prevent excessive dust build-up.
9. Refer to resource manuals and other related indoor air quality documents for further building-wide evaluations and advice on maintaining public buildings. Copies of these materials are located on the MDPH's website: <http://mass.gov/dph/iaq>

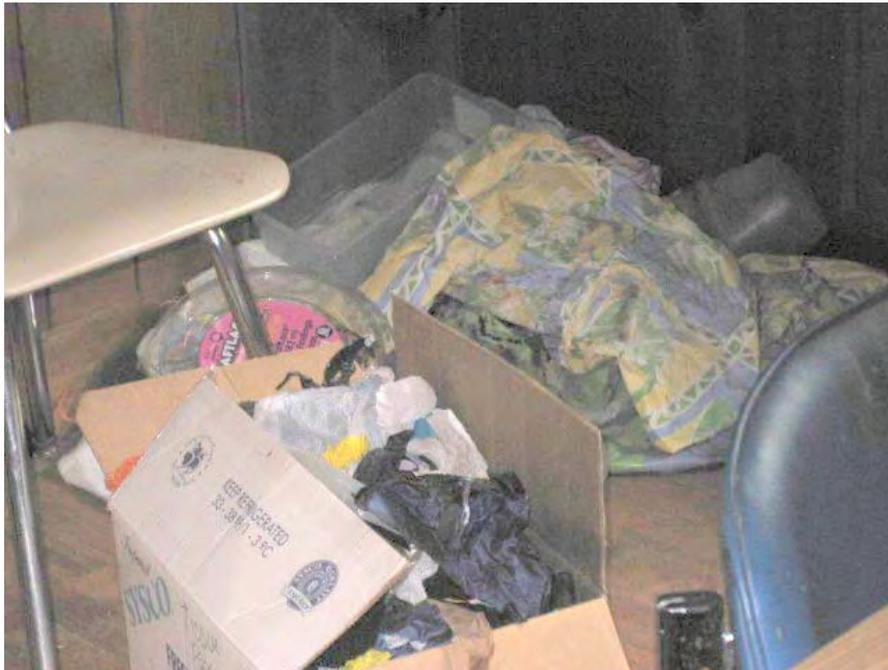
Picture 11

Items Observed in Boxes and on Floor

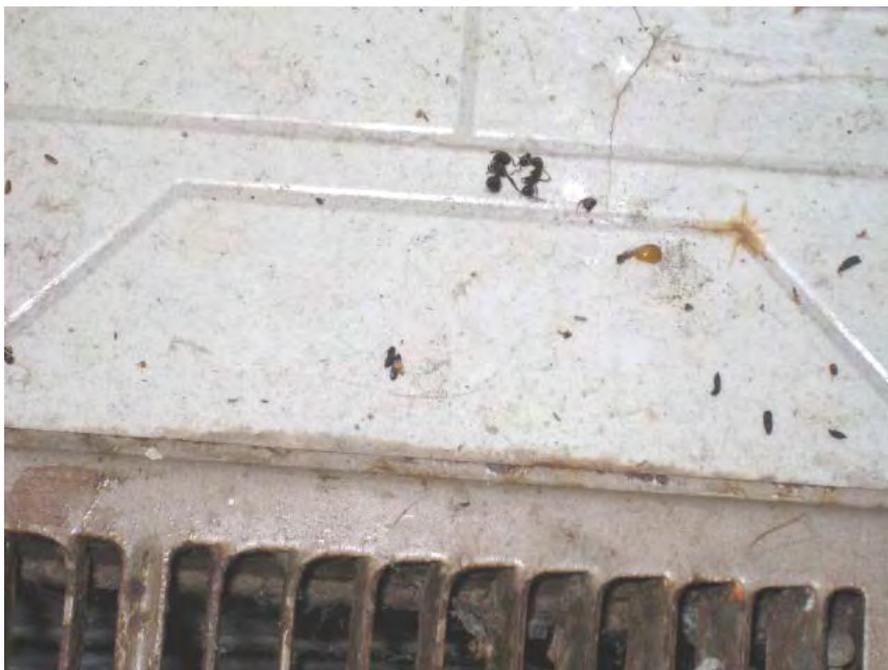
Picture 12

In several unoccupied rooms of the building rodent droppings were observed on floors and carpets (Picture 12). Rodent infestation can result in IAQ related symptoms due to materials found in their wastes. Mouse urine contains a protein that is a known sensitizer (US EPA, 1992).

Rodent Droppings on Floor

A three-step approach is necessary to eliminate rodent infestation:

1. cleaning of waste products from the interior of the building;
2. reduction/elimination of pathways/food sources that are attracting rodents; and
3. removal of the rodents.

To eliminate exposure to allergens, rodents must be removed from the building. Please note that removal, even after cleaning, may not provide immediate relief since allergens can persist in the building's interior for several months after rodents are eliminated (Burge, 1995).
