INDOOR AIR QUALITY ASSESSMENT

**Theodore Herberg Middle School
501 Pomeroy Street
Pittsfield, Massachusetts**

Prepared by:
Massachusetts Department of Public Health
Bureau of Environmental Health
Indoor Air Quality Program
July 2012

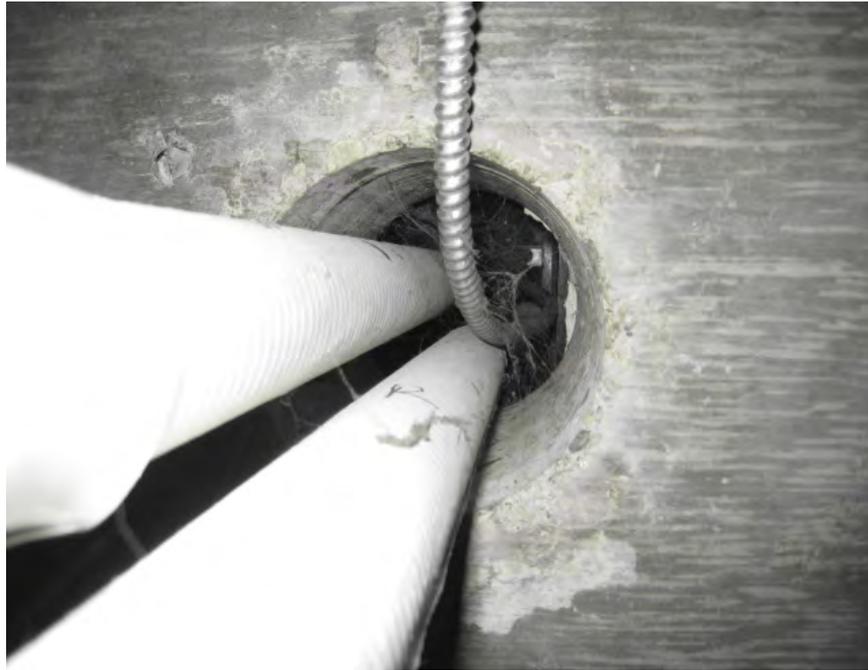
Picture 1

Mold colonization/growth would be expected to be present in an unconditioned cement floor crawlspace that is subjected to moisture. Efforts should be made to reduce moisture, circulate air and reduce/eliminate potential pathways for mold, spores, and associated odors to migrate into occupied areas. The most obvious means for odors and pollutants to migrate between the crawlspace and occupied areas on the ground floor are holes and spaces surrounding utility pipes (e.g., fire suppression plumbing, radiators, univents) (Pictures 1-3). Airflow tends to rise and these breaches can serve as pathways to draw air, odors and particulates from the crawlspace into hallways and classrooms. This condition is known as the stack effect. All holes and gaps should be sealed with fire-rated sealant foam or other appropriate material.

Unsealed Heating Pipe/Electrical Conduit Hole in Crawlspace

3. Seal all utility pipes, fire suppression systems pipes, conduit and other penetrations in the ceiling and walls of the crawlspace, in the floor of classrooms, inside unit ventilators and plumbing using an expandable, fire-rated sealing compound.

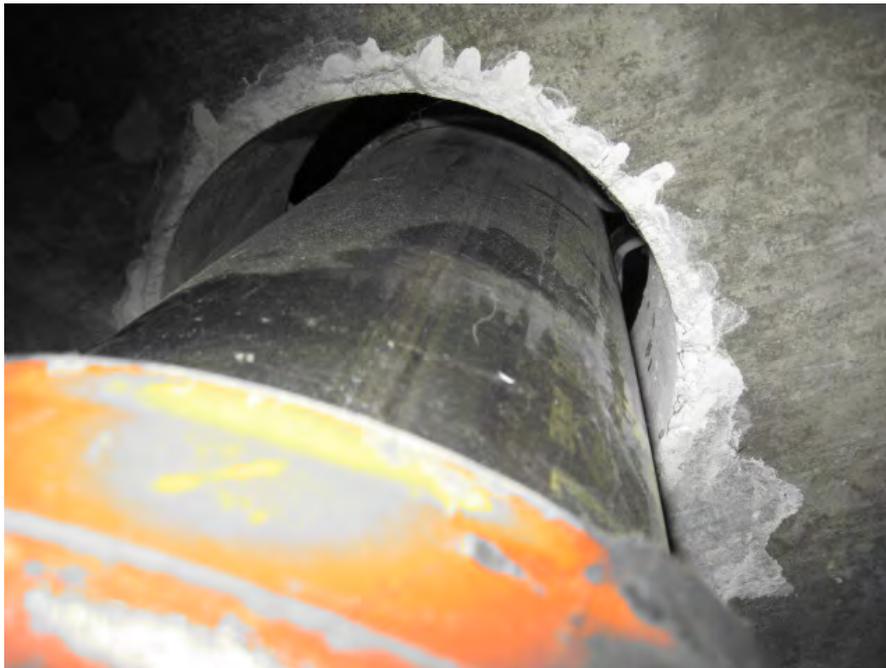
Picture 2

Unsealed Fire Suppression System Pipe Hole in Crawlspace

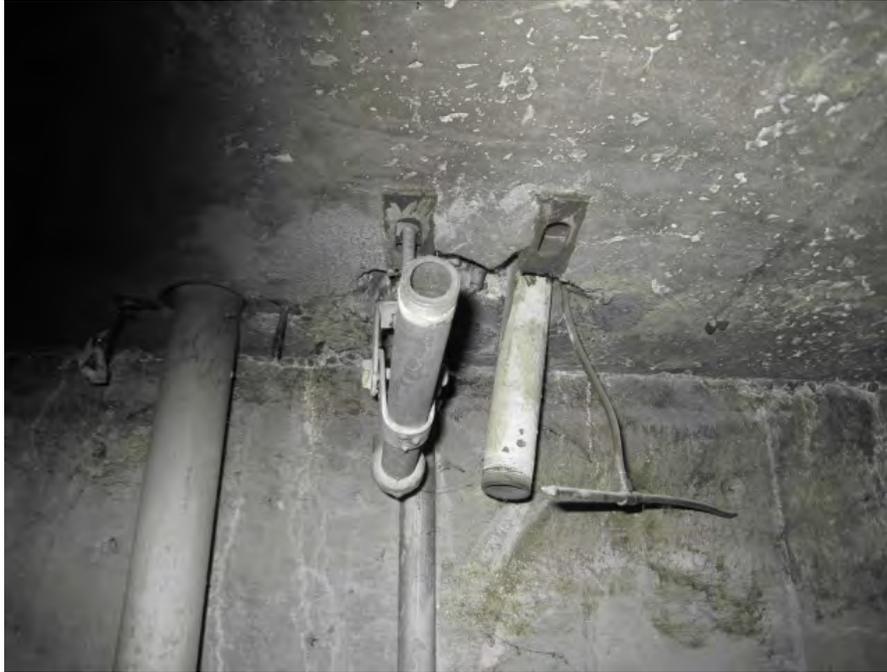
Picture 3

Open Abandoned Pipes in Crawlspace

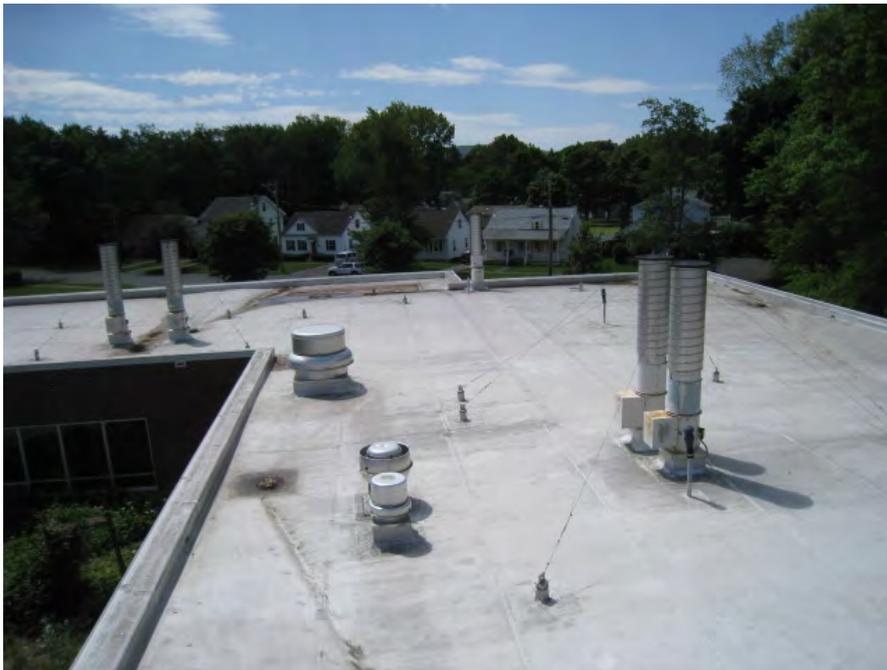
Picture 4

BEH staff also examined a portion of the roof. The roof contained a significant number of exhaust vents (Picture 4) which were not operating at the time of the assessment. Exhaust ventilation systems must operate in order to remove water vapor, odors and other pollutants from restrooms, storerooms, custodial closets and other locations where odors and/or water vapor is present. Without an operating ventilation system, odors will tend to linger within the building.

Roof Exhaust Vents

6. Install a door sweep beneath the boiler room door. Install weather-stripping around the door frame to render it airtight.
7. Examine all exhaust vents on the roof and repair as needed. Operate exhaust vents for custodial closets during school hours.

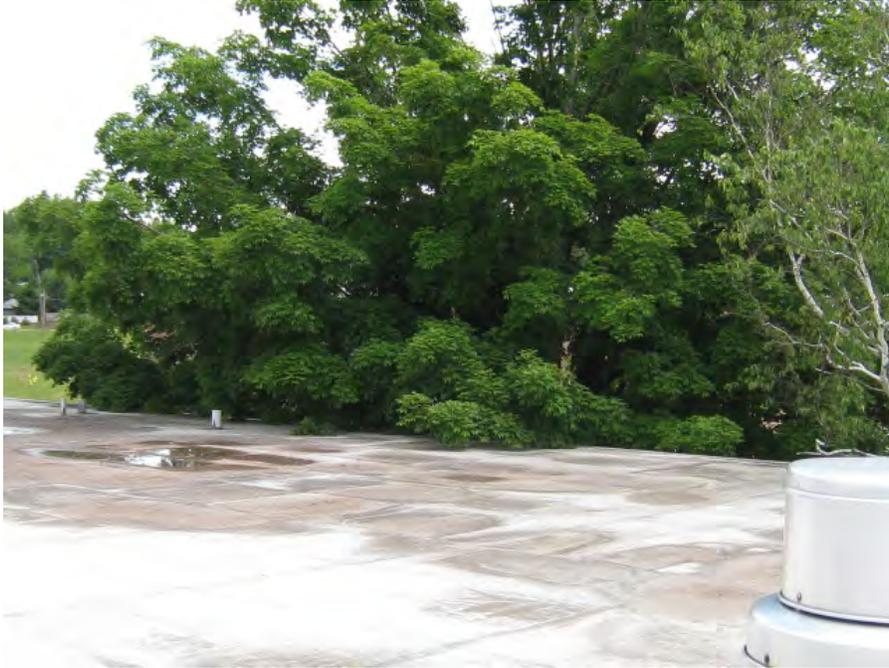
Picture 5

In addition to the lack of operating exhaust vents, large trees directly abut the side of the building and rest on the roof (Picture 5). Pollen and debris from trees can clog ventilation systems or provide harborage for insects, rodents, birds and other pests resulting in a source of

allergens and mold within the building. In addition, the growth of roots against exterior walls can bring moisture in contact with brick, eventually leading to cracks and/or fissures in the foundation below ground level. Over time, this process can undermine the integrity of the building envelope and provide a means of water entry into the building through capillary action through foundation concrete and/or masonry (Lstiburek & Brennan, 2001).

Trees Abutting and Leaning on Building Roof

1. Consider installing an exhaust motor on the vent for the elevator mechanical room.
2. Remove large trees that abut the side and rest on the roof of the building.

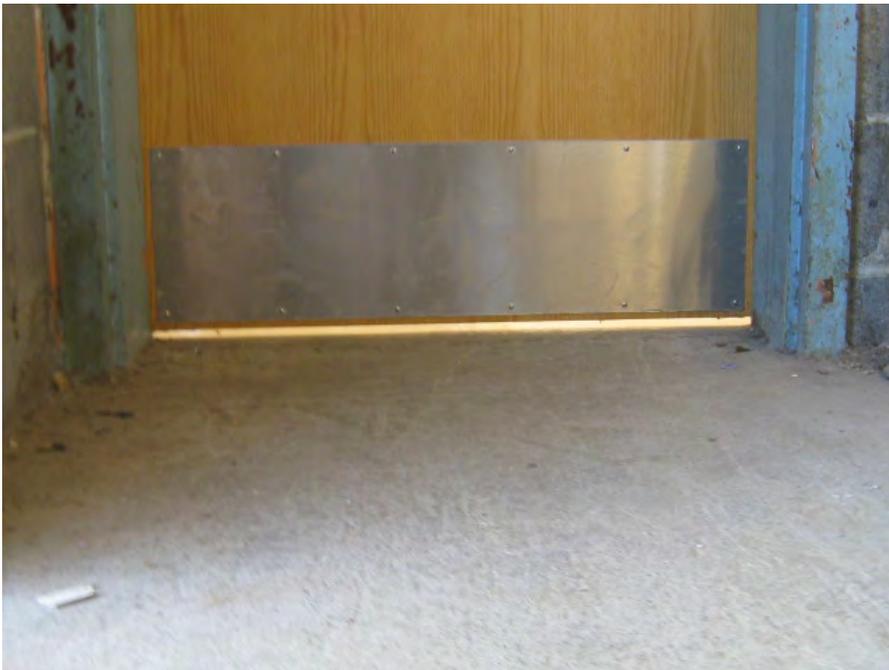
Picture 6

Concerns related to other odors independent from the crawlspace flooding were also expressed. An art workshop that is currently used for classroom space had reported propane-like odors. The boiler room access door exists in this room. Light could be seen penetrating through the space underneath this door, indicating it is not airtight (Picture 6). This door space is a likely pathway for boiler room odors to enter this room.

Space beneath Boiler Room Door

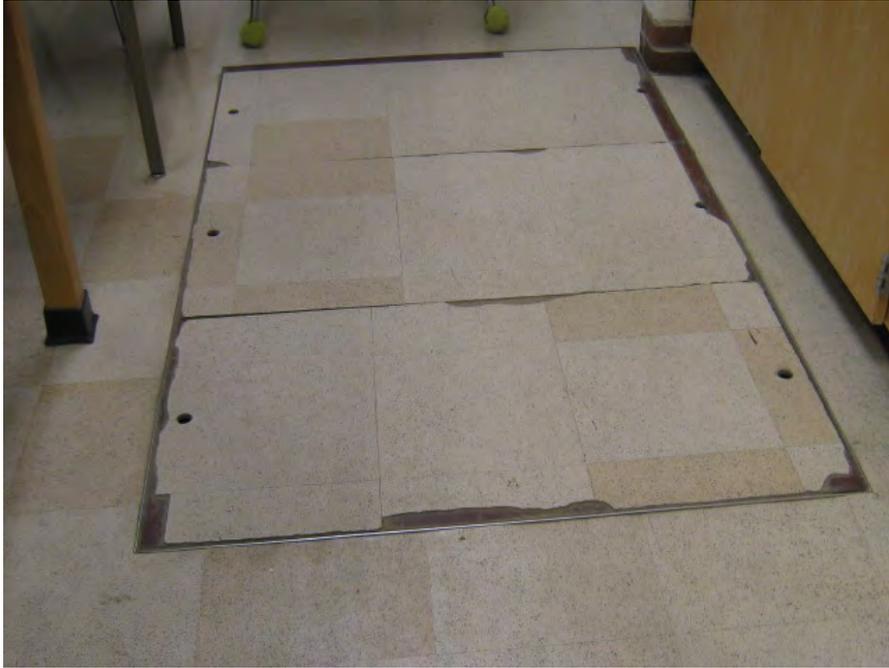
Picture 7

School officials report sewer odors in a science classroom. The source of the odors was believed to be an acid neutralization tank that was installed in the floor of this room without a trap (Picture 7). Without a trap, odors from the sewer system would back up into the acid neutralization tank and then into the classroom through the hatch in the floor. According to the school officials, equipment to prevent this odor backup was installed following the BEH visit.

Access Hatch to Acid Neutralization Tank Installed in the Floor

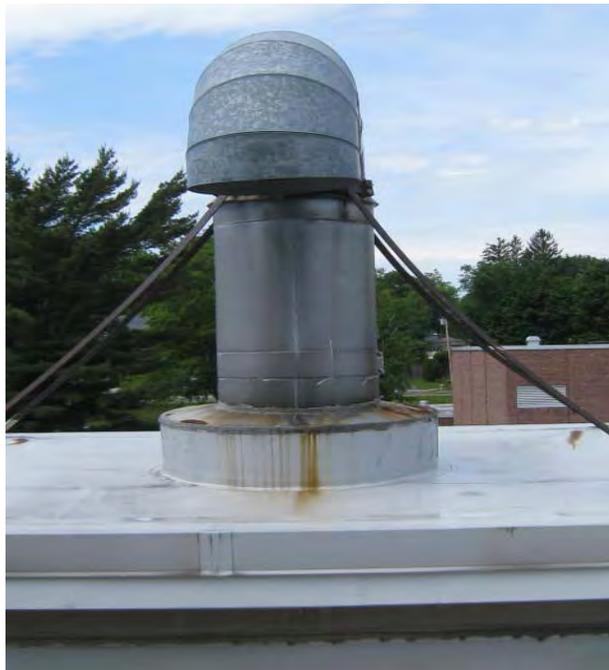
Picture 8

A significant odor of hydraulic fluid oil (HFO) was detected in the elevator machine room. This room has an exhaust vent that terminates on the roof to a non-motorized “candy cane” vent (Picture 8). The HFO odor indicated that a leak exists in the hydraulic system for the elevator and should be repaired. In its current condition, the exhaust vent provides little or no removal of air and odor from the elevator machine room. In addition, no means exists for transfer air to enter the elevator machine room to aid odor removal.

Non-Motorized "Candy Cane" Vent

8. Repair HFO leaks in elevator system.
9. Refer to resource manuals and other related indoor air quality documents for further building-wide evaluations and advice on maintaining public buildings. These materials are located on the MDPH's website: <http://mass.gov/dph/iaq>.
