INDOOR AIR QUALITY ASSESSMENT

**Massachusetts Registry of Motor Vehicles
165 Liberty Street
Springfield, Massachusetts**

Prepared by:
Massachusetts Department of Public Health
Bureau of Environmental Health
Indoor Air Quality Program
August 2012

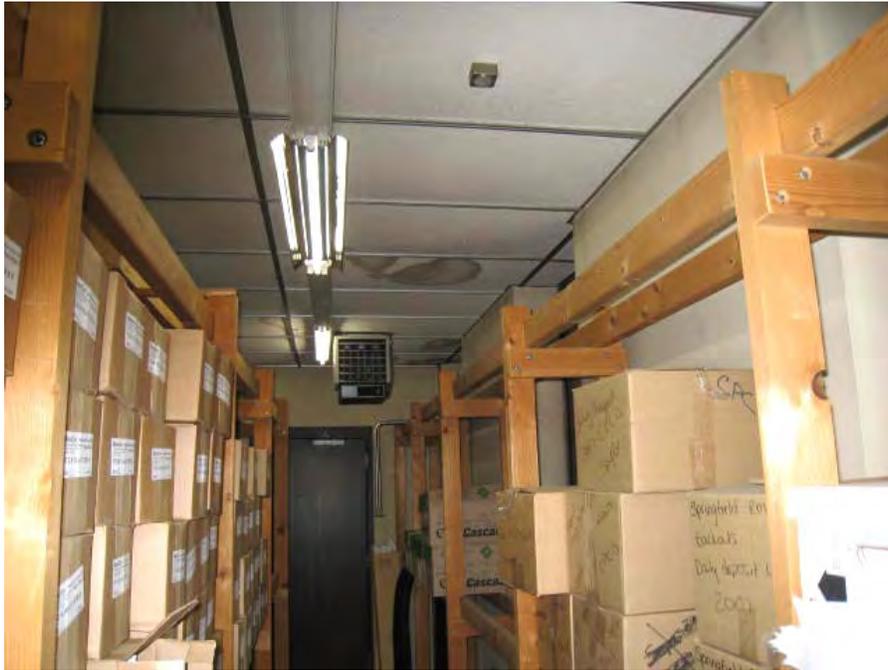
Picture 1

License Plate Storeroom

3. Examine methods to provide exhaust ventilation for the license plate storeroom.
4. Render the rear exterior door weather-tight. Ensure tightness of doors by monitoring for light penetration and drafts around doorframes.

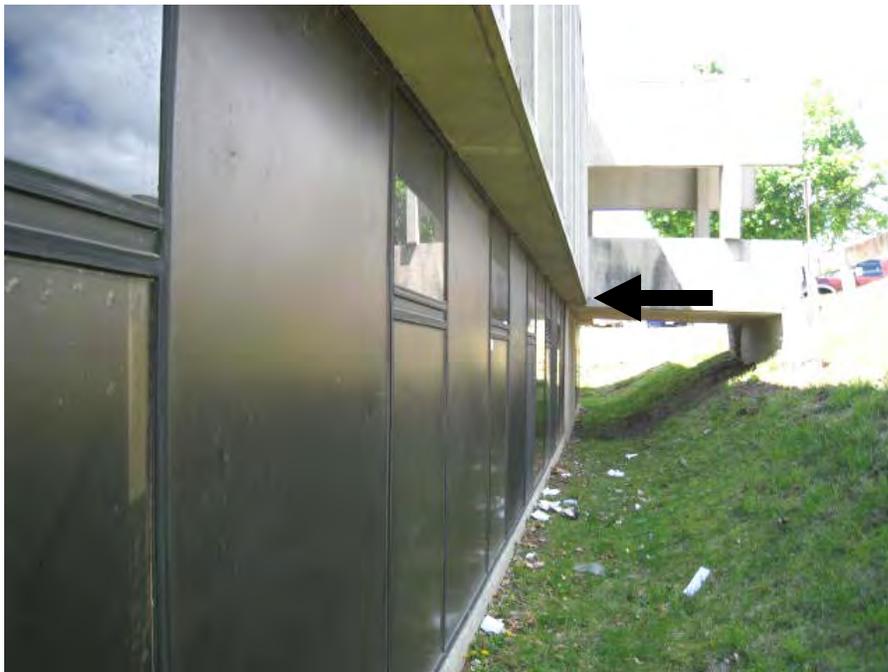
Picture 2

Mechanical ventilation on the upper floor is provided by rooftop air-handling units (AHUs). Fresh air is drawn into the AHUs and delivered to occupied areas via ductwork. Recirculated air is directed into the office space by ceiling-mounted fresh air diffusers. Return air is ducted back to the rooftop AHUs. At the time of the assessment, the HVAC system on the upper floor appeared to be deactivated. Mechanical ventilation on the lower floor is provided by ceiling-mounted AHUs located in the license plate storeroom. Fresh air for these AHUs is drawn through an intake vent on the east exterior wall that is roughly at the same level as the parking lot

Fresh Air Intake, Lower Level (Arrow)

5. Consideration should be given to reconfiguration of the traffic pattern around the RMV to minimize vehicle exhaust entrainment by the lower level AHUs. If not feasible, consideration should be given to relocating the fresh air intakes for this system.

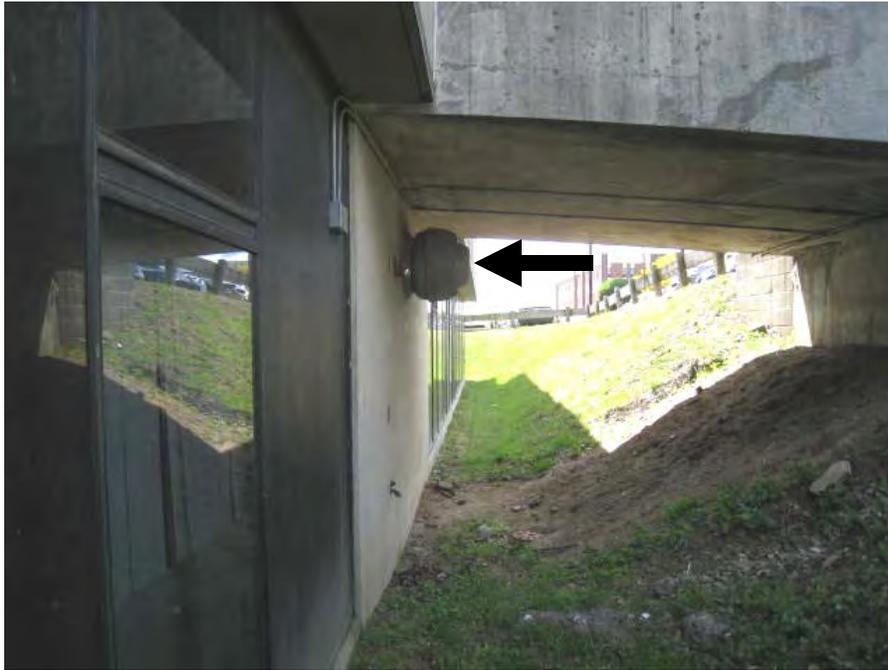
Picture 3

(Picture 2). Exhaust ventilation appears to be provided by an exhaust fan located beneath the front entrance walkway (Picture 3), which was not operating at the time of the assessment. The AHUs in the license plate storeroom show signs of corrosion, which has led to significant damage to the AHU cabinets (Pictures 4 and 5). The corrosion indicates likely failure of the drip pans to provide appropriate drainage of condensation when the AHUs are operating in cooling mode. The corrosion has affected the structural integrity of the cabinets, resulting in air from the license plate storeroom being drawn into the AHUs (Pictures 6 and 7). In addition, the corrosion is an indication that the AHUs are aging/becoming damaged through routine use and nearing the end of their useful service life. These AHUs are likely original equipment, over 40 years old. According to the American Society of Heating, Refrigeration and Air-Conditioning Engineers (ASHRAE), the service life for a unit heater (hot water or steam) is 20 years, assuming routine maintenance of the equipment (ASHRAE, 1991).

Deactivated Exhaust Vent under Main Entrance Walkway

1. Operate the ventilation system during business hours on the upper and lower levels of the building. Repair all supply and exhaust equipment as needed to improve ventilation and reduce noise.

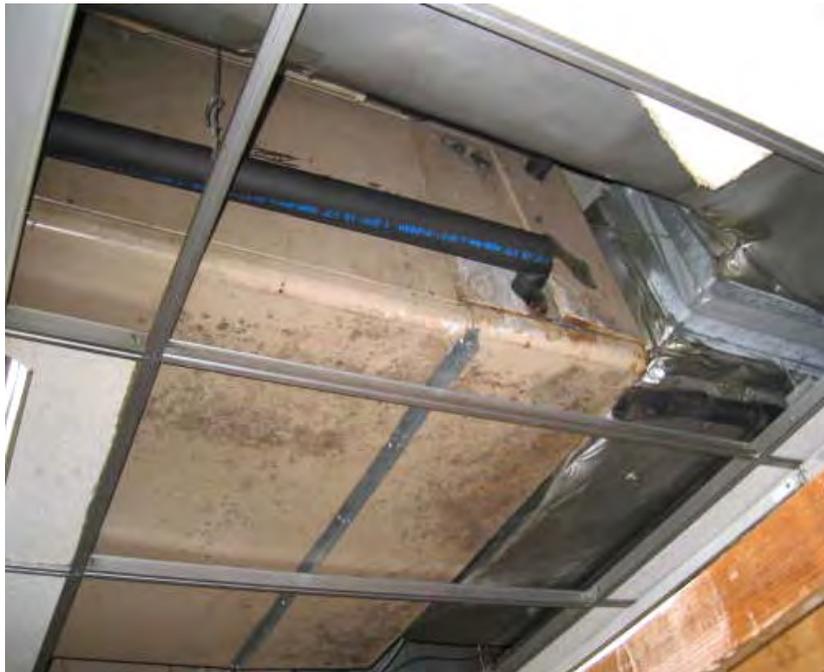
Picture 4

Damaged AHU in License Plate Storeroom

2. Repair the AHUs in the license plate storeroom to provide adequate drainage and to prevent air from being drawn from the room. If not repairable, consideration should be given to replacing the damaged AHU that services the lower level.

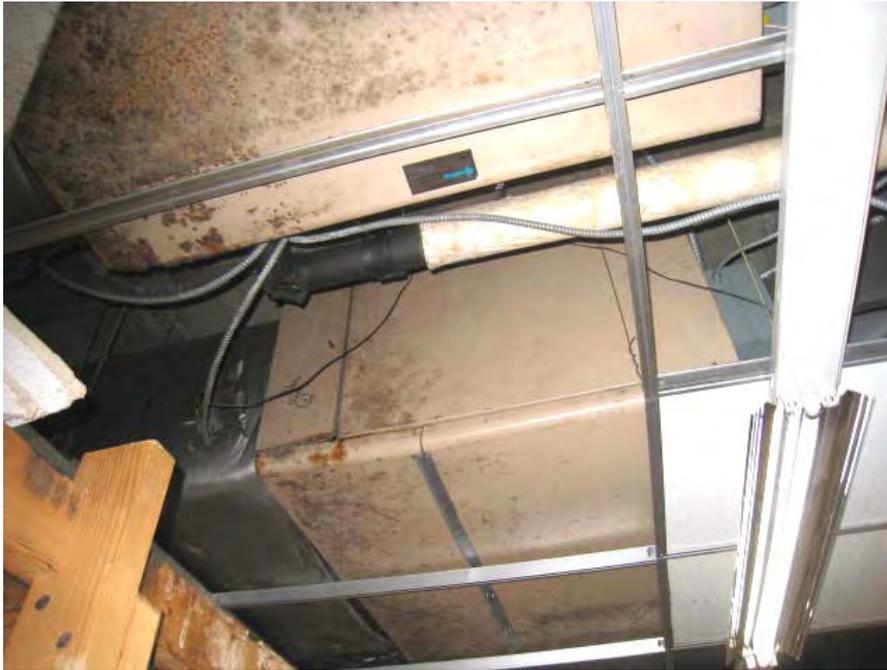
Picture 5

Damaged AHU in License Plate Storeroom

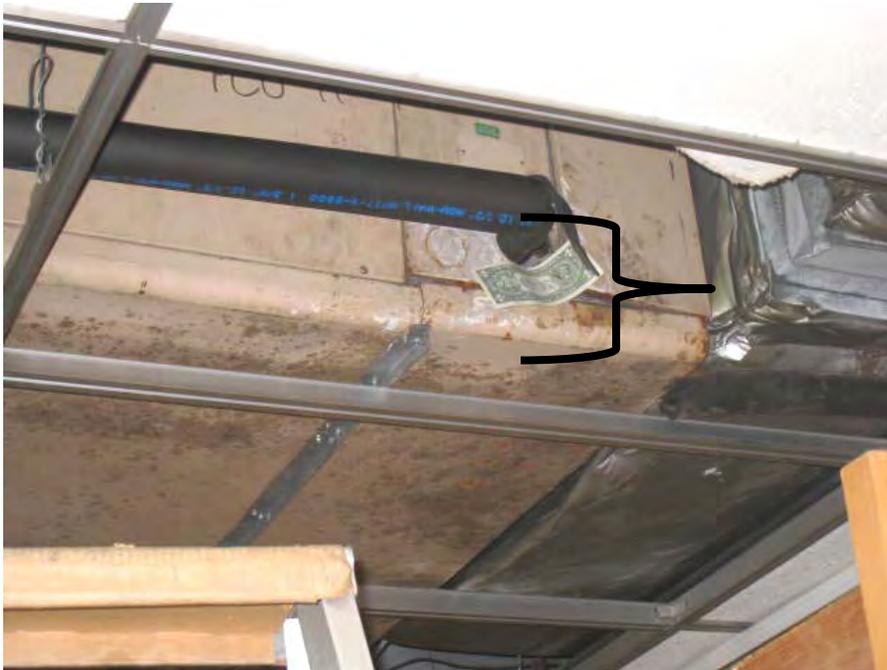
Picture 6

- Damage to the AHUs allows air to be drawn into the fresh air system from the license plate storage room, which contains a large number of cardboard boxes and freshly made license plates. Both cardboard and freshly made license plates can off-gas volatile organic compounds (VOCs), which can be irritating to the eyes, nose and respiratory system. VOCs can then be drawn into the AHUs and distributed into the RACE office.

**Air Draw through Damaged AHU Cabinet in License Plate Storeroom
See Dollar Bill (Bracket) as Demonstration**

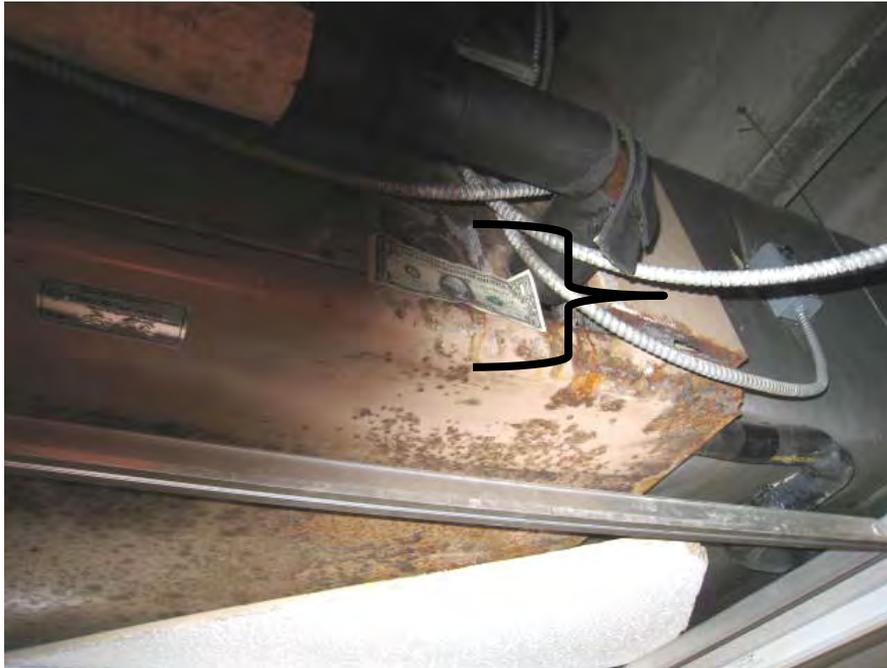
Picture 7

**Air Draw through Damaged AHU Cabinet in License Plate Storeroom
See Dollar Bill (Bracket) as Demonstration**

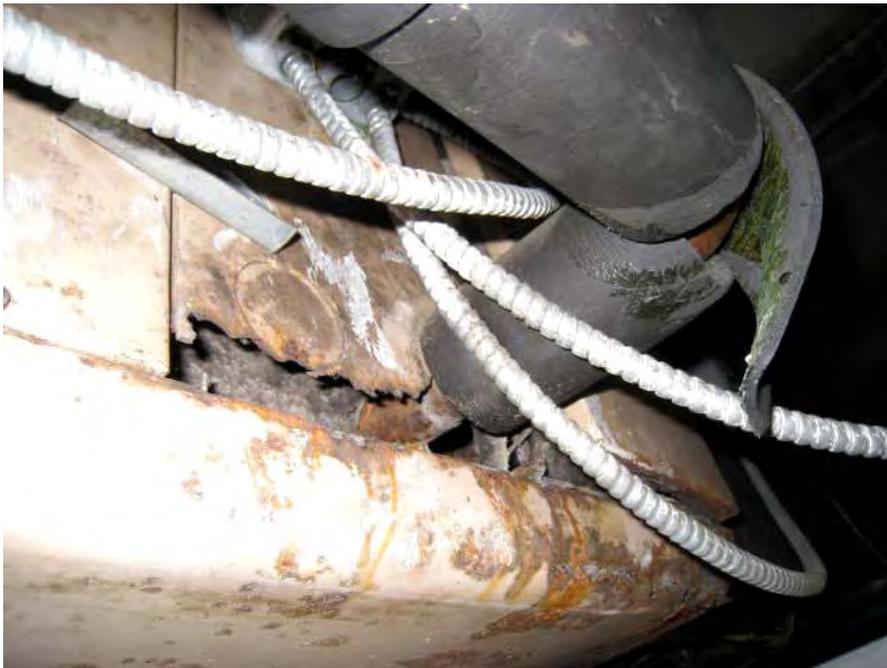
Picture 8

A few areas had water-damaged ceiling tiles (Table 1). Of note were missing ceiling tiles below the AHUs in the license plate storeroom. The missing ceiling tiles are likely a result of repeated water damage due to condensation from the failed AHU drip pan/drainage system as well as failed pipe insulation (Pictures 8 and 9). Water-damaged ceiling tiles can provide a source of mold and should be replaced after a water leak is discovered and repaired.

Corrosion Damage to AHU Cabinet and Insulation

9. Ensure leaks are repaired and replace water-damaged ceiling tiles.
10. Refer to resource manuals and other related indoor air quality documents for further building-wide evaluations and advice on maintaining public buildings. Copies of these materials are located on the MDPH's website: <http://mass.gov/dph/iaq>.

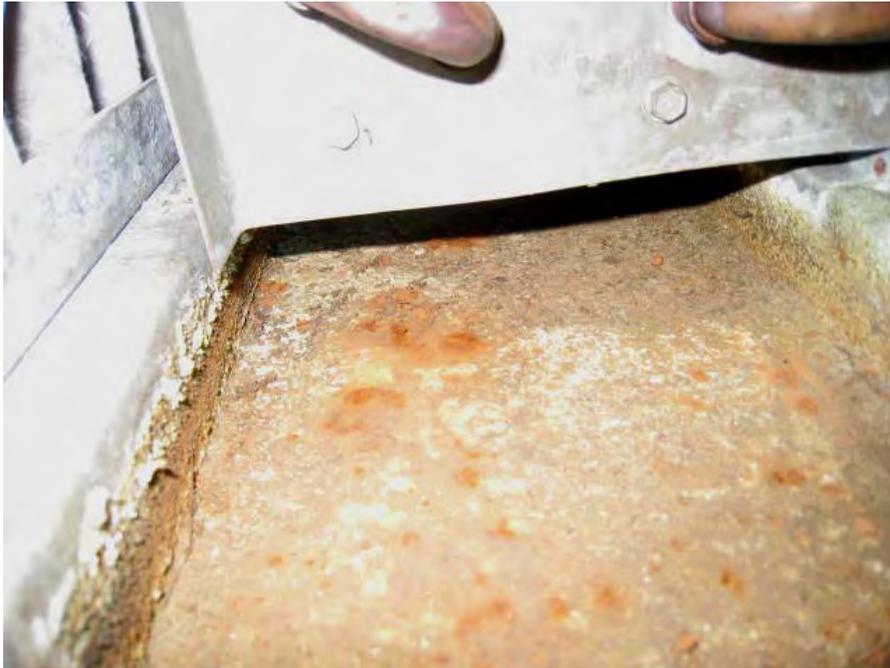
Picture 9

- The license plate room does not appear to have exhaust ventilation to remove odors from stored materials.
- The water damage to the AHU cabinets indicates that standing water likely exists in the cabinets when the system is in its cooling mode, which can ultimately lead to microbial growth.

Heavily Corroded Drip Pan inside AHU

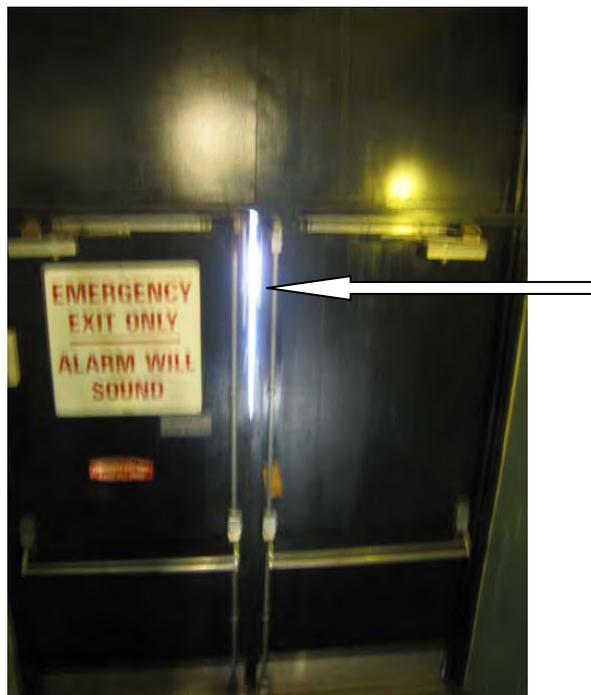
Picture 10

Gap between Rear Exterior Doors (Arrow)
