# **INDOOR AIR QUALITY ASSESSMENT**

**Wakefield Memorial High School  
60 Farm Street  
Wakefield, Massachusetts**

Prepared by:  
Massachusetts Department of Public Health  
Bureau of Environmental Health  
Indoor Air Quality Program  
December 2012

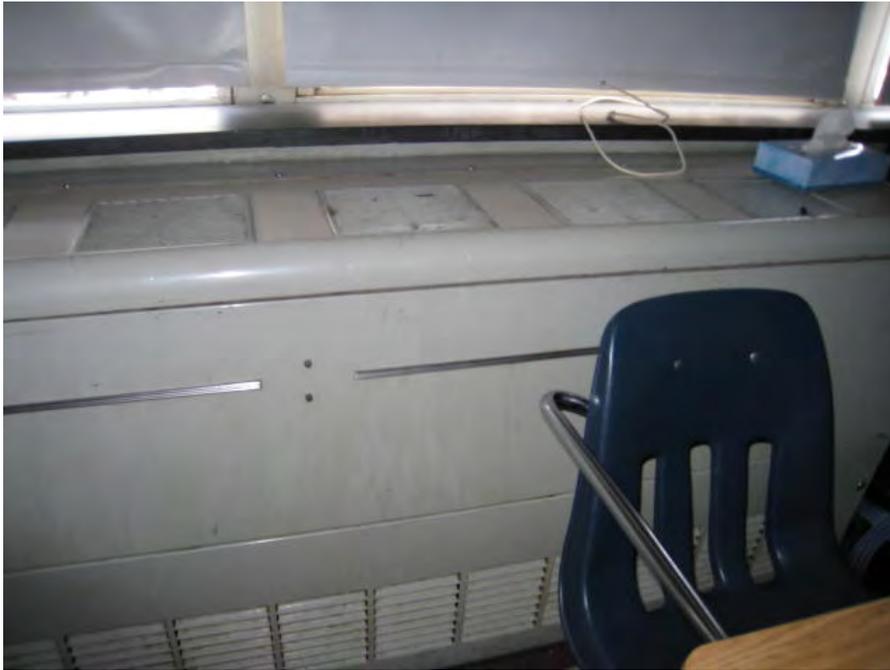
**Picture 1**

Fresh air to classrooms along exterior walls is supplied by unit ventilator (univent) systems (Picture 1). A univent draws air from the outdoors through a fresh air intake located on the exterior wall of the building (Picture 2). Return air from the classroom is drawn through an air intake located at the base of the unit ([Figure 1](#)). Fresh and return air are mixed, filtered, heated and provided to classrooms through an air diffuser located in the top of the unit. As mentioned, univents were found deactivated in many rooms/areas in the school at the time of assessment (Picture 3; Table 1) and some room occupants reported that the univents in their rooms were nonfunctional and had been so for a significant period of time. In addition, some univents were found obstructed by furniture and other items on top of air diffusers and/or in front of return vents along the bottom of the units (Picture 1). Other univents were found with missing/damaged covers and panels ajar (Picture 4), which can allow air to bypass the filter and allow dust and dirt to be entrained inside. In one case the univent cover was held on by tape (Picture 4). The univents that were opened and examined were found to have accumulated dust and debris inside (Picture 5). Univent cabinets, intakes and diffusers should be vacuumed out each time the filter is changed to remove dust and debris. In order for univents to provide fresh air as designed, they must remain “on” and operating while rooms are occupied. Furthermore, units must remain free of obstructions.

**Unit ventilator**

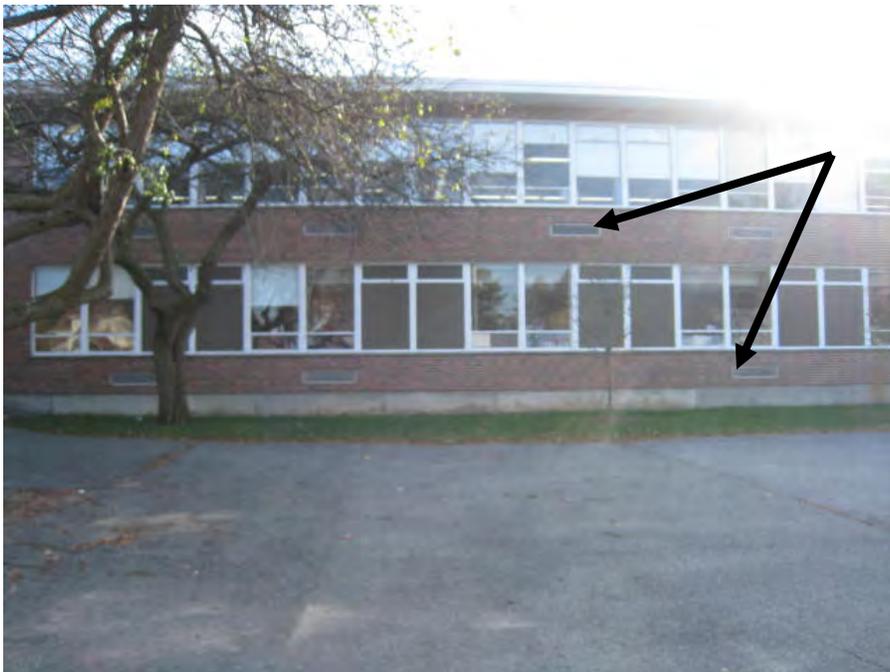
**Picture 2**

**Univent air intakes (examples at arrows)**

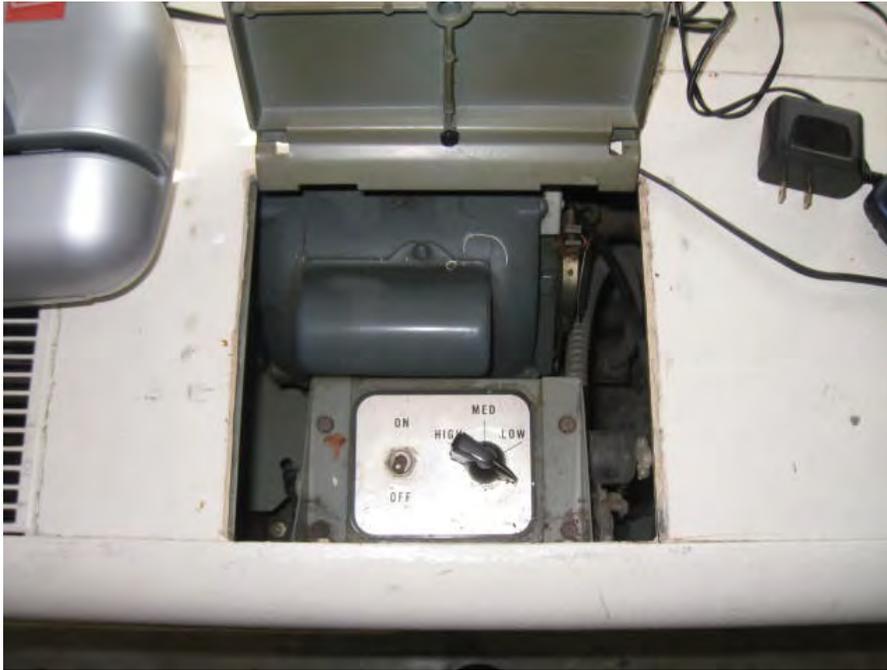
**Picture 3**

**Univent controls, showing unit in “off” position**

1. Operate all ventilation systems throughout the building including univents, unit exhausts and interior classroom HVAC systems continuously during periods of occupancy to maximize air exchange and reduce excess heat, particularly in interior computer rooms (e.g., 1228 & 1230).
2. Consult with an HVAC engineering firm regarding the feasibility of repair vs. replacement of ventilation system components given their age. In the interim, work with

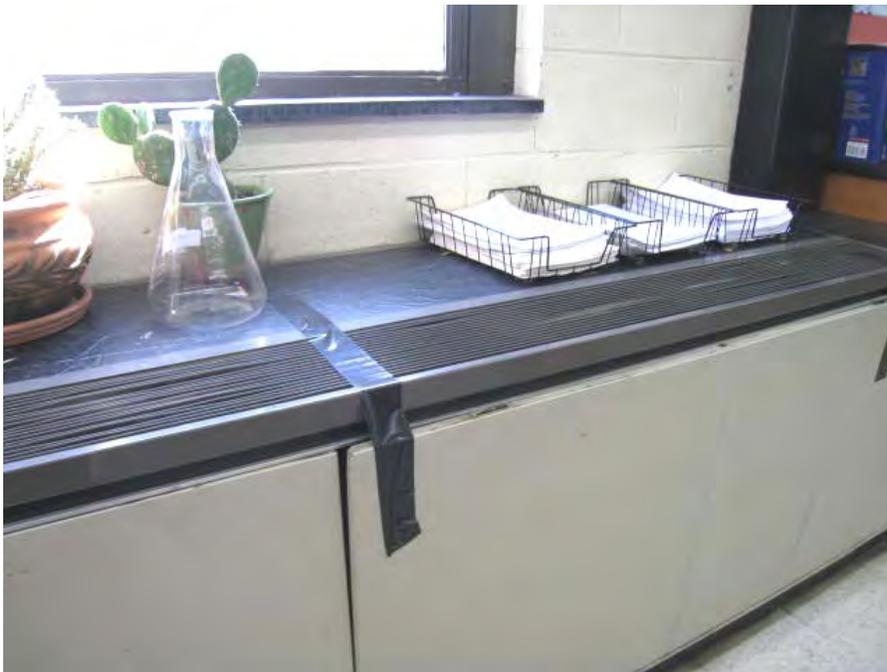
**Picture 4**

**Univent cover ajar/taped shut**

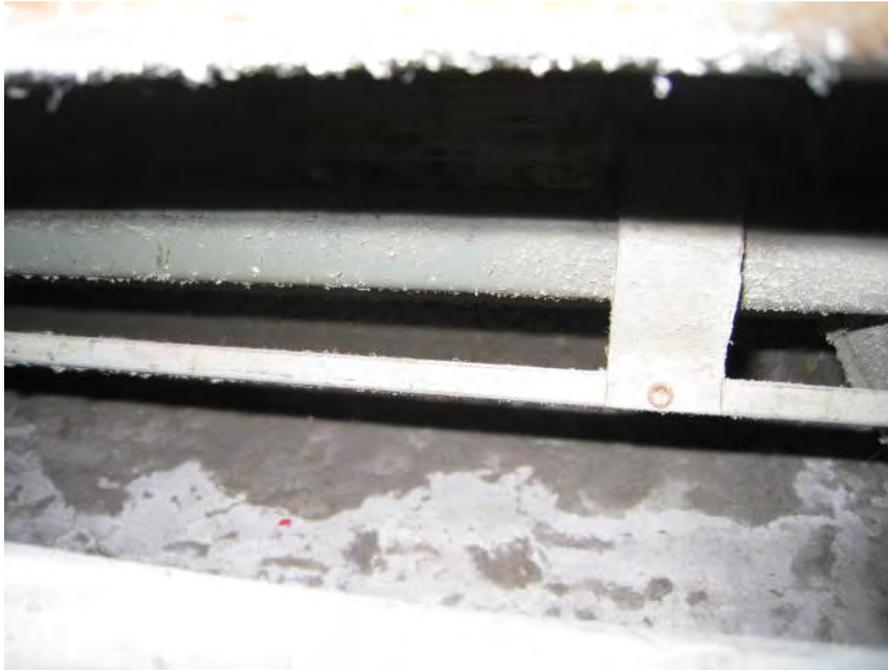
**Picture 5**

**Dusty interior of univent cabinet**

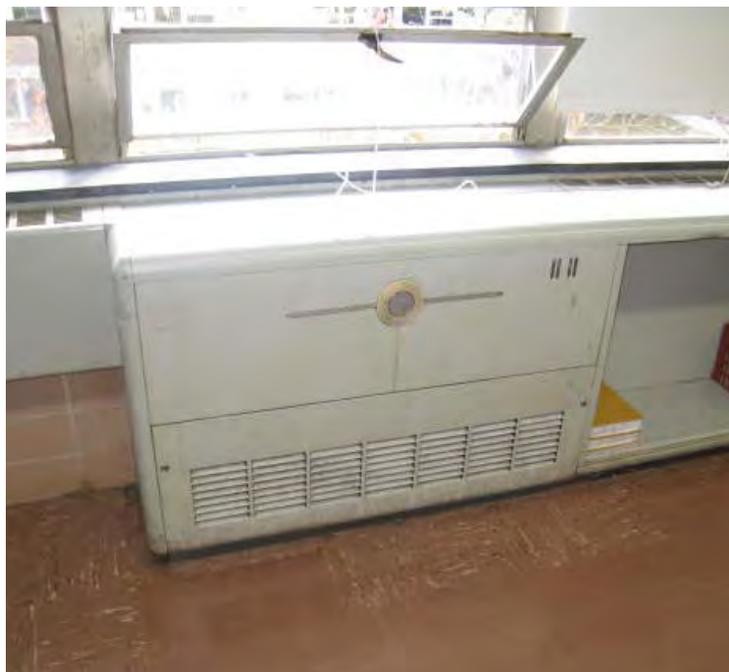
**Picture 6**

**Unit exhaust ventilator**

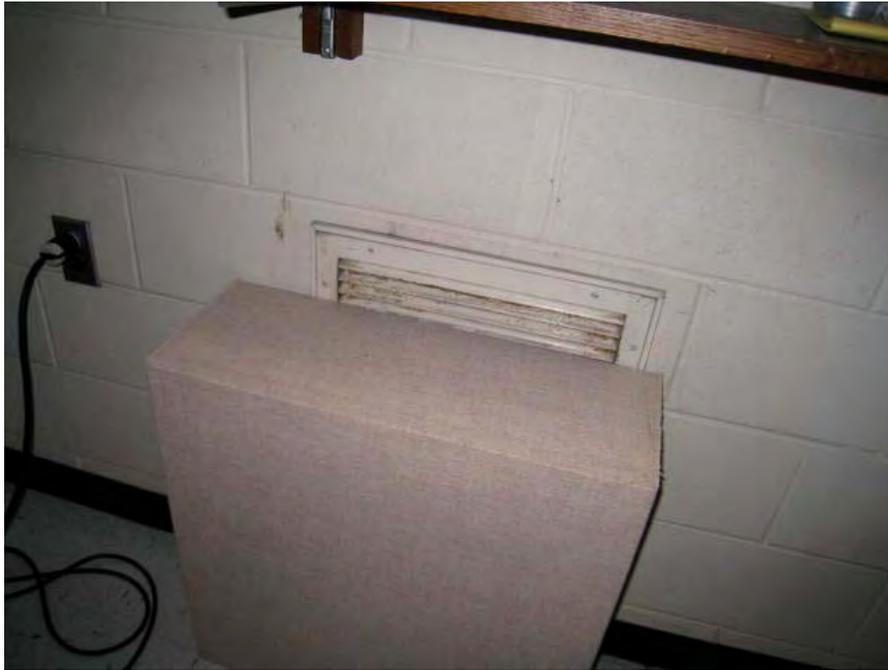
**Picture 7**

**Blocked exhaust vent**

4. Have HVAC firm evaluate the interior condition of ductwork and whether cleaning is recommended/necessary.
5. Remove all blockages/items from the surface of univent air diffusers and return vents (along front/bottom) to ensure adequate airflow. Remove all blockages from exhaust vents.

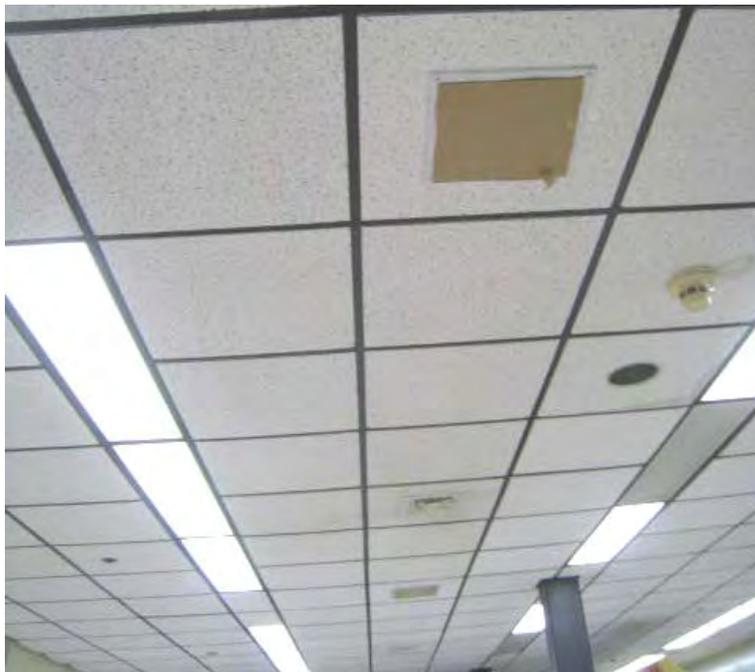
**Picture 8**

cardboard (Picture 8). In many rooms exhaust vents are located near hallway doors, which are generally left open. However, with the hallway doors open the exhaust vent will tend to draw air from the hallway *into* the classroom, instead of drawing stale air *from* the classroom. Therefore it is recommended that classroom doors remain shut while exhaust vents are operating to function as designed.

**Blocked supply vents**

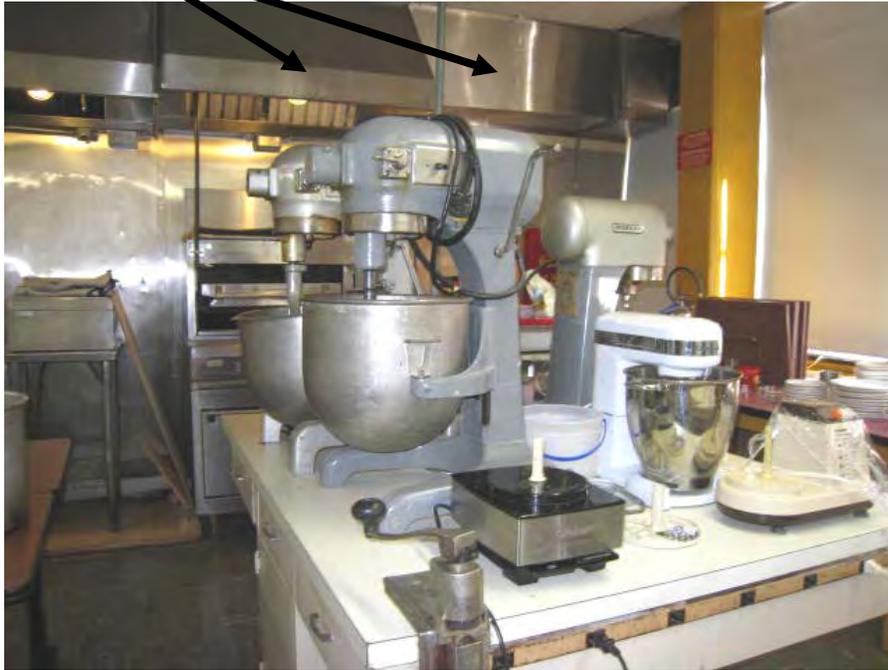
**Picture 9**

**Culinary arts room, note large exhaust hoods above cooking equipment (arrows)**

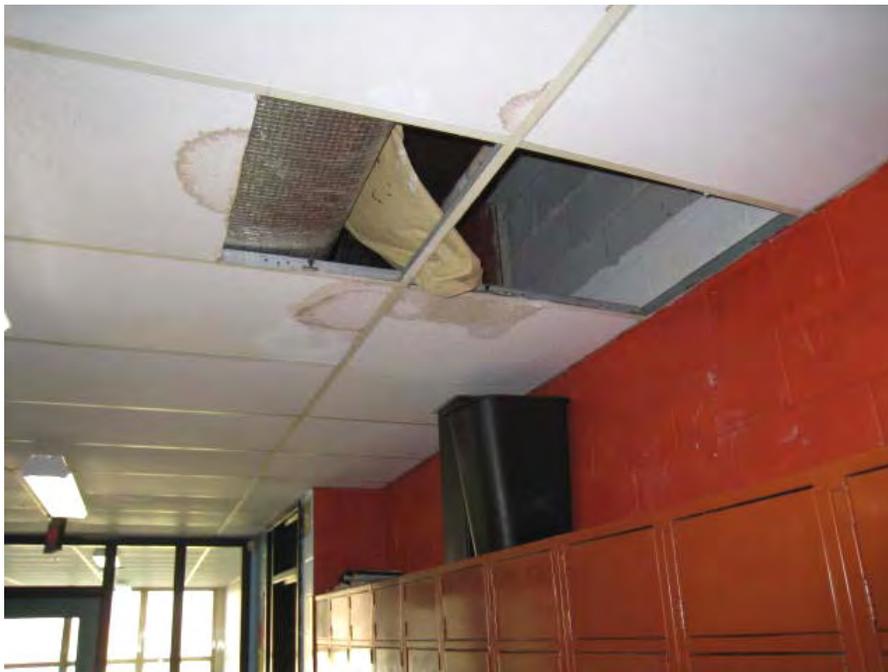
**Picture 10**

**Water-damaged and missing ceiling tiles in hallway, note water-collection bucket**

10. Ensure roof flashing/junctions and plumbing leaks are repaired and replace any remaining water-damaged ceiling tiles and wall materials. Examine the area above these tiles for mold growth. Disinfect areas of water leaks with an appropriate antimicrobial, as needed.

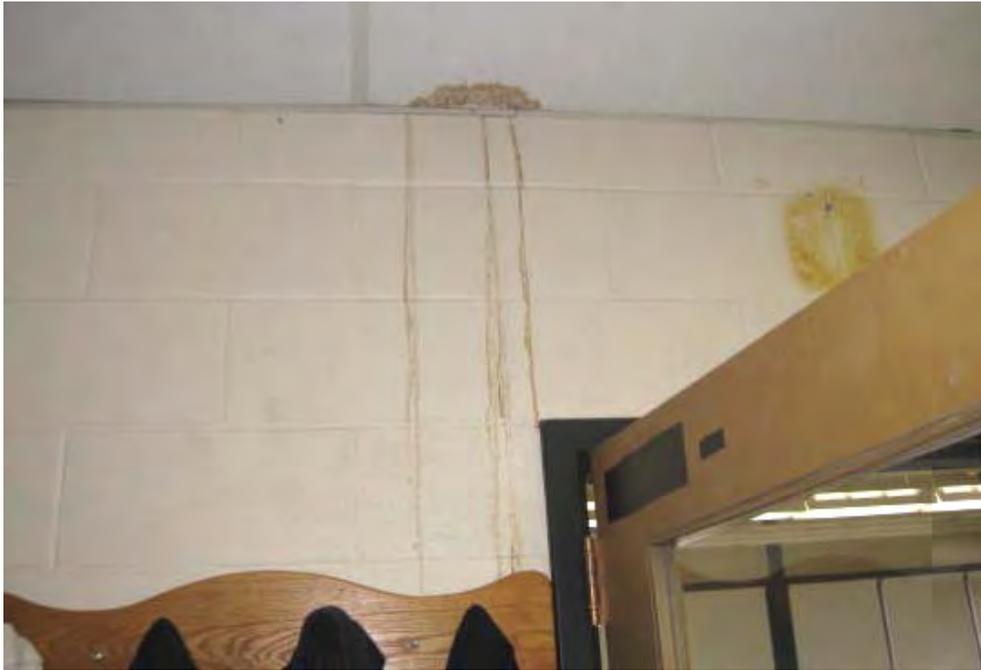
**Picture 11**

**Signs of water leakage and water-damaged ceiling tile**

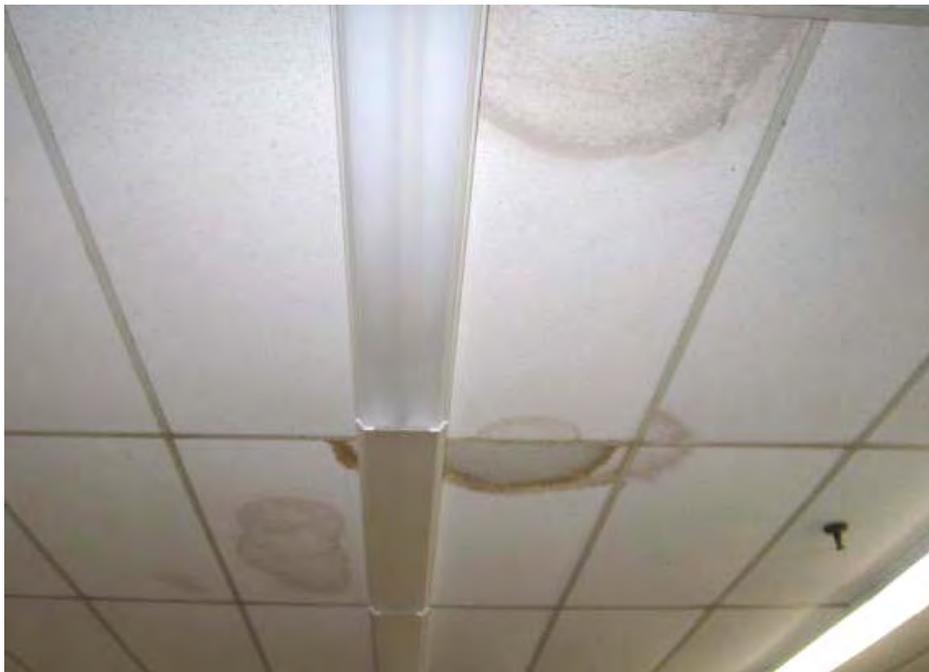
**Picture 12**

**Water-damaged ceiling tiles**

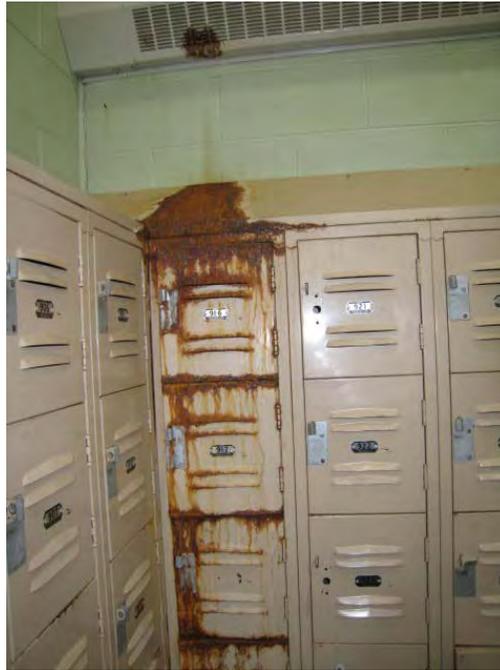
**Picture 13**

**Water damage to metal lockers in girls' gym area**

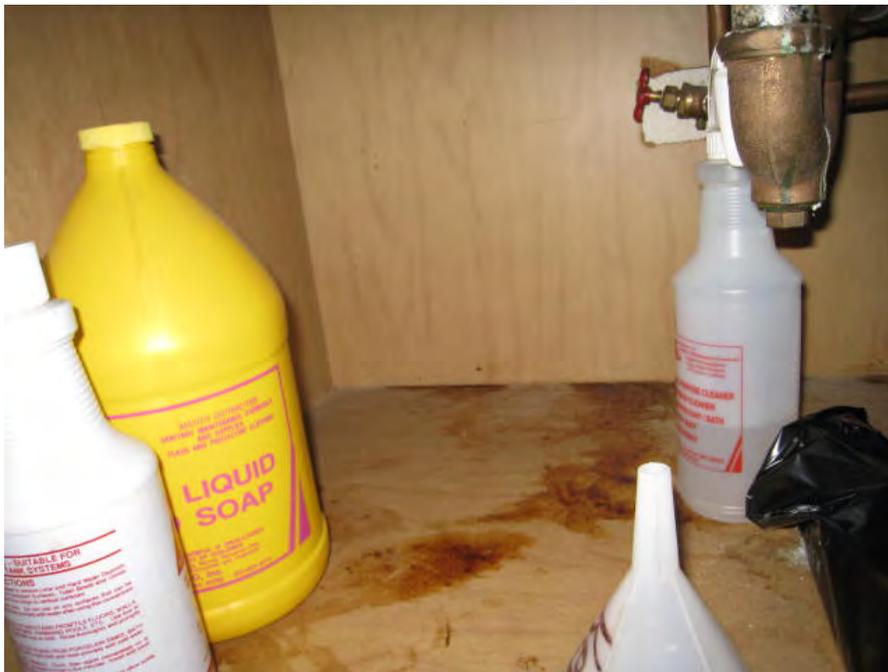
**Picture 14**

Sinks were observed in many areas. There was evidence of past water leaks under some of the sinks (Picture 14), and porous items such as paper and cardboard were stored under sinks.

When porous items, including the wood of the cabinets, are moistened by plumbing leaks they can be subject to microbial growth.

**Evidence of water leak under sink**

11. Have areas of cracks and missing mortar on the outside of the building repointed to prevent water infiltration.
12. Inspect all sinks for leaks and repair as needed. Refrain from storing porous items or large quantities of items under sinks.

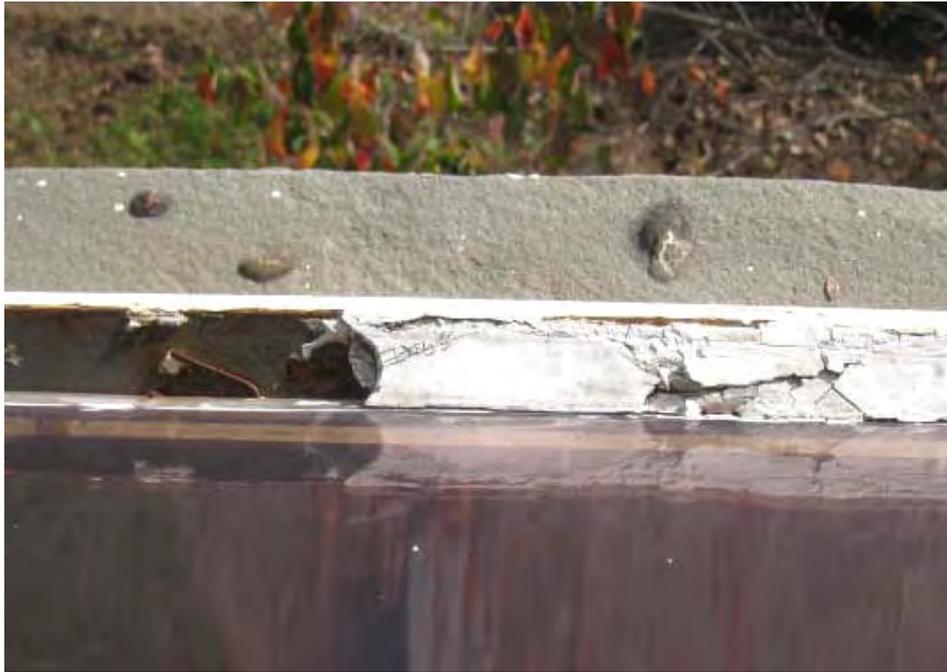
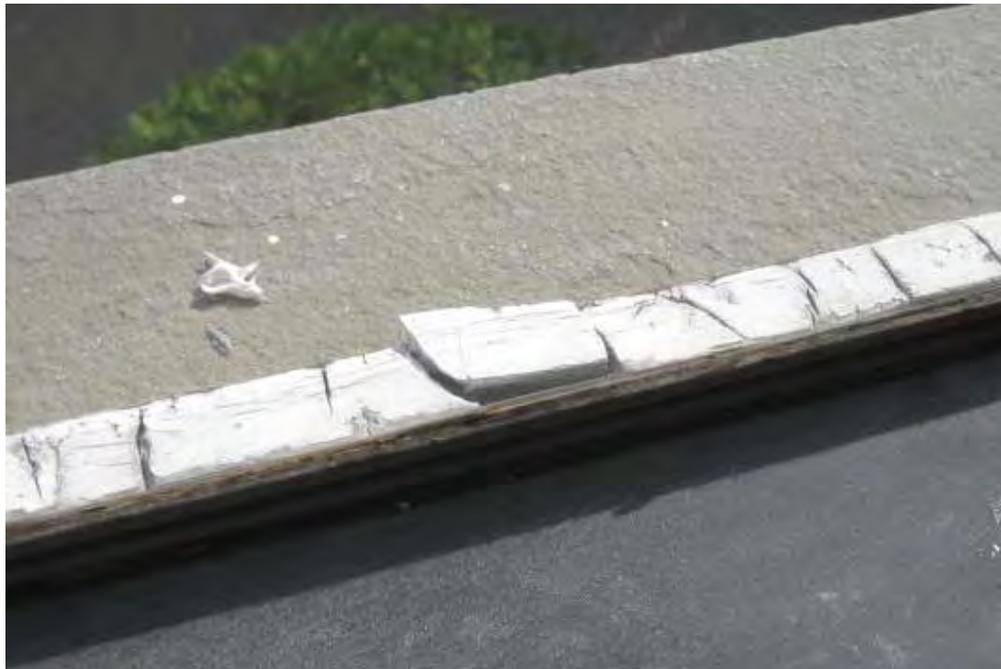
Missing/damaged caulking was observed around windows (Picture 15 and 16), which can result in air/moisture infiltration and damage to interior building materials (e.g., walls, ceiling tiles, flooring). Depending on its age, window (and joint) sealant may be composed of regulated materials [e.g., asbestos, polychlorinated biphenyls (PCBs)]. If so, materials should be addressed in accordance with US Environmental Protection Agency (US EPA) regulations. For additional information regarding PCBs, please consult MDPH guidance (Appendix B).

**Missing/damaged window caulking**

2. Consider a long-term plan to replace windows (where needed) to prevent air/moisture infiltration.

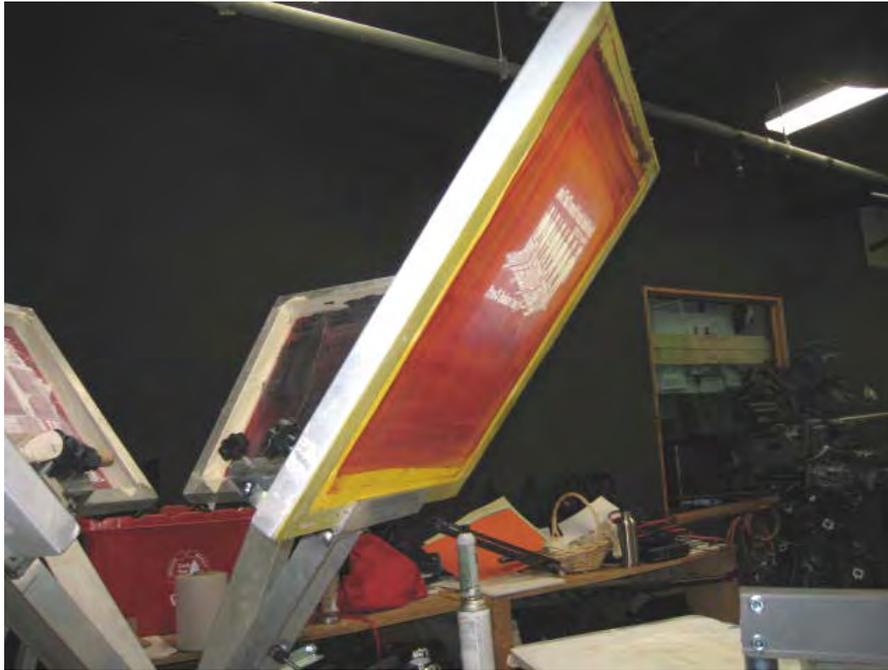
**Picture 17**

Art materials such as paint were found in several areas of the school, including the TV studio area (Picture 17). Art materials can emit a variety of TVOCs and should be used in areas with sufficient supply and exhaust ventilation.

**Silk-screening materials in television studio room**

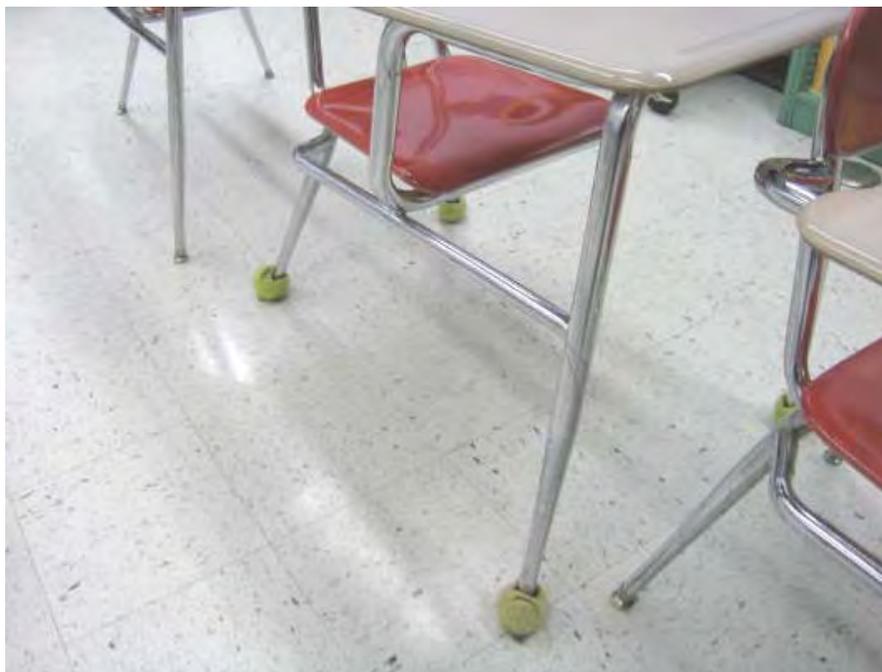
**Picture 18**

In an effort to reduce noise, tennis balls had been sliced open and placed on the base of desk/chair legs in some classrooms (Picture 18). Tennis balls are made of a number of materials that are a source of respiratory irritants. Constant wearing of tennis balls can produce fibers and

cause VOCs to off-gas. Tennis balls are made with a natural rubber latex bladder, which becomes abraded when used as a chair leg pad. Use of tennis balls in this manner may introduce latex dust into the school environment. Some individuals are highly allergic to latex (e.g., spina bifida patients) (SBAA, 2001). It is recommended that the use of materials containing latex be limited in buildings to reduce the likelihood of symptoms in sensitive individuals (NIOSH, 1997).

**Tennis balls used as glides**

21. Consider replacing tennis balls with latex-free tennis balls or glides.
22. Change the filter on the univent in the nurse's office and then inspect it for signs of oil leakage; repair if needed. Remove sound baffling from the cover of the univent in this room. Also inspect the exterior vent of the unit to see if odorous materials are being entrained into the unit. If these measures do not abate the odor, consider consulting an HVAC contractor for additional inspection and repair of this unit.

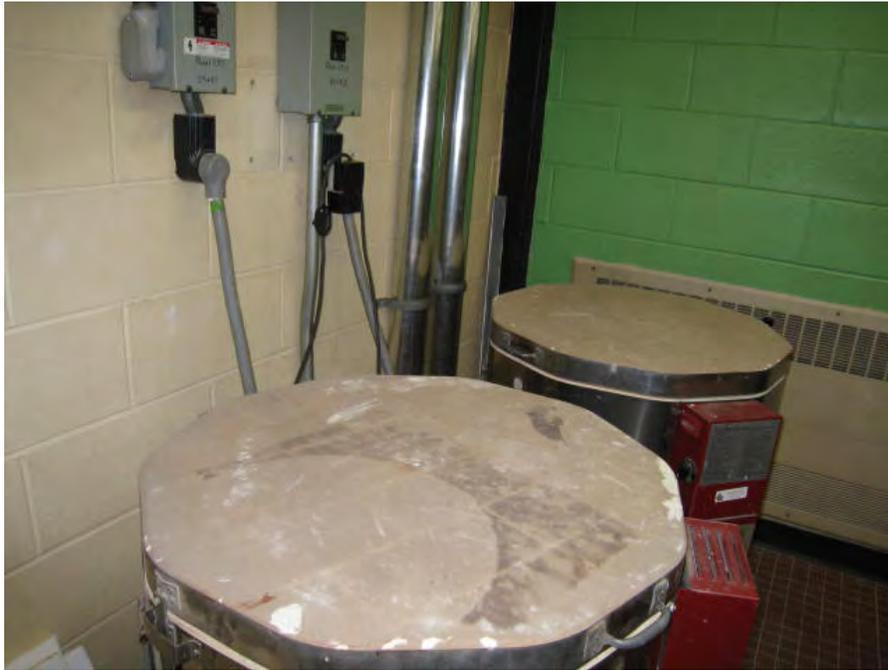
**Picture 19**

Other conditions that can affect indoor air quality were observed during the assessment. Two pottery kilns were observed in a storeroom adjacent to the art area (Picture 19). Pottery kilns can be a significant source of water vapor, particulate and other related pollutants when operating. In addition, a pottery kiln is a source of waste heat that can present a safety/fire hazard. The kilns appeared to be electrically operated, and there was exhaust piping from the backs of each of them leading out of the room. The kilns were not outfitted with a hood to draw heat and pollutants from the outside of the kilns. Kilns should be vented directly outdoors and

kept away from students. Bottles of pottery glazing materials were examined and they were labeled as “lead free”, which is appropriate and recommended to protect the safety and health of staff and students.

**Electric pottery kilns, note exhaust pipes from rear of unit, no hood exhaust**

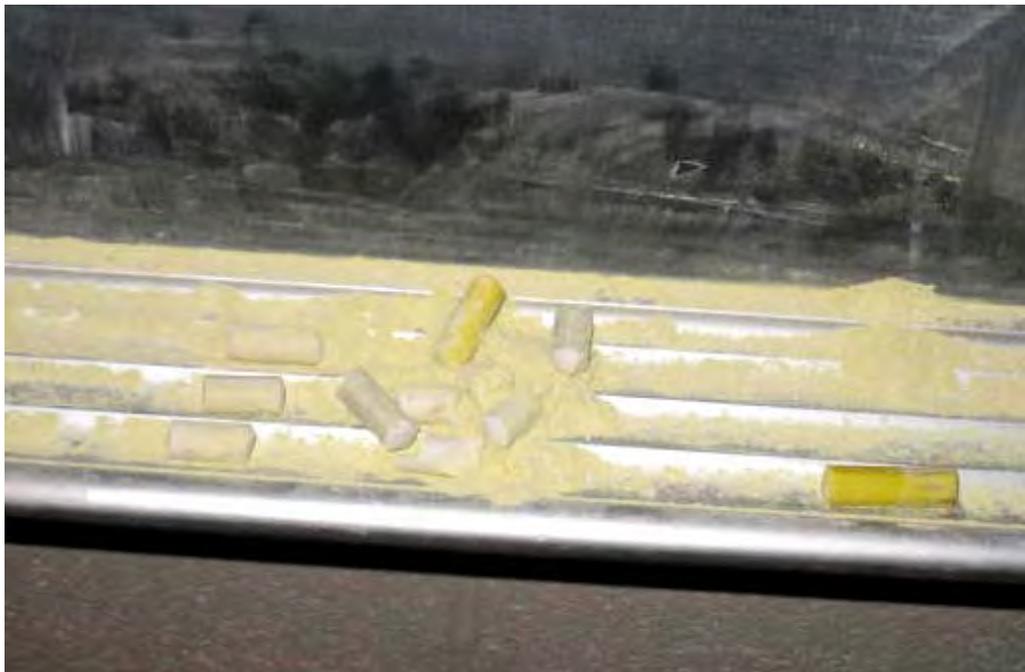
**Picture 20**

BEH/IAQ staff observed chalk/dry erase board trays containing a build-up of chalk dust (Picture 20) and whiteboard marker debris. These materials can be aerosolized by air movement from doors opening and closing, and/or foot traffic and may present a respiratory irritant.

**Chalk tray with build-up of chalk dust**

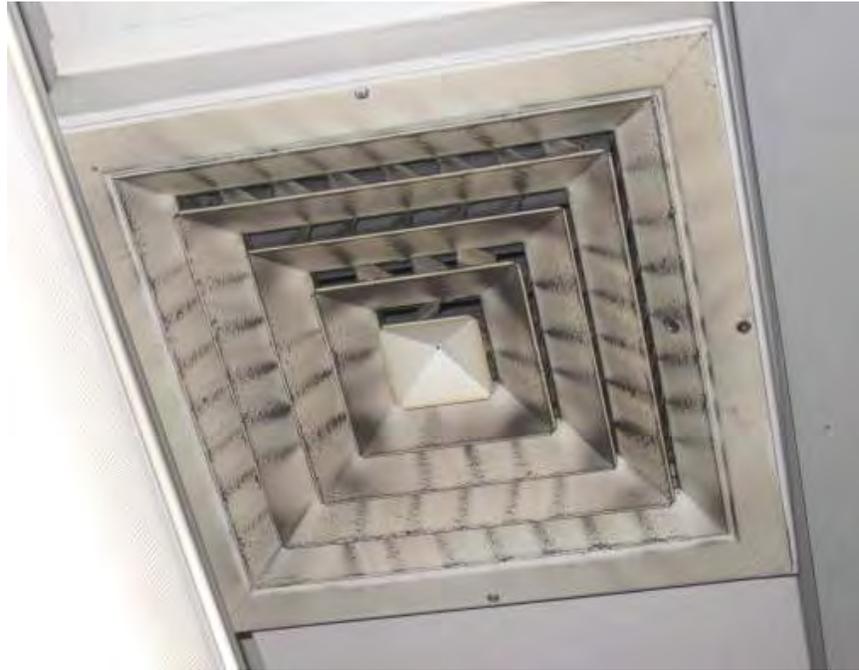
**Picture 21**

Dust was also observed accumulated on the blades of personal fans, univent diffusers, supply vents and exhaust vents/motors (Pictures 21 through 23). Univents, vents and fans should be cleaned periodically in order to prevent them from serving as a source of aerosolized particulates.

**Dusty supply vents**

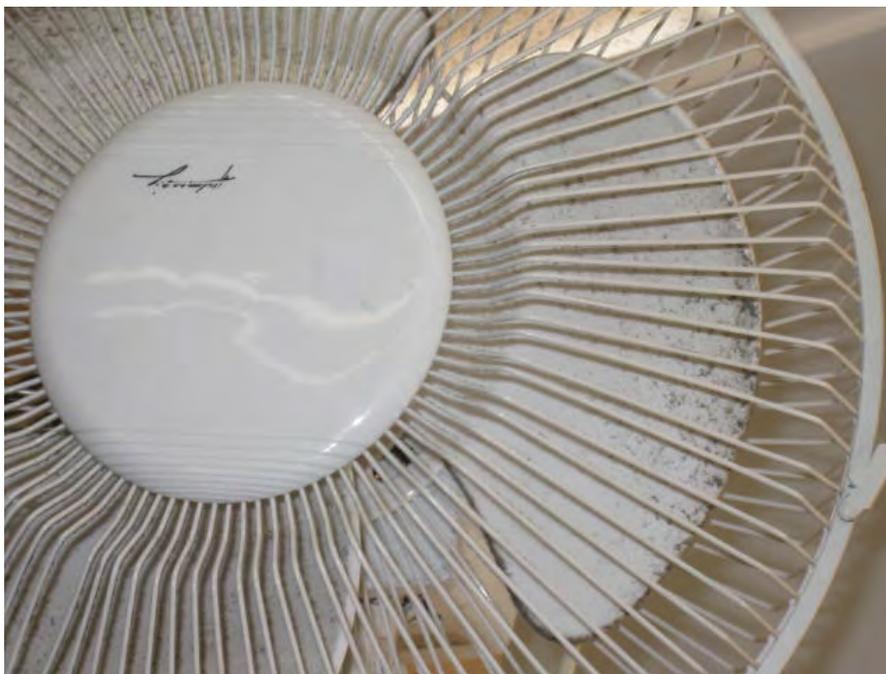
**Picture 22**

**Dusty personal fan**

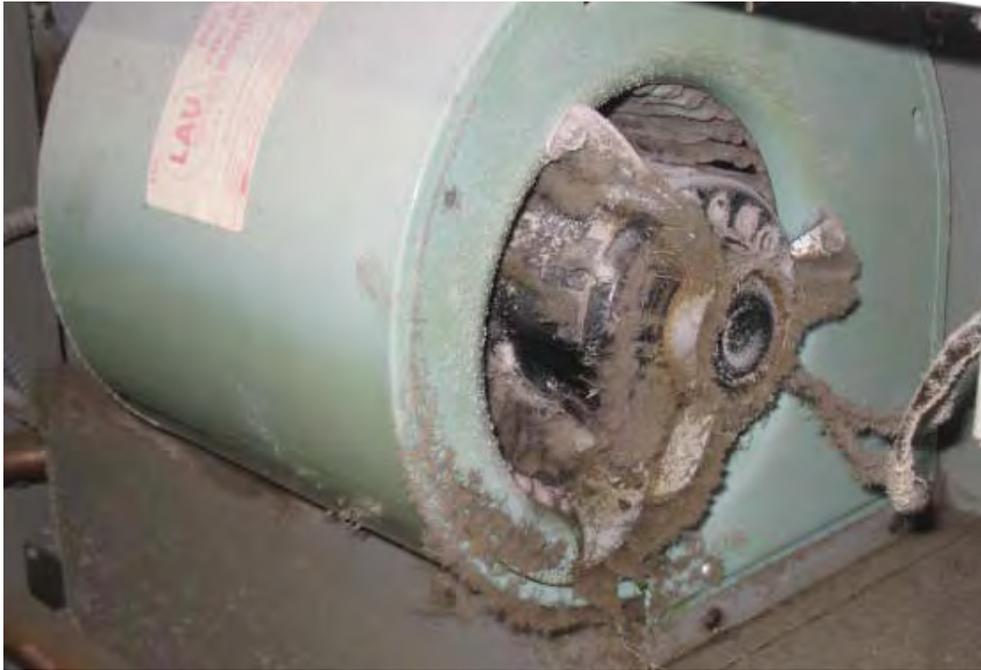
**Picture 23**

**Accumulated dust and debris inside exhaust motor**

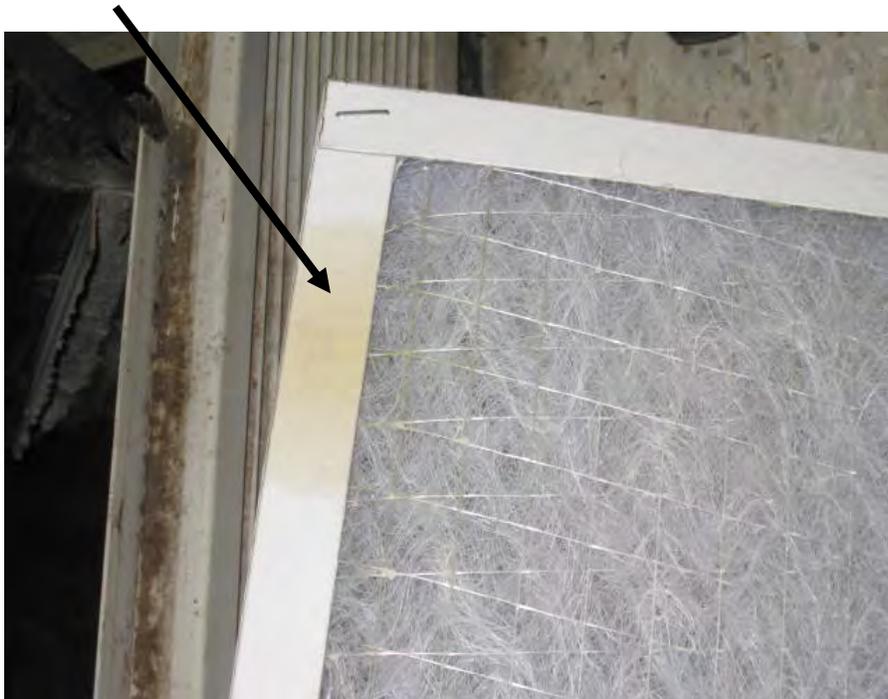
**Picture 24**

There was a report of an odor in the nurse’s office, potentially originating from the univent. The nurse reported that the odor smelled “sour” and that reportedly persisted on clothes after the workday. The univent was opened and examined during the BEH/IAQ visit. No obvious source for the odor was identified. An oily stain was noted on the univent filter (Picture 24), which may indicate a fluid leak inside the univent, or may indicate that a small amount of lubricating oil was spilled when the unit was last serviced. It was recommended that the univent

**Oily stain (arrow) on univalent filter in the nurse's room**

filter be changed to see if the stain reoccurs, so that any fluid leaks can be identified and repaired. In addition, the material lining the univent cover, intended to reduce noise from the unit, was noted to be soiled (Picture 25). This material cannot be cleaned, but it can be removed without changing the function of the univent which may reduce odors from the unit.

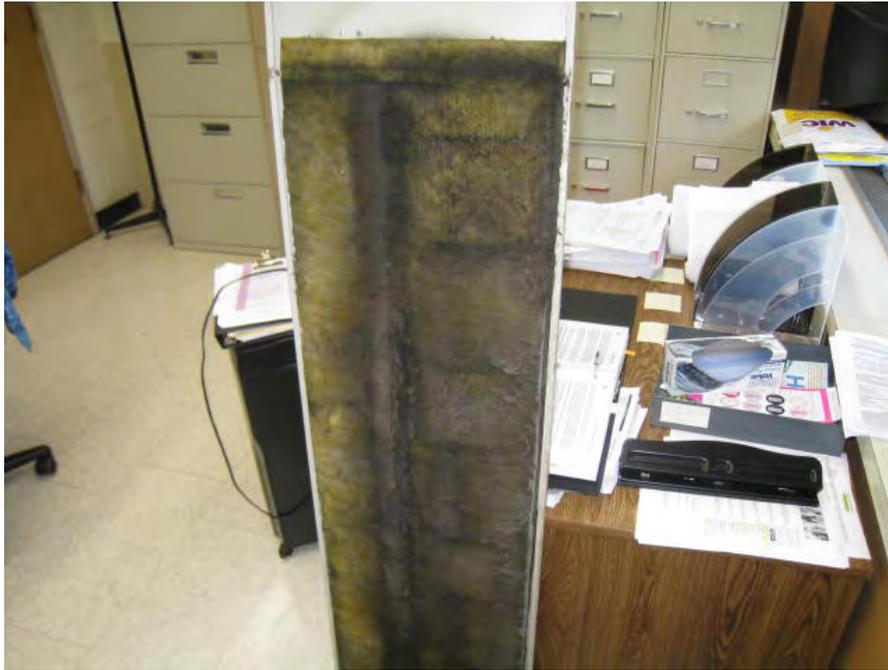
**Picture 25**

**Dusty/dirty sound-baffling material on univent cover in nurse's room**
