INDOOR AIR QUALITY ASSESSMENT

**Westfield Athenaeum
6 Elm Street
Westfield, Massachusetts**

Prepared by:
Massachusetts Department of Public Health
Bureau of Environmental Health
Indoor Air Quality Program
January 2012

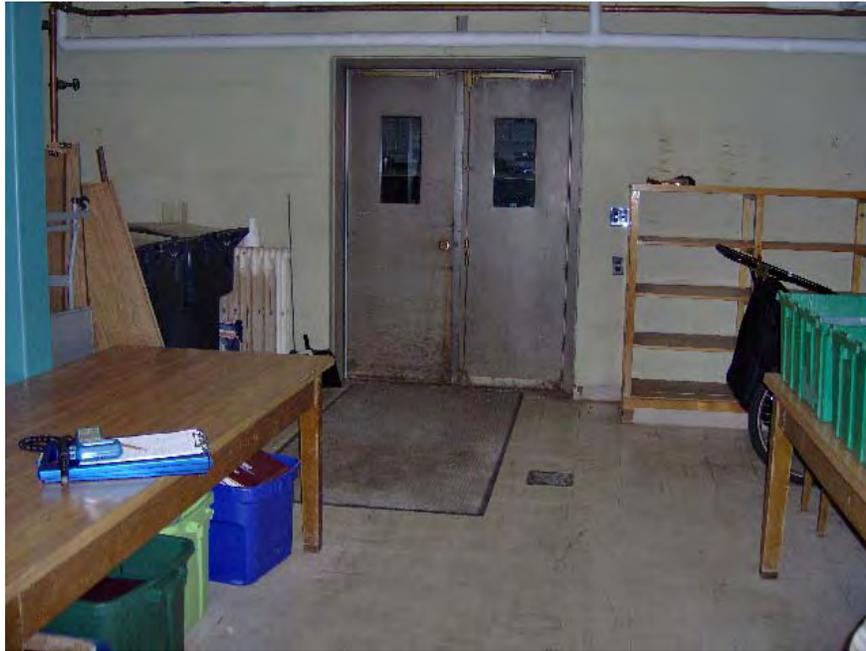
Picture 1

This assessment was limited to the 1966 wing first floor and the basement area below. As reported by Mr. Linquist, water had flooded the garage, which then entered the storage room area through a connecting door (Picture 1). Mr. Linquist also reported that conditions inside the building were extremely humid during the storm. As a result of the tropical storm, occupants on the 1966 wing first floor expressed concerns regarding odors.

Garage Access Door in Storeroom

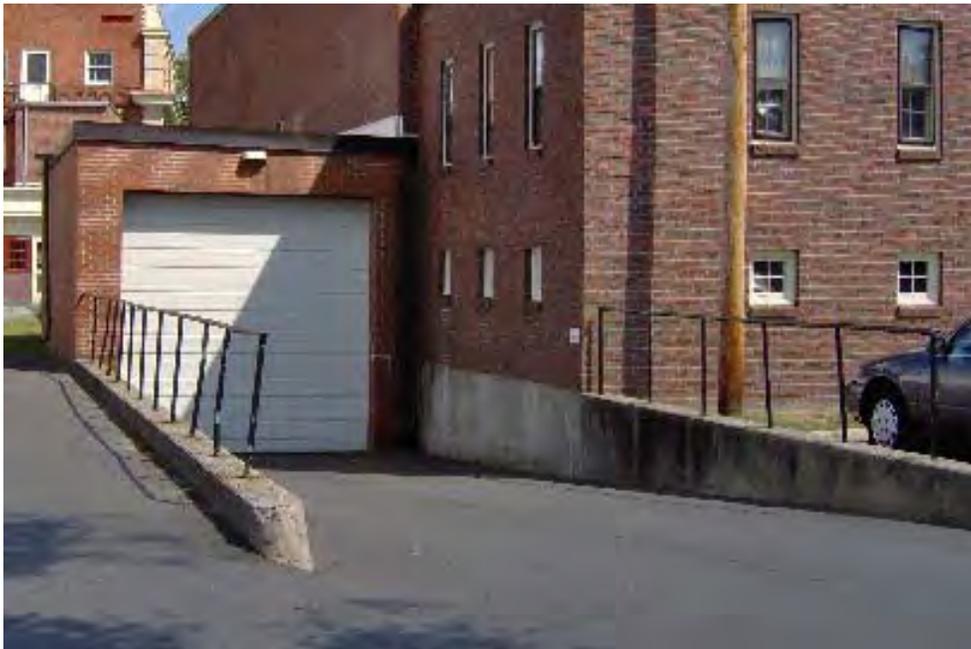
Picture 2

The configuration of the garage resulted in both flooding of the storage room and pressurization of the storage room. The driveway to the garage slopes downward from the parking lot (Picture 2). Rainwater flowed into an interceptor drain at the base of the building (Picture 11). Of note is that the interceptor drain does not span the garage door opening which allowed for water to penetrate into the garage. The garage floor was still moistened 16 days after the tropical storm (Picture 12), indicating poor drainage of the garage. With the fan in Picture 10 operating, moisture from the garage floor was directed into the storage room, increasing the relative humidity. The interceptor drain is connected to a sump pump located inside the storage room (Picture 5). Mr. Trafficante reported that the pump has backed up during severe storms causing water penetration and damage to the area surrounding the pumps.

Storage room odors observed in the occupied areas of the WA are directly related to the configuration of the garage and pressurization created by tropical storm winds. The garage door faces west (Picture 2). The WA garage is not equipped with either a mechanical exhaust system or openable windows to either remove emissions or provide cross ventilation. In a steady westerly wind, the garage may become pressurized forcing air into the storage room, which in turn may become pressurized, forcing odors from the storage room into occupied space via the elevator and HVAC system. If a window/passive vent/opening existed in the east wall of the garage, the pressurization would be relieved and impact to the occupied spaces in the WA by tropical storm winds would be reduced.

Garage Entrance Facing West, Note Slope Downward towards the Garage Door

1. Consider installing a passive or mechanical exhaust fan in the garage to vent vehicle exhaust from the building. If not feasible, remove bricks from the east wall of the garage to reduce pressurization during time of high westerly winds.

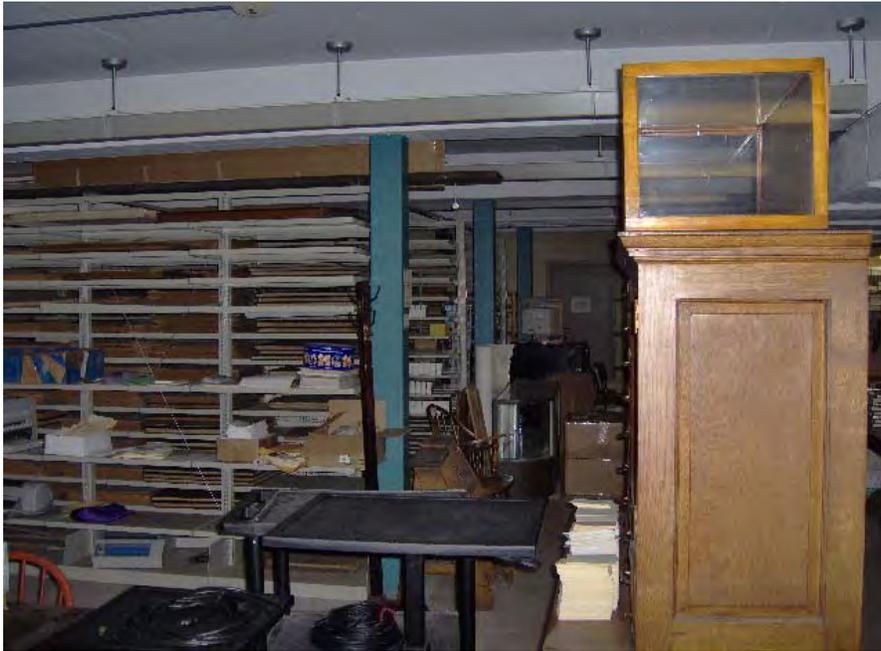
Picture 3

As mentioned previously, the relative humidity conditions in the basement are of concern relative to moisture/mold growth. The basement storage room had a relative humidity of 71 percent. Prolonged relative humidity concentrations indoors above 60 percent can foster mold growth in susceptible porous materials such as cardboard, paper, books, cloth and other materials, which are present in the WA storage room. One indication of the presence of water-damaged materials was the detection of a musty odor upon entering the basement. This odor was due to the significant amount of books, paper products and other materials that were water-damaged and likely supporting mold growth. BEH staff identified a number of materials with evidence of moisture, water damage and mold colonization/growth including: missing or

Basement Storage/Workroom

3. Examine the feasibility of installing a mechanical exhaust ventilation system for the basement storage/workroom.
4. Check the weather-stripping around the bookmobile interior door. Check for air-tightness by monitoring for light and/or drafts around doors. Ensure doors accessing the basement fit completely flush with threshold.

8. Use dehumidifiers in below grade areas during hot, humid weather to reduce relative humidity. Ensure dehumidifiers are cleaned and maintained as per the manufacture's instruction to prevent microbial growth.

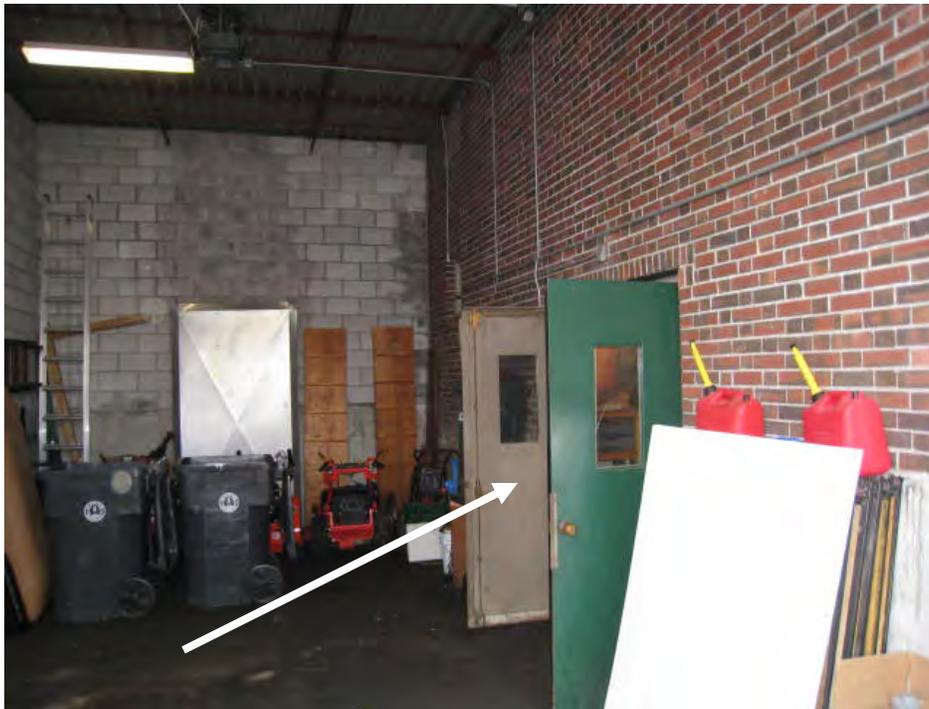
Picture 4

The basement contains a large storage/workroom (Picture 3), a mechanical ventilation room, an auditorium and several small rooms used for various community purposes. The garage is adjacent to the basement storage room on the north exterior wall of the 1966 wing. A double door connects the basement and garage (Picture 4). Windows in the building are openable with the exception of transom windows in the basement which were painted over and were not openable at the time of the assessment.

Door Connecting the Basement to Garage (arrow)

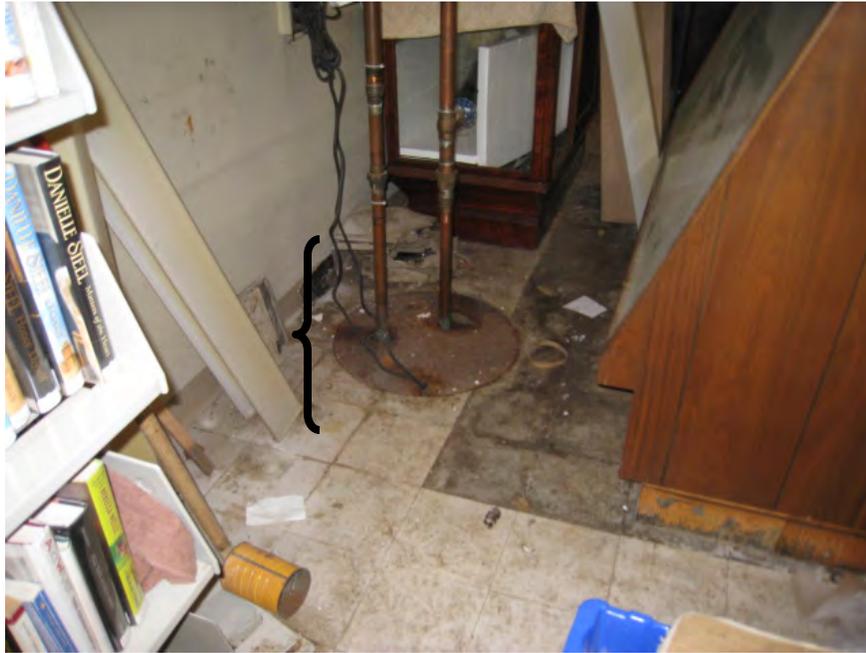
Picture 5

the MDPH recommended comfort range. It is important to note that relative humidity measured indoors exceeded the outdoor measurement of 60 percent at the time of the assessment. This can indicate that sources of moisture exist in the storage room area. In addition to the water that flooded the basement, the storage room contains a sump pump with a heavily rusted lid (Picture 5), indicating repeated water vapor exposure. The lid is open and can readily allow for water vapor to enter the storage room, which from the storage room.

Sump Pump inside the Storeroom

2. Consider replacing the sump pump for the garage drain inside the garage. If not feasible, render the sump pump as airtight as possible to prevent moisture evaporation into the storage room.

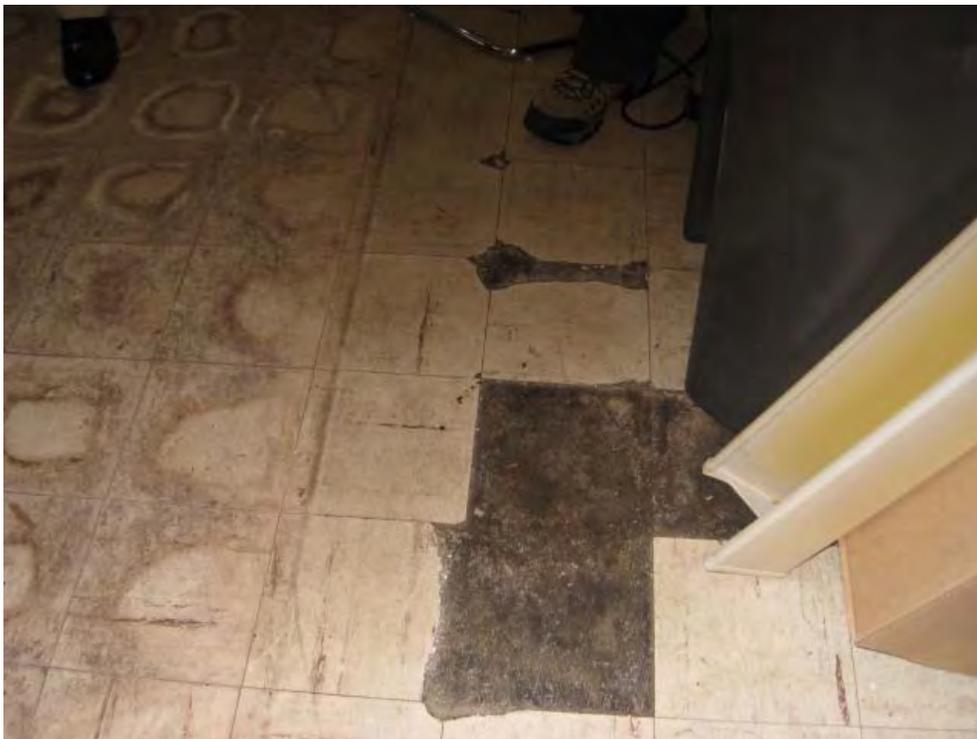
Picture 6

damaged floor tiles (Picture 6), cardboard boxes, pipe insulation and books stored on shelves along the back wall (Picture 7). Of note are the books in Picture 7, which are stored on metal shelves located on the exterior foundation wall. While the flooding may have caused some of the mold growth on these books, the shelving also appears to be subject to condensation. Fasteners that affix the shelving to the foundation wall show signs of water damage (Picture 8). The wall where the shelving is attached is also the foundation for the building (Picture 9) located beneath the grass in Picture 1. Since this foundation wall is below grade and constructed in the 1950s, it is likely that the cement is not insulated. The wall would serve as a thermal bridge² which would lower the shelves' temperature below the dew point, resulting in condensation moistening any book stored along this wall during hot, humid weather. This process would occur during summer months and it is likely that the water damage and mold growth to the books on this shelf preceded the tropical storm damage.

Damaged/Missing Floor Tiles

5. Remove any mold-contaminated materials (including stored items) in the basement.
6. Remove and replace any water-damaged/mold-colonized building materials (e.g., floor tiles). This measure will remove actively growing mold colonies that may be present. Remove mold contaminated materials in a manner consistent with recommendations found in “Mold Remediation in Schools and Commercial Buildings” published by the US Environmental Protection Agency, Office of Air and Radiation, Indoor Environments Division, Washington, DC. This document can be downloaded from the US EPA website at: http://www.epa.gov/iaq/molds/mold_remediation.html.

13. Consult with a licensed asbestos inspector to ascertain whether pipe insulation and floor tiles contain asbestos and encapsulate or remove in conformance with Massachusetts law. Do not remove/replace water-damaged ceiling tiles until this issue is resolved.

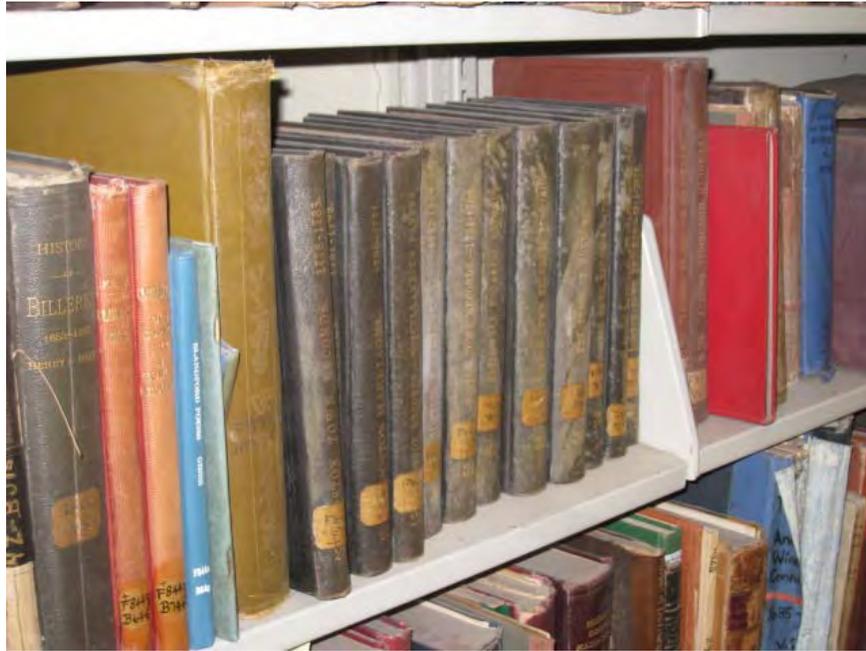
Picture 7

Books Stored on Back Wall

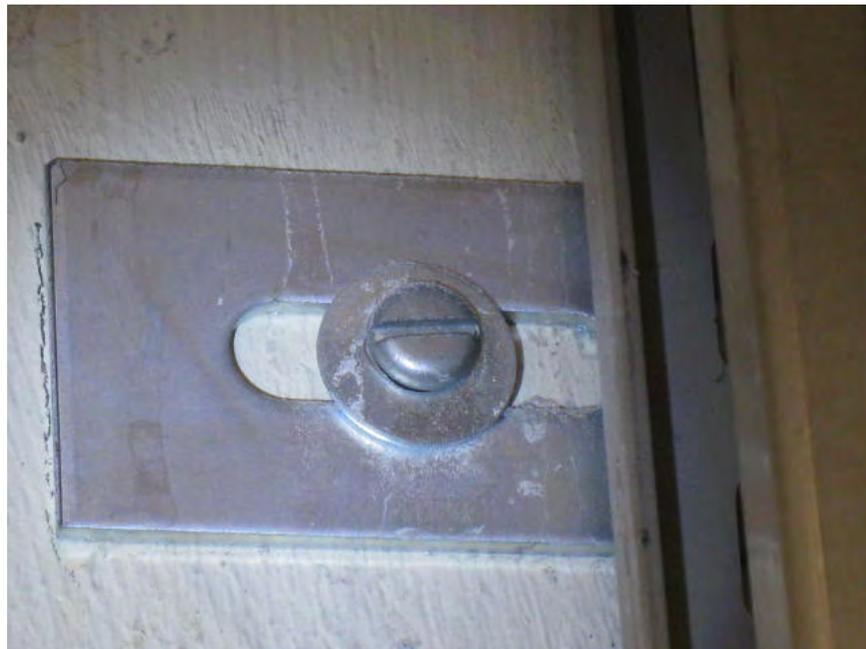
Picture 8

Shelf Fastener with Signs of Dried Condensation on its Surface

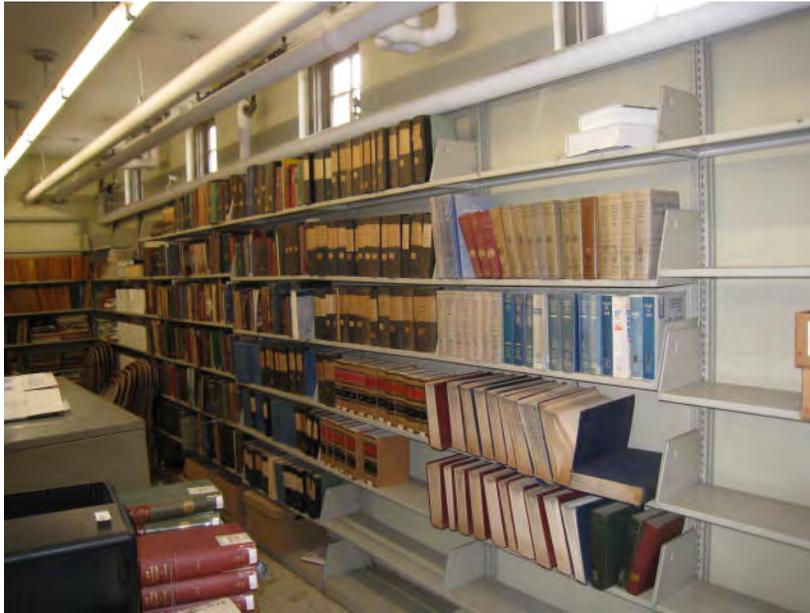
Picture 9

Books on Shelf Attached to Foundation Wall

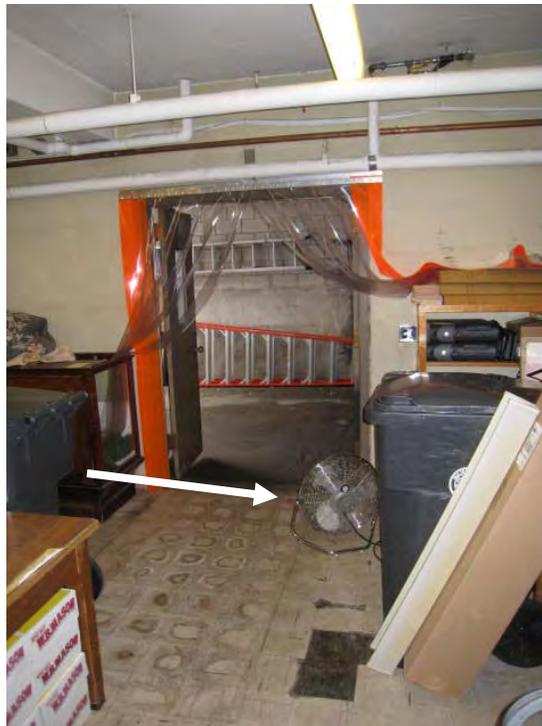
Picture 10

In order to reduce the potential for further odor migration, a fan placed at the garage door was moving air from the garage into the basement (Picture 10). The fan in its original position pressurized the storage room and force odors into the occupied areas via the noted pathways. BEH staff recommended that the fan be reversed to draw air from the storage room into the garage, which would act to depressurize the storage room and prevent odor migration to occupied areas.

Open Garage Access: fan (arrow) was originally positioned to inject air into storeroom. BEH staff reversed fan direction to draw air and moisture from storeroom.

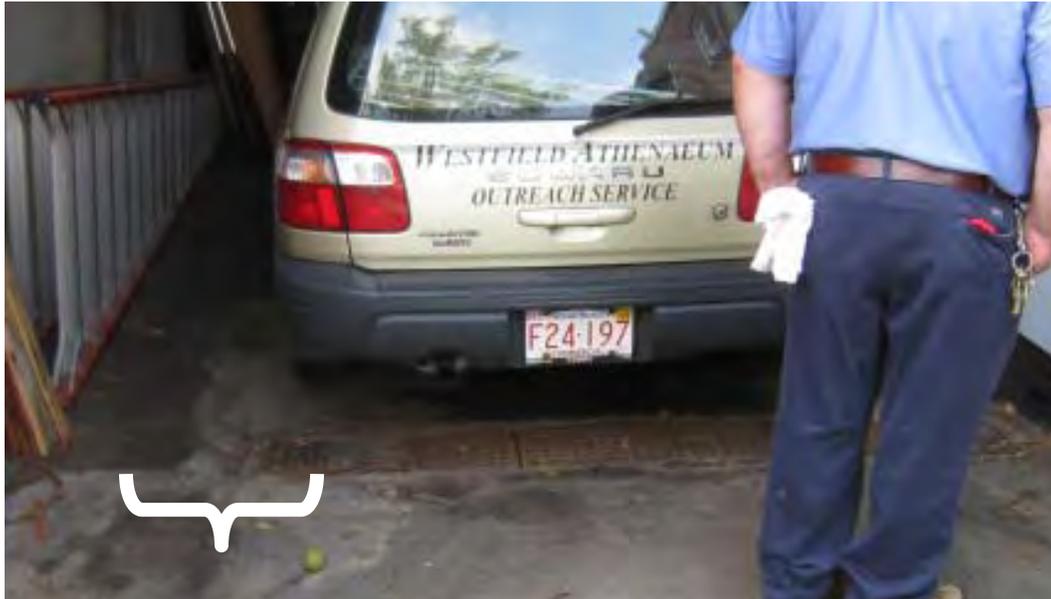
Picture 11

Interceptor Drain, Note Space between Wall and Drain, Moistened Concrete Floor Days after Storm

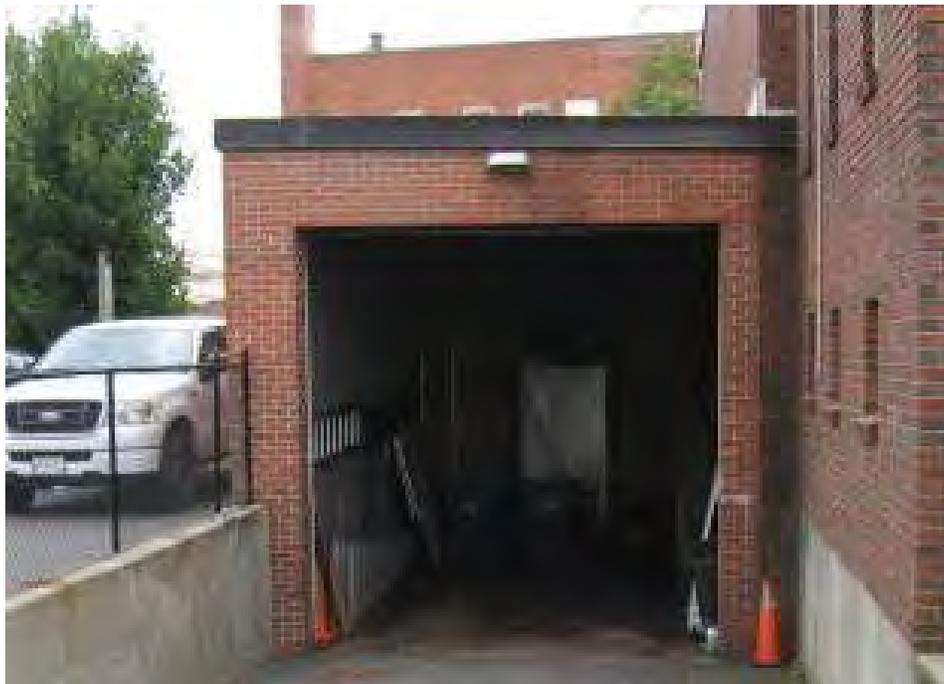
Picture 12

The roof of the garage is flat but slopes toward the 1996 north wing creating another means for water to migrate towards the building structure. The roof has one drain catch basin that leads to a grassy area but there are no rain gutters or downspouts allowing water to pool at the base of the foundation as evidenced by water damage along the exterior wall at the seam of the basement and garage (Picture 13). In this condition, water can penetrate through the garage walls to continue to moisten the garage floor.

Garage Floor Moistened 16 Days after Tropical Storm

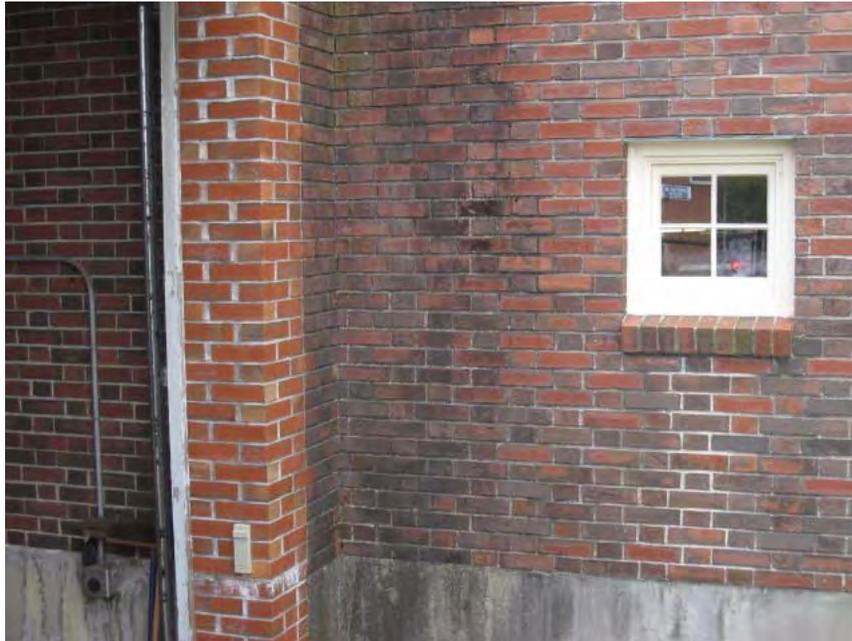
Picture 13

Water Damaged Exterior Wall

9. Seal utility holes and other potential pathways to eliminate pollutant paths of migration from the basement to the first floor.
10. Install gutters and downspouts on the garage roof to direct rainwater at least 5 feet away from the foundation. Remove foliage to no less than five feet from the foundation.

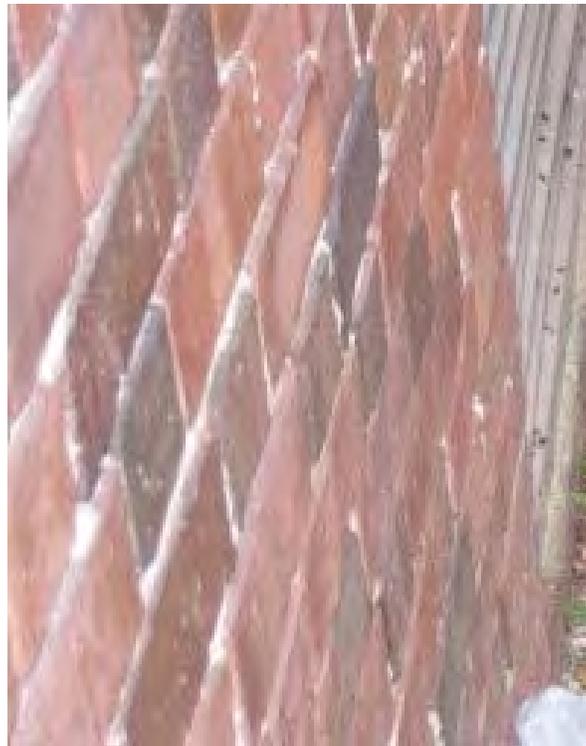
Picture 14

Efflorescence was observed in bricks along the side of the building (Picture 14). Efflorescence is a characteristic sign of water damage to brick and mortar, but it is not mold growth. As moisture penetrates and works its way through mortar, brick or plaster, water-soluble compounds dissolve, creating a solution. As the solution moves to the surface of the material, the water evaporates, leaving behind white, powdery mineral deposits.

Efflorescence on Exterior Wall

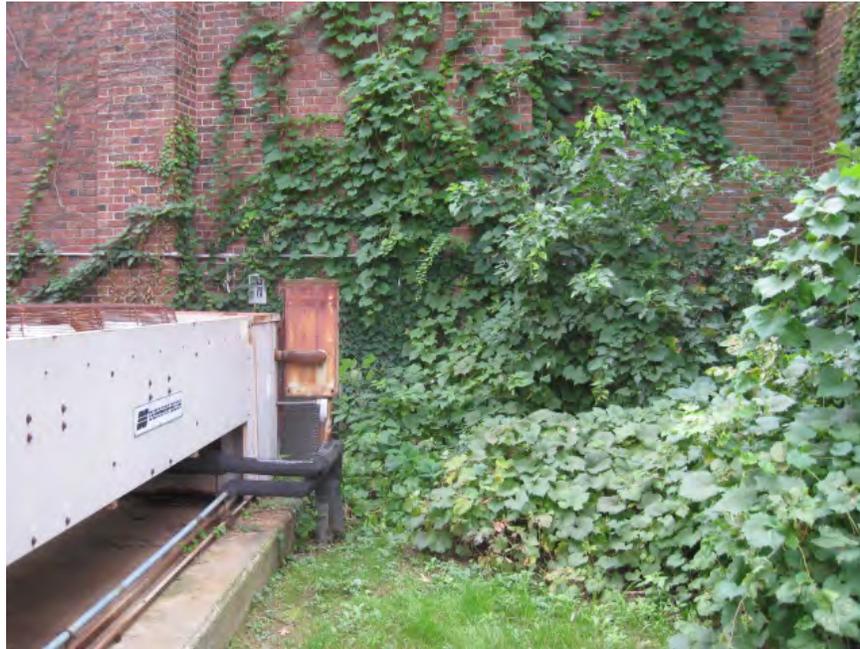
Picture 15

Shrubbery and grassy areas are growing in close proximity to foundation walls (Pictures 15, 16). The growth of roots against exterior walls can bring moisture in contact with brick, eventually leading to cracks and/or fissures in the foundation below ground level. Over time, this process can undermine the integrity of the building envelope and provide a means of water

Shrubs/Plants on and abutting Exterior Wall

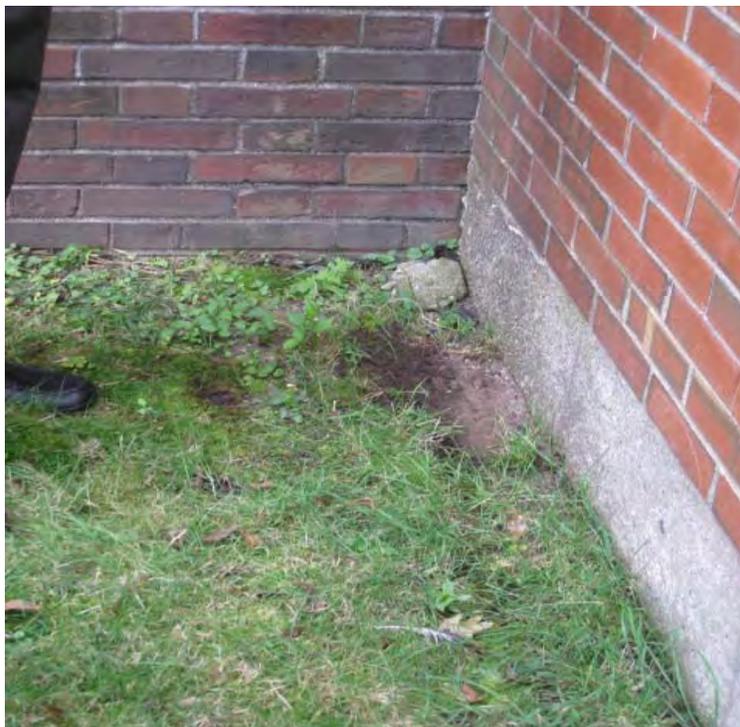
Picture 16

Grass Area at Foundation

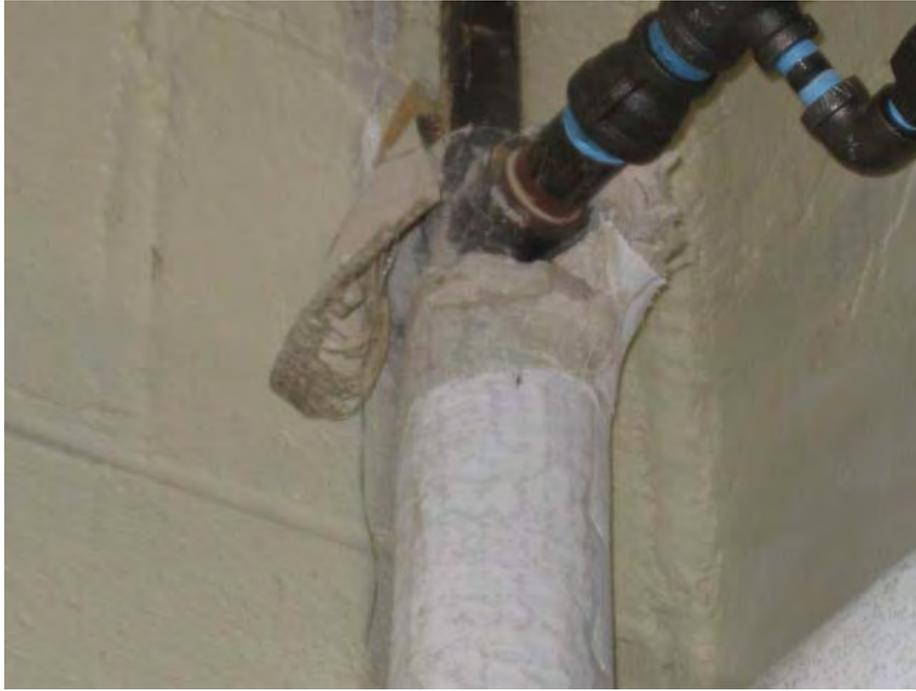
Picture 17

During the course of the assessment, a number of pipes exposing an insulation material (Picture 17) and water-damaged floor tiles were observed in the basement level of the WA. Due to the potential for these materials to contain asbestos, testing to should be done by a licensed contractor. If it is asbestos is present, it should be remediated in conformance with all applicable Massachusetts asbestos abatement and hazardous materials disposal laws.

Exposed Pipe Insulation
