INDOOR AIR QUALITY ASSESSMENT

**Massachusetts State Lottery
11 Cummings Park
Woburn, Massachusetts**

Prepared by:
Massachusetts Department of Public Health
Bureau of Environmental Health
Indoor Air Quality Program
March 2012

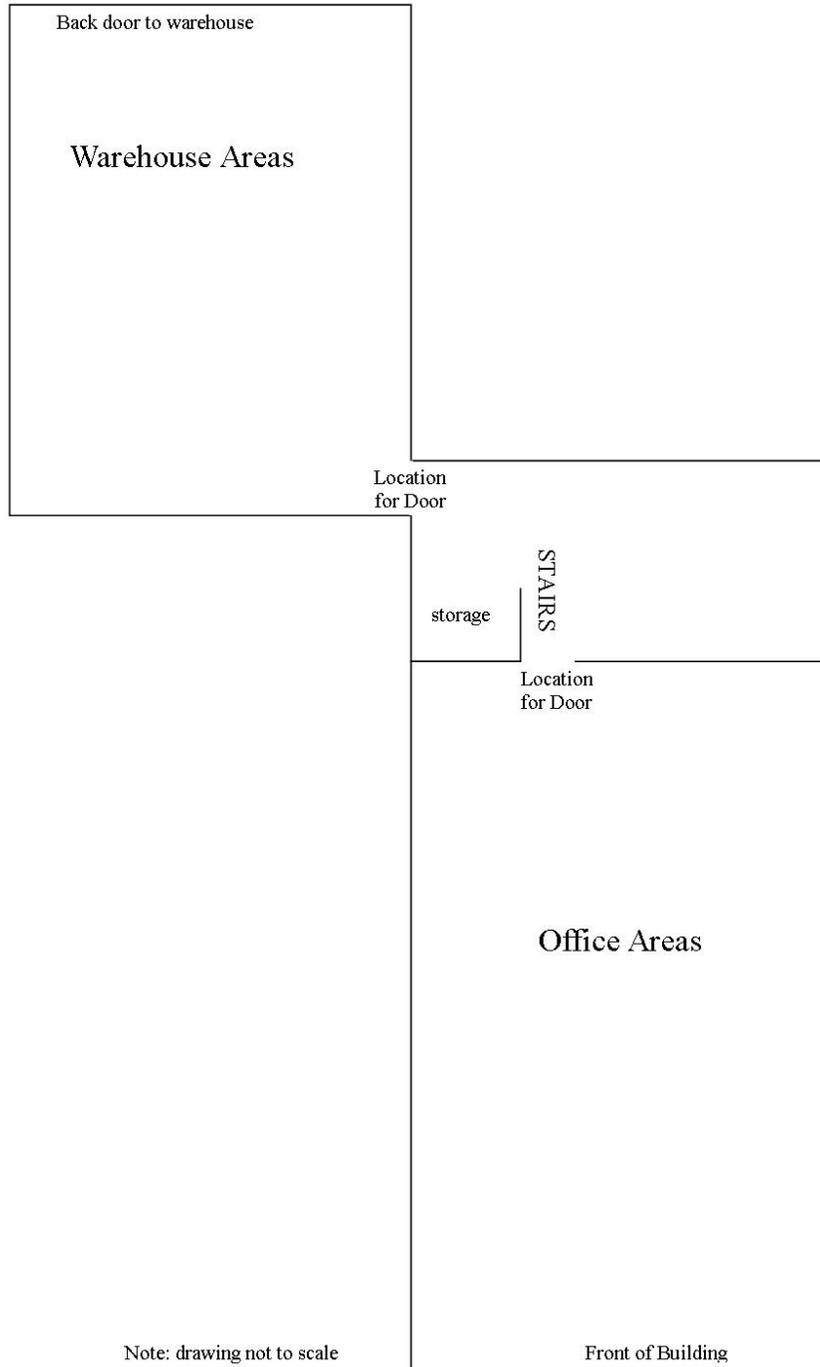
Figure 1:
General Layout of the Woburn State Lottery Office and Warehouse Spaces, showing suggested locations for doors or plastic strip doors

The warehouse did not appear to have any means of mechanical ventilation. The MSL has a garage style door at the rear of the building that is not weathertight, which allows cold air

to infiltrate the warehouse. In addition, no doors exist to separate the warehouse from office space. Under certain wind/weather conditions air from the garage door can pressurize the warehouse, which forces VOCs/odors from printed/plastic materials into offices areas, where the HVAC system may capture and recirculate these pollutants. This likely occurs due to the lack of mechanical exhaust ventilation in the warehouse to remove VOCs/odors from stored materials coupled with the lack of doors separating office areas from the warehouse. Since the operation of the HVAC system in the offices is intermittent due to the thermostat setting, no fresh air to dilute or exhaust ventilation to remove VOCs was occurring during the assessment. VOCs may be irritating to the eyes, nose and respiratory system.

1. Consideration should be given to separating the warehouse and storage areas from the office areas as feasible to prevent VOC/odor infiltration from stored printed and plastic materials. While VOC levels are not suggestive of health impacts, related odors can result in irritant symptoms for some individuals. This may be achieved by installing doors or plastic strip doors in two locations as shown in Figure 1.

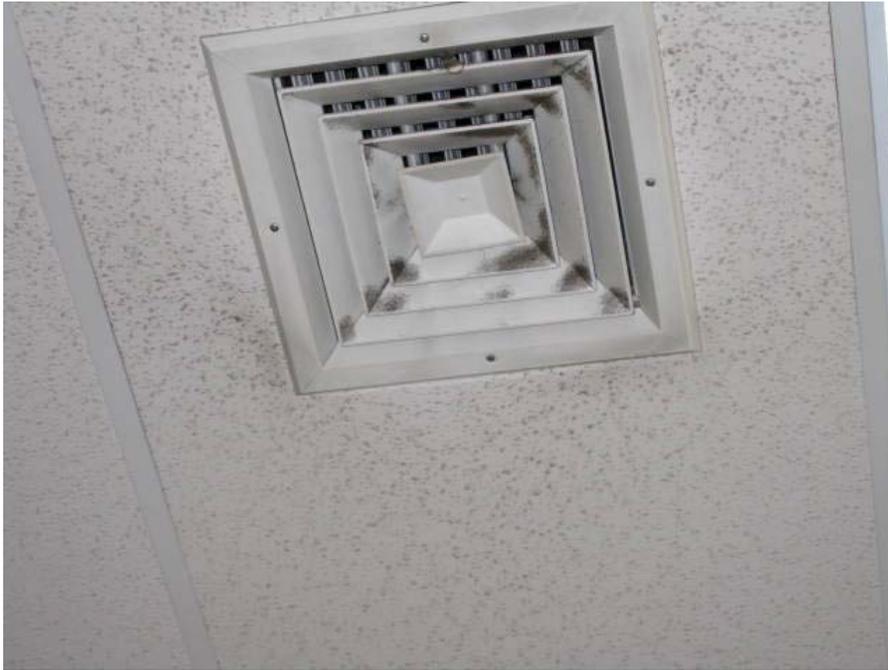
Picture 1

Mechanical ventilation is provided by rooftop air-handling units (AHUs). Fresh air is drawn into the AHUs and delivered to occupied areas via ductwork through supply vents (Picture 1). Return air is drawn into vents connected to the rooftop AHUs by ductwork in the ceiling plenum.

Personal fans and heaters were observed in some areas. Fan blades from these units can accumulate dust/debris. Re-activated fans can aerosolize accumulated dust. Fans should be cleaned regularly to prevent aerosolization of dust. Dust and debris was also noted on some supply and exhaust vents (Table 1, Picture 1); these should be cleaned regularly to prevent the aerosolization of dust/debris.

Supply vent (note dirt on diffuser)

8. Clean air diffusers, return vents and personal fans periodically of accumulated dust/debris.
9. Remove water-damaged ceiling tiles and examine for source of water. Replace all missing and ajar ceiling tiles and monitor for future leaks.

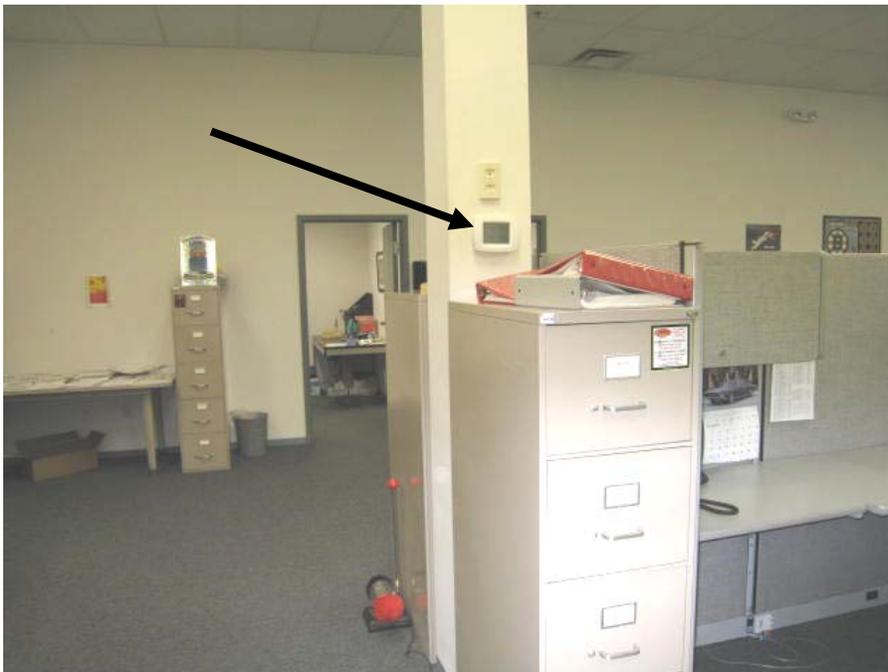
Picture 2

In addition, one of the thermostats was located on an interior pillar above a filing cabinet which obstructs airflow to its temperature sensor (Picture 2). Thermostats should be located in a manner to allow air circulation so that they accurately measure room temperatures and respond accordingly.

Thermostat located on pillar next to filing cabinet

4. Ensure that thermostats are operable and are placed in a location to readily measure room temperature. The areas around and beneath thermostats should be clear of obstructions, and heat-producing office equipment should not be located in close proximity.

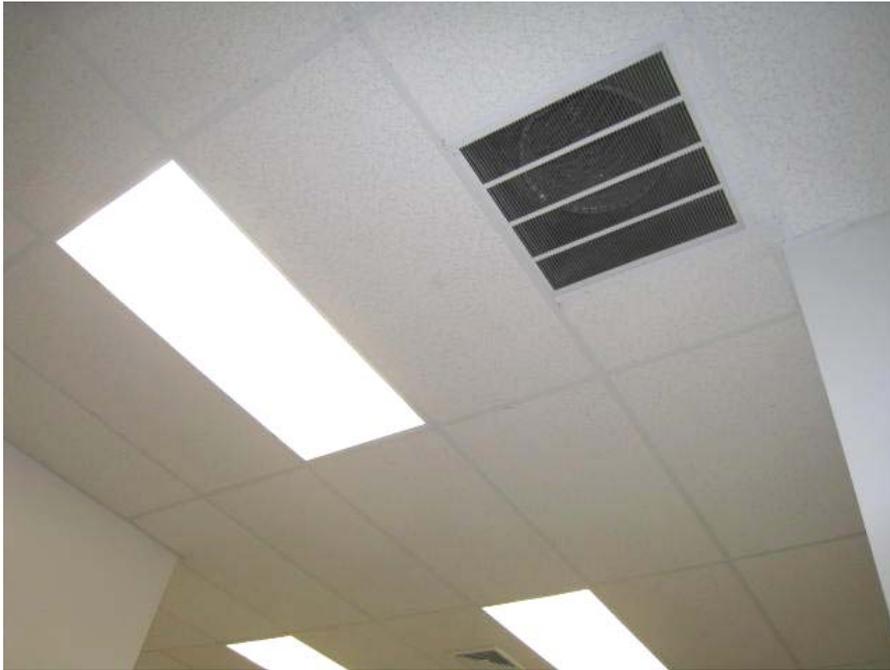
Picture 3

Exhaust ventilation to the space is provided by ceiling-mounted exhaust grates in the main office area (Picture 3). Additional exhaust ventilation is located in restrooms and is activated via light switches. It is recommended that exhaust ventilation in bathrooms be continuous during occupied hours rather than in response to a light switch.

Exhaust vent

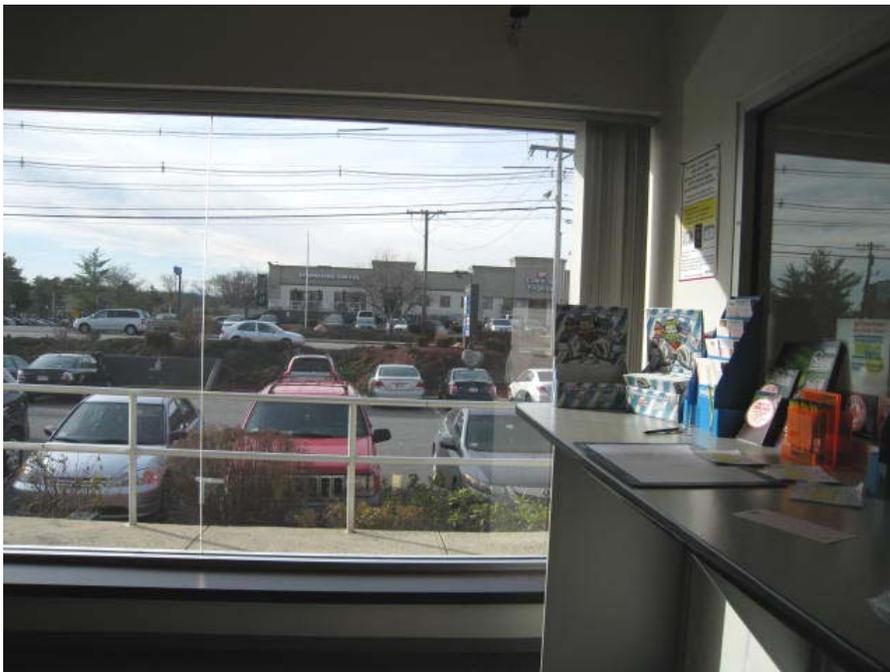
Picture 4

Note that the customer service area at the front of the building has a large single-paned window along the front (Picture 4), which faces approximately west. During the assessment, the temperature of this window was measured with an infrared thermometer at 82 ° F when the sun was shining on it with an outdoor temperature of 66 ° F. This window may be a source of

significant solar heating (e.g., solar gain) which would heat the customer service area independent of the HVAC system during clear weather and, because it is single-paned, may also allow for heat to escape on cold, cloudy days.

Large single-paned window in front area of State Lottery building

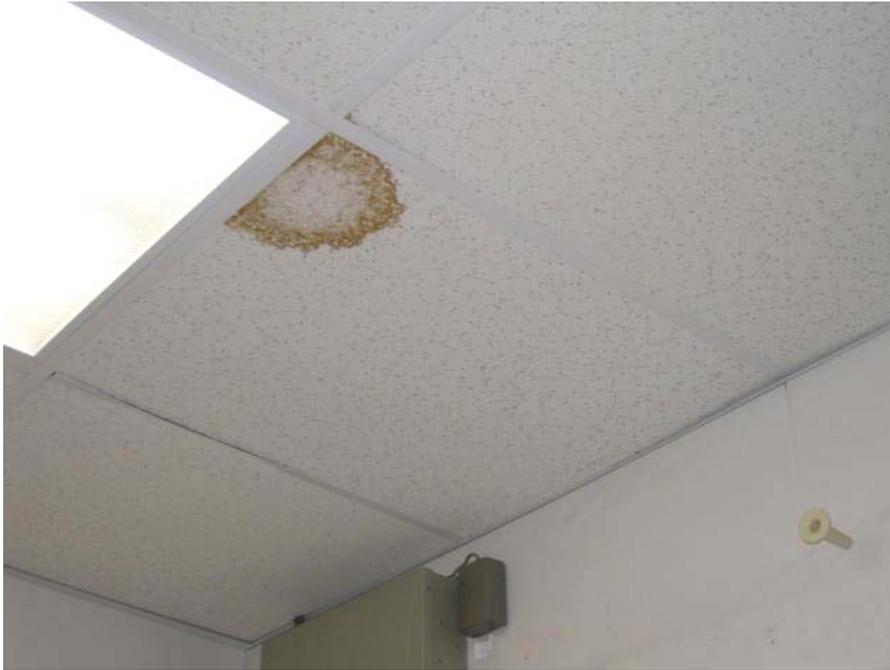
Picture 5

A water-damaged ceiling tile was found in the server room (Picture 5). Water-damaged ceiling tiles indicate leaks from either the roof or plumbing system. If repeatedly moistened, ceiling tiles can be a medium on which mold can grow. Water-damaged tiles should be replaced after a water leak is discovered and repaired.

Water-damaged ceiling tile in server room

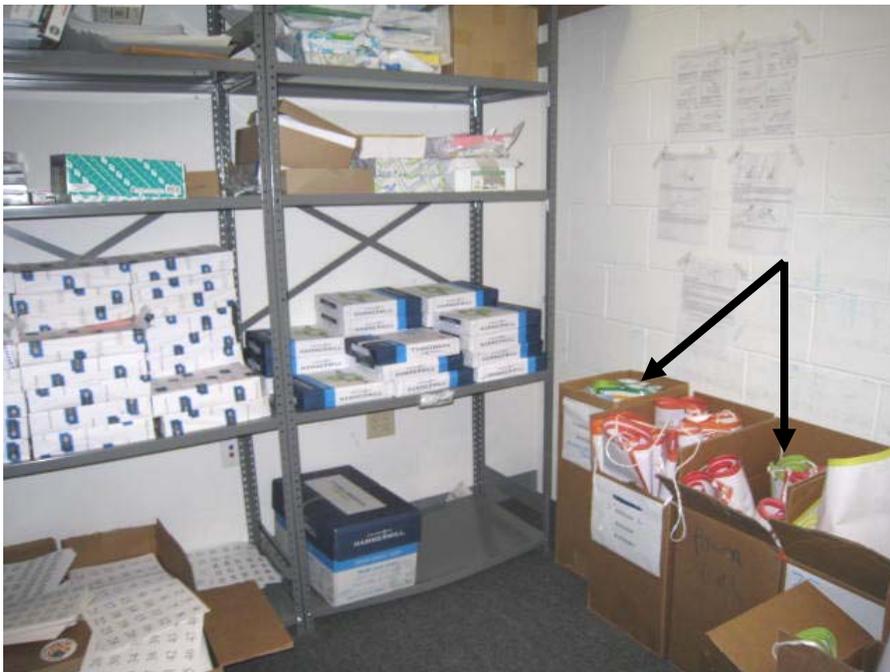
Picture 6

In an effort to determine whether VOCs were present in the building, air monitoring for TVOCs was conducted. Outdoor air samples were taken for comparison. Outdoor TVOC concentrations the day of the assessment were ND (Table 1). As shown in Table 1, slight TVOC readings of 0.4 ppm were found in various areas tested in the office space and readings above 1 ppm were found in several locations in the warehouse area. Not unexpected, the highest readings were found in the storage room containing stored materials (Picture 6), which also had a detectable “plastic” odor emanating from plastic-coated/vinyl banners. Other printed materials found in the warehouse may also emit TVOCs.

Storage room for papers and new banners (arrows showing banners in boxes)

2. Consideration should be give to installing adequate exhaust ventilation in the warehouse to remove odors and VOCs directly.
3. To maximize air exchange, set thermostats to the fan “on” position to operate the ventilation system continuously during business hours.

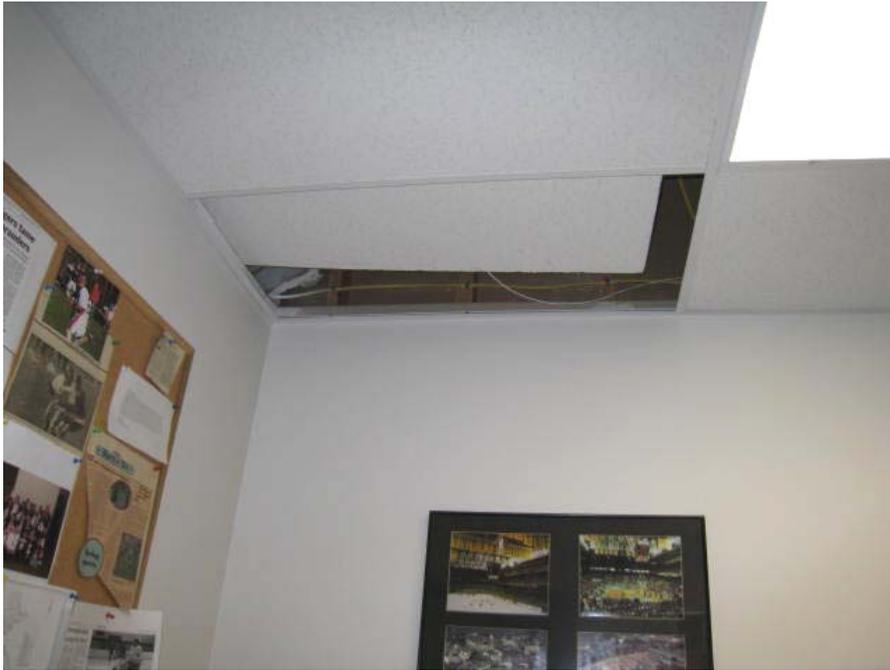
Picture 7

An ajar ceiling tile was observed in one area of the building (Table 1, Picture 7). Ceiling tiles should be flush with the tile system to prevent movement of materials from the plenum into occupied space. Accumulated dust, dirt and particulates may be disturbed and serve as a source of eye and respiratory irritation.

Ajar ceiling tile
