INDOOR AIR QUALITY ASSESSMENT

**Department of Transitional Assistance
9 Walnut Street
Worcester, Massachusetts**

Prepared by:
Massachusetts Department of Public Health
Bureau of Environmental Health
Indoor Air Quality Program
June 2012

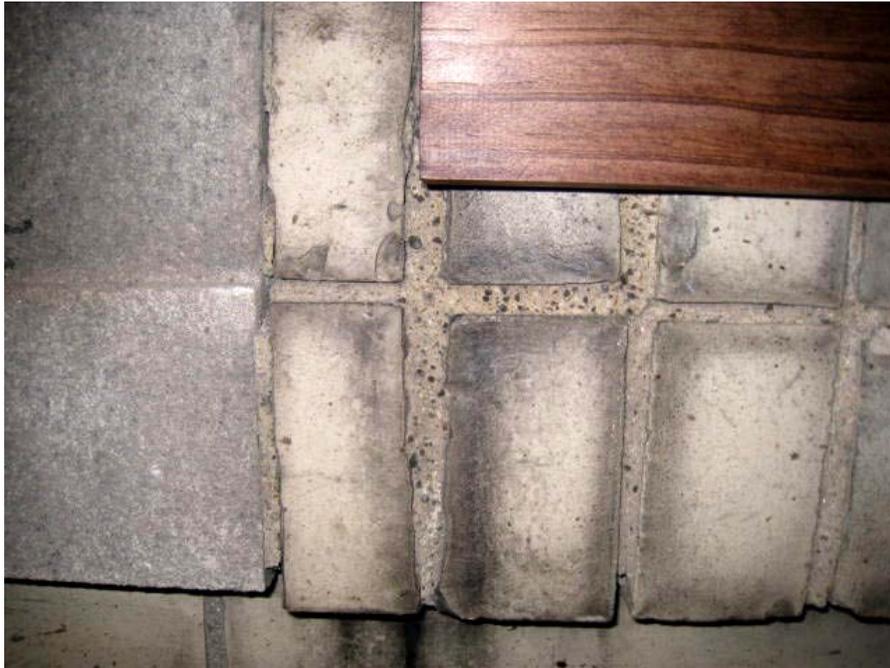
Picture 1

The concern was dark discoloration of bricks in the corner and below the windowsill (Pictures 1 and 2), which was thought to be mold growth. The window was located behind water-damaged gypsum wallboard (GW) noted in previous BEH IAQ assessments of the DTA offices (MDPH, 2006; MDPH, 2011). The GW had been removed following the 2011 assessment, exposing the window. The window had been bricked-in during a previous renovation.

- In an effort to ascertain the nature of the staining, BEH staff used a knife blade to scrape the surface of the brick. No particles could be produced using this method, indicating that the stain is within the brick material and not on its surface.

- BEH staff also attempted to remove materials from the stained brick using alcohol wipes. No residue could be removed from the brick, further supporting the theory that the stain is ingrained within the matrix of the brick.

Based on these observations, it does not appear that the stain on the brick is mold. Therefore there is no opportunity for mold/particulate to become aerosolized. It is likely that the

stain occurred when the window was exposed to the outdoor elements prior to the construction of the building bridge. In view of these findings at the time of the visit, the following conclusions and recommendations are provided:

Discolored Brick

1. Continue monitoring the bridge roof for sign of water penetration.
2. Refer to resource manual and other related indoor air quality documents located on the MDPH's website for further building-wide evaluations and advice on maintaining public buildings. These documents are available at: <http://mass.gov/dph/iaq>.

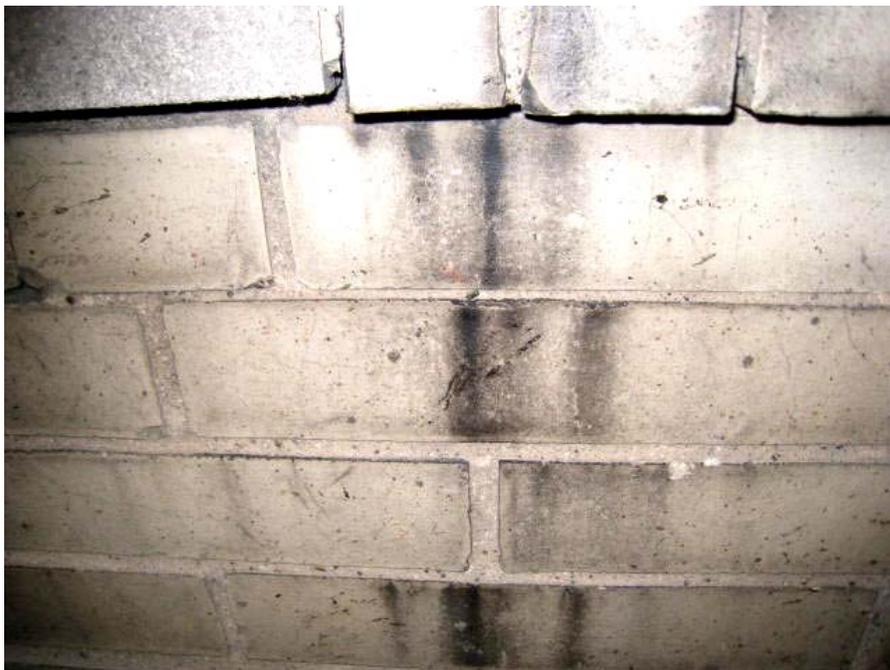
Picture 2

Discolored Brick

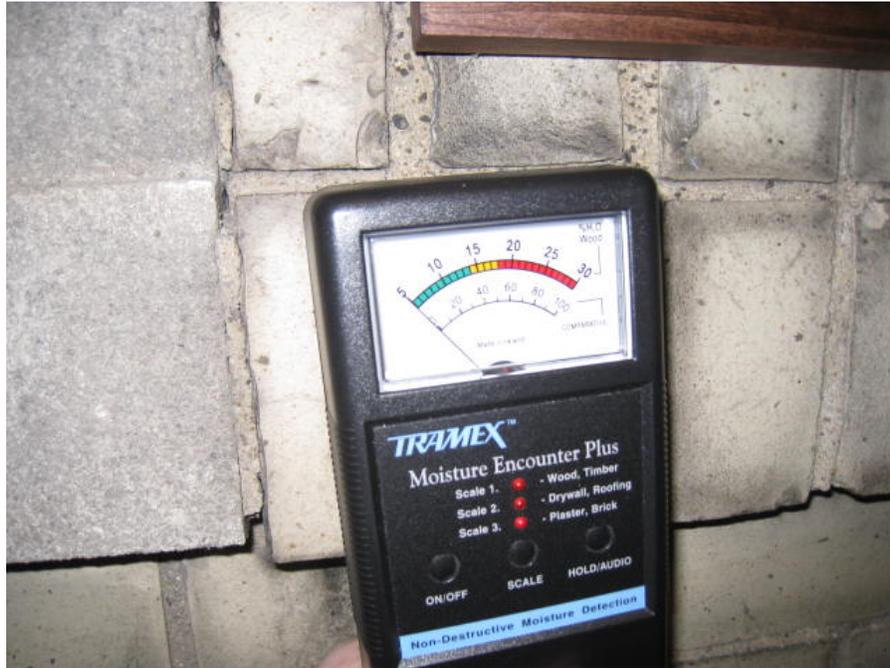
Picture 3

- BEH staff conducted moisture sampling on and around the stained brick using a non-invasive moisture meter (Picture 3). All materials evaluated had no measurable moisture content (i.e., they were dry).

Moisture Measurement of Brick, Showing Non-Detectable Moisture Reading
