INDOOR AIR QUALITY ASSESSMENT MOLD INVESTIGATION

**Department Of Children and Family
810 Memorial Drive
Cambridge, Massachusetts**

Prepared by:
Massachusetts Department of Public Health
Bureau of Environmental Health
Indoor Air Quality Program
March 2013

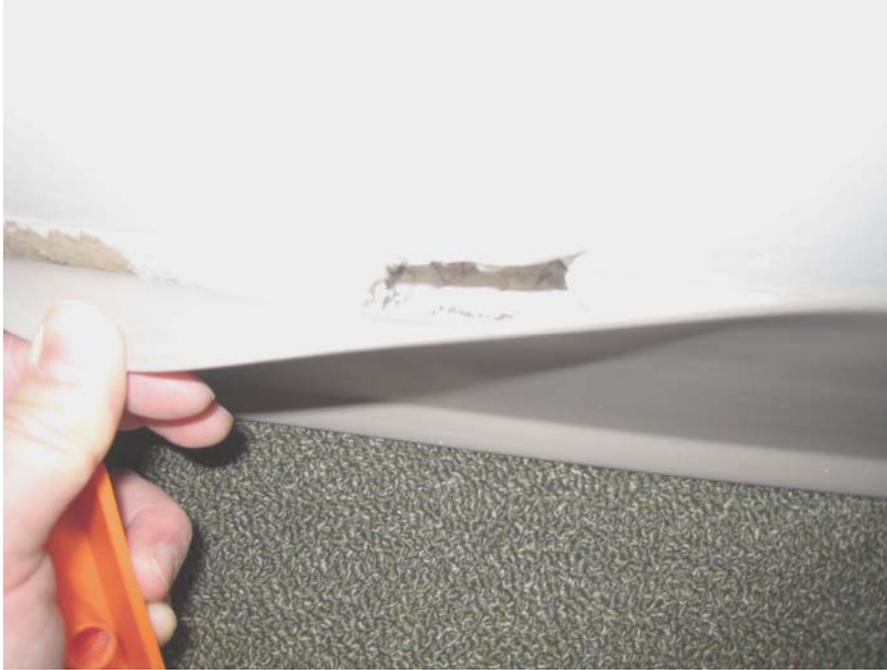
Picture 1

The areas impacted by water damage included some offices and cubicle area for legal staff. As reported by DCF staff, industrial fans and dehumidifiers were used to dry the area; holes were cut into gypsum wallboard (GW) walls to facilitate drying (Picture 1). Following drying activities, carpet tiles were reportedly replaced, walls were repainted, and coving was reinstalled (Picture 2). At the time of the MDPH assessment, restoration efforts in the DCF space had been completed. BEH staff conducted moisture testing of GW in renovated areas and found no measureable levels of moisture. Some water-damaged items were observed (Picture 3); these items should be replaced if materials were not dried completely.

Hole cut in wall to facilitate drying, currently masked by coving

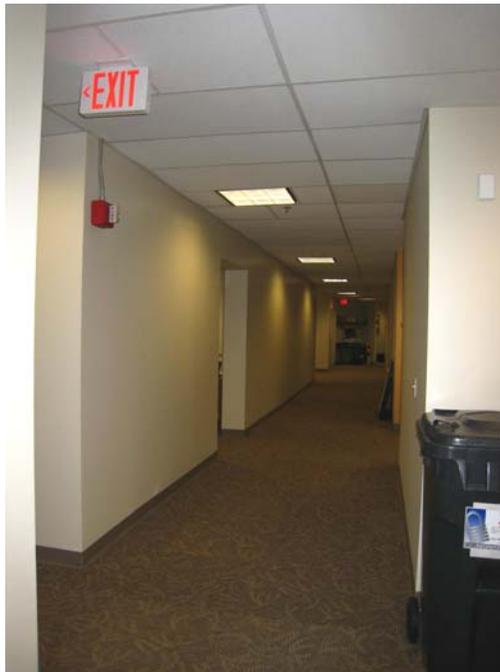
Picture 2

Refinished water-damaged space

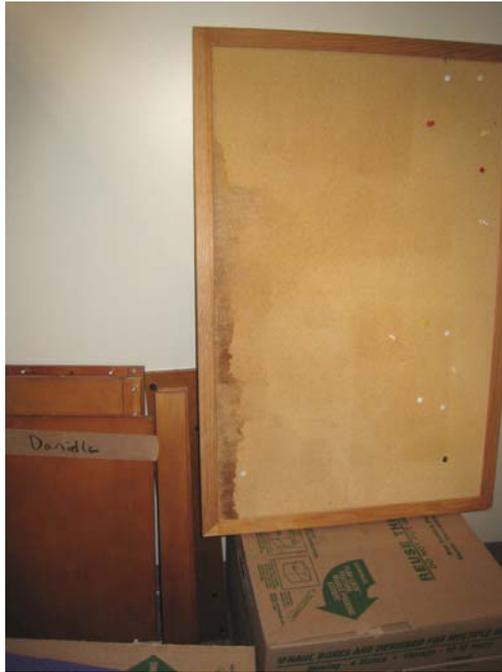
Picture 3

Water-damaged cork board

1. Replace any remaining water-damaged office furnishings if items were not dried within an appropriate time frame (i.e. 24 to 48 hours).
2. Replace water-damaged wallboard in Unit 3/111 area. Perform construction activities during the weekend, when the building is unoccupied. Care should be taken to ensure the area is thoroughly cleaned after wallboard is replaced to prevent exposure of staff to construction dust.

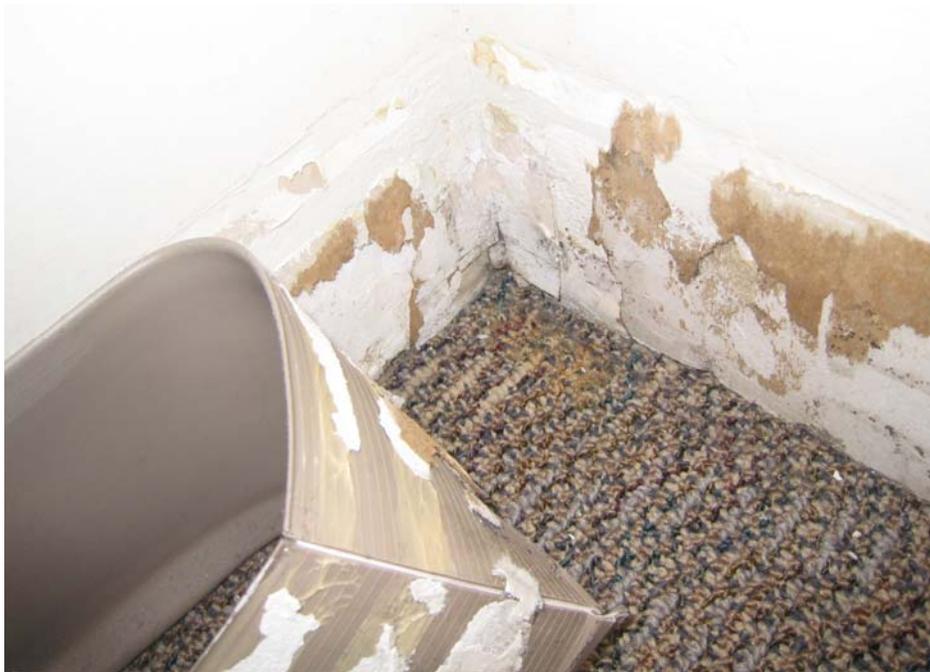
Picture 4

At the request of Richard Powers, Area Director, the BEH/IAQ staff also examined Unit 3/111 space, an area that is not currently occupied. As reported by Mr. Powers, an air handling unit (AHU) in this space leaked during the summer of 2012. Building maintenance reportedly took steps to remove water and dry the area. BEH staff examined the area for water damage. While no materials were found to be wet, black spots indicative of mold growth were observed behind vinyl wall coving (Picture 4).

Black spots indicative of mold growth

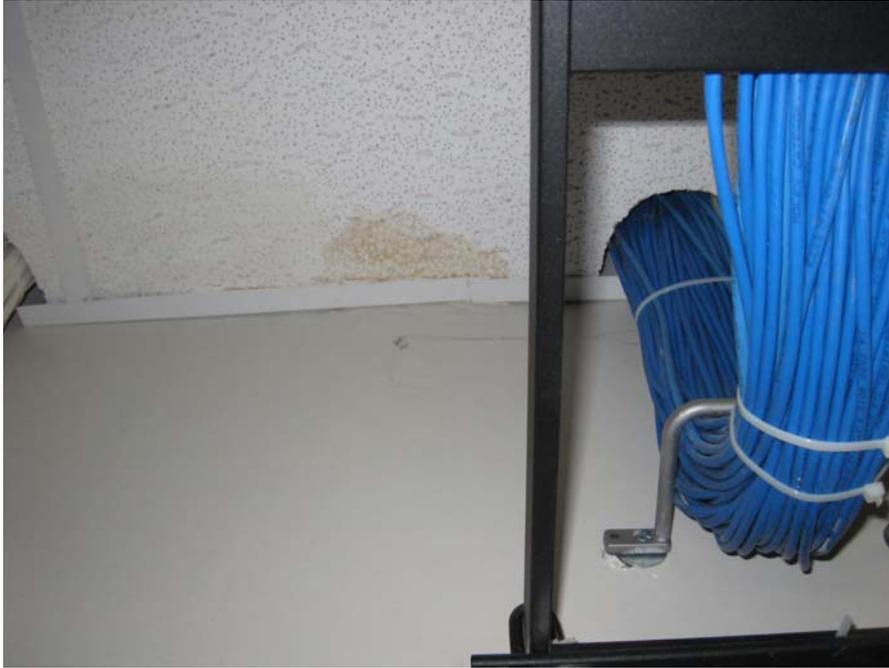
Picture 5

Water-damaged ceiling tiles were observed in a few areas (Picture 5). These can be an indication of pipe leaks or water penetration through the building exterior. If wet for a prolonged period of time, water-damaged ceiling tiles can be a source of mold growth. Tiles should be replaced after a leak source is discovered and repaired.

Water-stained ceiling tile

3. Replace water-damaged ceiling tiles.
4. Remove dust/debris from exhaust vents.
5. Repair loose floor tiles in the women's restroom.
6. Refer to resource manuals and other related indoor air quality documents for additional building-wide evaluations and advice on maintaining public buildings. These materials are located on the MDPH's website: <http://mass.gov/dph/iaq>.

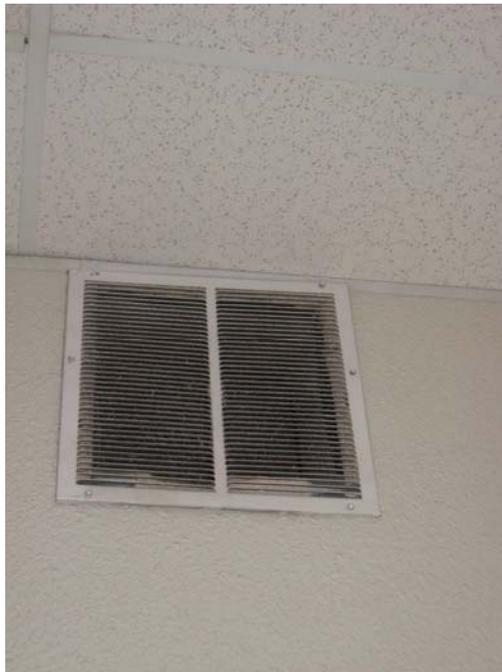
Picture 6

Staff reported odors in the women's restroom, which is accessed through the waiting area. BEH/IAQ staff noted a single exhaust vent serving this sizable bathroom. This vent was observed to be occluded with dust (Picture 6), which can hinder removal of odors and moisture. Additionally, loose and missing floor tiles were observed, (Picture 7), which can expose the subfloor to moisture and also present a tripping hazard.

Dusty exhaust vent in women's bathroom

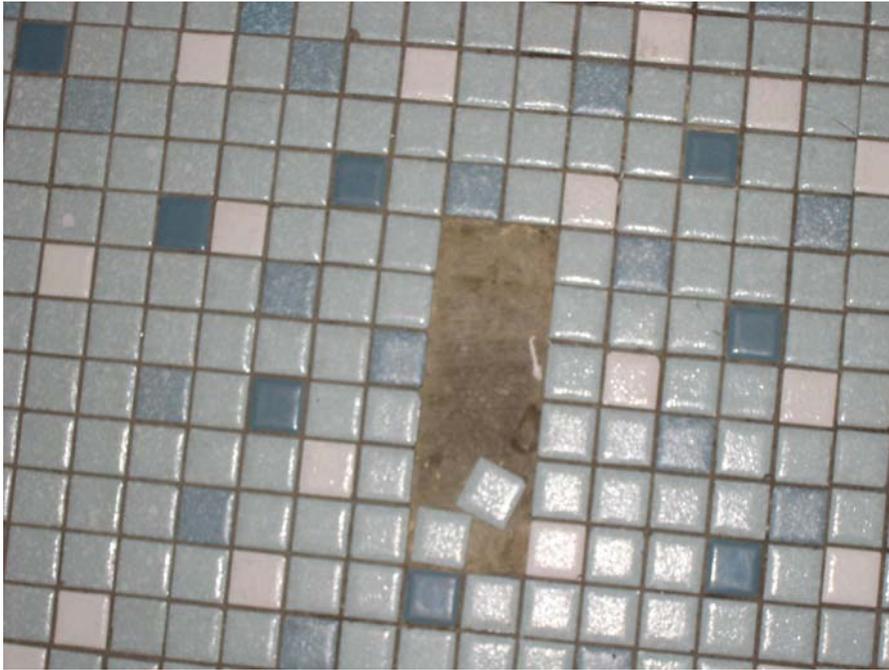
Picture 7

Loose floor tiles
