# **WATER DAMAGE/MOLD INVESTIGATION**

**Massachusetts Department of Mental Health  
25 Staniford St  
Boston, Massachusetts**

Prepared by:  
Massachusetts Department of Public Health  
Bureau of Environmental Health  
Indoor Air Quality Program  
July 2014

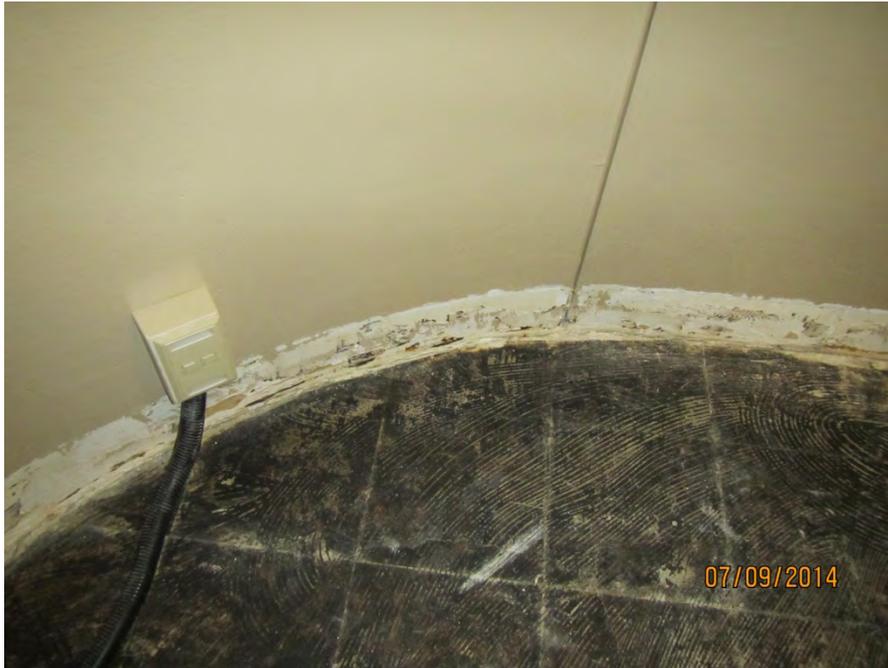
**Picture 1**

reportedly called immediately after MDMH staff had discovered the water damage within 24 hours of the leak. Carpeting had been removed (Picture 1) from three offices directly impacted (rooms 3088, 3089 and 3090). The plaster ceilings had also been removed. The full lath-and-plaster wall between rooms 3090 and 3089 had been removed and other walls in all three rooms had been removed up to approximately 2.5 feet high to ensure all water-impacted materials were removed in affected areas (Pictures 2 and 3). Carpeting was also removed along the adjacent wall in the hallway (Picture 4). The drain lines had been repaired (Picture 5), and contractors had reportedly disinfected the flooring once the carpet had been removed.

**Water-damaged carpeting removed from office**

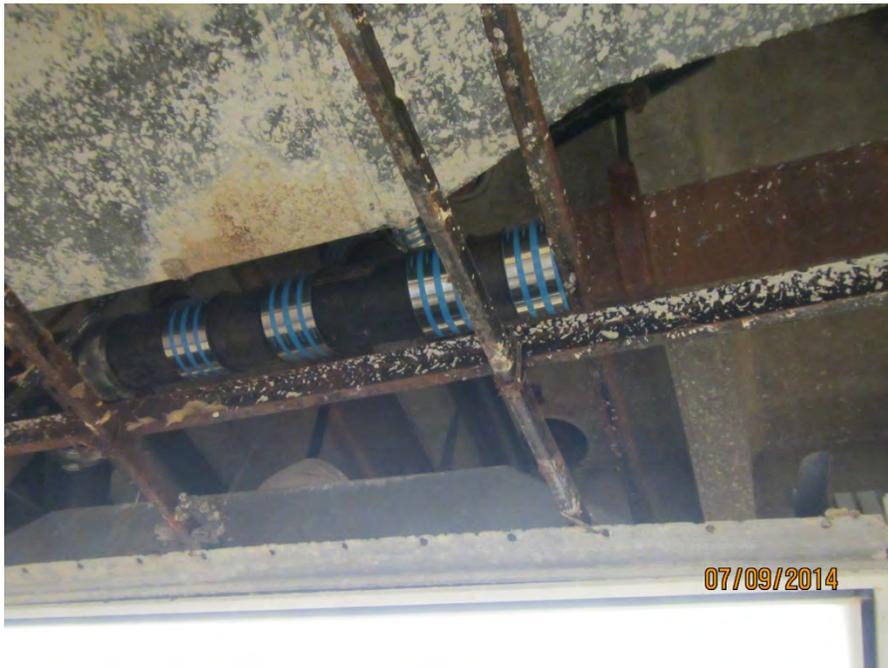
**Picture 2**

**Plaster ceilings removed to make plumbing repairs**

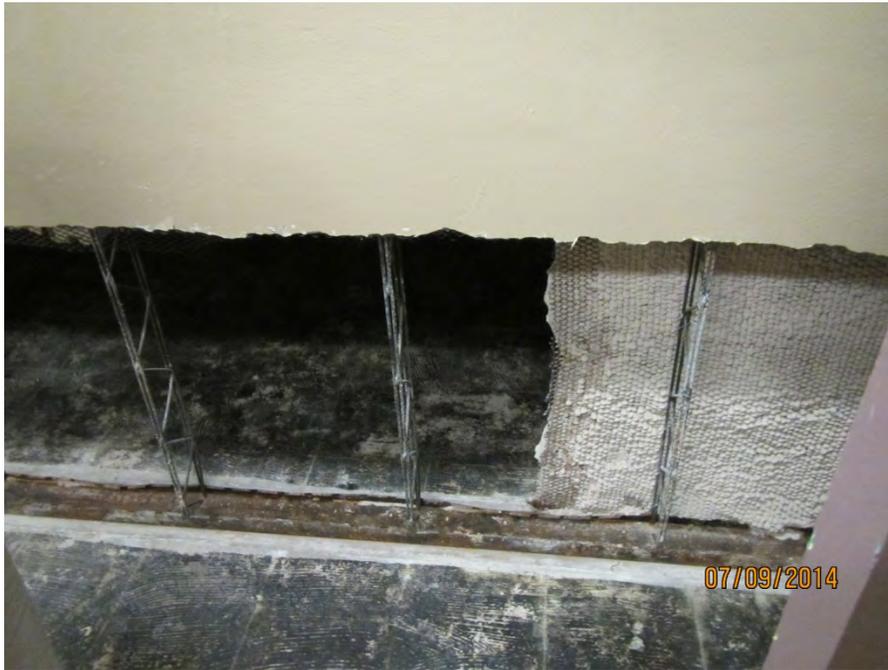
**Picture 3**

**Bottom 2.5 feet of plaster walls removed in affected areas**

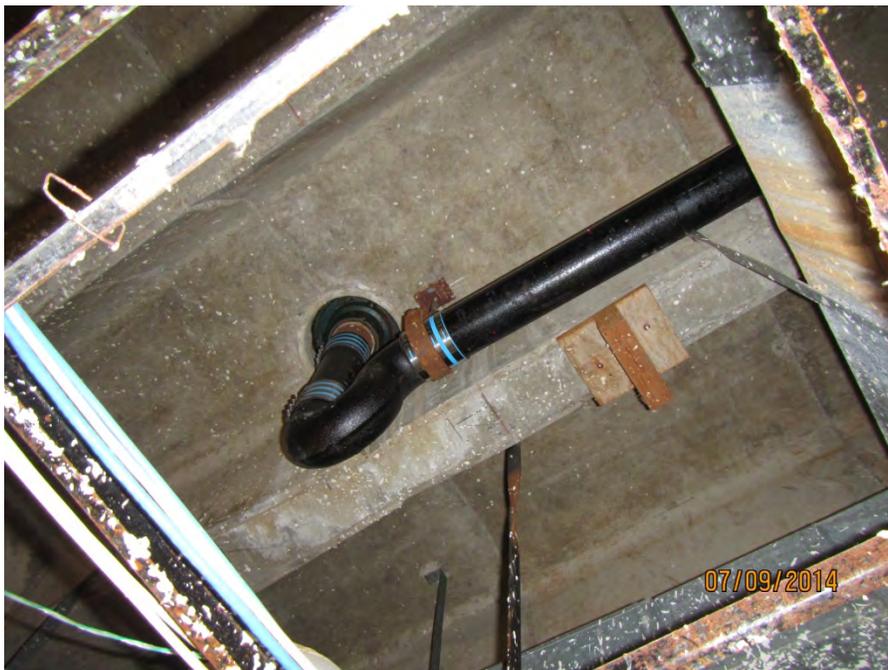
**Picture 4**

It was reported to BEH/IAQ staff that a sewer drain line in a fourth floor bathroom had become clogged. When the water had backed up the pipe, it caused the failure of a corroded fitting which discharged water above several offices on the third floor. Contractors were

**Plumbing repairs to sewer drain line**

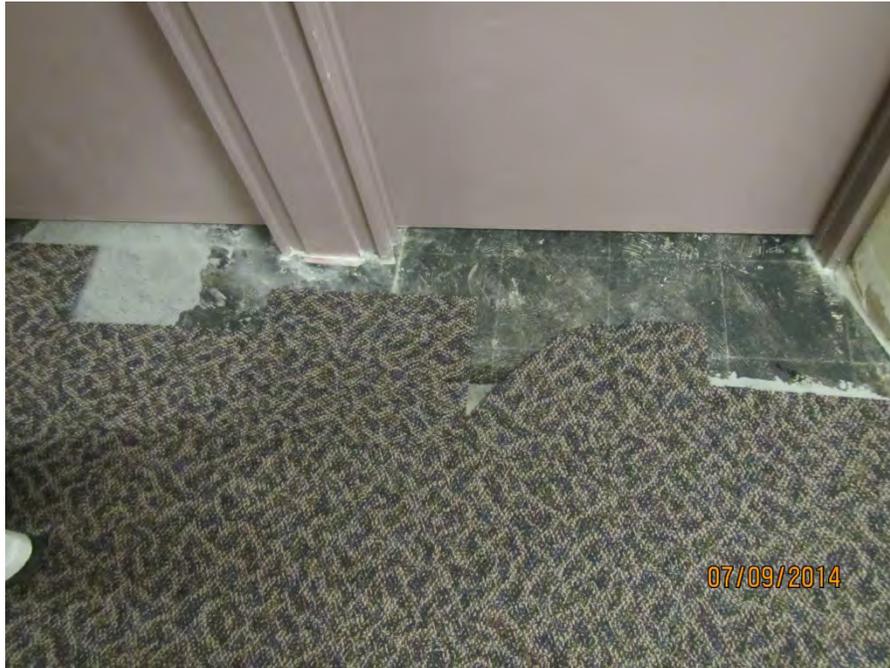
**Picture 5**

**Water-damaged carpeting removed and partially replaced in the third floor hallway**

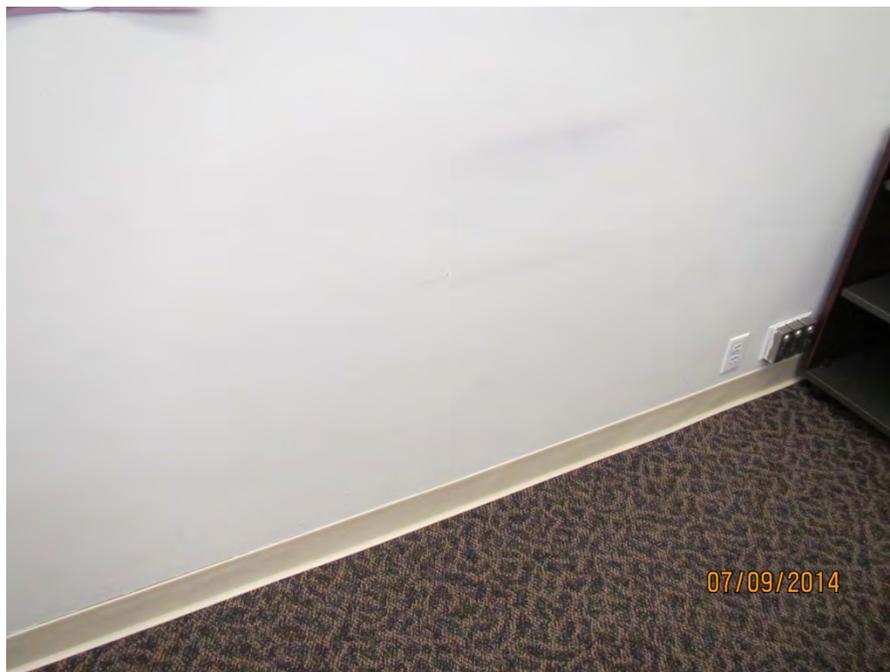
**Picture 6**

**Lower 2.5 feet of water-damaged plaster wall removed and newly replaced; carpeting and coving also new**

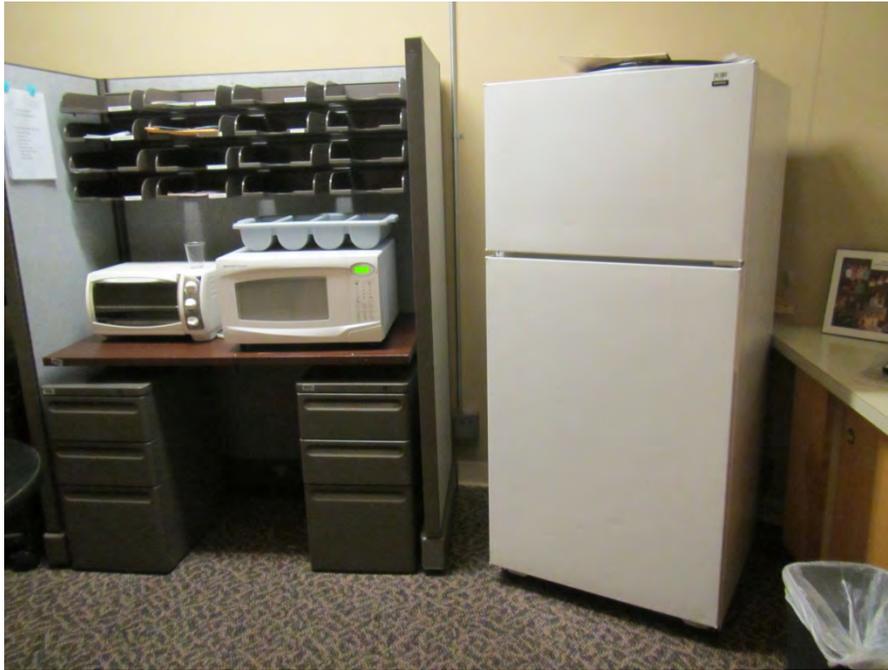
**Picture 9**

Several refrigerators, water coolers, and water bottles were observed to be placed on top of carpeted areas (Picture 8). These moisten carpeting and lead to mold growth. Moving the appliances to tiled areas or placing rubber mats underneath them will protect the carpet.

**Refrigerator on carpeted surface**
