# **ODOR INVESTIGATION**

**Chicopee City Hall  
17 Springfield St  
Chicopee, Massachusetts**

Prepared by:  
Massachusetts Department of Public Health  
Bureau of Environmental Health  
Indoor Air Quality Program  
January 2014

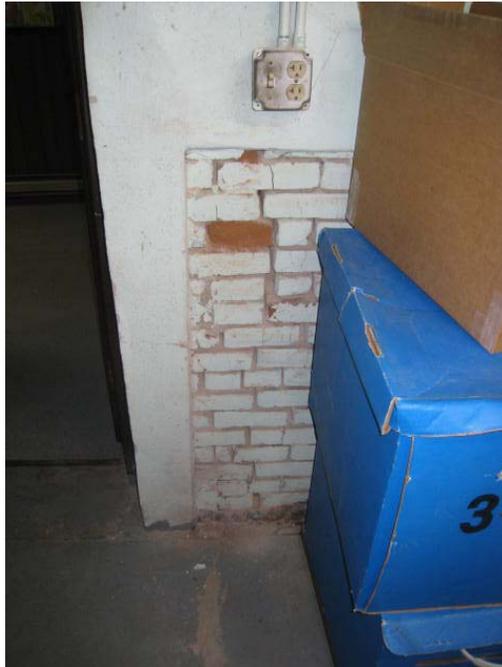
**Picture 1**

drainpipes installed when CCH was constructed in 1871. As reported by CCH staff, the basement has flooded after major rain events through the access panel and around door jambs (Picture 1), which indicates that breaches have likely existed in the drainpipes beneath CCH for an undetermined time. It is likely that fuel vapors entered the basement through various breaches in the floor, particularly around doors, the hatchway and outer wall of the vault.

**Base of wall showing signs of water damage**

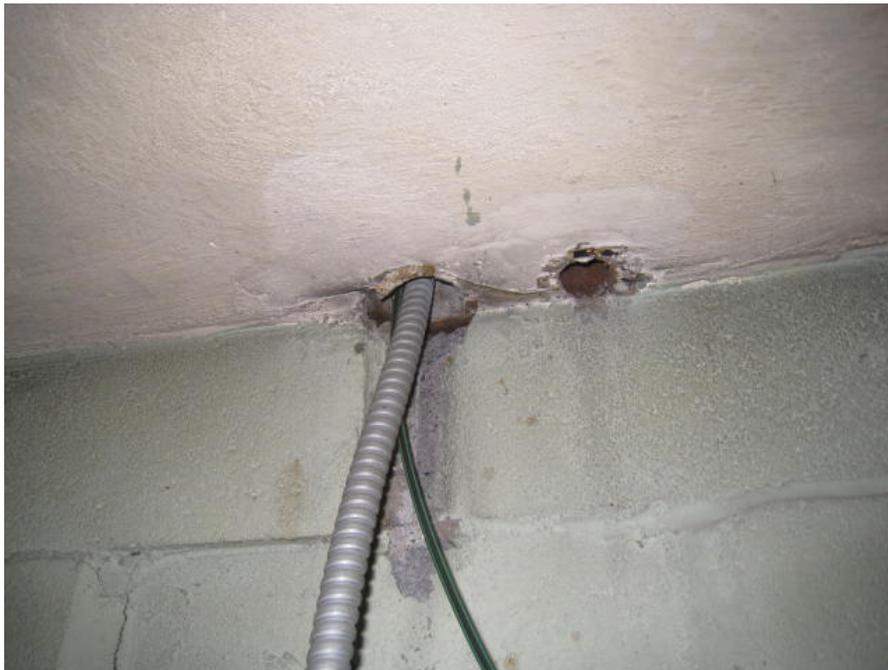
**Picture 2**

Based on the initial assessment, it appeared that the odors were migrating into occupied areas of the first floor through numerous holes in the basement ceiling (Picture 2). In addition, holes drilled through the vault wall (Picture 3) also served as pathways for odor infiltration.

**Openings in vault ceiling**

1. Seal all holes penetrating from the vault into occupied spaces.
2. Seal all open seams in the floor between the vault walls and the basement floor. Remove water-damaged wainscoting.
3. Repair the leaking pipes in the crawlspace.
4. For further building-wide evaluations and advice on maintaining public buildings, see the resource manual and other related indoor air quality documents located on the MDPH's website at [www.mass.gov/dph/iaq](http://www.mass.gov/dph/iaq).

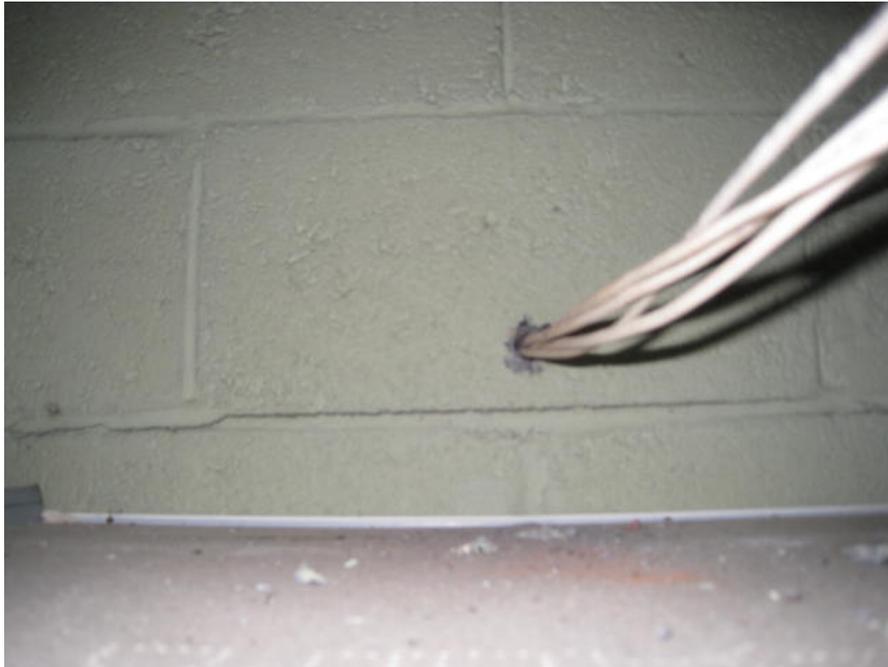
**Picture 3**

**Hole drilled in vault wall, TVOCs measured 15 ppm**

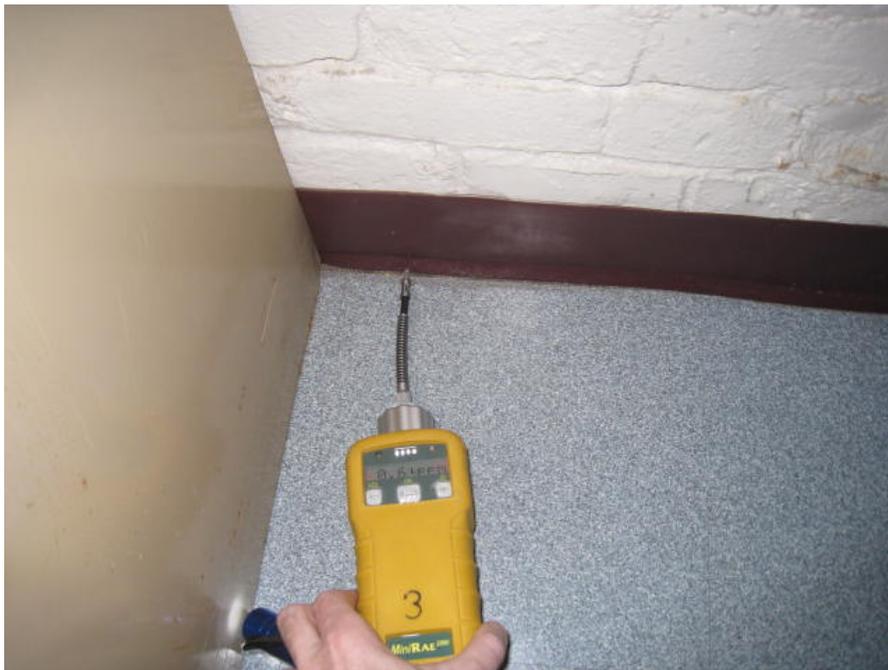
**Picture 4**

TVOC sampling was conducted on the first floor. All TVOC levels in the breathing zone and around breaches on the floor were non-detectable. BEH/IAQ staff took measurements in the basement where the odor was noticeable. BEH staff traced the odor to areas along the seam between the vault's exterior wall and the basement floor as well as around doorframes in the basement. BEH staff measured TVOCs in a range of 2 to 16 ppm at various locations at the base of doors frames and wainscoting along the exterior walls of the vault (Pictures 4 and 5). This indicated that open seams allowed for fuel oil vapors to enter the basement space.

**TVOC testing beneath floor coving**

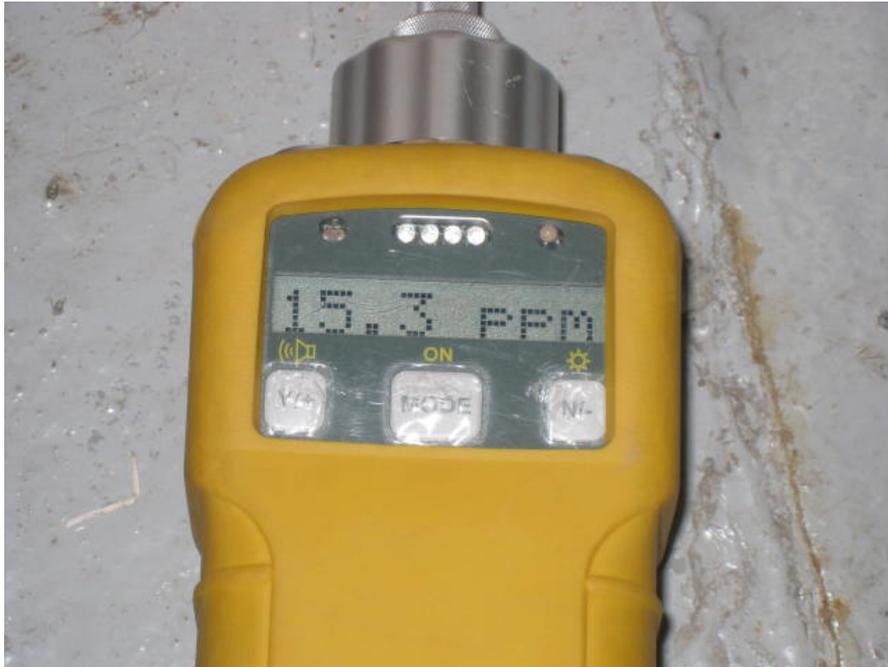
**Picture 5**

**Example of TVOC measurement at floor level**

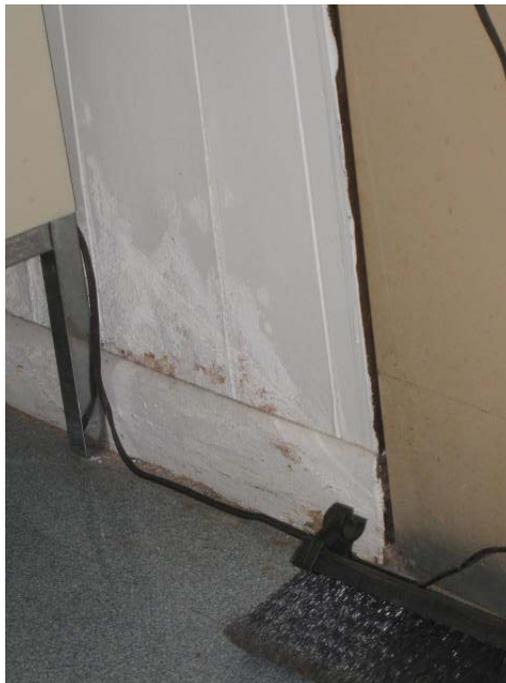
**Picture 6**

Water-damaged wainscoting (Picture 6) was tested at floor level and found to be saturated. Moisture test results indicate that moisture from the crawlspace appears to be moistening the wainscoting; these results also suggest that this may be a pathway for fuel oil vapors to enter the basement from the crawlspace.

**Water-damaged wainscoting along exterior basement vault wall at floor level**
