INDOOR AIR QUALITY ASSESSMENT ODOR INVESTIGATION

**Hanson Town Hall
542 Liberty Street
Hanson, Massachusetts**

Prepared by:
Massachusetts Department of Public Health
Bureau of Environmental Health
Indoor Air Quality Program
November 2014

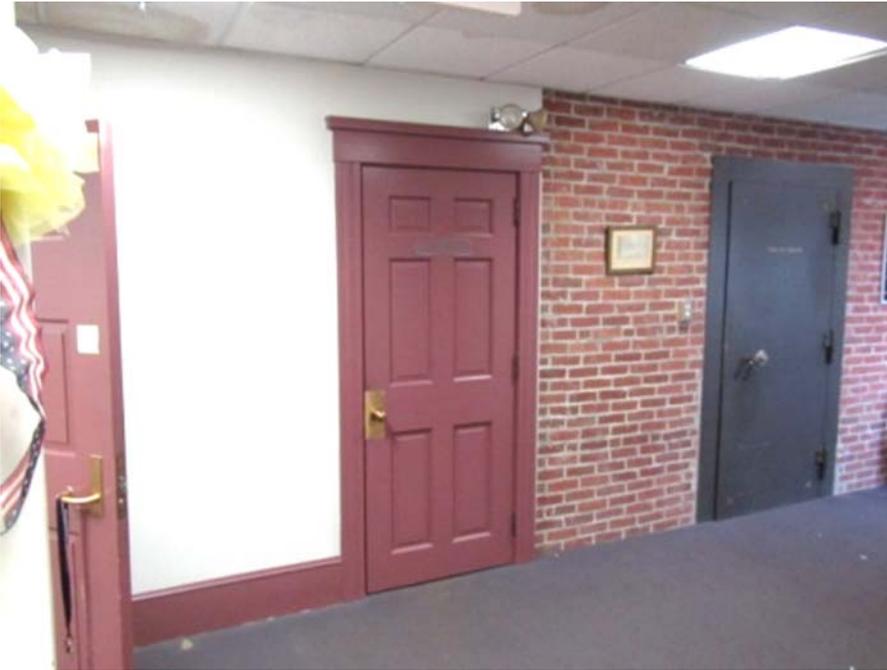
Picture 1

It was reported that odors, described as earth/decaying debris, have been on-going over the past several weeks. On the day of the assessment, slight odors were detected in the west end portions of the building (Table 1). It is important to note that the door to the basement is located in the west end hallway (Picture 1). Odors grew increasingly stronger upon entering the basement. BEH/IAQ staff noted substantial drafts around open utility holes in the common wall to the crawlspace (Pictures 2 through 4). BEH/IAQ staff removed the access panel to the crawlspace (Pictures 4 and 5) and immediately detected a strong pungent earth/decaying odor. Mr. San Angelo reported that a pest control company representative had recently entered the confined crawlspace but could not identify the source of the odor.

Access door to the basement in the west end of the building

1. Depressurize the basement/crawlspace relative to the first floor by using exhaust fans in basement windows to draw air away from the stairwell/occupied areas.
2. Temporarily seal basement access door with plastic and duct tape.
3. Seal around open/abandoned utility holes in basement ceiling/walls to prevent unwanted paths of drafts/odor migration.

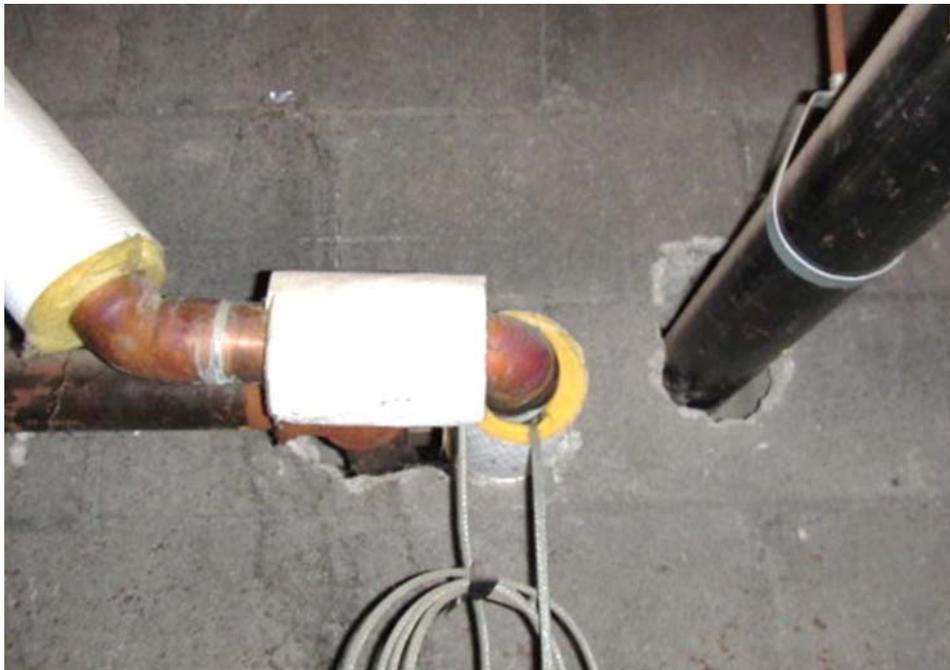
Picture 2

Spaces around utilities in common wall with crawlspace where strong drafts/odors were penetrating

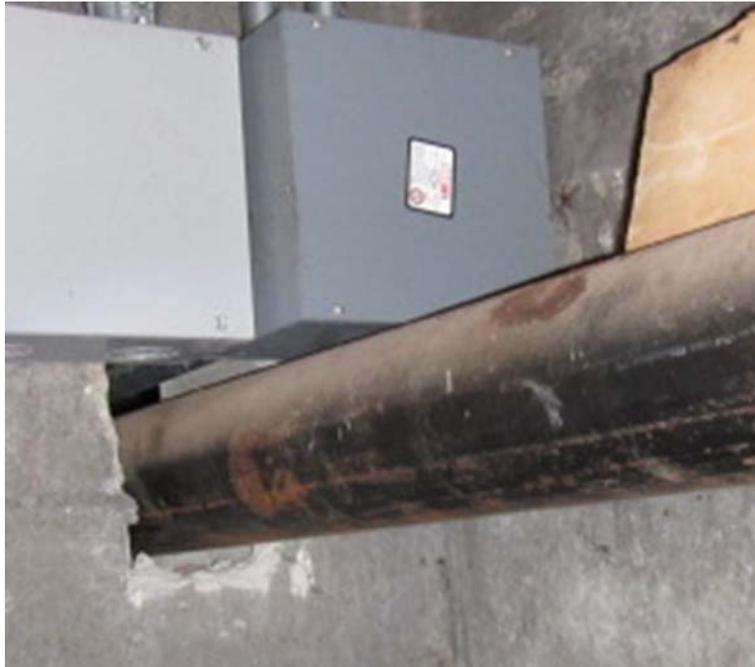
Picture 3

Spaces around utility pipe in common wall with crawlspace where strong drafts/odors were penetrating

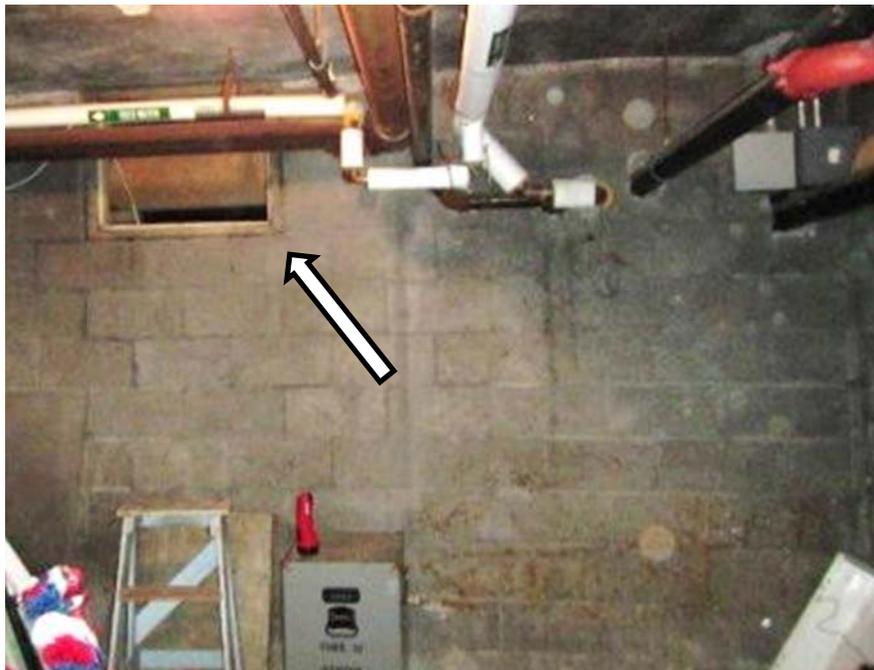
Picture 4

Access hatch (arrow) and spaces around utility pipes in common wall with crawlspace where strong drafts/odors were penetrating

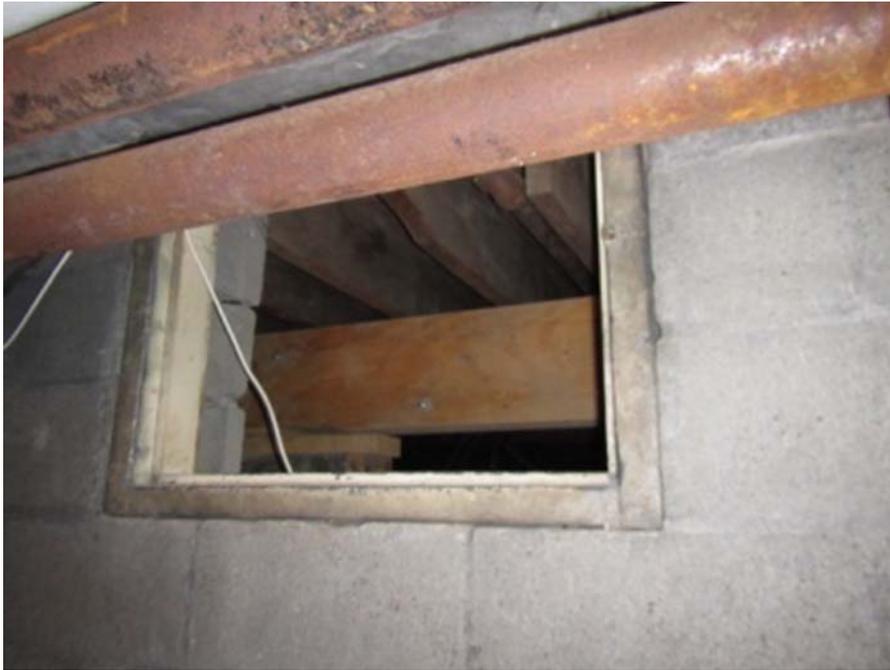
Picture 5

Crawlspace access hatch

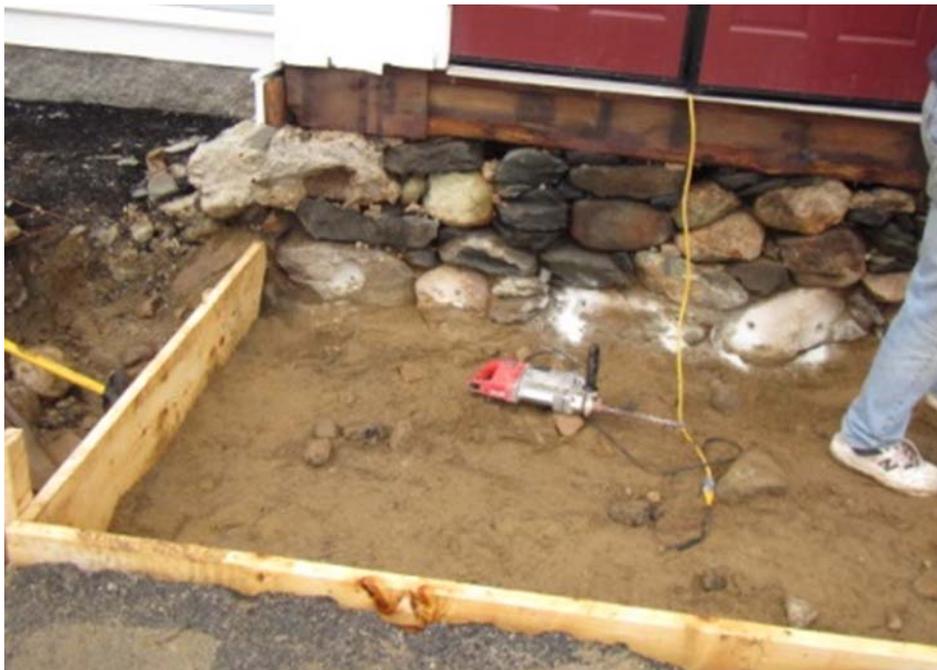
Picture 6

Drafts from the crawlspace were particularly strong the day of the assessment due to masonry work being done along the front/main entrance to the building, which removed the concrete stairs to create large breaches in the cobblestone foundation (Picture 6). The assessment occurred on a day of high winds (Picture 7), which pressurized the crawlspace forcing odors into the basement. The basement became pressurized from both the crawlspace drafts and a wall-mounted heater/blower (Picture 8), which then forced odors up the stairwell, which then passed through spaces in the basement stairwell door (Pictures 9 and 10) and into the western end of the HTH.

Masonry work exposing large breaches in cobblestone foundation

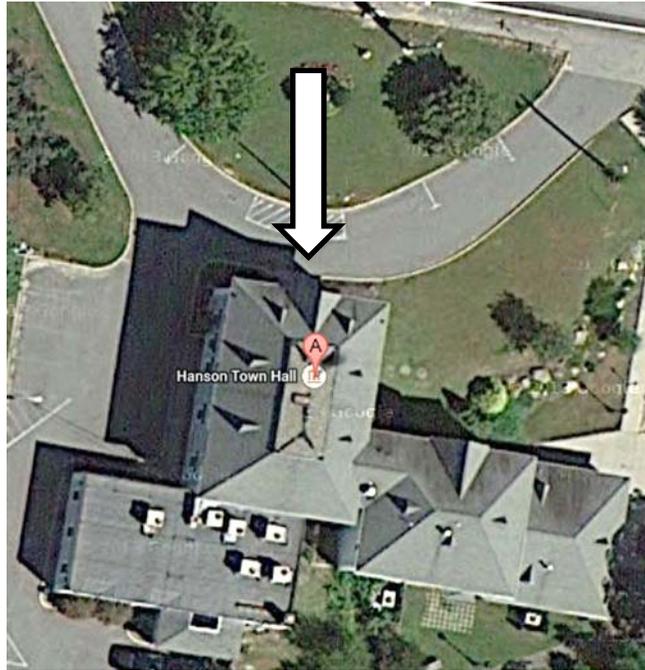
Picture 7

Aerial view of Hanson Town Hall showing wind direction (arrow) and location of exposed cobblestone foundation in preceding picture

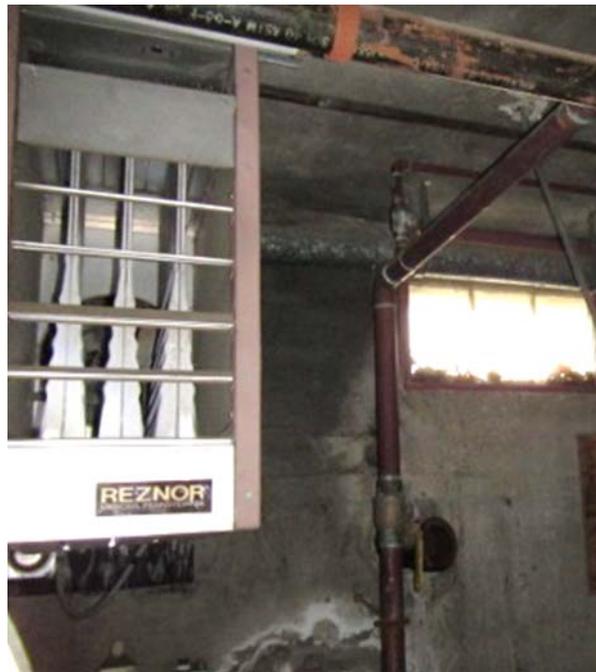
Picture 8

Ceiling-mounted blower in basement

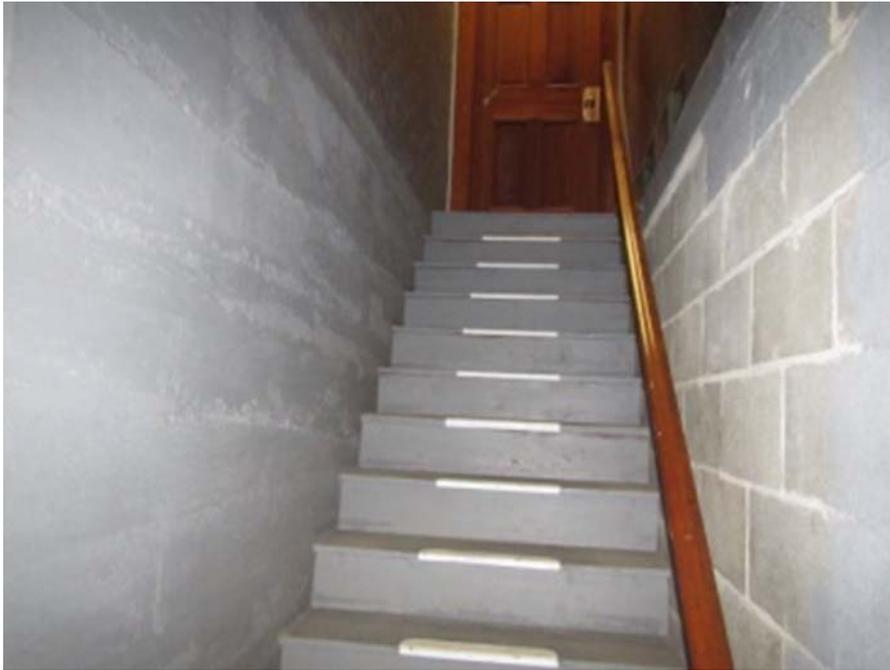
Picture 9

Basement stairwell leading up to the west end of the building
