INDOOR AIR QUALITY ASSESSMENT

**Montague Town Hall
1 Avenue A
Montague, Massachusetts**

Prepared by:
Massachusetts Department of Public Health
Bureau of Environmental Health
Indoor Air Quality Program
November 2014

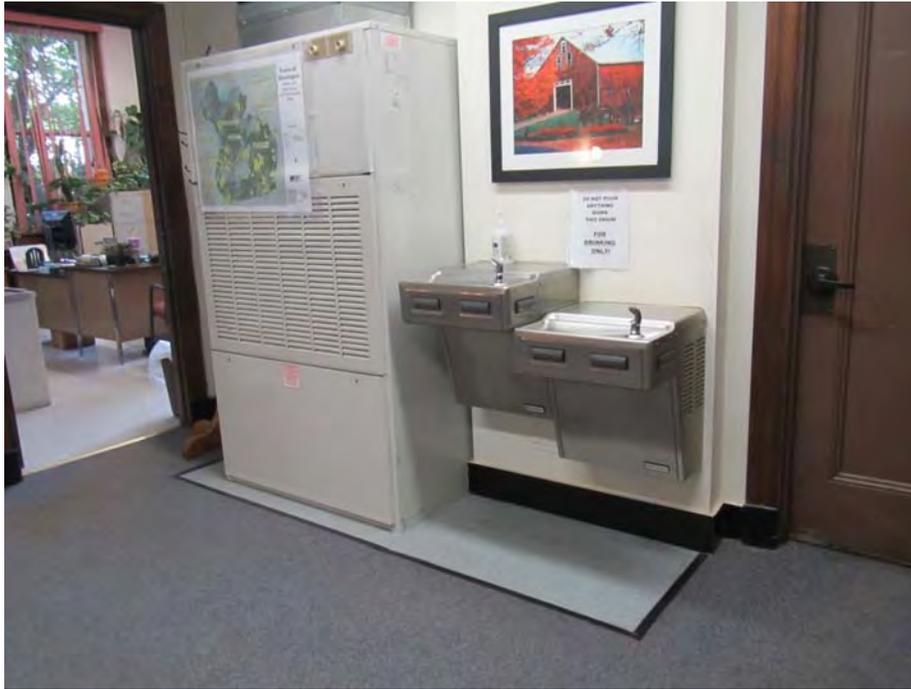
Picture 1

AHU in hallway

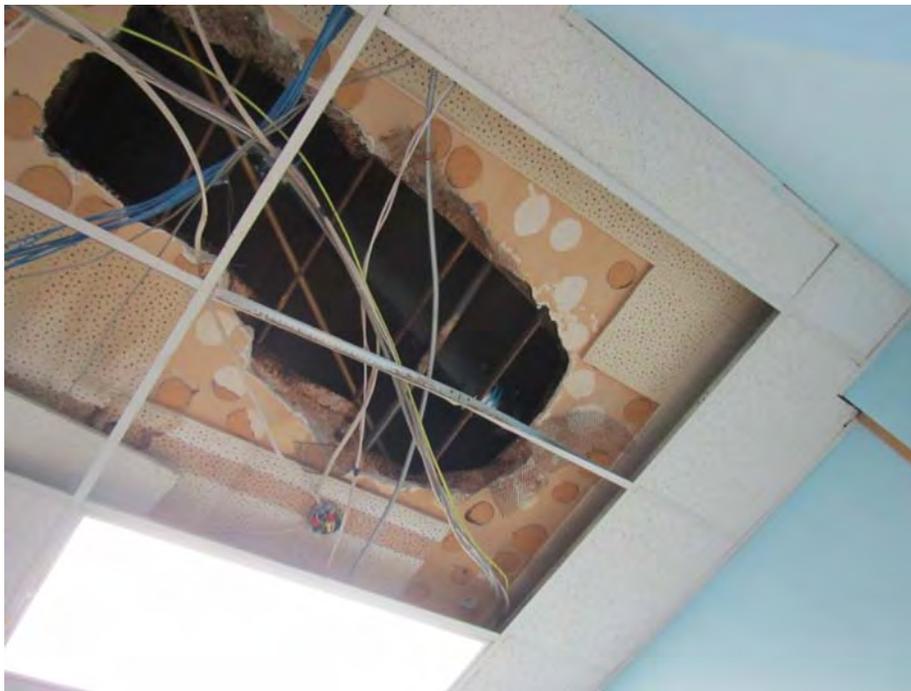
Picture 2

There have been a variety of concerns associated with this building related to recurring water infiltration and resulting damage. Recently the building had been subject to a sewer pipe break inside the ceiling. Due to the design and materials the building is composed of, including cement block/brick ceiling/pipe enclosures, leaks from plumbing are not often detected quickly and are very difficult to repair. It was reported that one leak had probably been ongoing for over a month. At the time of the visit, the ceiling and some walls had been opened and the piping had been repaired. Water-damaged items had reportedly been removed. The wall and ceiling in the affected area had not yet been repaired at the time of the visit (Picture 2).

Hole in ceiling where leak was repaired. Note construction of ceiling above dropped ceiling tiles

5. Finish repairs to plumbing, remove any remaining water-damaged materials, and close/finish openings in walls and ceilings. If possible, leave hatch openings to allow for easier access in case of a new plumbing problem, but ensure that any coverings/access doors fit tightly to prevent odors or particulate matter from entering occupied spaces.

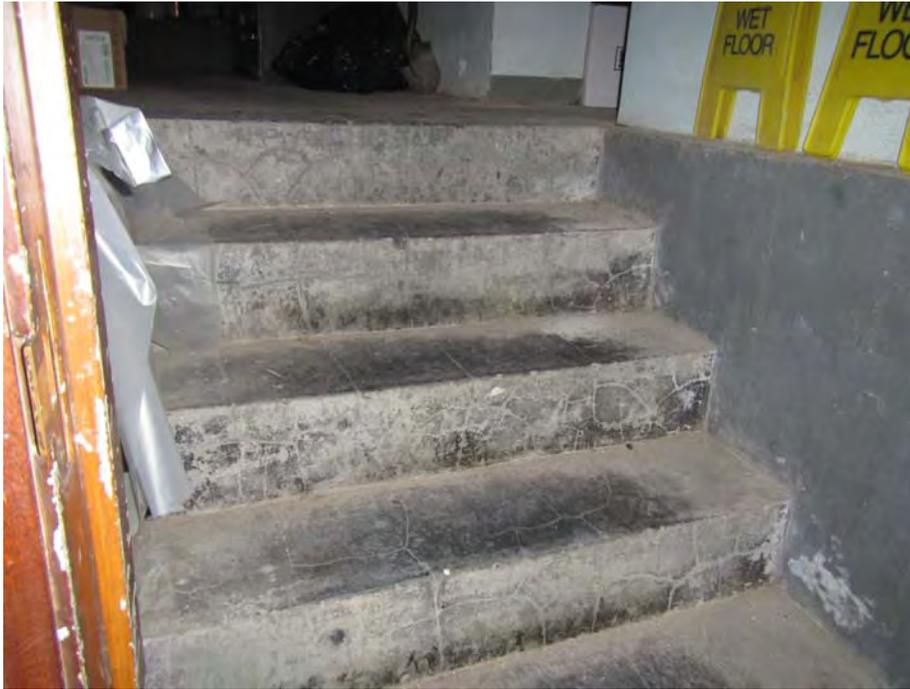
Picture 3

In addition, the vault and other basement areas are impacted by water infiltration from outside due to chronic/poor drainage issues. Reportedly, during the spring, a combination of

high groundwater levels and rainfall produces conditions where water pools/flows into areas of the basement (Picture 3). Without significant repairs, including foundation work and improving drainage away from the building, these conditions render the affected portions of the building unsuitable for occupancy and/or storage.

Water-stained stairs where infiltration and flow is reported during springtime

8. Consider consulting with an expert in building/landscape drainage issues to determine how to direct water away from the foundation.
9. Do not store items in or otherwise use areas of the basement subject to seasonal water infiltration until drainage problems can be remedied.

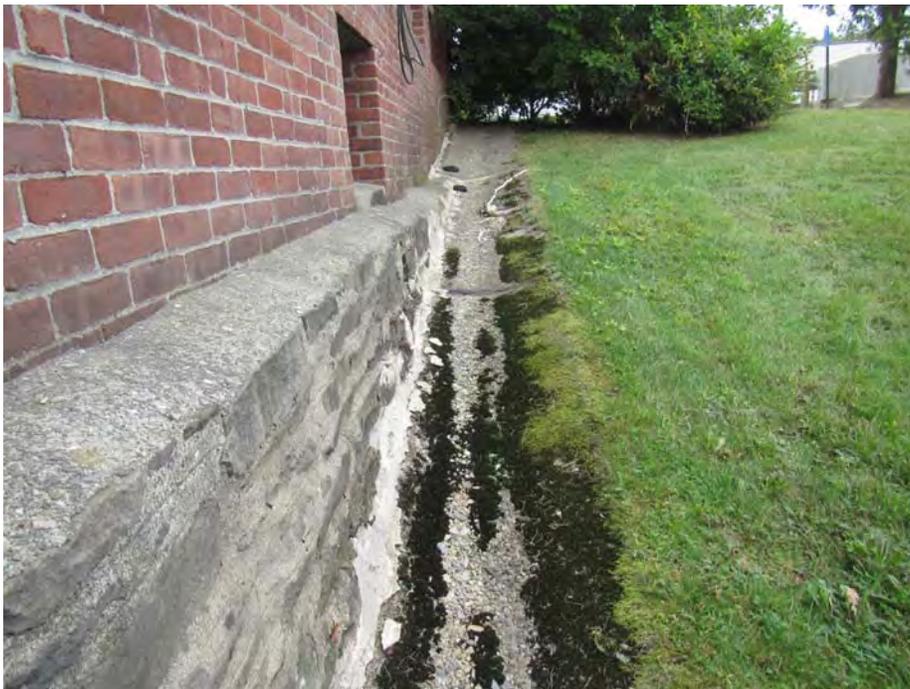
Picture 4

- The slope adjacent to the north side of the building has a tarmac that directs rainwater away from the foundation. The tarmac and sealant were damaged/deteriorated and the foundation was cracked, which can allow water to penetrate into the basement (Picture 4).

Concrete trough with moss growth, cracked foundation

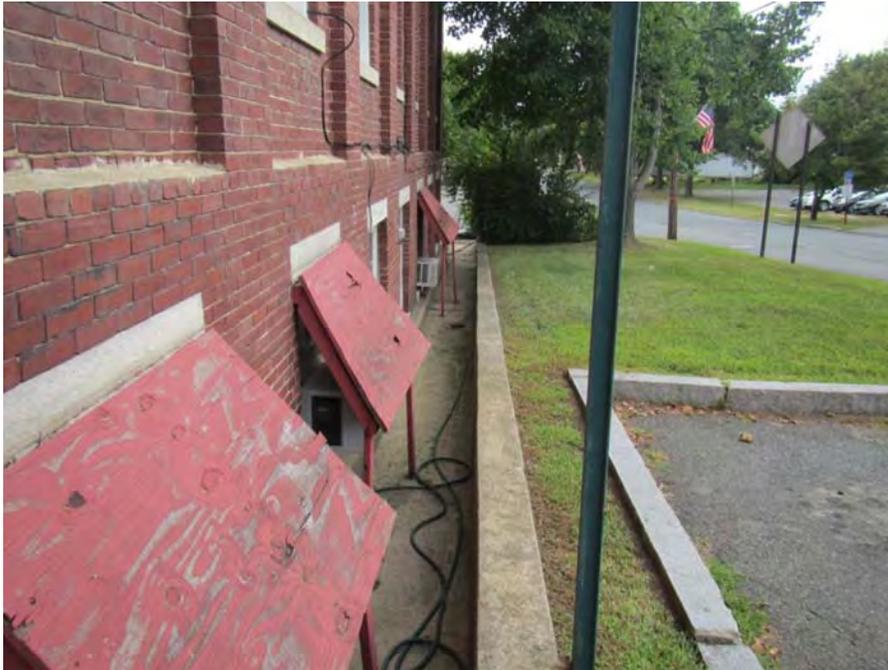
Picture 5

- A concrete trough is located along the foundation on the south side, of the MTH which is sloped towards the rear of the building and was likely installed to collect and drain rainwater away from the foundation (Picture 5). This is no longer functioning as intended and needs extensive repair or redesign.

Concrete drainage system for below-grade basement with deteriorated rain covers over window air conditioners

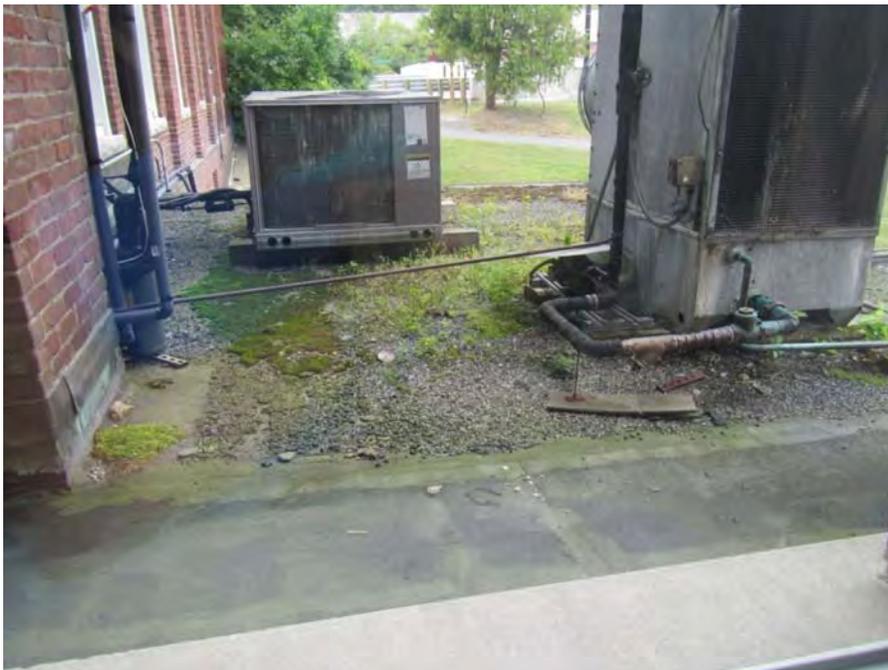
Picture 6

- The roof of the garage area is in very poor condition (Picture 6). The roof has been patched, reportedly several times, by an application of roofing tar, which has leaked into the building (Picture 7). This roof needs to be repaired in a more permanent manner.

Top view of low roof showing plant growth and deterioration

10. Consider adding gutters and downspouts to direct water away from the foundation.
11. Have the roof of the garage professionally repaired. Remove/clean roofing tar from the interior of the garage.

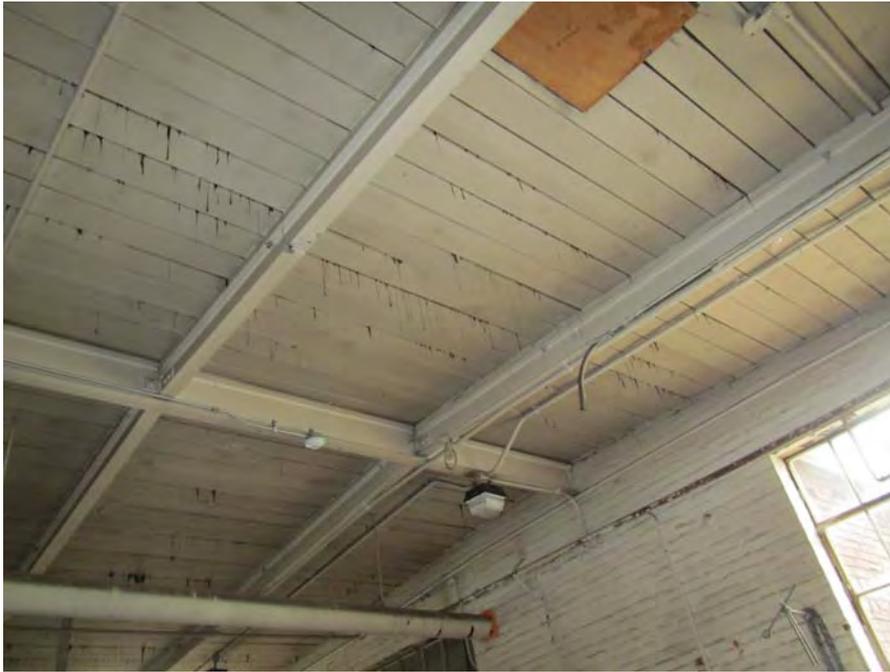
Picture 7

Numerous potential sources of VOCs and irritating odors were found in the garage, which is reportedly occupied by maintenance staff on occasion, and in other areas including fuels, paints and other chemicals (Picture 19). As mentioned previously and shown in Picture 7, the roof of the garage has been patched with roofing tar, which has penetrated through gaps in the roofing material into long strings that give off a characteristic odor and can easily break and fall into work areas. This method of roof repair is not adequate, and this tar material needs to be removed/cleaned.

Roofing tar leaks into the garage area

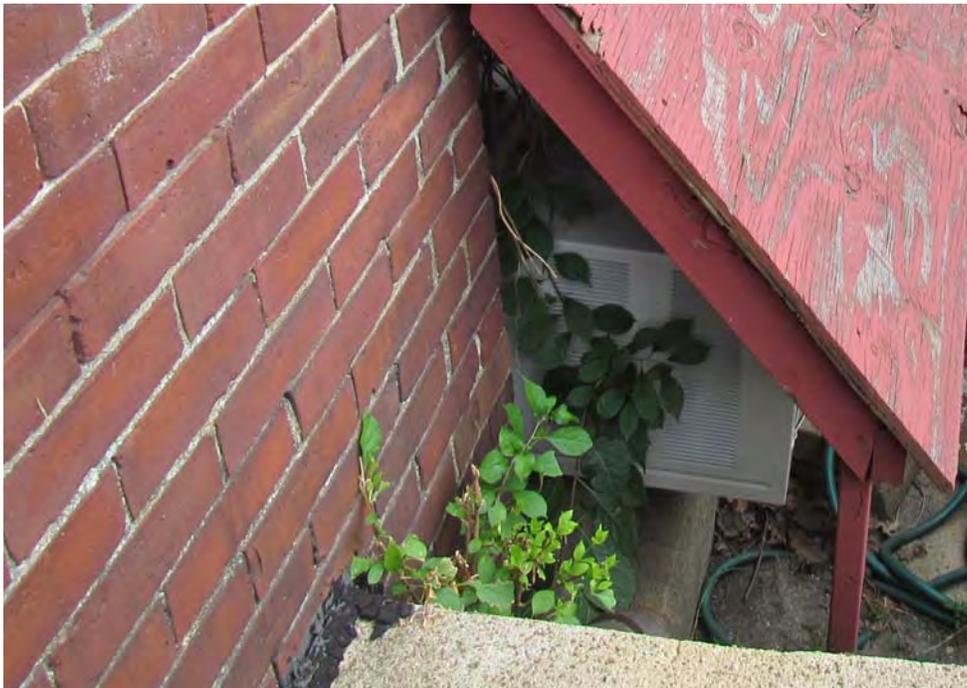
Picture 8

- Plants were observed in close proximity to the building (Pictures 6 and 8). The growth of roots against exterior walls can bring moisture in contact with brick, eventually leading to cracks and/or fissures in the foundation below ground level. Over time, this process can

undermine the integrity of the building envelope and provide a means of water entry into the building through capillary action through foundation concrete and/or masonry (Lstiburek & Brennan, 2001).

Plant growth against building foundation

12. Remove plants within five feet of the building's foundation.
13. Clean debris from exterior vents and seal them if not needed or install screens to prevent birds, rodents, insects and other pests from entering the building.

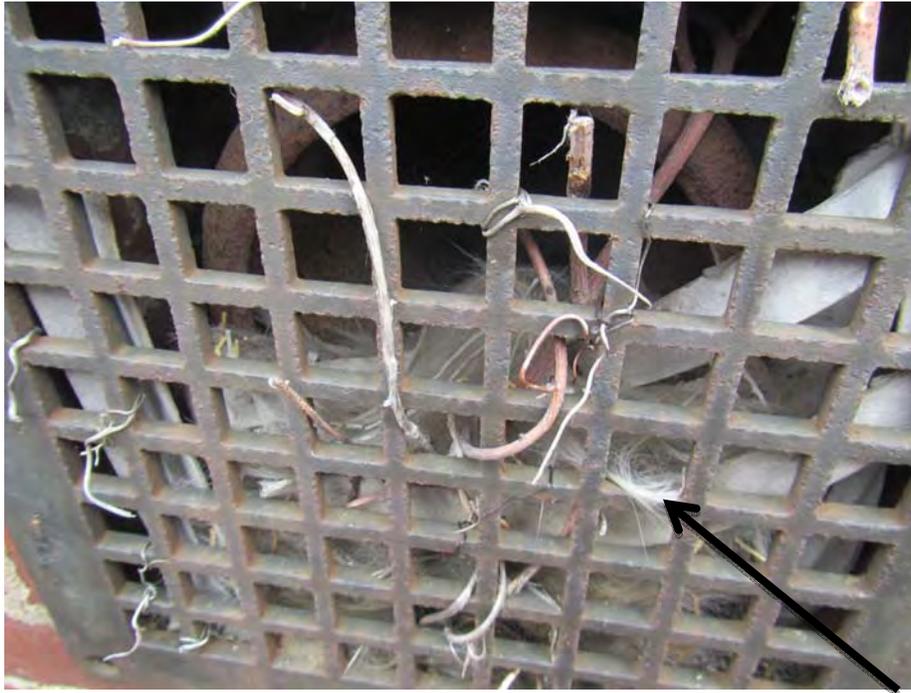
Picture 9

Exterior vent with debris and possible nesting materials

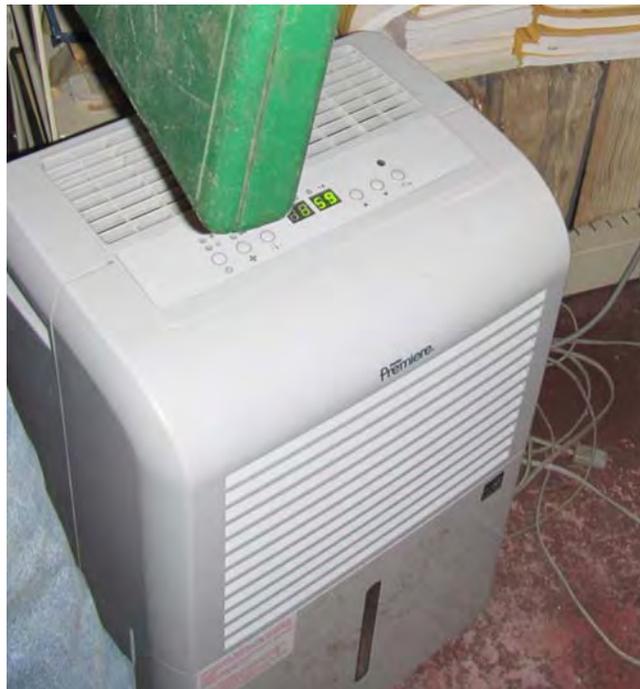
Picture 10

Dehumidifier in vault area

14. Empty and clean dehumidifiers regularly and maintain in accordance with manufacturer's instructions.
15. Consider moving the River Culture Office from the basement to an upper floor.

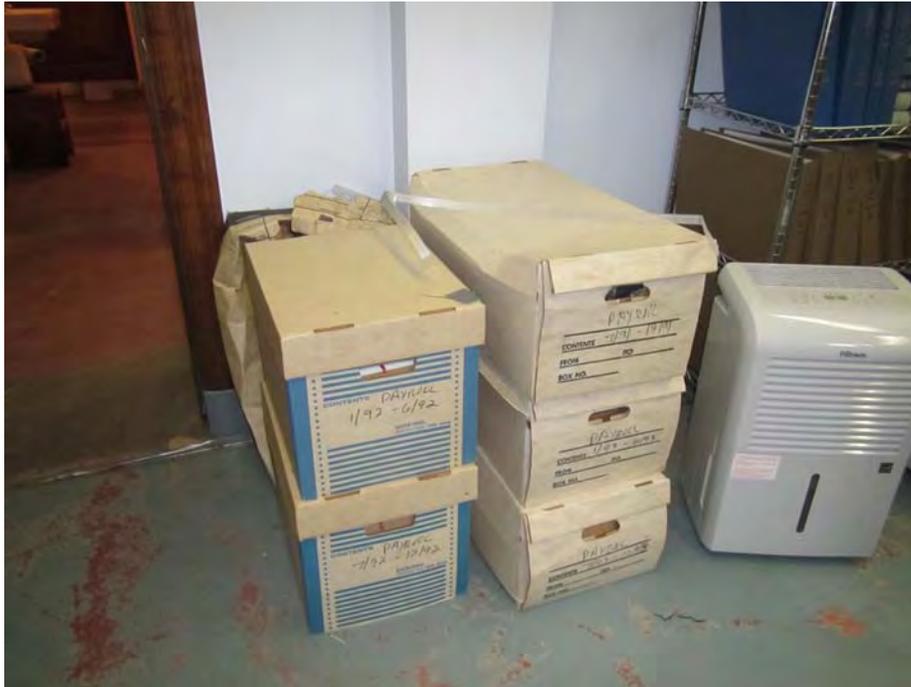
Picture 11

Dehumidifier and boxes on the floor in basement

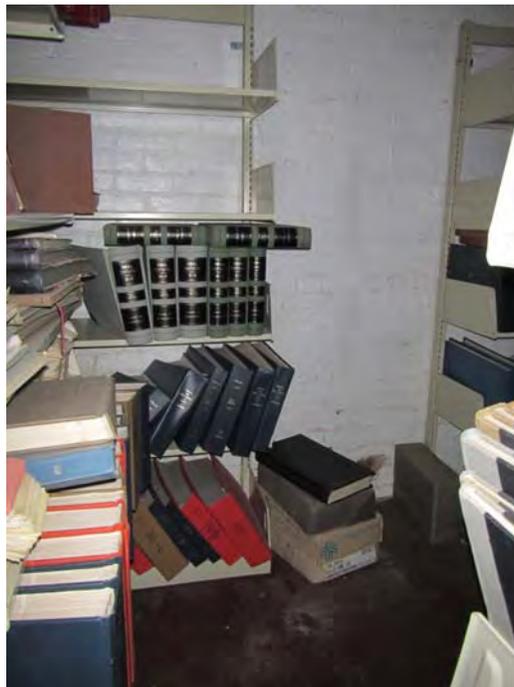
Picture 12

Books and items stored in the vault, including items on the floor

6. Investigate reports of unexplained moisture or odors promptly to find any new leaks as they are occurring.
7. As recommended in the 2006 MDPH report, remove and catalog items remaining in the vault area and remove them for restoration or disposal. Storage of items in the vault should be limited and new porous items should not be brought into the area. Use shelving or drawers for items so that nothing is on the floor.

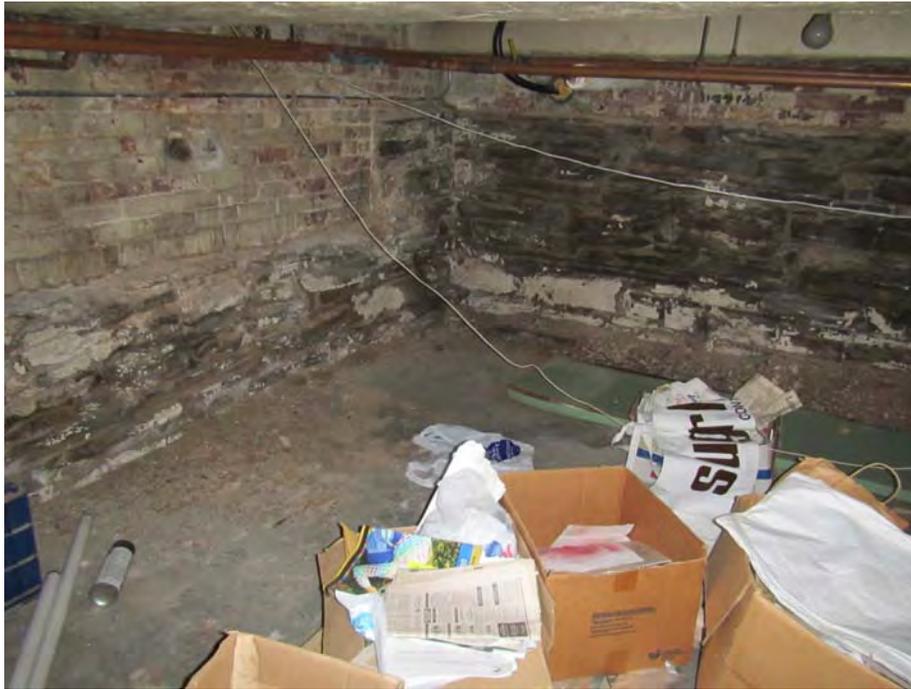
Picture 13

Items stored on the floor in below grade area

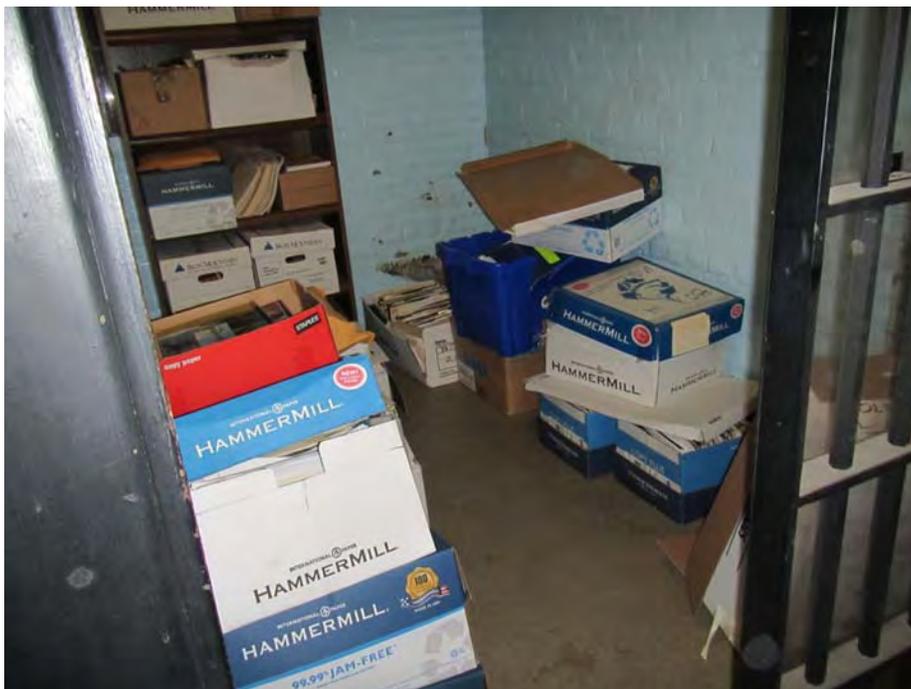
Picture 14

Items stored on the floor in the old lockup area

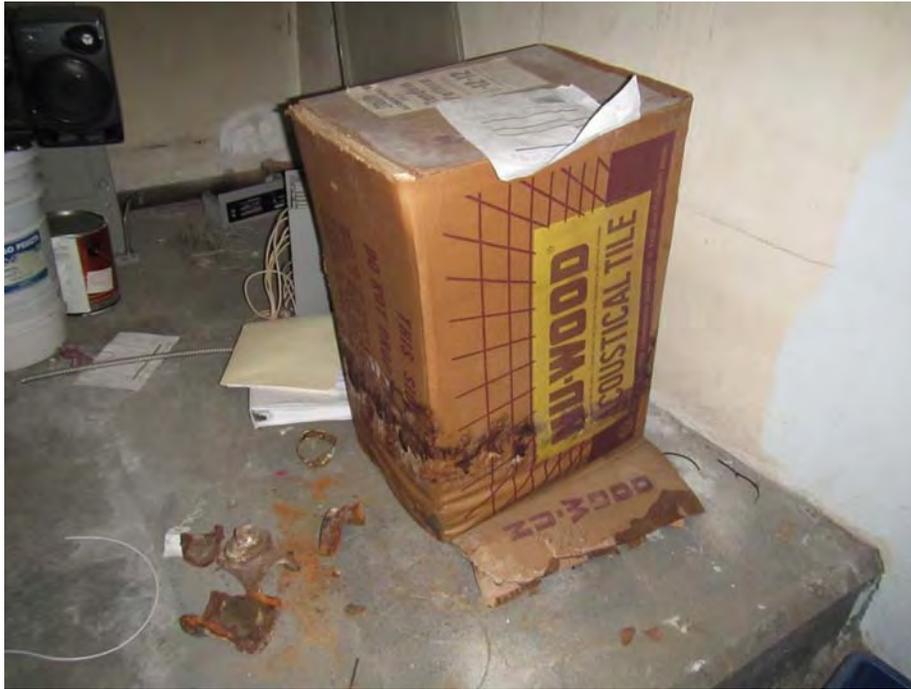
Picture 15

The recommendations in the previous MDPH 2006 report included removing/cataloguing and restoring stored materials in the vault and other areas. At the time of the September 10, 2014 visit, there were still significant amounts of porous materials (papers, etc.) stored in the vault and adjacent areas (Pictures 11 through 14). The vault area and other chronically damp areas are not suitable for storage of these materials. Furthermore, items stored there may be damaged from exposure to chronic dampness. New items should not be moved to this area and the previous recommendations regarding cataloguing and restoration should be followed. In the vault and other areas of the basement, items were found stored directly on the floor, which is likely to be subject to either condensation or flooding and has already lead to water damage of both boxes and contents (Picture 15). Any porous items stored in the basement and elsewhere in the

Water-damaged box in basement

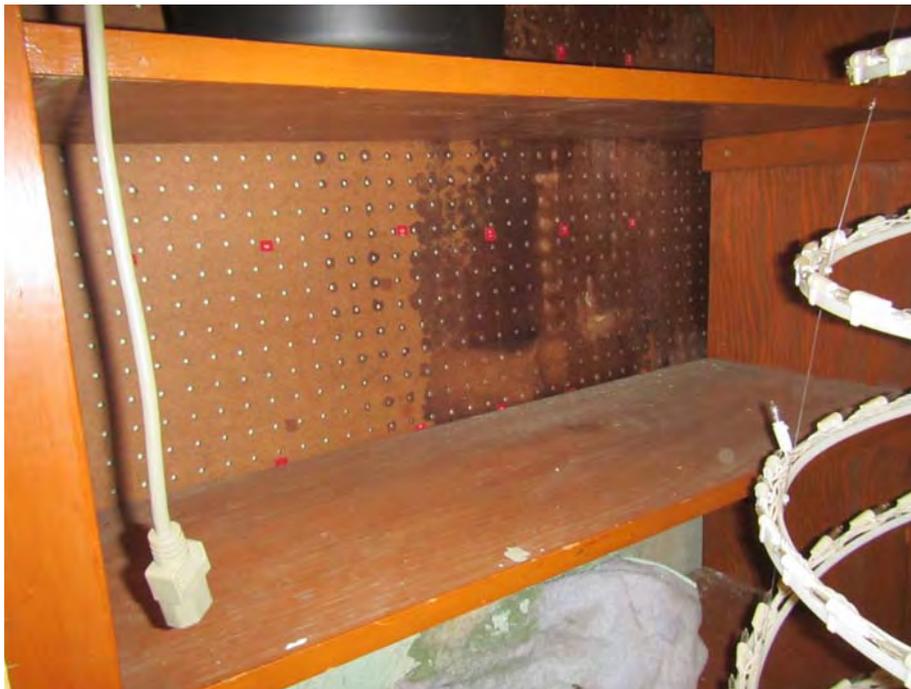
Picture 16

building should be in cabinets, on shelving or otherwise elevated off the floor. Water-damaged furniture was also observed in the basement areas of the building (Picture 16).

Water-damaged furniture in basement

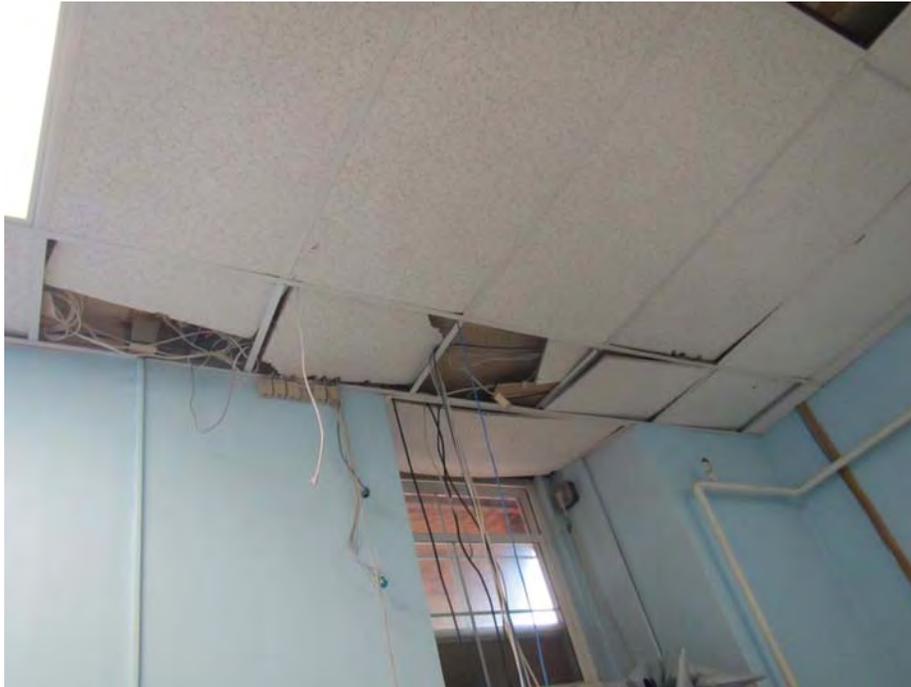
Picture 17

One area of the basement is the River Cultural Office. This office has been subject to water infiltration and is currently in a state of disrepair (Picture 17) due to remediation. In addition, carpeting was observed in this office (Picture 18) and other areas in the basement. Carpeting is not recommended in basement areas. The occupant of this office should be moved to an area outside of the basement if possible.

Ceiling repairs in the River Culture Director's office

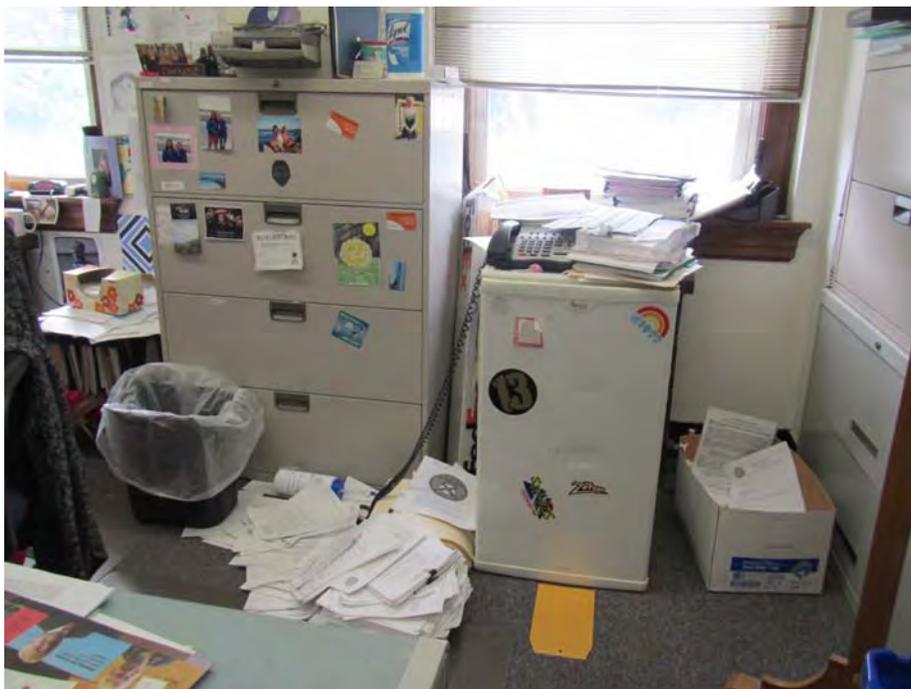
Picture 18

Refrigerators and water coolers were found on carpeted areas (Picture 18). These appliances can spill or leak, leading to water damage to carpeting and other adjacent items. Refrigerators and water coolers should be placed in non-carpeted areas or on a waterproof mat.

Refrigerator on carpet, note also papers and items

19. Consider placing waterproof mats under refrigerators and water coolers to prevent leaks/spills from damaging carpet.
20. Ensure that mops and mop buckets are dry when they are stored to prevent odors.

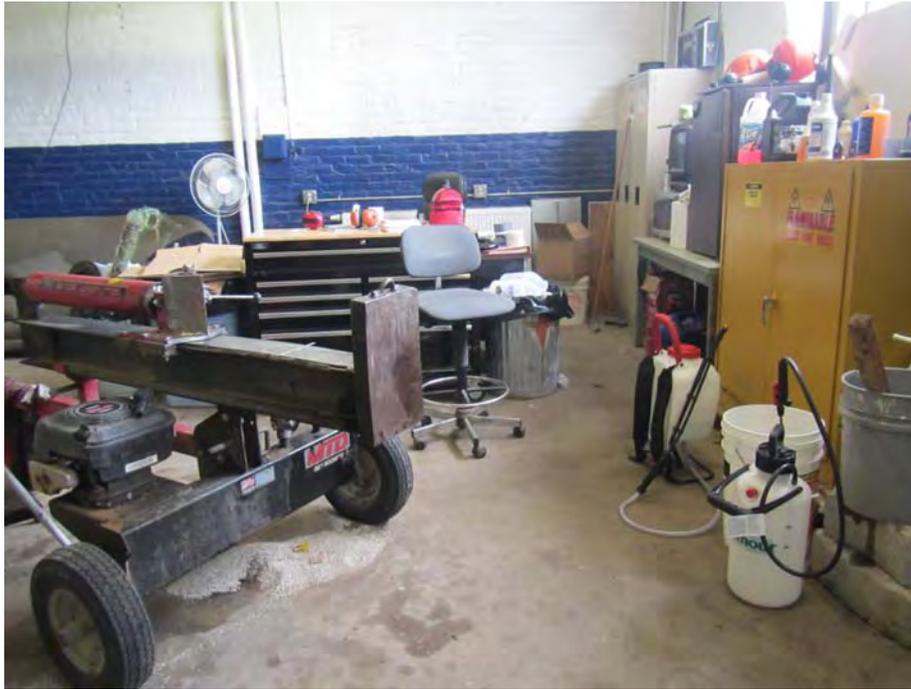
Picture 19

Items in garage area, including chemicals and fuels that may give off VOCs

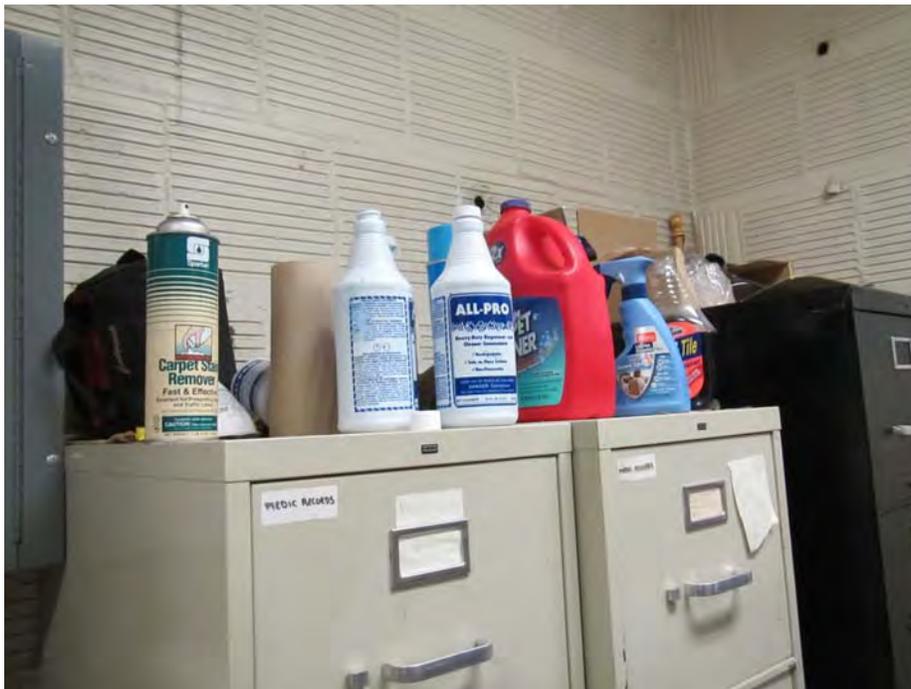
Picture 20

Cleaning products, air fresheners and deodorizing materials were observed in some areas (Table 1; Picture 20). Air deodorizers contain chemicals that can be irritating to the eyes, nose and throat of sensitive individuals. Many air fresheners contain 1,4-dichlorobenzene, a VOC which may cause reductions in lung function (NIH, 2006). Furthermore, deodorizing agents do not remove materials causing odors, but rather mask odors that may be present in the area.

Cleaning and sanitizing products in an office

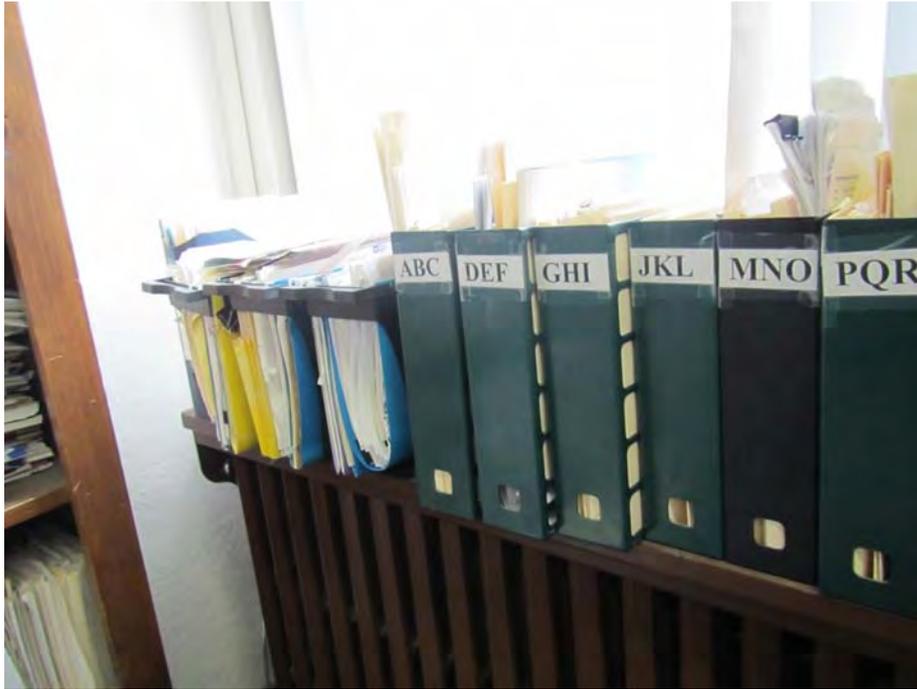
Picture 21

Other conditions which may affect IAQ were observed during the assessment. In a number of areas, items were observed on the floors, windowsills, bookcases and desks (Table 1; Pictures 18 and 21). The large number of items stored provides a source for dusts to accumulate. These items (e.g., papers, folders, boxes) make it difficult for custodial staff to clean. Items should be relocated and/or be cleaned periodically to avoid excessive dust build up. Storage of paper records and similar materials in this office may be creating a significant problem with cleaning and dust control. As recommended previously, existing paper records need cataloguing and options for long-term storage, and planning for future records, or paper reduction strategies, is also warranted.

Items stored near a window

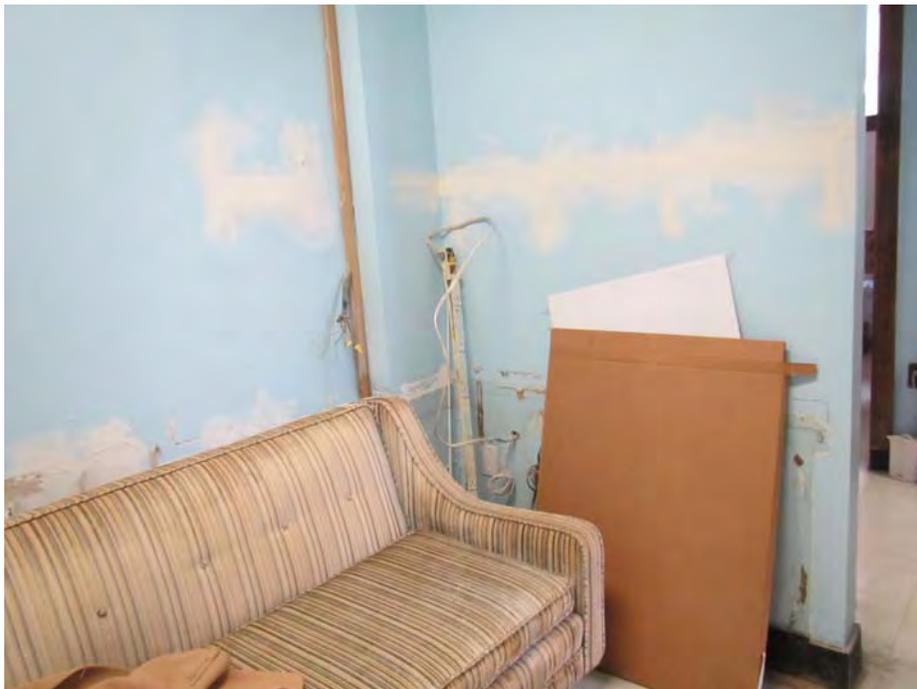
Picture 22

upholstered furniture is not recommended in an office environment. Upholstered furniture, pillows and cushions are covered with fabric that comes in contact with human skin. This type of contact can leave oils, perspiration, hair and skin cells. In addition to being a source for fleas, upholstered furniture may accumulate dust mites, which feed upon human skin cells and excrete waste products that contain allergens. In addition, if relative humidity levels increase above 60 percent, dust mites tend to proliferate (US EPA, 1992). In order to remove dust mites and other pollutants, frequent vacuuming of upholstered furniture is recommended (Berry, M.A., 1994). It is also recommended that upholstered furniture be professionally cleaned on an annual basis. If an excessively dusty environment exists due to outdoor conditions or indoor activities (e.g., renovations), cleaning frequency should be increased (every six months) (IICRC, 2000).

Upholstered couch in River Culture office

28. Clean upholstered furniture regularly and have professionally cleaned on an annual basis.
29. Ensure that any gaps/spaces between the insulated attic space shown in Pictures 23 and 24 are sealed to prevent migration of particulate matter from insulation into occupied areas.
30. Clean air conditioner filters and maintain them in accordance with manufacturer's instructions. Replace the cloth/clothing around these units with a suitable water and mold-resistant material.
31. Store new and spent fluorescent bulbs in sturdy containers to prevent breakage. Dispose of spent fluorescent bulbs properly.
32. Refer to resource manuals and other related indoor air quality documents for further building-wide evaluations and advice on maintaining public buildings. These materials are located on the MDPH's website: <http://mass.gov/dph/iaq>.

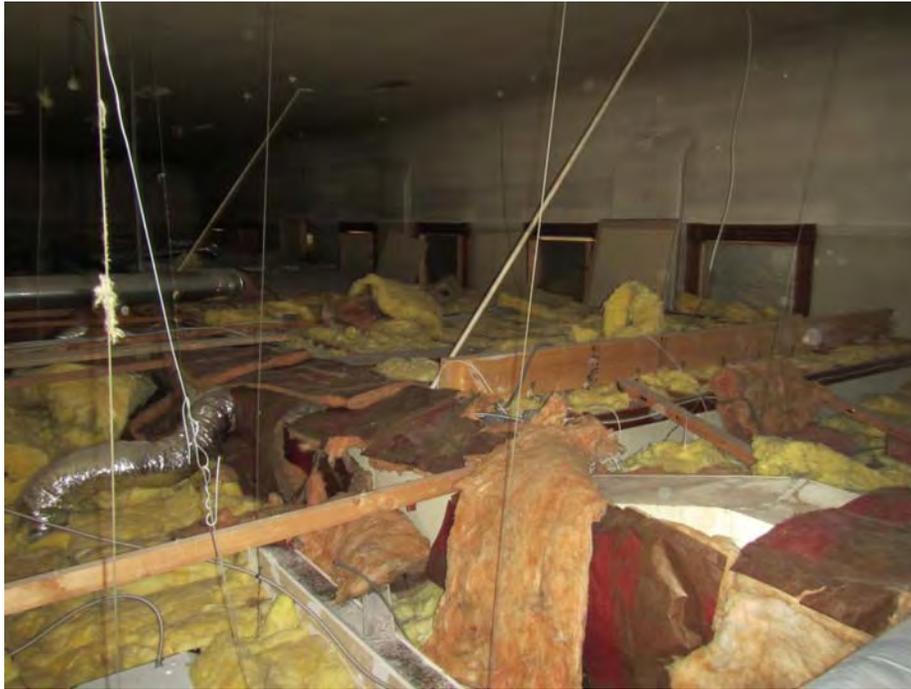
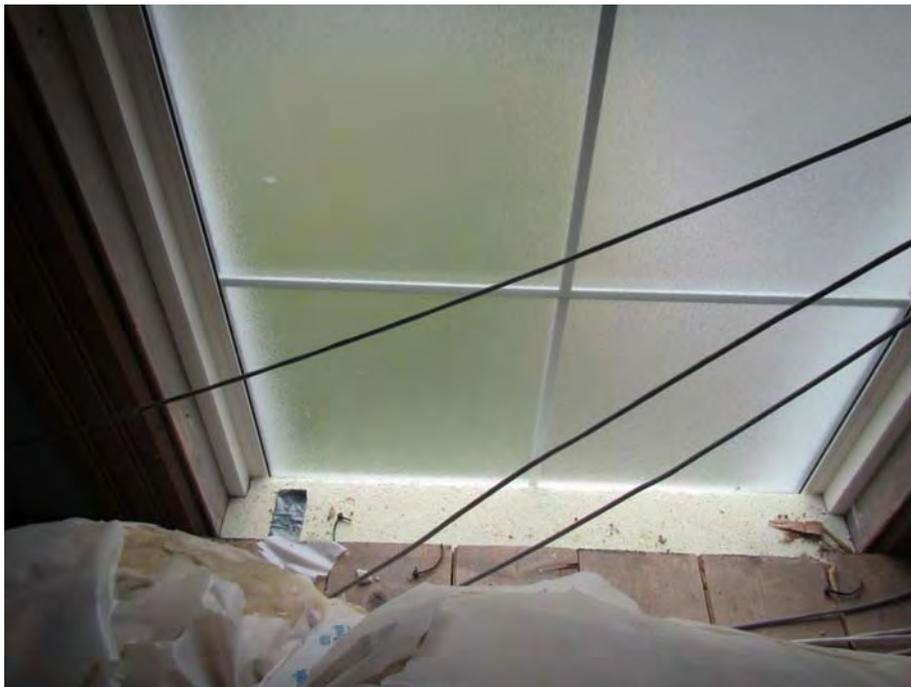
The attic area was also examined during the September 10, 2014 visit. According to staff, the building had undergone some recent energy retrofits, including insulation. One area of the attic, directly above occupied space had been insulated with a variety of materials arranged in a seemingly haphazard formation (Picture 23) with exposed edges of materials, which may allow for the release of irritating particles of fiberglass and other materials when disturbed. It was observed that in at least some cases, the areas where the tall windows had been bisected by the flooring (Picture 24), was sealed with an expandable foam. However the construction of this ceiling/floor and the methods used is likely to have left gaps where particulate matter from insulation can enter occupied areas. Any gaps/holes found should be sealed.

Insulation in attic

Foam sealing gap between attic and floor below

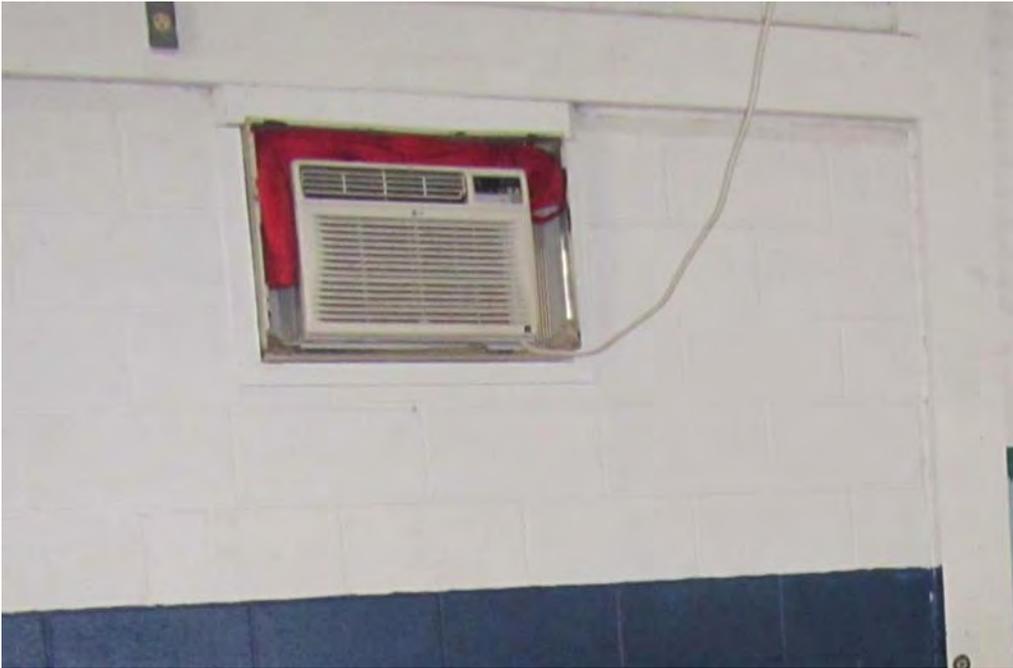
Picture 25

Some of the basement areas are equipped with window air conditioners. These can be helpful in providing cooling, dehumidification and some air exchange. Air conditioners are typically equipped with filters that need to be cleaned in accordance with manufacturer's instructions. In addition, as shown in Picture 25, gaps around some of these units were observed

to have cloth or items of clothing set around them, presumably to reduce infiltration of outside air. Cloth is not water or air resistant and can become mold-colonized if repeatedly moistened and may also provide access and/or harborage for pests from outside.

Window air conditioner with cloth/clothing around it

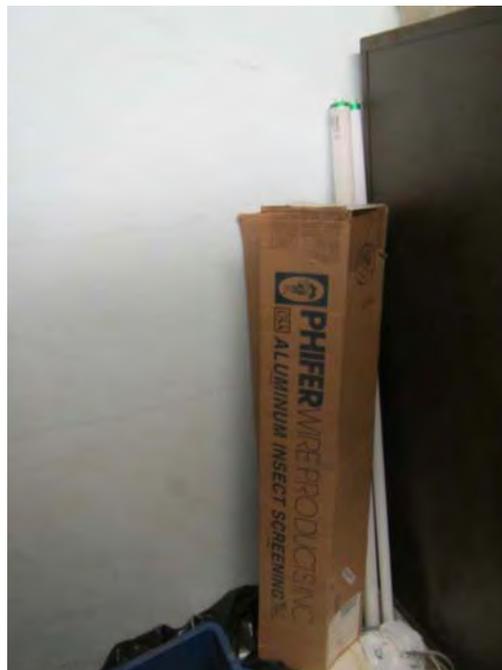
Picture 26

Finally, some fluorescent bulbs, it is unknown if they were new or used, were improperly stored (Picture 26). These items can release glass, dusts and mercury if broken. They should be stored in a sturdy container and/or properly disposed of.

Improperly stored fluorescent bulbs
