INDOOR AIR QUALITY ASSESSMENT

**Department of Children and Families
South Central Area Office
185 Church Street
Whitinsville Section of
Northbridge, MA**

Prepared by:
Massachusetts Department of Public Health
Bureau of Environmental Health
Indoor Air Quality Program
July 2014

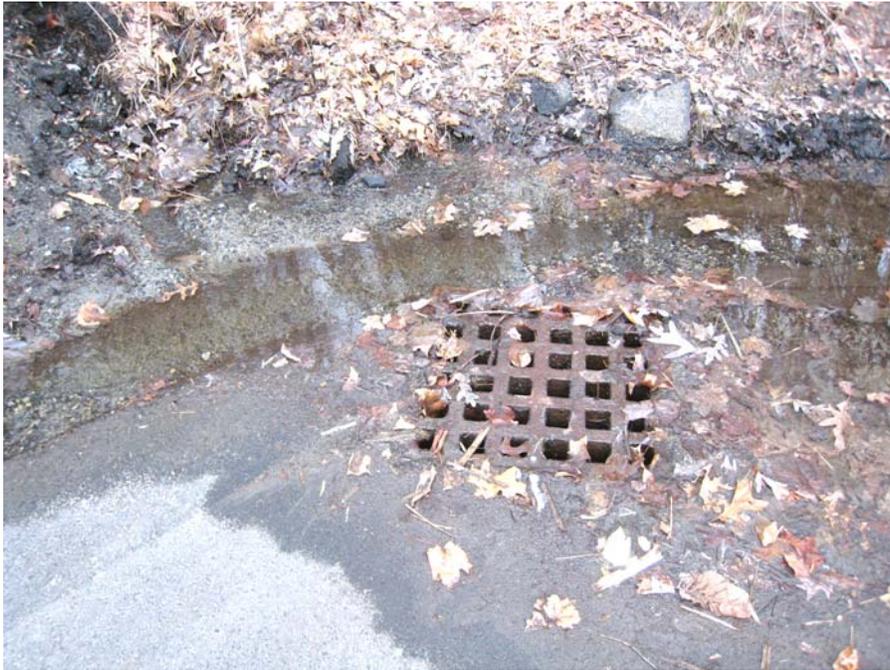
Picture 1

water from the back of the building were occluded with leaves/debris. At the time of the assessment, BEH/IAQ staff observed leaves around the sewer grates, high water level within sewer drains, and pooling water (Pictures 1 and 2). Water shedding off the hill behind the building likely added to the water load (Picture 3). In anticipation of weekend precipitation, BEH/IAQ staff recommended that sandbags be placed around the exterior to direct water away from the building. DCF staff reported that building management had sandbags installed the evening of April 4, 2014.

Leaf debris surrounding sewer grate and pooling water several days after storm

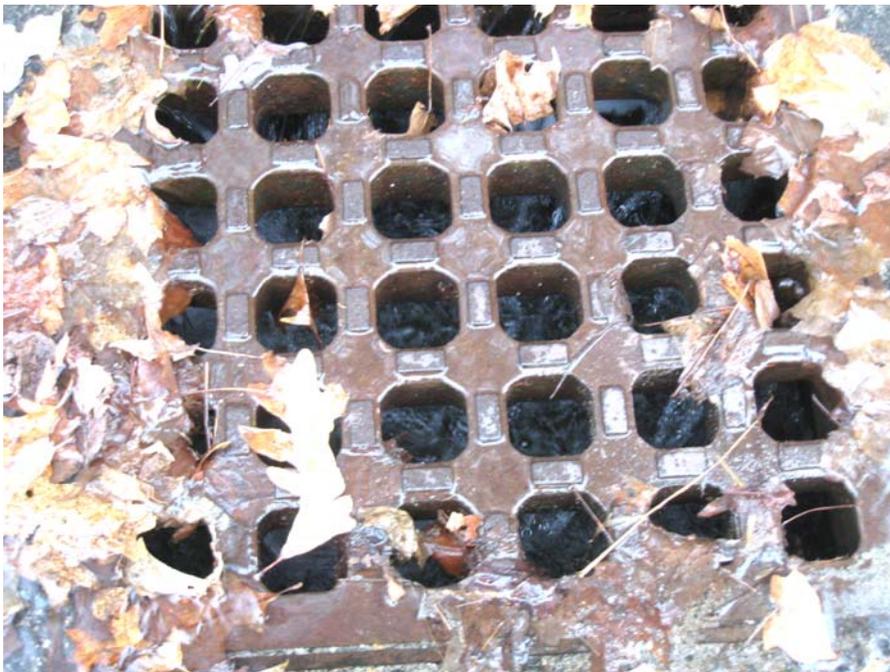
Picture 2

High water level within drain several days after storm

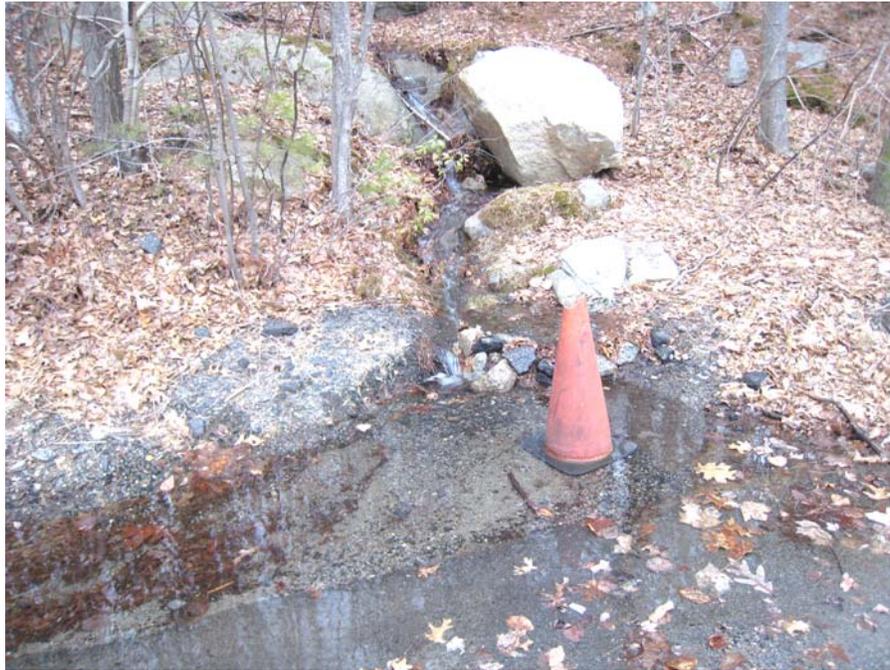
Picture 3

Water shedding off hill

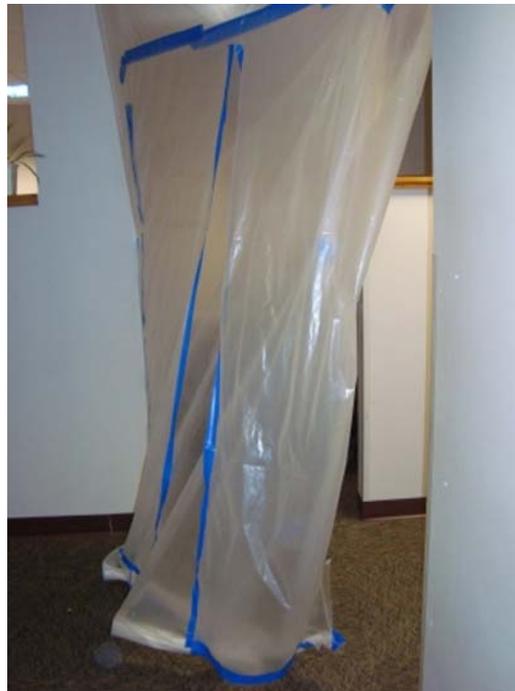
Picture 4

Drying activities were still on-going at the time of the April 4, 2014 assessment. As mentioned, plastic barriers were used to separate affected areas from un-affected areas (Pictures 4 and 5); however, staff indicated concerns that the plastic ‘doors’ were not preventing movement of dust/debris into occupied areas. BEH/IAQ staff examined carpet tiles and conducted moisture testing on all walls in the impacted area. Carpet tiles were dry at the time of assessment, although some tiles were no longer adhered to the floor. BEH/IAQ staff noted that vinyl coving had been removed, and holes were cut into the walls to allow for proper drying (Picture 6). Bookcases and file cabinets were also elevated to allow air circulation and thorough drying of carpets (Picture 7). Tubes were inserted into the holes of some walls to allow air to be pumped into the wall cavity, which aided drying (Picture 8). Although walls were dry in many of the areas affected, some GW was wet at the time of the April 4, 2014 assessment (Figure 1).

Plastic barrier, note plastic is not adhered to floor or walls

- Install zipping plastic barriers to create access to water-damaged areas.
- Install a fan or HEPA-filtered air purifier near access ways to remediation areas to prevent movement of dust into occupant areas.

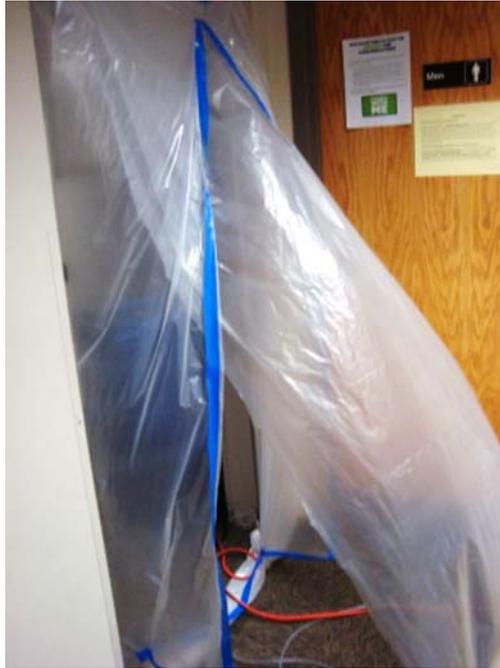
Picture 5

Barrier between spaces, note air pressurizing plastic barrier towards occupied areas

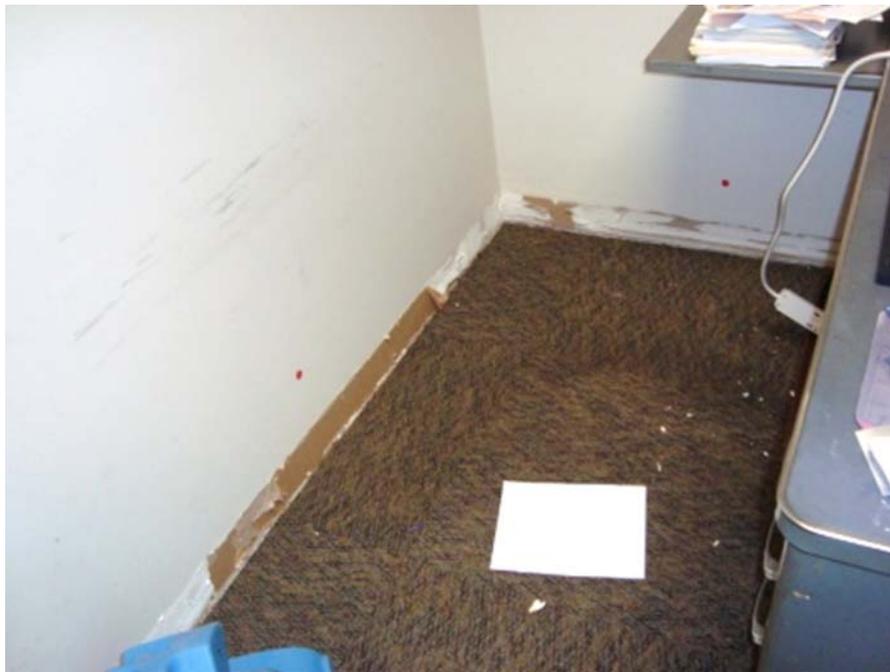
Picture 6

Vinyl base coving removed from water-damaged gypsum wallboard

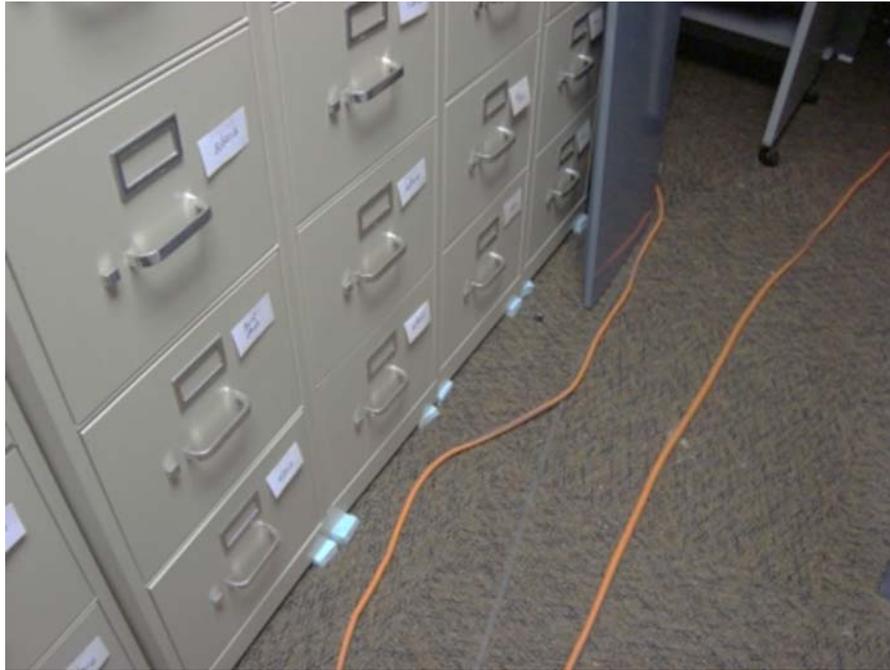
Picture 7

Styrofoam pieces used to elevate file cabinets to allow carpet drying

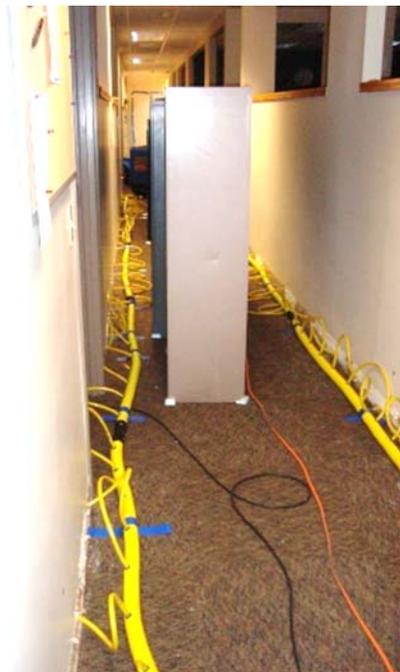
Picture 8

Tubes delivering air into wall cavity to facilitate drying

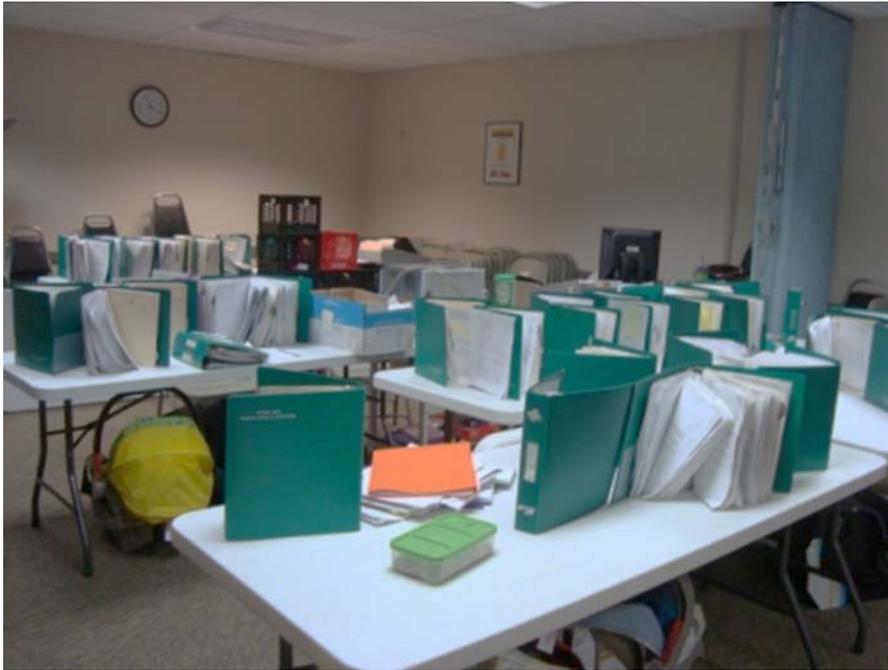
Picture 9

During the April 4, 2014 assessment, BEH/IAQ staff also observed paper files/materials damaged by water (Picture 9). While steps were taken to dry these materials, measures should also be taken to ensure that items such as books are dried thoroughly. Due to its compressed nature, the binding of books can often hold moisture. Furthermore, the glues used to adhere pages to the book cover can be a source of nutrients for mold to grow.

Water-damaged paper files propped for drying

- Consider scanning/copying water-damaged paper files that cannot dry properly to prevent potential for mold growth.

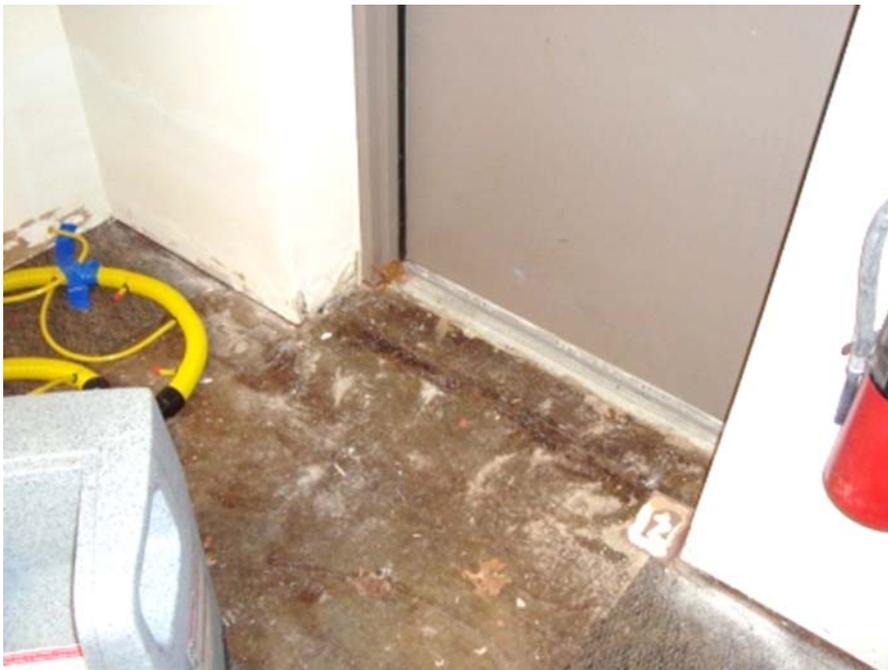
Picture 10

One doorway through which water entered building

- Replace lifting carpet floor tiles with new carpet tiles.
- Consider installing vinyl floor tiles in the access areas for the two exterior doors at the rear of the office space (Picture 10).

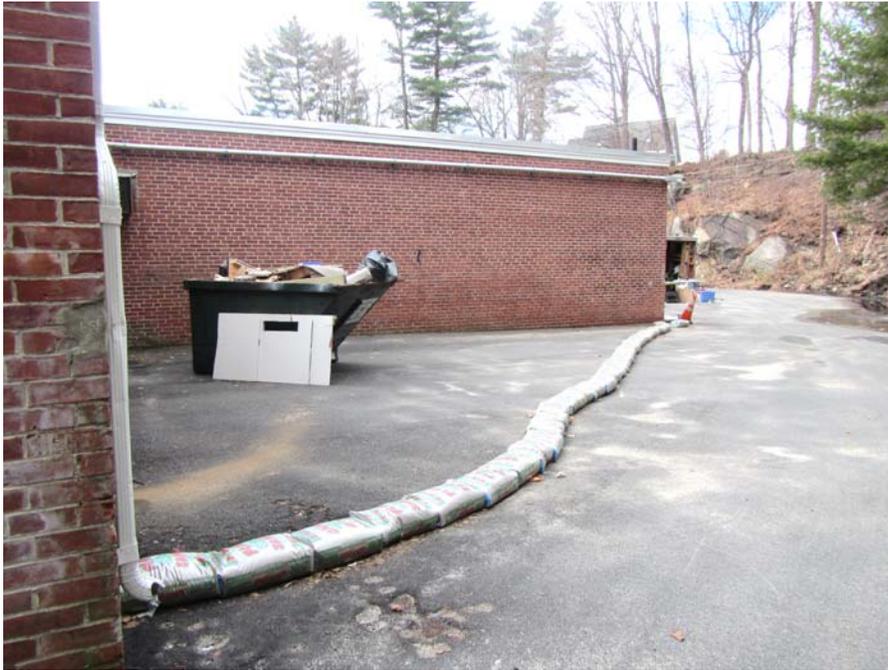
Picture 11

During the follow-up assessment on April 9, 2014, BEH/IAQ staff noted sandbags were in place behind the building to prevent future flooding (Picture 11). BEH/IAQ staff observed that GW and insulation in a number of areas had been removed and/or replaced (Figure 1; Pictures 12 and 13). BEH/IAQ staff took moisture measurements to ensure all wet materials were dry; all GW that was not removed had dried.

Sandbags used to create barrier against water

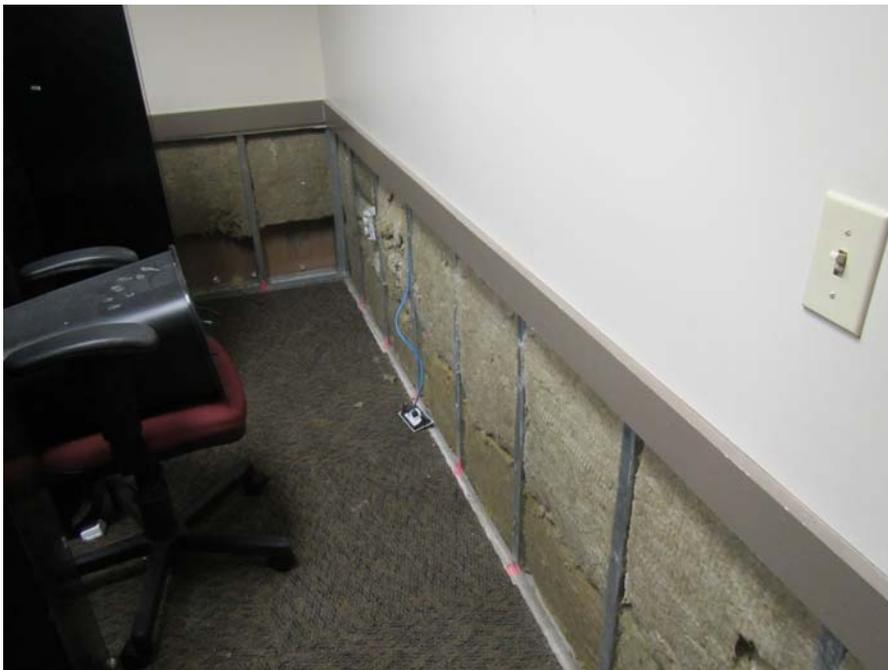
Picture 12

Water-damaged gypsum wallboard removed; removal of insulation in progress

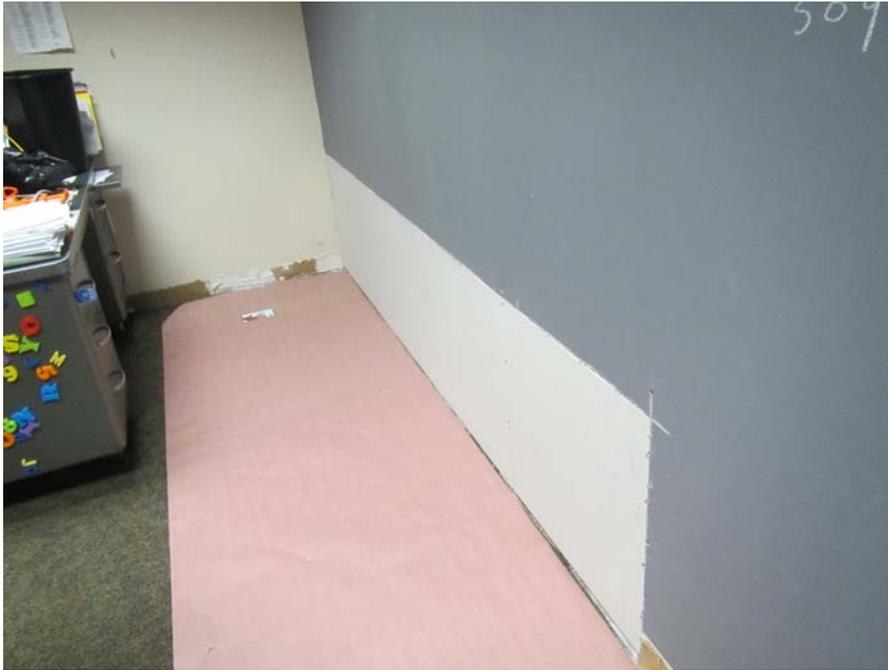
Picture 13

Water-damaged gypsum wallboard replaced

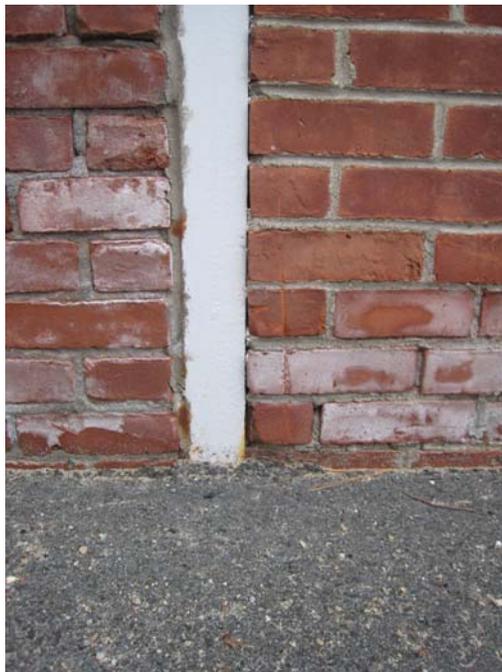
Picture 14

During an examination of the building exterior, BEH/IAQ staff observed efflorescence and missing mortar, particularly at the rear of the building (Picture 14). Efflorescence is a characteristic sign of water damage to brick and mortar, but it is not mold growth. As moisture penetrates and works its way through mortar, brick or plaster, water-soluble compounds dissolve,

creating a solution. As the solution moves to the surface of the material, the water evaporates, leaving behind white, powdery mineral deposits. The aforementioned conditions are indicative of the chronic moisture experienced at the back of the building. Over time, these conditions can undermine the integrity of the building envelope and provide a means of water entry into the building via capillary action through foundation concrete and masonry (Lstiburek & Brennan, 2001). In addition, these breaches may provide a means for pests/rodents into the building.

Efflorescence and missing/damaged mortar
