INDOOR AIR QUALITY ASSESSMENT

**Lake Street Elementary School
17 Lake Street
Spencer, Massachusetts**

Prepared by:
Massachusetts Department of Public Health
Bureau of Environmental Health
Indoor Air Quality Program
March 2014

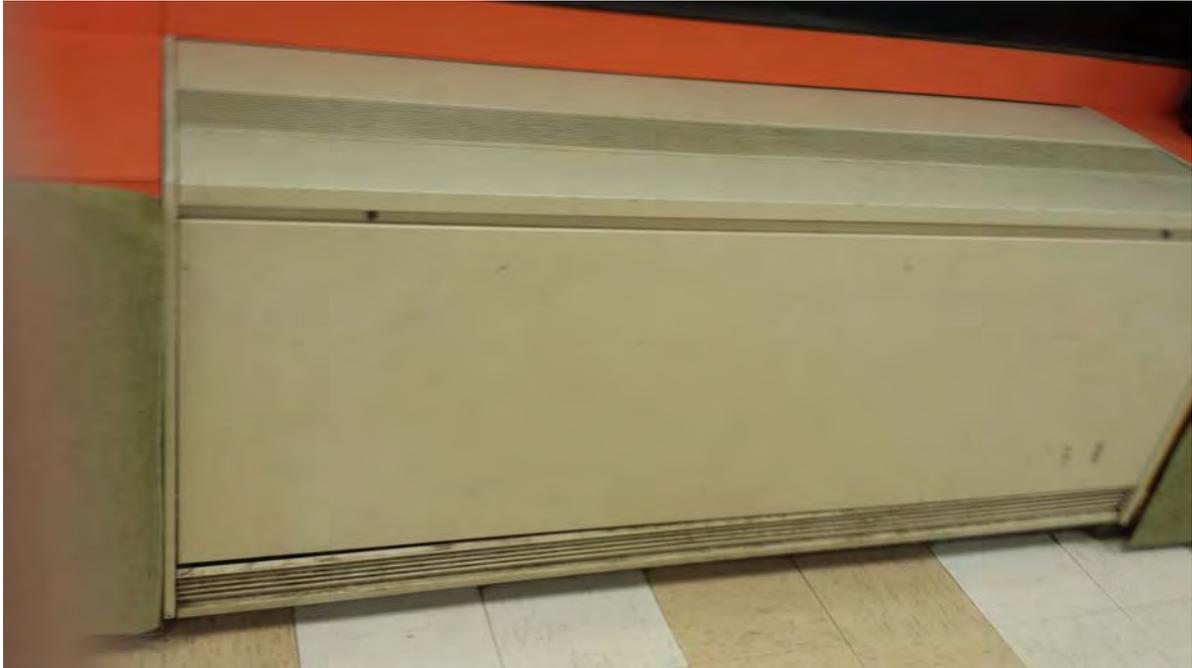
Picture 1

Fresh air in the majority of classrooms is supplied by unit ventilators (univents) (Picture 1). A univent is designed to draw air from outdoors through a fresh air intake located on the exterior wall of the building. Return air is drawn through an air intake located at the base of each unit where fresh and return air are mixed, filtered, heated or cooled and provided to classrooms through an air diffuser located in the top of the unit ([Figure 1](#)). At the time of the assessment, univents were found deactivated or obstructed with classroom items in a number of areas (Table 1). In order for univents to provide fresh air as designed, intakes/returns must remain free of obstructions. Importantly, these units must remain on and be allowed to operate while rooms are occupied.

Unit ventilator (univent)

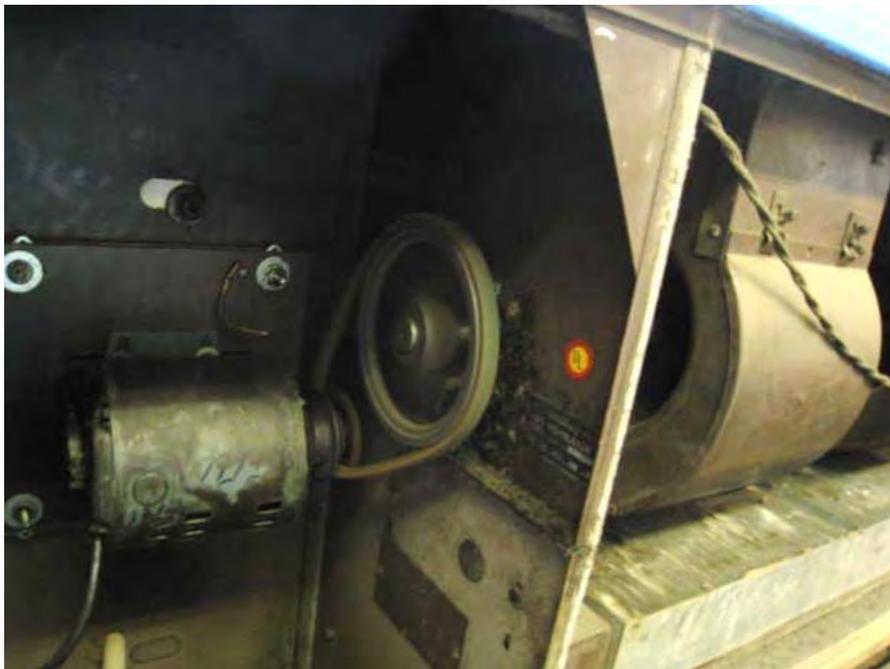
Picture 2

difficult to maintain, since compatible replacement parts are often unavailable. As an example, fan belts in univents appeared to be loose (Picture 2), which can lead to decreased fan velocity and increased noise. According to the American Society of Heating, Refrigeration and Air-Conditioning Engineers (ASHRAE), the service life¹ for a unit heater, hot water or steam is 20 years, assuming routine maintenance of the equipment (ASHRAE, 1991). Despite attempts to maintain the univents, the operational lifespan of the equipment has been exceeded. Maintaining the balance of fresh air to exhaust air will become more difficult as the equipment ages and as replacement parts become increasingly difficult to obtain.

Univent with loose fan belt

16. Consider upgrading ventilation equipment. Maintaining the balance of fresh air to exhaust air will become more difficult as the equipment ages (i.e., classroom univents, exhaust vents, and AHUs in common areas) and as replacement parts become increasingly difficult to obtain. Based on the age, physical deterioration, and availability of parts, BEH recommends that an HVAC engineering firm evaluate options to determine feasibility of repairing/replacing the equipment.

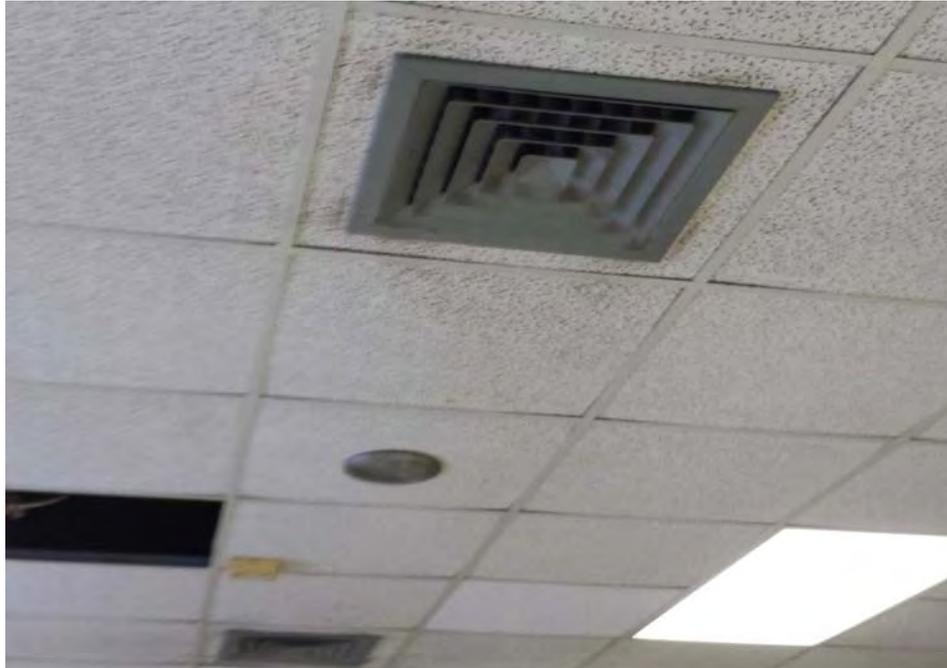
Picture 3

Ceiling-mounted supply diffusers; note dust on louvers/ceiling tiles and missing ceiling tile

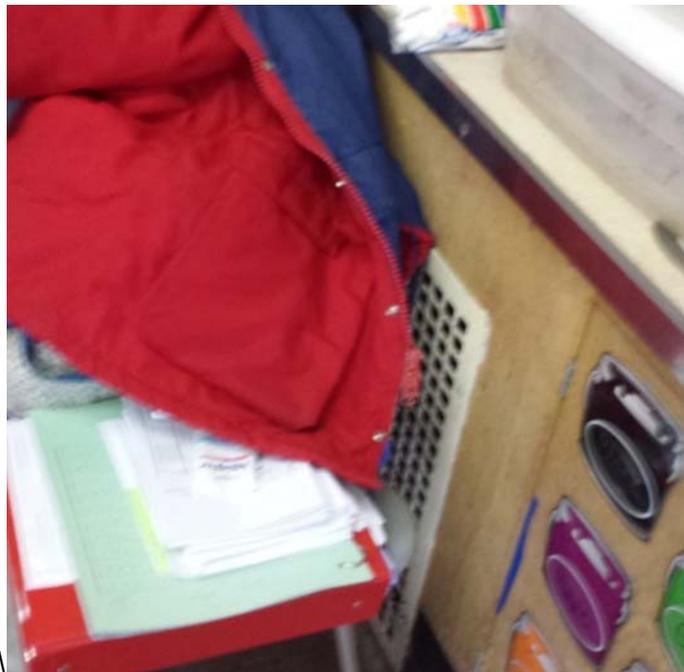
Picture 4

Exhaust ventilation in most classrooms is provided by wall-mounted vents (Picture 4). In some classrooms, exhaust vents are located in coat closets (Picture 5). Exhaust vents were also found obstructed in some areas and many of them appeared to be off or drawing very weakly (Table 1).

Exhaust vent, obstructed by items

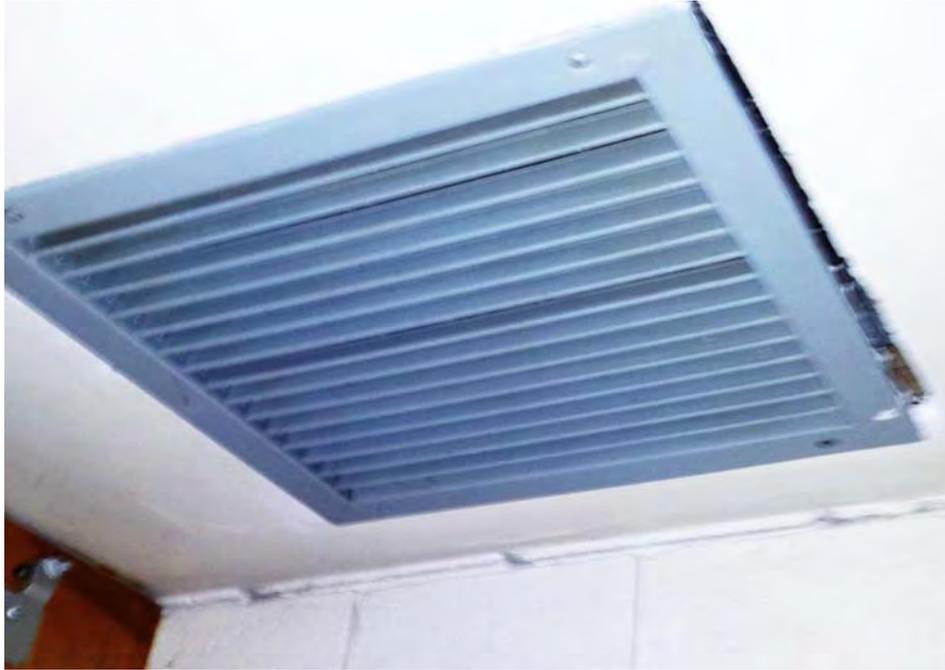
Picture 5

Exhaust vent located in closet, note grill is ajar

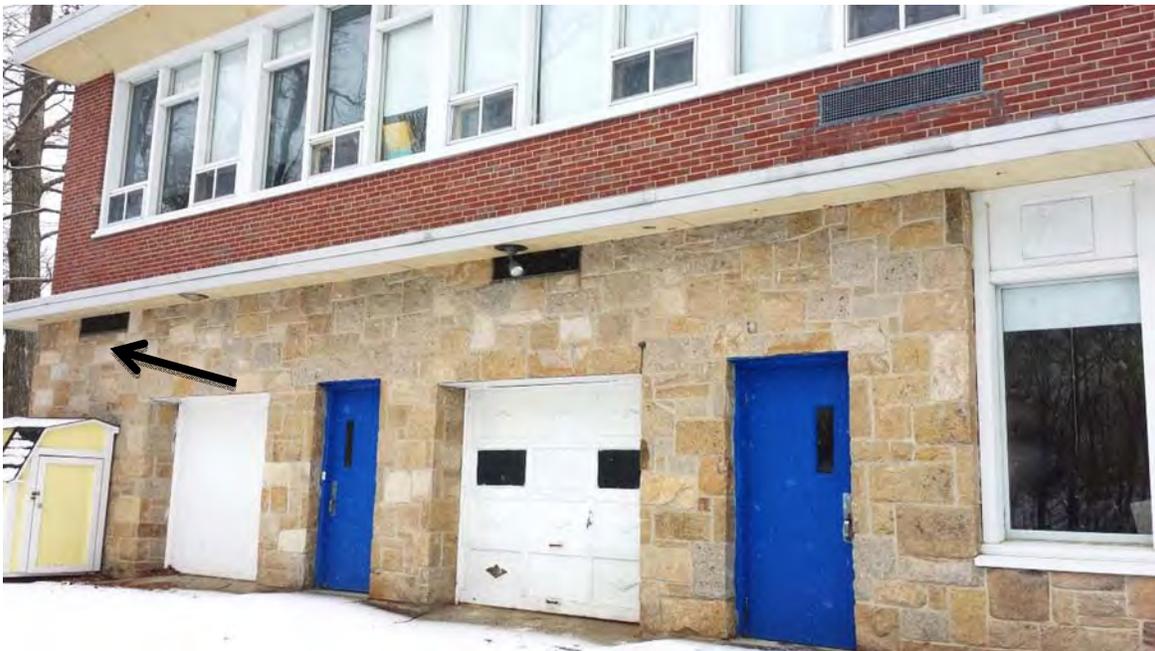
Picture 6

Adding to the potential condensation issue are other conditions noted in and around the library. As mentioned, the south wall of the library has a garage door opening (Picture 6). The exterior face of this garage door is currently covered with plywood panels (Picture 7). The base of the plywood showed water damage. In addition, leaves were found accumulated against the bottom of the paneling. Little sealant was observed in the seams of the plywood panels. Without proper sealant, moisture can penetrate through the seams.

The univent can also draw moist air into the library. The univent fresh air intake is located above a tool shed, which is flush against the exterior wall (Picture 6). The space between the back of this shed and exterior wall would be prone to moisture accumulation. Without airflow, the wood backing of the shed and debris accumulated in this gap cannot readily dry, allowing mold growth to occur. The univent can then draw in moisture, odor, and materials from this area via the fresh air intake and subsequently distribute these products throughout the library.

Exterior south wall of library with adjacent garage door, note tool shed below library fresh air intake (arrow)

1. Contact a professional regarding the possibility of increasing the height of the furnace stack to avoid entrainment of odors.
2. Consider sealing the former garage door with a watertight wall equipped with appropriate drainage.
3. Consult with an HVAC engineering firm for a plan to replace ventilation system components. Take into consideration the current and likely future uses of spaces to determine the placement of supply and exhaust ventilation to maximize airflow and removal of pollutants and odors, including dedicated exhaust ventilation in areas where copy machines and laminators are used.

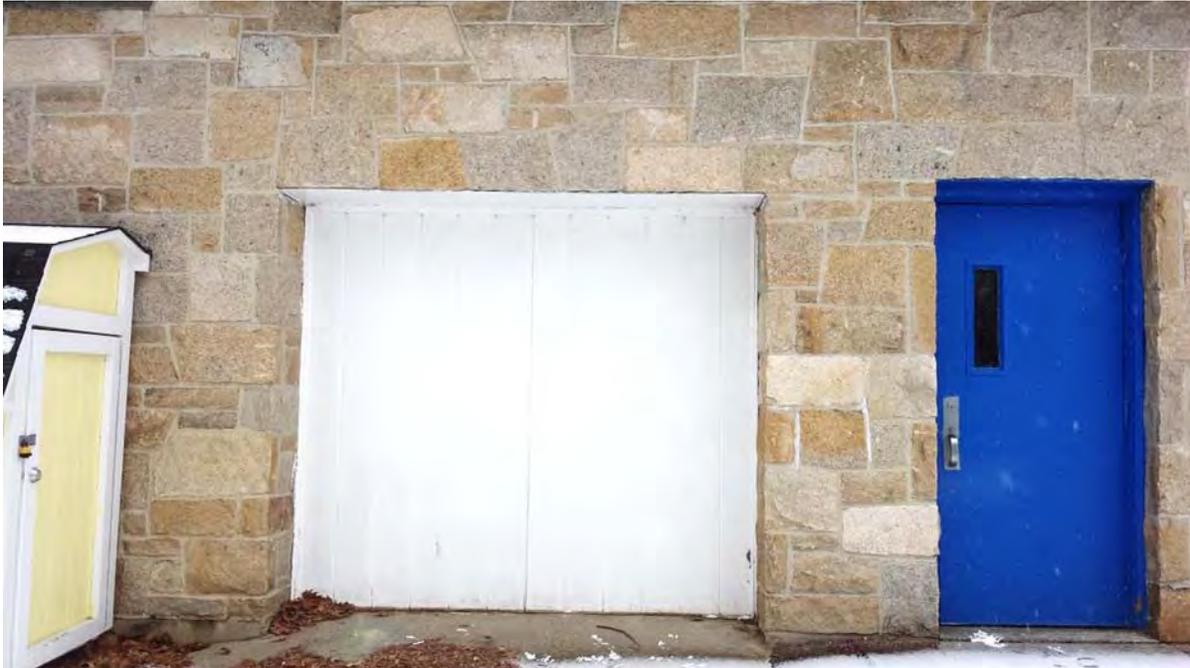
Picture 7

Original door opening appears to be sealed with plywood on its exterior face

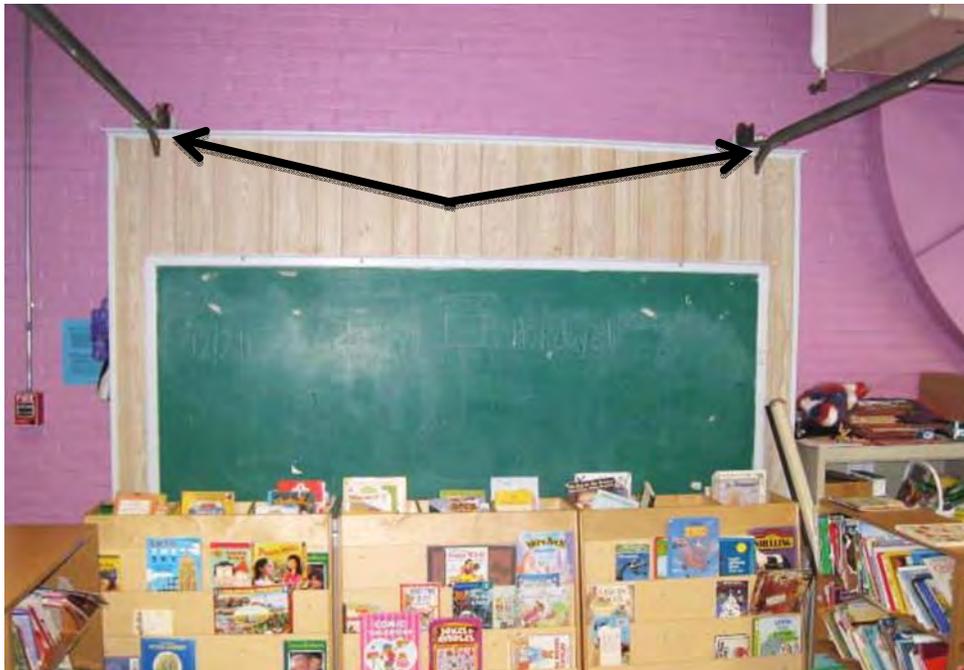
Picture 8

Within the library, a wooden frame with paneling was installed to conceal the garage door (Picture 8). The wood cover was installed around the original pull-down garage door rails. This covering appears to be hollow and not thoroughly insulated. Since the exterior plywood is unsealed and the interior lacks insulation, moisture, pests, and dusts can enter the library. Hot, moist air that penetrates through the exterior plywood can moisten debris accumulated within the wood-framed structure. If not dried within a 24 to 48 hour period, this moistened debris as well as water-damaged wood paneling can serve as a source of mold growth.

Former garage door covered by a wood paneling, note garage door railings (arrow)

9. Open the paneling box in the library and remove any water-damaged materials. Insulate the interior of the wall with a sufficient amount of insulation.

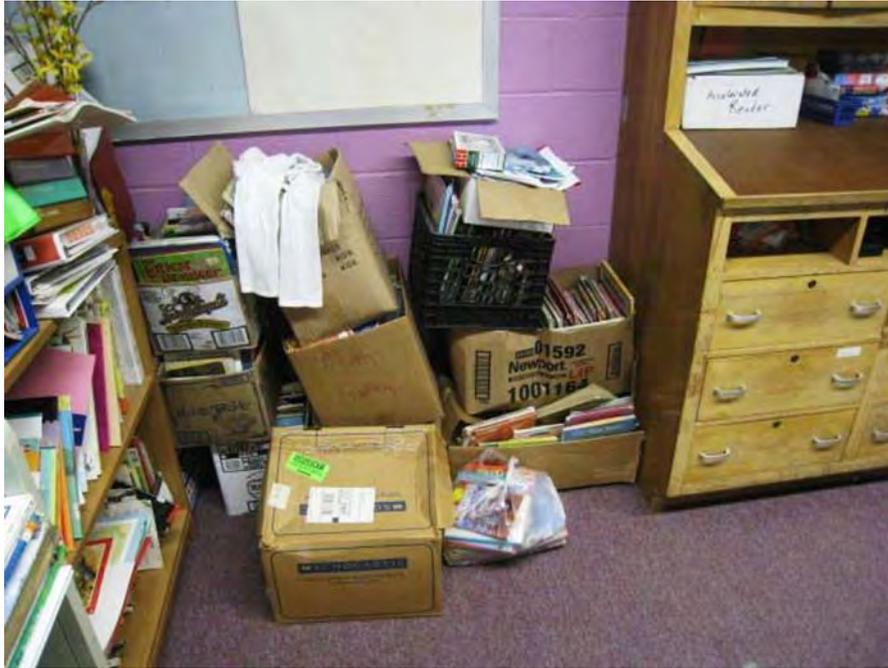
Picture 9

A number of other items in the library can become colonized with mold if moistened by condensation during hot, humid weather. These materials include books, cardboard boxes (Picture 9), upholstered furniture, and beanbags (Picture 10). If these materials are in close proximity to the return vent of the library univent, dust, mold spores and odors may be entrained and then distributed when the univent is operating.

Books in cardboard boxes on floor

12. Discard boxes stored on library floor. Examine material in boxes and discard if water-damaged/mold colonized.
13. Remove upholstered furniture from the library.

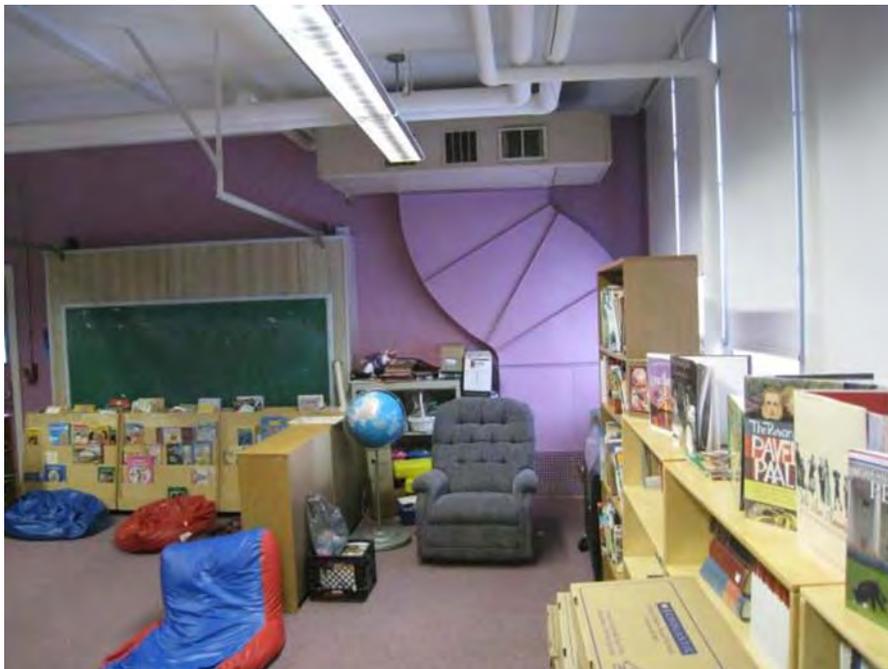
Picture 10

Upholstered furniture in front of univent fresh air intake, note bean bag chairs and similar items on floor

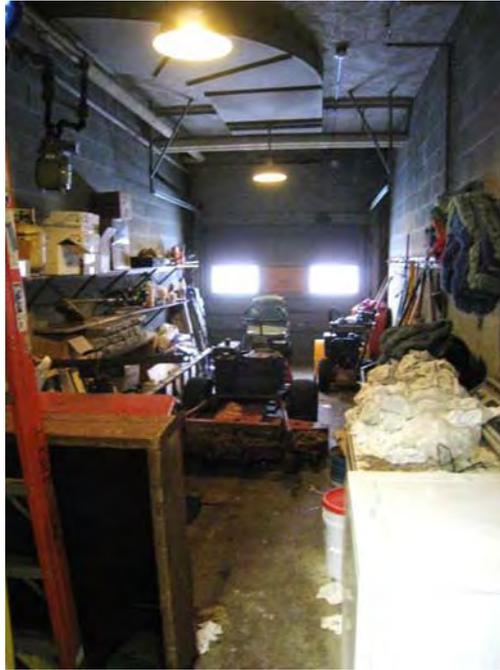
Picture 11

A garage is located adjacent to the library. This garage contains an industrial-sized lawn mower (Picture 11), washer, dryer (Picture 12), and various other materials. The door separating this garage from the library was not airtight. The worn/damaged weather-stripping (Picture 13) can allow hot, moist air from outside, as well as vapors and odors from the stored materials and

Lawn mower in garage

4. Repair the hole in the chimney for the furnace.
5. Reseal the door leading from the library to the garage with weather-stripping and a door sweep.
6. Consider housing the lawn mower in a different location to avoid exhaust entrainment by the univent fresh air intake located above the garage door.

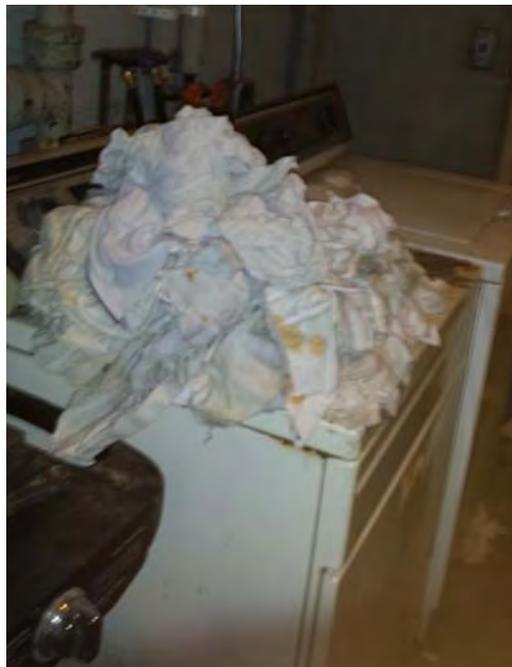
Picture 12

the lawn mower to penetrate into the library. In addition, the dryer vent exhausts directly into the garage area, which would add additional moisture to the garage, which can then migrate into the library via the interior garage door.

Washer and dryer in garage

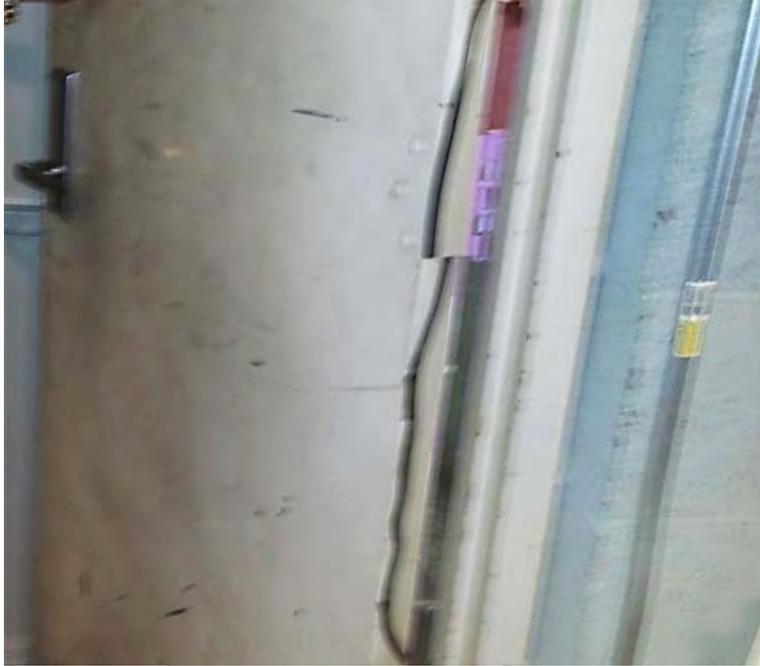
Picture 13

Door to garage area from library; note damaged weather-stripping

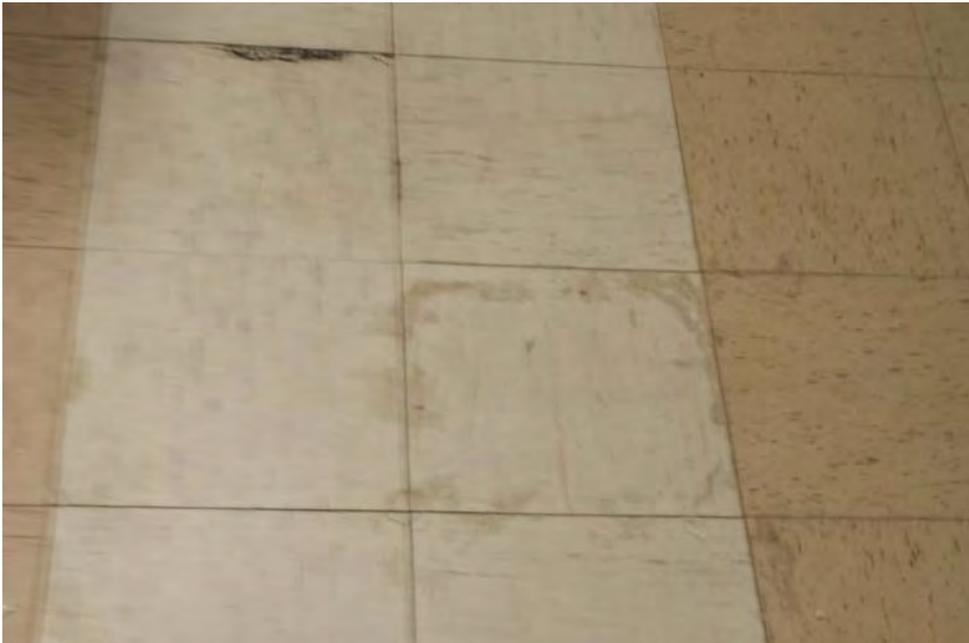
Picture 14

Floor tiles in some areas showed signs of historic water damage, including mastic that had dissolved and come up to the top of tiles (Picture 14). This material is a sign of past water affects to the tiles, but is not mold.

Floor tiles showing water damage/lifted mastic

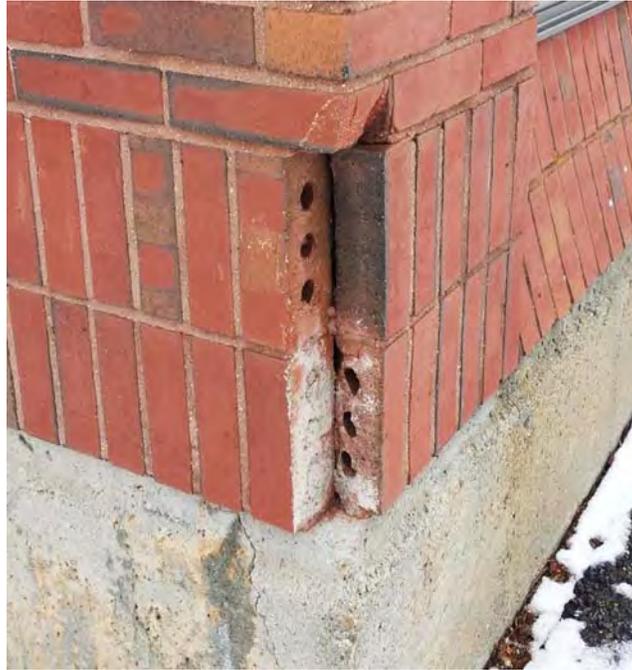
Picture 15

BEH/IAQ staff examined the exterior of the building to identify breaches in the building envelope and/or other issues that could provide a source of water penetration. Damage was noted to brickwork (Picture 15) and concrete (Picture 16) along the edge of the building. These conditions can undermine the integrity of the building envelope and provide a means of water entry by capillary action into the building through exterior walls, foundation concrete, and masonry (Lstiburek & Brennan, 2001). In addition, these breaches in exterior areas can provide a means of drafts and pest entry into the building.

Damaged brickwork

26. Have repairs made to the exterior of the building envelope, including brick and concrete damage.
 27. Ensure indoor plants are equipped with drip pans. Examine drip pans periodically for mold growth and disinfect with an appropriate antimicrobial, as needed. Move plants away from the air stream of mechanical ventilation equipment.

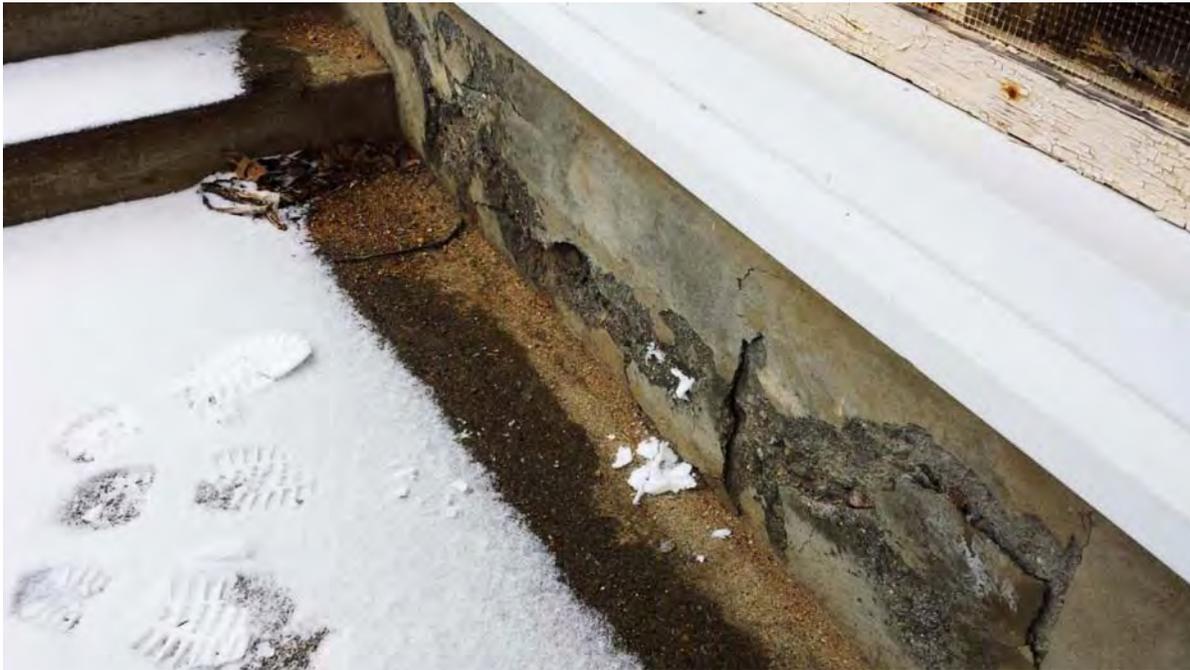
Picture 16

Damaged concrete

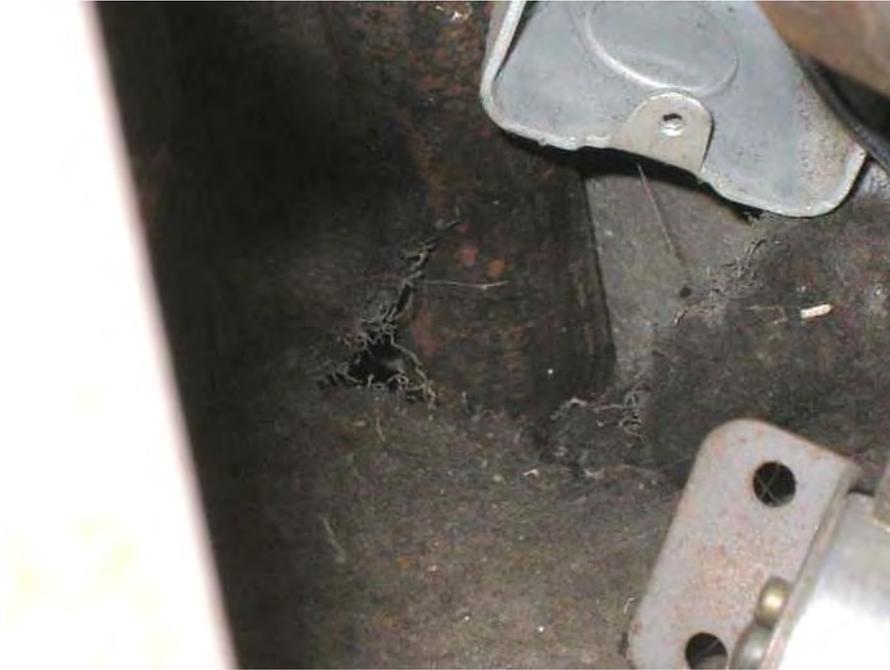
Picture 17

Other conditions that can affect IAQ were observed during the assessment. The univents in classrooms 6 and 7 were opened and examined. There were large gaps around the pipes to the univent where they entered through the floor (Pictures 17 and 18). Directly below these two classrooms is the boiler room. Occupants of these classrooms had complained of exhaust-like odors. Gaps around pipes provide a pathway for odors and pollutants from the boiler room to migrate into occupied areas. These breaches should be sealed with an appropriate fire-rated sealant and checked for tightness every time the univents are serviced.

Gap in univent cabinet leading to boiler room

2. Investigate the source of the diesel odors near the fuel tank shown in Picture 20.
3. Repair/seal holes where pipes enter univent cabinets using appropriate fire-rated sealant.

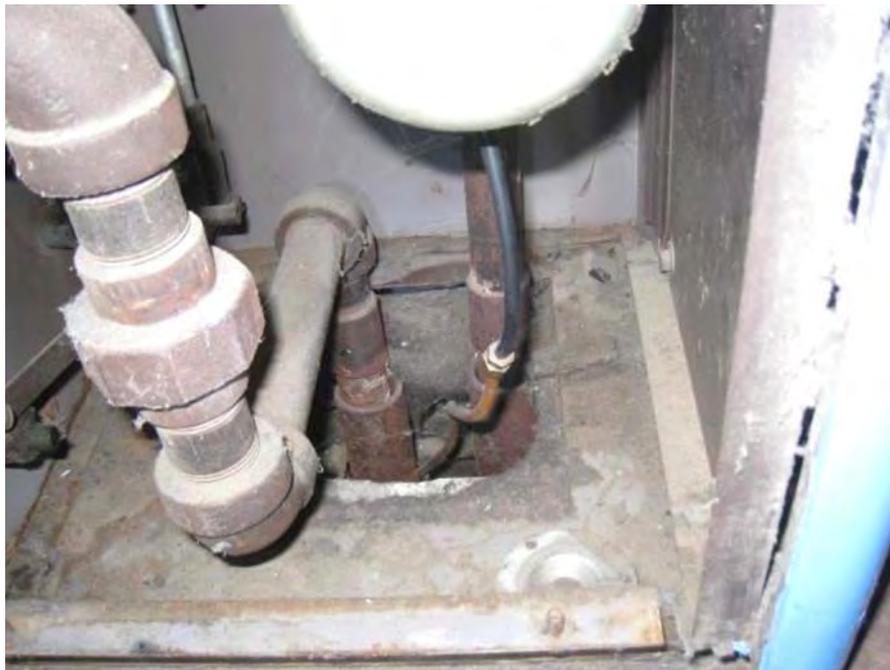
Picture 18

Gap where pipe enters univent cabinet

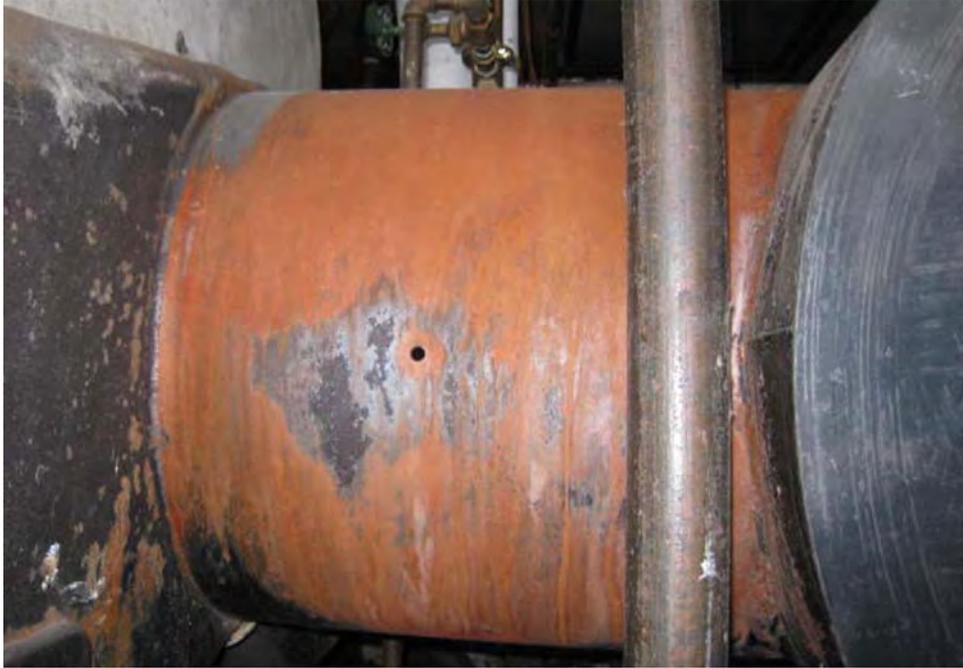
Picture 19

Breaches were also observed in chimney of the main boiler located in the boiler room (Picture 19). This hole should be sealed to prevent the escape of exhaust gases to the indoor environment.

Hole in boiler chimney

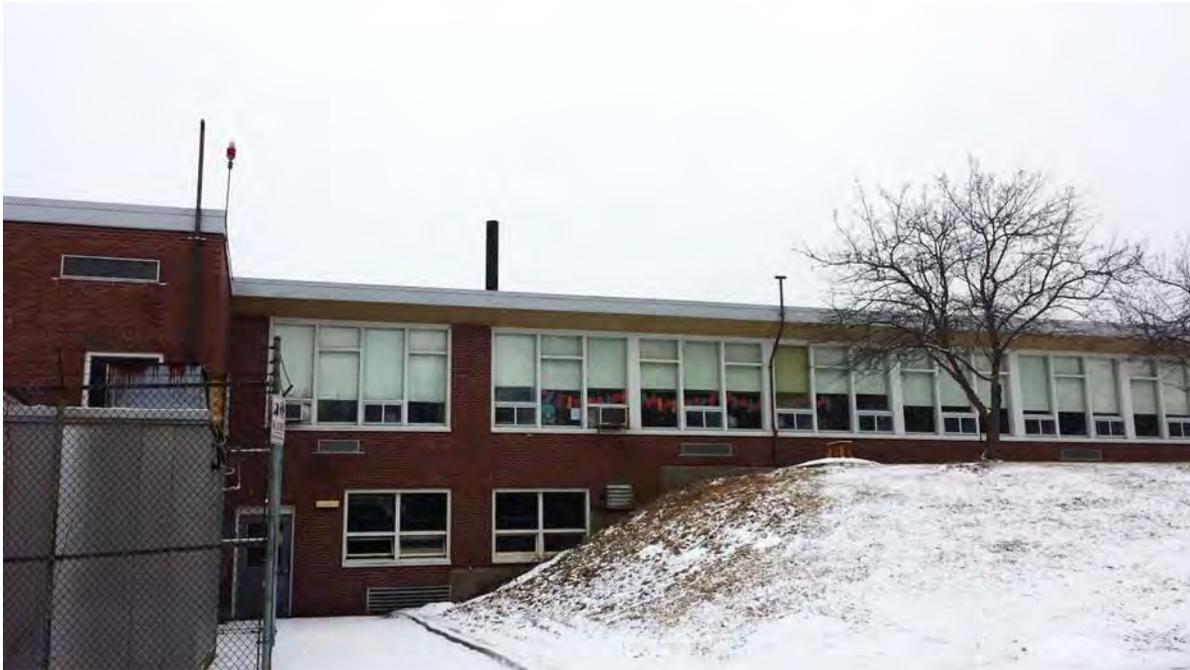
Picture 20

When examining the outside of the building, BEH/IAQ staff noted a diesel odor in the area adjacent to the fuel tank (Picture 20). It also appears that the chimney for the building's furnace systems is shorter than expected. These two conditions can potentially result in odors, particulates, and products of combustion entering the building through windows and air intakes. The kitchen in particular may be susceptible to the infiltration of odors and exhaust, due to the location of the air intakes. The influx of oil odors and combustion products into the kitchen is enhanced by the kitchen hood, which would tend to draw more make-up air into the building.

The strong diesel odor in this area may indicate a leak or malfunction of the tank or associated equipment. One of the recommendations of the 2006 report was to raise the fuel pipe vent higher than the school roof, which appears to have been done. Additional measures to reduce odors could be taken, including raising the chimney height. The Spencer Public Schools should contact a professional regarding potentially increasing the height of the chimneystack to further reduce the potential for entrainment of odors.

Location of fuel tank and chimney

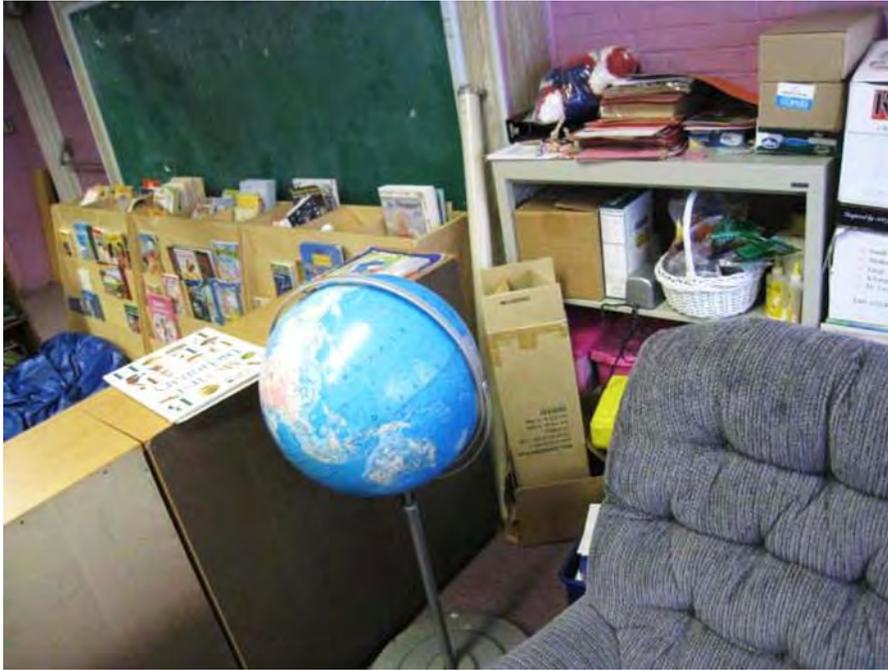
Picture 21

Upholstered furniture, pillows/cushions and large stuffed animals were seen in several classrooms and the library (Picture 21). Upholstered furniture, pillows, and cushions are covered with fabric that comes in contact with human skin. This type of contact can leave oils, perspiration, hair, and skin cells. Dust mites feed upon human skin cells and excrete waste products that contain allergens. In addition, if relative humidity levels increase above 60 percent, dust mites tend to proliferate (US EPA, 1992). Frequent vacuuming of upholstered furniture is recommended to remove dust mites and other pollutants (Berry, 1994). It is also recommended that upholstered furniture (if present in schools), be professionally cleaned on an annual basis. If outdoor conditions or indoor activities (e.g., renovations) create an excessively dusty environment, cleaning frequency should be increased (every six months) (IICRC, 2000).

Plush items and other items stored in the library

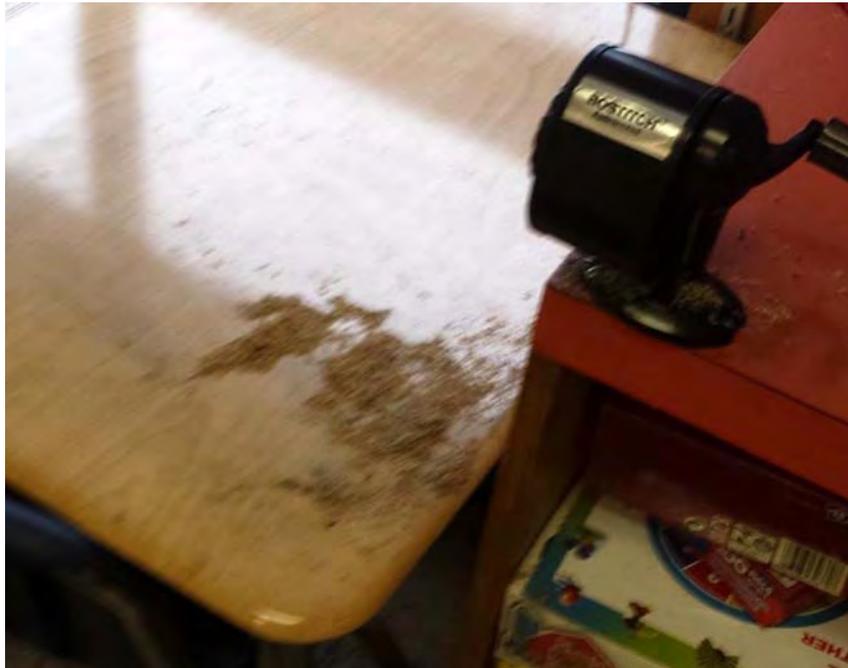
Picture 22

Accumulations of pencil shavings were observed in some areas (Table 1; Picture 22). Pencil shavings can become a respiratory irritant if airborne.

Pencil shavings

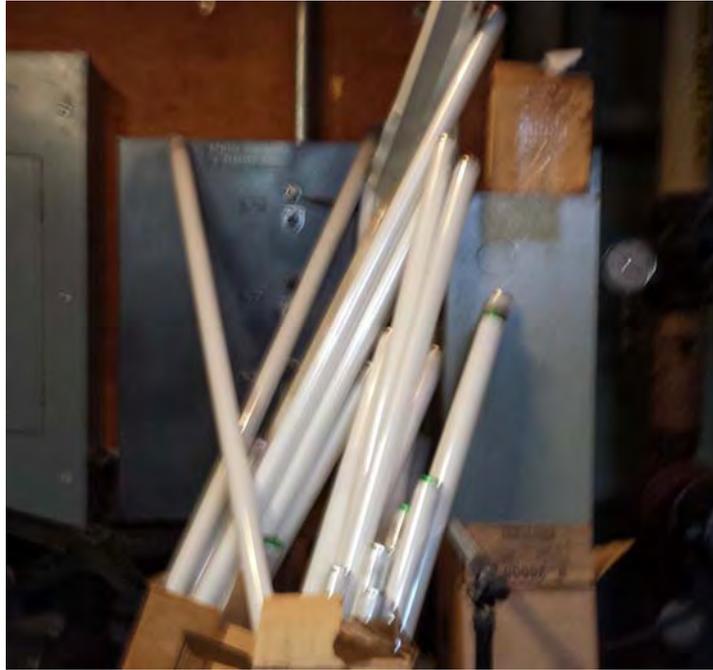
Picture 23

Fluorescent bulbs improperly stored
