INDOOR AIR QUALITY ASSESSMENT

**Commonwealth of Massachusetts
Department of Transitional Assistance
21 Spring Street
Taunton, MA**

Prepared by:
Massachusetts Department of Public Health
Bureau of Environmental Health
Indoor Air Quality Program
March 2014

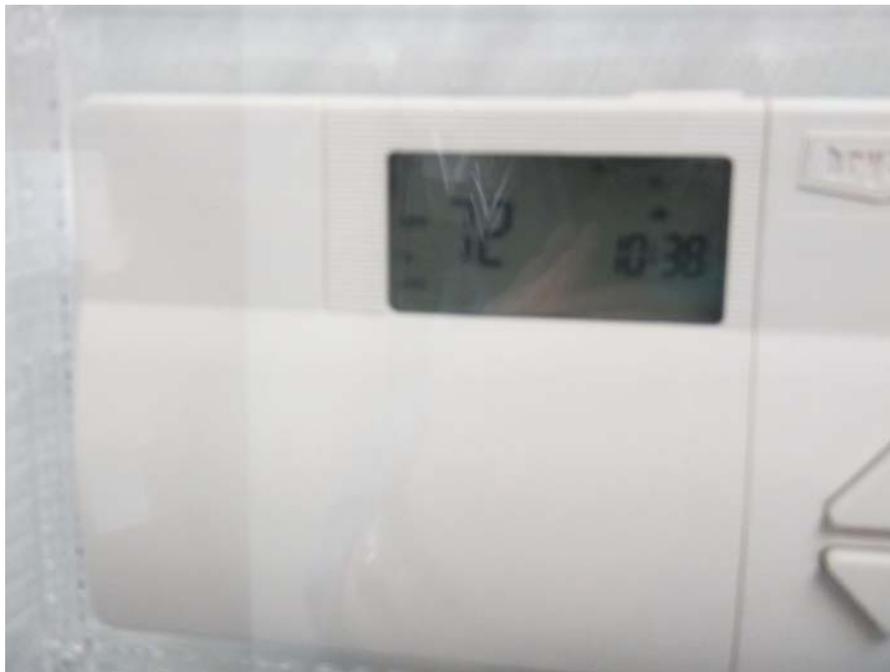
Picture 5

The HVAC system is controlled by digital thermostats. Thermostats examined had a fan switch with two settings, *on* and *auto* (Picture 5). When the fan is set to *on*, the system provides a continuous source of air circulation and filtration. The *automatic* setting on the thermostat activates the HVAC system at a pre-set temperature. Once the pre-set temperature is reached, the HVAC system is deactivated. Therefore, no mechanical ventilation is provided until the thermostat re-activates the system. At the time of assessment, the thermostat fan setting as in the “auto” position. As mentioned, this thermostat setting can limit airflow. The MDPH typically recommends that thermostats be set to the fan *on* setting during occupied hours to provide continuous air circulation. All of the thermostats examined at the DTA were set to the fan *auto* setting at the time of assessment.

Digital thermostat set to fan "auto"

1. Set thermostats to the fan “on” position to provide continuous air circulation/filtration during business hours.
2. Work with building management and/or an HVAC engineer to make provisions for supply ventilation in the reception area.

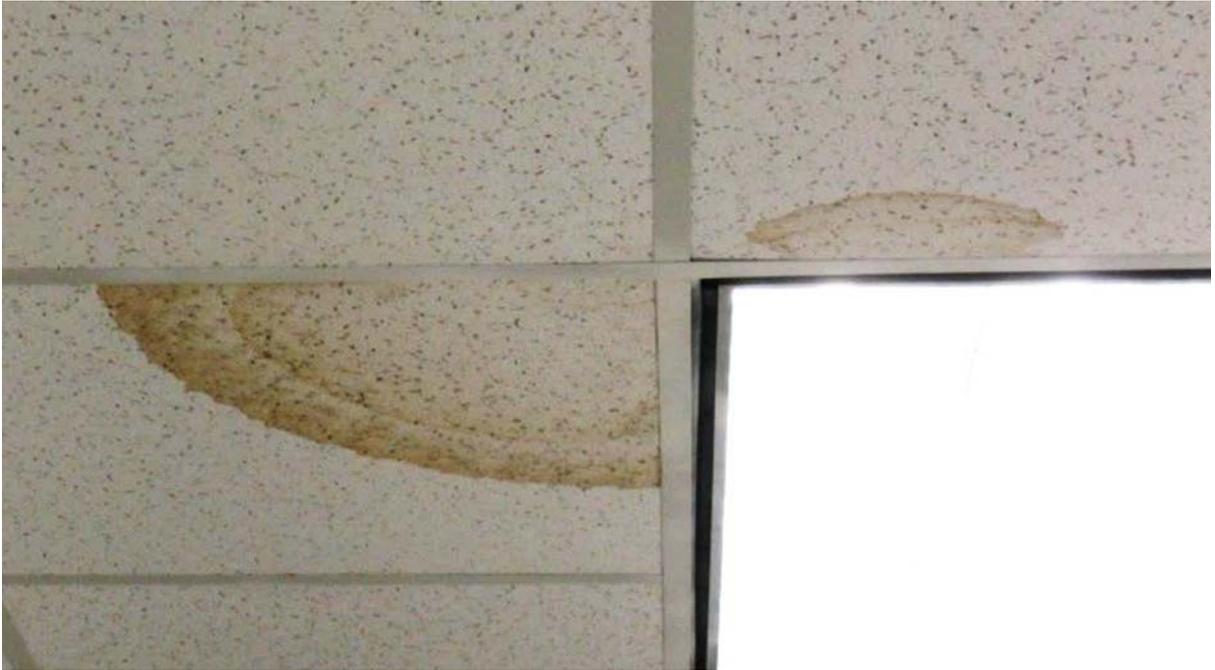
Picture 6

In order for building materials to support mold growth, a source of water exposure is necessary. The main concern voiced by DTA employees was related to musty odors from chronic water leaks in the central/open work area. DTA staff pointed out water-damaged ceiling tiles, specifically in workstations 151-156 (Picture 1; Picture 6). It was reported that ceiling tiles in these areas have been changed a number of times due to repeated leaks. BEH/IAQ staff removed tiles in this area to observe conditions in the ceiling plenum. Approximately 3 to 4 feet above the ceiling tile system appeared to be a metal/tin-style ceiling (Picture 7), which would not

Water-damaged ceiling tiles in common work area (151-156) where reoccurring leaks were reported

1. Work with building management to help identify areas of chronic leaks within DTA occupied space. Building management should consult with a professional roofing contractor to ensure leaks are repaired.

3. Replace water-damaged ceiling tiles (e.g., areas 151-156, conference room) once leaks are repaired. Monitor for further leaks. If staining of ceiling tiles reoccurs, report to building management for prompt remediation.

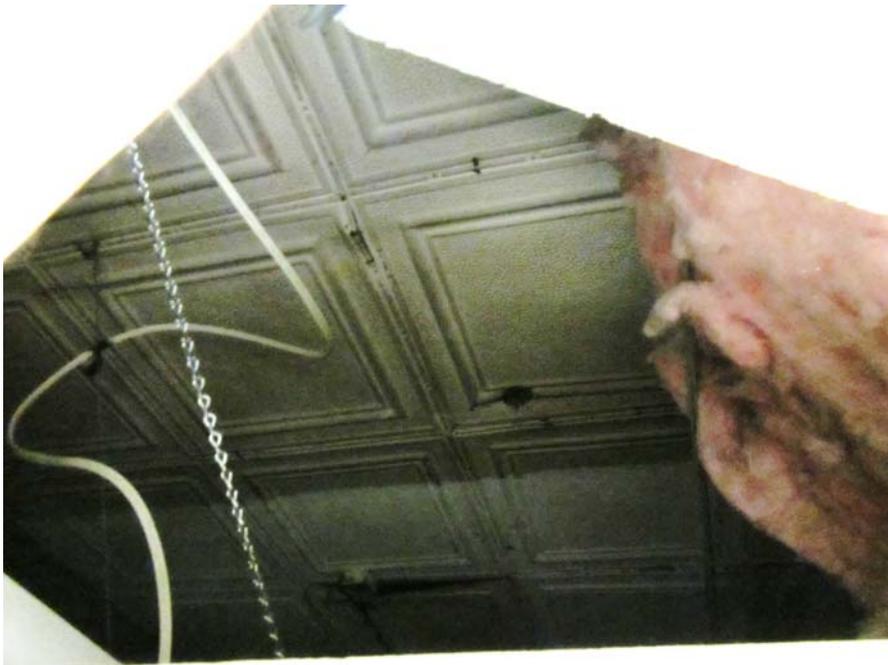
Picture 7

be conducive to mold growth. However, bats of fiberglass insulation (Pictures 7 and 8), as well as old/loose ceiling tiles were found resting directly on top of water stained ceiling tiles observed. These absorbent materials are likely the source of musty odors reported by occupants.

Metal ceiling panels above water-damaged ceiling tiles in common work area (151-156)

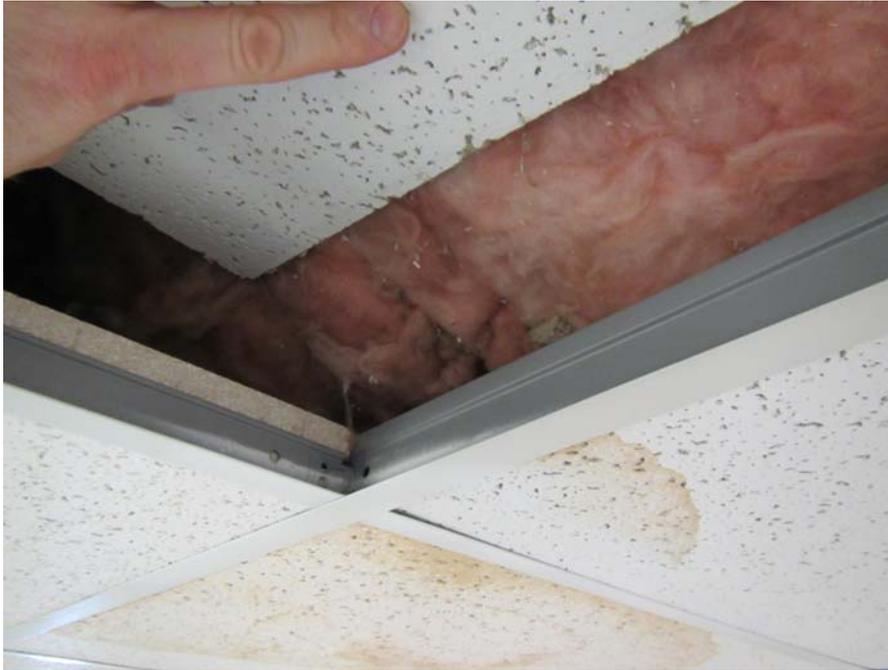
Picture 8

Fiberglass insulation above water-damaged ceiling tiles in common work area (151-156)

2. Remove water-damaged fiberglass insulation, particularly in areas where chronic leakage occurs, to remove absorbent materials and prevent musty odors.

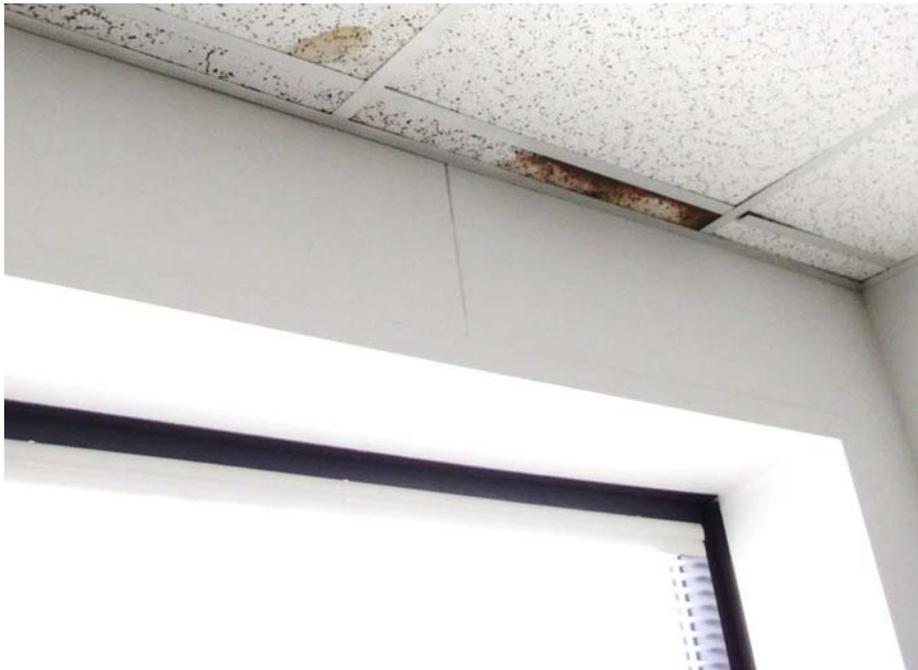
Picture 9

Water-damaged ceiling tiles were also observed in the conference room above windows (Picture 9). BEH/IAQ Staff also noted fiberglass insulation above water-stained ceiling tiles in the conference room. Water-damaged ceiling tiles in the copy room are reportedly from an elbow joint leak that has since been repaired (Pictures 10 and 11). BEH/IAQ staff did not observe any active leakage at the time of assessment.

Water-damaged ceiling tiles in conference room

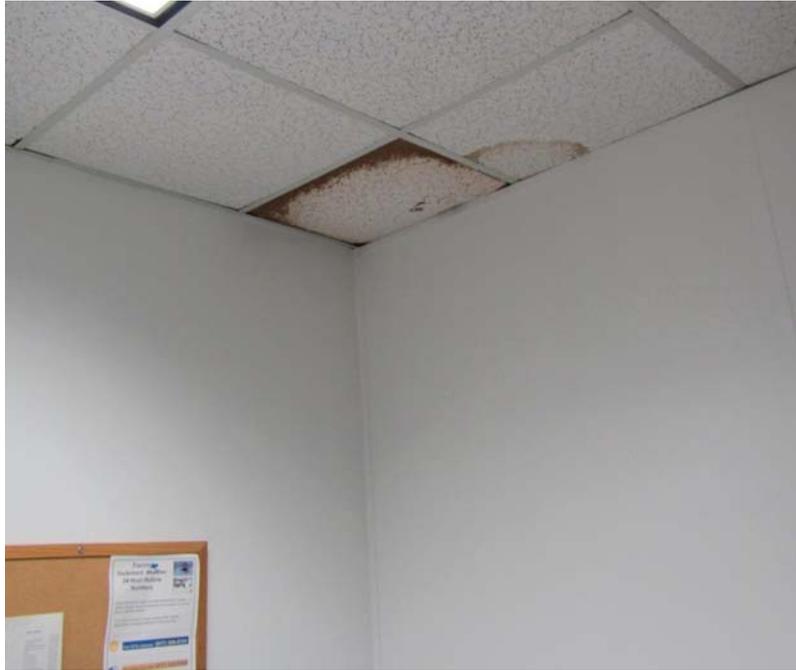
Picture 10

Water-damaged ceiling tiles in copy room

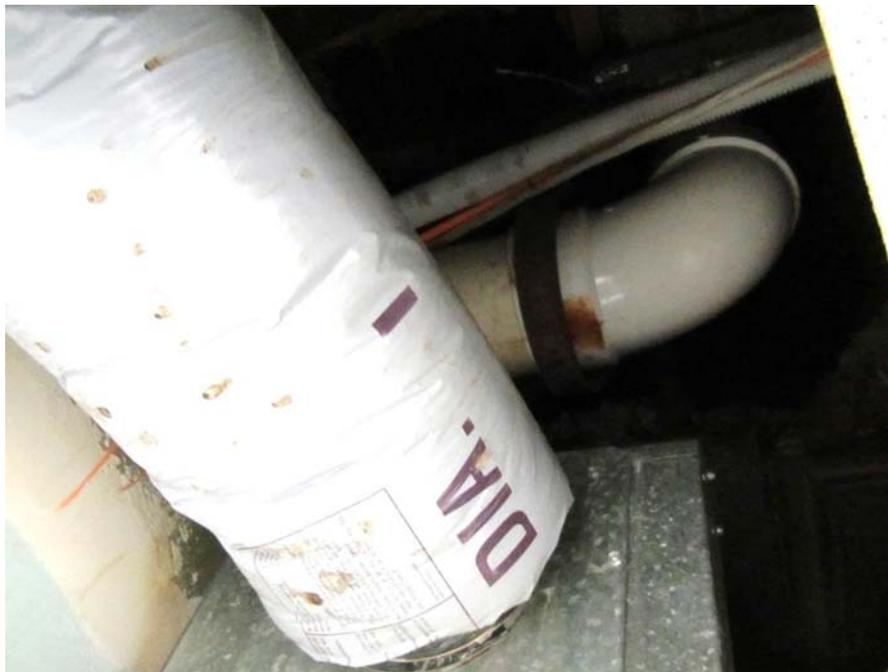
Picture 11

Leaking elbow joint (repaired) above water-damaged ceiling tiles in copy room

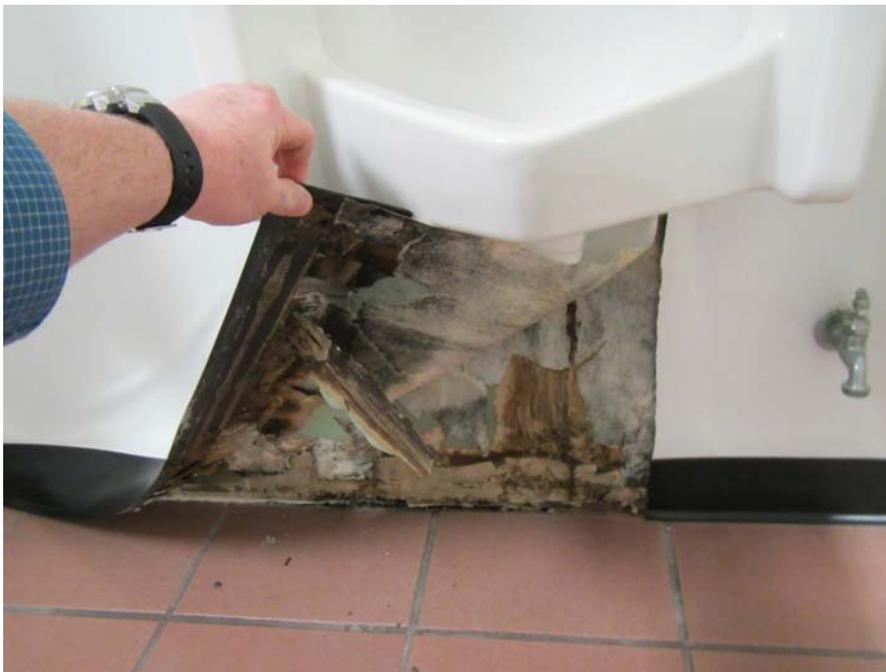
Picture 13

Visible mold growth from chronic moisture exposure was observed in both the men's and women's employee restrooms. Walls in these areas, as well as other perimeter walls throughout the space (e.g. Area Director's office), consist of gypsum wallboard (GW) panels sealed with vinyl wallpaper (Picture 12). BEH/IAQ staff peeled back the material in several areas along the restroom floor near water sources (e.g., toilets, pipes) and found GW water-damaged and colonized with mold (Pictures 13 through 15). Since GW is a porous material prone to mold growth, use of it along restroom walls that can experience repeated moisture exposure is not recommended. Since the vinyl covering serves as an impermeable barrier, the GW cannot dry; moisture trapped behind the vinyl wallpaper can result in further damage.

Water-damaged/mold-colonized gypsum wallboard in employee men's restroom

5. Remediate damaged walls in the restrooms.
 - a. Contain/isolate areas of remediation. If the areas cannot be properly contained/isolated, remediation work should be conducted during non-business hours.

- b. Remove water-damaged/mold-colonized GW in employee restrooms in a manner consistent with recommendations found in “Mold Remediation in Schools and Commercial Buildings” published by the US Environmental Protection Agency (US EPA, 2001).

- e. Consider using a water/mold-resistant material such as cement board instead of GW in areas of chronic water leaks (e.g., restrooms).
 - f. Ensure air-handling units are deactivated and seal vents temporarily in remediation areas during removal/remediation of GW.

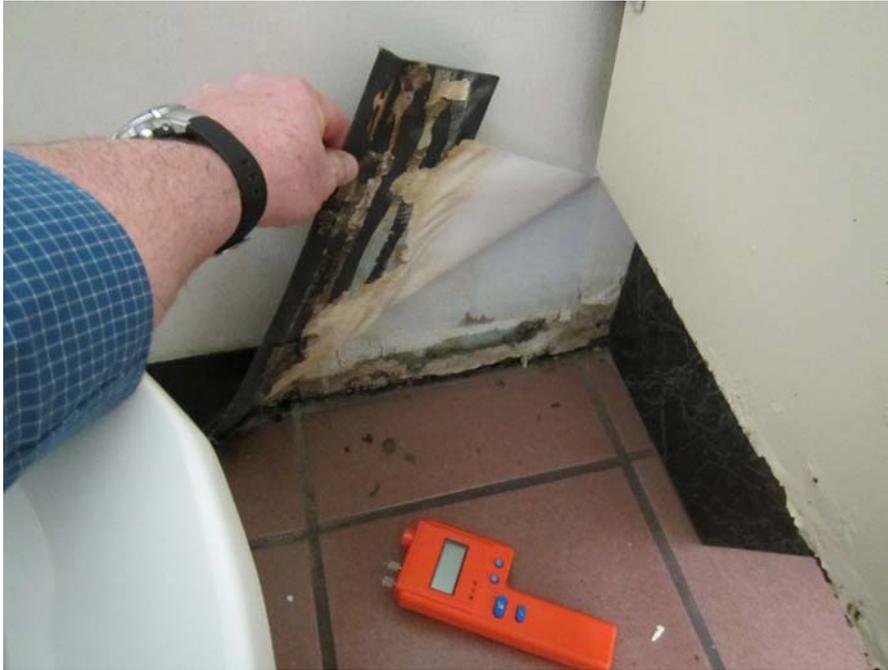
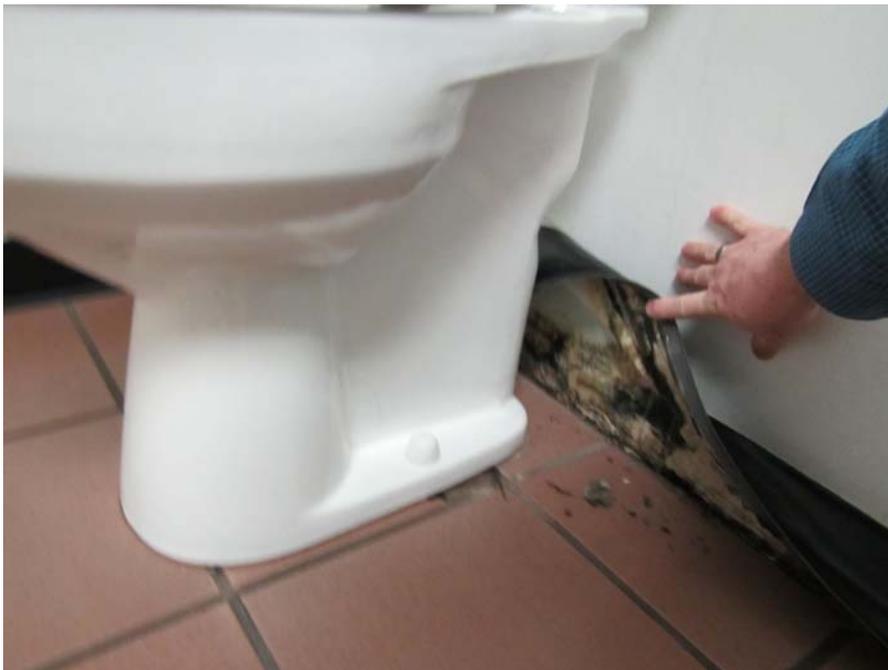
Water-damaged/mold-colonized gypsum wallboard in employee women's restroom

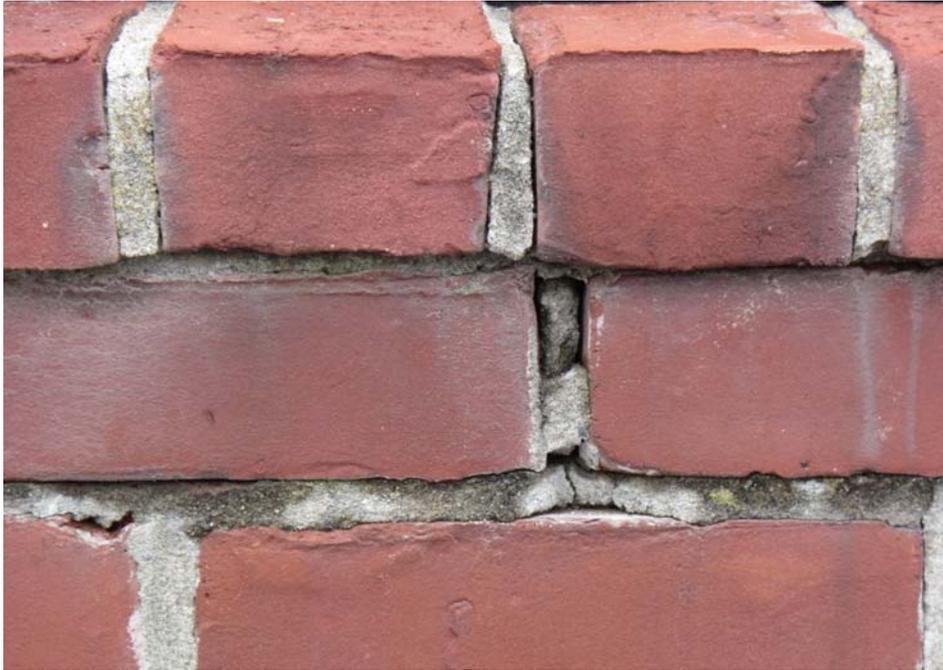
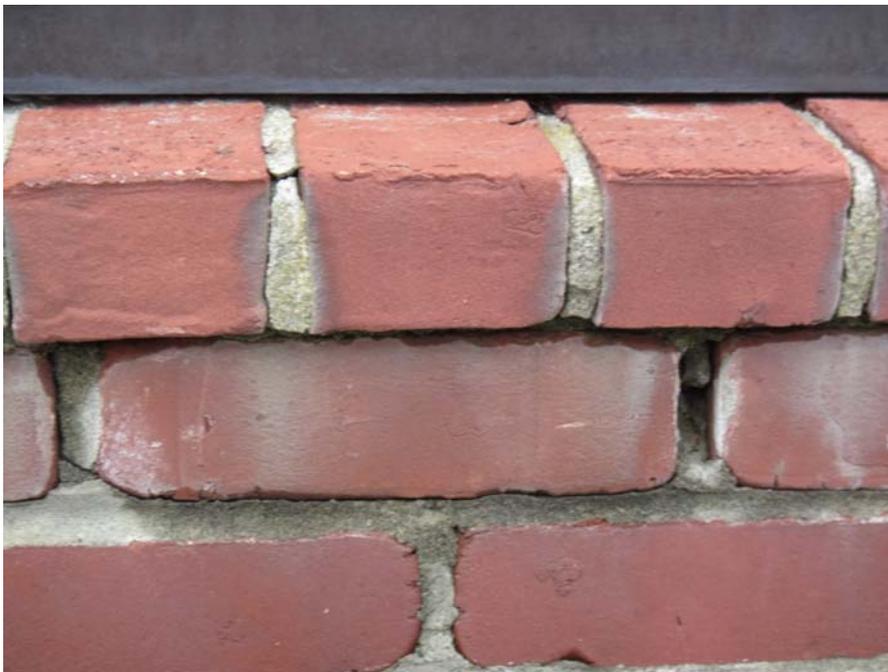
Occasional water infiltration was also reported in the Area Director's office. The Area Director indicated that water leakage from above the windows occurs during wind-driven rain events. Signs of water damage in the interior wall, including bubbling vinyl wallpaper, were observed. BEH/IAQ staff examined conditions on the exterior outside these areas and noted mortar around brickwork in need of repointing (Pictures 16 and 17). The condition of the building exterior (e.g. missing mortar) is likely source of water infiltration.

Missing/damaged mortar around exterior brick outside DTA

7. Re-point exterior brick to prevent further water damage and water penetration.
8. Ensure refrigerators are cleaned out regularly. Clean moldy gaskets with a mild detergent or antimicrobial agent, if cannot be adequately cleaned consider replacing.
9. Avoid the use of scented products including air fresheners.
10. Replace missing/damaged ceiling tiles.
11. Repair damaged wallboard in lunchroom.
12. Refer to resource manual and other related indoor air quality documents located on the MDPH's website for further building-wide evaluations and advice on maintaining public buildings. These documents are available at <http://mass.gov/dph/iaq>.

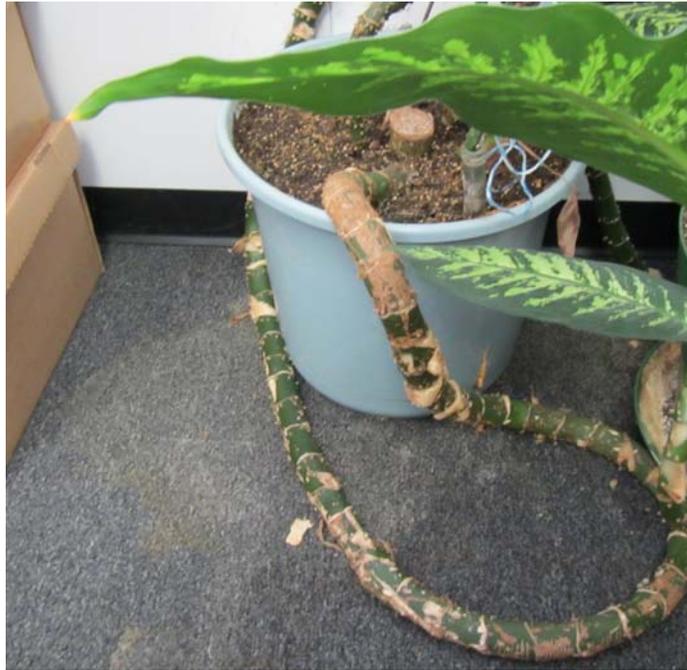
Picture 18

Other water damage issues were noted by BEH/IAQ staff. Plants were observed in several areas. Water-damaged/stained carpeting was observed beneath plants in the conference room as a result of over-watering or leaking drip pans (Picture 18). In some cases, plants were resting on paper or cardboard (Picture 19). Plants, soil, and drip pans can serve as sources of mold/bacterial growth. Porous materials such as paper and dirt/debris trapped in carpets can be a source of mold growth, if moistened repeatedly. Plants should be properly maintained, over-watering of plants should be avoided, and drip pans should be inspected periodically for mold growth.

Water-damaged/stained carpeting under plants in conference room

5. Remove large plants from carpeted area in conference room. Refrain from placing plants on porous materials (e.g., paper, cardboard, carpeting).
6. Avoid overwatering of plants. Ensure flat surfaces around plants are free of potting soil and other plant debris. Examine drip pans periodically for mold growth and disinfect with an appropriate antimicrobial where necessary.

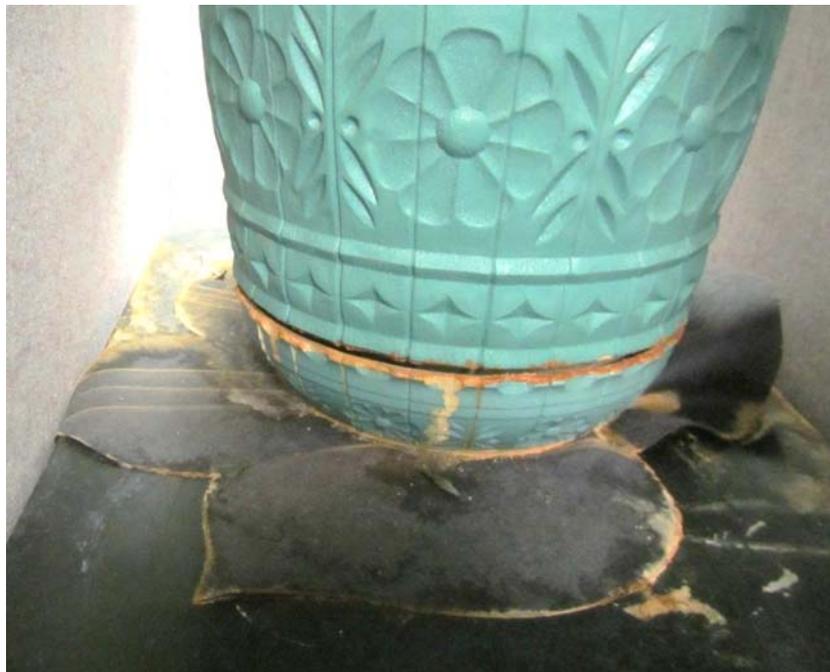
Picture 19

Plant on water-damaged/mold-colonized cardboard in work area

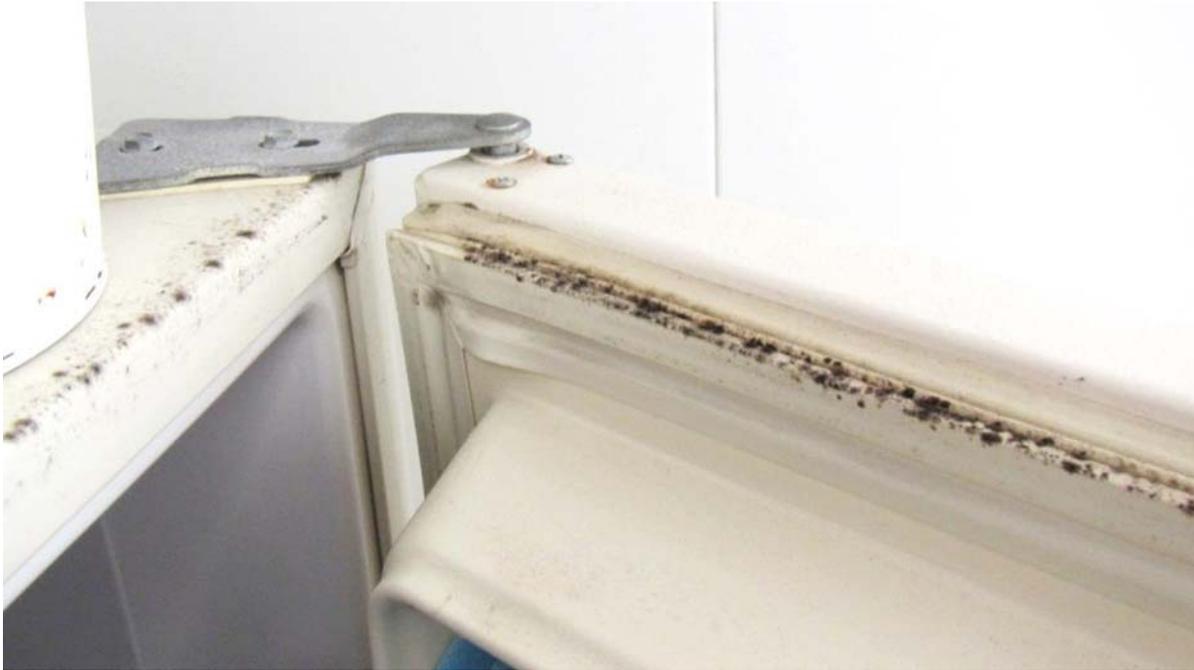
Picture 20

The lunchroom contains two refrigerators, white and tan. Visible mold growth was seen on the exterior of the tan refrigerator and on gaskets inside (Picture 20). Mold and debris trapped in the gasket can result in irritation or illness.

Mold growth on tan refrigerator/gasket in lunchroom

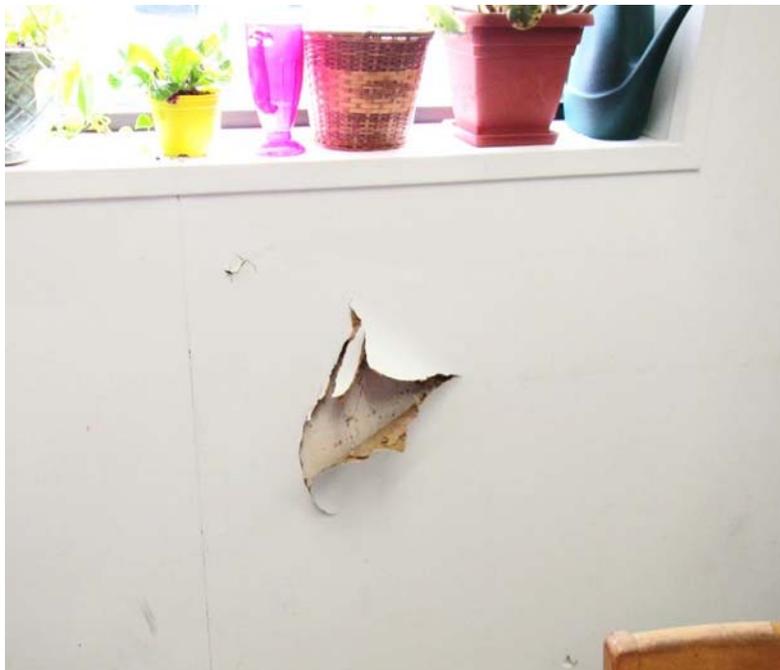
Picture 21

Other conditions that can affect indoor air quality were observed during the assessment. Physically damaged GW was noted in the lunchroom (Picture 21), and missing/ajar or broken ceiling tiles were observed in a few areas (Table 1). Holes in walls should be repaired/sealed and ceiling tiles should be intact and flush with the tile system to prevent movement of materials from the wall cavity and ceiling plenum, respectively, into occupied space where they can serve as a source of odors and/or irritation.

Damaged drywall in lunch room
