WATER DAMAGE/MOLD INVESTIGATION

**West Bridgewater Middle-High School
155 West Center St
West Bridgewater, MA**

Prepared by:
Massachusetts Department of Public Health
Bureau of Environmental Health
Indoor Air Quality Program
July 2014

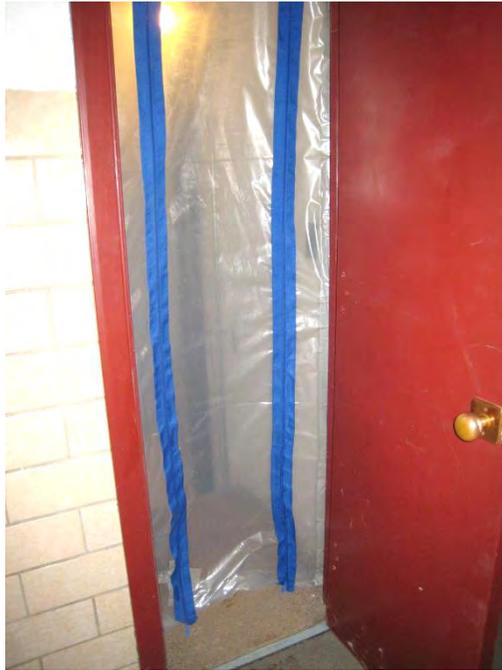
Picture 1

At the time of the BEH/IAQ assessment, a plastic containment door was noted at the entry to the basement boiler area (Picture 1). Water that had discharged from the broken supply pipe had been removed, the affected areas had been cleaned, and the electricity was operating (Picture 2). Dehumidifiers and fans were in place to remove moisture and dry the basement. The concrete basement was relatively dry, and no musty odors were observed. BEH/IAQ staff did detect some boiler-related odors. BEH/IAQ staff noted the presence of some water near the stairwell to the basement (Picture 3); Ms. Hamblin indicated that the water infiltration observed is not from the flood but from groundwater penetration that occurs annually.

Plastic containment door to basement boiler area

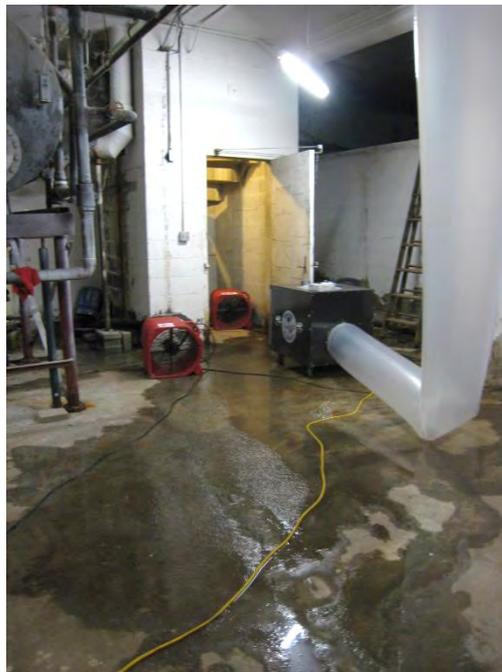
Picture 2

Water on floor near basement stairs

1. Continue to dry the basement area by operating fans and dehumidifiers.
2. Examine remaining porous materials in the basement for signs of water damage. Remove any water-damaged materials in a manner consistent with recommendations found in “Mold Remediation in Schools and Commercial Buildings” published by the US Environmental Protection Agency (US EPA, 2001).
3. Thoroughly clean the school to prevent any remaining dust/debris from persisting within the indoor environment.
4. Seal breaches and pipes and spaces in the univent cabinet walls in a manner that prevents the movement of materials from the basement to occupant areas.

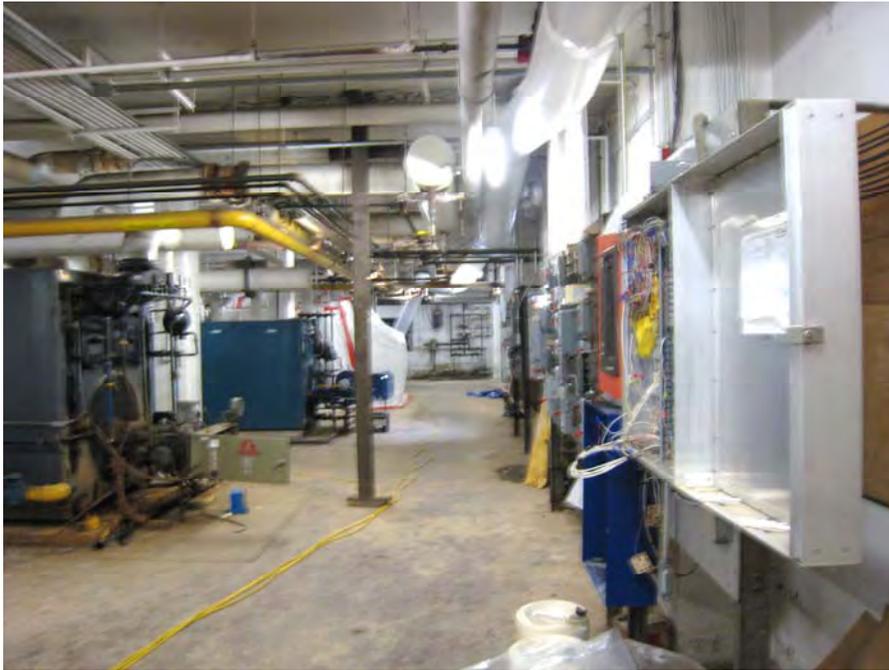
Picture 3

Dry basement area

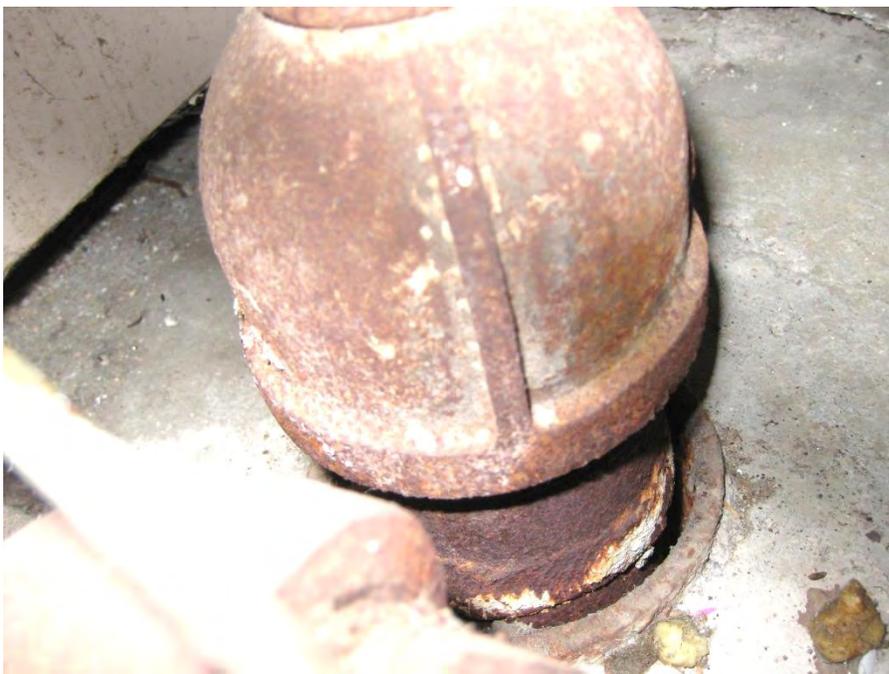
Picture 4

As mentioned, WBMHS staff were concerned about the impacts of the flooding to classrooms in close proximity to the boiler room. No basement/musty odors were observed in occupant areas at the time of assessment. BEH/IAQ staff examined classrooms above the basement for pathways that would allow movement of moisture/materials from the basement boiler areas to occupant areas. Breaches around pipes penetrating through the floor were observed in univent cabinets (Picture 4). Openings were also observed in the cabinet wall that separates the univent cabinet from the fan compartment (Picture 5). When a univent is operating, the fan can draw basement air up through breaches around pipes through openings in the univent cabinet wall, where the basement air is subsequently mixed and distributed to the

classroom. Since the openings in the univent wall are above the filtration compartment, dust/debris/odors that may be suspended in the basement air may also be circulated. Similar breaches were observed around heat/water pipes in the gym area.

Breach around univent pipe

Please note that at the time of assessment, univents were not operating. This would likely minimize any potential of movement of materials/odors from the basement to occupant areas. BEH/IAQ staff recommended that spaces around all pipes be sealed with a fire-rated foam insulation prior to re-activation of univents.

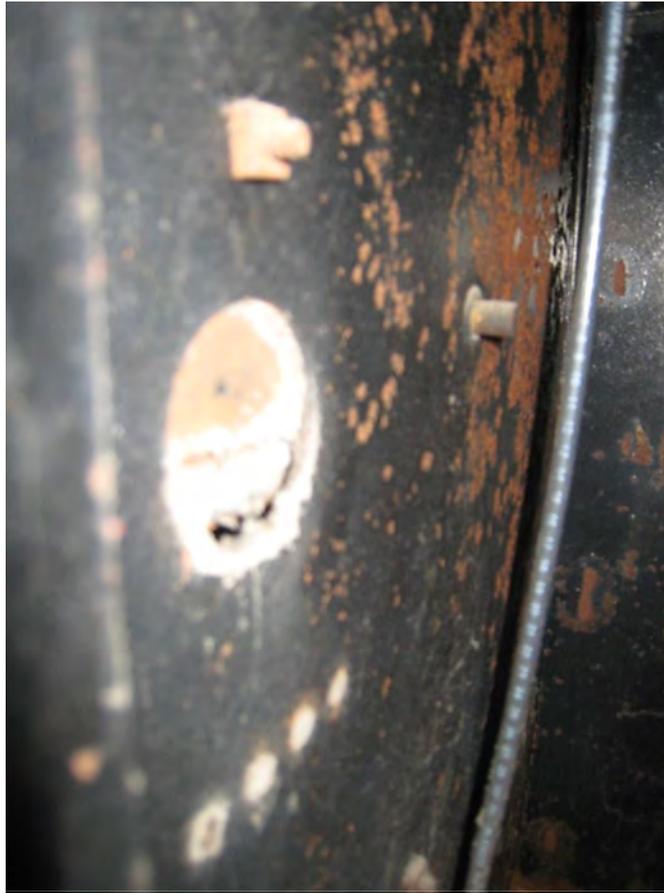
Picture 5

Space in univent cabinet wall
