INDOOR AIR QUALITY WATER DAMAGE ASSESSMENT

**Plymouth County District Attorney's Office
32 Belmont Street and 231 Main Street
Brockton, MA**

Prepared by:
Massachusetts Department of Public Health
Bureau of Environmental Health
Indoor Air Quality Program
November 2015

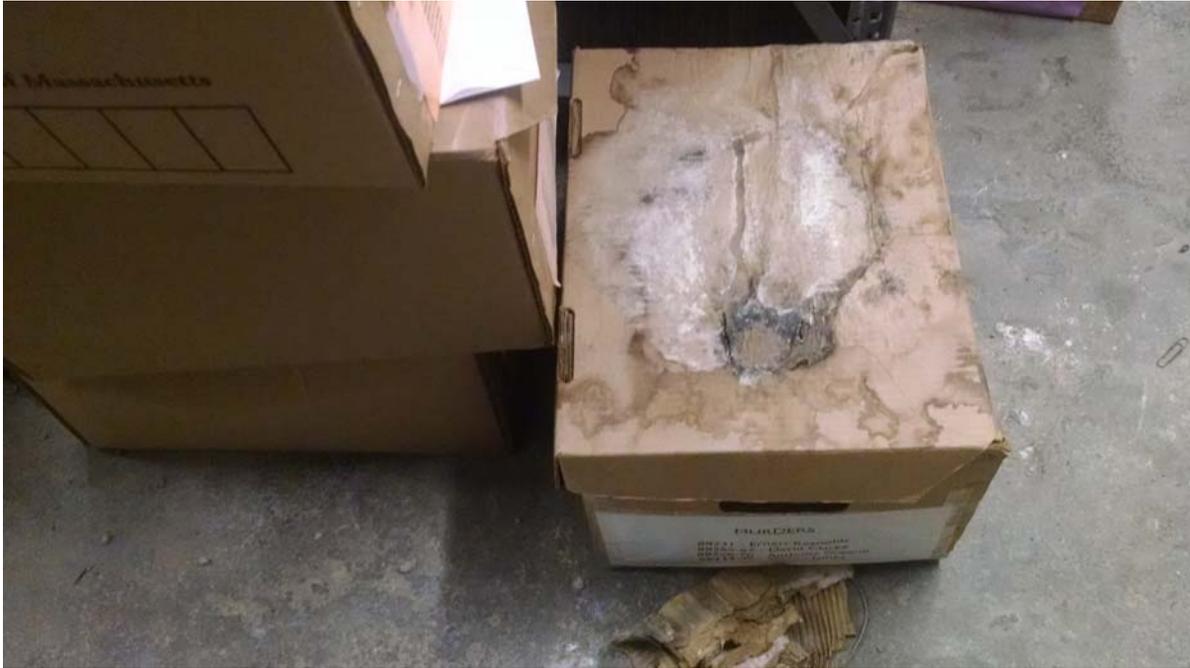
Picture 1

As mentioned, the visit was prompted by reports of water-damaged materials observed in the basements at each location (Picture 1), which are unfinished spaces consisting of concrete floors and cement walls. It was reported by DA's office staff that the main building experiences chronic leakage as a result of runoff from the building's parking lot. Measures have been taken to reduce runoff impacts to the basement; however, leaks are still experienced periodically. Staff regularly examine basement conditions in the main building after rain events.

Water-damaged box and files

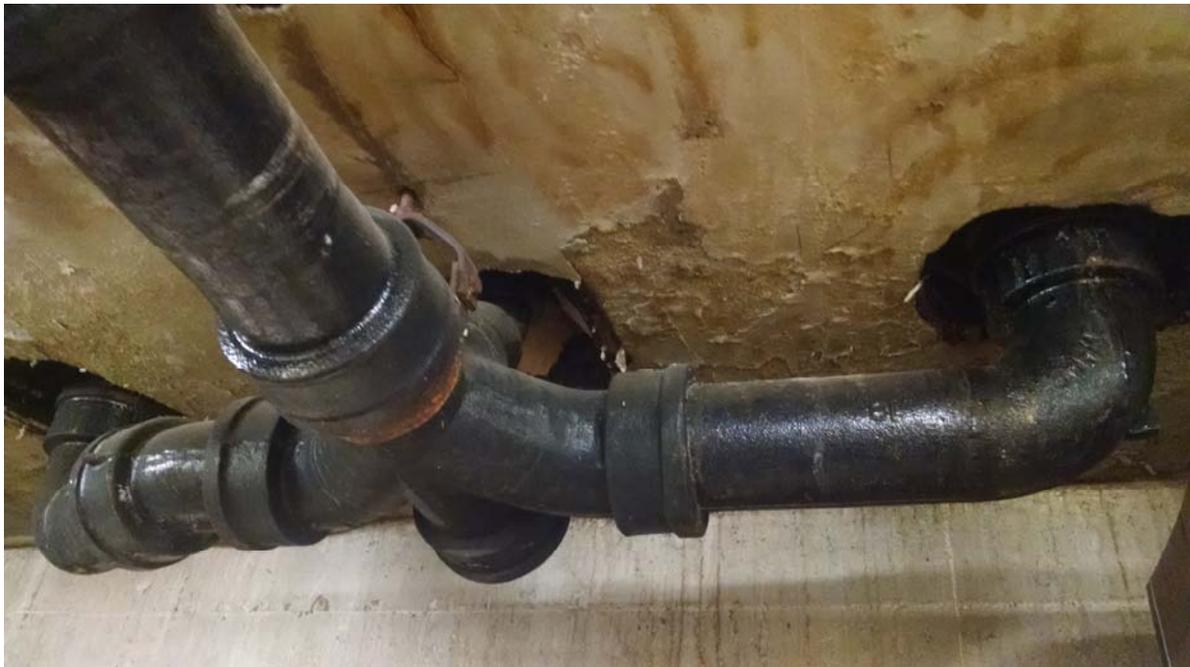
Picture 2

Staff reported that a pipe leak likely resulted in the damage observed to files stored in the basement of the satellite building (Picture 2). The timeframe of the pipe leak was unknown; a number of files were found damaged by staff retrieving items from the storage area.

Pipe leak resulting in water damage in the satellite basement
