INDOOR AIR QUALITY ASSESSMENT ODOR INVESTIGATION

**North Shore Community College
Health Professions Building
Danvers Campus
1 Ferncroft Road
Danvers, Massachusetts**

Prepared by:
Massachusetts Department of Public Health
Bureau of Environmental Health
Indoor Air Quality Program
May 2015

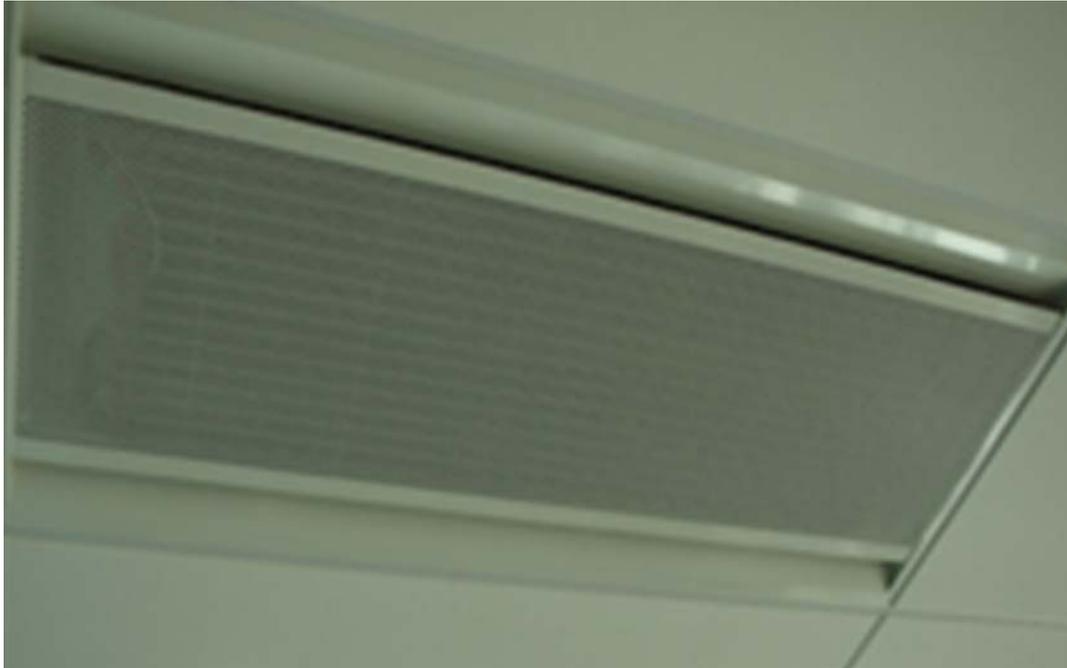
Picture 1

Chilled beam unit in ceiling tile system

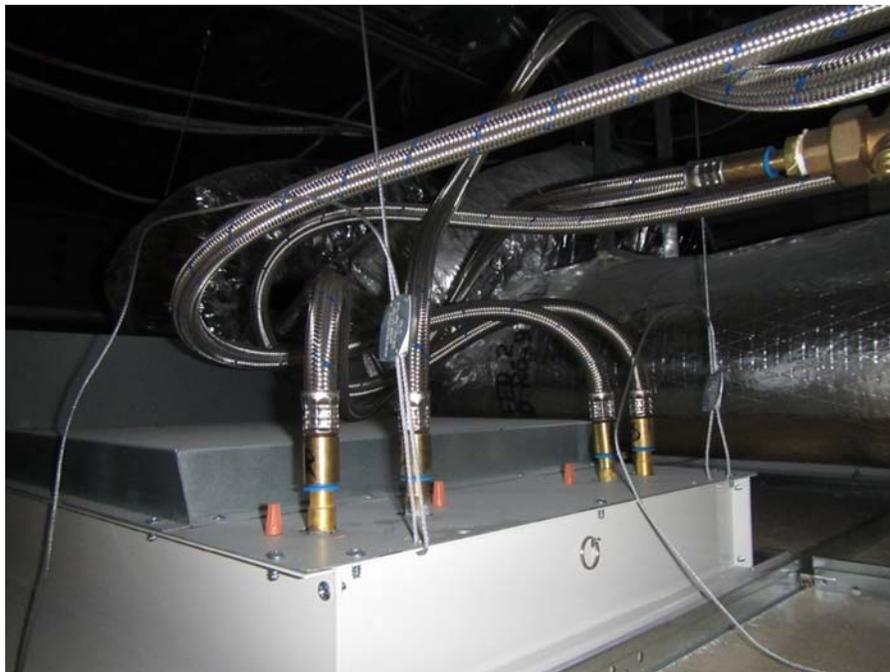
Picture 2

Chilled beam unit showing supply and return connections for heat and cooling coils

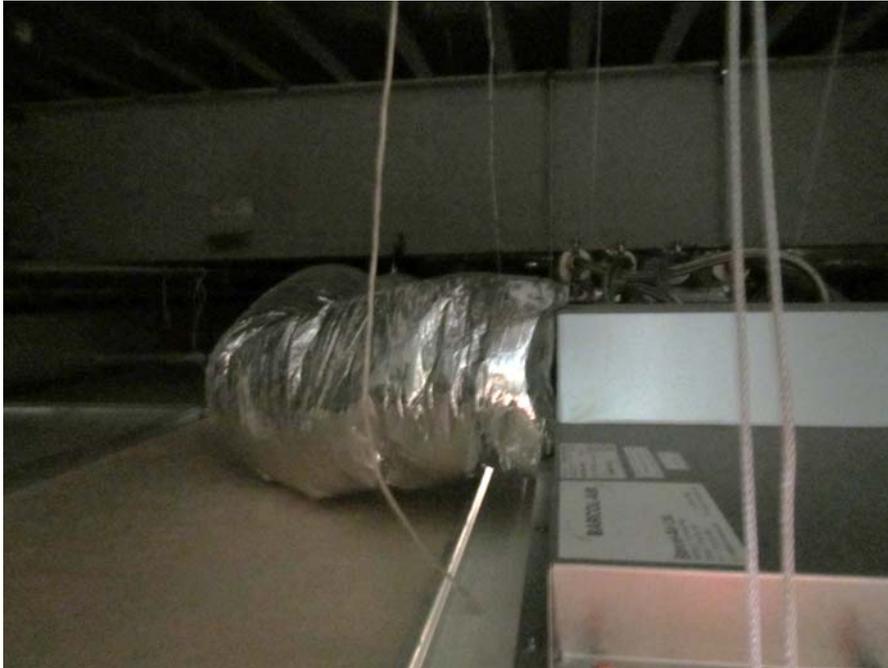
Picture 3

Chilled beam unit with ducted supply air from AHU attached

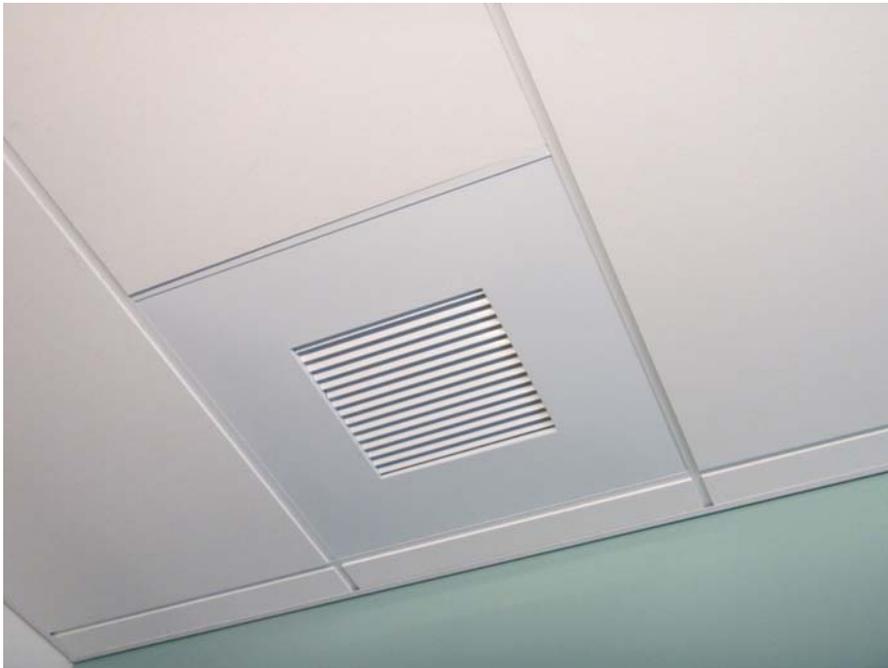
Picture 4

Exhaust air is drawn into ducted vents in the ceiling (Picture 4) and reportedly directed outside of the building. It is important to note that HPSSB reportedly uses the main exhaust system (return system) of each floor's AHU for bathrooms and kitchen areas as well. These areas normally require separate local exhaust ventilation directed immediately outside of the building. NSCC facilities staff reported that the ventilation system involves 100% fresh air intake and that no exhaust air is exchanged with fresh air supply. However, since the HVAC system utilizes a heat recovery/desiccant wheel to retain heat/cooling energy of exhaust air and reduce humidity levels of incoming fresh air, this configuration presents several possible moisture and microbial concerns. These concerns are discussed in the "Microbial/Moisture Concerns" section of this report. Although brush seals and purge sections are helpful in reducing the exchange of supply and exhaust air streams, in general heat recovery/desiccant wheels are not recommended where total separation of the air streams are required.

Ducted exhaust vent

- d. Verifying that high-humidity point sources of exhaust ventilation are not interfering with the humidity control of the AHU in their current configuration. To alleviate health concerns, plans should be considered to directly exhaust these sources (restrooms, kitchens, scrub sinks, etc.) if they are contributing to water vapor intrusion into the supply side ducts. Building/plumbing codes may also require direct venting of these areas.

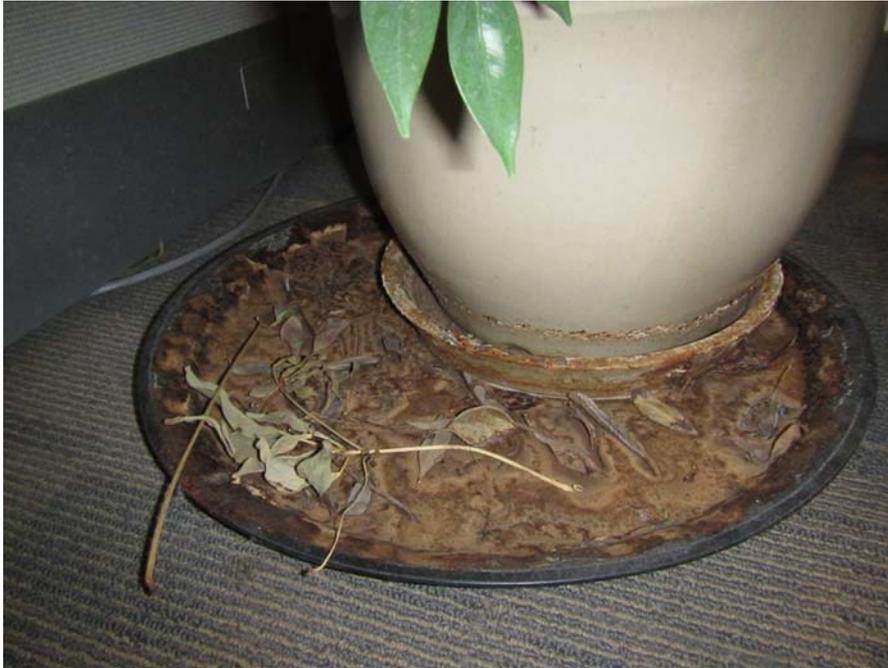
Picture 5

As mentioned, the assessment was prompted by musty odors in a third floor office suite. Upon entering the reception area of the third floor office suite, BEH/IAQ staff detected a slight musty odor. There was a large plant in this area that appeared to be improperly maintained (Picture 5). Plants should be properly maintained and equipped with drip pans. Plants should also be located away from ventilation sources to prevent aerosolization of dirt, pollen, or mold. Overwatering and lack of drip pan cleaning/maintenance can promote microbial growth and associated odors. These odors can be distributed through the office space via pressure differentials. It is strongly recommended that this plant be removed from the office suite to prevent exacerbating any unrelated musty odors in the space.

Unmaintained plant/drip pan in reception area

3. Remove the unmaintained large plant in the reception area to avoid contributing to the musty odors experienced in the third floor office suite.
4. Should the inspection of the AHU heat exchanger coils show signs of fouling and mold growth, these components should be cleaned promptly according to manufacturer recommendations.

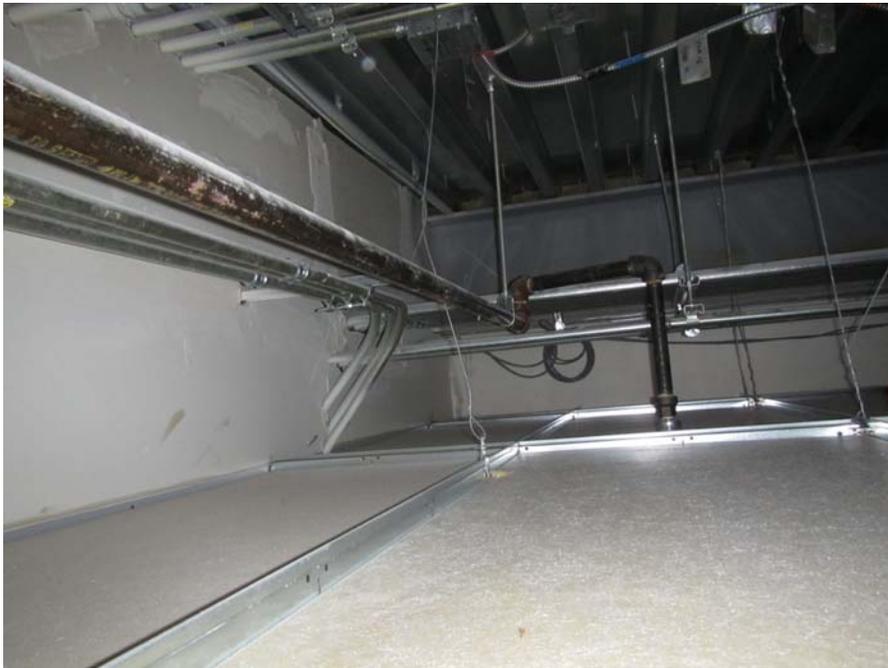
Picture 6

In addition to the reception area, BEH/IAQ staff noted a musty odor in room #337 and a slight musty odor in room #338. No water-damaged ceiling tiles or other building materials were observed in these areas. BEH/IAQ staff examined conditions above the ceiling tiles in areas of the odor complaints. No signs of recent water penetration were evident in these areas (Picture 6). More invasive techniques such as lifting carpet tiles and cutting inspection holes in wallboard were not conducted at the time of the assessment; these actions could be used to rule out any minor leaks/condensation behind building materials. Since no obvious signs of leaks or water penetration were evident at the time of the assessment another source likely exists for the musty odors.

No signs of water damage above ceiling tile system

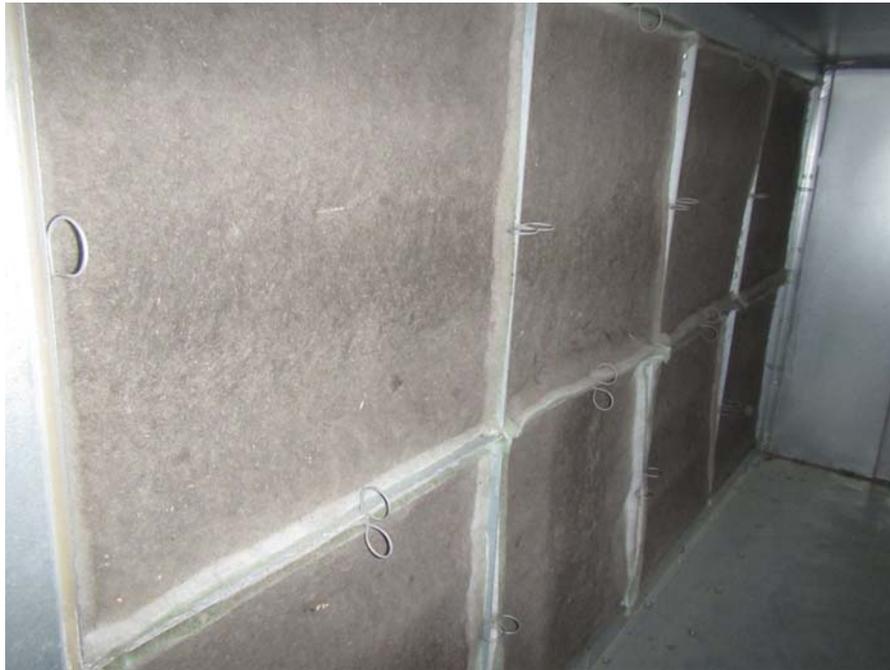
Picture 7

Dirty filters in third floor AHU appear to be not of proper MERV rating

- a. Installing manufacturer recommended air filters of proper efficiency and changing at correct frequency.
 - b. Cleaning AHU heat exchanger coils and drip pans regularly.
