# **INDOOR AIR QUALITY ASSESSMENT**

**Massachusetts Rehabilitation Commission Office  
170 Pleasant Street  
Fall River, Massachusetts**

Prepared by:  
Massachusetts Department of Public Health  
Bureau of Environmental Health  
Indoor Air Quality Program  
October 2015

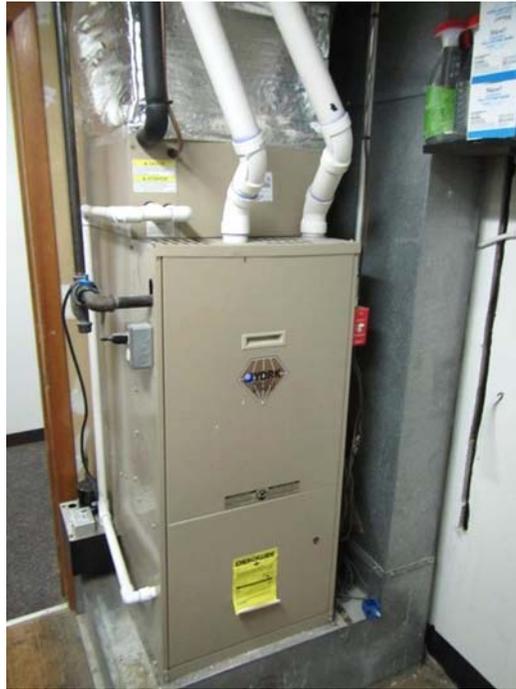
**Picture 1**

Several air handling units (AHUs) were located in closets/utility rooms (Picture 1). It could not be determined if any of the units had fresh air intakes on the outside of the building. AHUs distribute tempered air to occupied spaces via ducted supply vents (Picture 2). AHU return vents are located mostly in hallways (Picture 3); offices do not have return vents. Most office doors were open at the time of the assessment, but these doors did not appear to be undercut to create a means for air to exit these spaces when the doors are closed. Without undercut doors hallway return vents cannot remove stale air from offices if the doors are closed. Restrooms are equipped with exhaust vents.

**One of the air-handling units for the MRC space**

1. Complete repairs of items indicated in the letter included as Appendix A.
2. Investigate whether there is a supply of fresh air for the building. Consider building modifications to supply fresh outside air to the AHUs. Use openable windows during temperate times of the year to supply additional fresh air. Ensure windows are closed tightly at the end of each day.

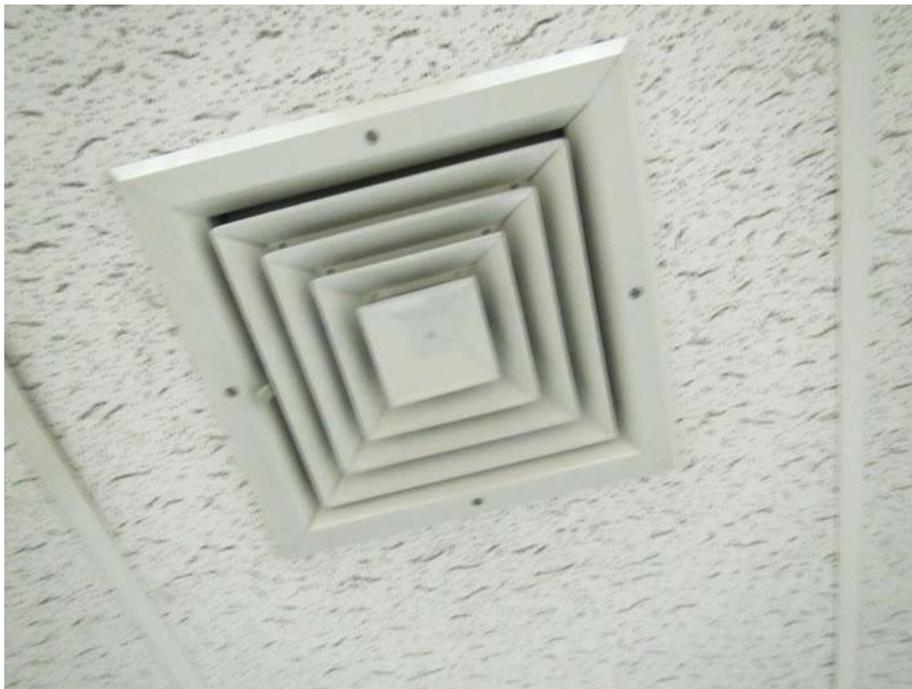
**Picture 2**

**Supply vent**

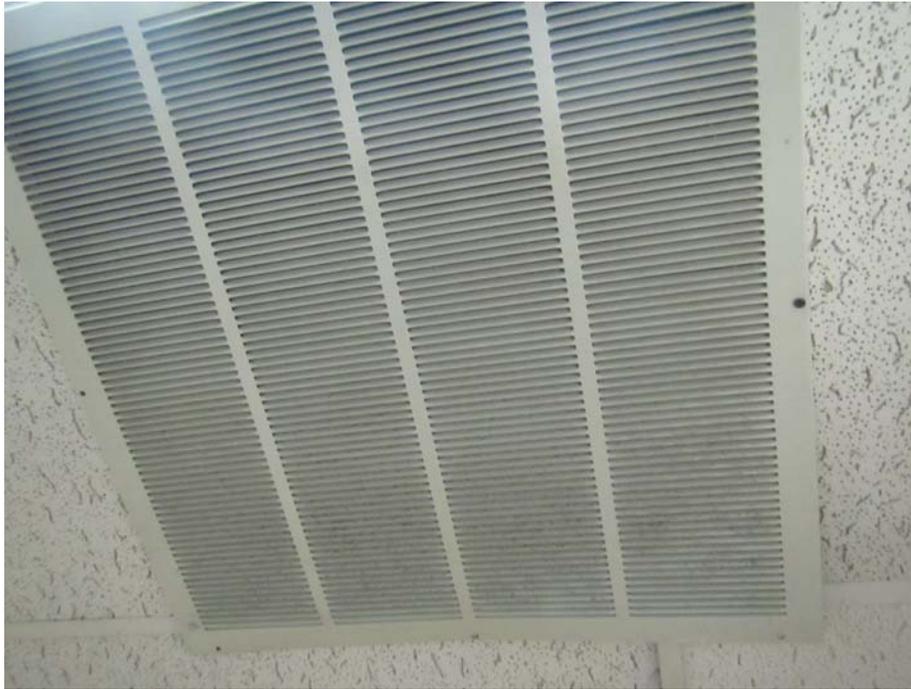
**Picture 3**

**Return vent in hallway**

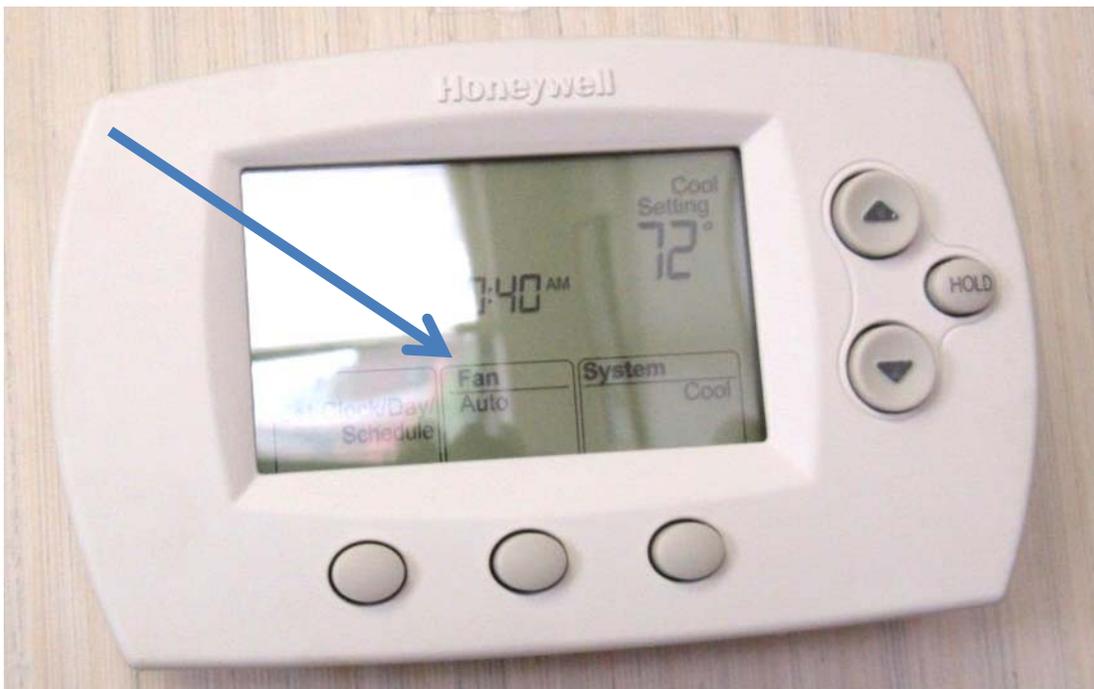
**Picture 4**

To maximize air exchange, the MDPH recommends that both supply and exhaust ventilation operate continuously during periods of occupancy. Thermostats were observed in several areas set to the “automatic” setting (Picture 4), which will activate the HVAC system only when the thermostats call for heating or cooling. The MDPH recommends that thermostats be set to the fan “on” setting during occupied hours to provide a *continuous* source of fresh air and filtration.

**Electronic thermostat, note fan set to “auto” (arrow)**

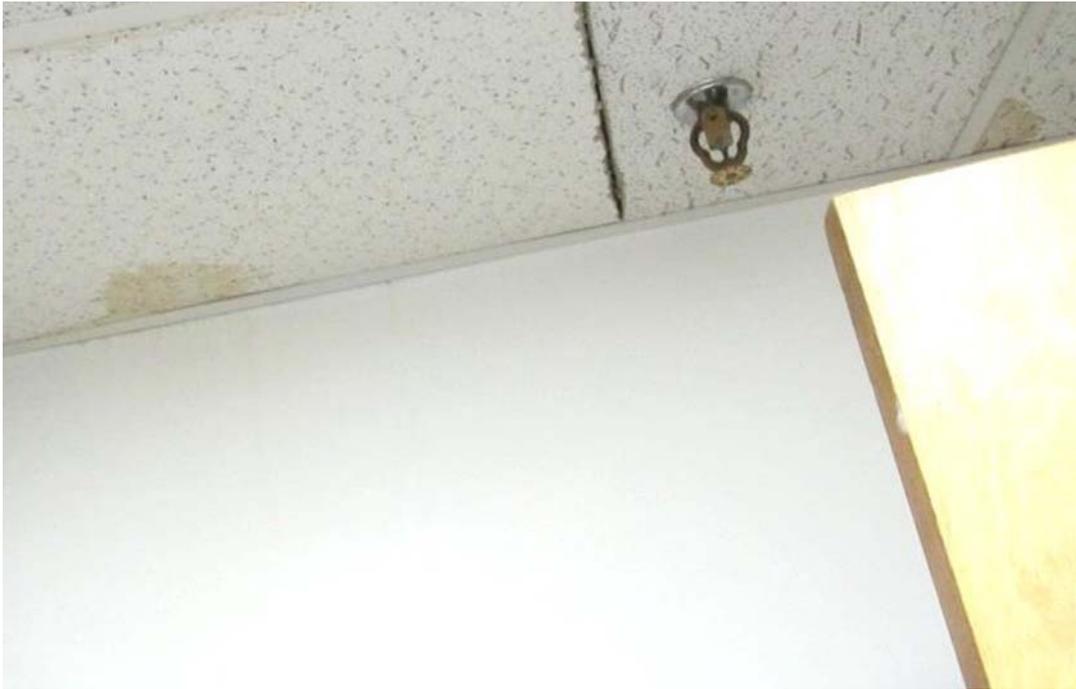
**Picture 5**

Additional moisture-related issues were noted in the MRC space. Water-damaged ceiling tiles were observed in some offices and utility/storage areas (Picture 5). Water-stained walls

were observed in the hallway between the main area and the Annex (Picture 6). These conditions reportedly stem from leaks from the roof through a non-MRC-accessible storage area on the fourth (top) floor. Water-damaged ceiling tiles can be a source of mold and should be replaced once the leaks are repaired. In addition, water damage to building materials and items in storage on the fourth floor may become a source of mold or odors to MRC-occupied space if any pathways exist between floors.

**Water-damaged ceiling tiles**

4. Seal/make repairs to windows in conference room and make repairs/replace damaged windowsill materials.
5. Replace water-damaged ceiling tiles once the sources of water have been repaired.

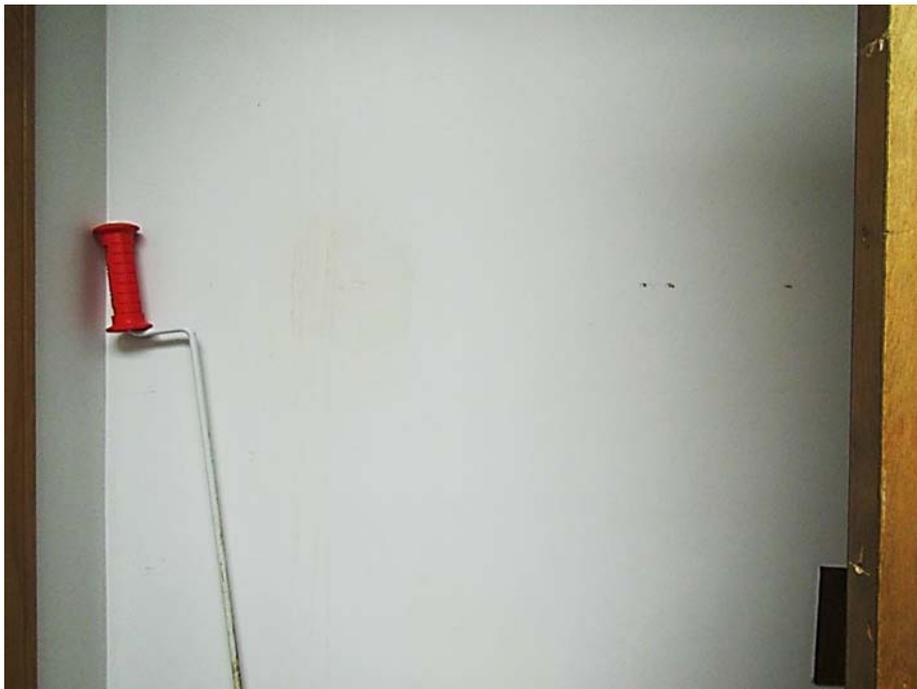
**Picture 6**

**Water-damaged paint (stains and streaks) in hallway between main area and the Annex**

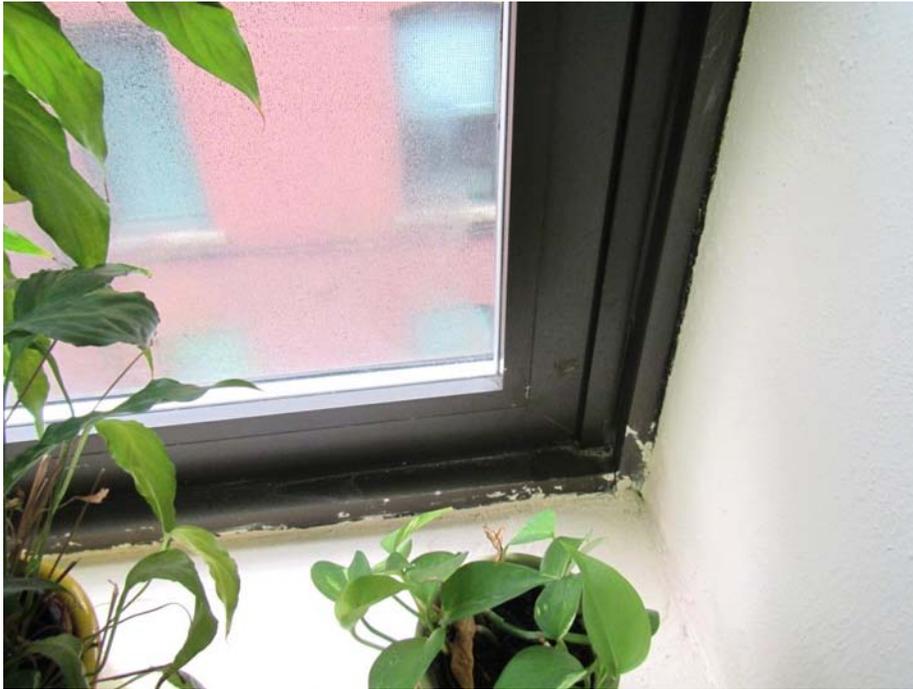
**Picture 7**

Water-damaged windowsills were observed in the main conference room (Picture 7). The windows in this area do not seal well and should be repaired. The water-damaged windowsill materials should be repaired/replaced. Until the windows have been repaired, no items, particularly porous ones, should be placed in areas with known water infiltration issues.

Plants were observed in some offices and open areas (Pictures 7 and 10). Plants can be a source of pollen and mold, which can be respiratory irritants to some individuals. Plants should be properly maintained, over-watering of plants should be avoided and drip pans should be inspected periodically for mold growth and cleaned or replaced as necessary.

**Water-damaged windowsill and plant**

8. Maintain indoor plants, use non-porous drips pans and prevent overwatering.

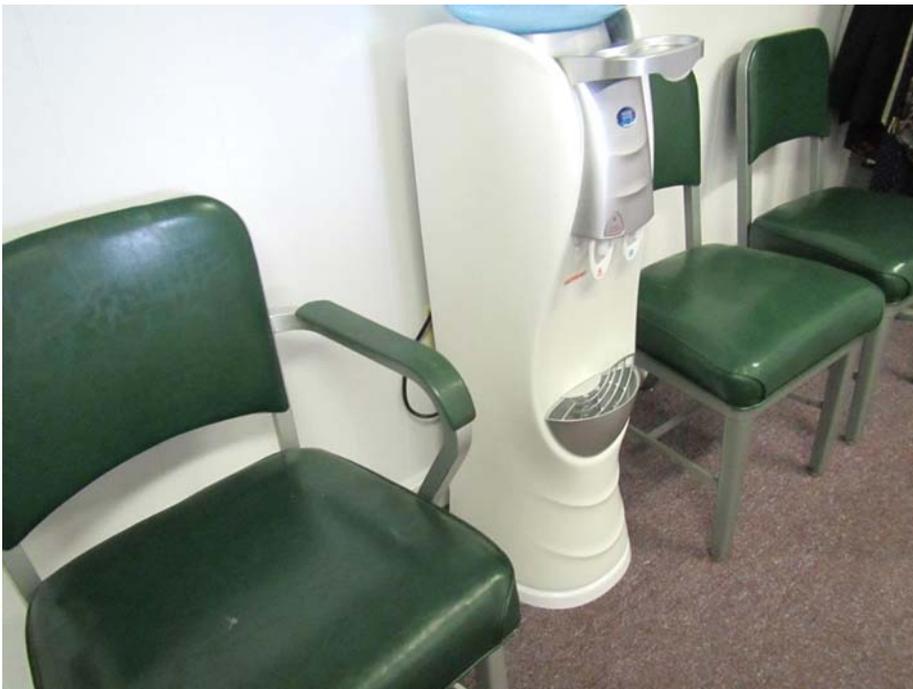
**Picture 8**

Carpeting in the Annex hallway was found to be damp, likely due to elevated relative humidity in this area due to infiltration of water and moist air through damaged brickwork; possibly spills/leaks from the water cooler located on the carpet in this area may have also contributed (Picture 8). Water coolers should be placed in tiled areas or on waterproof mats. In an attempt to reduce humidity and dry building materials, a dehumidifier was placed in the Annex conference room (Picture 9). These appliances need to be regularly emptied and maintained to prevent odors from stagnant water/accumulated debris.

**Water cooler on carpet**

6. Consider placing water dispensers on non-carpeted areas or place a waterproof mat underneath them.
7. Remove any water-damaged/mold-contaminated building materials/stored items on the 4<sup>th</sup> floor.

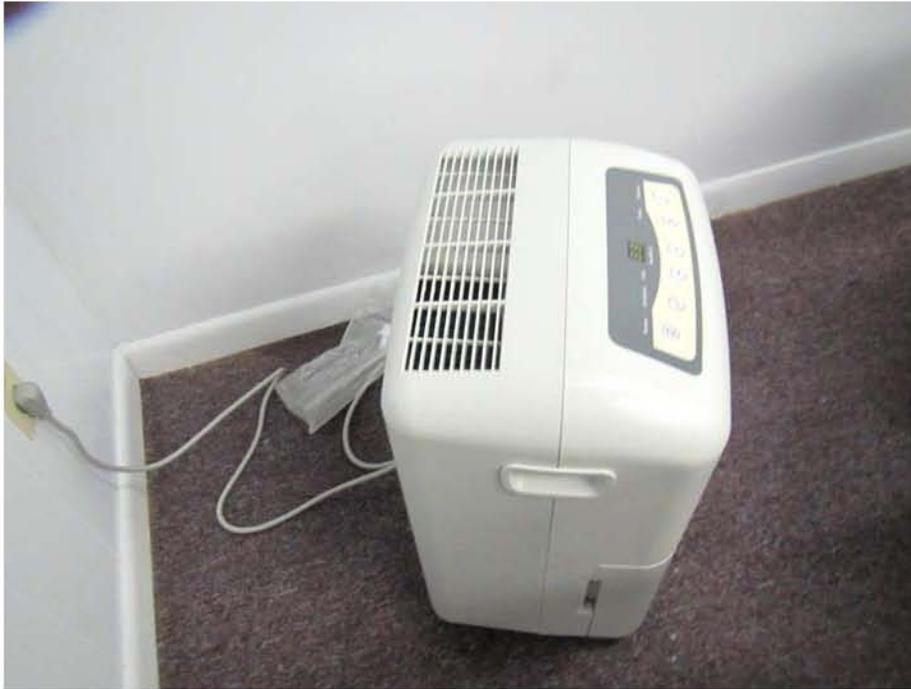
**Picture 9**

Indoor relative humidity ranged from 50 to 70 percent (Table 1). All were within the MDPH comfort range except for the Annex conference room. The MDPH recommends a comfort range of 40 to 60 percent for indoor air relative humidity. In addition, conditions of relative humidity above 70 percent can be conducive to water damage and microbial growth on porous materials. The elevated relative humidity in the Annex conference room is reflective of other conditions there, which are described further under “Microbial/Moisture Concerns” below.

**Dehumidifier in Annex conference room**

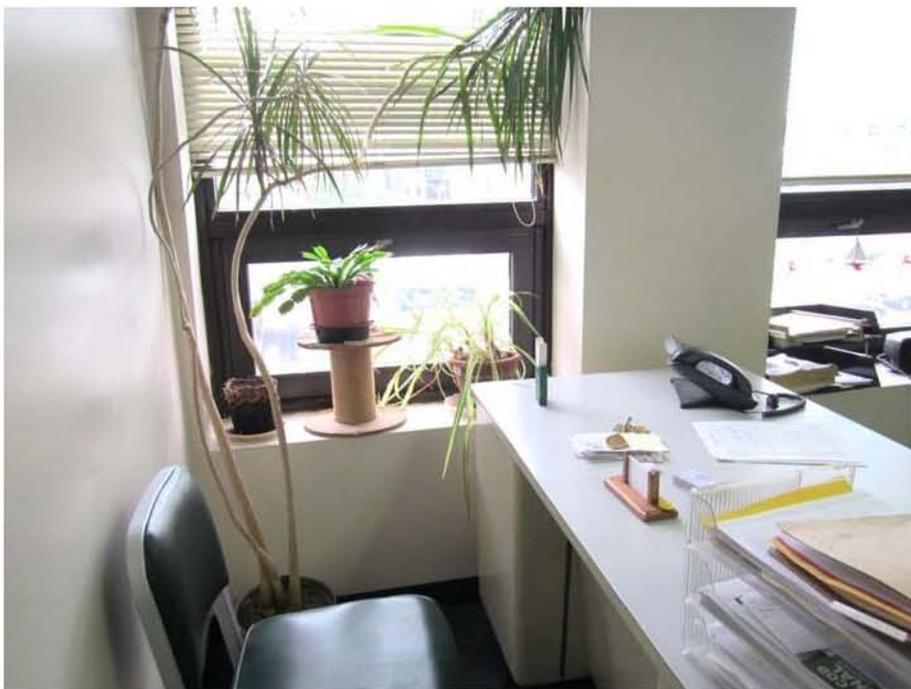
**Picture 10**

**Plants in an office**

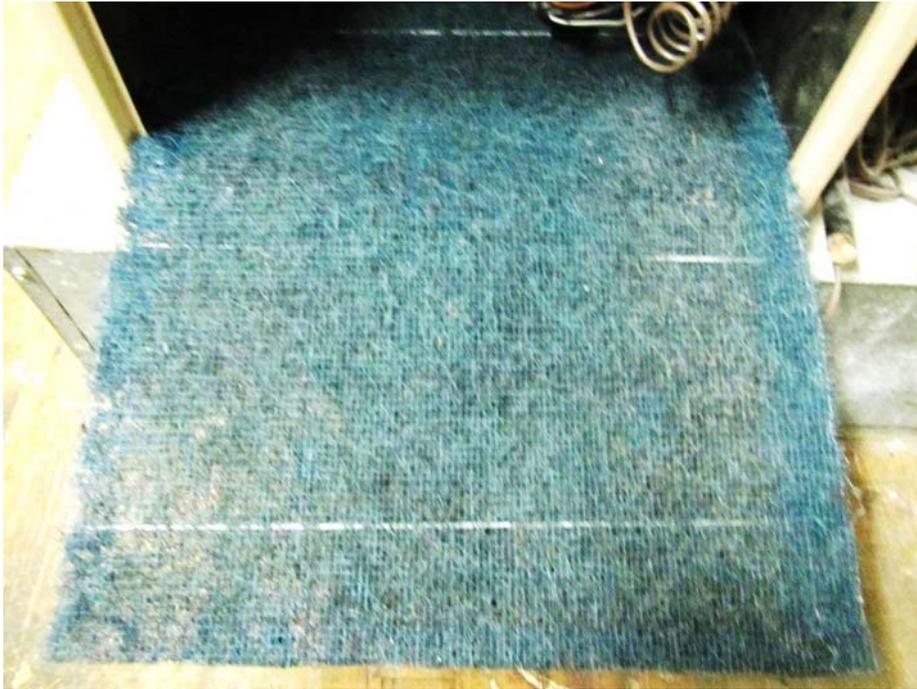
**Picture 11**

Filters in some of AHUs were examined and were found to be of a type that provides minimal filtration (Picture 11). The dust spot efficiency is the ability of a filter to remove particulate matter of a certain diameter from air passing through the filter. Filters that have been determined by ASHRAE to meet its standard for a dust spot efficiency of a minimum of 40 percent would be sufficient to reduce many airborne particulates (Thornburg, 2000; MEHRC, 1997; ASHRAE, 1992). Pleated filters with a Minimum Efficiency Reporting Value (MERV) dust-spot efficiency of 9 or higher are recommended. Note that increasing filtration may require evaluation and adjustments to the AHUs to deal with the increased resistance to flow of higher MERV value filters.

**Mesh filter in AHU**

9. Reduce the use of dry erase materials, hand sanitizer and cleaning/scented products to avoid exposure to TVOCs.
10. Replace filters in AHUs with those providing improved filtration. Consider upgrading to a MERV value of 9; change filters regularly.
11. Clean vents and personal fans to avoid reaerosolizing dusts.
12. Store items in an organized manner and move them to clean periodically to prevent a buildup of dust.
13. Ensure that used clothing stored in the office has been cleaned.
14. Refer to resource manuals and other related indoor air quality documents for further building-wide evaluations and advice on maintaining public buildings. These materials are located on the MDPH's website: <http://mass.gov/dph/iaq>.
