INDOOR AIR QUALITY WATER DAMAGE ASSESSMENT

**EOHHS Service Center
300 Howard Street
Framingham, Massachusetts**

Prepared by:
Massachusetts Department of Public Health
Bureau of Environmental Health
Indoor Air Quality Program
September 2015

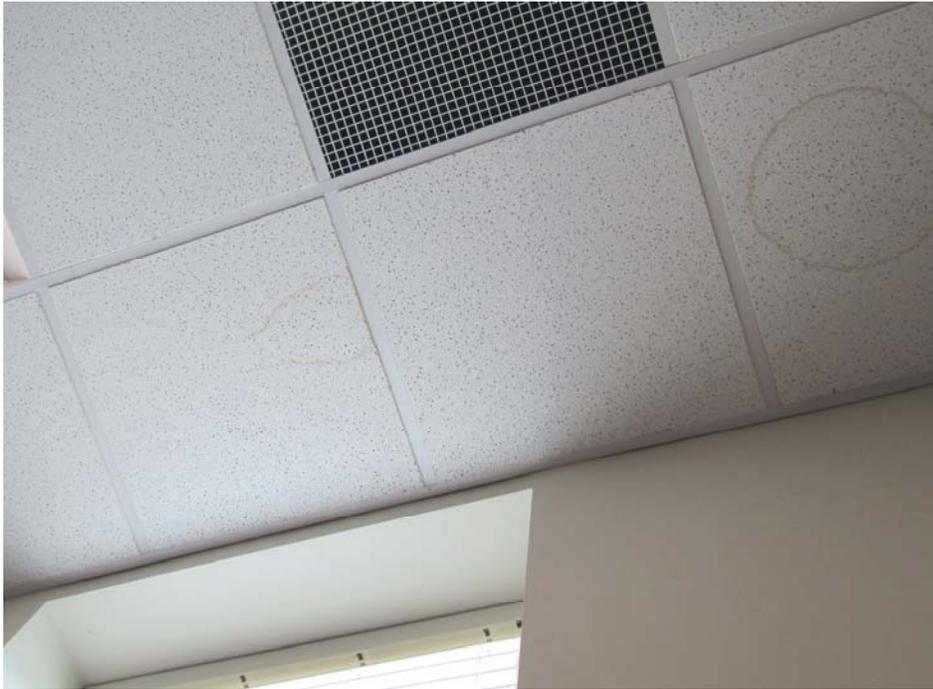
Picture 1

- Water-damaged ceiling tiles on the second floor near windows along the south edge of the building (Pictures 1 through 3). Water had also been reported on a desktop in this area;
- Water-damaged and one visibly wet ceiling tile towards the middle of the building (Pictures 4 and 5);
- Water-damaged and mold-colonized gypsum wallboard on the lower level along the north side of the building (Pictures 6 and 7). Carpet squares had been removed in this area and some coving had been removed from the wall, but the wallboard had been wet long enough to grow mold.

Stained ceiling tiles on front (south) side of the building

1. Water-damaged/mold-colonized building materials should be removed in a manner consistent with recommendations found in “Mold Remediation in Schools and Commercial Buildings” published by the US Environmental Protection Agency (US EPA, 2001). Wallboard that has become mold-colonized should be removed to a level of a foot above where it was moistened.
2. Develop a system to allow employees to report water infiltration/damage rapidly to applicable contacts in building management/maintenance.
3. Consider systematically performing building walk-throughs following any severe weather to check for and remediate any leaks promptly. If possible, have the landlord perform these checks during weekends when needed to address problems when they occur during unoccupied periods.
4. Have the areas shown in Pictures 8 and 9 on the roof finished/repaired as soon as possible.

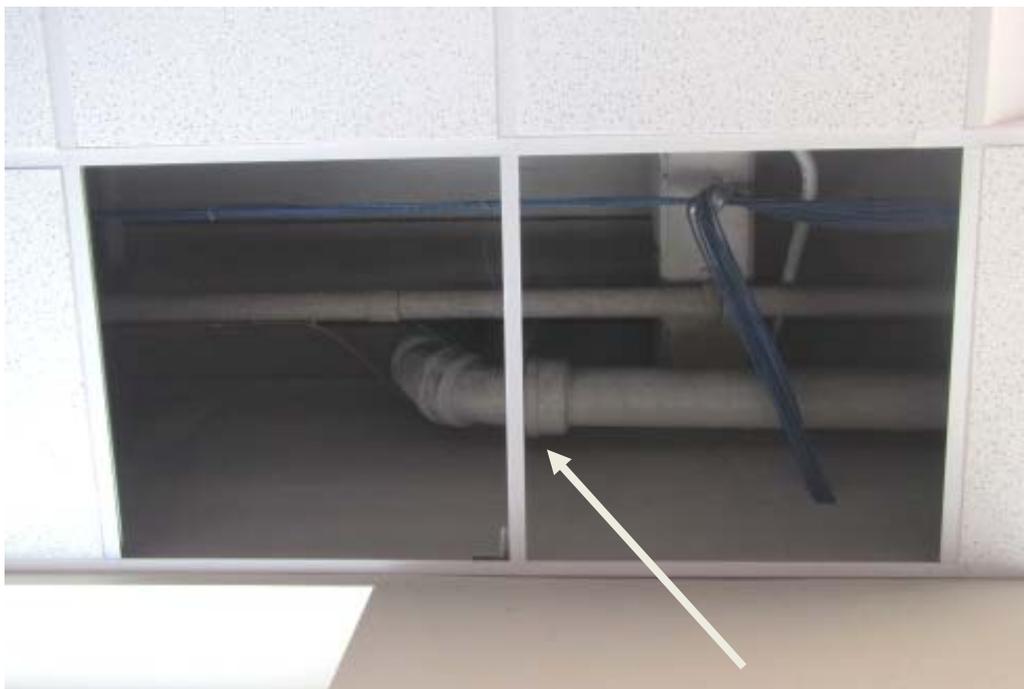
Picture 2

Removed ceiling tiles showing roof drain (large pipe, arrow)

5. Investigate the function of the roof drains and drainage pipes (e.g., Pictures 2 and 17) and have repairs made as needed.
6. Consider repairs to the roof of the building to improve drainage and reduce the chance of water infiltration.
7. Investigate the integrity of the brickwork along the rear/north of the building and make repairs as needed.
8. Improve drainage along the rear wall to prevent erosion.
9. Replace spray-on insulating materials around windows as seen in Picture 10 with an appropriate permanent material.
10. Refer to resource manuals and other related indoor air quality documents for further building-wide evaluations and advice on maintaining public buildings. Copies of these materials are located on the MDPH's website: <http://mass.gov/dph/iaq>.

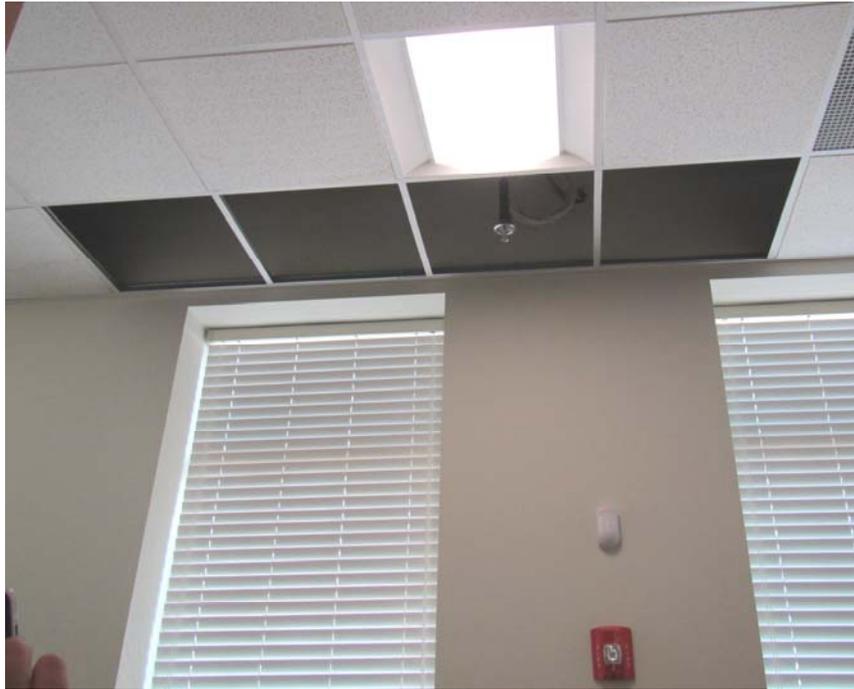
Picture 3

Removed ceiling tiles

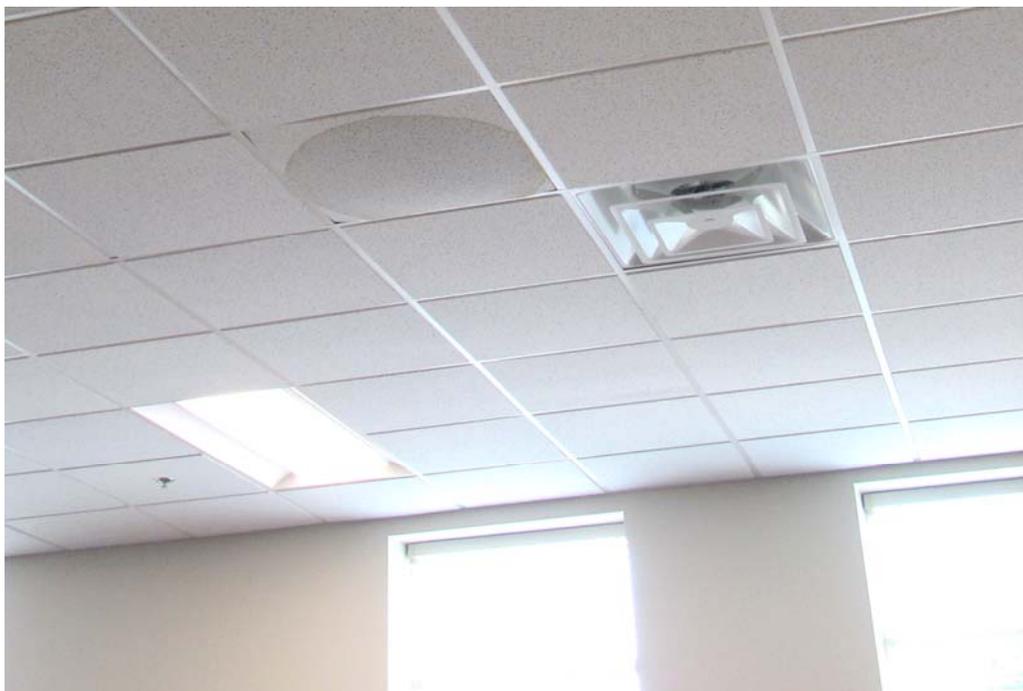
Picture 4

Visibly wet ceiling tile

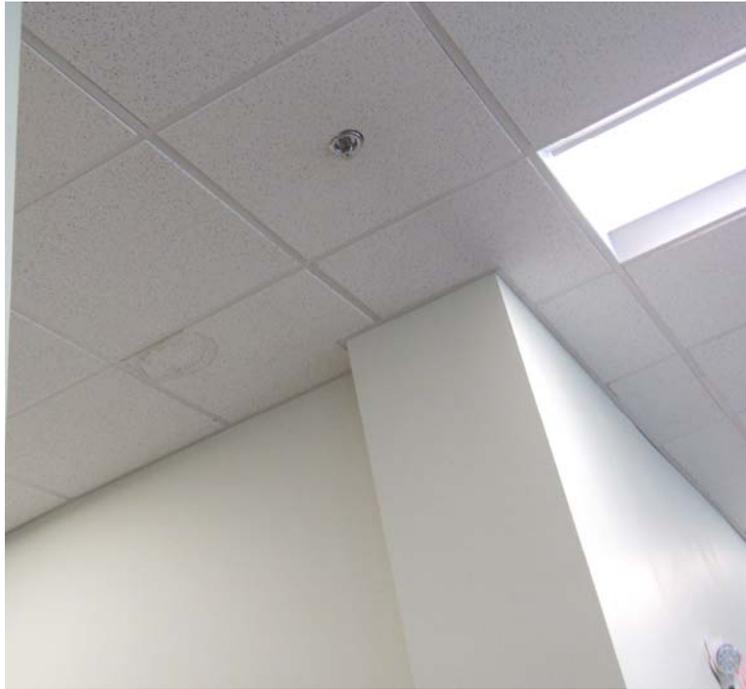
Picture 5

Stained ceiling tile in center of the second floor

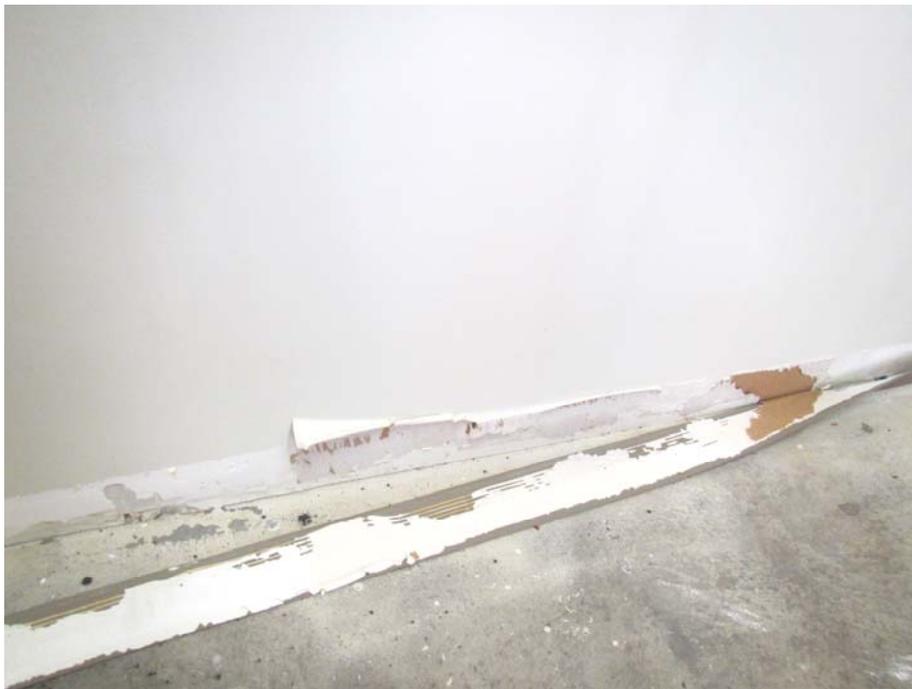
Picture 6

Water-damaged, mold-colonized gypsum wallboard behind removed coving on first floor

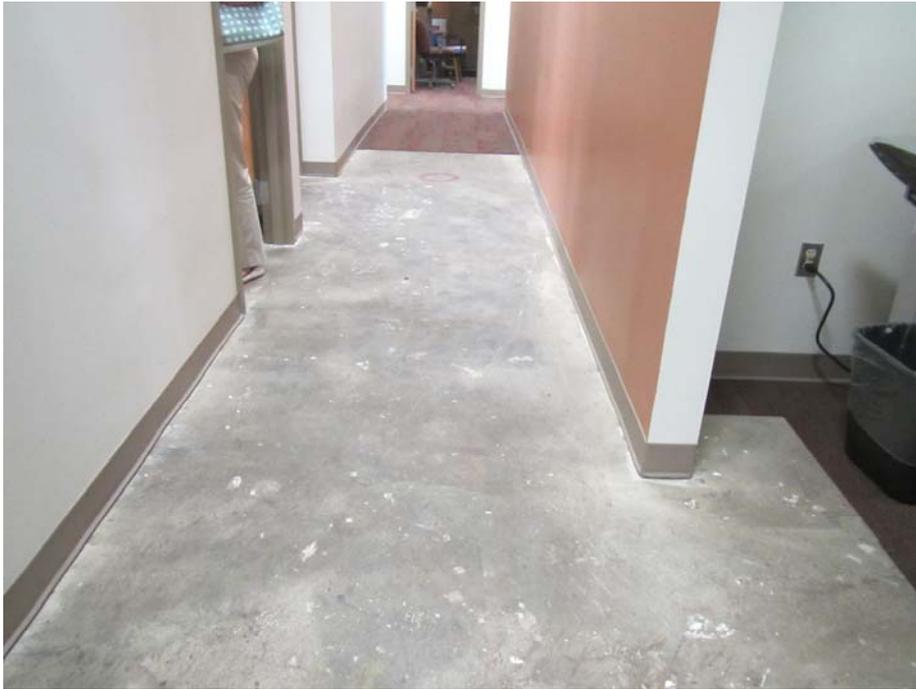
Picture 7

First floor hallway with carpet squares removed

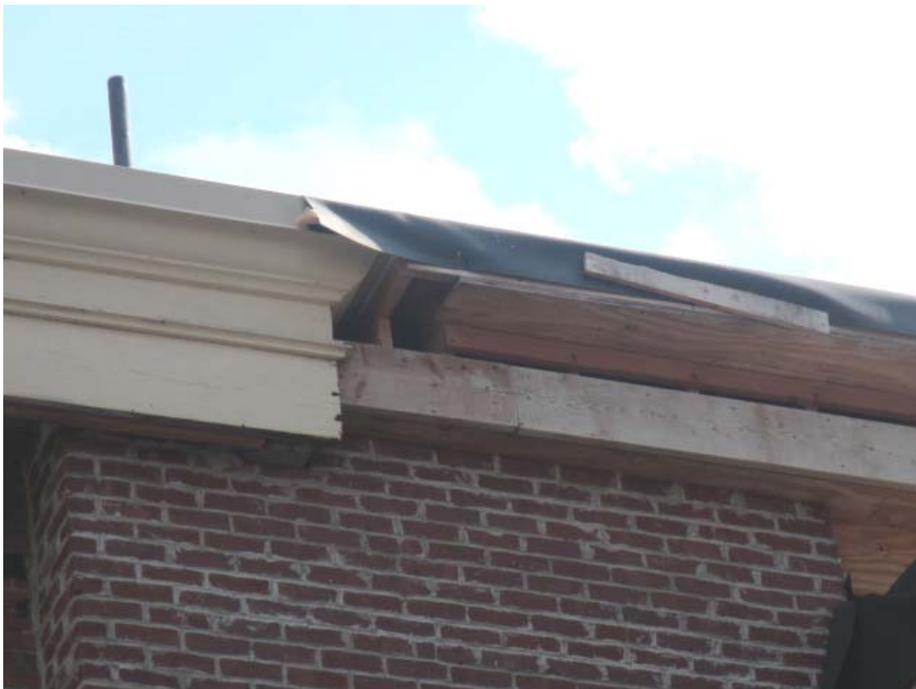
Picture 8

- The northeastern edge of the roof is unfinished with exposed wood and unfolded/tacked in tar paper (Pictures 8 and 9), which would allow water infiltration from rain into the building interior in wind-driven rain.

Unfinished/damaged roof along north side of building

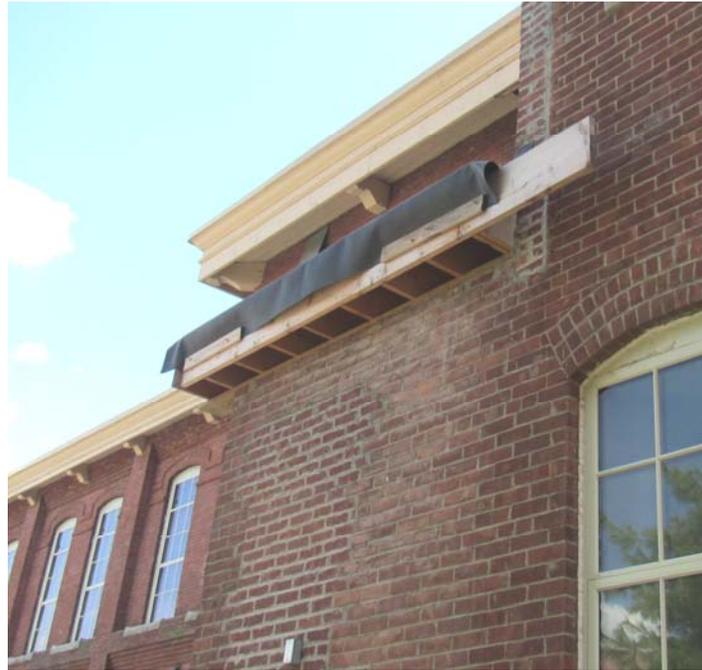
Picture 9

Unfinished/damaged roof

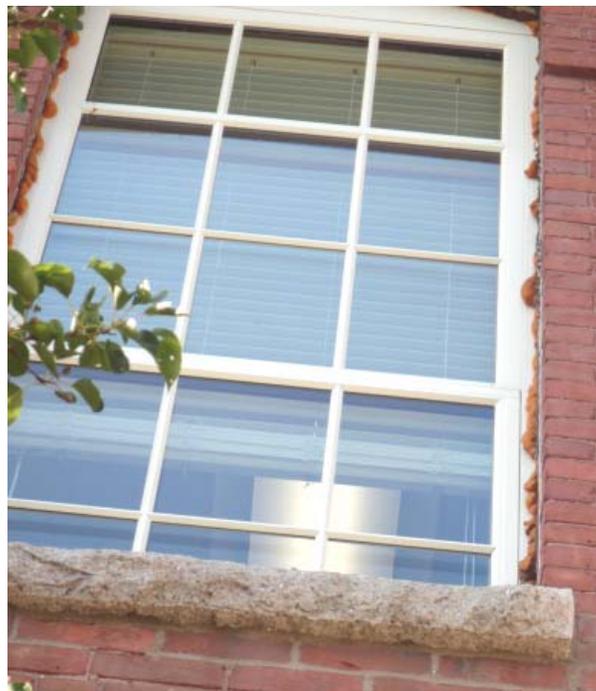
Picture 10

- Windows on the southeastern side of the building appear to be sealed with spray foam (Picture 10), which is not a suitable material for use as window sealant.

Spray foam used to seal windows on south side of building

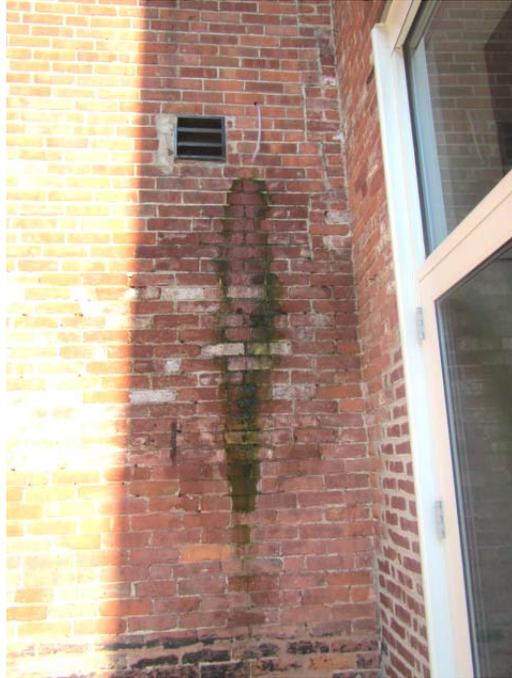
Picture 11

- The exterior wall has a stepped, ornamental brick feature that is installed in a manner to create small ledges in the exterior wall. Mortar between seams between bricks in this feature deteriorated in several areas (Pictures 11 through 14) and appears to have been repaired inconsistently due to the presence of missing/deteriorated mortar. The brick ornamental feature appears to be at the same level as the floor of the office space that was water damaged due to the August 15, 2015 thunderstorm.

Discolored, damp brick wall

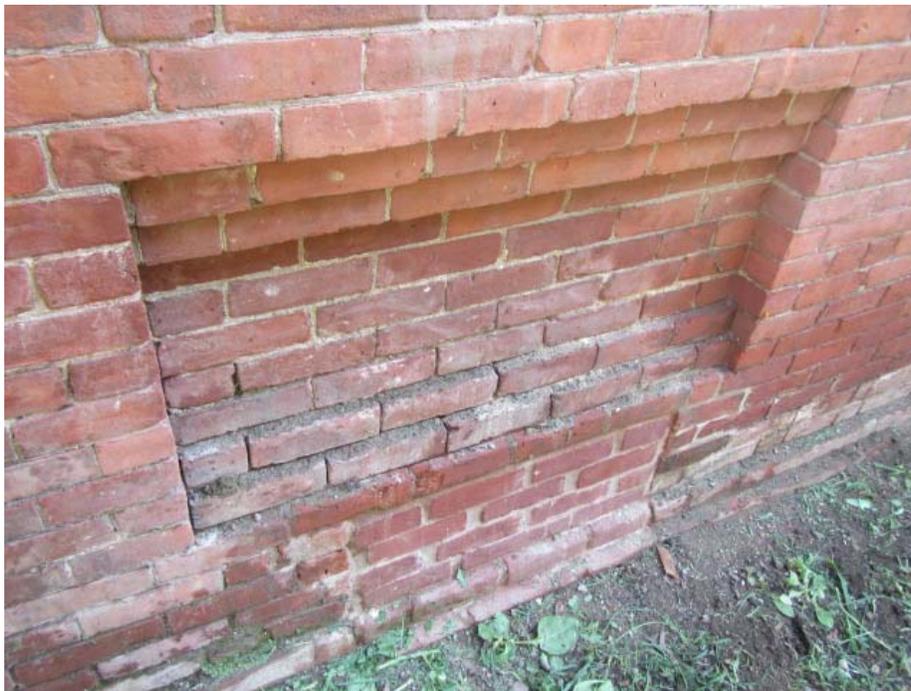
Picture 12

Stepped, brick ornamental feature with damp brickwork and missing mortar

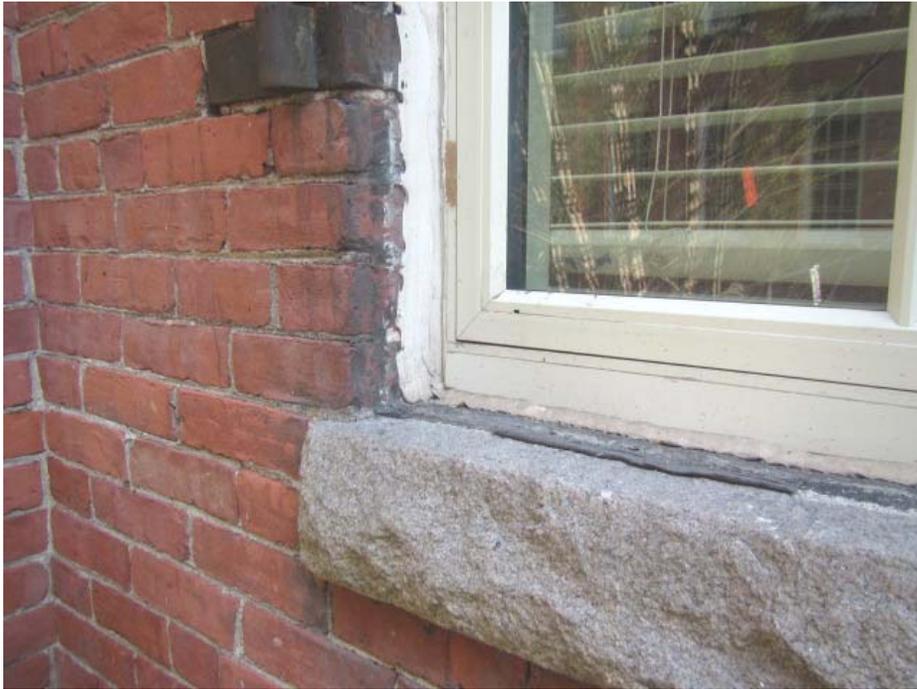
Picture 13

Damaged brickwork and old shutter hinge

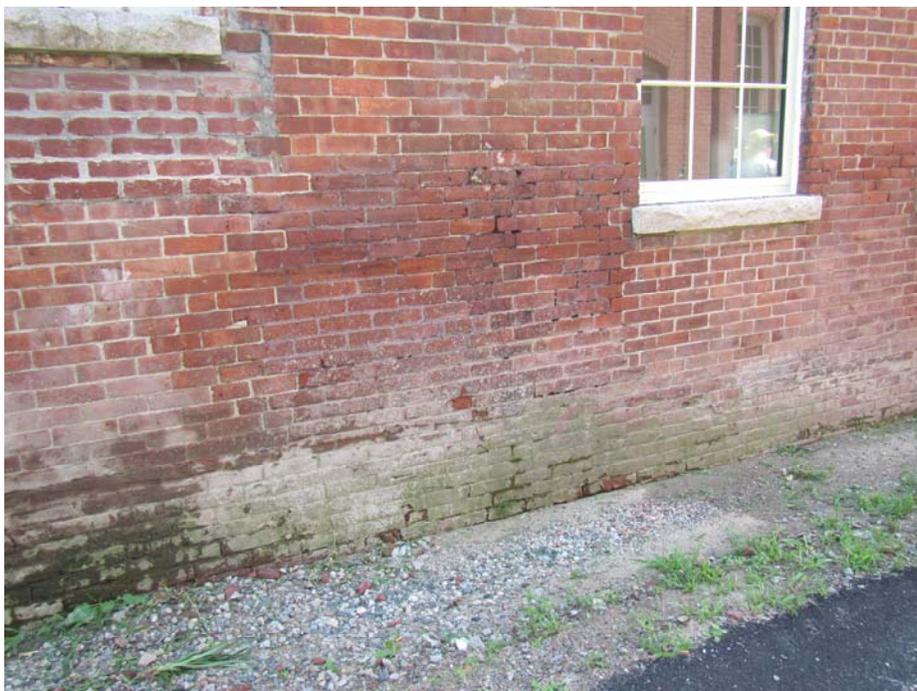
Picture 14

Damaged brickwork

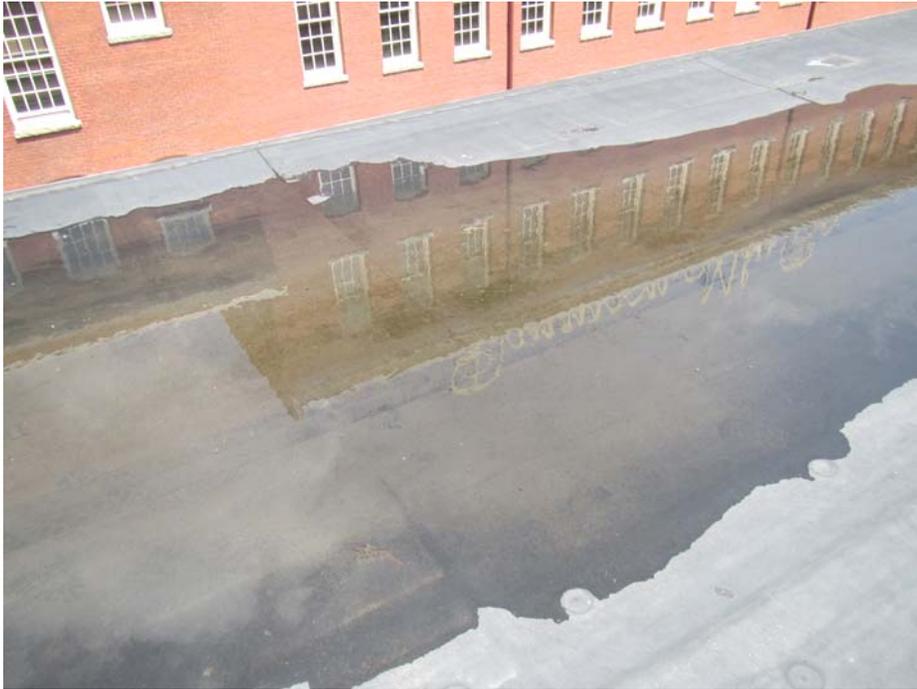
Picture 15

- As noted in the post-occupancy visit on July 10, 2015, the roof of this building has low spots that collect rainwater and roof drains that function poorly (Pictures 15 and 16).

Water pooling on roof

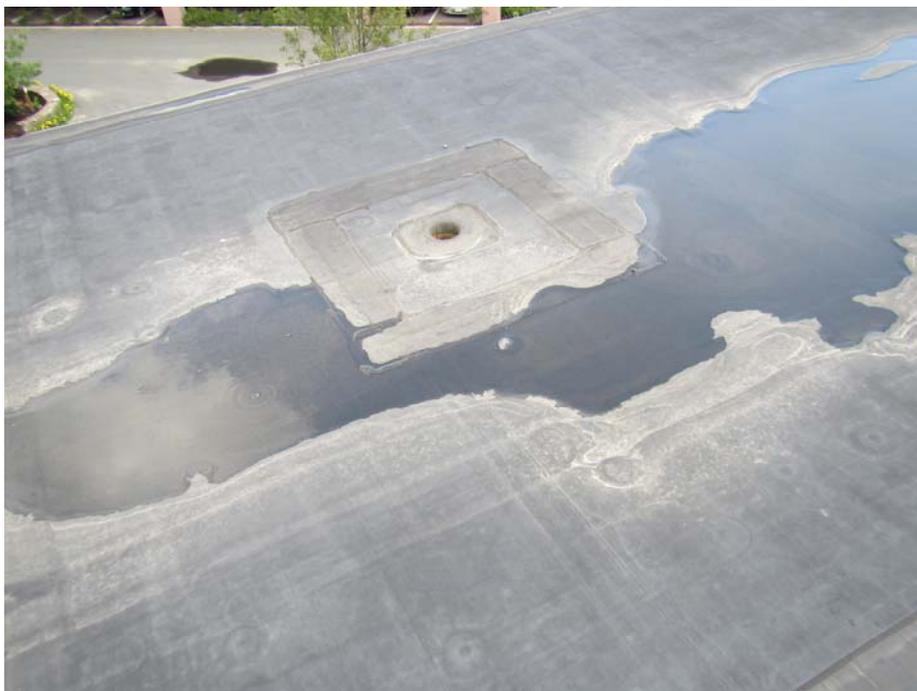
Picture 16

Water pooling around roof drain higher than the roof

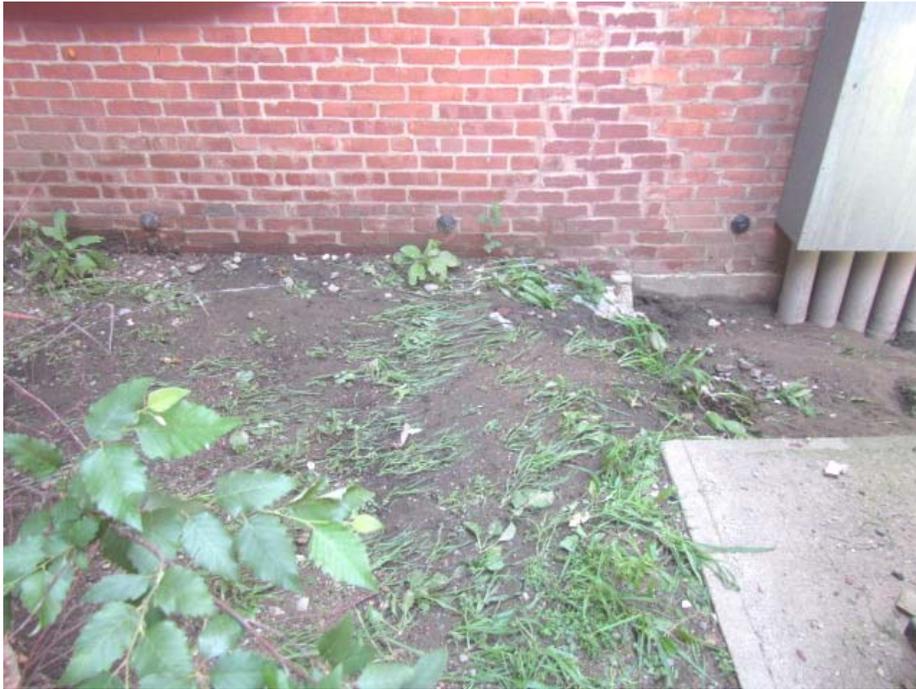
Picture 17

2015 with winds gusting over 45 miles per hour from the west (nws.gov). The building was exposed to a significant amount of wind driven water as evidenced by flattened grass (Picture 17) and soil displaced onto a cement slab in a corner of the building along its north side near the water damaged office space. Flattened grass as well as soft, eroded, displaced soil suggests that a large quantity of water had accumulated in the corner of the exterior wall and rapidly drained over this area in a short period of time.

Flattened grass from fast-moving water

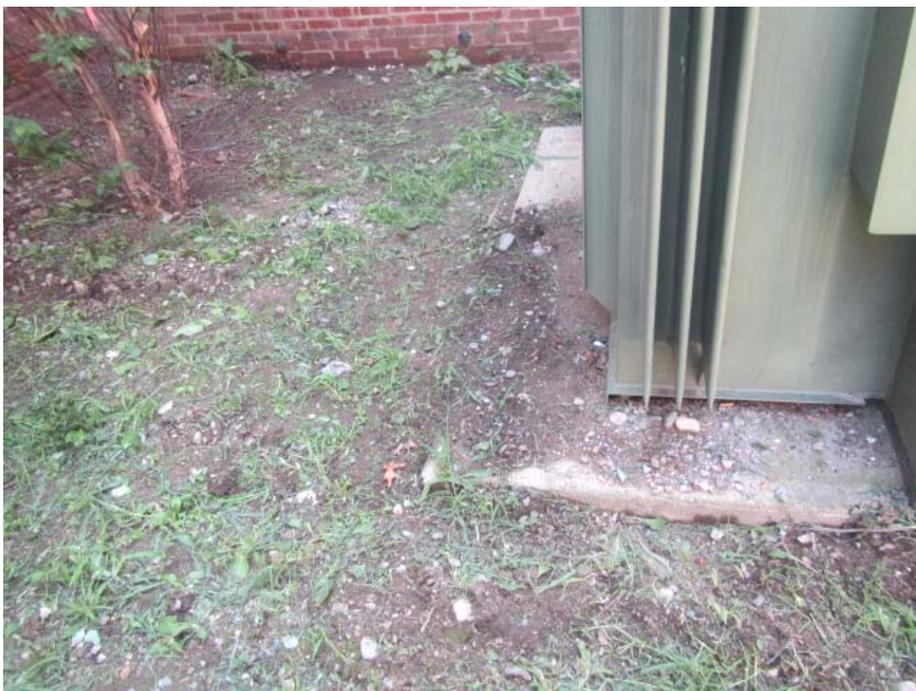
Picture 18

Flattened grass and displaced soil due to fast-moving water
