ODOR ASSESSMENT

**Community Enterprises
287 High Street
Holyoke, Massachusetts**

Prepared by:
Massachusetts Department of Public Health
Bureau of Environmental Health
Indoor Air Quality Program
September 2015

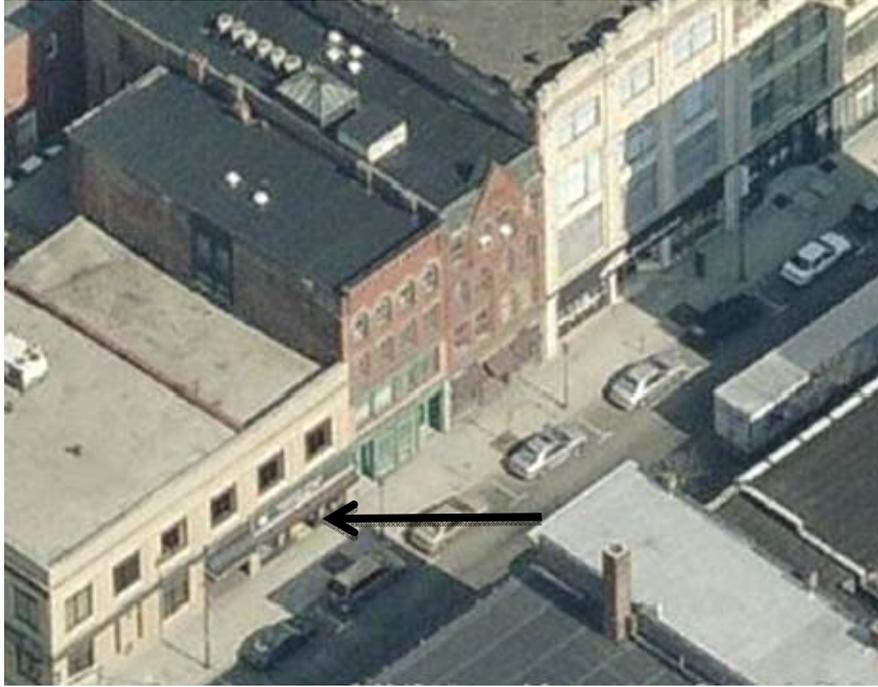
Picture 1

The CE consists of two adjoining four-story stone buildings in downtown Holyoke (Picture 1). Subsequent renovations joined the two buildings together as a single office space. Windows do not open in the CE space. Similarly-sized buildings adjoin the CE on the block.

Community Enterprises Building (Arrow is the location of the nail salon)

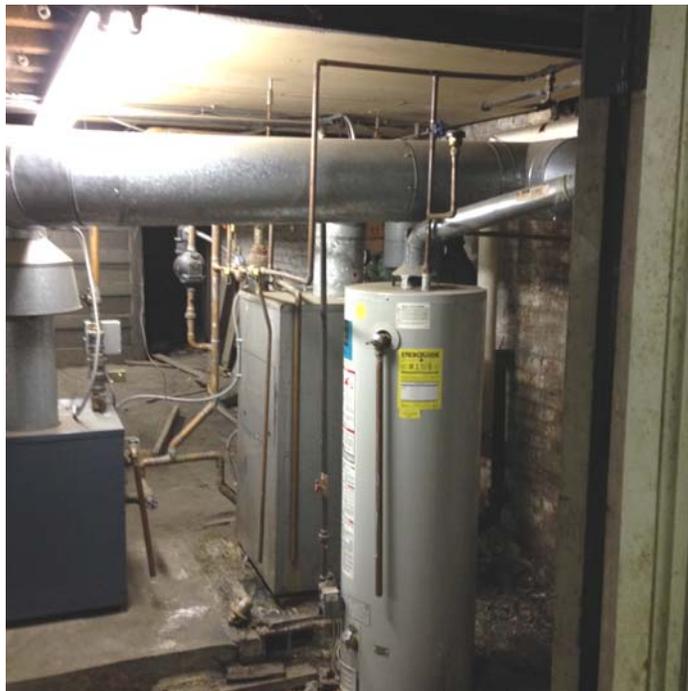
Picture 2

Mold concerns initiated the request for assessment. Of note was the condition of the basement floor. The rear half of the basement contains the furnace and water heater installed on a dirt floor (Picture 2). The front part of the basement has a concrete floor. Installed over the concrete is a tongue-in-groove wooden floor, which appears to be rotting (Pictures 3 and 4). Either rotting wood or the dirt floor can be ready sources of mold. Of note is the presence of a passive vent in the basement door that leads to CE first floor offices (Picture 5). Basement odors were detected outside this door when it was closed. It is likely that mold spores and other odors are entering the CE through the passive door vent.

Rear half of the basement with furnace and water heat installed on a dirt floor

1. Install a combustion air vent for the furnace and water heater to provide outdoor air to these devices. Once completed, seal the basement passive door vent shown in Picture 5 with an appropriate material, or replace the door with a solid one.

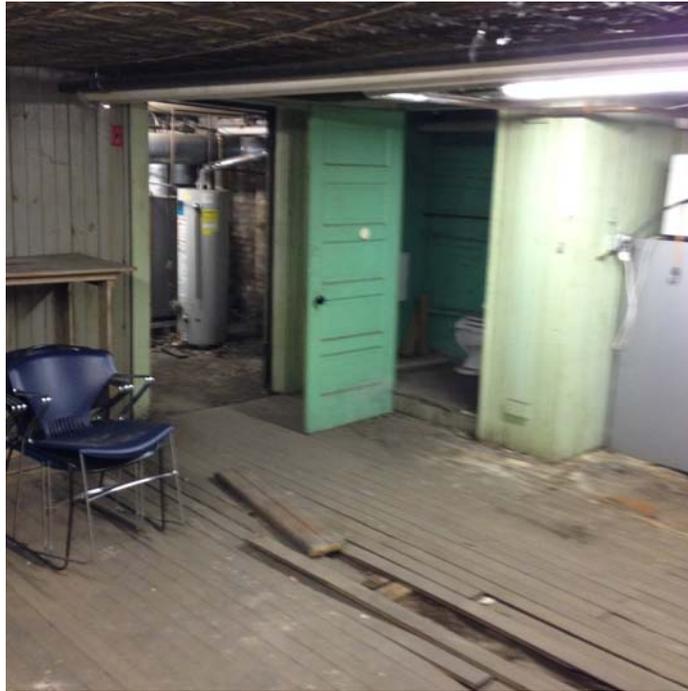
Picture 3

levels of particulate matter (including PM2.5) can be at higher levels than those measured outdoors. As noted previously, the basement has a wood floor that is rotting in sections installed over a cement foundation. Walking on this floor by BEH/HHD staff likely increased PM2.5 concentrations.

Rotting tongue-in-groove floor

2. Install weather-stripping and a door sweep on the basement door to render it as airtight as possible.
3. Seal any openings in the shared wall on the CE side with an appropriate fire-rated sealant.
4. Remove water-damaged/rotted floor materials in the basement.
5. Refer to resource manuals and other related indoor air quality documents for further building-wide evaluations and advice on maintaining public buildings. Copies of these materials are located on the MDPH's website: <http://mass.gov/dph/iaq>.

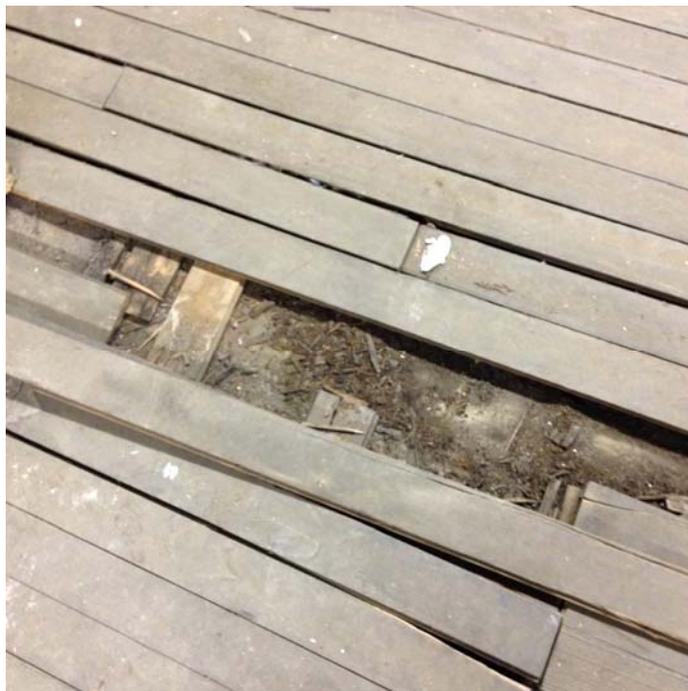
Picture 4

Close-up of rotting tongue-in-groove floor

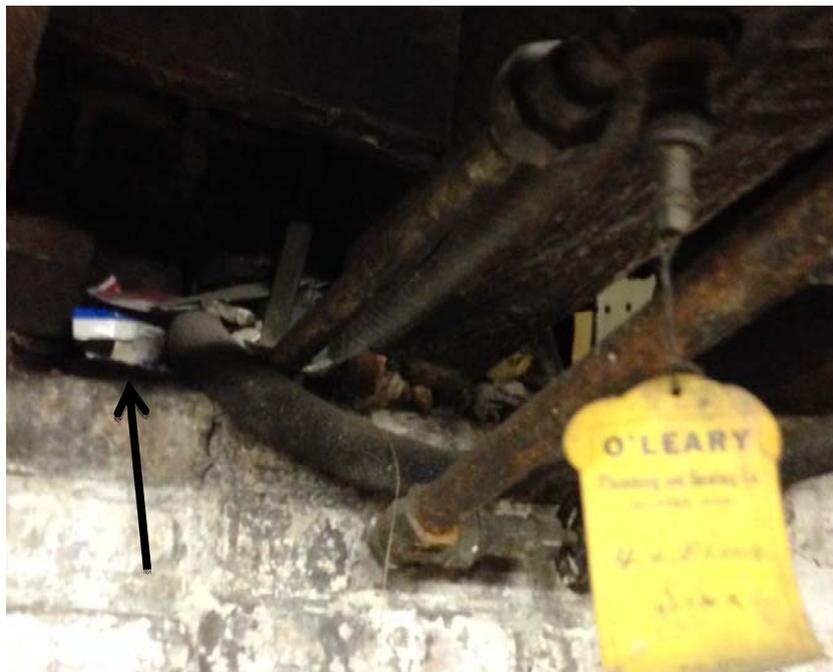
Picture 6

Location of highest VOC measurement in the CE basement

| Location | Carbon Dioxide (ppm) | Carbon Monoxide (ppm) | Temp (°F) | Relative Humidity (%) | TVOCs (ppm) | PM2.5 (µg/m ³) | Occupants in Room | Windows Openable | Ventilation | | Remarks |
|---|---|---|---|---|---|---|---|---|---|---|---|
| Basement | 565 | ND | 74 | 58 | 0.3-1.4 | 58 | 0 | N | N | N | VOC reading highest at hole in shared wall at water supply pipe |
