# **WATER DAMAGE FOLLOW-UP**

**Massachusetts Department of Children and Families  
33 East Merrimack Street  
Lowell, Massachusetts**

Prepared by:  
Massachusetts Department of Public Health  
Bureau of Environmental Health  
Indoor Air Quality Program  
August 2015

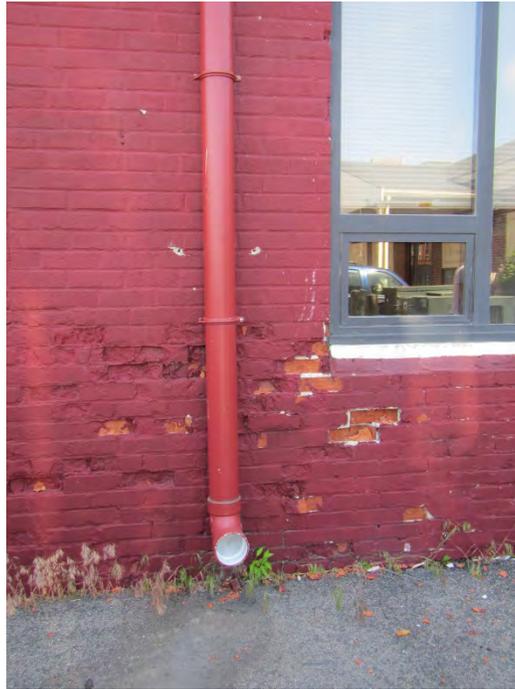
**Picture 1**

- Repair of water-damaged windowsills and window areas in Ms. Ortiz office.
- Replacement of water-damaged ceiling tiles in the Adoption Unit and Investigative Unit B.
- Replacement of the downspout around which the original ice dams had formed (Picture 1). Note that the end of this downspout is very close to the building, which may allow water to pool at the base of the foundation. If possible, the downspout should be extended to direct rainwater away from the foundation. Damage to mortar and brick remains where ice formations had previously been noted (Pictures 1 and 2). Over time, these breaches in the building envelope can provide a source of water penetration into the building.

**New downspout with damaged bricks, note spout does not extend from the foundation**

4. Contact a masonry firm to make repairs to exterior brickwork to prevent water infiltration and damage to building materials.
5. Consider extending the downspout shown in Picture 1, away from the building.

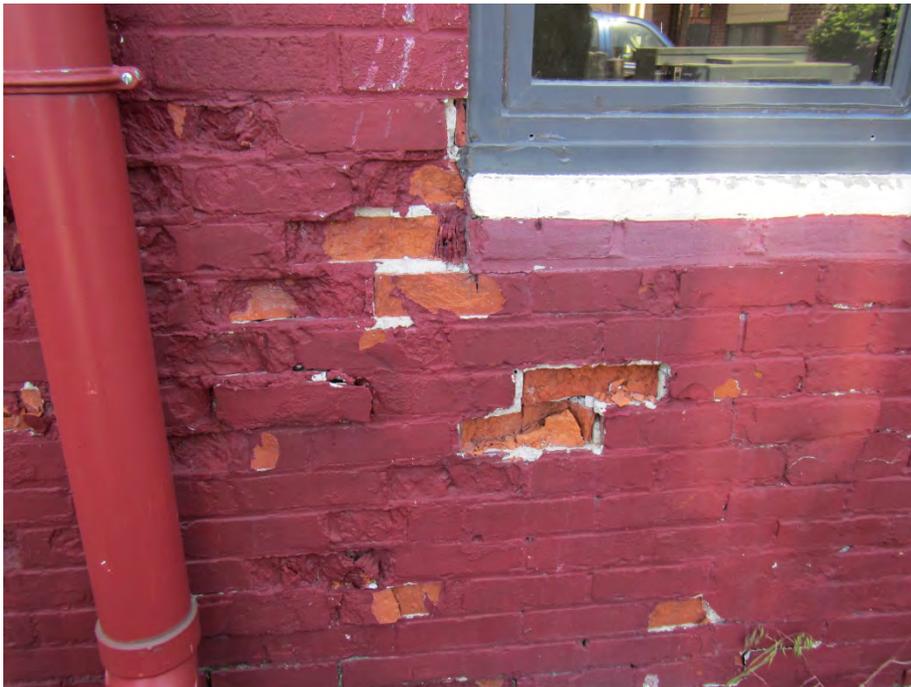
**Picture 2**

**Closer view of damaged brickwork**

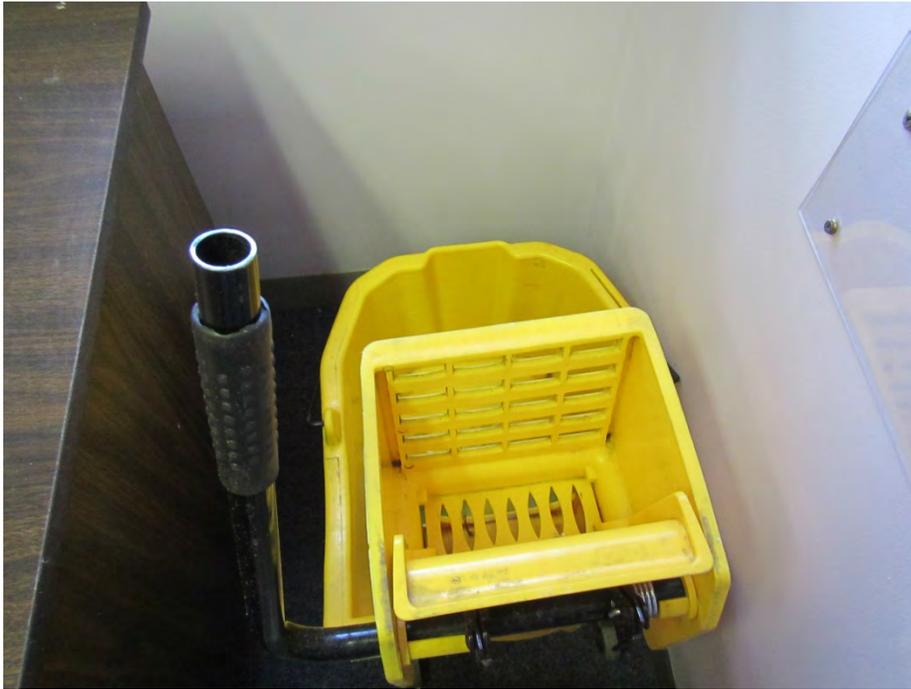
**Picture 3**

Additional water-damaged ceiling tiles and other signs of water intrusion were observed due to the current roof leaks (Pictures 3 and 4). It was reported by building maintenance staff and occupants that ceiling tiles had been changed recently but that more recent leaks have occurred leading to additional stained tiles. At the time of the visit, the building owner's

**Water collection bucket**

1. Conduct roof repair work as indicated.
2. Once roof damage has been fixed, replace any remaining water-damaged ceiling tiles and carpet squares.
3. Water-damaged building materials should be removed in a manner consistent with recommendations found in “Mold Remediation in Schools and Commercial Buildings” published by the US Environmental Protection Agency (US EPA, 2001).

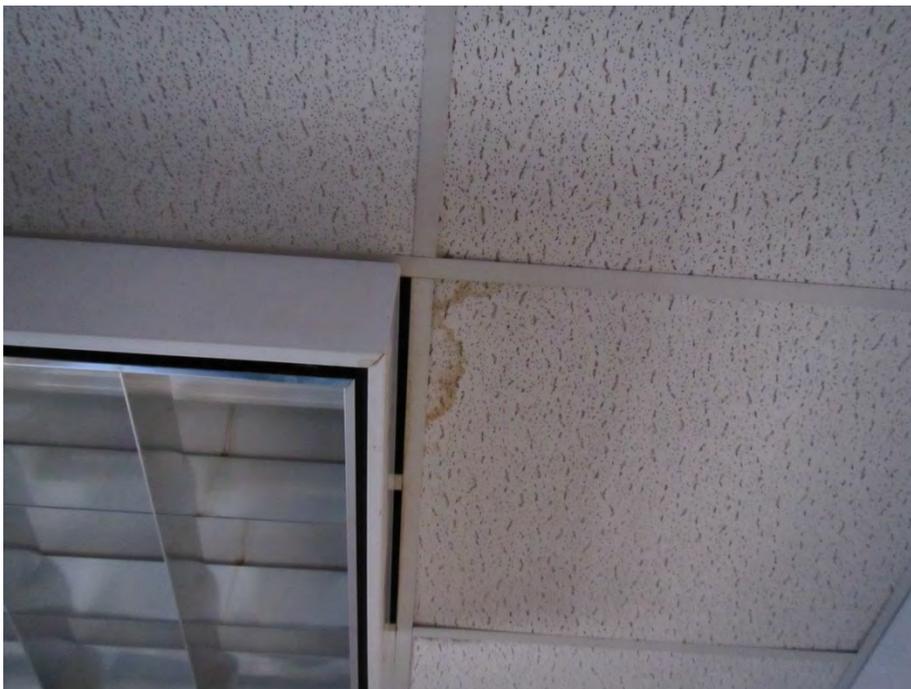
**Picture 4**

**Water-damaged ceiling tile**

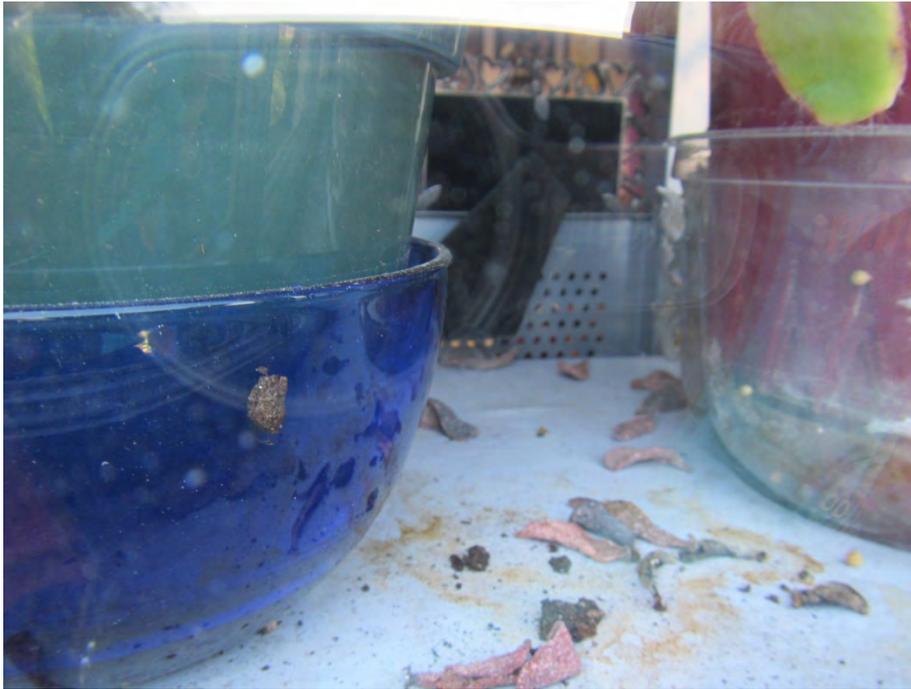
**Picture 5**

- Poorly maintained plants (Picture 5), including some without drip pans. Plants can be a source of pollen, mold and odors, particularly if they are not well maintained or chronically overwatered. Spills from plants can damage surfaces if they are not protected with drip pans.
- Water coolers and refrigerators in carpeted areas (Pictures 6 and 7). Spills or leaks from these appliances can moisten carpeting. When possible, they should be placed in non-carpeted areas or on waterproof mats.
- Stains/spills inside refrigerators/freezers (Pictures 8 and 9). Refrigerators should be cleaned regularly, including removal of spoiled food and cleaning of surfaces with an antimicrobial solution to prevent odors and microbial growth.

**Plant debris and water-stained surface**

6. Repair the downspout shown in Picture 10.
7. Trim plants away from the side of the building.
8. Properly maintain indoor plants.
9. Consider placing water dispensers and refrigerators in non-carpeted areas or on waterproof mats.

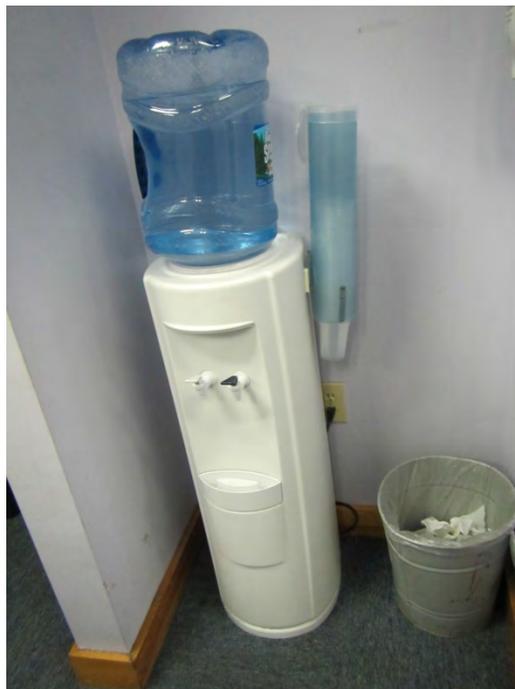
**Picture 6**

**Water cooler on carpet**

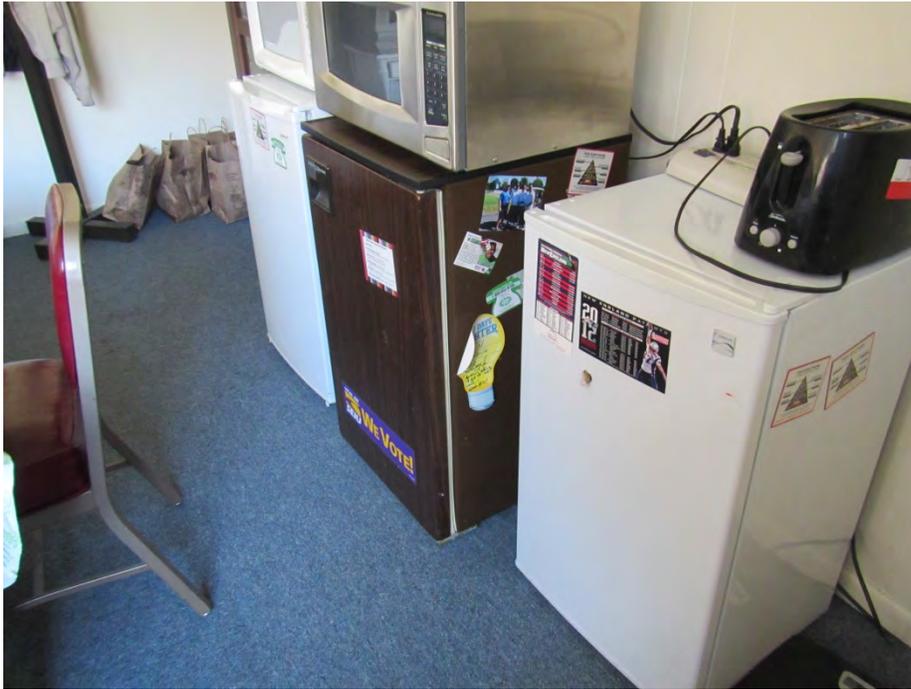
**Picture 7**

**Refrigerators on carpet**

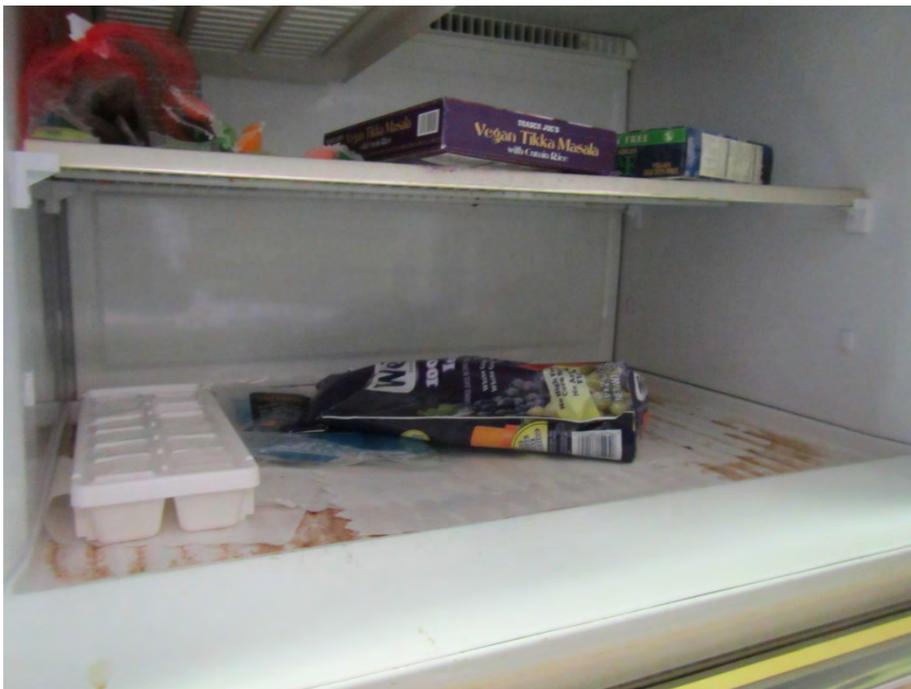
**Picture 8**

**Stains/spills inside freezer compartment**

10. Ensure that refrigerators are cleaned regularly.
11. Avoid the use of air freshener/scented products.
12. Use the principles of Integrated Pest Management (IPM), including removal of food, food debris and harborage for pests inside the building. Additional information on IPM can be

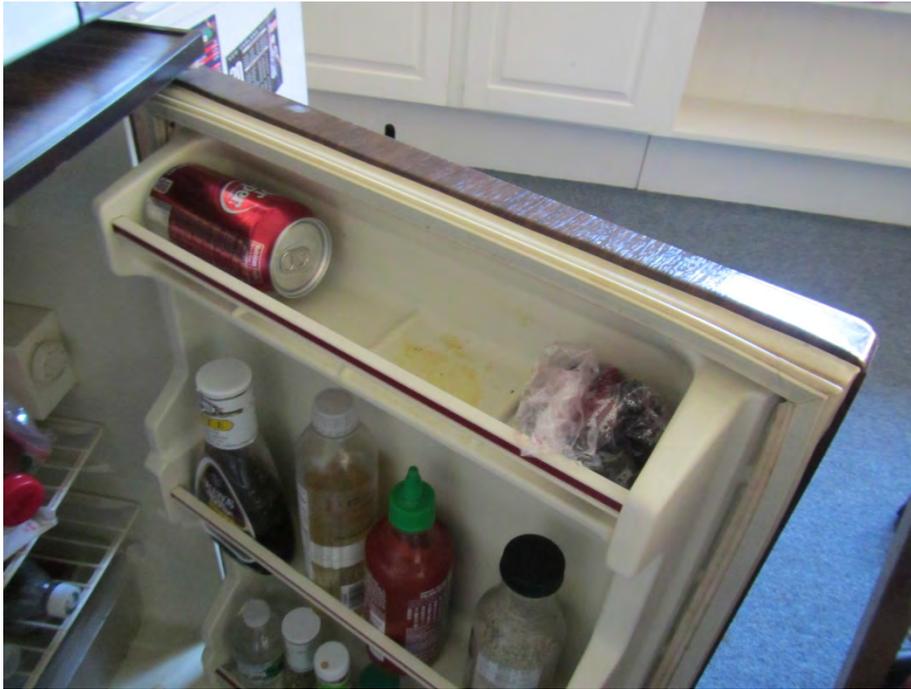
**Picture 9**

**Stains/spills inside refrigerator**

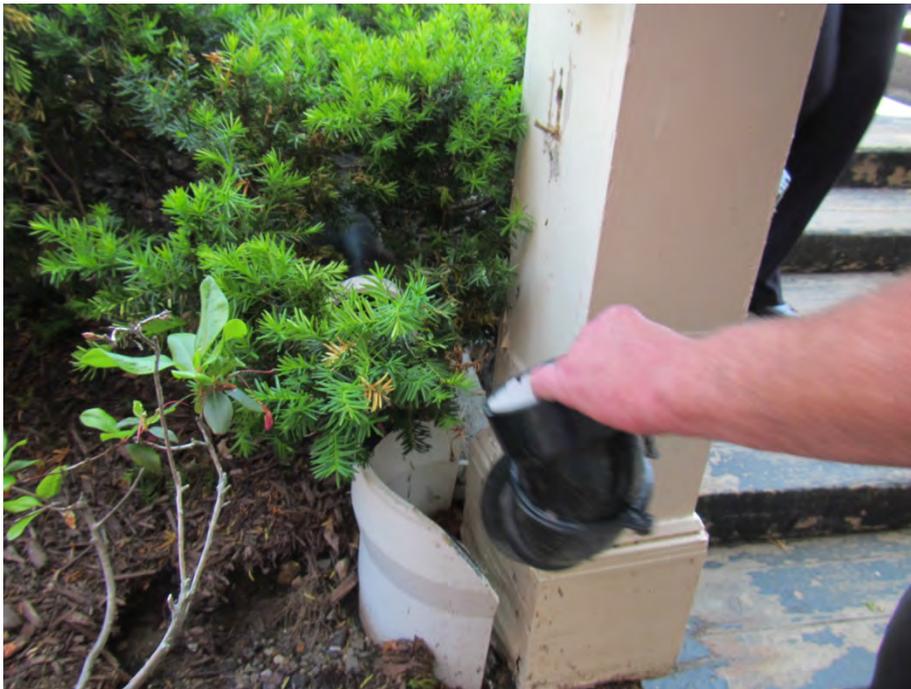
**Picture 10**

In addition, conditions of the building's exterior were noted that may result in further water infiltration and other problems. A downspout off the peaked roof at the front of the

building was broken/disconnected (Picture 10), which should be repaired to direct water away from the building. Plants were also observed to be in close proximity to the building foundation (Picture 10). Plants can hold moisture against the building and plant roots can eventually weaken building materials. These conditions can undermine the integrity of the building envelope and provide a means of water entry by capillary action into the building through exterior walls, foundation concrete and masonry (Lstiburek & Brennan, 2001). In addition, these breaches can provide a means of drafts and pest entry into the building.

**Broken downspout, also note plants in close proximity to building materials**
