INDOOR AIR QUALITY REASSESSMENT

**Abbot Public Library
235 Pleasant Street
Marblehead, Massachusetts 01945**

Prepared by:
Massachusetts Department of Public Health
Bureau of Environmental Health
Indoor Air Quality Program
August 2015

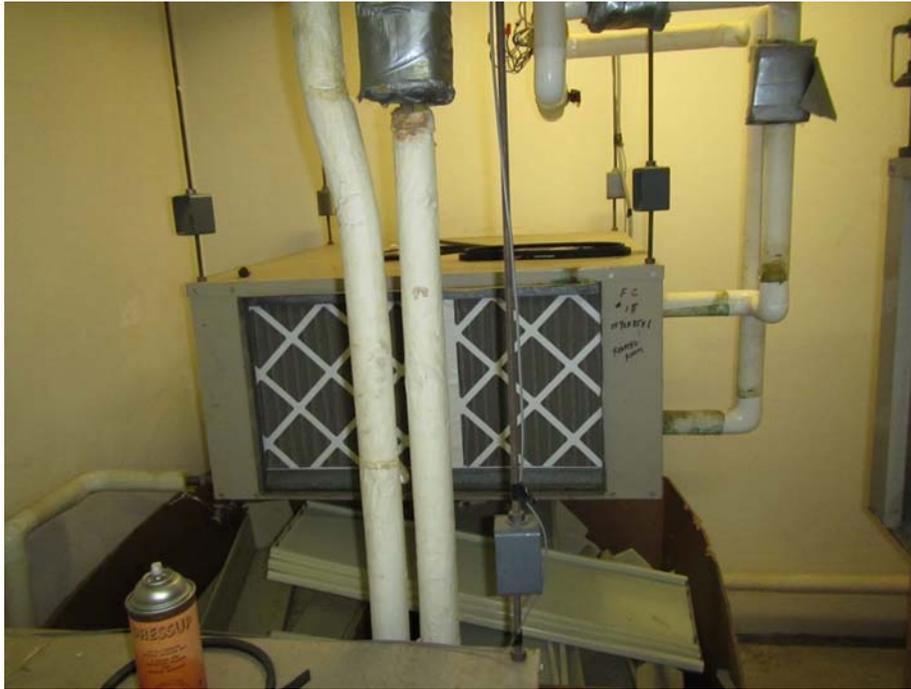
Picture 1

Air handling units (AHUs) in mechanical (“mixing”) room

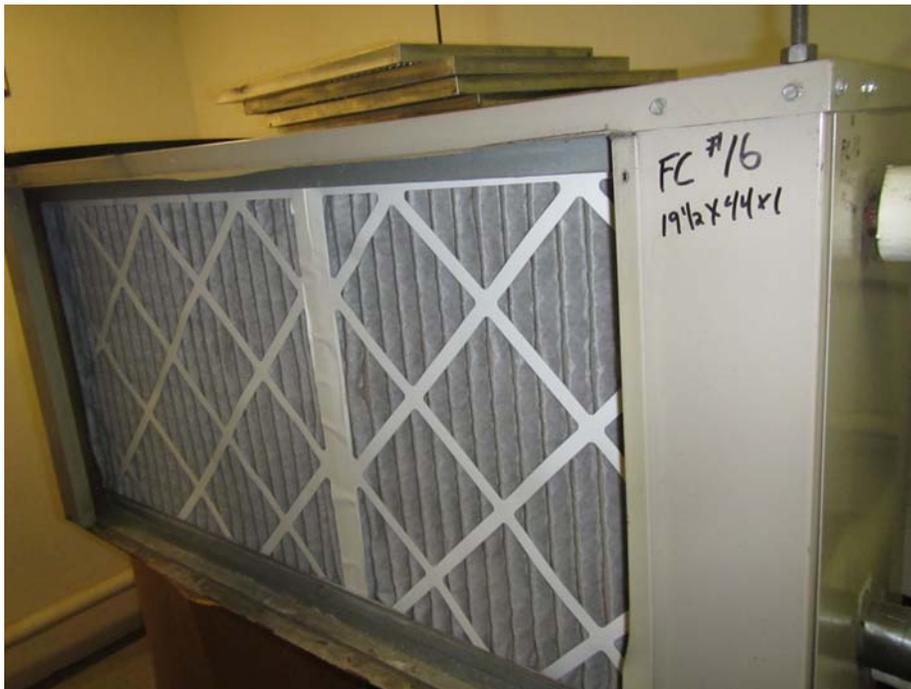
Picture 2

AHU showing pleated filter return area

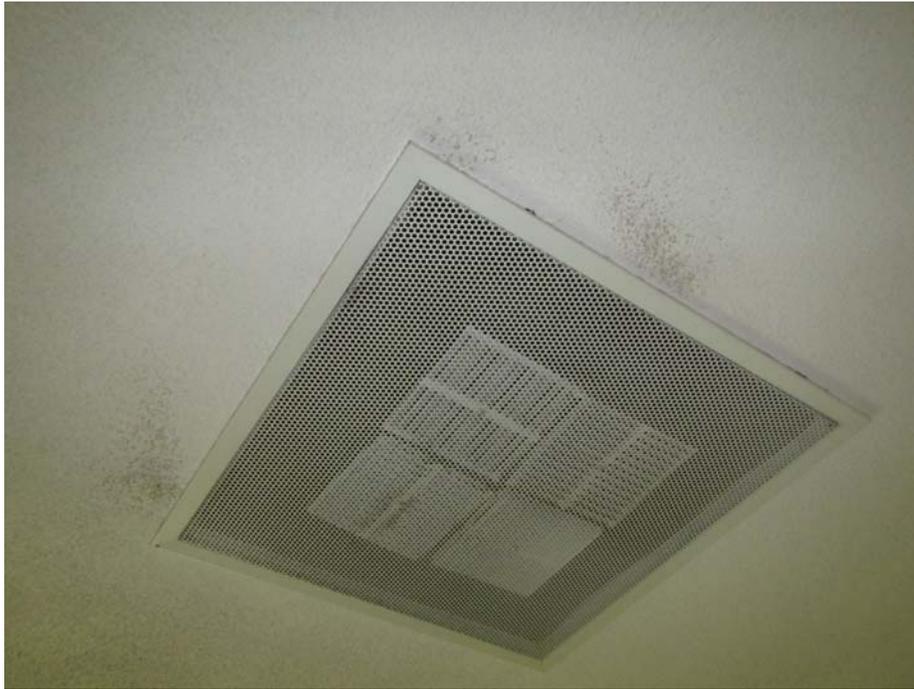
Picture 3

Ceiling mounted supply vent (note surrounding dust and debris)

17. Periodically clean supply diffusers and return grates to avoid re-aerosolizing particulate matter.
18. Replace any missing ceiling tiles to avoid the migration of moisture, odors and pollutants throughout the APL.

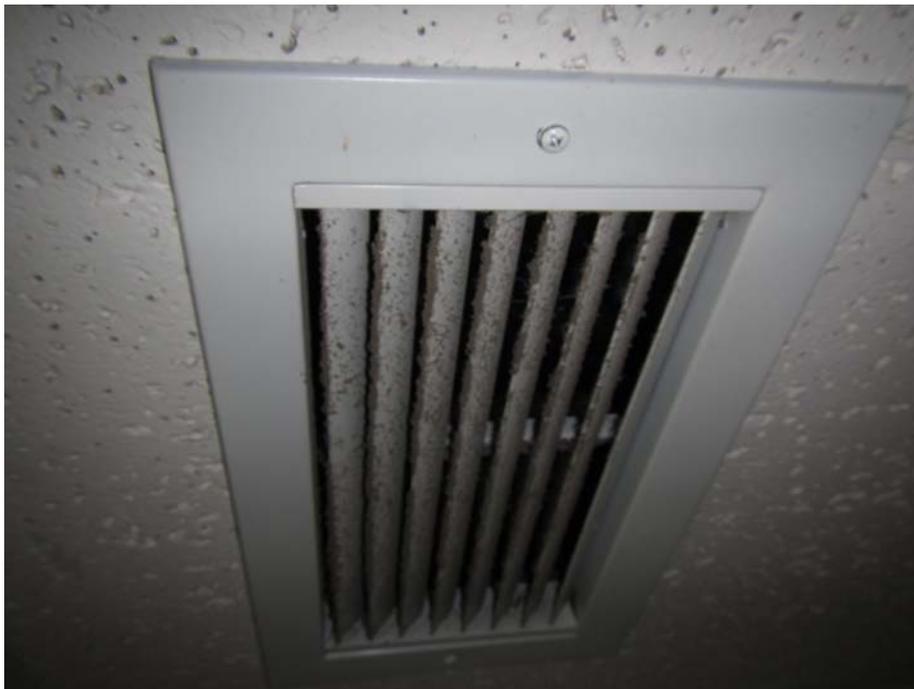
Picture 4

Ceiling-mounted return vent (note dust/debris)

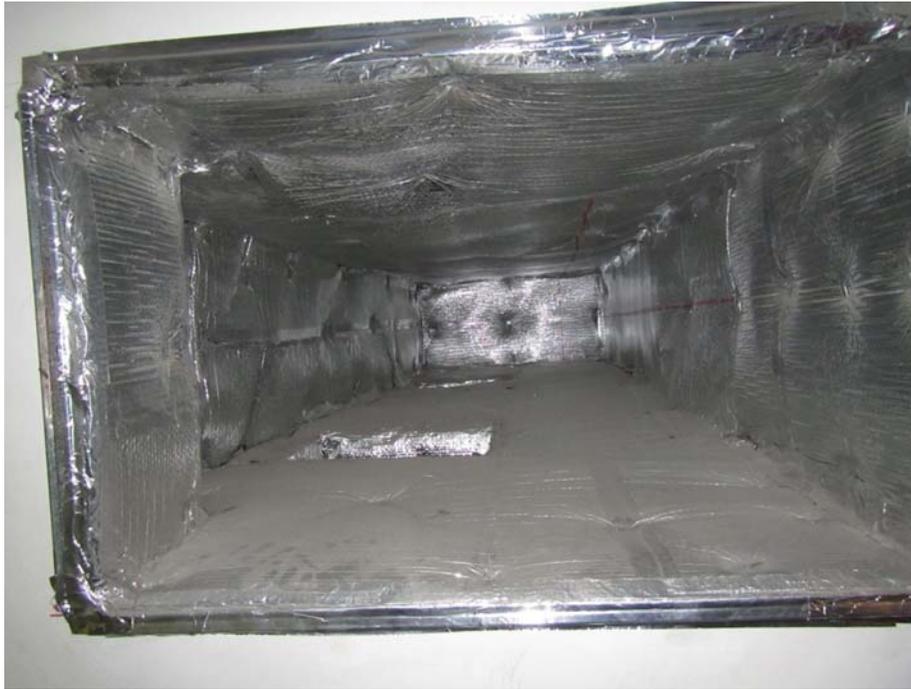
Picture 5

Main return duct to mixing room (note new lining)

- **Action:** Complete. It appears that the fibrous return duct was replaced with a new lining.
- **Remove stored items from HVAC mechanical room.**
- **Action:** Not completed. Many water-damaged boxes and both new and old dusty filters were observed stored in the mechanical room which is part of the HVAC ductwork.

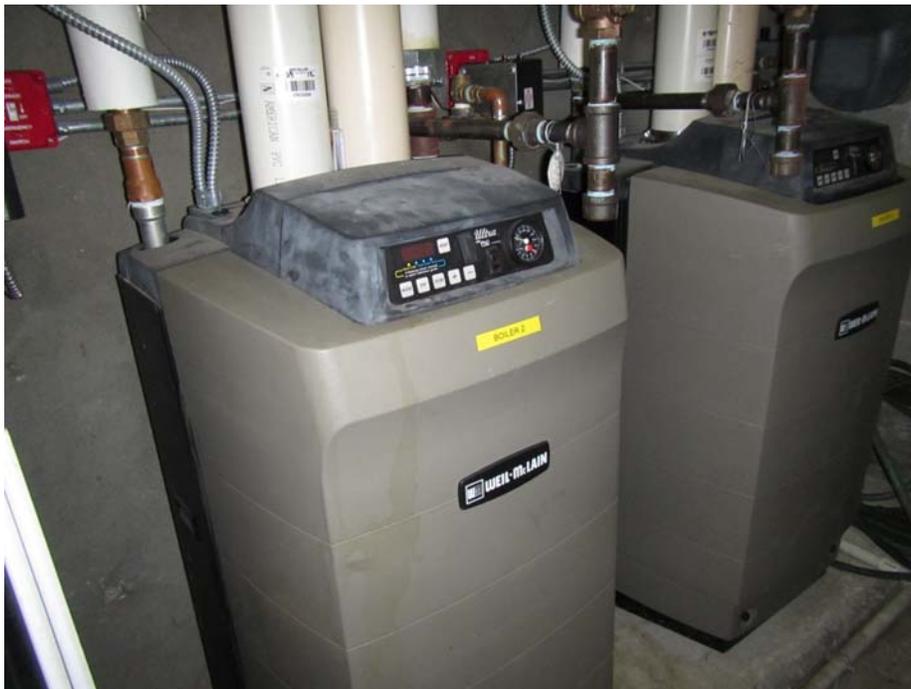
Picture 6

Gas-fired boilers in lower level

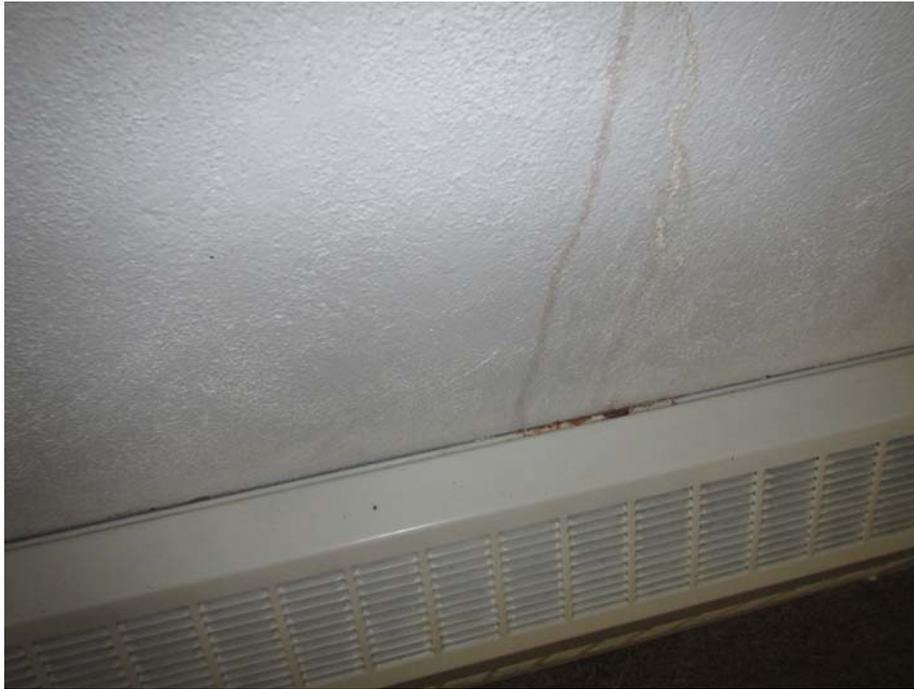
Picture 7

Hot water radiator in lower level (note cracked/water-damaged wall)

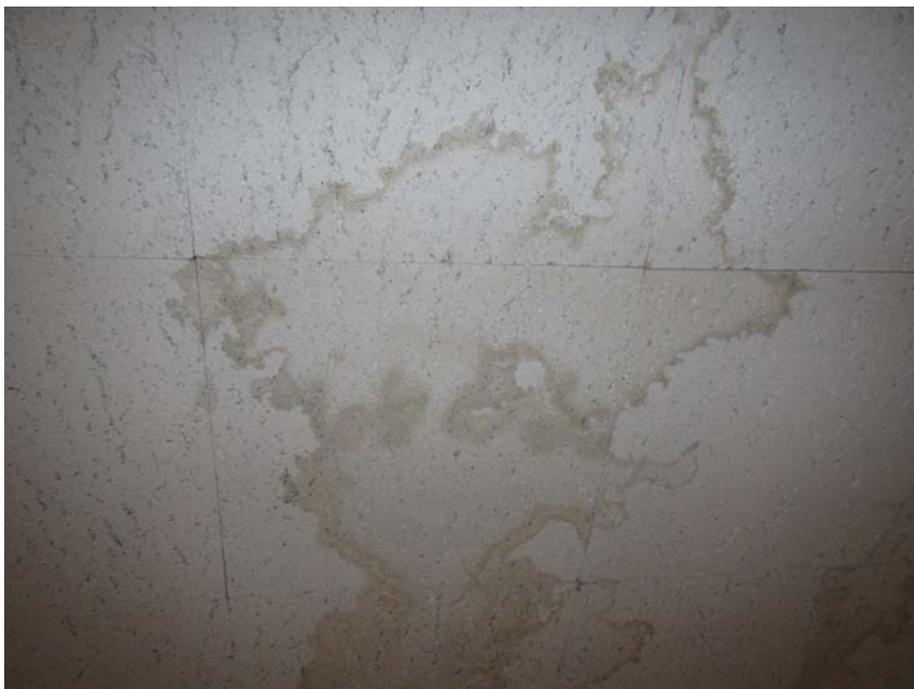
Picture 8

Water-damaged/mold-colonized ceiling tiles were seen throughout the APL (Pictures 8 and 9; Table 1). Water-damaged ceiling tiles indicate leaks from either the roof or plumbing system and can provide a source for mold growth. These tiles should be replaced after a water leak is discovered and repaired. The original building has older, interlocking ceiling tiles which may contain asbestos. Before disturbing these tiles, care should be taken to have them tested for asbestos and if they contain asbestos they must be professionally remediated/disposed of in a manner consistent with Massachusetts asbestos remediation laws (MDLI, 1993).

Water-damaged ceiling tiles

- b. Once the leaks causing water-damaged ceiling tiles are fixed, replace the ceiling tiles. Before disturbing the interlocking ceiling tiles of the original building, care should be taken to have them tested and professionally remediated/disposed of should they test positive for asbestos.

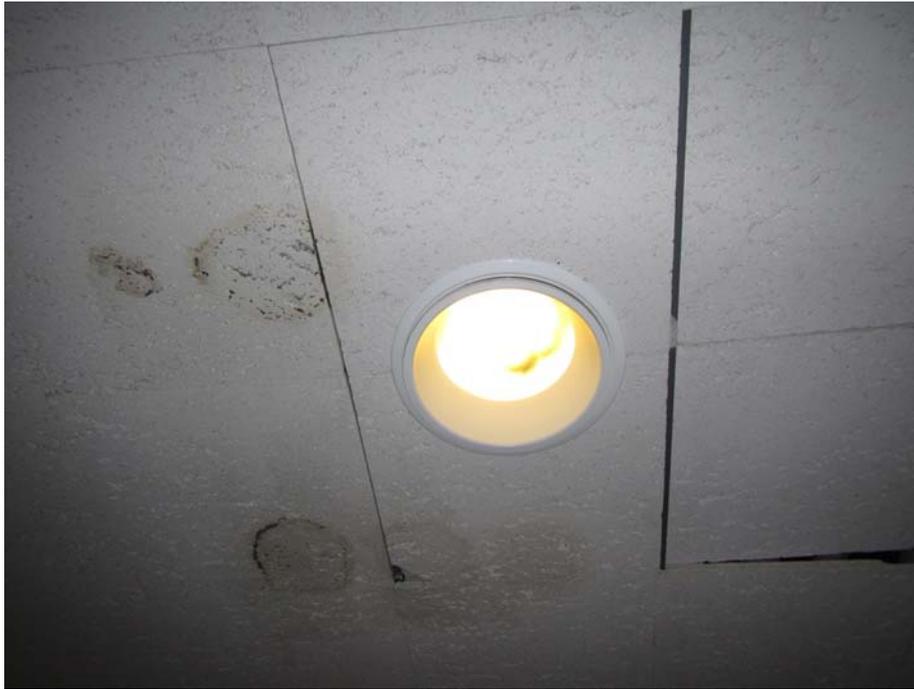
Picture 9

Water-damaged/mold-colonized ceiling tiles

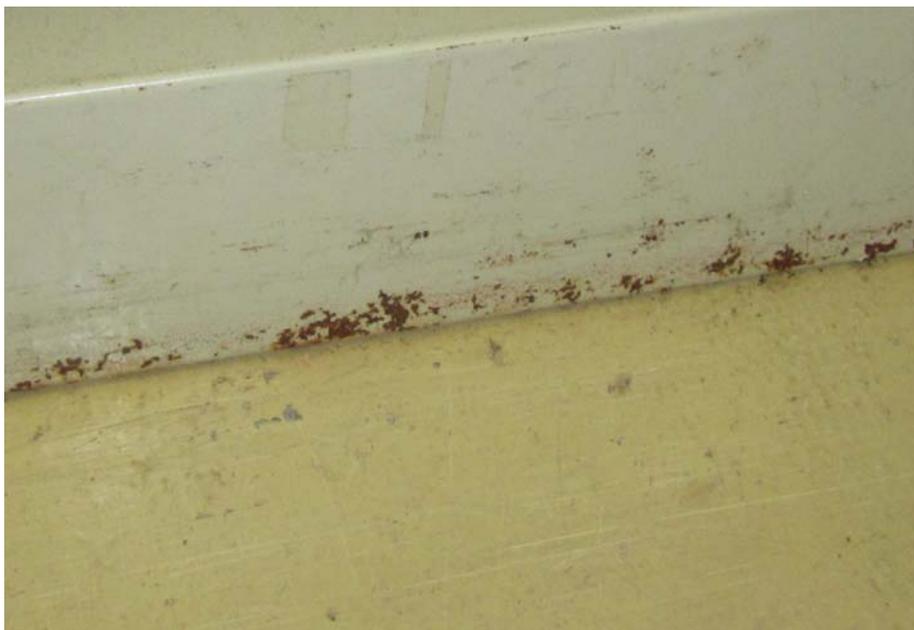
Picture 10

remove their children from the room due to their children's apparent respiratory reactions to the conditions in this area. BEH/IAQ staff detected the musty odor and noted metal shelving in contact with the uninsulated slab floor. The temperature of the shelving likely drops below the dew point, which results in the formation of condensation. The metal shelving also showed signs of rusting (Picture 10), indicating prolonged moisture exposure. Condensation can result in chronic moistening of the area rug and of books on the lower levels of the shelving leading to microbial colonization.

Metal shelving showing signs of rust

7. Remove area rug in Children's room and explore alternative replacement flooring such as nonporous rubber or foam mats.
 8. Until further condensation/moisture control strategies are implemented, books in the lower levels of the library should not be kept on the bottom row of the metal shelving.

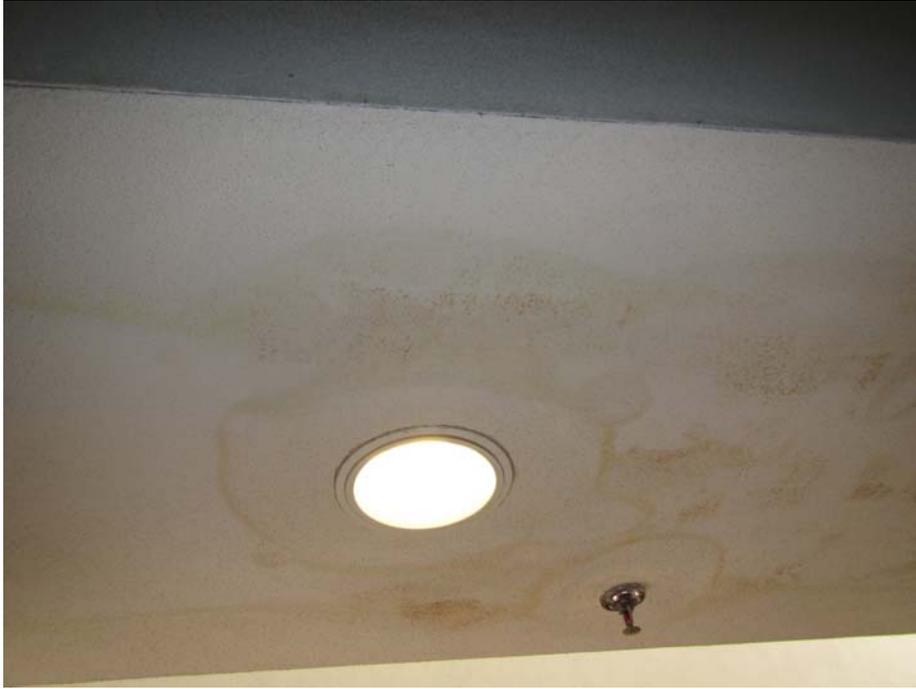
Picture 11

The joining of the original building with the 1991 addition may be another source of water infiltration at the APL. A large portion of the water-damaged ceiling appeared to be along

the intersection of the addition (Pictures 11 to 12). The joining of different roof pitches with different roofing materials and flashing is a common source for leaks in buildings.

Water-damaged ceiling

- a. The intersection of the original building and the 1991 addition should be examined by a roofing contractor to ensure that it is not contributing to water infiltration.

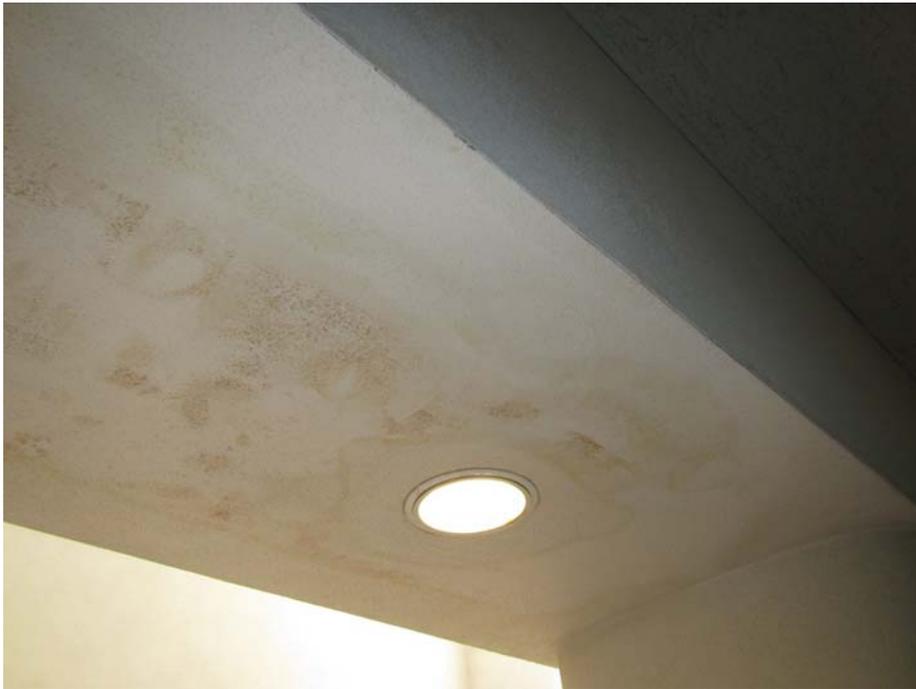
Picture 12

Water-damaged ceiling

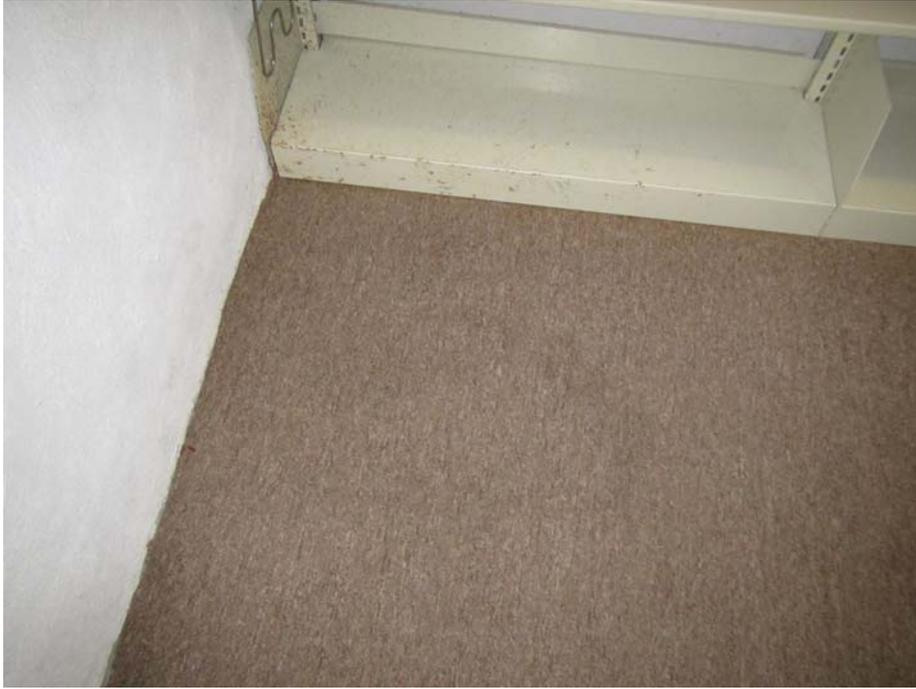
Picture 13

It was reported that the APL is subject to both high groundwater and storm water events. Both of which have impacted the lower level of the APL in the past. Of note are reports of carpeting in the lower level being saturated after storm events (Picture 13). Ms. Rogers reported that during these rain events, storm water runs down the sloped driveway of the APL and has flooded the lower levels in the past (Picture 14). BEH staff observed a drain at the bottom of this driveway. Drains must be kept free of sediment and debris for them to function properly. As mentioned in the 2011 report, it is not recommended to have carpeting in below grade spaces due to condensation and chronic moisture issues. Any carpeting that was not properly dried within 48 hours of becoming saturated should be discarded due to the likelihood that mold has colonized it. Nonporous, rubber or foam mats should be considered for the Children's area in lieu of carpeting.

Water-damaged carpeting in lower level

5. Consider connecting the return ductwork directly to the AHU units rather than using the mixing room.
 6. Remove water-damaged carpeting in lower level and replace with nonporous flooring (e.g. tiles).

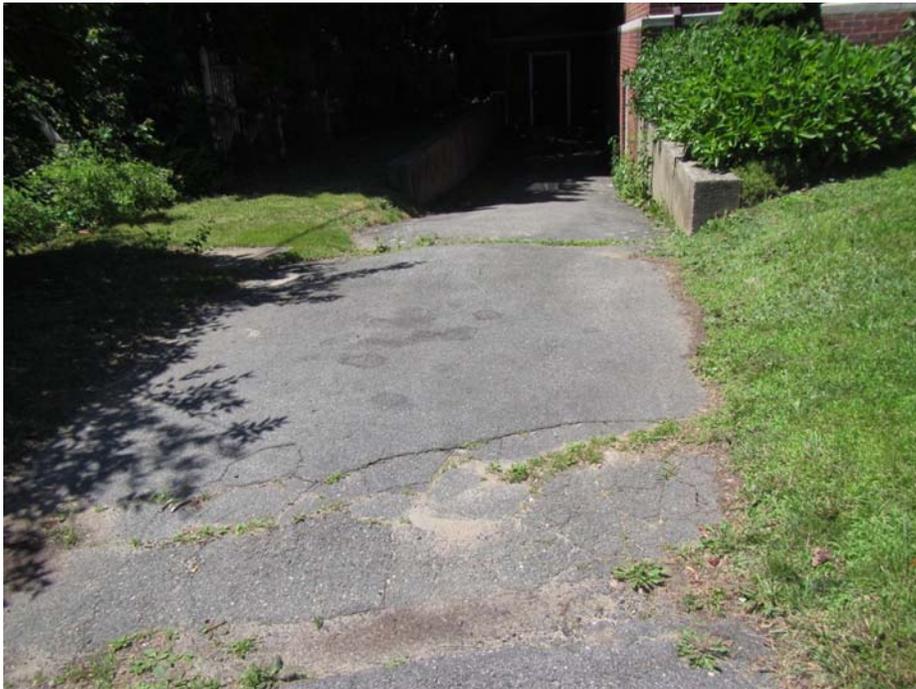
Picture 14

Driveway off Pleasant Street, sloped toward APL

- e. Remove debris/plant growth in gutter and downspout system to allow water to be directed away from the foundation.
 - f. Regularly clean debris/sediment from storm drains and consider installing a berm at the entrance of the driveway to prevent heavy storm water flow from overflowing into the APL.

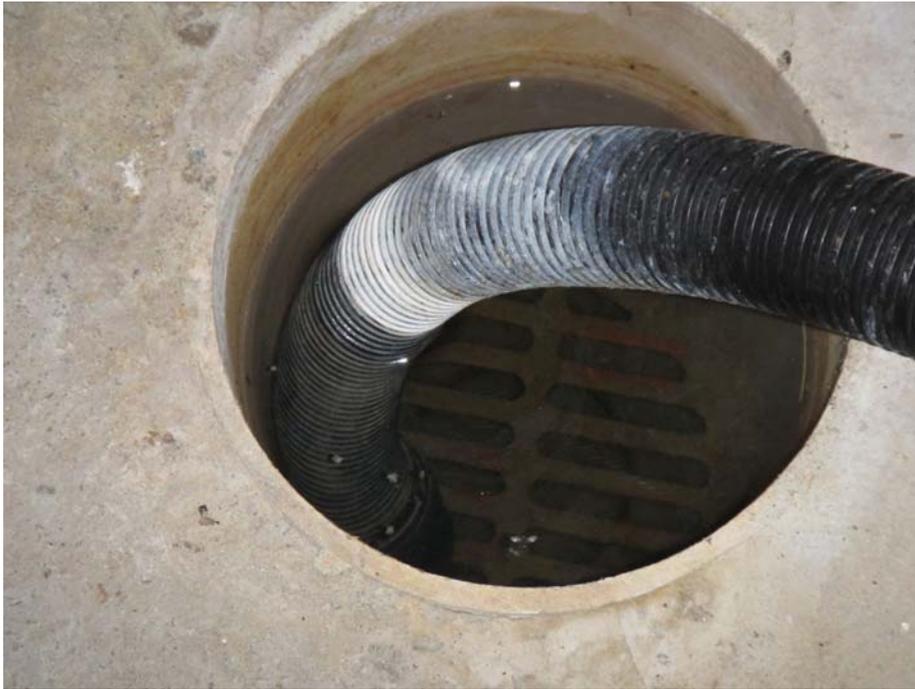
Picture 15

A drain in the boiler room was noted to have a high level of standing water. There was a wet/dry vacuum cleaner hose in the drain hole (Picture 15). It appears this wet/dry vacuum is routinely used to empty the drain to avoid overflows. High groundwater/moist basements can damage any porous materials stored on the floor as well as add to the humidity problem at the APL. Although the Meeting room had a sump pump to control some of the water issues, the boiler room area did not appear to have a sump pump installed.

Hose in drain in boiler room, note high water level

- d. Repair the drains in the boiler room and/or install a sump pump to remove accumulated water.

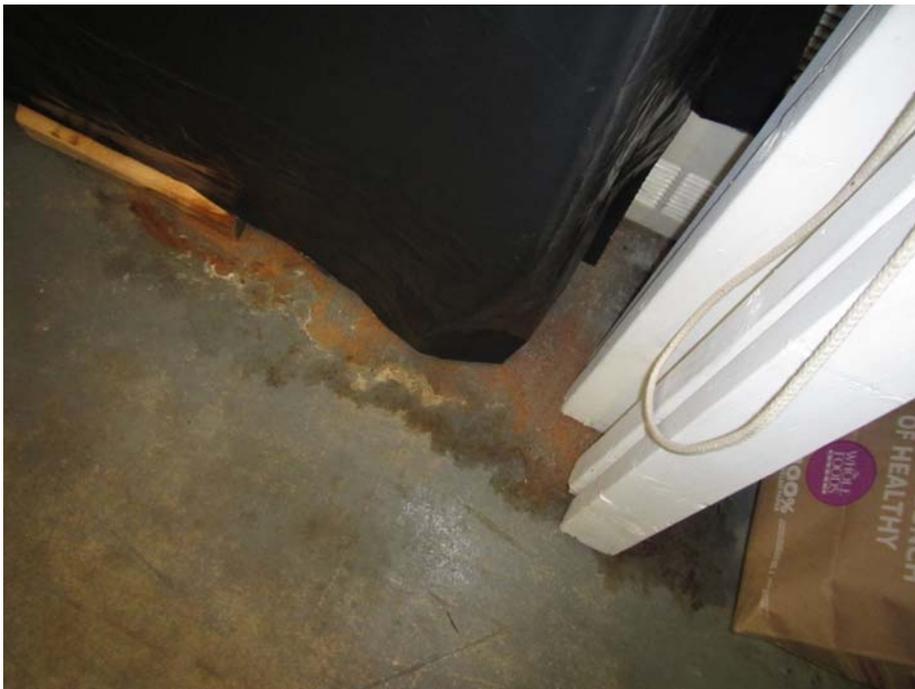
Picture 16

The APL utilizes a lower level storage room to sort/store books and other porous materials. This area is subject to chronic flooding and high humidity (Picture 16). Storing porous materials in unconditioned areas can result in damage to the materials. It was reported by

Book storage/sorting room floor with standing water, staining and porous items

9. Use dehumidifiers or supplemental AC units until the HVAC system has been repaired to reduce humidity to desired levels.
10. Use an alternative location on the upper levels to store and sort books to prevent water damage to these materials.

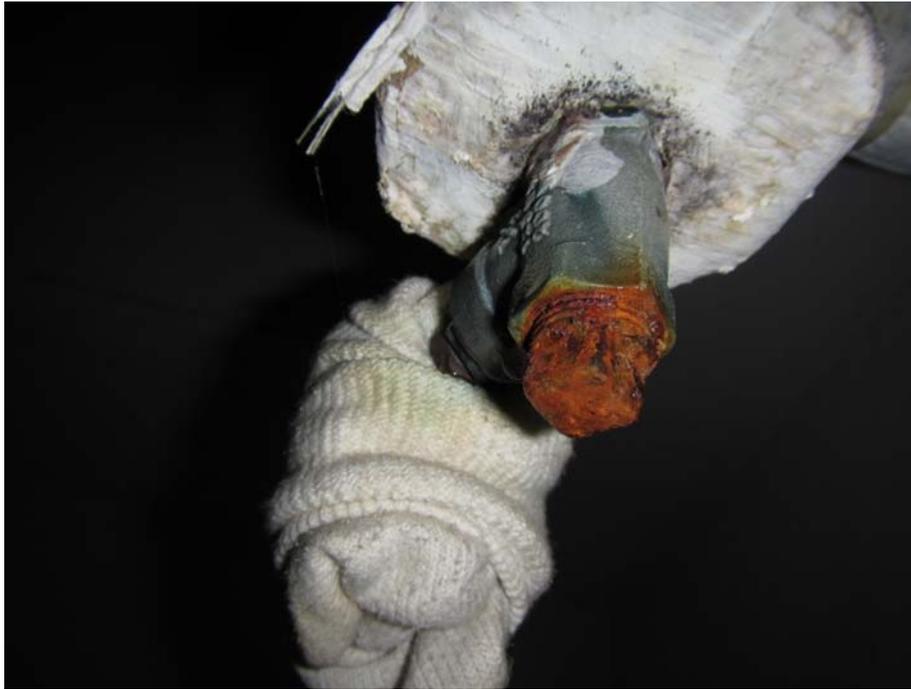
Picture 17

The mixing room continues to have active condensation on uninsulated sections of the cooling lines (Picture 17). Insulation repairs should be made to reduce condensation after confirming that there is no leak in the pipe fitting. As mentioned in the 2011 report, there are breaches from the mixing room to the attic; it is very important to seal any breaches that allow warm, moist air to enter the mixing room and AHUs. Microbial growth, dust and irritants on stored items (boxes, old filters etc.) in the mixing room also have the potential to be distributed throughout the APL (Picture 18). Keeping the mixing room clean, dry and free of any stored porous items is vital to the IAQ of the building. One solution would be to directly connect the return ductwork to the AHUs.

Water actively dripping from uninsulated cooling line section

3. Remove water-damaged boxes, old filters and new filters from the mechanical room (mixing room). Inspect cooling pipes for leaks and repair insulation to prevent further condensation/leaks. Keep this room clean, it is vital for good IAQ in the building.

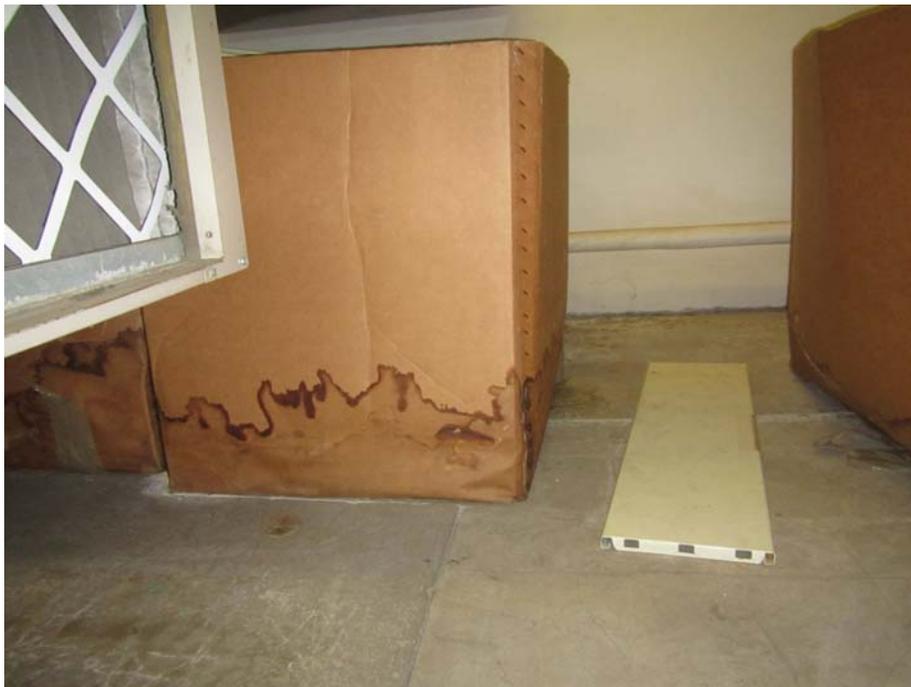
Picture 18

Water-damaged porous items inside the mixing room

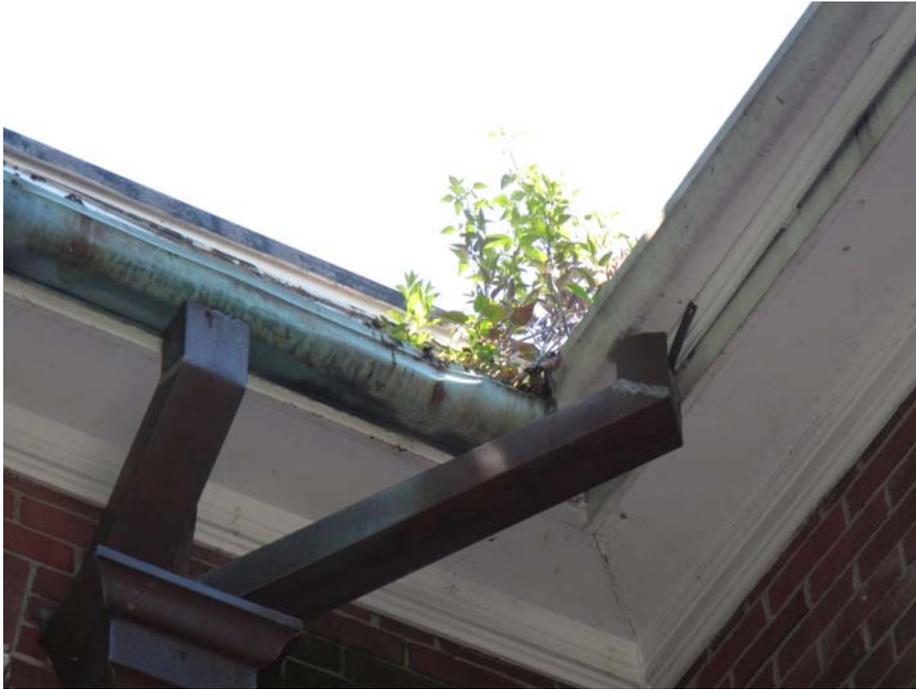
Picture 19

Although a number of improvements to the gutter/downspout system were made since the 2011 visit, a gutter/downspout at the front of the building appeared to be clogged with debris and plant growth (Picture 19). This equipment should be monitored on a regular basis to ensure proper drainage away from the building.

Debris-filled gutter with plant growth

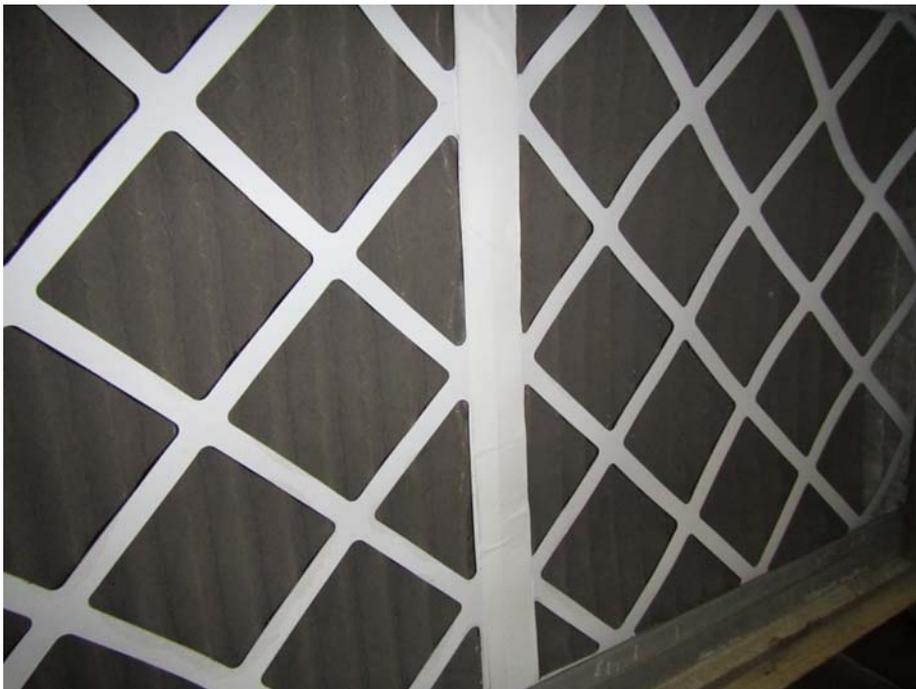
Picture 20

BEH staff noted AHU filters in the mechanical room were occluded with dust and debris (Picture 20). In addition, both used, soiled filters and new filters were stored uncovered in the mechanical room (Picture 21). Since this room serves as the mixing room, it is essentially part of the ductwork of the HVAC system. Any dirty, dusty, water-damaged stored items may further

Air filter in AHU occluded with dust

11. Remove vegetation within 5 feet of the building.
12. Refrain from leaving windows and doors open during operation of AC units.
13. Change the filters for the AHU units quarterly. Ensure that the filters have the recommended minimum 40% dust spot efficiency accounting for manufacturer limitations with pressure drop. Bag and dispose of the old filters immediately after installing the new filters. Store new filters covered in a clean, dry location.

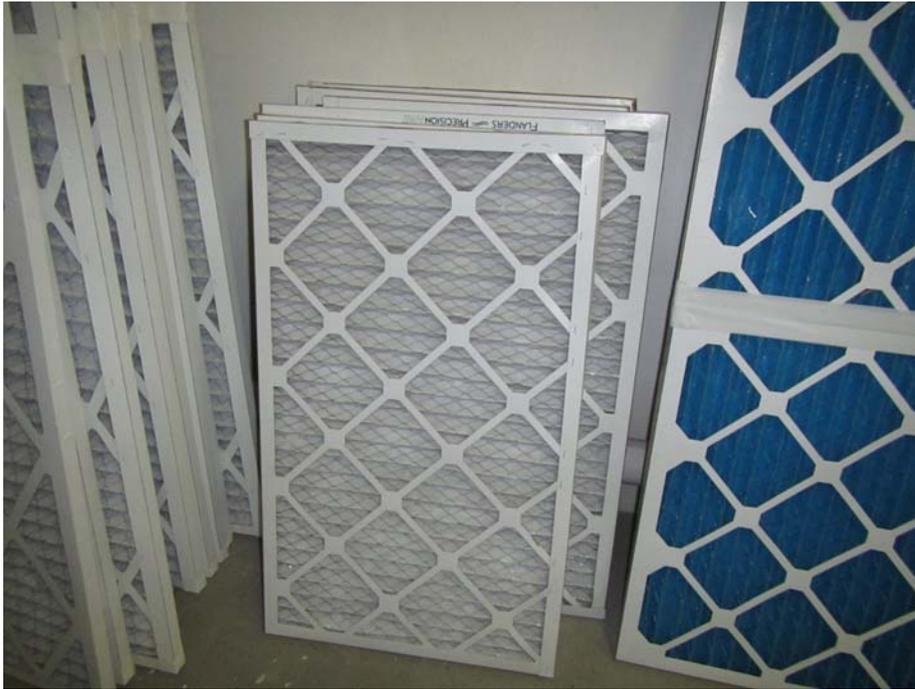
Picture 21

increase dust and debris to the HVAC system. In addition, the new filters that are left in this room may become contaminated with dust and debris before they are even installed. Again, this room should not be used for storage and should be thoroughly cleaned on a regular basis. Old filters should be discarded immediately and new filters should be kept sealed in a clean location. The filters in these AHUs should be monitored and changed at least quarterly to help reduce the dust and particulate matter found in the APL.

Clean filters kept unprotected in dusty mixing room may also be subject to water damage

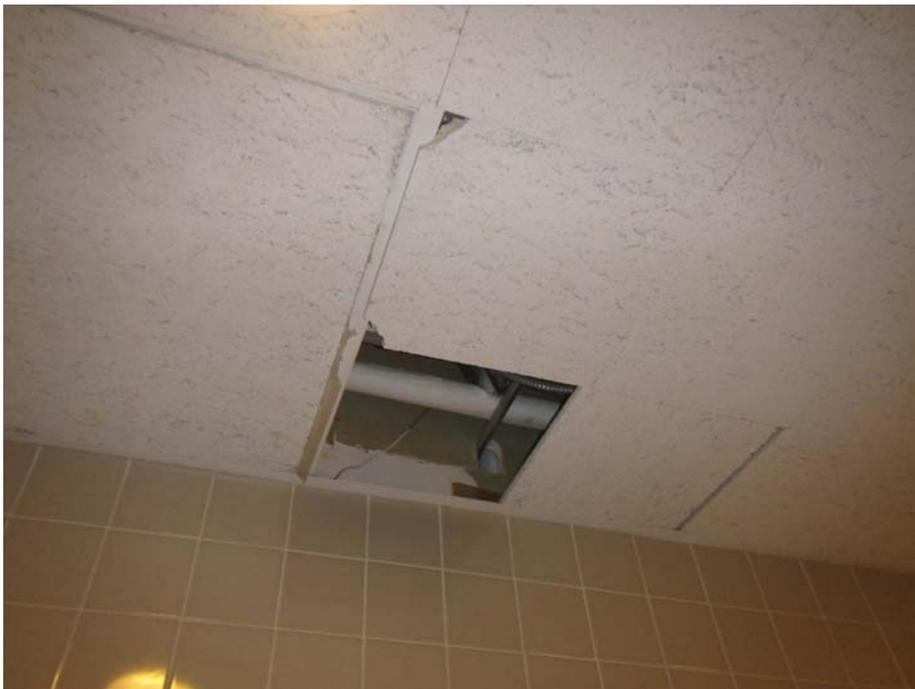
Picture 22

A number of areas had missing ceiling tiles (Picture 22), including the women's room. These tiles should be replaced to avoid the migration of dust, moisture and odors from the plenum into occupied spaces.

Missing ceiling tile in restroom
